# FINAL Preliminary Assessment Report Tempe Readiness Center City of Tempe, Arizona

Perfluorooctanesulfonic Acid (PFOS) and Perfluorooctanoic  
Acid (PFOA) Impacted Sites  
ARNG Installations, Nationwide

September 2020

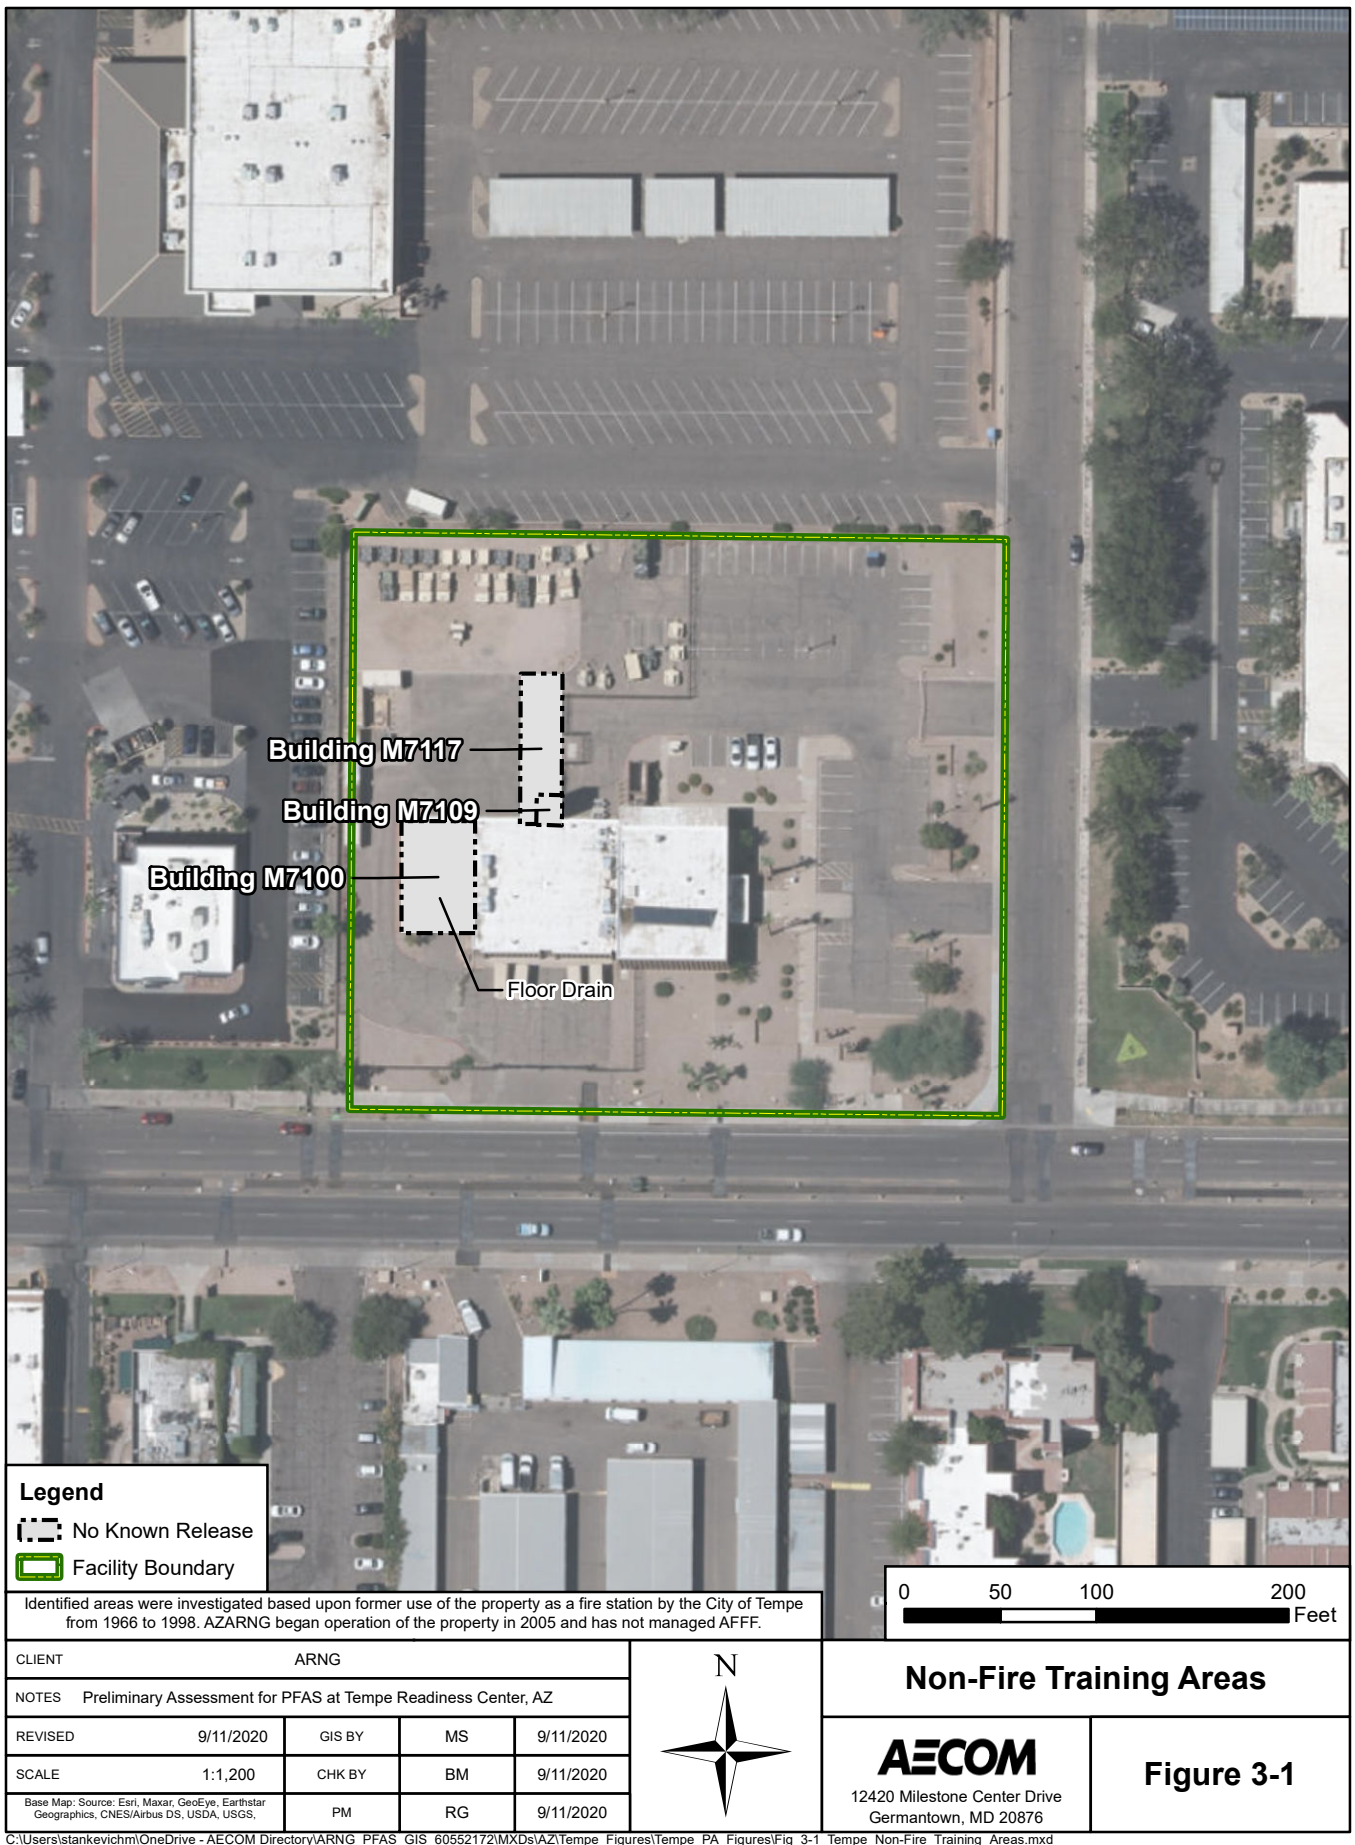
Non-FTAs were investigated as part of the PA. Based on the city of Tempe Fire Department's use of Fire Station #1 from 1966 to 1998, the Maintenance Bay and The Fire Tower and Concrete Wash Pad were investigated during this PA. AZARNG has not managed AFFF at the site. However, it is possible that the city of Tempe did during their operation of Fire Station #1 from 1966 to 1998. A description of each non-FTA is presented below, and the non-FTAs are shown on **Figure 3-1**, with photographs appearing in **Appendix C**.

The Maintenance Bay is located at the western most portion of the Tempe RC Building M7100. The geographical coordinates are 33°25'20.9"N; 111°55'26.1"W. It is suspected that firetrucks belonging to the city of Tempe Fire Station #1 would have been stored in this area. A floor drain is located approximately 15 feet north of the bay entrance; however, the outfall location is unknown. It can be assumed that any material released during the city of Tempe's tenure at the site would have been transported offsite via the sanitary sewer or storm sewer before discharging. It is possible AFFF had been stored in the former truck bay during its use by the city of Tempe Fire Department; however, prior use or storage of AFFF at the Tempe RC could not be verified.

The Fire Tower Building M7109) is located on the side of the Tempe RC Building M7100. The geographical coordinates are 33°25'21.2"N; 111°55'25.4"W. The Concrete Drainage Pad (M7117) is located north of the fire tower and measures approximately 5 feet wide by 75 feet long. A storm drain is located at the north end of the Concrete Drainage Pad. The outfall location for the storm drain was not identified during the PA site visit. The geographical coordinates of the Concrete Drainage Pad are 33°25'21.4"N; 111°55'25.6"W.

The Concrete Drainage Pad is believed to have been used by the city of Tempe Fire Department for washing firetrucks. Additionally, this area also contains a fire hose lift used to drain fluids from hoses prior to storage. It is unknown if any hoses with AFFF were rinsed and drained in this area during the city of Tempe's tenure at the site. Historical information regarding the city of Tempe's use of the property was not available. Any material released would have been transported to the storm sewer system and was not discharged into open drainage onsite. AZARNG has not managed AFFF at the site..

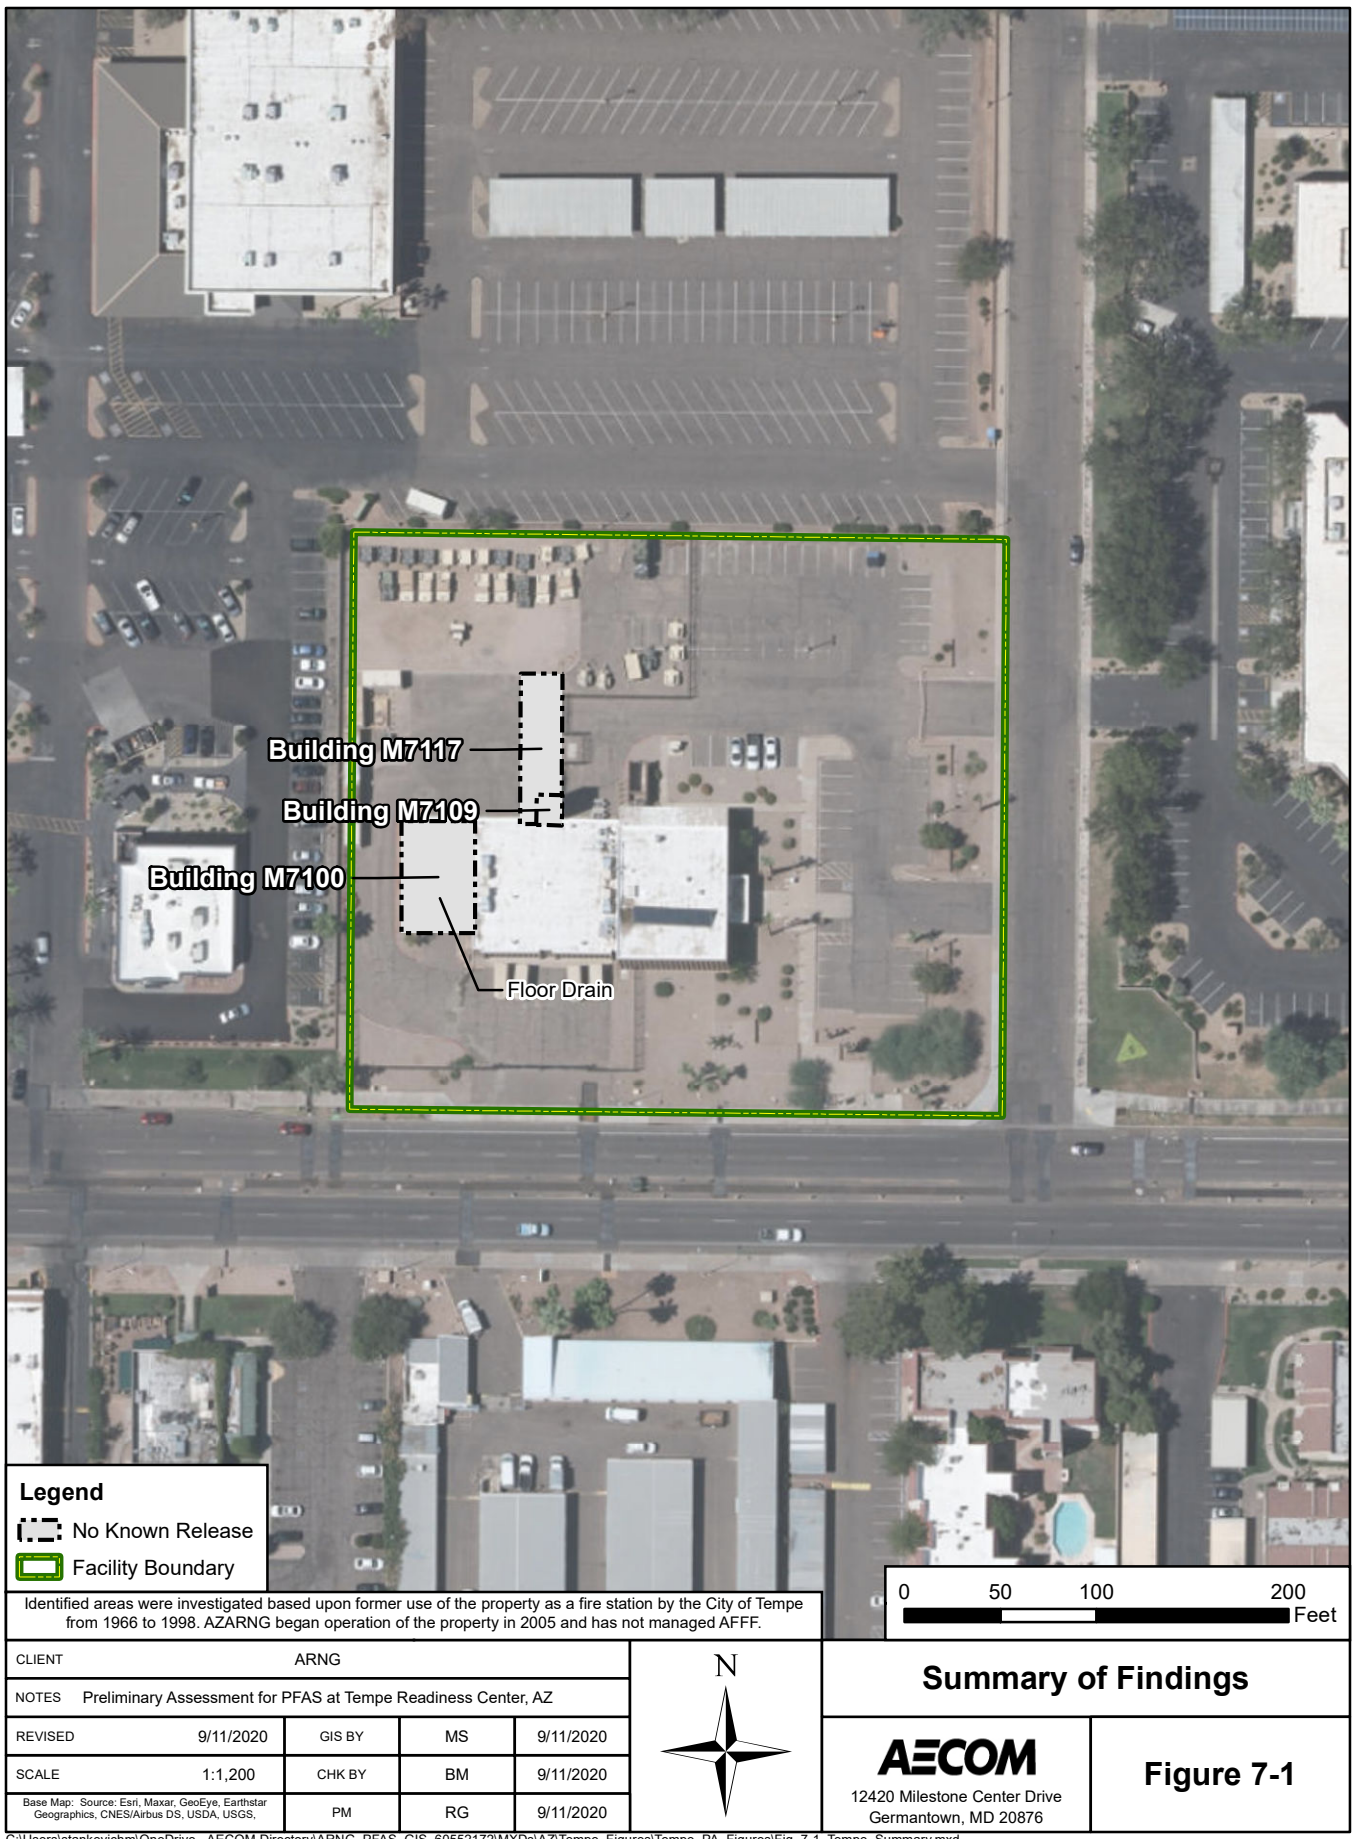
<b>Summary of Findings</b>	
 12420 Milestone Center Drive Germantown, MD 20876	<b>Figure 7-1</b>

No PFAS releases relating to current or historical activities at Tempe RC were identified during this PA. However, the city of Tempe operated a fire station at the property prior to AZARNG ownership. No information was available regarding the operational history of the site prior to 2005. These findings are depicted on **Figure 7-1**. **Table 7-1** summarizes these areas and presents the rationale why they are not considered to be viable sources of PFAS:

Based upon available information, no AZARNG-related AOIs were identified during the PA. No known or suspected releases of PFAS have been identified at Tempe RC, as AZARNG did not manage AFFF at the Tempe RC. Additionally, there is no evidence of offsite releases of PFAS potentially impacting the Tempe RC. Therefore, no further action is warranted under CERCLA.

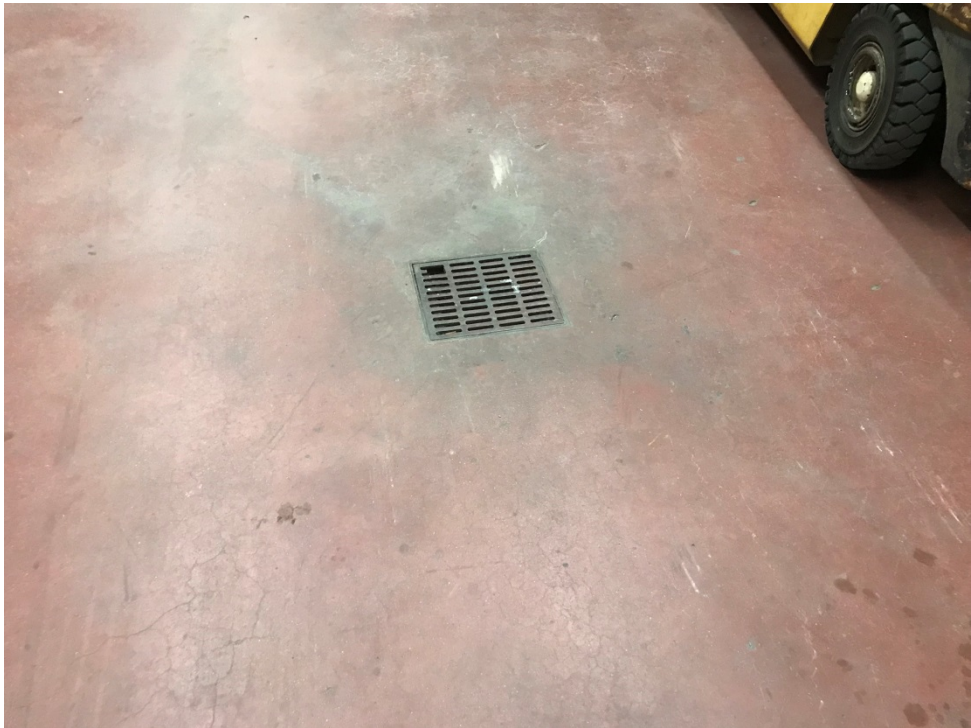
Army National Guard, Preliminary Assessment for PFAS		Tempe Readiness Center	Tempe, Arizona
<b>Photograph No. 1</b>

<b>Description:</b>  Looking north. Floor drain in the Tempe Readiness Center (building M7100) Maintenance Bay.  Photo Date: 11/27/18			
<b>Photograph No. 2</b>

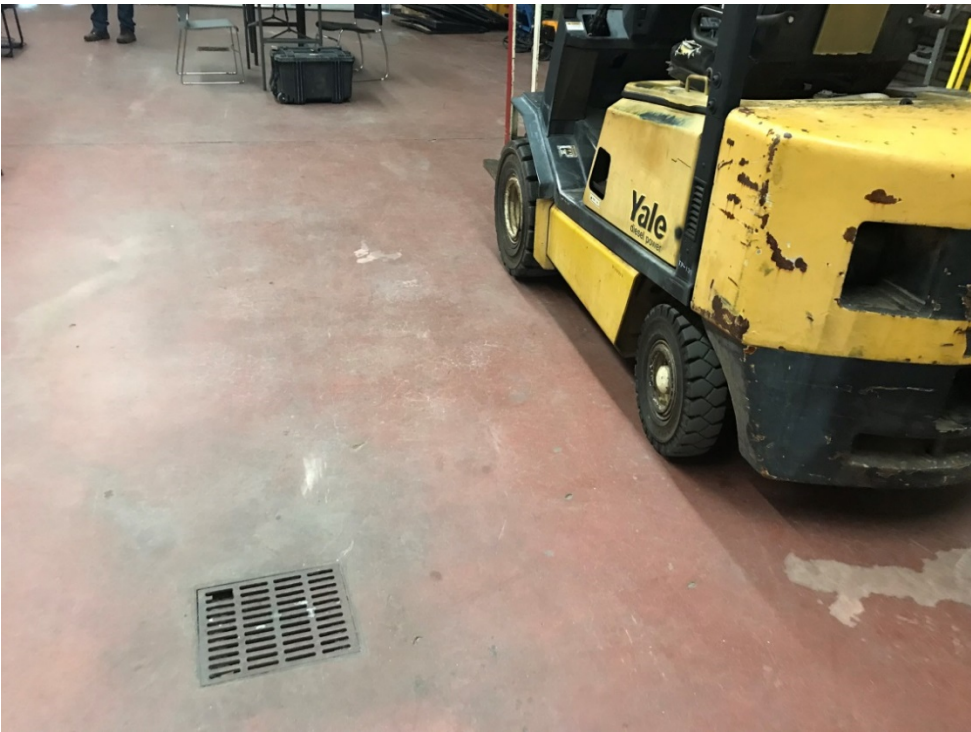
<b>Description:</b>  Looking north. Floor drain in the Tempe Readiness Center (building M7100) Maintenance Bay.  Photo Date: 11/27/18

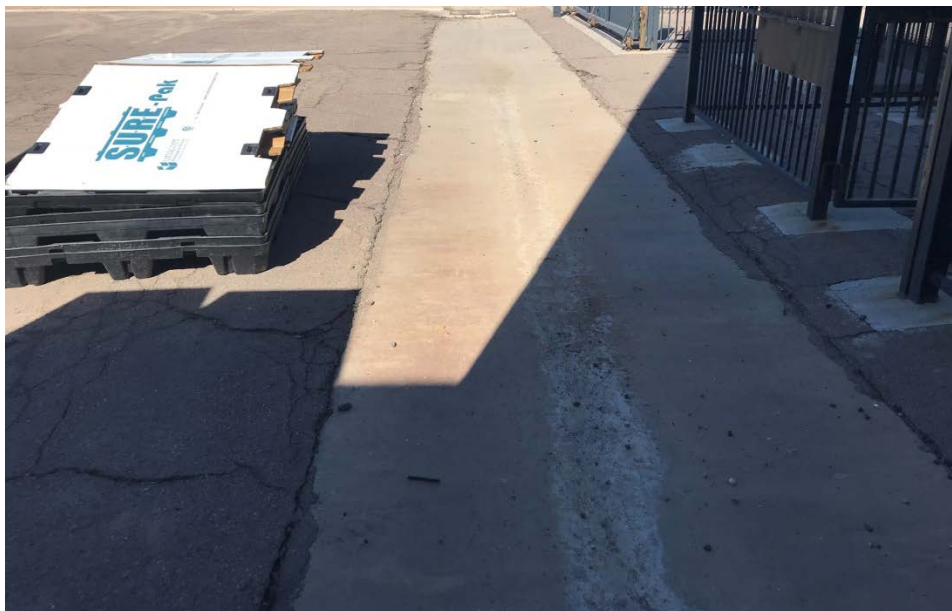
Looking north. Concrete drainage pad (M7117) located north of the Fire Tower (M7109). Surface water drains to a storm drain located at the north end of the concrete drainage pad.

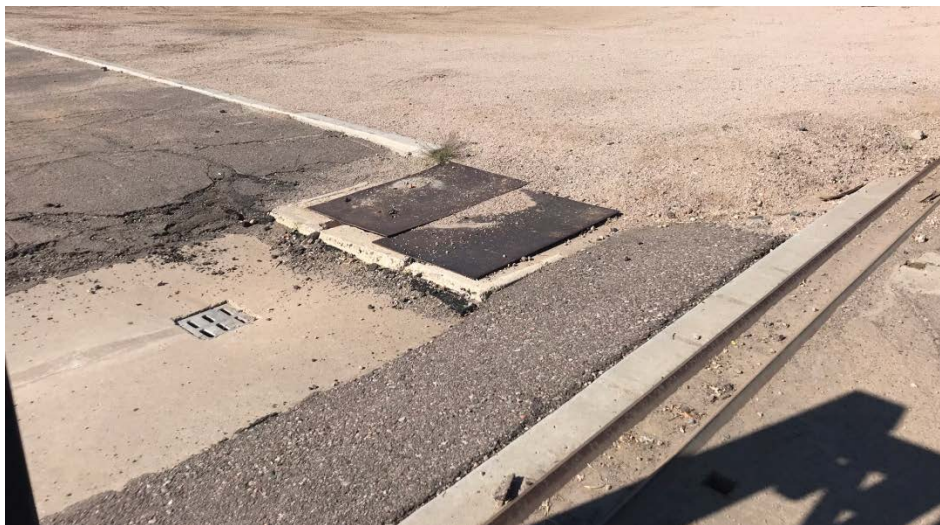
### Photograph No. 4

Looking southwest. Storm drain at the end of the concrete drainage pad (M7117).
