*National Guard Readiness Center  
Industrial Hygiene Evaluation  
Washington D.C. Armory  
Washington D.C., 20003*

Project No. 1061-14  
October 12, 2012

Project: Industrial Hygiene Evaluation  
Washington D.C. Armory

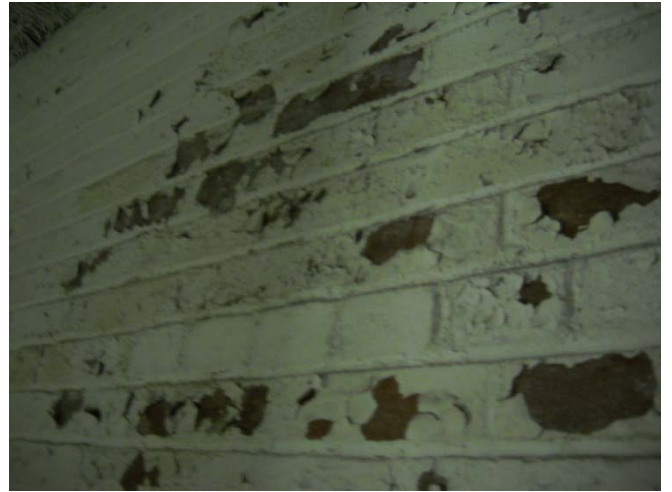
Boiler Room, peeling white paint

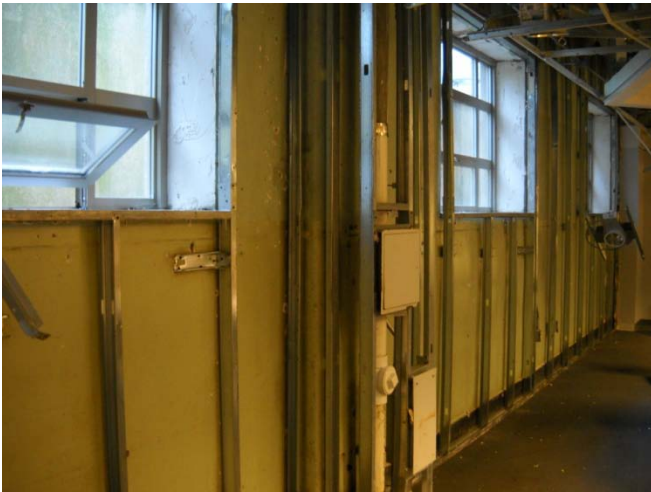
Hazard". Room 12-W was stripped of its walls to the studs on its perimeter wall, and had water-stained carpeting.

Room 12-W ("Microbial Hazard"), wall studs following drywall removal

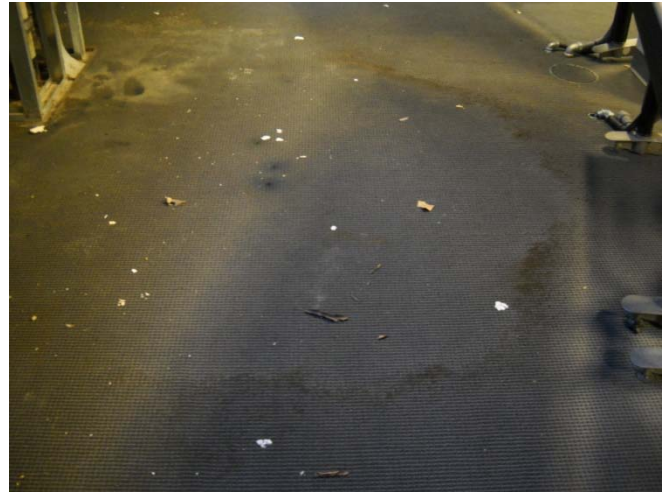
Room 12-W ("Microbial Hazard"), stained carpet

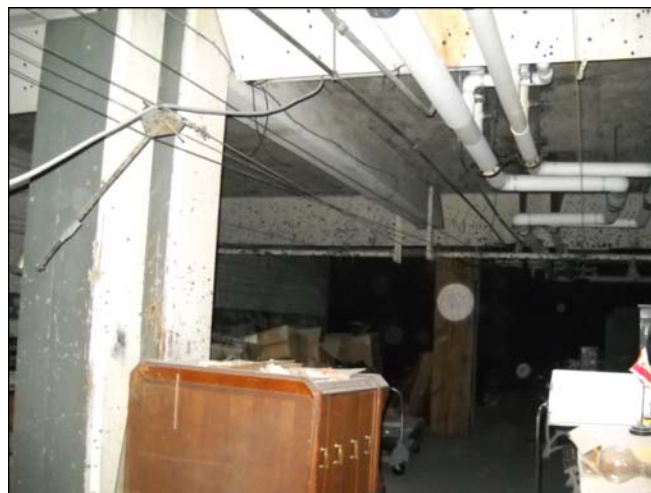
Former Indoor Firing Range

The former indoor firing range is currently used for storage. It is uncertain whether it was remediated to the protocols specified in NG Pam 420-15. Remediation wipe sample results were not posted, nor were any signs posted restricting access to the area. The bullet trap was not still in the “bullet trap area”.

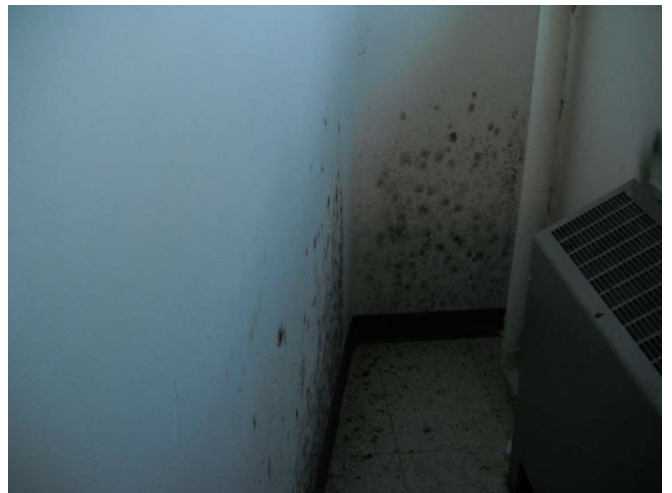
3. Bonus Environmental, LLC did not identify any PACM that was considered to be in poor or damaged condition.
4. Bonus Environmental, LLC identified approximately 60 ft<sup>2</sup> of moldy drywall in Room 119 (Maintenance Room).

Room 119, fungal growth on walls

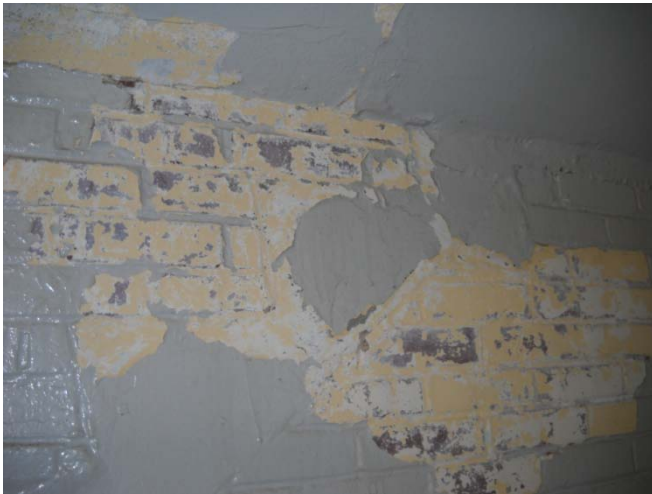
Room D-9T-S (men's restroom), peeling blue paint

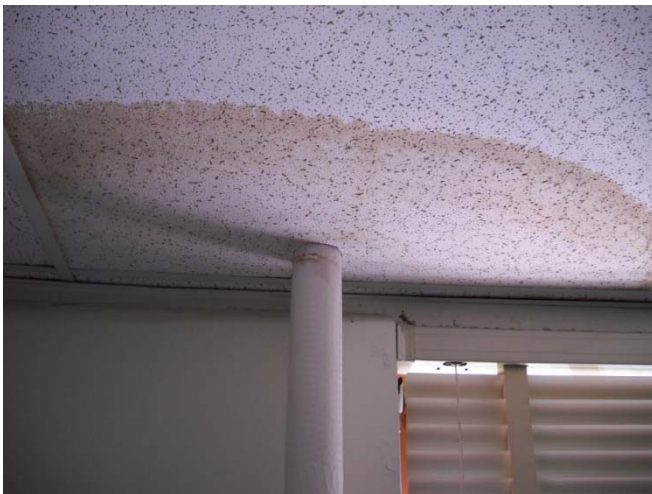
5. Bonus Environmental, LLC identified approximately 8 ft<sup>2</sup> of stained drop ceiling tile from three locations in the Washington D.C. Armory.
6. Bonus Environmental, LLC found the housekeeping practices within Washington D.C. Armory in good order.

Room 17-C-S, stained dropped ceiling tile
