# FINAL Preliminary Assessment Report Hilo Army Aviation Support Facility #2, Hawai'i, Hawai'i

Perfluorooctanesulfonic acid (PFOS) and  
Perfluorooctanoic acid (PFOA) at Impacted Sites  
ARNG Installations, Nationwide

September 2020

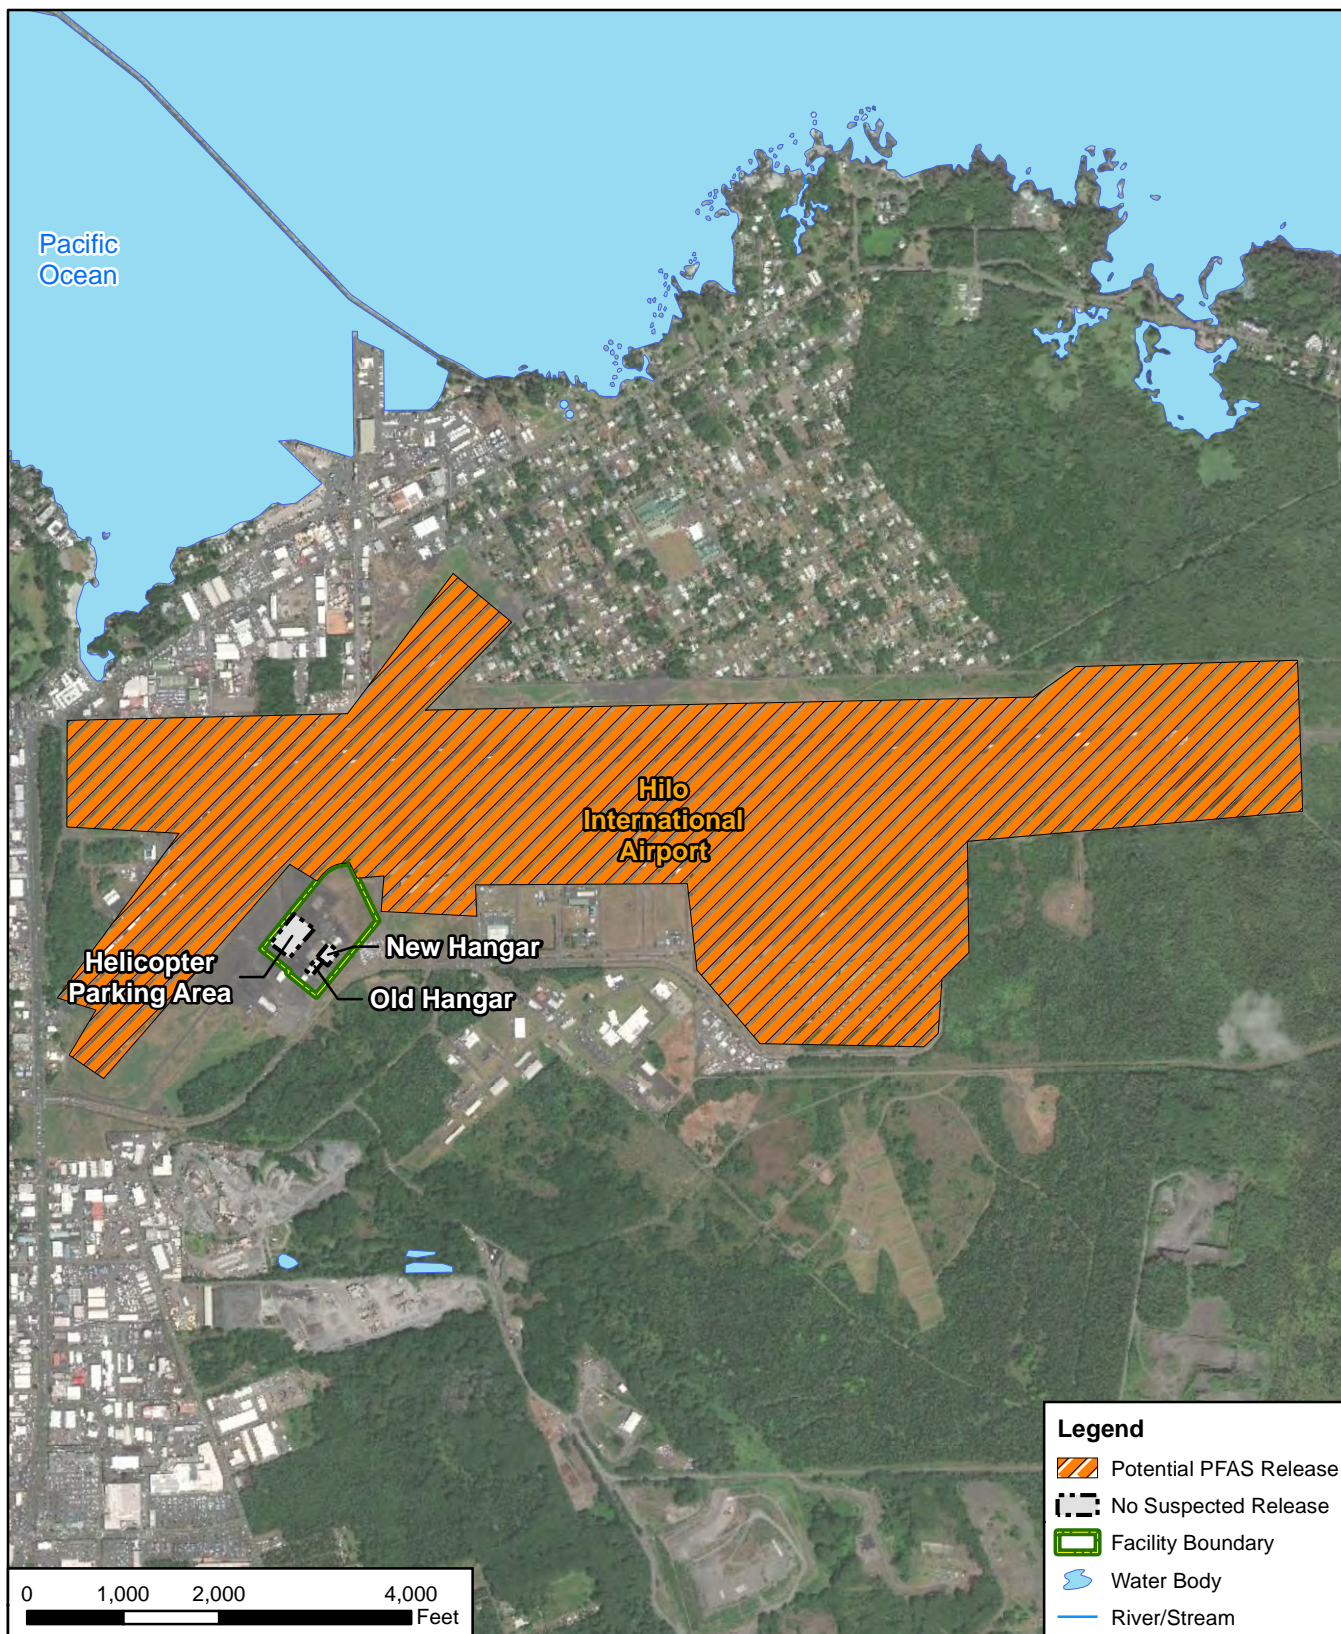
**Figure ES-1**

No known or documented releases of PFAS to the environment were identified at the facility during the preparation of this PA report. Hilo International Airport was identified as an adjacent source of PFAS, because eight major air incidents have occurred at the airport. At one of the incidents in the early 1990s, Hilo AASF #2 personnel indicated that they assisted with the response using water and Halon extinguishers (non-aqueous film forming foam [AFFF]). The response actions, location, and extinguishing agents used (if any) are generally unknown for the other incidents (Hawaii.gov, 2020).

Based on the PA findings regarding the historical use, storage or disposal of aqueous film forming foam at the facility, there is no potential for exposure to PFAS contamination in soil, groundwater, surface water, and sediment (**Figure ES-1**). Based on the United States (US) Environmental Protection Agency (USEPA) Unregulated Contaminant Monitoring Rule 3 (UCMR3) data, it was indicated that no PFAS were detected in a public water system above the USEPA's lifetime Health Advisory (HA) within 20 miles of the facility. The HA is 70 parts per trillion for PFOS and PFOA, individually or combined. PFAS analyses performed in 2016 had method detection limits that were higher than currently achievable. Thus, it is possible that low concentrations of PFAS were not detected during the UCMR3 but might be detected if analyzed today.

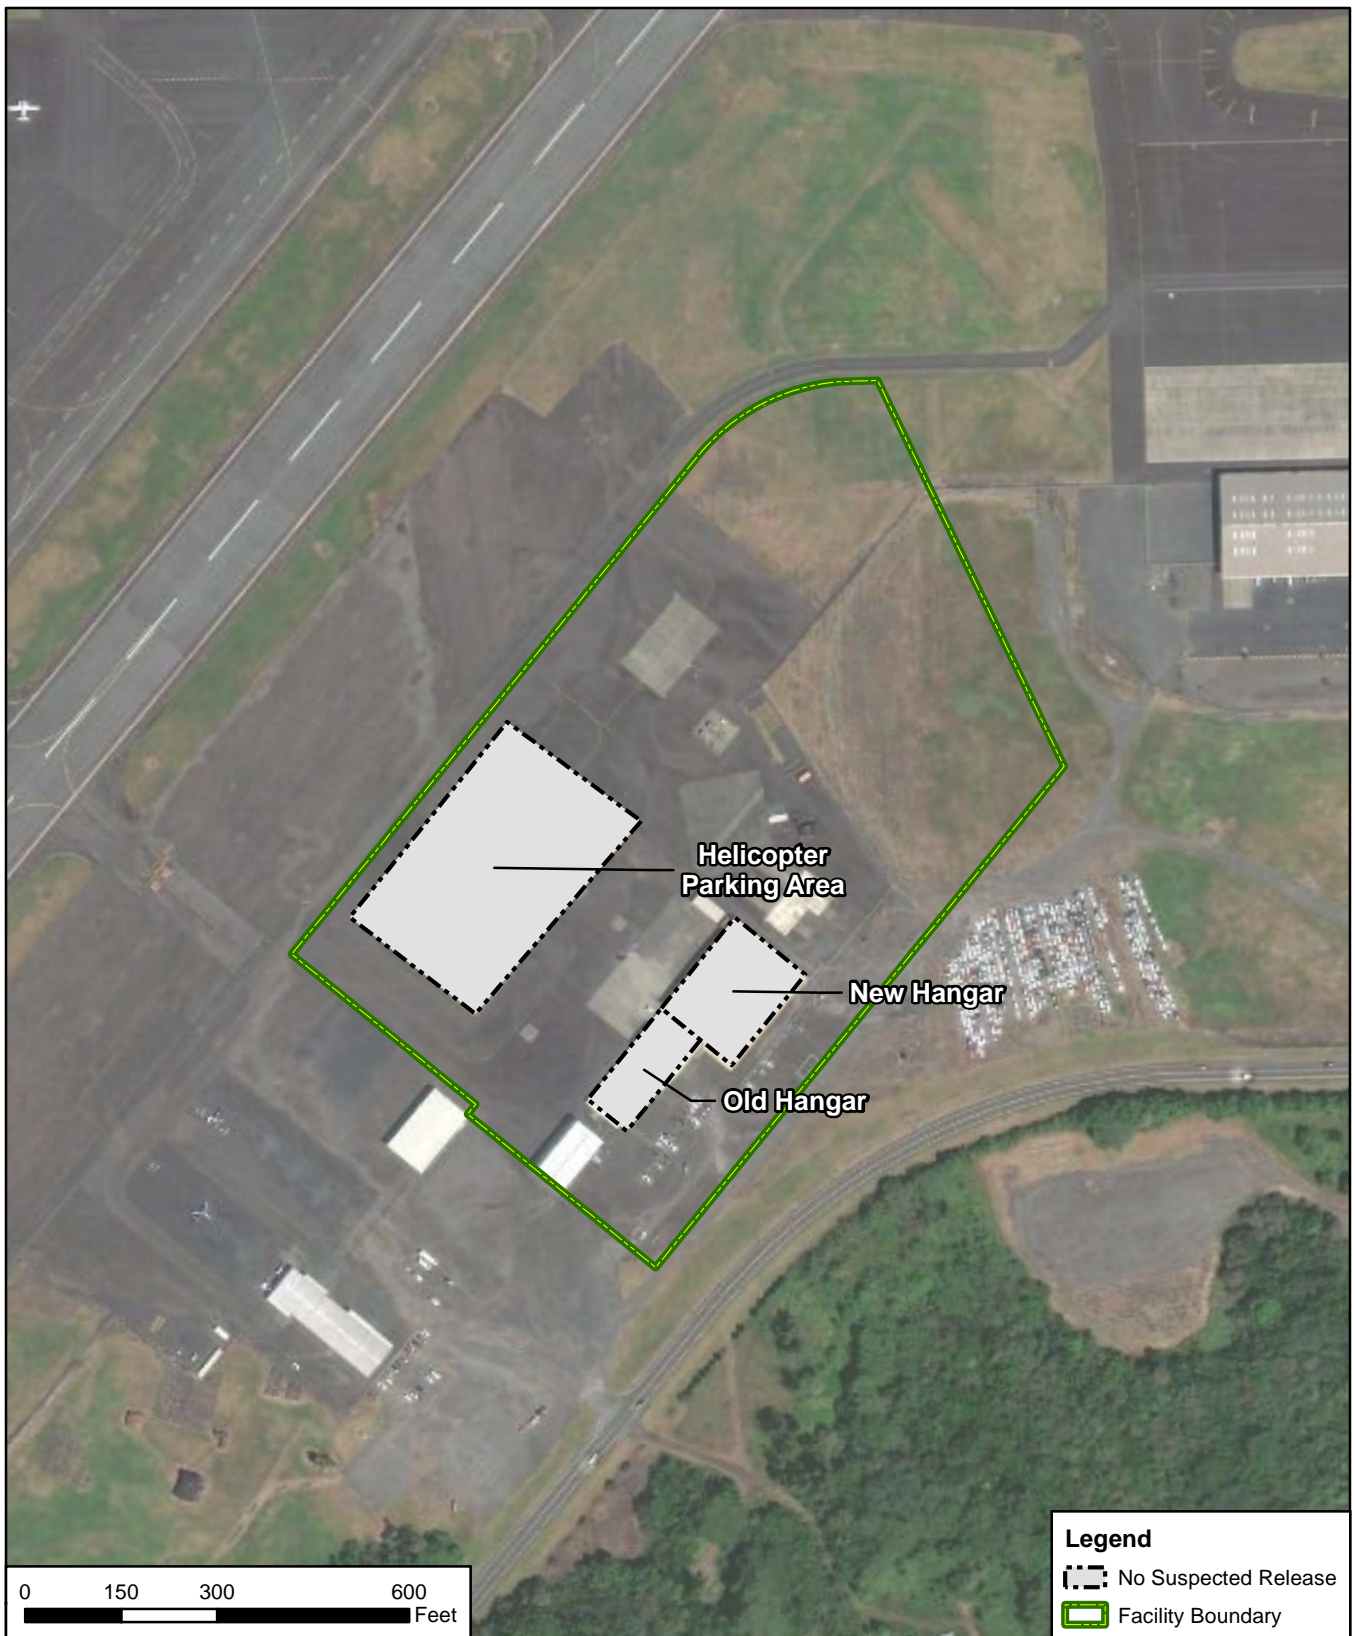
**Figure 3-1**

The helicopter parking area is located north of the two Hilo AASF #2 hangars. Adjacent to each of the helicopters is a Halon (non-AFFF) fire extinguisher. There are no AFFF fire extinguishers present within the parking area. According to the interviewee, the tarmac and parking area pavement was replaced in 2000. The helicopter parking area is not considered a suspected PFAS release area due to the lack of AFFF storage and use.

The Old Hangar was built in 1983 and is used as a maintenance hangar. The Old Hangar stores various maintenance-related chemicals but contains no AFFF according to the interview with the Hilo AASF #2 personnel and confirmed during the VSI. The fire suppression system within the building is a water sprinkler system. The Old Hangar is not considered a suspected PFAS release area due to the lack of AFFF storage and use.

The New Hangar was built around 2000 for helicopter maintenance use. The New Hangar is located adjacent to the Old Hangar and stores maintenance-related chemicals and solvents but contains no AFFF according to interviews with the Hilo AASF #2 personnel and confirmed during the VSI. The fire suppression system is a water sprinkler system. A trench drain is located near the hangar door. According to the interviewee, the trench drain is used to prevent water from the outside getting into the hangar. The trench drain is connected to the storm water drain. The New Hangar is not considered a suspected PFAS release area due to the lack of AFFF storage and use.

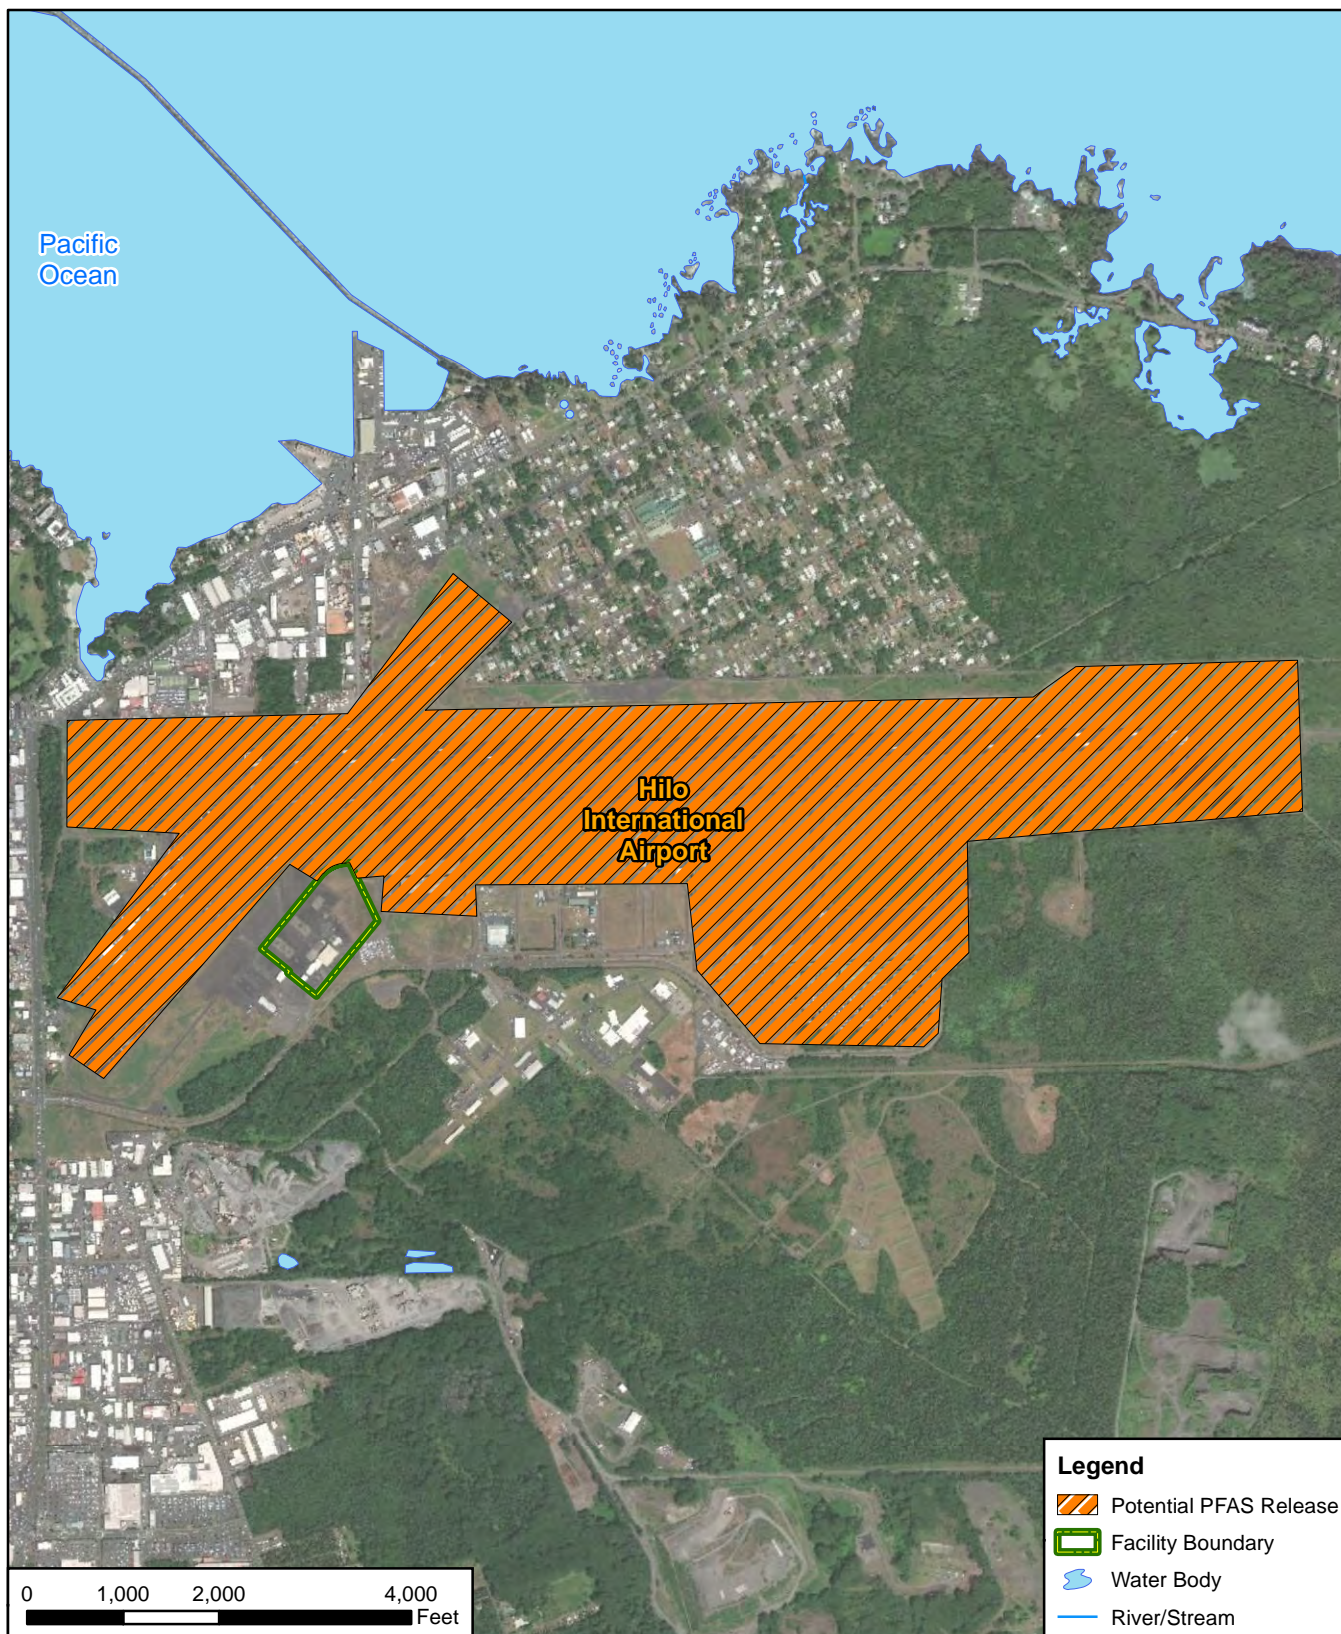
Adjacent Source	
Preliminary Assessment for PFAS at Hilo AASF #2, HI

According to the interviewee, in the early 1990s, an emergency response was conducted on a private plane crash at the Hilo International Airport. During the response action, the personnel at the Hilo AASF #2 used water and a green fire extinguisher to put out the fire on the plane. The interviewee suggested that the extinguisher contained Halon (non-AFFF). Eight major air incidents, some of which have resulted in fire, have occurred at Hilo International Airport between 1957 and 2000 (Hawaii.gov, 2020). The response actions, exact location of the incidents, and extinguishing agents used are unknown, but the airport's crash rescue team is the first responder.

Hilo International Airport personnel were not interviewed during the PA because they were unavailable at the time of the PA. Therefore, it is not known if AFFF is or were used or stored at the airport currently or historically. Because the presence of AFFF at the airport cannot be confirmed, and multiple major air incidents have occurred, Hilo International Airport has been identified as a potential off-facility PFAS source area. **Figure 5-1** shows the location of Hilo International Airport (as a potential PFAS source area) in relation to the Hilo AASF#2.

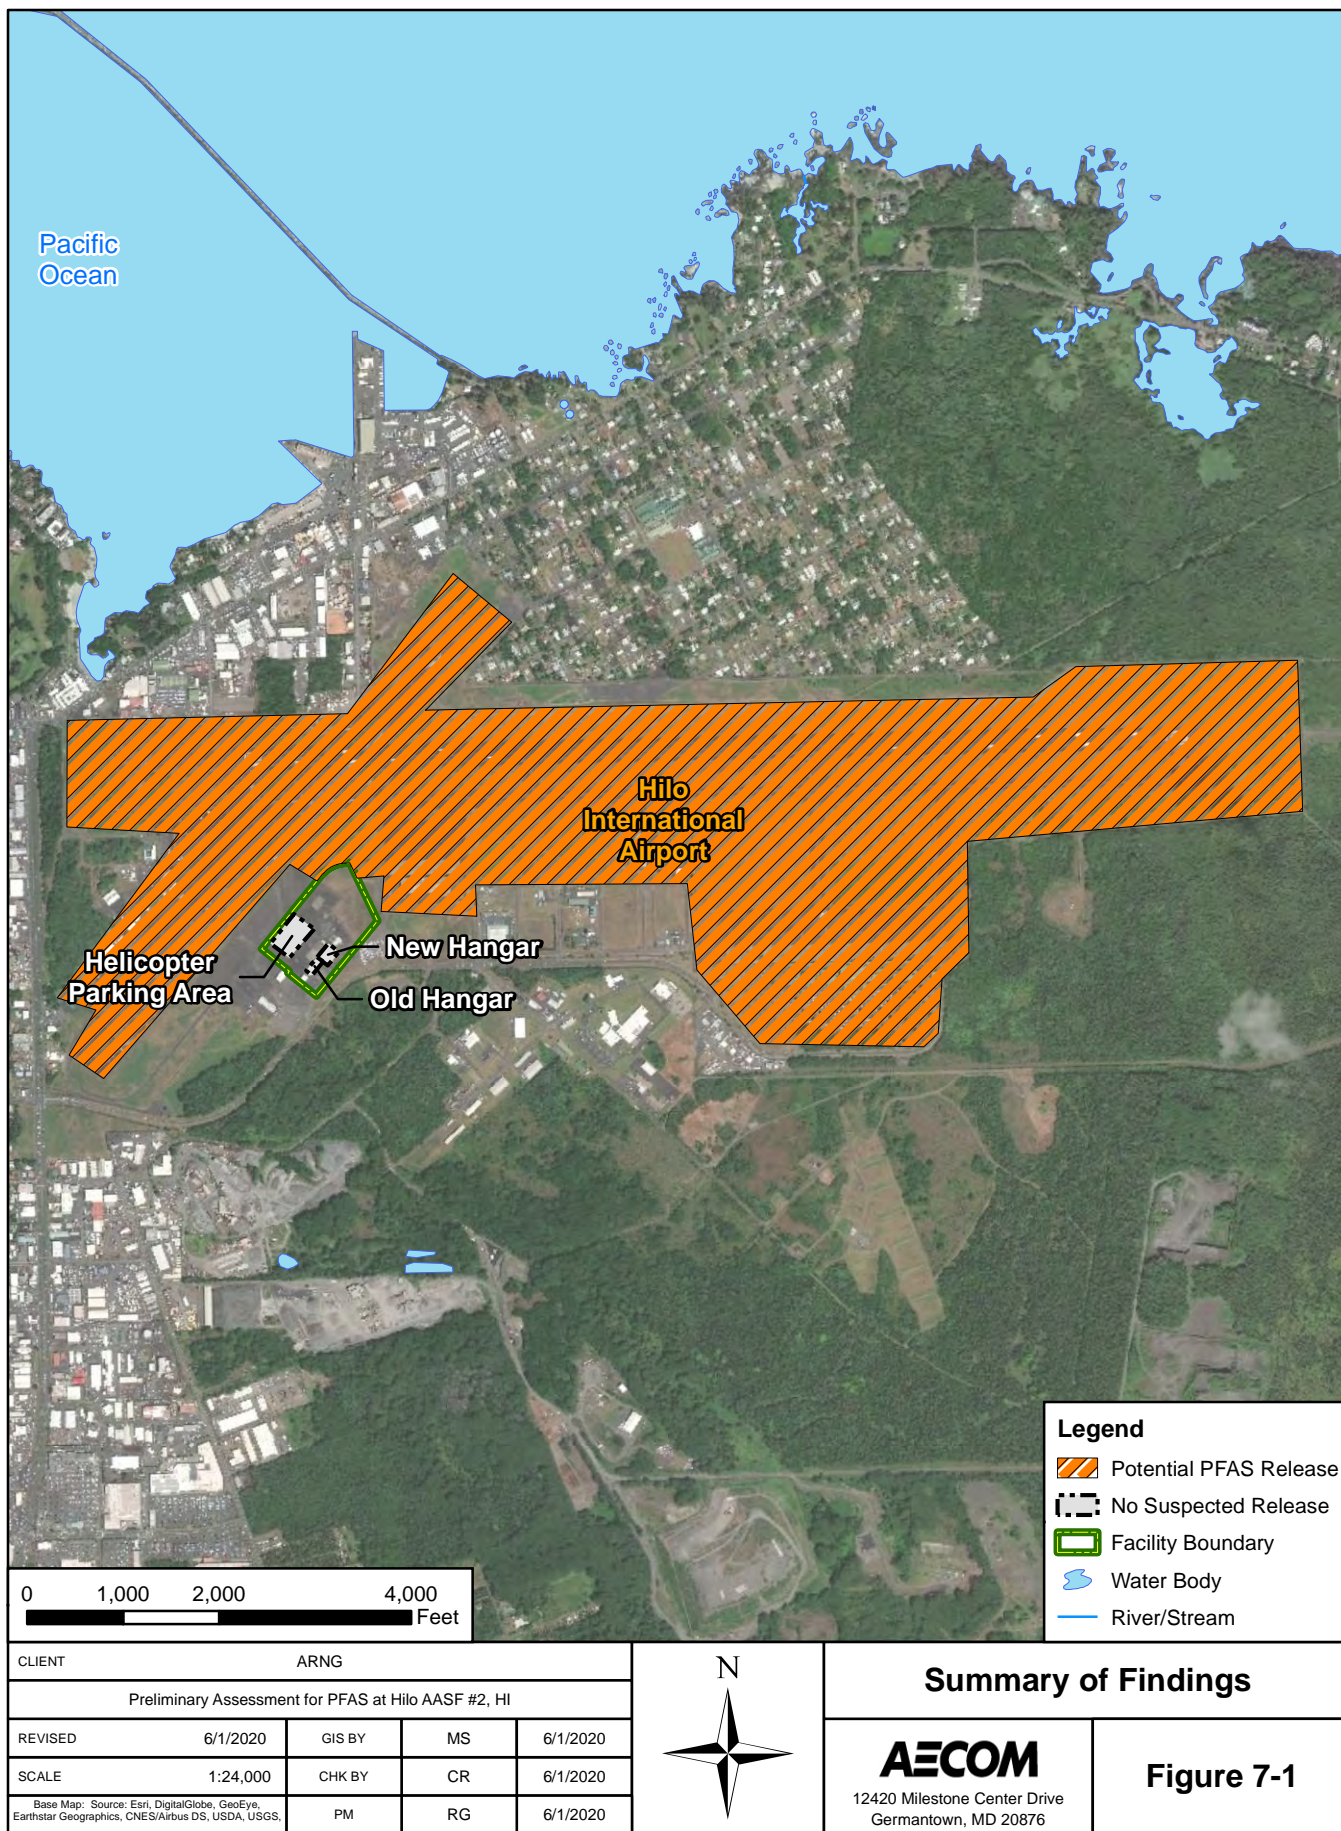
No known or documented releases of PFAS to the environment were identified during PA activities at the Hilo AASF #2 facility. In addition, no AFFF is known to have ever been stored or disposed of at the facility, either historically or at the time of the PA. Therefore, there is no potential for exposure to PFAS contamination in soil, and groundwater from onsite sources. **Figure 7-1** presents a summary of the PA findings.

Based on the documented absence (1989 to present) of the use, storage or disposal of PFAS-containing materials at Hilo AASF #2, no AOIs were identified during the PA. No evidence was found to indicate that current or former ARNG activities contributed to PFAS contamination in soil, groundwater, surface water, or sediment at the facility or adjacent areas. Hilo AASF #2 will not move forward in the CERCLA process.
