FINAL Preliminary Assessment Report AASF #3 Bates Field, Mobile, Alabama

Perfluorooctanesulfonic Acid (PFOS) and Perfluorooctanoic
Acid (PFOA) Impacted Sites
ARNG Installations, Nationwide

September 2020

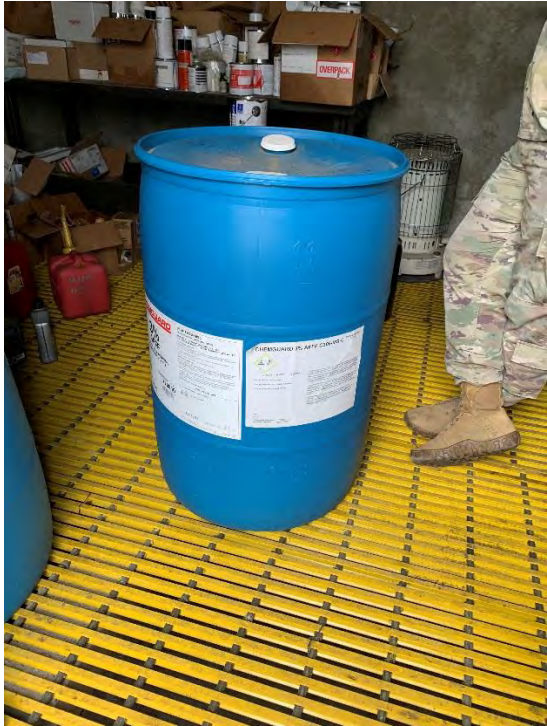
During the PA site visit, ALARNG personnel noted that after the AFFF system upgrade from 2016 to 2018, the contractor tasked with the system upgrade left two 55-gallon drums containing Chemguard 3% onsite. These drums contain leftover concentrate because the tank had been filled to capacity. ALARNG personnel currently stage these drums within a chemical storage building with secondary containment. At the time of the visual inspection, no evidence of drum leaks, rust, or spills were apparent.

Army National Guard, Preliminary Assessment for PFAS	AASF #3 Bates Field	Mobile, Alabama
<p>Photograph No. 5</p> <p>Description:</p> <p>Looking South</p> <p>One of the 55-gallon drums containing 3% concentrate</p> <p>Photo Date: 4/9/19</p>

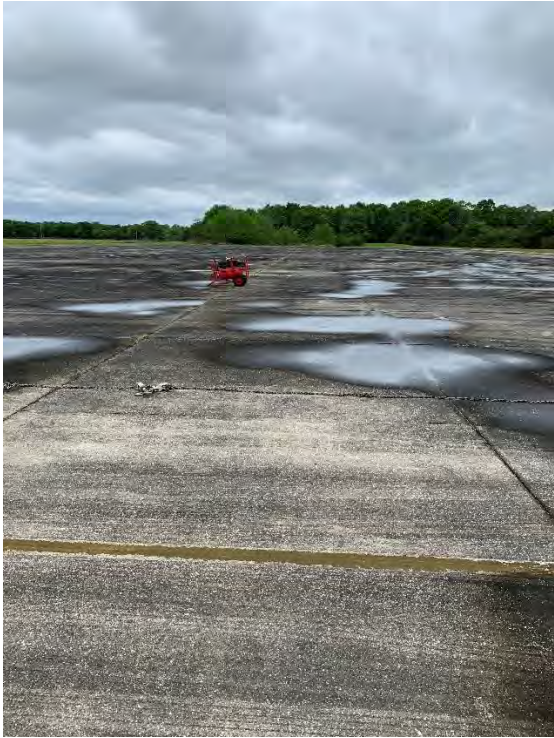
APPENDIX C – Photographic Log		
Army National Guard, Preliminary Assessment for PFAS	AASF #3 Bates Field	Mobile, Alabama
<p>Photograph No. 7</p> <p>Description:</p> <p>Looking Northwest</p> <p>General view of Ramp with mobile Purple K unit</p> <p>Photo Date: 4/9/19</p>

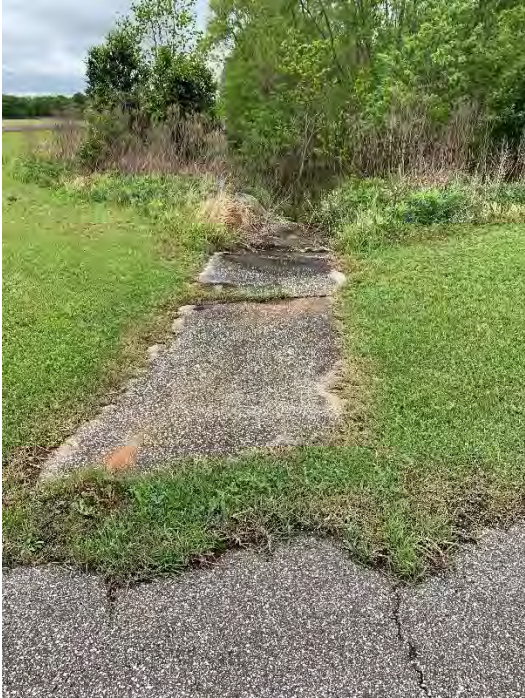
<p>Photograph No. 8</p> <p>Description:</p> <p>Looking Northwest</p> <p>General view of retention pond</p> <p>Photo Date: 4/9/19</p>

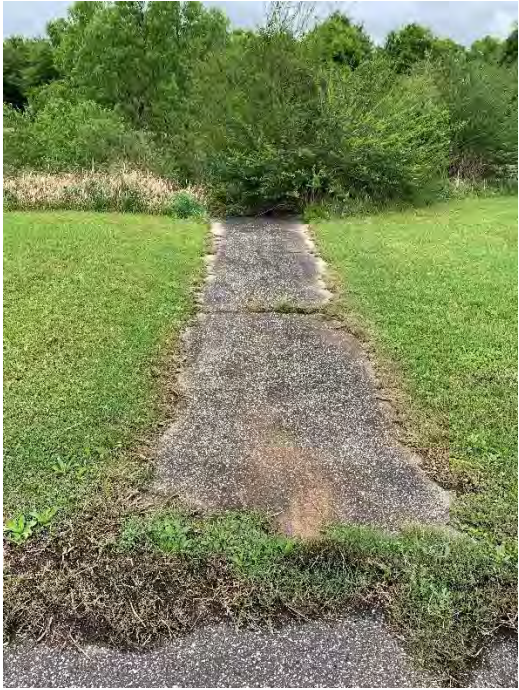
Army National Guard, Preliminary Assessment for PFAS	AASF #3 Bates Field	Mobile, Alabama
<p>Photograph No. 9</p> <p>Description:</p> <p>Looking Northwest</p> <p>General view of retention pond</p> <p>Photo Date: 4/9/19</p>
