FINAL Preliminary Assessment Report AASF #1 RW Shepherd, Montgomery, Alabama

Perfluorooctanesulfonic Acid (PFOS) and Perfluorooctanoic
Acid (PFOA) Impacted Sites
ARNG Installations, Nationwide

September 2020

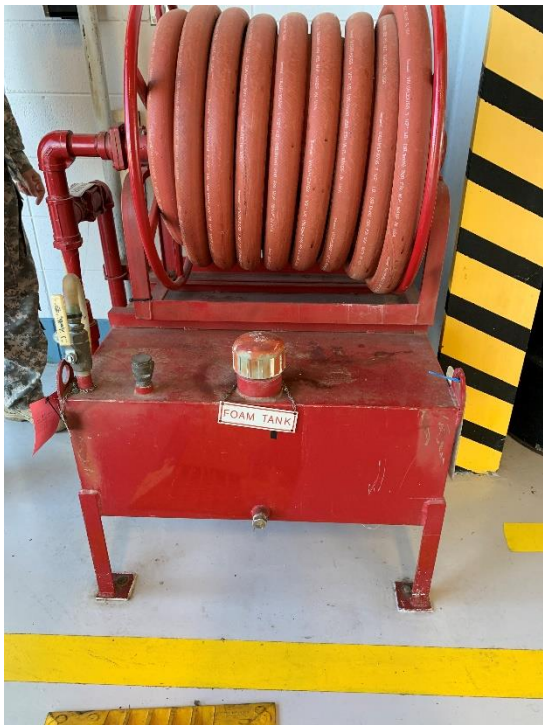
Army National Guard, Preliminary Assessment for PFAS		AASF #1 RW Shepherd	Montgomery, Alabama
Photograph No. 1

Description: Unknown direction Typical AFFF foam tank on hangar floor Photo date 4/10/19			
Photograph No. 2

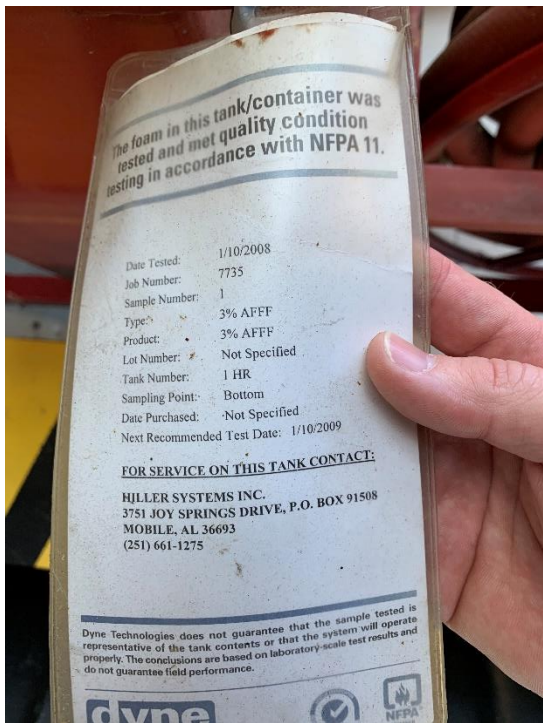
Description: Unknown direction Inspection tag on AFFF foam tank in hangar Photo Date: 4/10/19

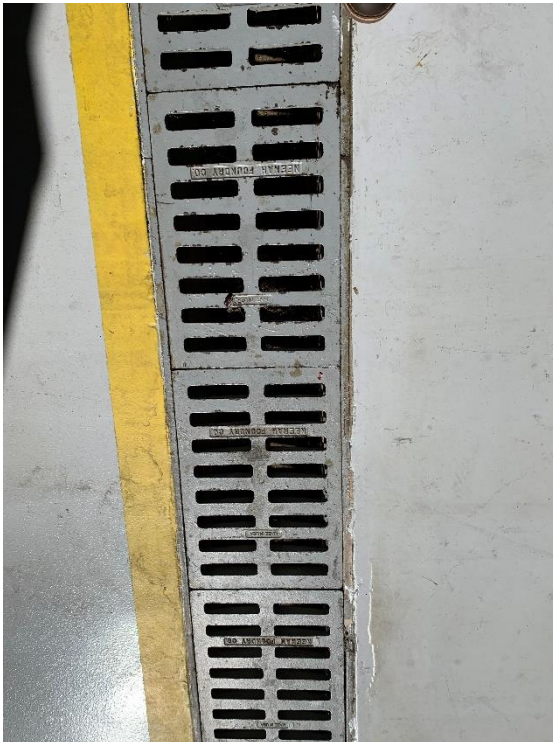
Army National Guard, Preliminary Assessment for PFAS		AASF #1 RW Shepherd	Montgomery, Alabama
Photograph No. 5 Description: Unknown direction Typical floor drain in hangar. Floor drains located on the north and south sides of hangar building Photo Date: 4/10/19

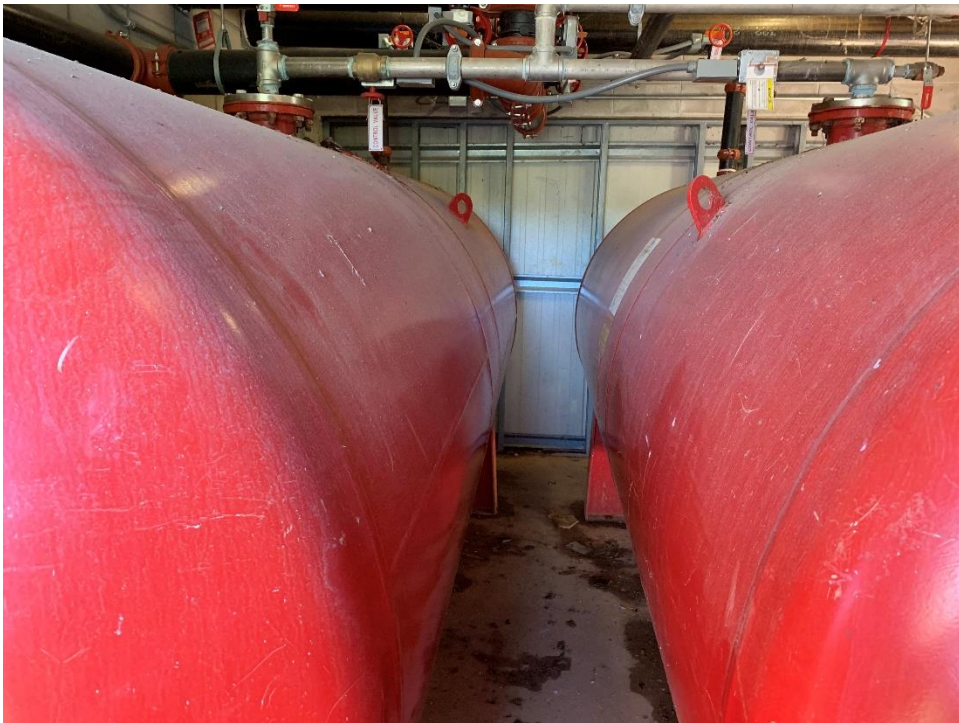
Photograph No. 6 Description: Unknown direction 2 800-gallon 3% AFFF concentrate tanks in mechanical room Photo Date: 4/10/19

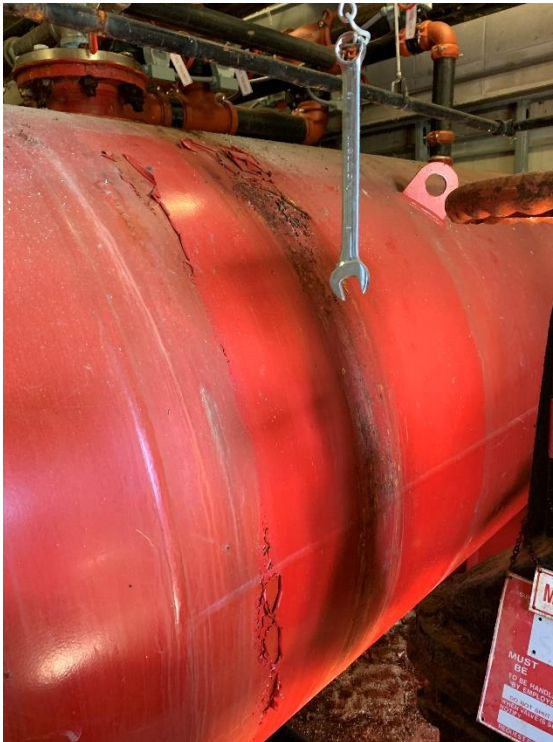
Seepage of AFFF is also evident from corrosion identified at the two 800-gallon 3% AFFF concentrate tanks, located in the mechanical room. ALARNG personnel also noted that during the AFFF concentrate replacement between 2006 and 2009, an unknown quantity of concentrate was spilled on the south side of the mechanical room, which consequently killed the grass. Except for the wash rack area, surface water surrounding the hangar drains via sheet flow. The apparent surface water flow direction is toward the north and northwest. However, surface water may flow to the low-lying Retention Areas 1 and 2, located southeast of the flight ramp and southwest of the hangar building, respectively.

Army National Guard, Preliminary Assessment for PFAS		AASF #1 RW Shepherd	Montgomery, Alabama
Photograph No. 7 Description: Unknown direction Evidence of corrosion of 800-gallon AFFF concentrate tanks in mechanical room Photo Date: 4/10/19

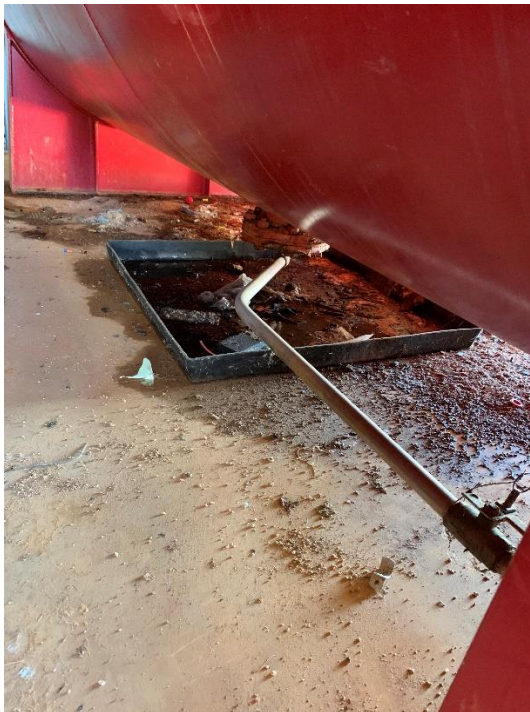
Photograph No. 8 Description: Unknown direction Evidence of leaking from of 800-gallon AFFF concentrate tanks in mechanical room Photo Date: 4/10/19

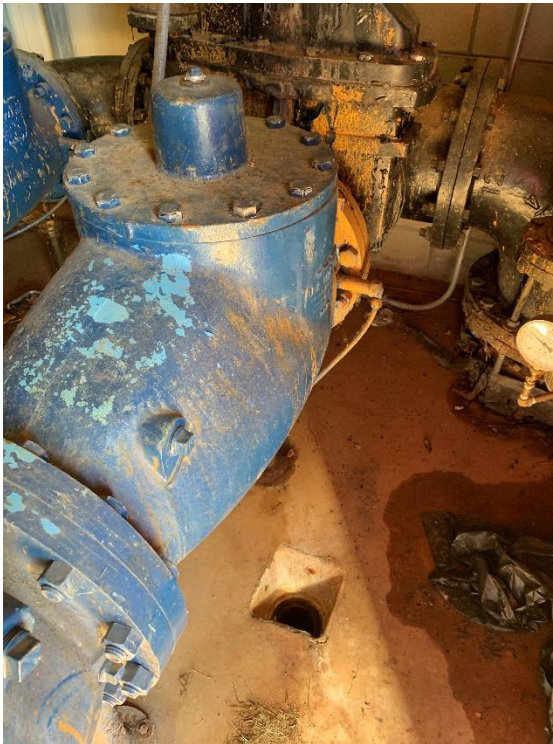
Army National Guard, Preliminary Assessment for PFAS		AASF #1 RW Shepherd	Montgomery, Alabama
Photograph No. 9 Description: Unknown direction Typical floor drains in mechanical room Photo Date: 4/10/19

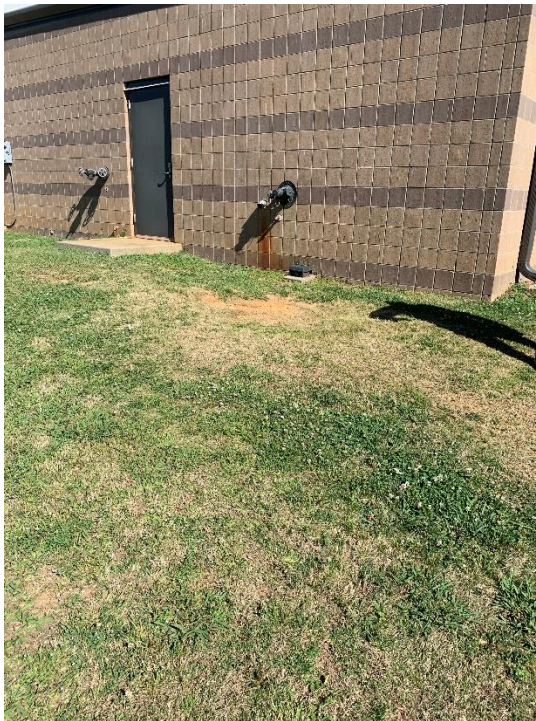
No written record of spills. anecdotal evidence of spilling AFFF concentrate outside of maintenance building when changing fuel in 2009. Killed grass. Also, noted corrosion at floor tanks + 800 gal concentrate tanks. 5 gal AFFF tank in Hot waste room shows signs of corrosion.

Photograph No. 10 Description: Looking Northwest Dead grass thought top be associated with AFFF release at south side of mechanical room Photo Date: 4/10/19

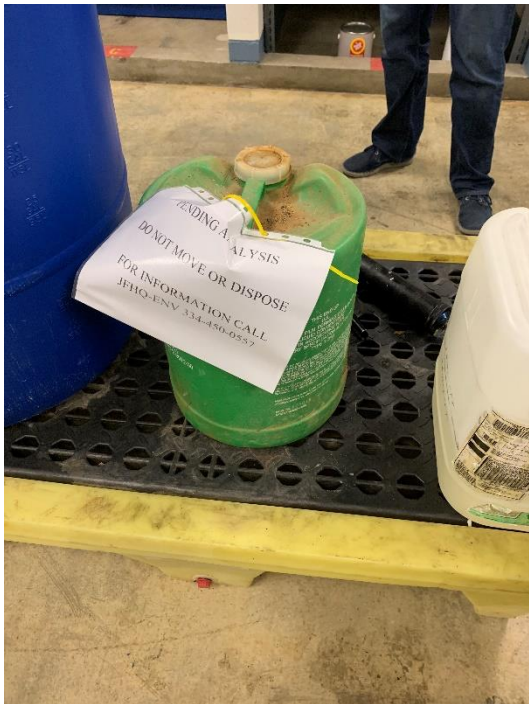
APPENDIX C – Photographic Log		
Army National Guard, Preliminary Assessment for PFAS		RW Shepperd AASF #1
		Montgomery, Alabama
Photograph No. 51 Description: Unknown direction 5-gallon jug containing 3% AFFF concentrate in hazardous waste storage room Photo date 4/10/19
