FINAL Preliminary Assessment Report Camp Navajo Bellemont, Arizona

Perfluorooctanesulfonic Acid (PFOS) and Perfluorooctanoic
Acid (PFOA) Impacted Sites
ARNG Installations, Nationwide

September 2020

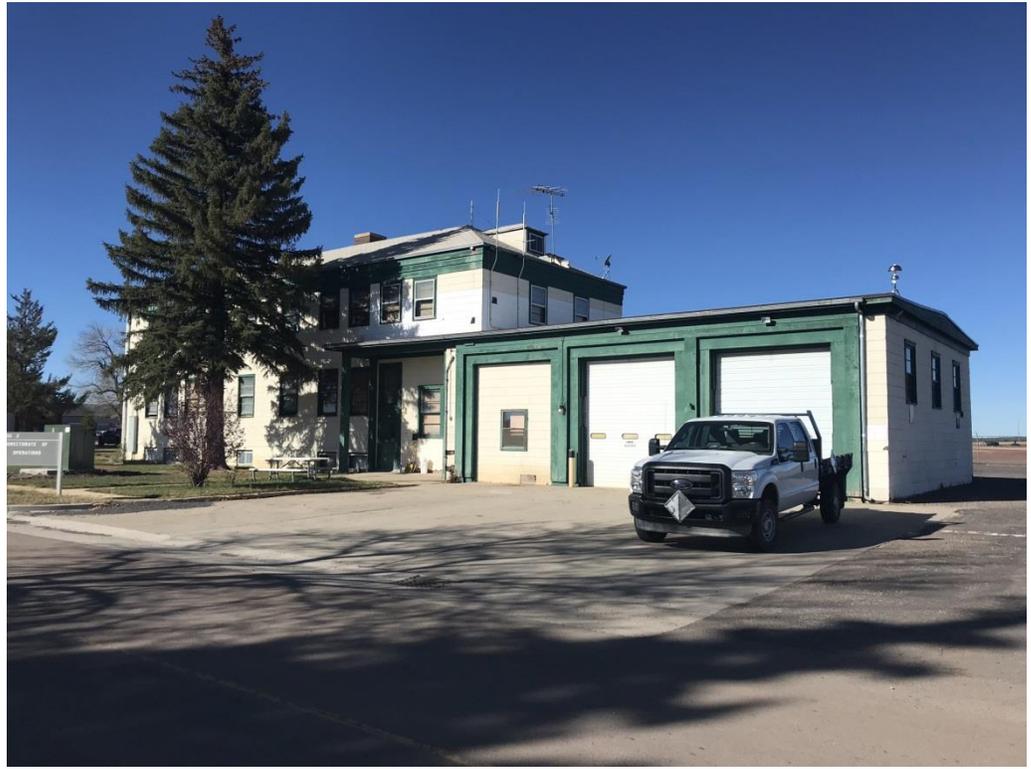
Building 2 east elevation
(view to W)

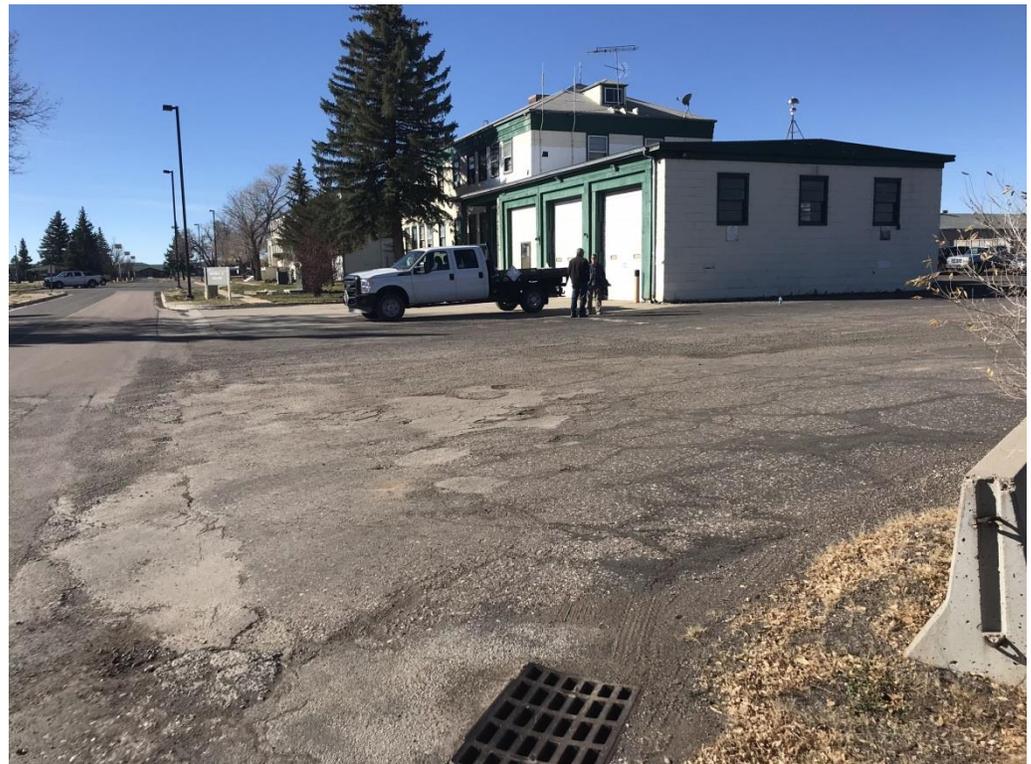
Photograph No. 2

Building 2 and storm drain
(view to S)

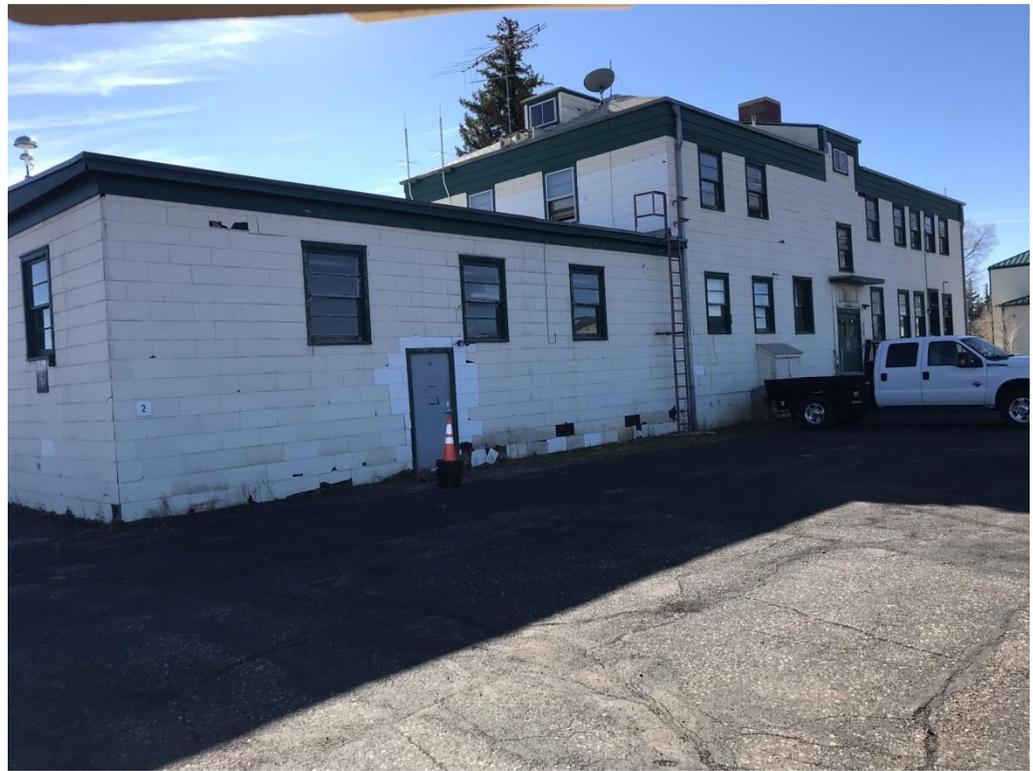
Building 2 west elevation
(view to SE)

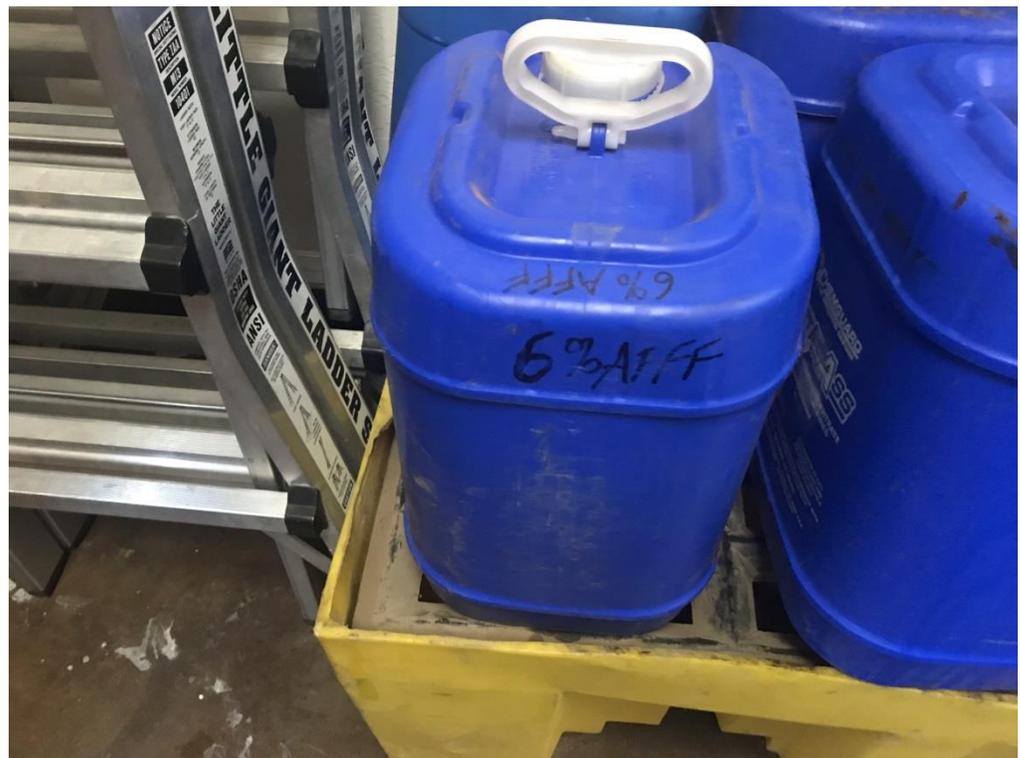
Photograph No. 4

AFFF (6%) in storage in
current Fire Station
(view is S)

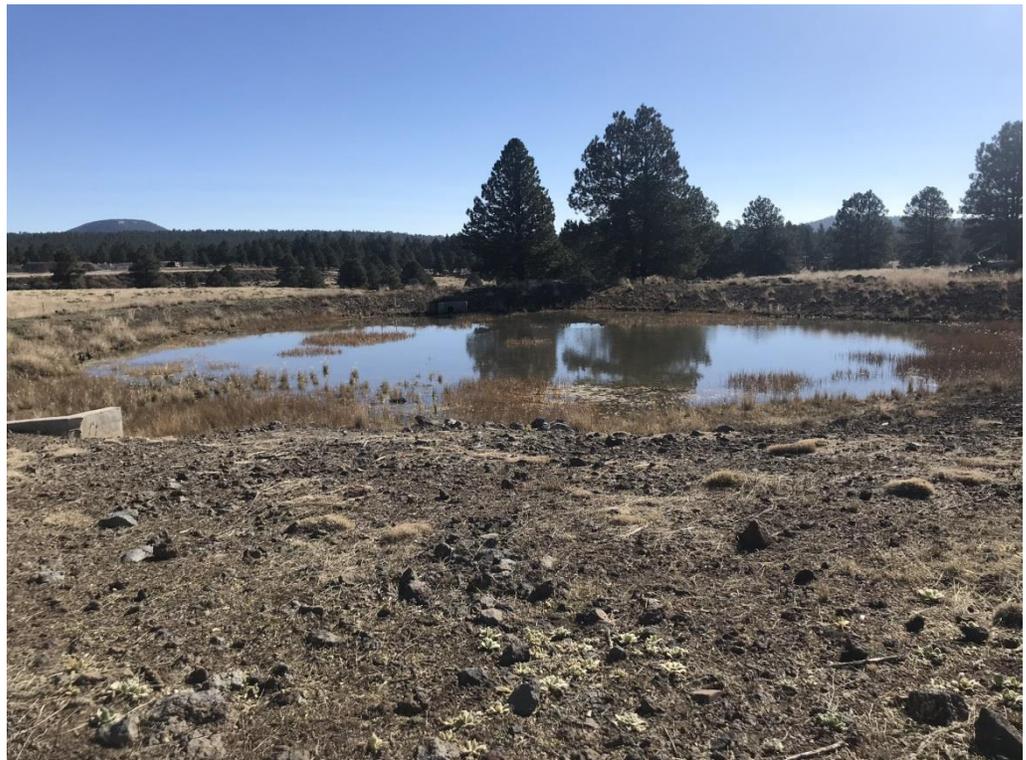
Photograph No. 6

Eastern holding ponds
(southern-most)

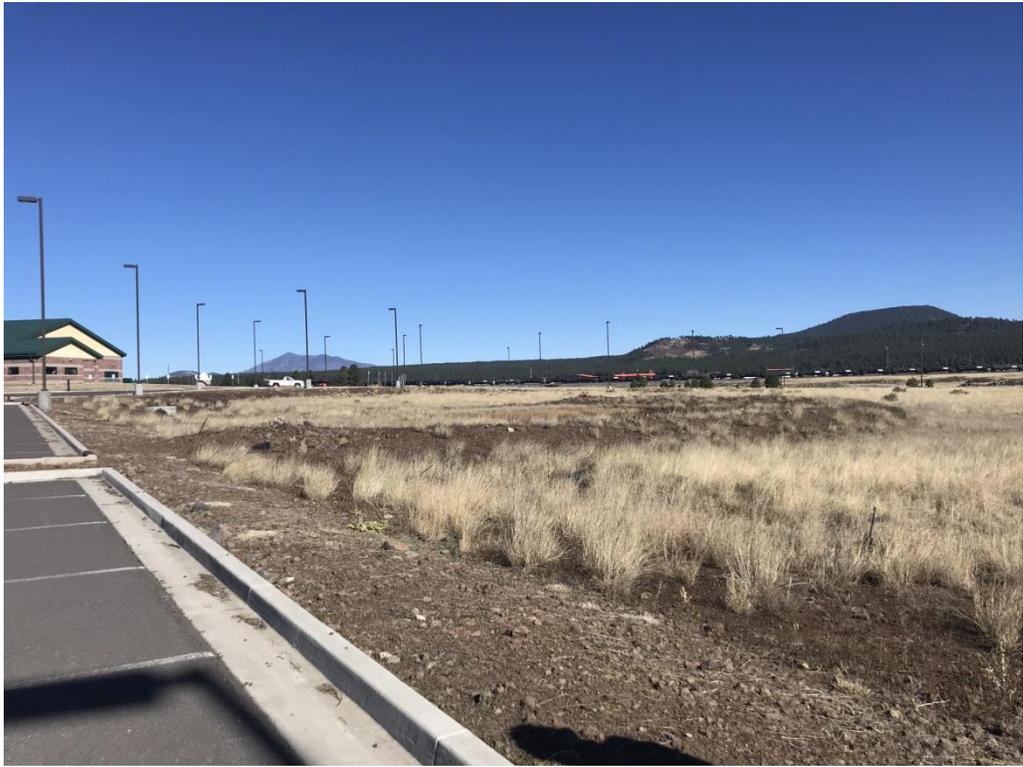
Photograph No. 7

Description:
Eastern holding ponds
(northern-most)
(view to NE)

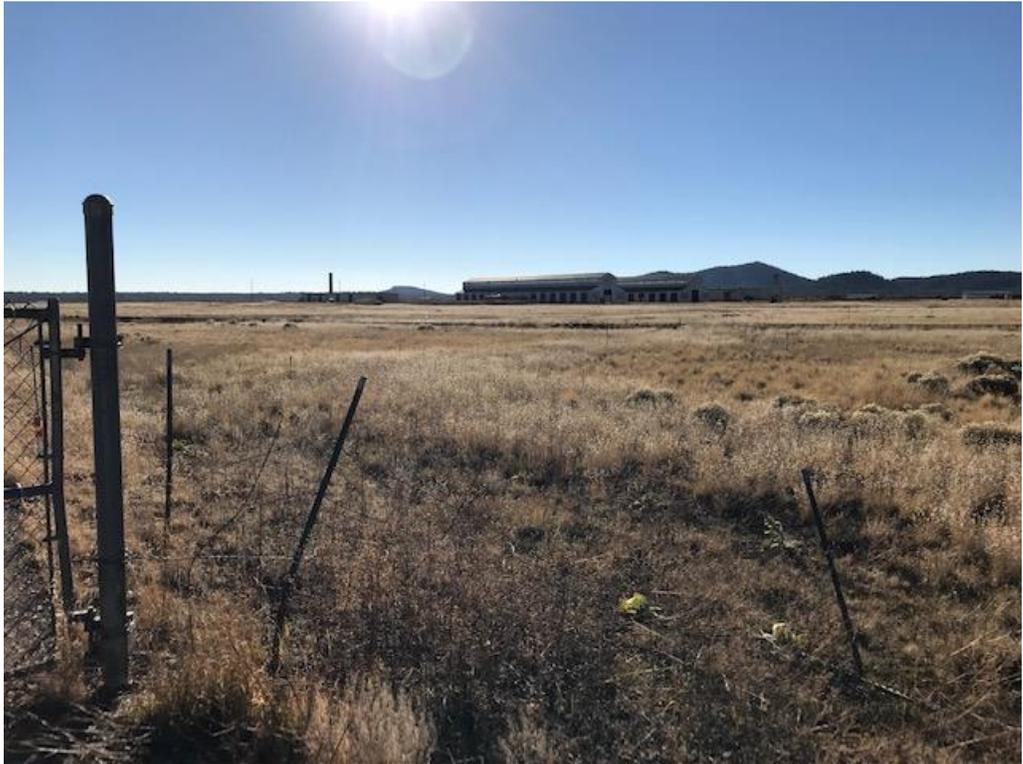
Photograph No. 8

Description:
200 Area
