FINAL Preliminary Assessment Report Silver Bell Army Heliport Marana, Arizona

Perfluorooctanesulfonic Acid (PFOS) and Perfluorooctanoic
Acid (PFOA) Impacted Sites
ARNG Installations, Nationwide

September 2020

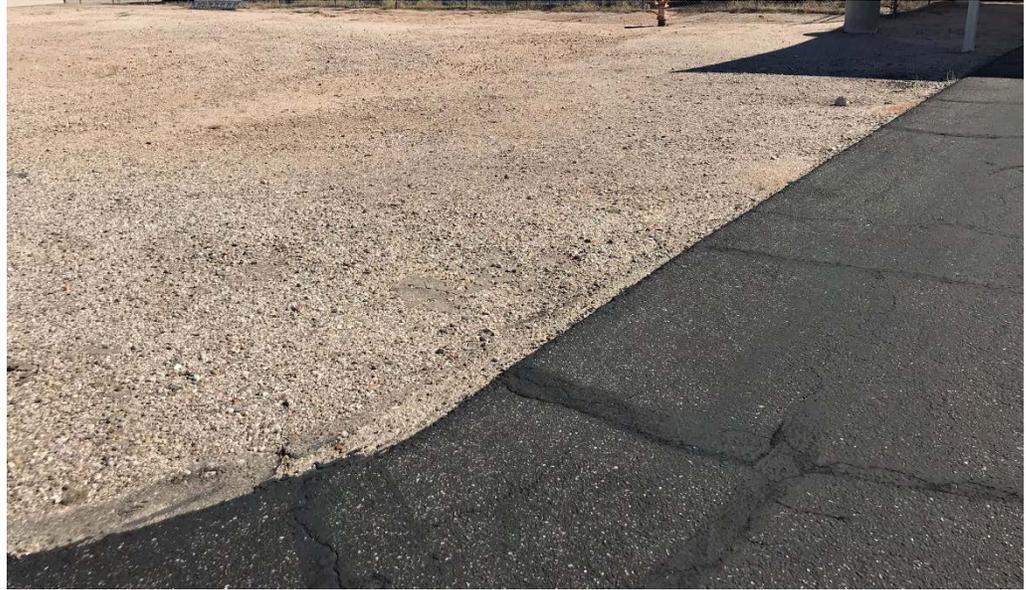
Dirt area north of former fire
station ramp (L4300)
(view to ESE)

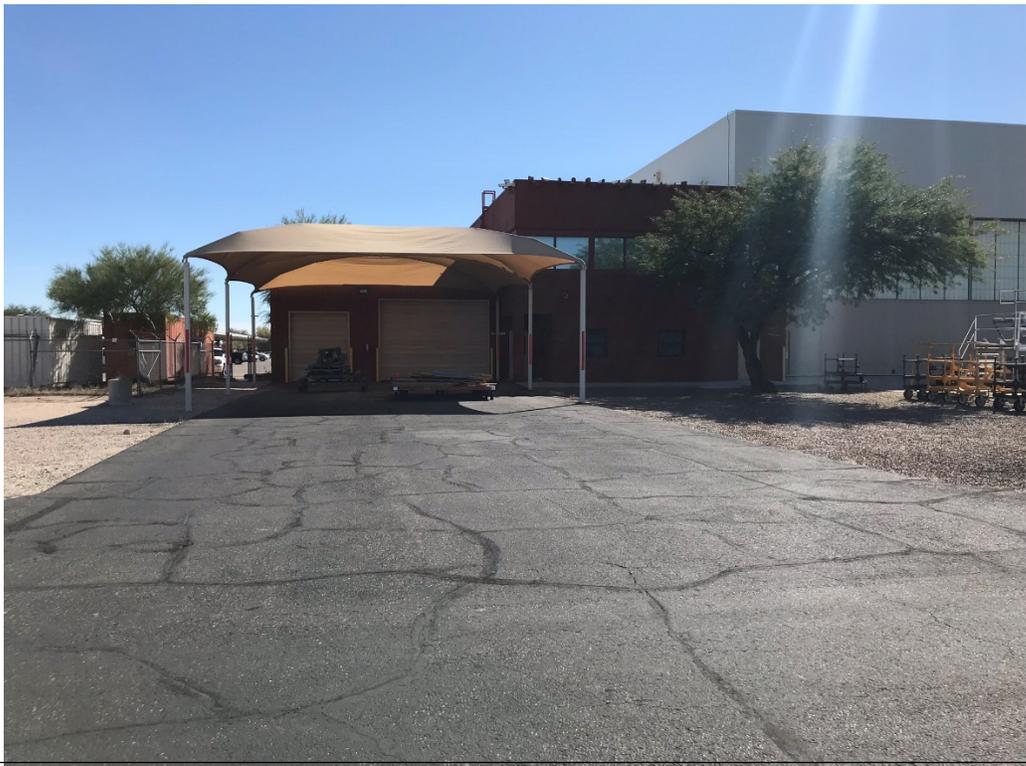
Photograph No. 2

Former fire station ramp
(L4300)
(view to SE)

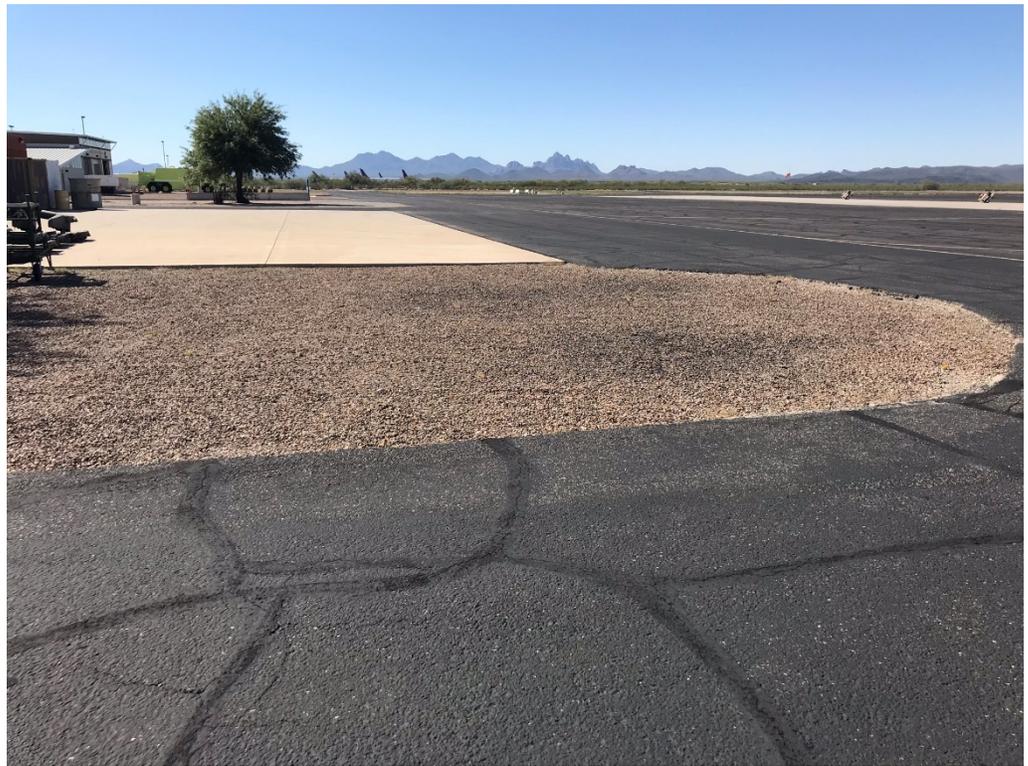
Former fire station ramp
(L4300) and low lying area
(view to SW)

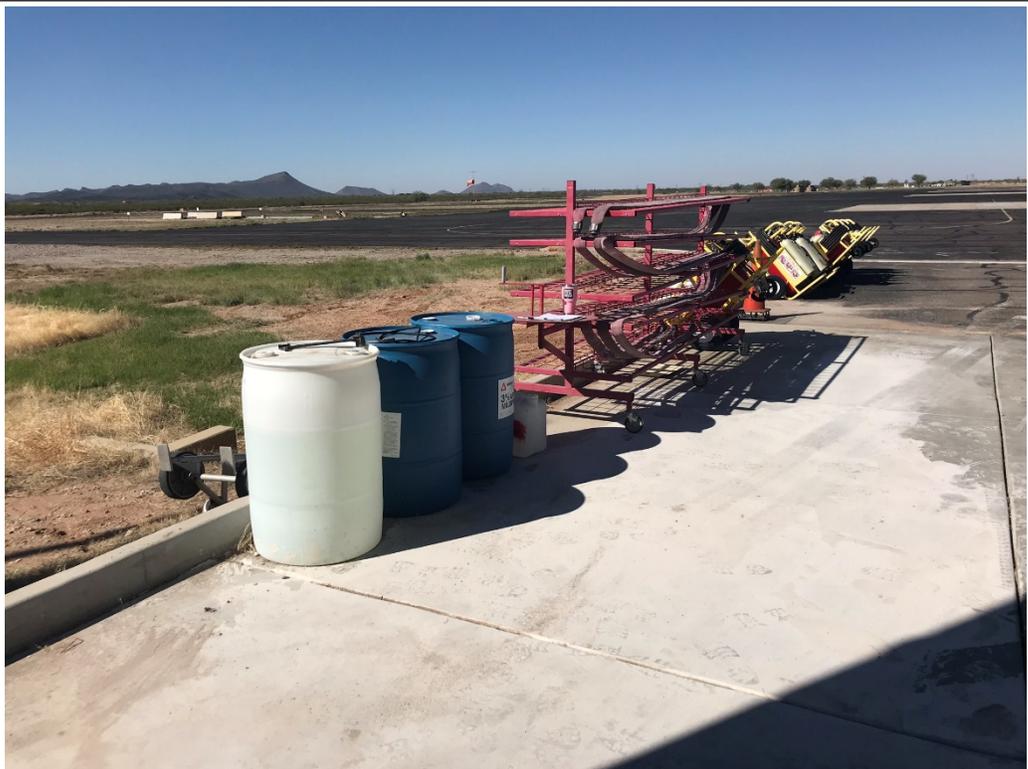
Photograph No. 4

AFFF and Tri-max storage
area on driveway of current
fire station (L4320)
(view is NE)

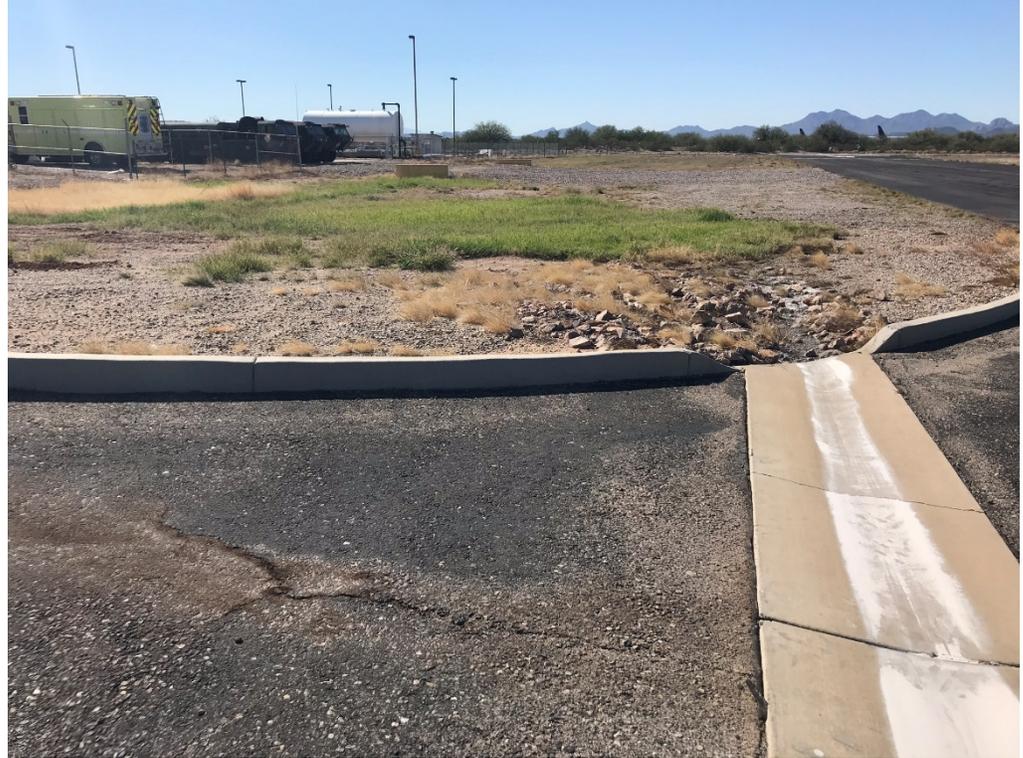
Drainage area next to AFFF
storage area and west of
current fire station (L4320)

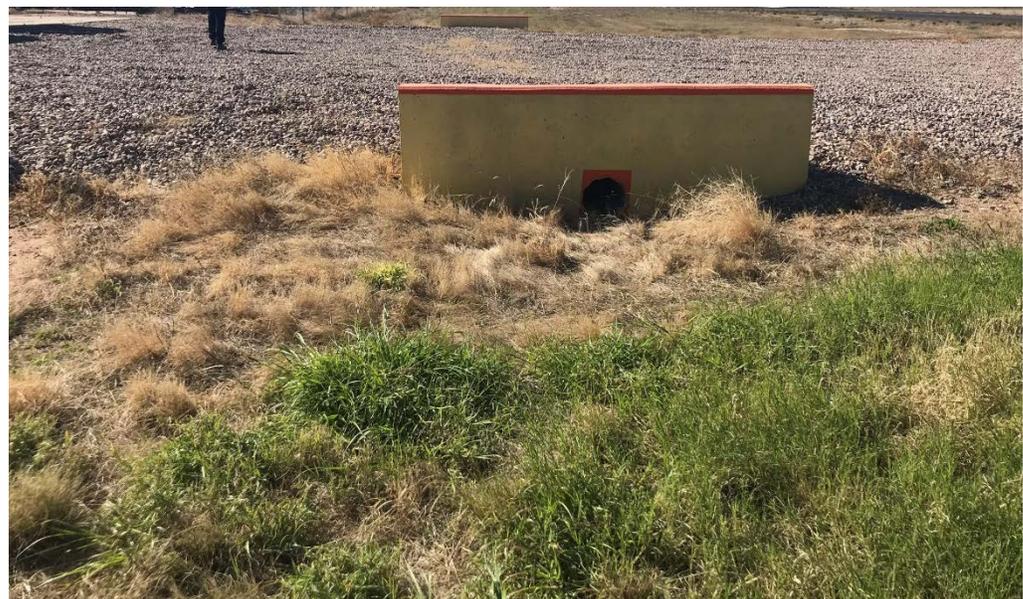
Photograph No. 6

Drainage ditch area west of
current fire station (L4320)

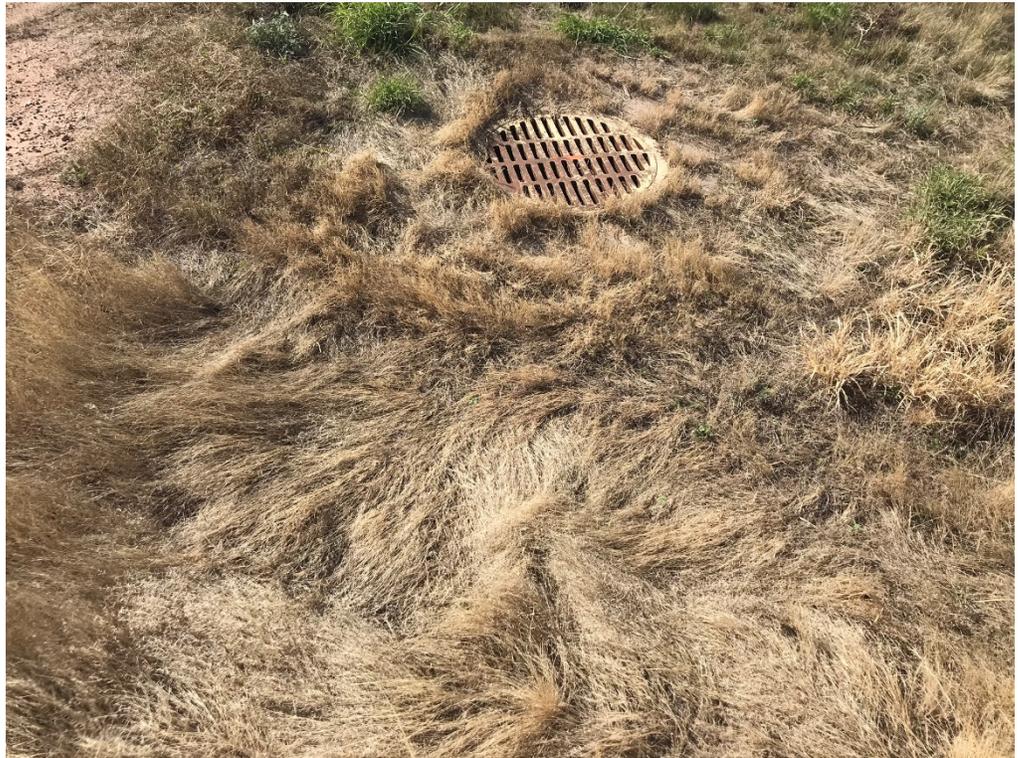
Drywell in drainage ditch
west of current fire station
(L4320)

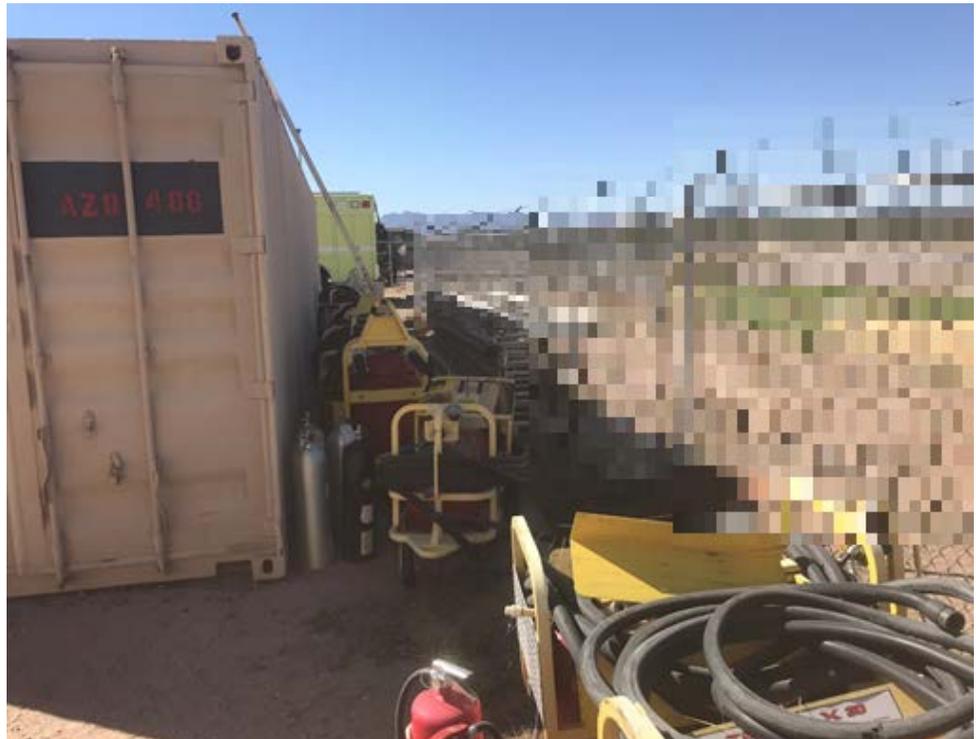
Photograph No. 8

Tri-max storage area west
of current fire station
(L4320)

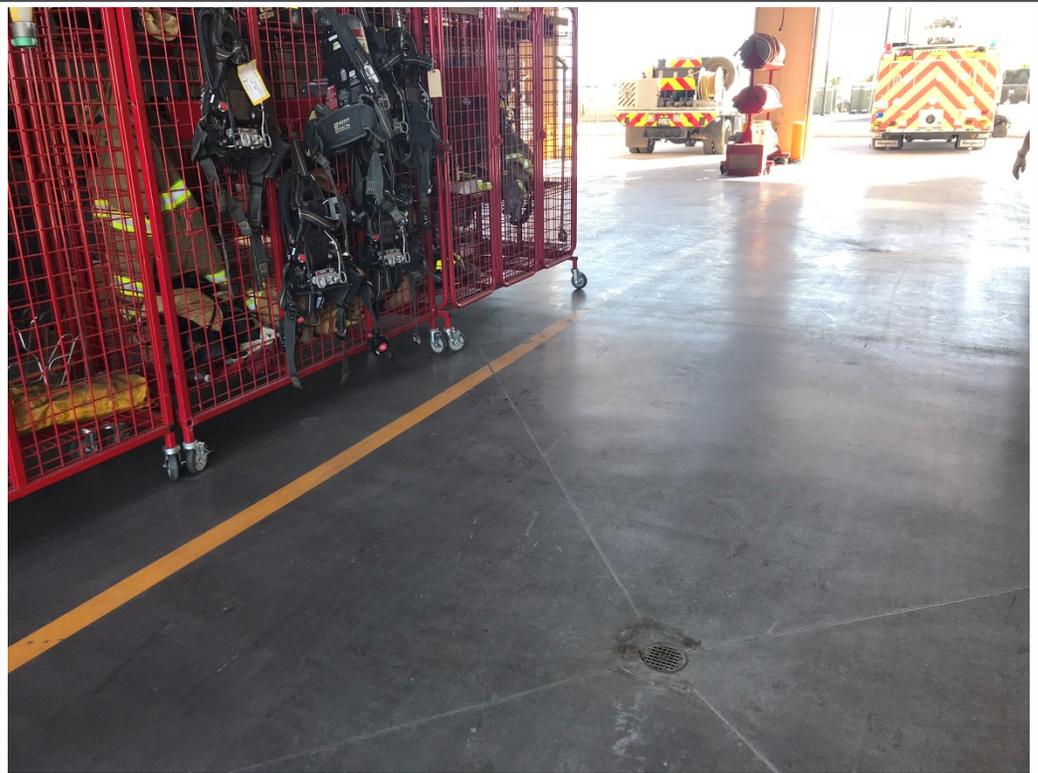
Floor drain in current fire
station bay (L4320)
(view to NW)

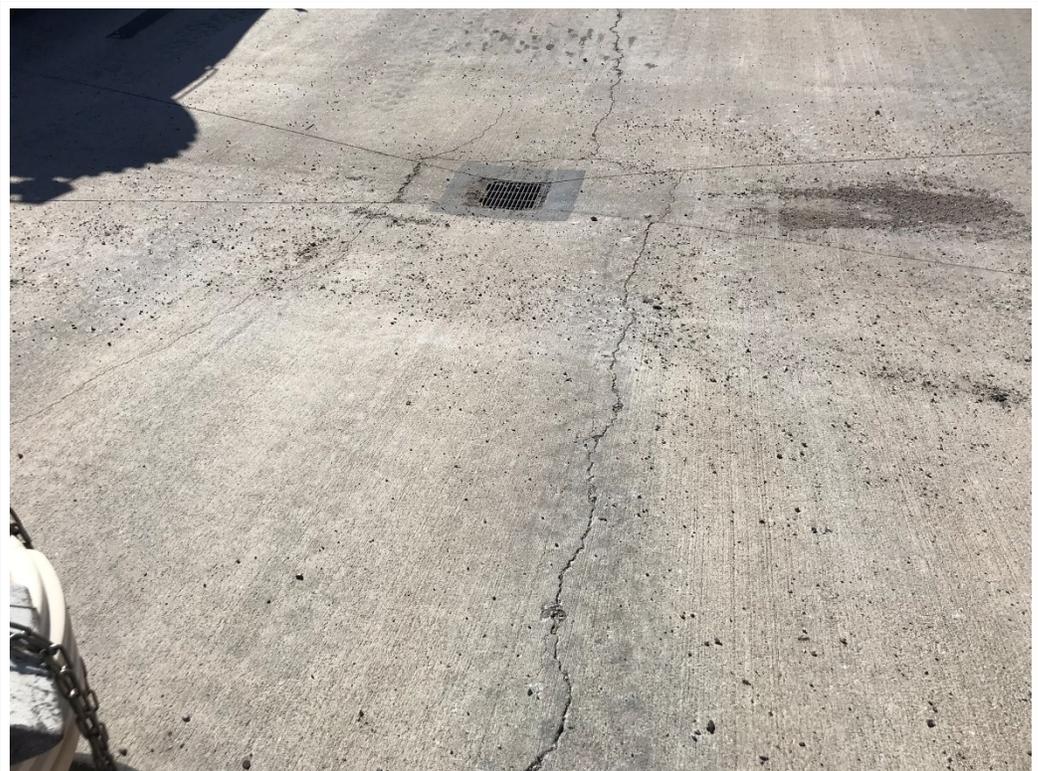
Photograph No. 10

Although the Wash Rack and Drain (L4603) has a drain directing fluids to the WWTP (L4710), it is possible that environmental releases of PFAS have occurred at the Wash Rack and Drain (L4603) due to cracks and/or leaks in the surface concrete or drainage piping to the WWTP (L4710). Furthermore, depending on the location of fire training exercises performed at the Wash Rack and Drain (L4603), the unpaved area to the northeast may have been exposed to liquids containing PFAS.

Spill pad drain concrete pad
with cracks

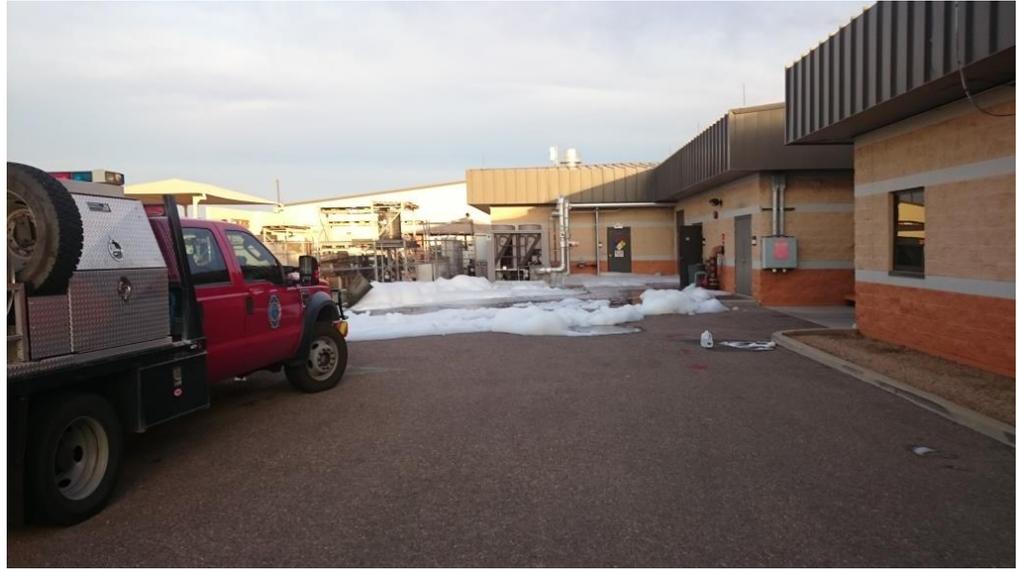
April 2017 release of AFFF
from fire riser room at the
back of the WAATS
building (L4605)

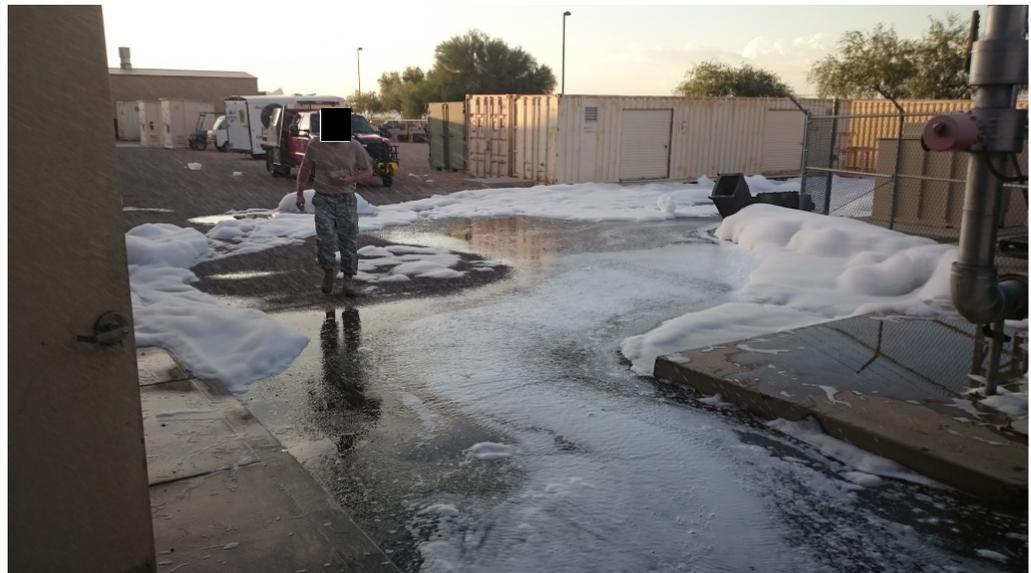
Photograph No. 12

April 2017 release of AFFF
from fire riser room at the
back of the WAATS
building (L4605)

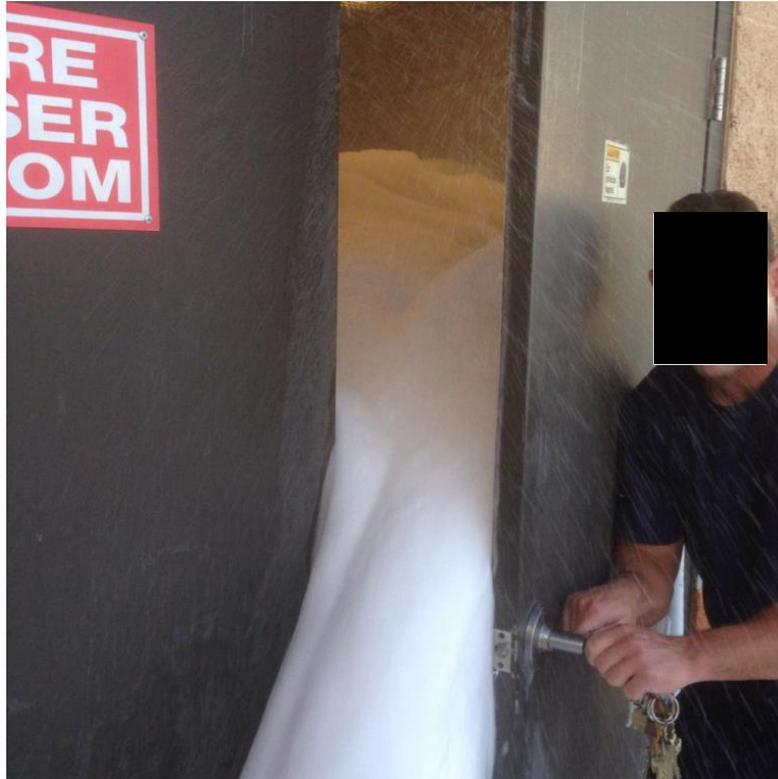
April 2017 release of AFFF
from fire riser room at the
back of the WAATS
building (L4605)

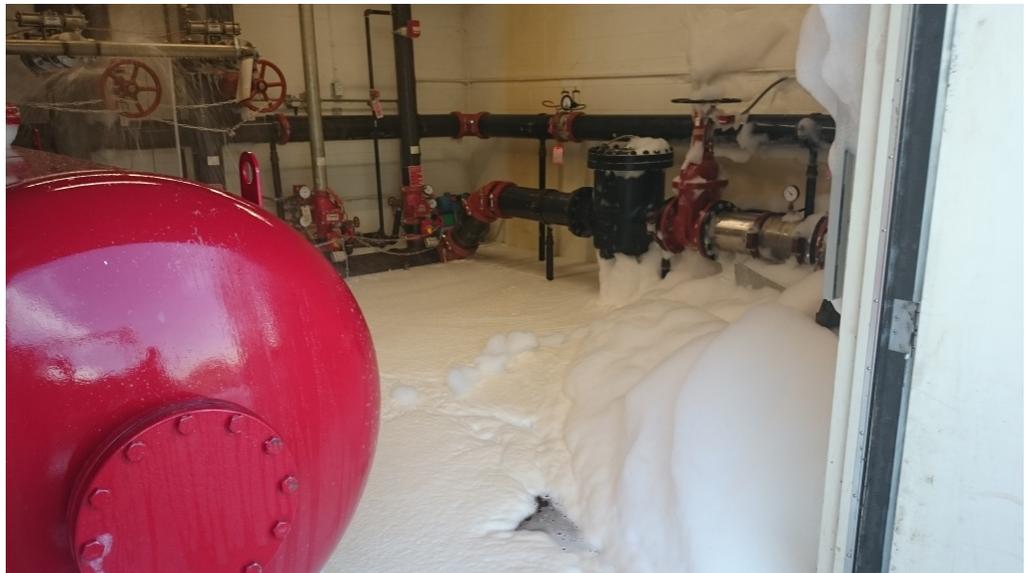
Photograph No. 14

April 2017 release of AFFF
from fire riser room at the
back of the WAATS
building (L4605)

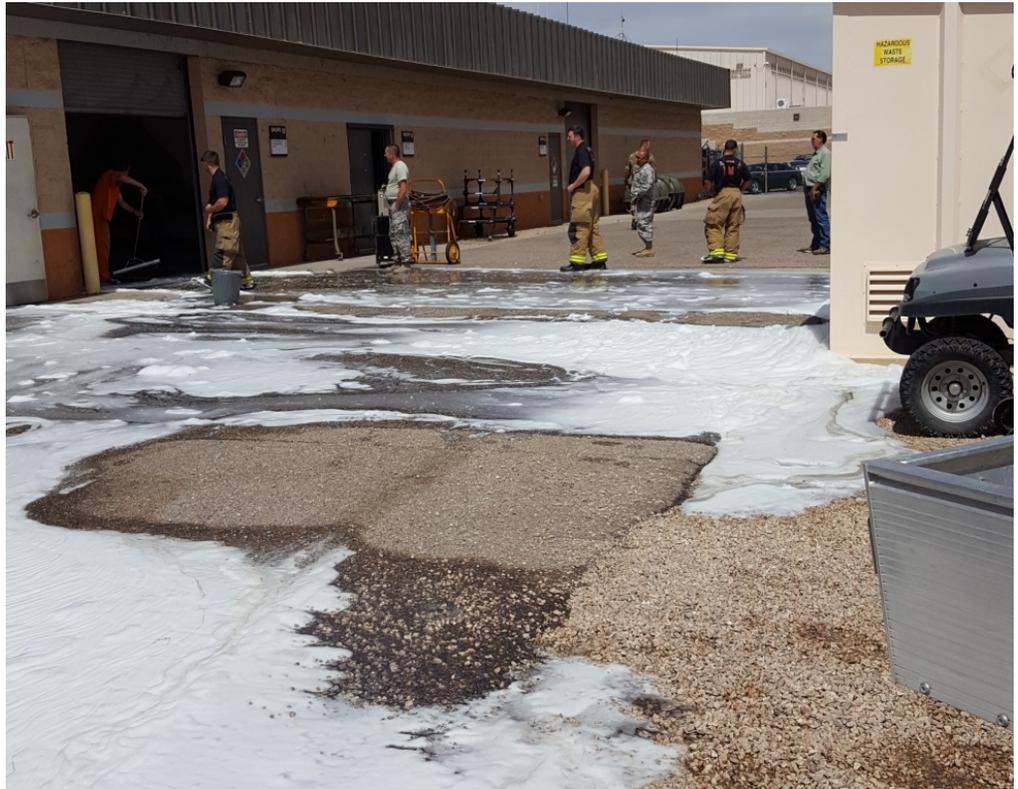
due to improper labeling. When the system was tested, the “old paint booth” riser activated and filled the room with AFFF, though it was no longer the paint booth at that moment, as it was used as the sheet metal shop. The volume of AFFF released is unknown. According to SBAH personnel, the release was squeegeed out, washed out, and pushed out to the gravel area northeast of the building.

May 2018 release of AFFF
from the “old paint booth”
at the back of the WAATS
building (L4605)

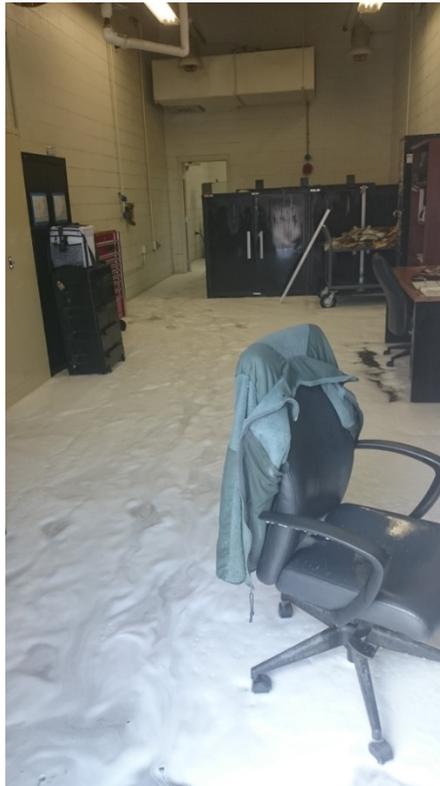
Photograph No. 16

May 2018 release of AFFF
from the “old paint booth”
at the back of the WAATS
building (L4605)

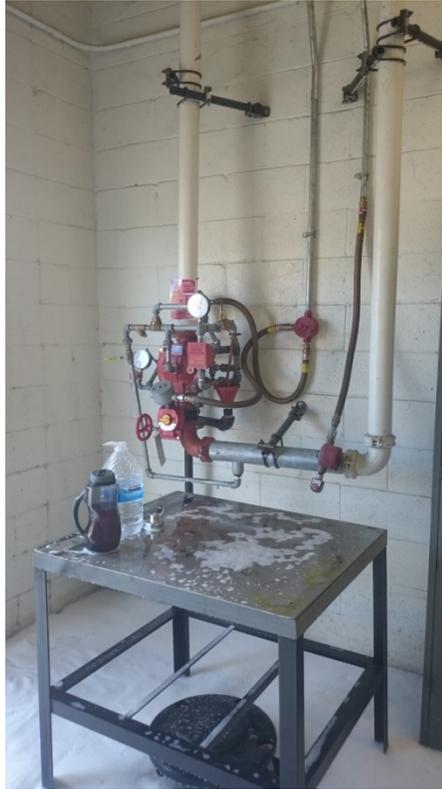
May 2018 release of AFFF from the “old paint booth” at the back of the WAATS building (L4605)

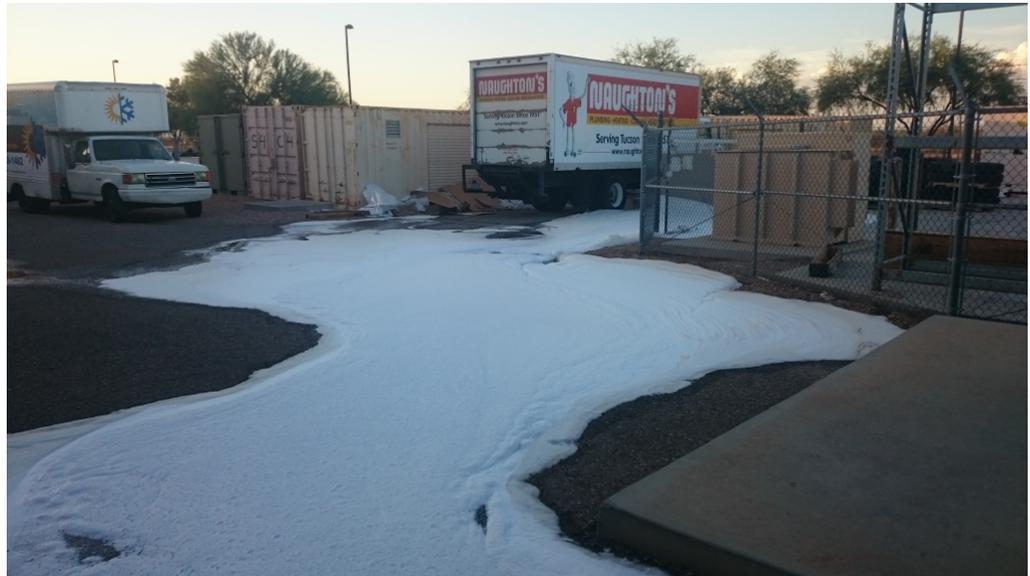
Photograph No. 18

July 2018 release of AFFF from fire riser room at the back of the WAATS building (L4605)

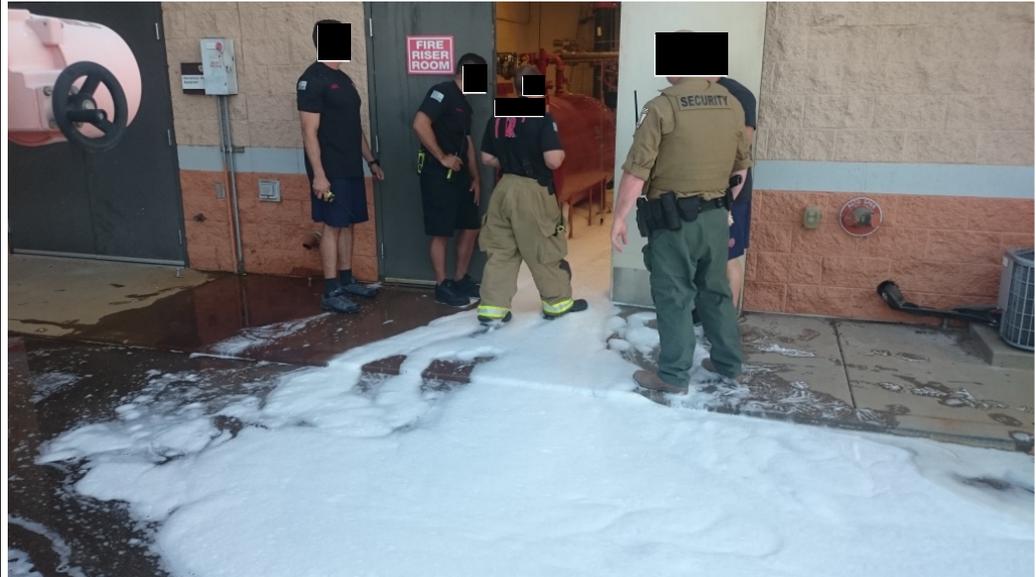
July 2018 release of AFFF
from fire riser room at the
back of the WAATS
building (L4605)

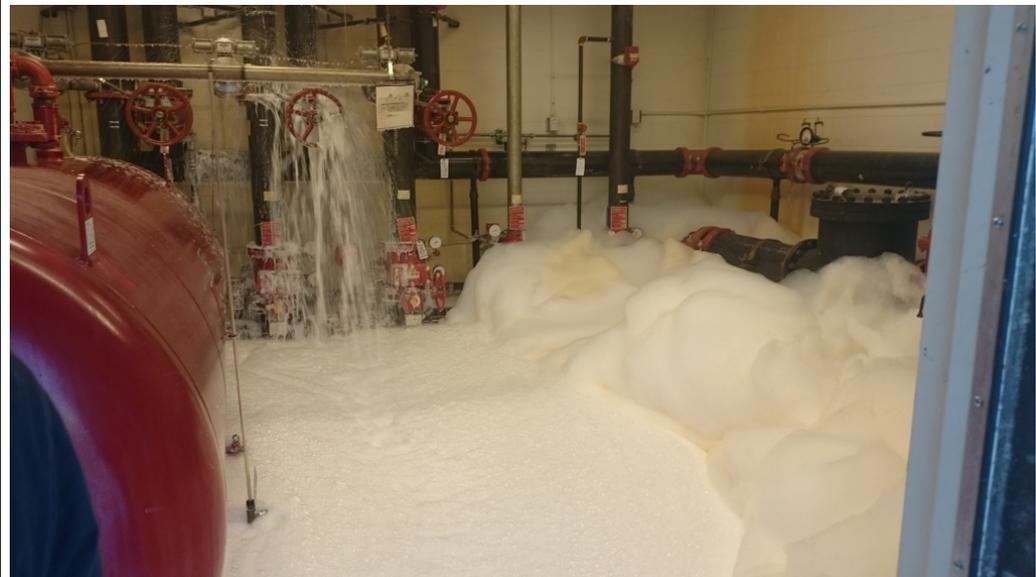
Photograph No. 20

July 2018 release of AFFF
from fire riser room at the
back of the WAATS
building (L4605)

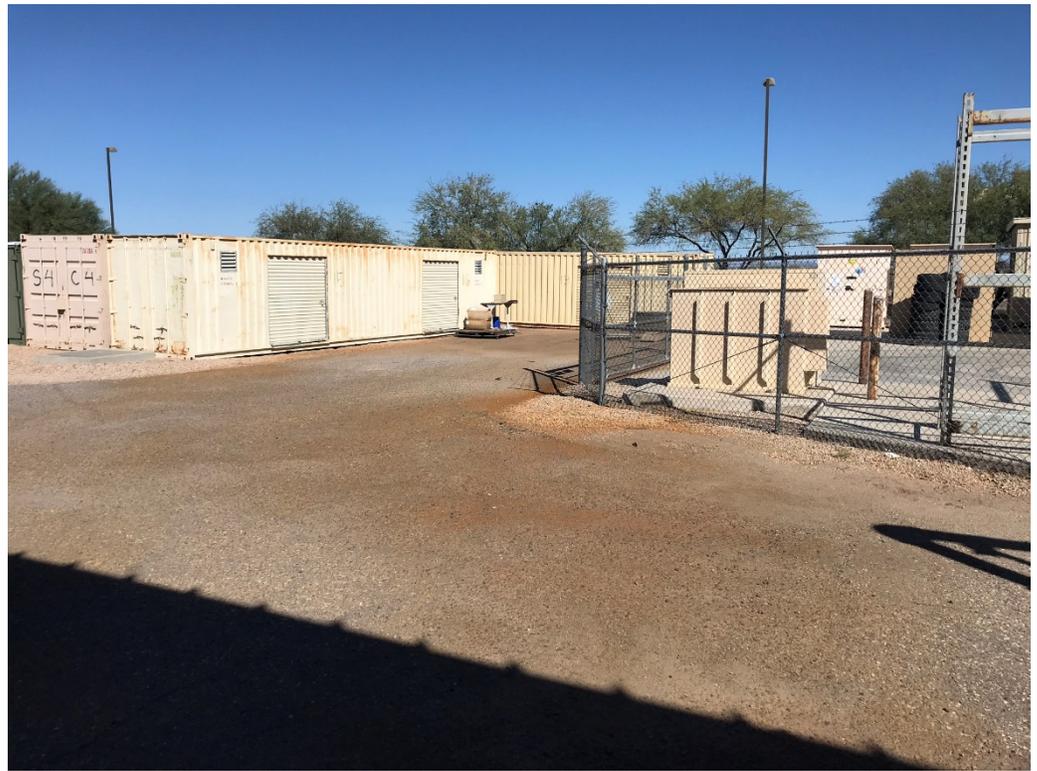
It is presumed that PFAS entered the environment in the unpaved areas to the northeast of the WAATS Hangar (L4605) as a result of these AFFF releases. Depending on the magnitude of the releases and rainfall following the events, PFAS may have also migrated to the stormwater feature to the northeast and to the stormwater retention basin. Possible staining was identified during the site visit in the bare earth area to the northeast.

Gravel area behind WAATS
(L4605) where the April 2017,
May 2018, and July 2018
releases occurred
