Preliminary Assessment Report

Robinson Maneuver Training Center, North Little Rock, Arkansas

Perfluorooctane-Sulfonic Acid (PFOS) and Perfluorooctanoic Acid
(PFOA) Impacted Sites
ARNG Installations, Nationwide

March 2020

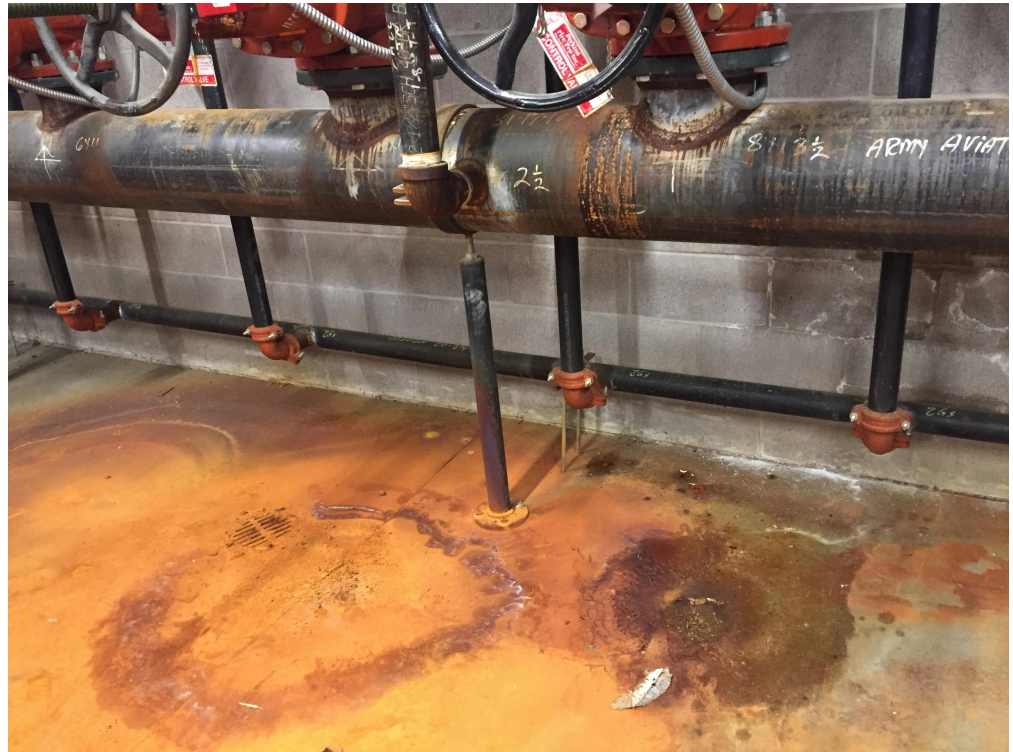
During the VSI, rust staining with white residue were observed on the concrete floor of the fire suppression system tank room, leading into a floor drain. RMTC personnel stated that the staining was most likely from water leaks, but an AFFF leak was possible. The floor drain is connected to the facility wastewater treatment plant (WWTP). All fire extinguishers observed within the building and in the immediate vicinity of the building were dry chemical fire extinguishers (non-AFFF).

Residual and rust staining observed nearby a floor drain in the AFFF fire suppression system pump room of Building 2800.

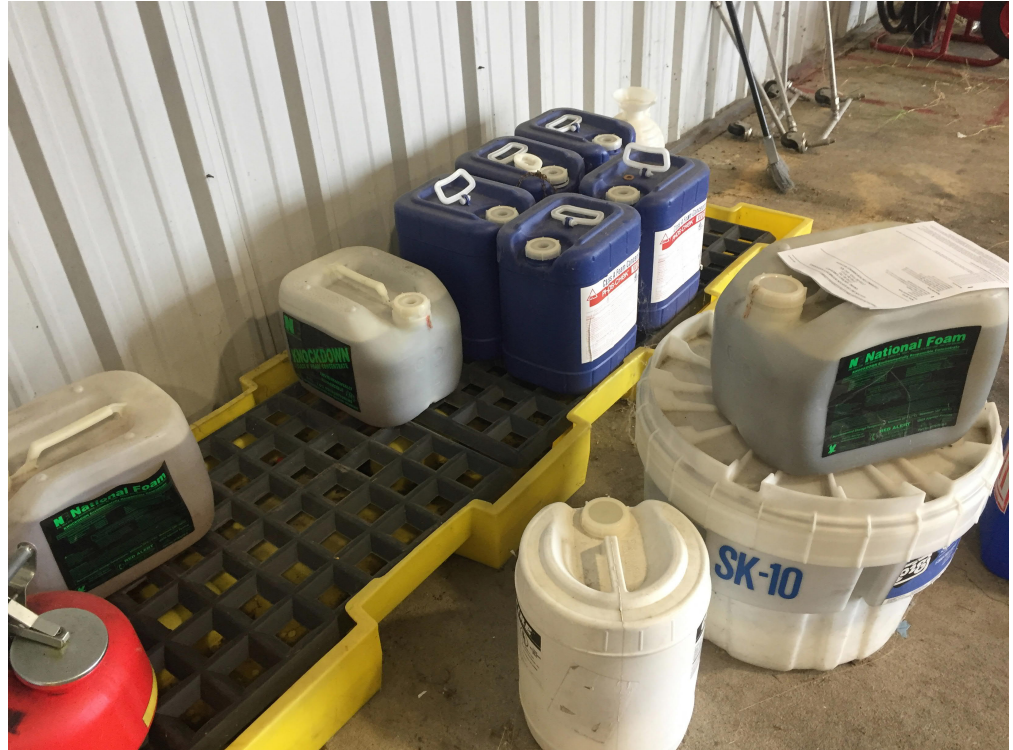
During the VSI, eight 5-gallon buckets of Class A foam were observed in storage at the Wash Bay. There was no evidence of AFFF storage despite reports of current storage.

A total of eight 5-gallon containers of Class A foam were observed stored in the Wash Bay.

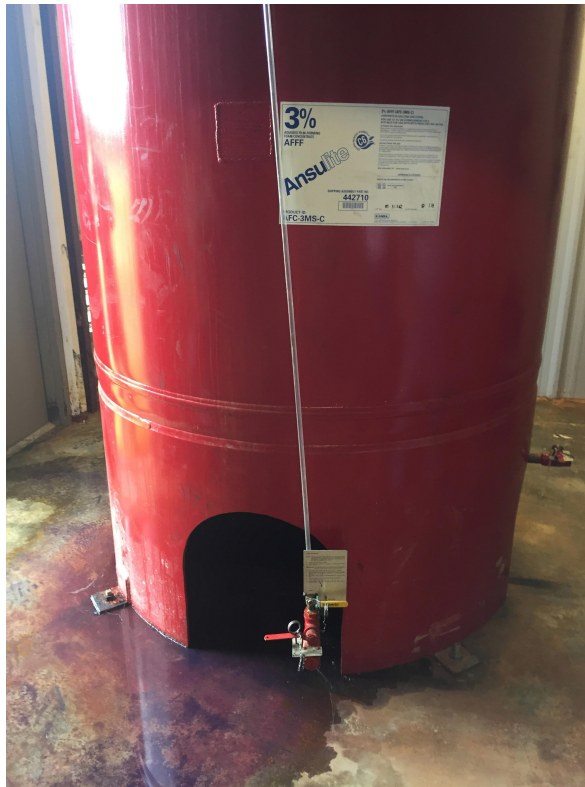
During the VSI, the fire suppression system tank room was found to have an active drip leak of AFFF from an overhead pipe. The AFFF was pooled in the area surrounding the AFFF tank. However, the spillage remained contained within the room as there were no floor drains or cracks in the concrete floor. Repair services were requested by RMTC and the day following the site visit (18 July 2019), a contractor used a suction truck to remove all the waste AFFF and capped off the leaking pipe.

AFFF was found to be actively leaking from an overhead pipe in the fire suppression system tank room of Building 28002. The AFFF was pooled in the area beneath the AFFF tank, which has a 1,100-gallon capacity and contains 3% AFFF of the brand Ansulite.

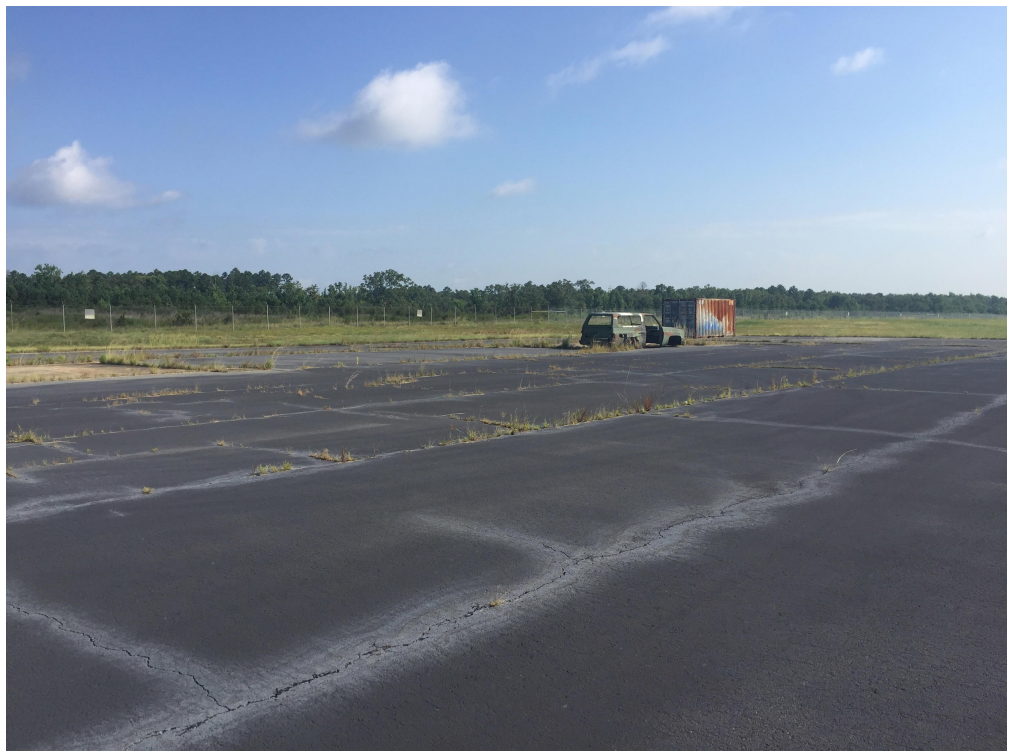
During the VSI of the Echo Pad, multiple cracks were observed throughout the pavement. A mock vehicle and Conex box were also observed stationed at the northern corner of the Echo Pad, where it was indicated that personnel would practice target spraying of the firehose. Drainage swales surround most of the Echo Pad and connect to Outfalls 004 and 005, which drain northeast to tributary creeks of the Arkansas River (Military Department of Arkansas, 2018).

The Echo Pad is an aircraft ramp/pad located at the Robinson Army Airfield where fire training activities involving AFFF are suspected to have occurred. A mock vehicle and Conex box is observed in the distance at the northern corner of the Echo Pad.
