# FINAL Preliminary Assessment Report Camp Roberts, California

Perfluorooctane-Sulfonic Acid (PFOS) and Perfluorooctanoic  
Acid (PFOA) Impacted Sites  
ARNG Installations, Nationwide

November 2019

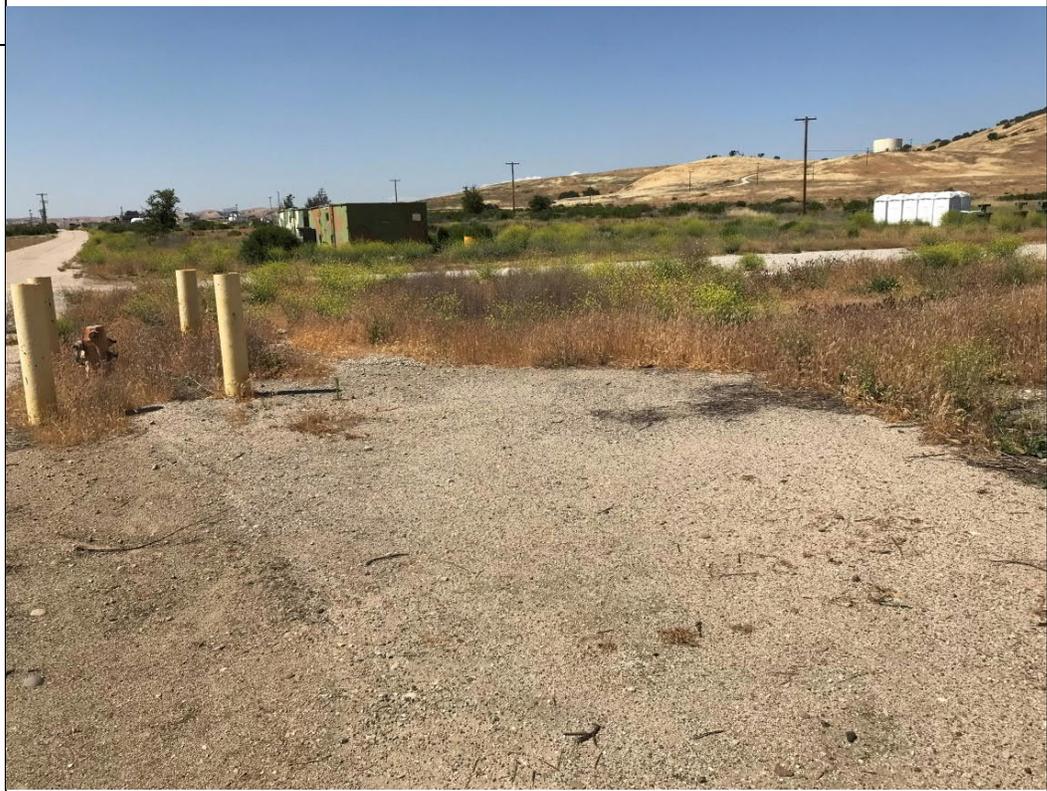
View of East Garrison Old Fire Training Area in vicinity of Camp Roberts Army Airfield. View to the west.

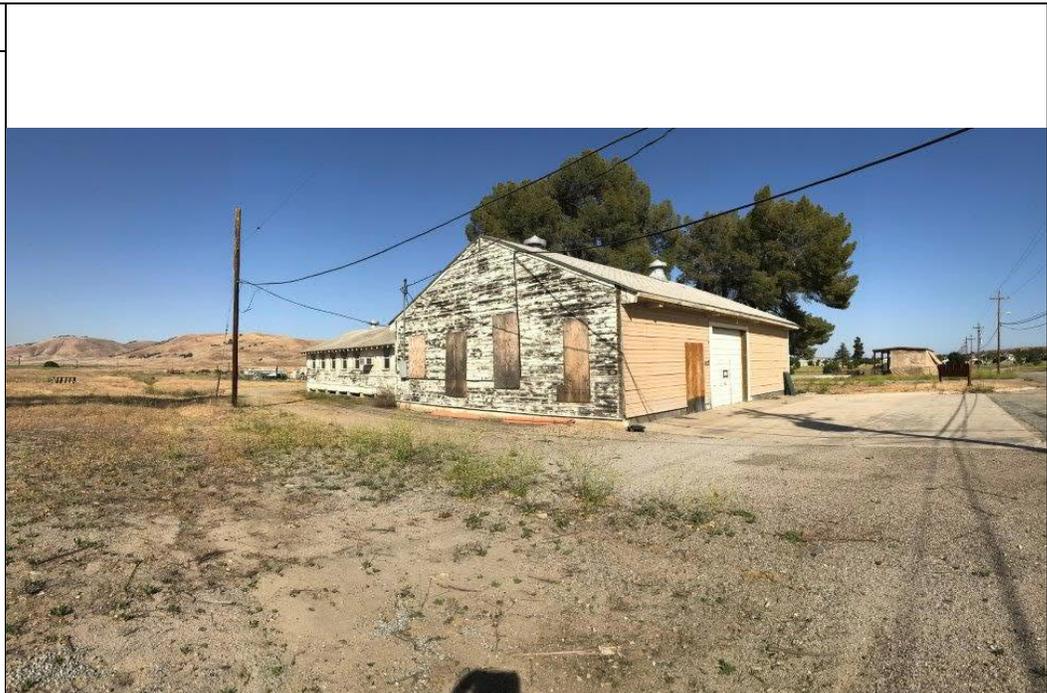
### Photograph No. 2

View of old Fire Station Building 7020 adjacent to Main Garrison Fire Training Area 2. View to the northeast.

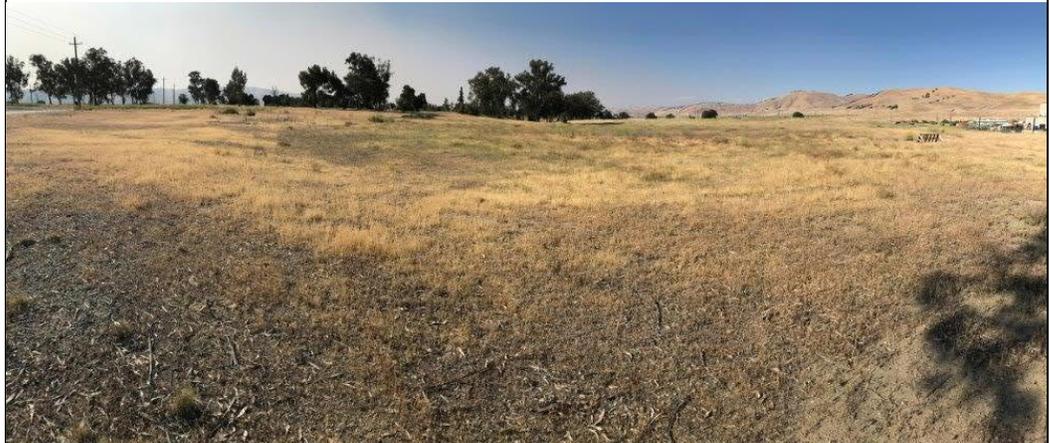
View of Main Garrison Fire Training Area 2 in vicinity of Building 7020. View to the northwest

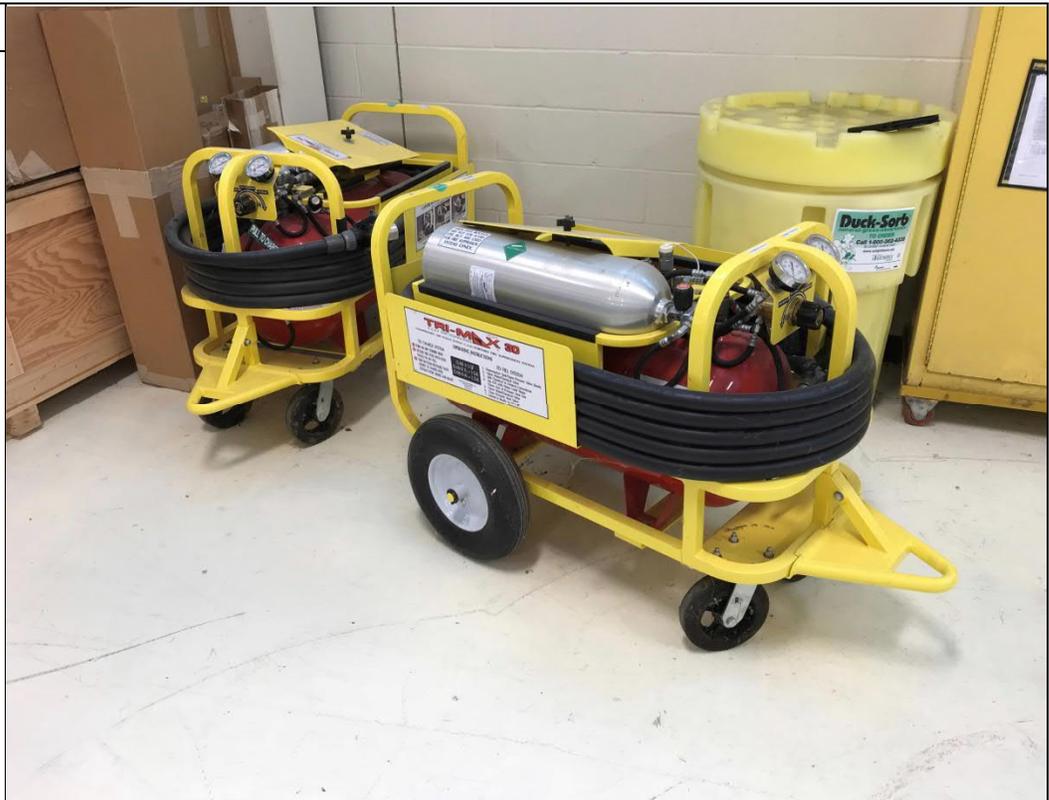
### Photograph No. 4

The CA ARNG TUAS division operates a hangar, designated as Building 1702, where they perform TUAS aircraft maintenance. The geographic coordinates of the hangar are 35°42'56.93"N and 120°45'54.64"W (**Figure 3-1**). During the PA site visit, two Tri-Max 30 crash fire rescue carts were observed to be stored in the hangar. Photographs of the carts are included in **Appendix C**. Labels on the carts indicated that they contained either 2 quarts of Class A, 1 gallon of Class B 3% or 2 gallons of Class B 6% foam. The TUAS staff indicated that the crash carts have never been used and further stated that no AFFF has been used at McMillan Airfield based on their recollection. Attempts were made via post-site visit follow-up requests to ascertain more information about the Tri-Max units, such as: whether the solution was changed out periodically, who would use these units in the case of an emergency, and who is responsible for maintaining the Tri-Max. No additional information was made available.

View of TUAS Hangar Building 1702 of Tri-Max 30 crash fire rescue carts.

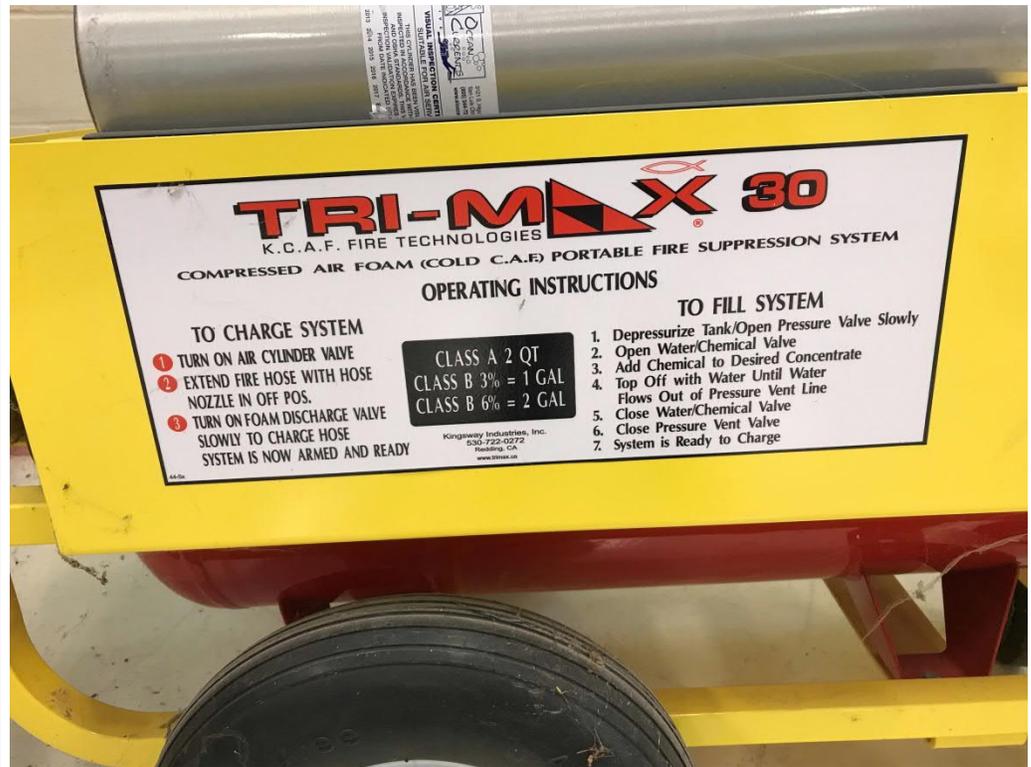
View of Tri-Max 30 crash fire rescue cart label. Cart is stored in TUAS Hangar Building 1702.

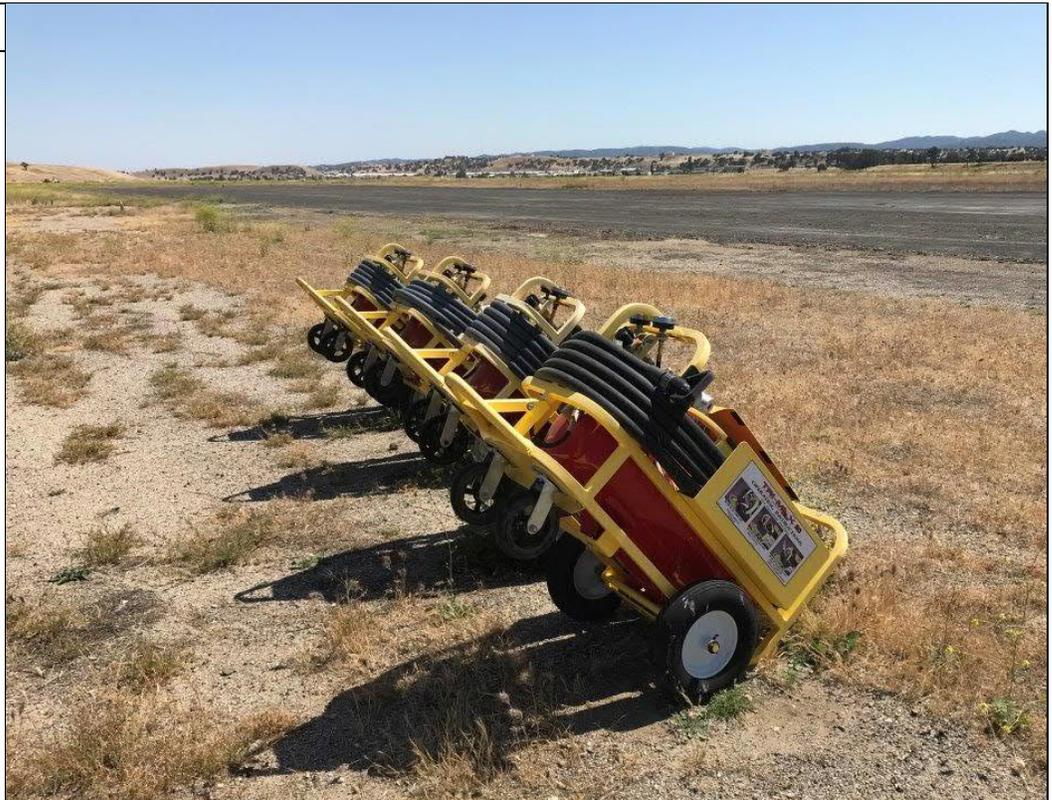
### Photograph No. 6

During the PA site visit, four Tri-Max 30 crash fire rescue carts were observed to be stored at the Airfield in an area historically used for parking aircraft. Photographs of the carts are included in **Appendix C**. Labels on the carts indicated that they contained either 2 quarts of Class A, 1 gallon of Class B 3% or 2 gallons of Class B 6% foam. Two of the carts were observed to be without compressed air tanks and cannot be used to dispense AFFF. The Airfield operations control staff that were interviewed indicated that the crash carts were charged but never used, and no AFFF has been used at or within the vicinity of the Airfield. If service was needed, it was provided by an off-site vendor.

View of East Garrison Camp Roberts Army Airfield Tri-Max 30 crash fire rescue carts stored adjacent to rotary wing landing field. View to the east.

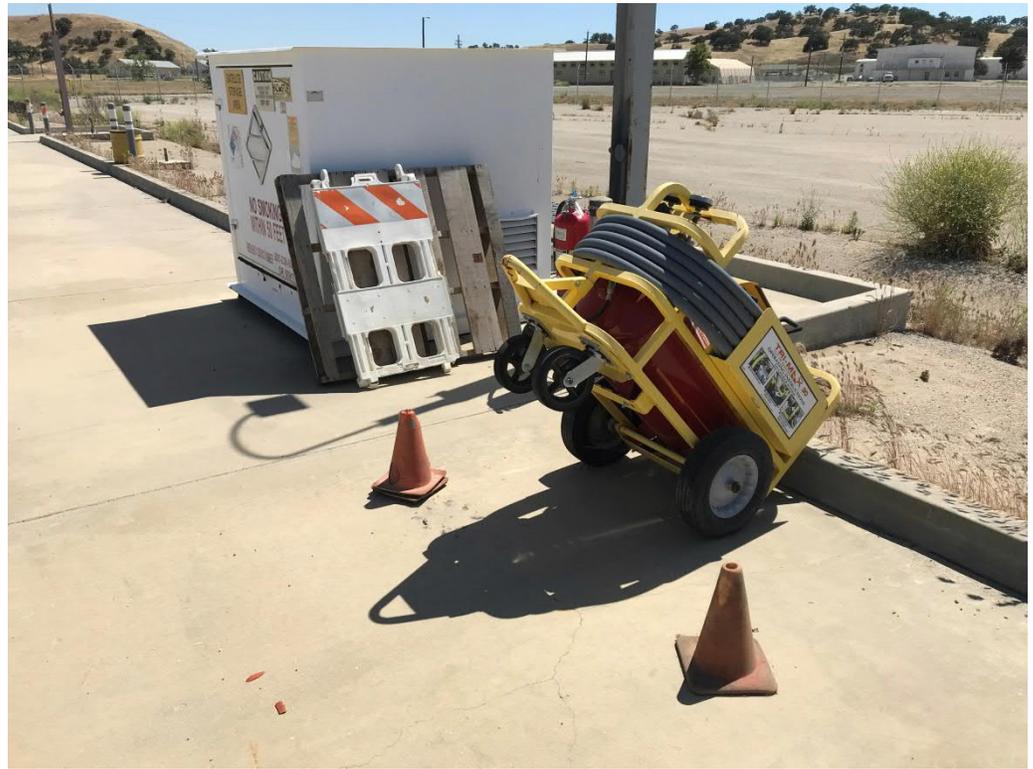
During the PA site visit, one Tri-Max 30 crash fire rescue cart was observed in the southern end of the field within a fuel point area. Photographs of the cart are included in **Appendix C**. Labels on the carts indicated that they contained either 2 quarts of Class A, 1 gallon of Class B 3% or 2 gallons of Class B 6% foam. Based on interviewee recollection, the cart has not been used, tested, or maintained. Any service needed would have been provided by an off-site vendor.

View of Tri-Max 30 crash fire rescue cart stored at a fueling depot situated at the south end of the Camp Roberts Parade Field. View to the southwest.

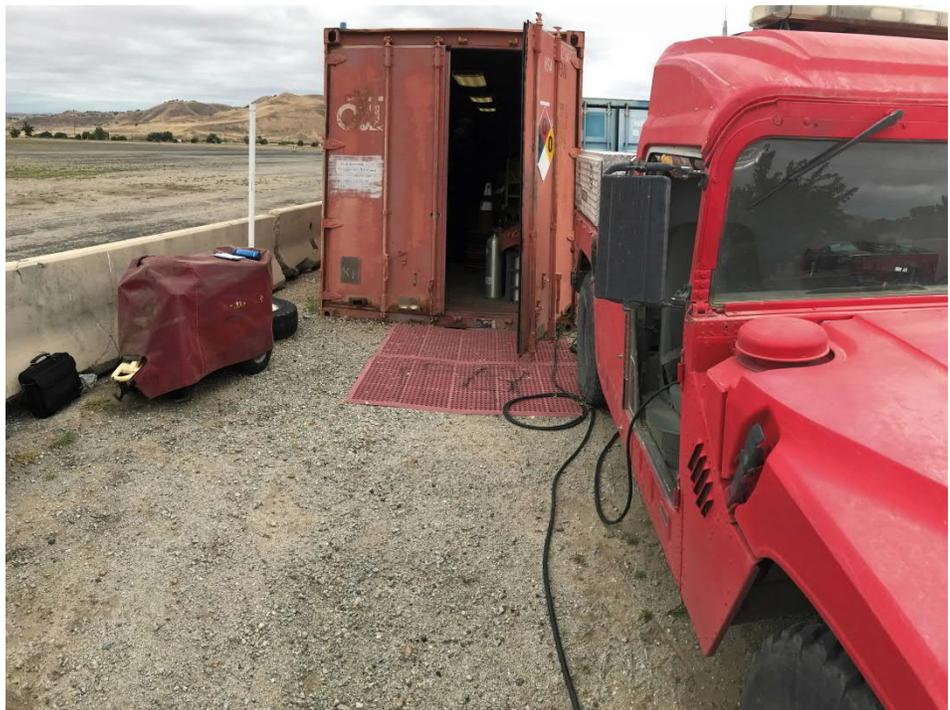
### Photograph No. 8

View of Camp Roberts Fire Department shipping container used at the fire station. View to the north.

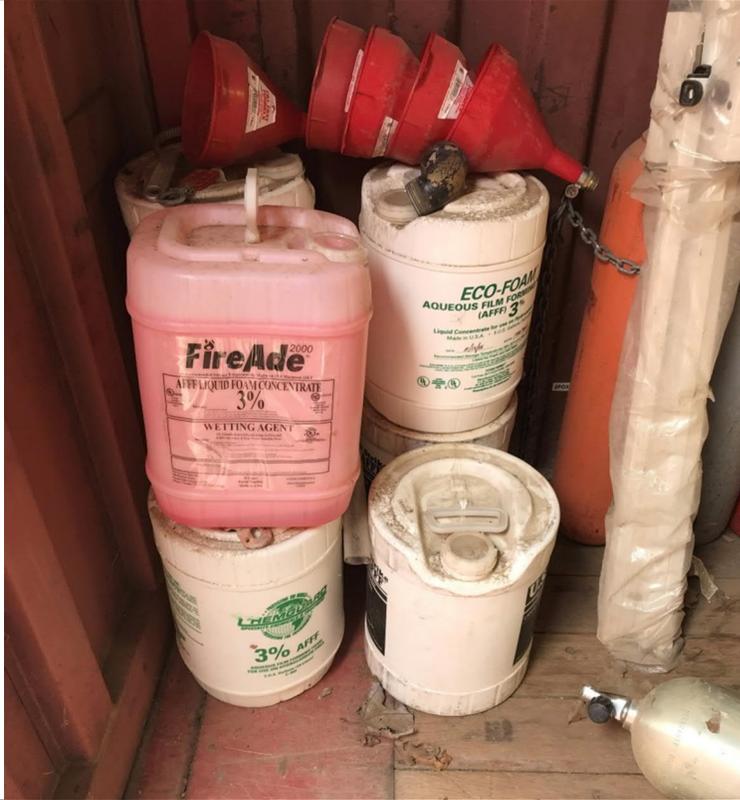
View of various AFFF brands stored in a shipping container situated to the west of the Camp Roberts Fire Department station.

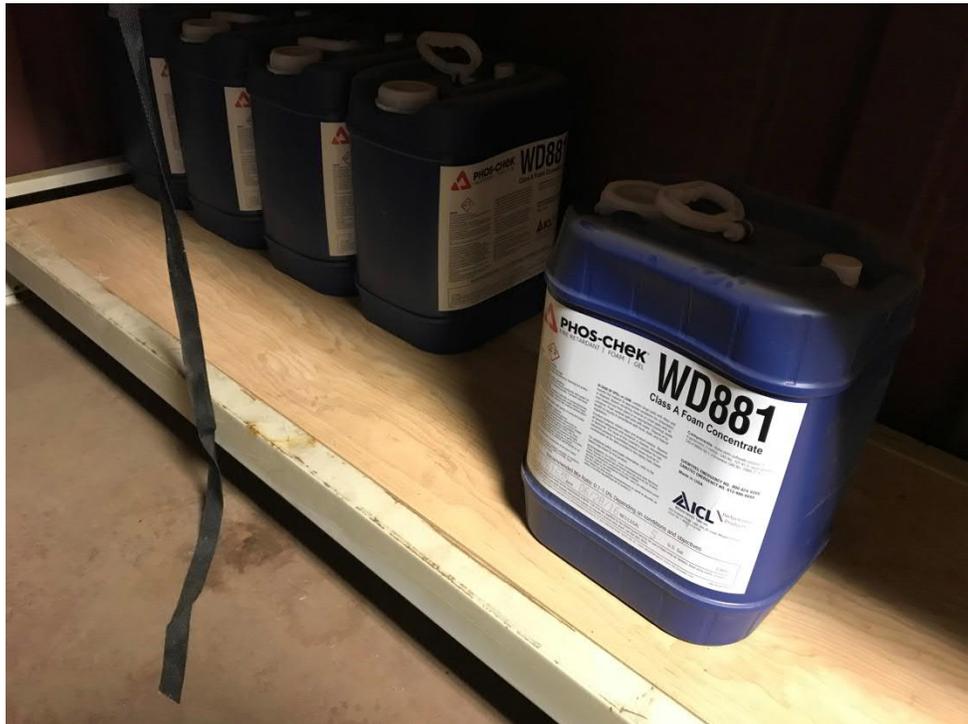
### Photograph No. 10

View of AFFF stored in a shipping container situated to the west of the Camp Roberts Fire Department station.

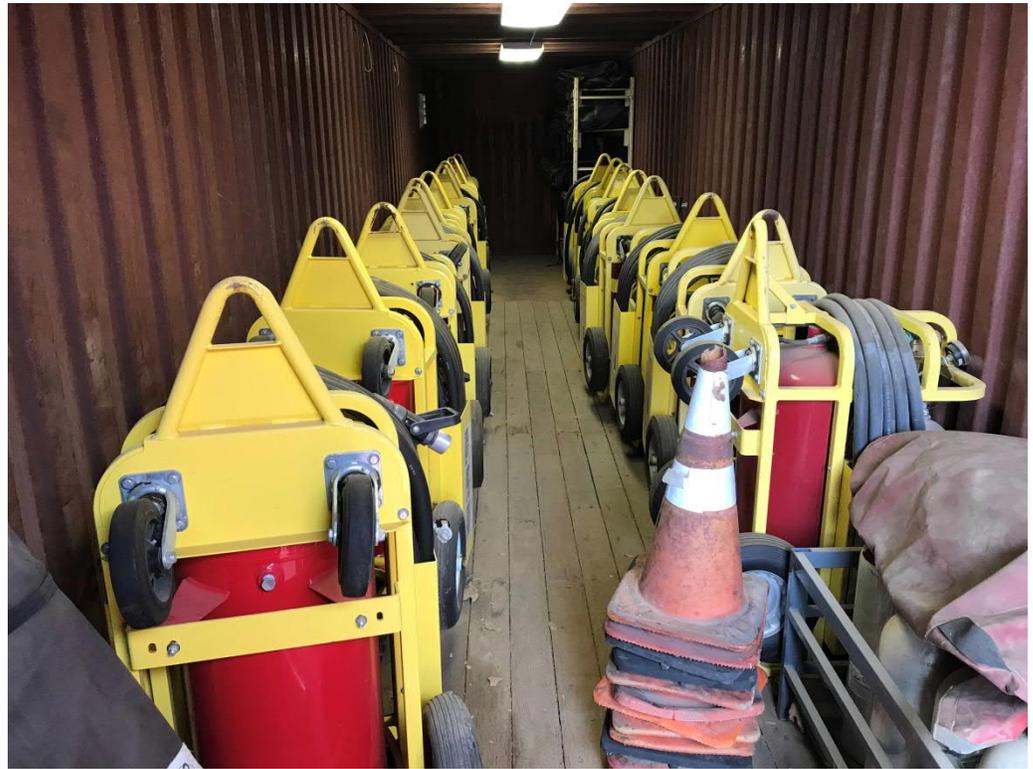
During the PA site visit a total of 20 Tri-Max 30 crash fire rescue carts were observed to be stored in or just outside of the container. According to CR FD staff interviewed, none of the carts are used, as they are designated as out-of-service due to various issues. Additionally, numerous 5-gallon plastic containers of various brands of AFFF were observed to be stored in the container. The inventory of AFFF stored included: 12 containers of Phos-Chek WD881 Class-A Foam Concentrate, one container of FireAde 2000 3% AFFF Liquid Foam Concentrate, five containers of Eco-Foam 3% AFFF, and one container of US First Strike 3% AFFF Liquid Foam Concentrate. Material safety data sheets of the various AFFF products are included in **Appendix A**.

According to CR FD staff interviewed (whose tenure covers the last 22 years), the crash carts were historically filled with AFFF in an area outside the door of the container. Staff that were interviewed indicated that incidental leaks and spills may have occurred, however, details specific to the filling of carts were not recalled.

View of Tri-Max 30 crash fire rescue carts stored in a shipping container situated to the west of the Camp Roberts Fire Department station.

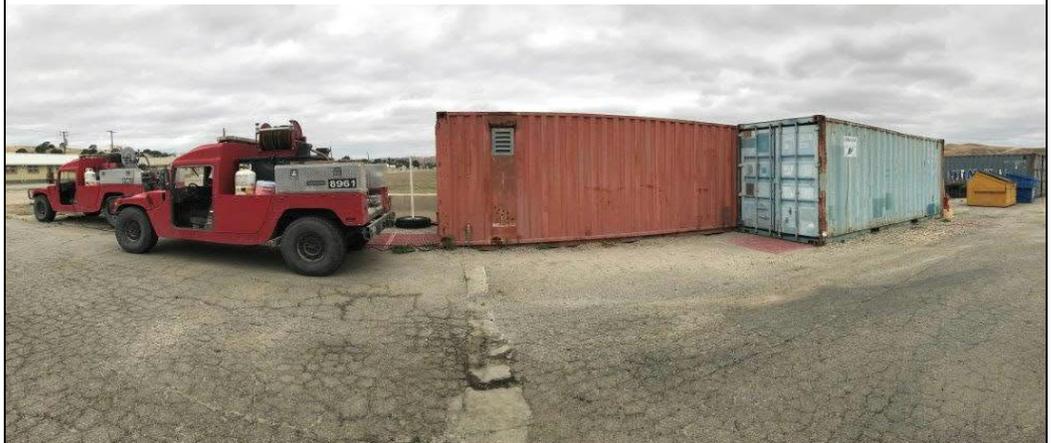
### Photograph No. 12

The area was observed to be gravel covered and relatively flat, with no discernable surface water flow direction. Groundwater beneath the area flows towards the east/northeast. No stormwater drainage infrastructure was observed in the immediate vicinity of the shipping container.

View to the west of the shipping container used by the Camp Roberts Fire Department for storage purposes.

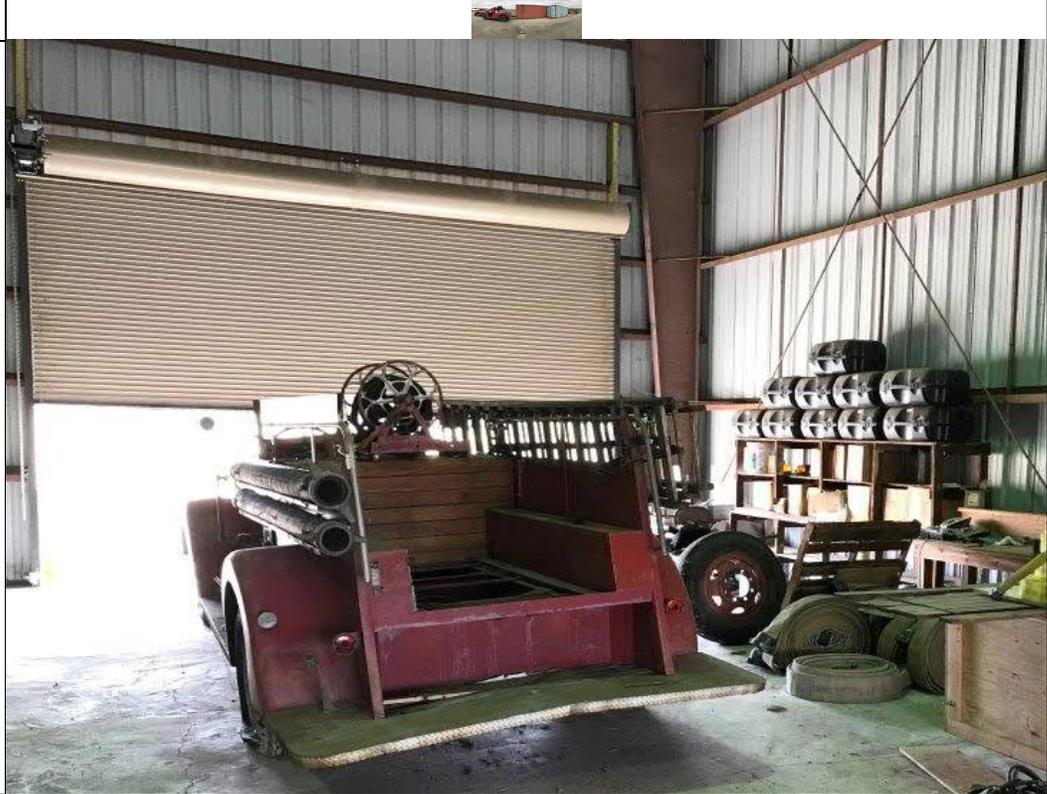
Building 3000 is used by the CR FD mostly for storing training equipment and supplies. During the PA site visit, 19 5-gallon plastic containers of various brands of AFFF were observed to be stored on shelves in the eastern corner of the building. The inventory of AFFF stored included 15 containers of Ansulite 6% AFFF and 4 containers of Chemguard 6% AFFF. Material safety data sheets of the AFFF products stored in the building are included in **Appendix A**. The approximate geographic coordinates of the approximate center of the area are 35°46'13.06"N; 120°44'02.49"W (**Figure 3-1**).

View of the interior of the Building 3000 warehouse used for equipment storage by the Camp Roberts Fire Department. AFFF was observed during the PA to be stored on the bottom of the shelf situated in the right-center portion of photograph.

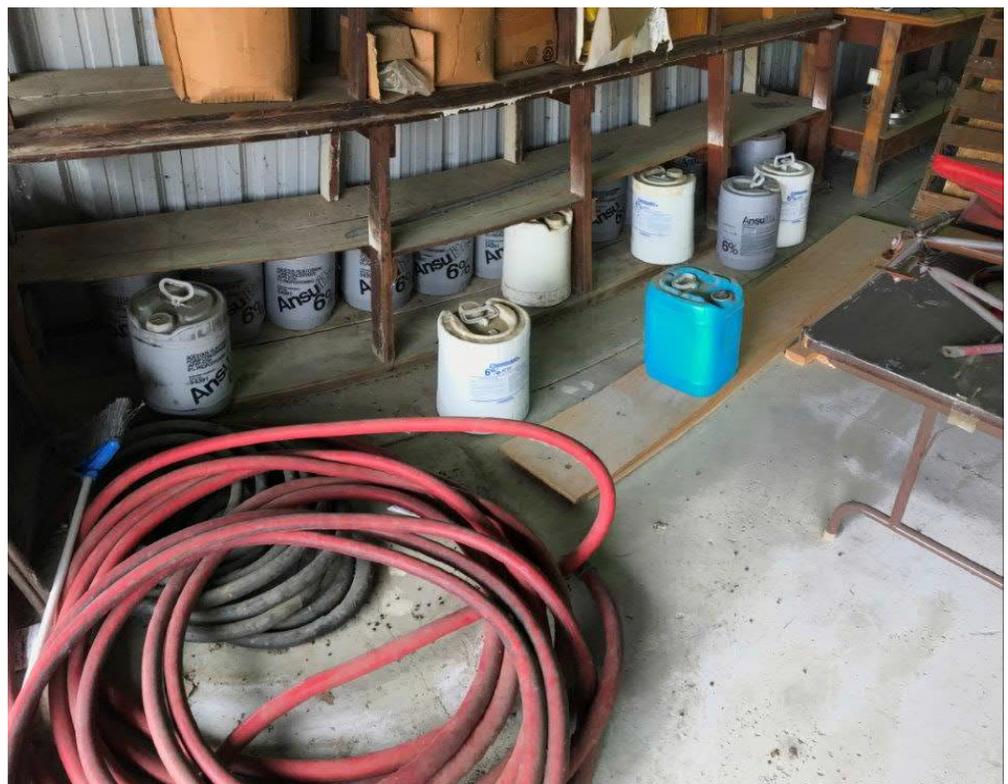
### Photograph No. 14

According to CR FD staff interviewed, the AFFF stored is purchased through Services Supply and has not been used since the early 2000s. Staff that were interviewed could not recall if there were any incidental spills or leaks of AFFF in the building.

View of various brands of AFFF stored in the Building 3000 warehouse used by the Camp Roberts Fire Department.

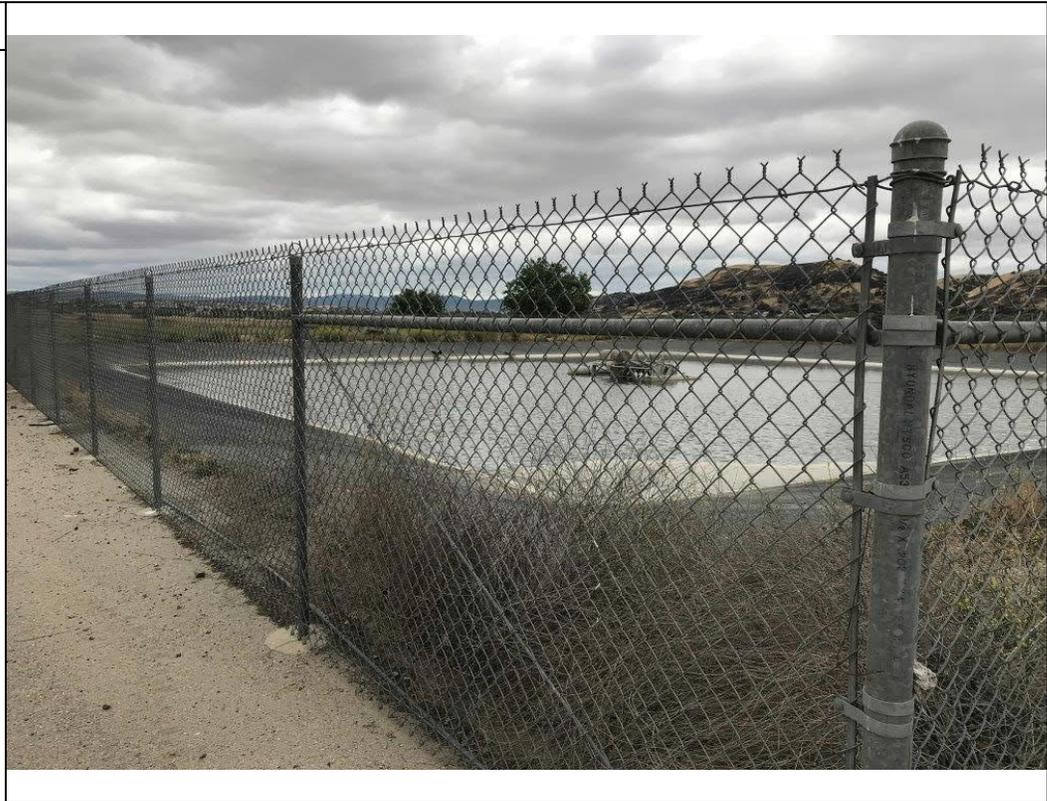
View of the Waste Water Treatment Plant settling/aeration ponds located in the East Garrison. View to the east.
