# FINAL Preliminary Assessment Report Mather AASF, California

Perfluorooctane-Sulfonic Acid (PFOS) and Perfluorooctanoic  
Acid (PFOA) Impacted Sites  
ARNG Installations, Nationwide

February 2020

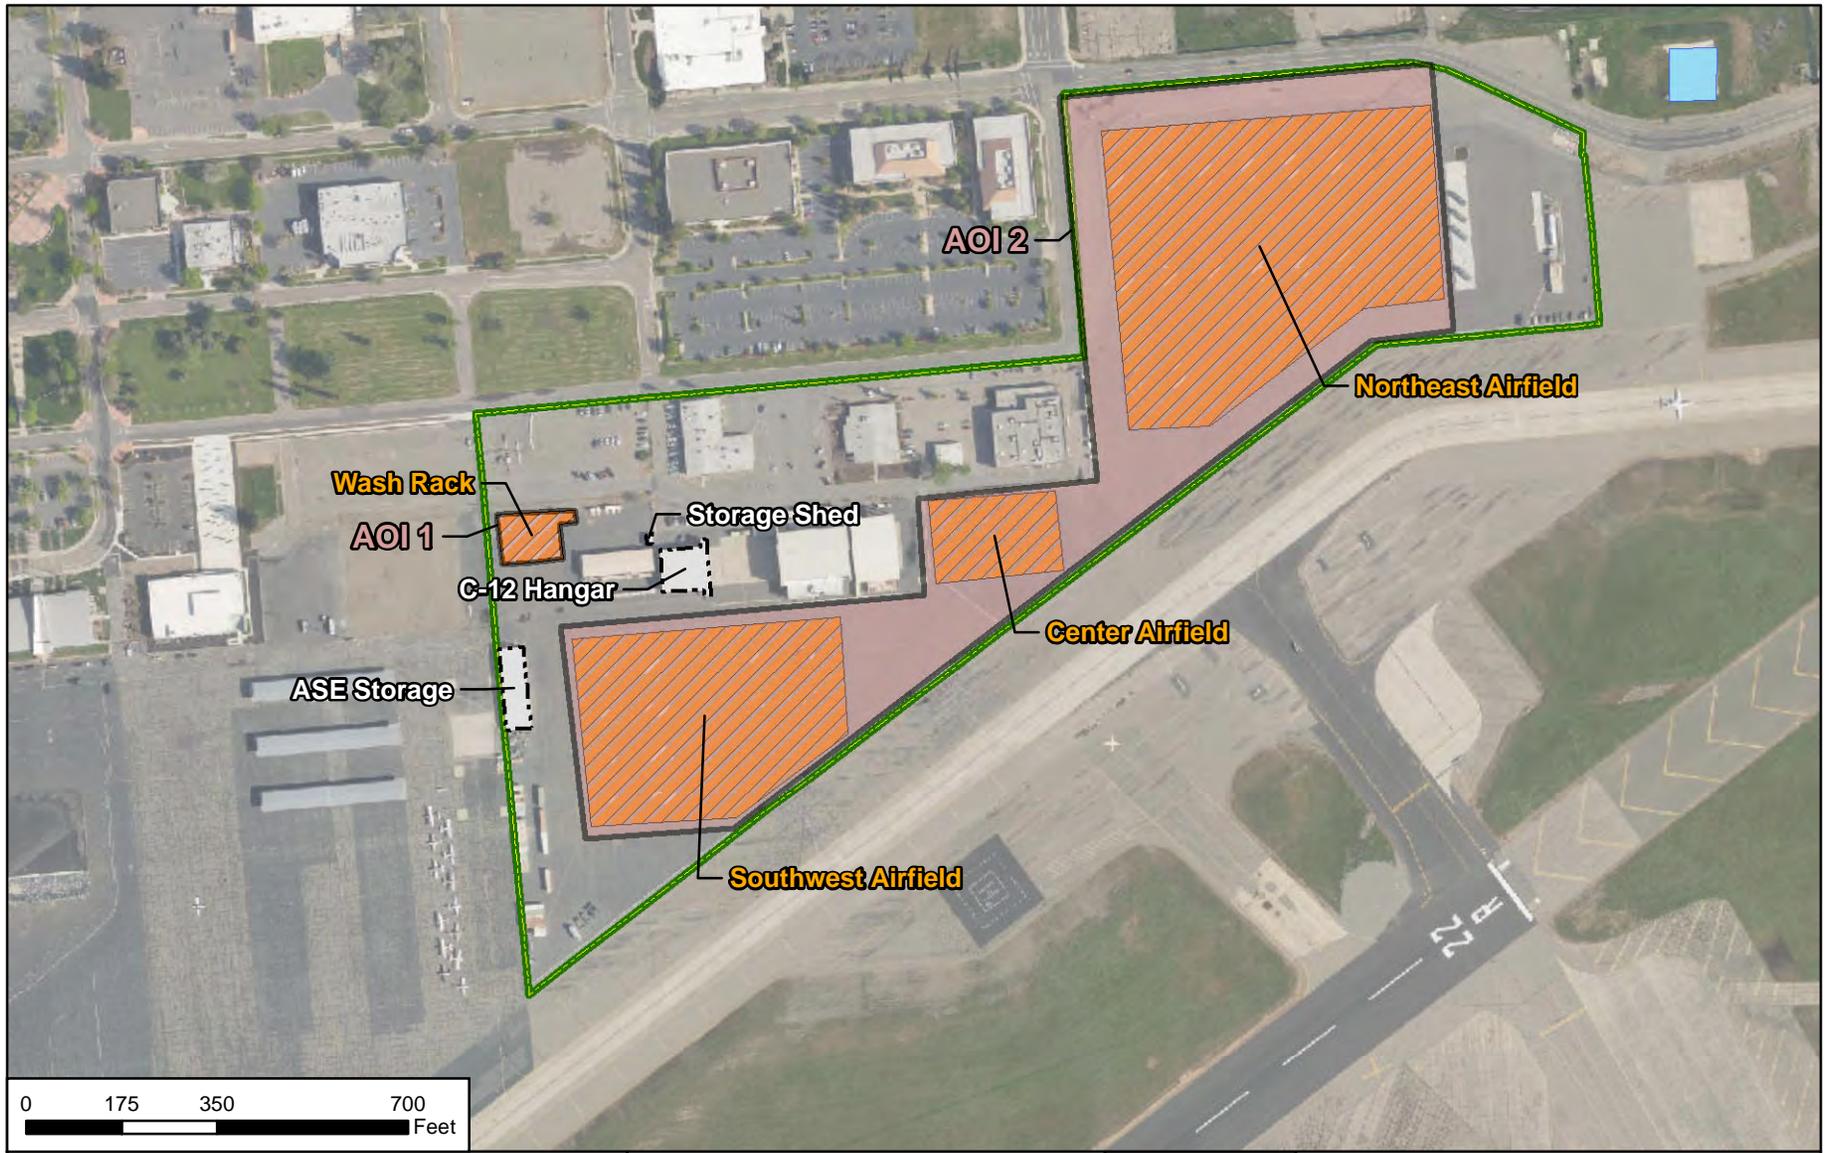
<b>Summary of Findings</b>	
<p>12420 Milestone Center Drive Germantown, MD 20876</p>	<b>Figure ES-1</b>

Two AOIs related to potential PFAS releases were identified at Mather AASF during the PA. The AOIs are shown on **Figure ES-1** and in **Table ES-1** below:

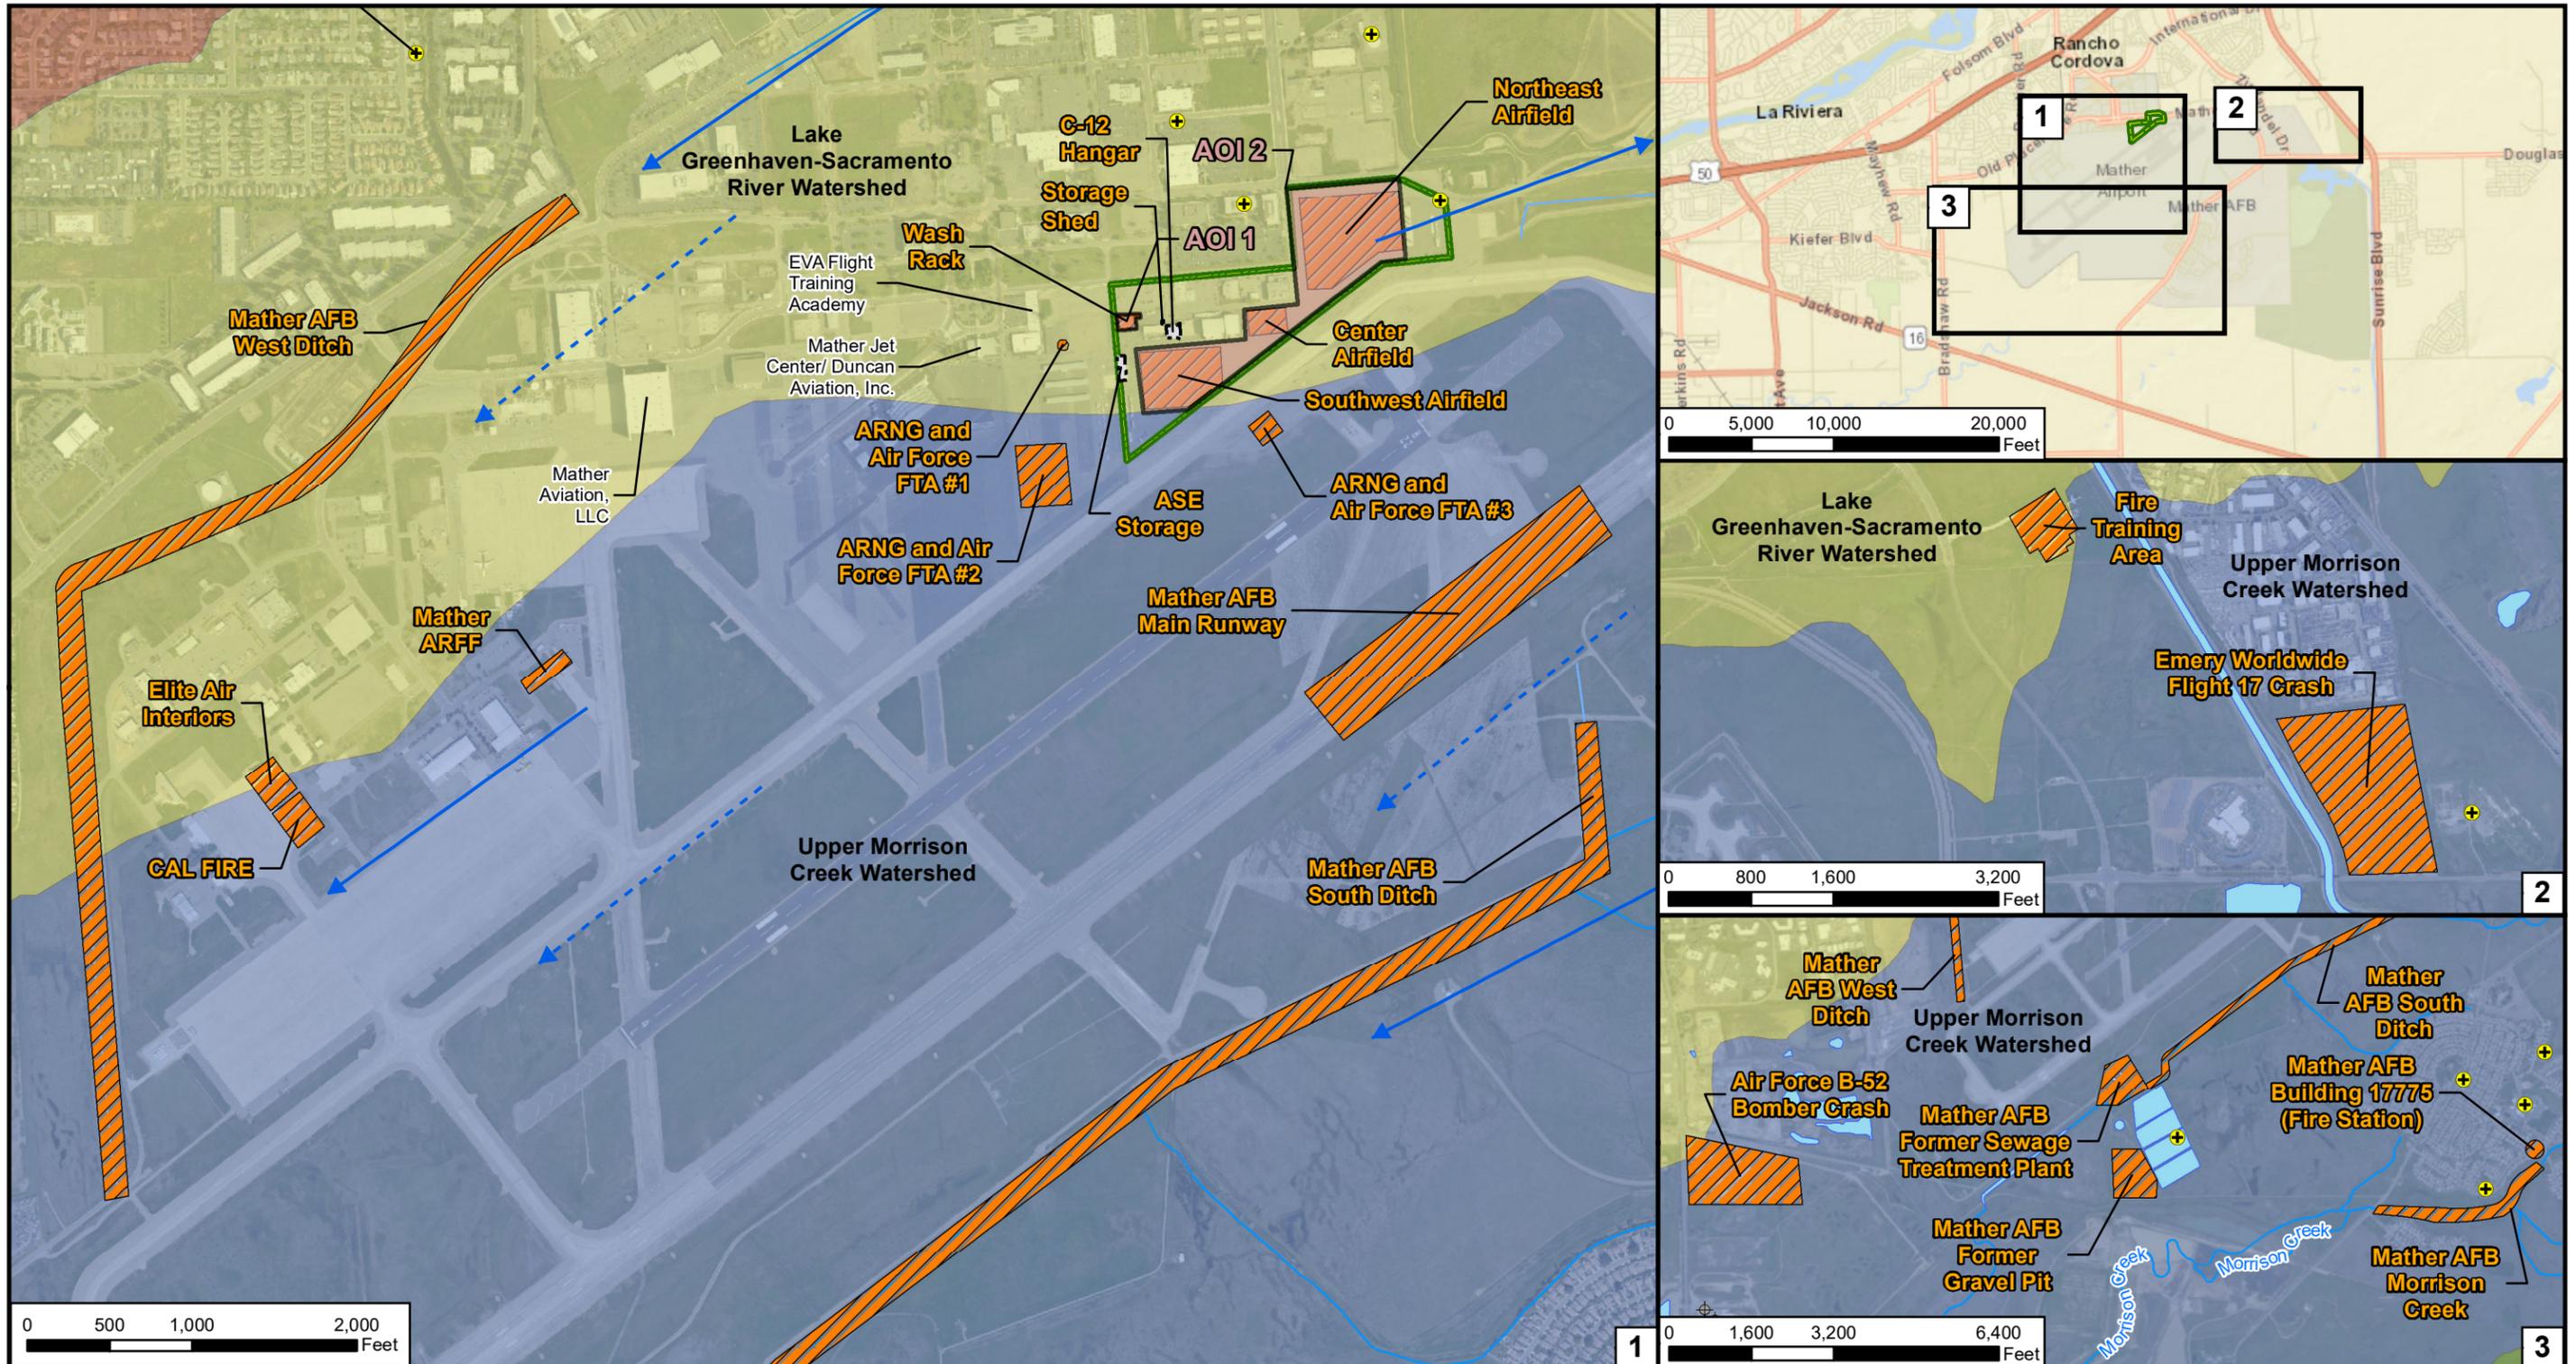
**Figure 6-1**

The wash rack was identified as an FTA during an interview with the CAARNG Staff Sergeant. The Staff Sergeant stated that there was a single fire training event conducted at the wash rack in approximately 2010. The fire training event involved the discharge of Tri-Max™ fire extinguishers, reportedly filled with Ansul SILV-EX Class A Foam (non-AFFF). However, some uncertainty about the contents of the Tri-Max™ fire extinguishers used in the training was introduced after the VSI found evidence of AFFF storage at the facility (see **Section 3.4** for more details). Therefore, the exact contents and amount of discharge from the Tri-Max™ fire extinguishers are unknown. Any foam that was discharged during the training was left in place to evaporate or disperse with the wind.

The wash rack is located at geographic coordinates 38°33'53.1"N; 121°17'39.1"W. The drains in the wash rack area lead to an oil water separator, which then flows into the sanitary sewer system. One Tri-Max™ fire extinguisher was observed next to the wash rack drain during the VSI. The Tri-Max™ extinguisher remains equipped with presumably either Class A foam or AFFF. The CAARNG Fire Safety Sergeant stated that the Tri-Max™ extinguishers have not been hydrostatically tested or replaced during his tenure of six years at the facility.

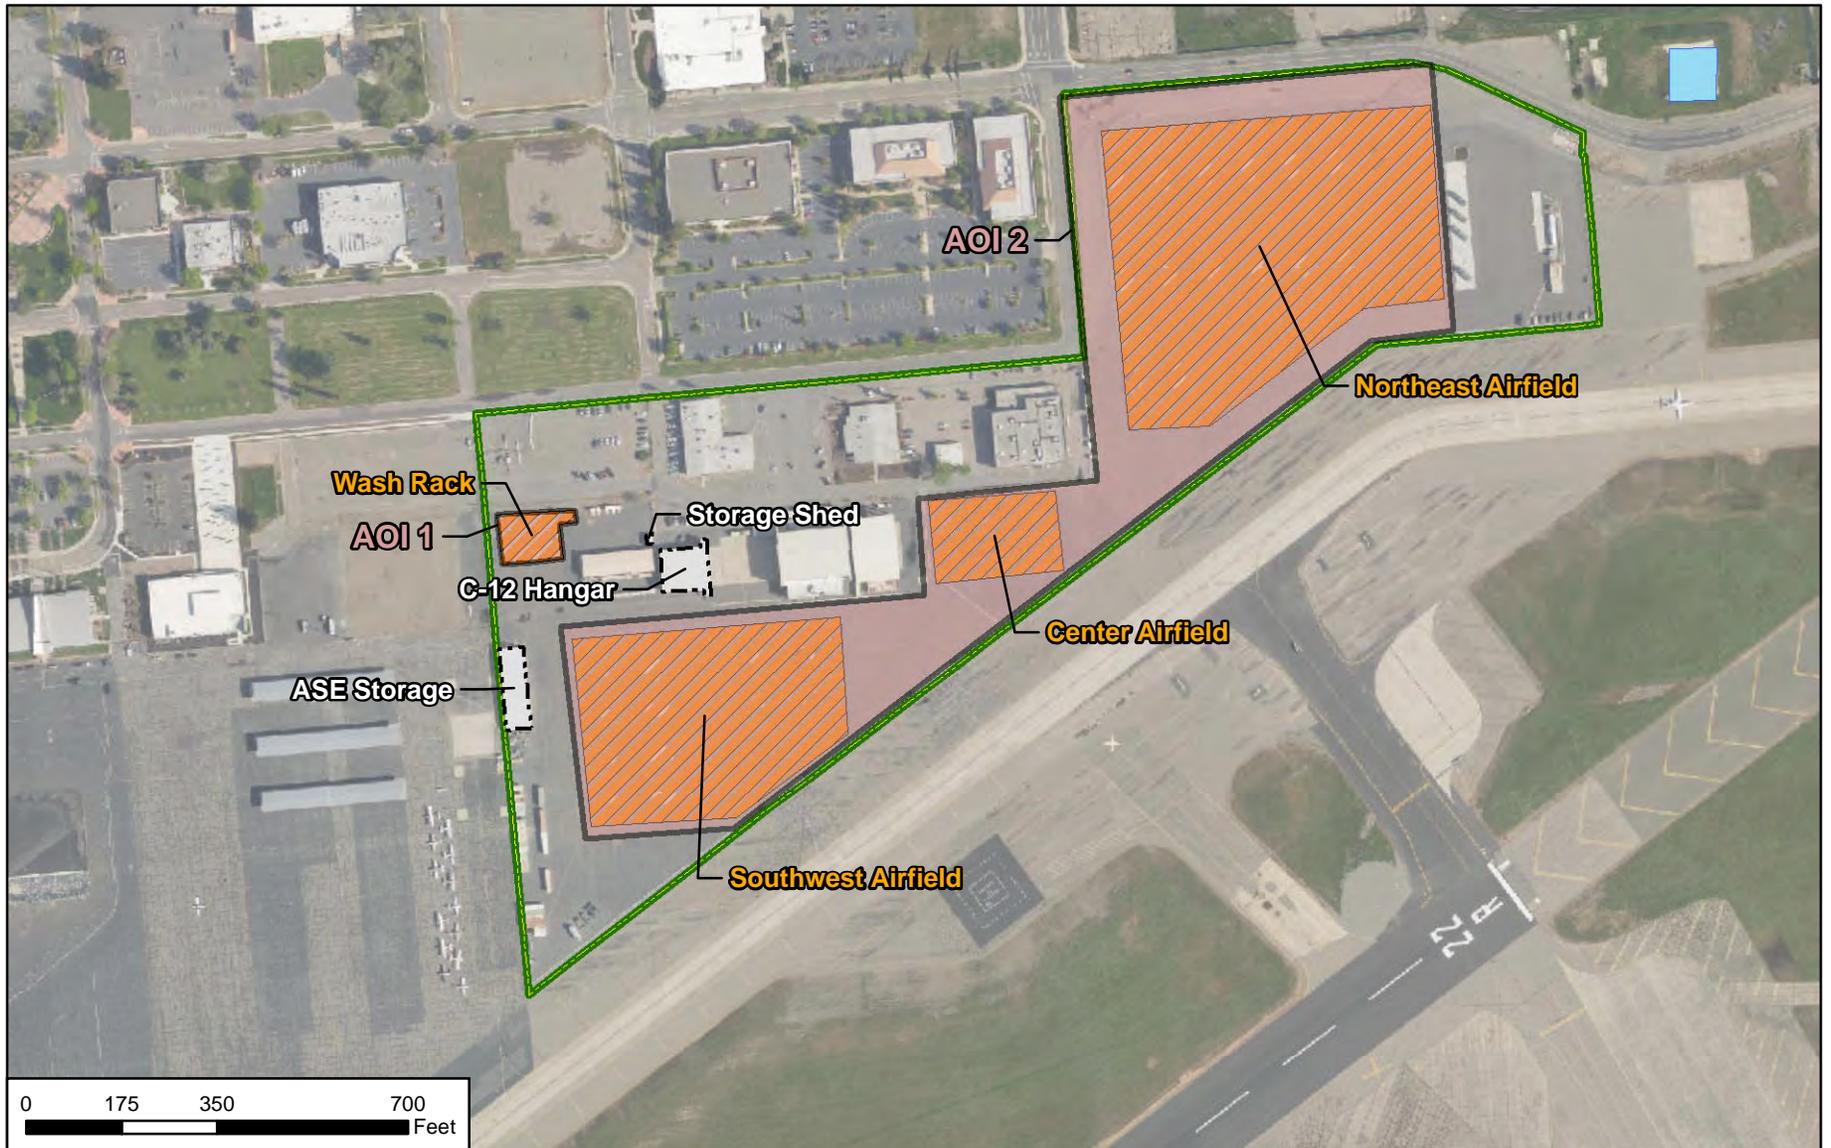
<b>Summary of Findings</b>	
<b>AECOM</b> 12420 Milestone Center Drive Germantown, MD 20876	<b>Figure 7-1</b>

The ASE Storage Building, C-12 Hangar, and Storage Shed at Mather AASF were determined to have no suspected PFAS release to the environment. Tri-Max fire extinguishers potentially containing AFFF were observed stationed either inside or outside of the ASE Storage Building and C-12 Hangar. The Storage Shed also contained AFFF 5-gallon buckets; however, in all instances, AFFF was not indicated to have ever leaked or been used at each location.

ARNG will evaluate the need for an SI at Mather AASF based on the potential receptors, the potential migration of PFAS contamination off the facility, and the availability of resources.

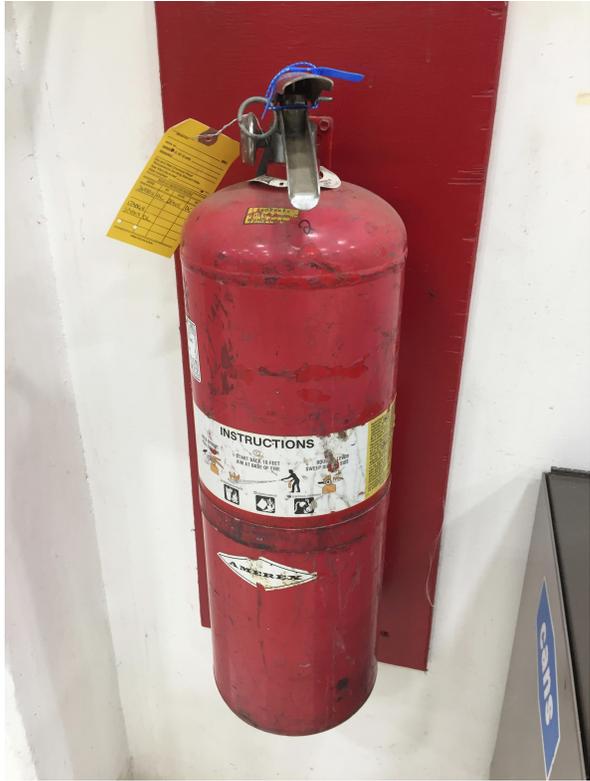
Army National Guard, Preliminary Assessment for PFAS	Mather AASF	Mather, California
<p><b>Photograph No. 3</b></p> <p><b>Date</b> <b>Time</b></p> <p><b>Description:</b> A dry chemical fire extinguisher (non-AFFF) observed in the C-12 Hangar</p> <p><b>Orientation:</b> North</p>

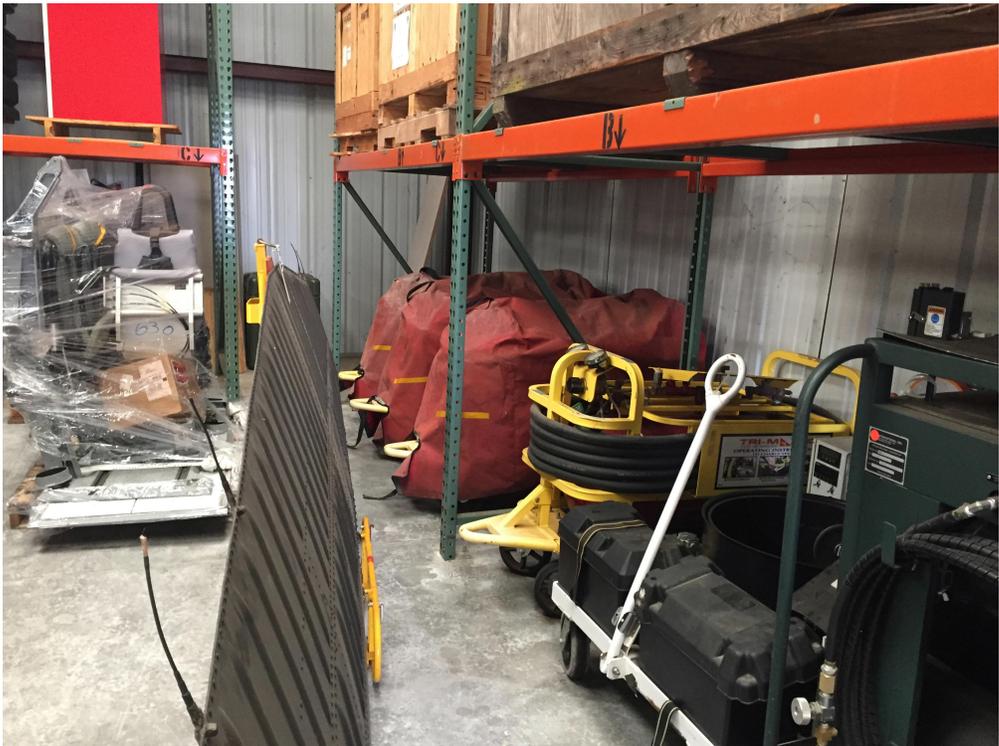
During the VSI, four Tri-Max™ fire extinguishers were observed stored in the AASF side of the building. The Tri-Max™ fire extinguishers were out of commission at the time and not indicated to have ever leaked or been used within the building.

<p><b>Photograph No. 4</b></p> <p><b>Date</b> 3/4/2019 <b>Time</b> 10:25</p> <p><b>Description:</b> Three Tri-Max 30 mobile fire extinguishers observed in the ASE Storage building</p> <p><b>Orientation:</b> West</p>

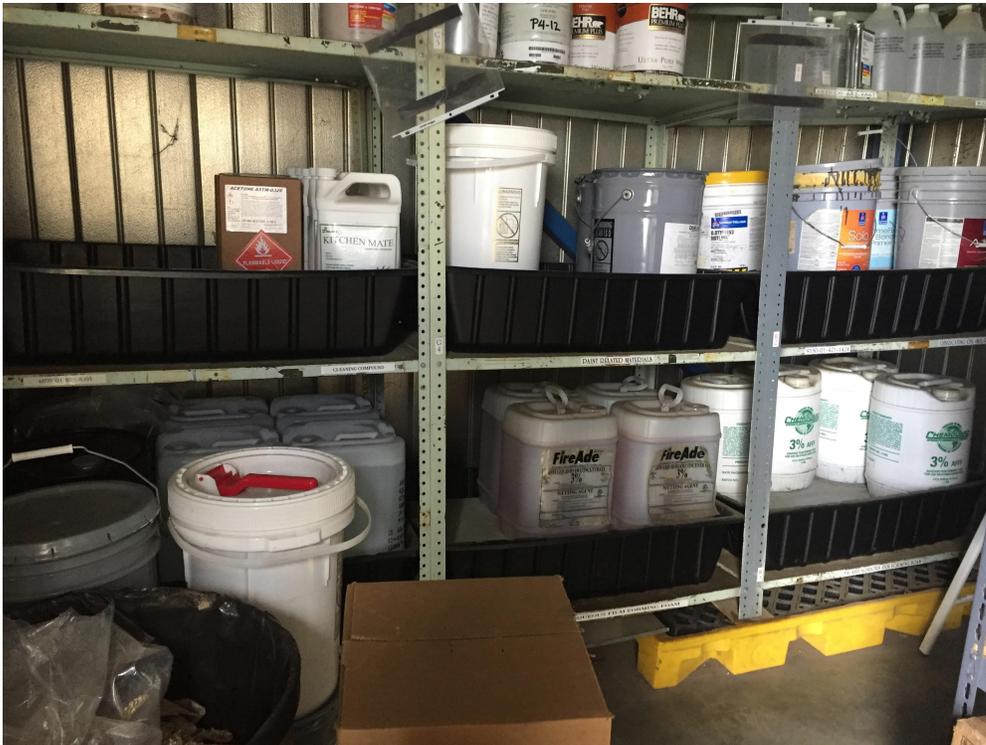
Army National Guard, Preliminary Assessment for PFAS	Mather AASF	Mather, California
<p><b>Photograph No. 5</b></p> <p><b>Date</b> 3/4/2019 <b>Time</b> 10:38</p> <p><b>Description:</b> Multiple 5-gallon buckets of 3% AFFF (brands FireAde 2000 and Chemguard) found in storage shed adjacent to the C-12 Hangar</p> <p><b>Orientation:</b> Southwest</p>

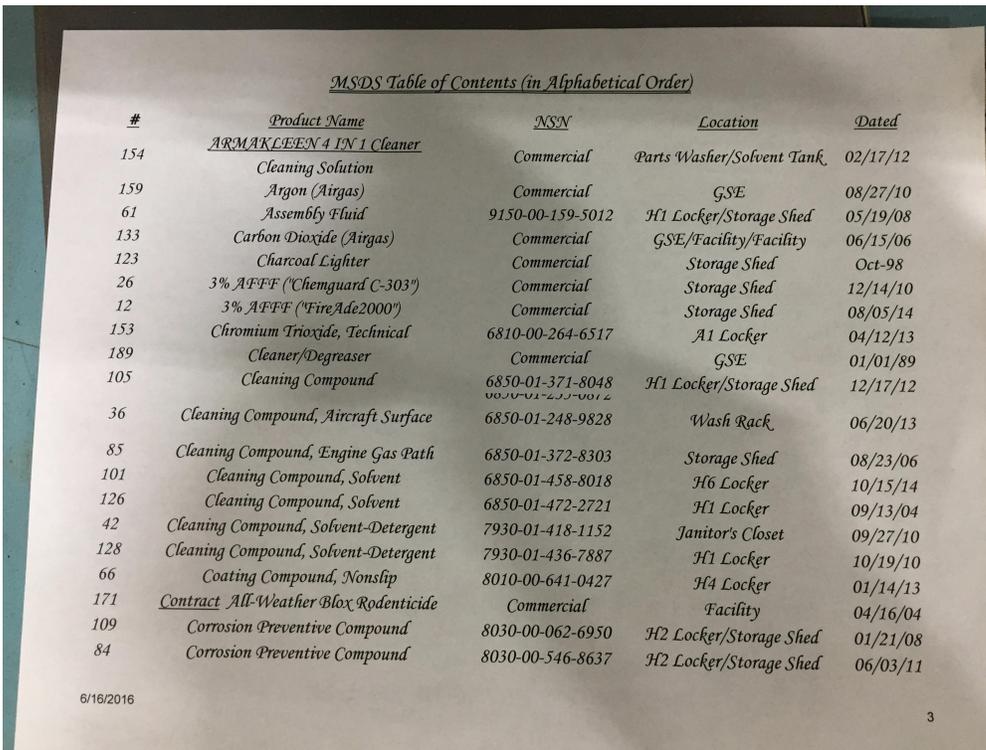
During the VSI, four FireAde 2000 3% AFFF and five Chemguard 3% AFFF 5-gallon containers were found stored in the shed. The interviewed CAARNG personnel were not aware of this AFFF storage and could not recall how the AFFF was obtained. It was hypothesized that the AFFF may have come from the CAARNG Roseville Armory, since Mather AASF conducts maintenance for the armory. The CAARNG Staff Sergeant initially recalled only using Ansul SILV-EX Class A Foam for fire training but could not state with certainty that AFFF was never used within the AASF after the discovery of the AFFF storage. The CAARNG personnel maintained records of the Chemguard 3% AFFF safety data sheet (SDS) within the facility, which is attached in **Appendix A**.

<p><b>Photograph No. 6</b></p> <p><b>Date</b> 3/4/2019 <b>Time</b> 10:32</p> <p><b>Description:</b> Facility safety data sheet records showing 3% AFFF products in the storage shed. However, the safety data sheet was only obtained for the 3% AFFF ("Chemguard C-303").</p> <p><b>Orientation:</b> East</p>
