# FINAL Preliminary Assessment Report Buckley Army Aviation Support Facility, Aurora, Colorado

Perfluorooctanesulfonic Acid (PFOS) and Perfluorooctanoic Acid  
(PFOA) Impacted Sites  
ARNG Installations, Nationwide

February 2021

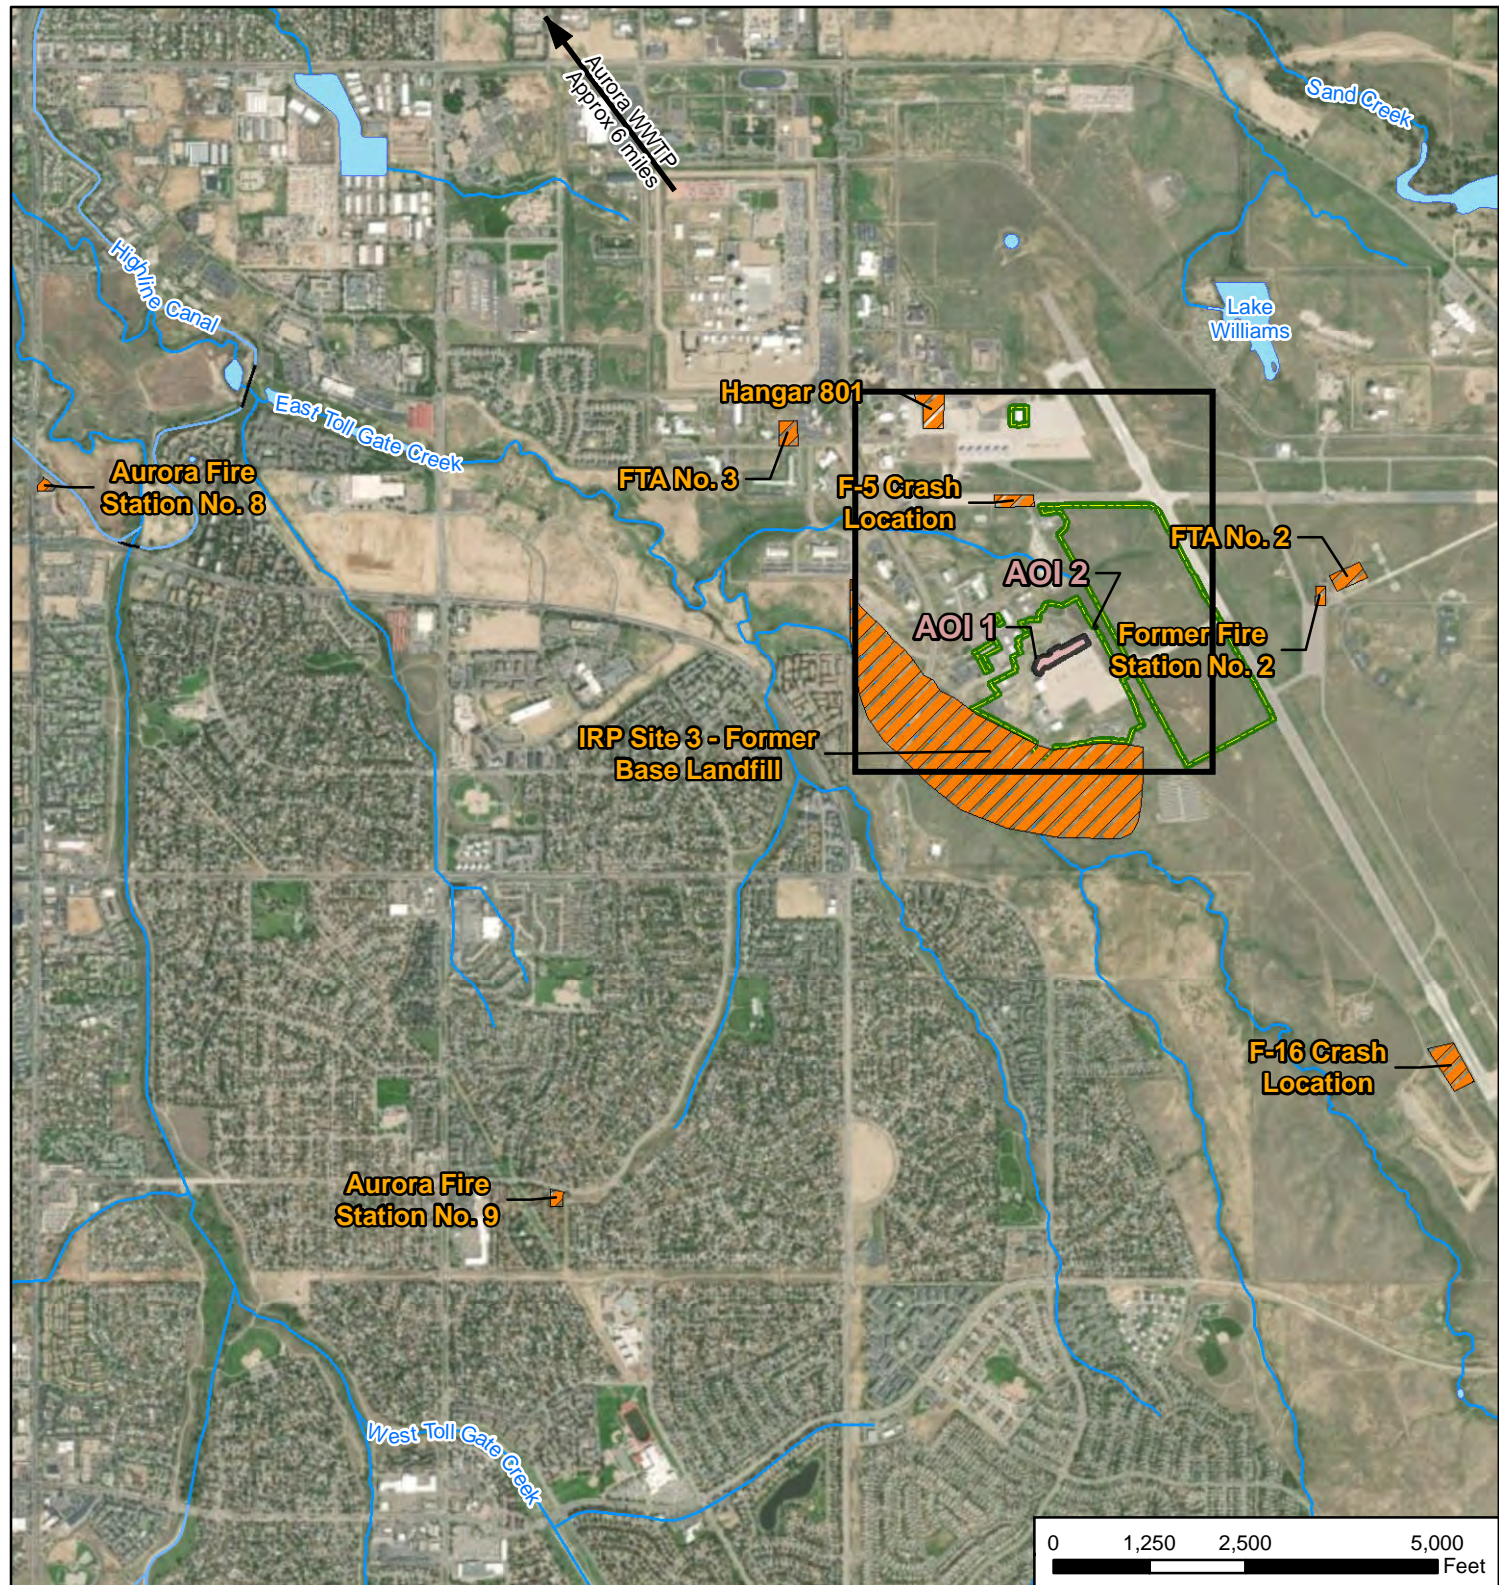
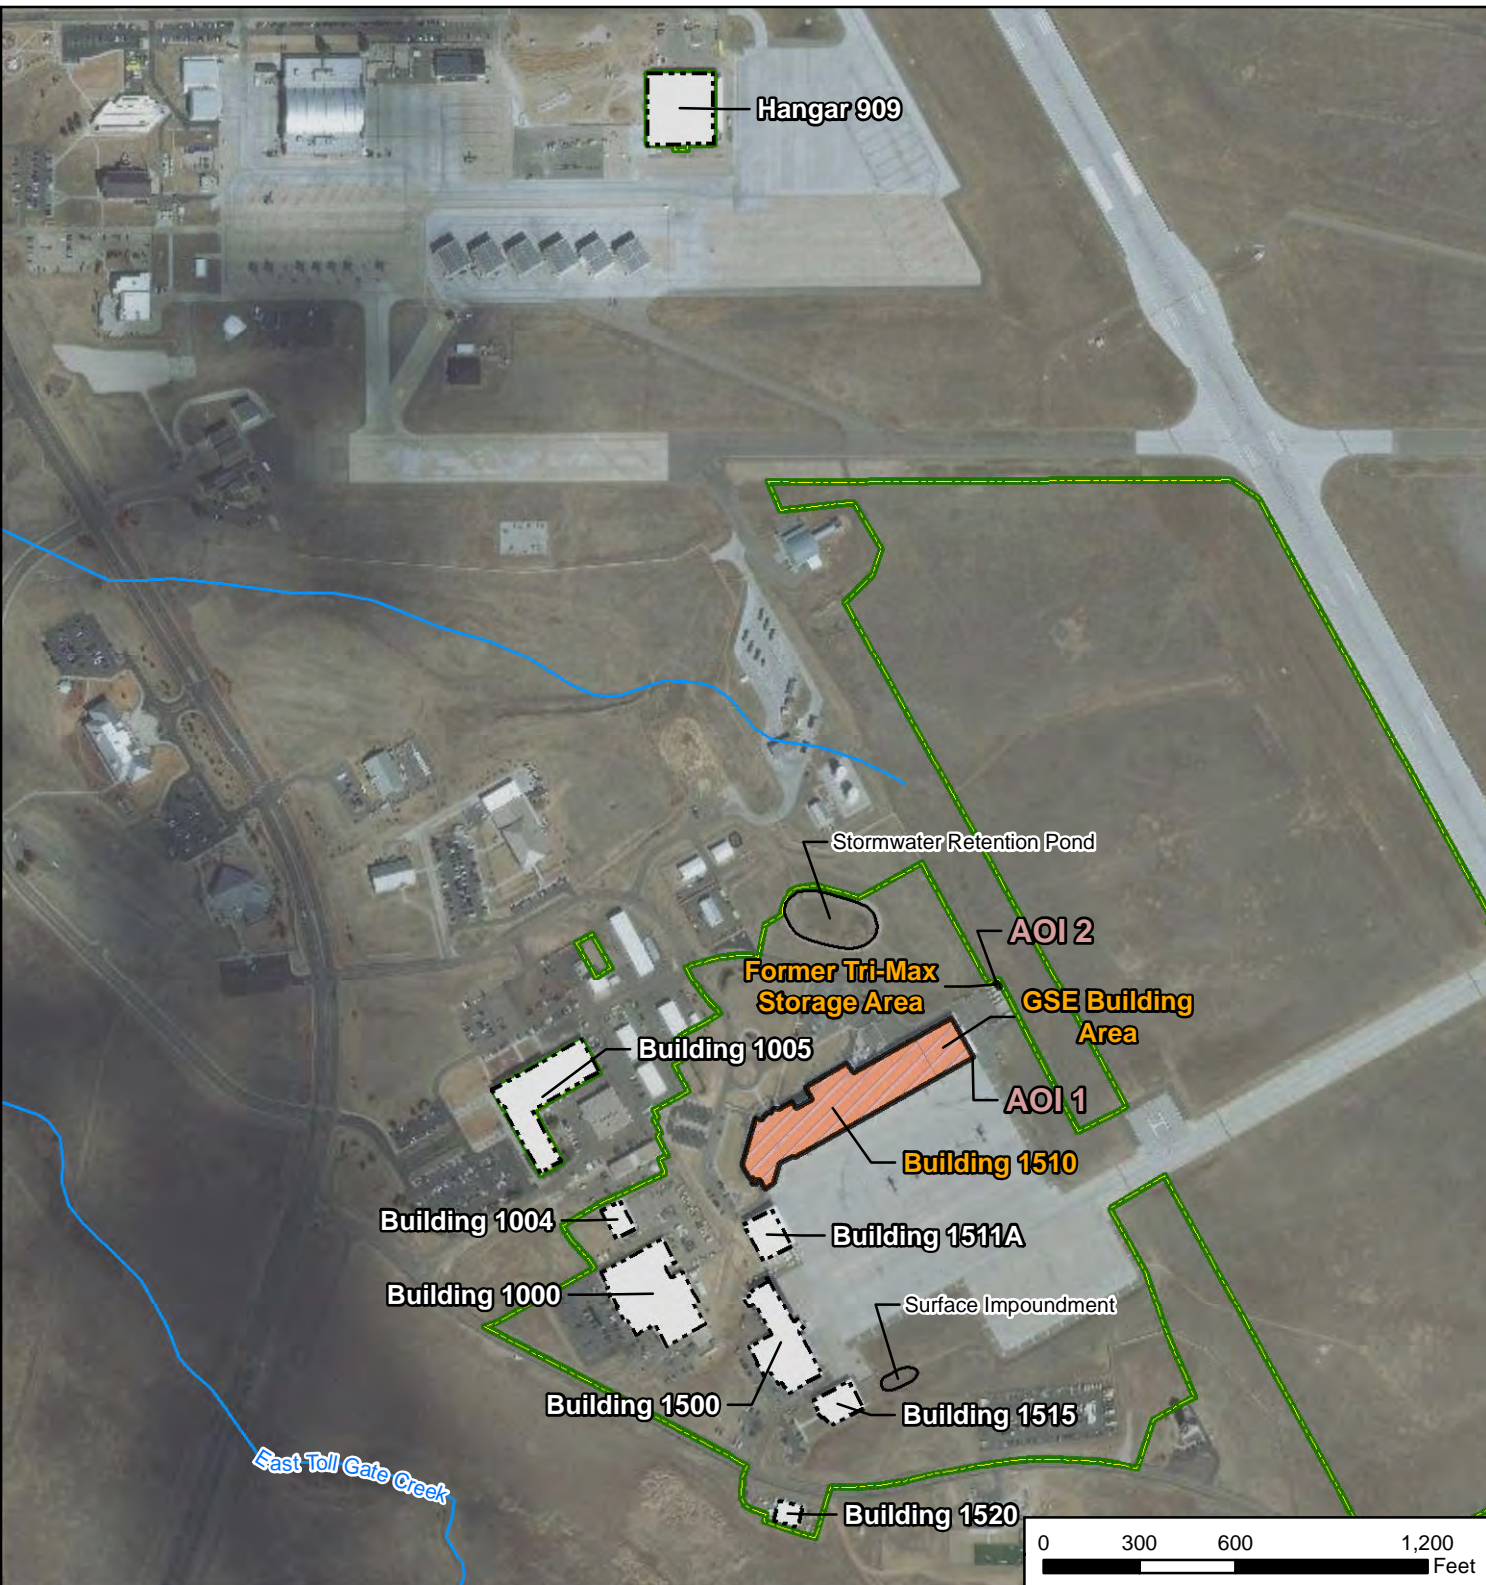
<b>Summary of Findings</b>	
	12420 Milestone Center Drive Germantown, MD 20876
Figure ES-1

Two AOIs related to potential PFAS release were identified at Buckley AASF based on PA data (**Figure ES-1**) and are summarized in **Table ES-1** below:

Based on the possible PFAS releases at AOI 2 and the uncertain content of High Expansion Foam (HEF) at AOI 1, there is potential for exposure to PFAS contamination in surface soil to site and construction workers, and trespassers via ingestion and inhalation; in subsurface soil to construction workers via ingestion and inhalation; and in surface water to site construction workers and off-facility recreational users via ingestion. There is also the potential for residents to consume produce grown off-facility that has been exposed to PFAS via the agricultural use of biosolids for fertilizer generated at the Robert W. Hite Treatment Facility and potentially containing PFAS from impacted wastewater from the facility. Additionally, domestic and irrigation wells downgradient of Buckley AASF create a potentially complete pathway for PFAS exposure to off-facility residents via ingestion of groundwater. Numerous adjacent sources were identified where PFAS releases to the environment occurred outside of the COARNG property boundary. The preliminary CSM for Buckley AASF, which presents the potential receptors and media impacted, is shown on **Figure ES-2**.

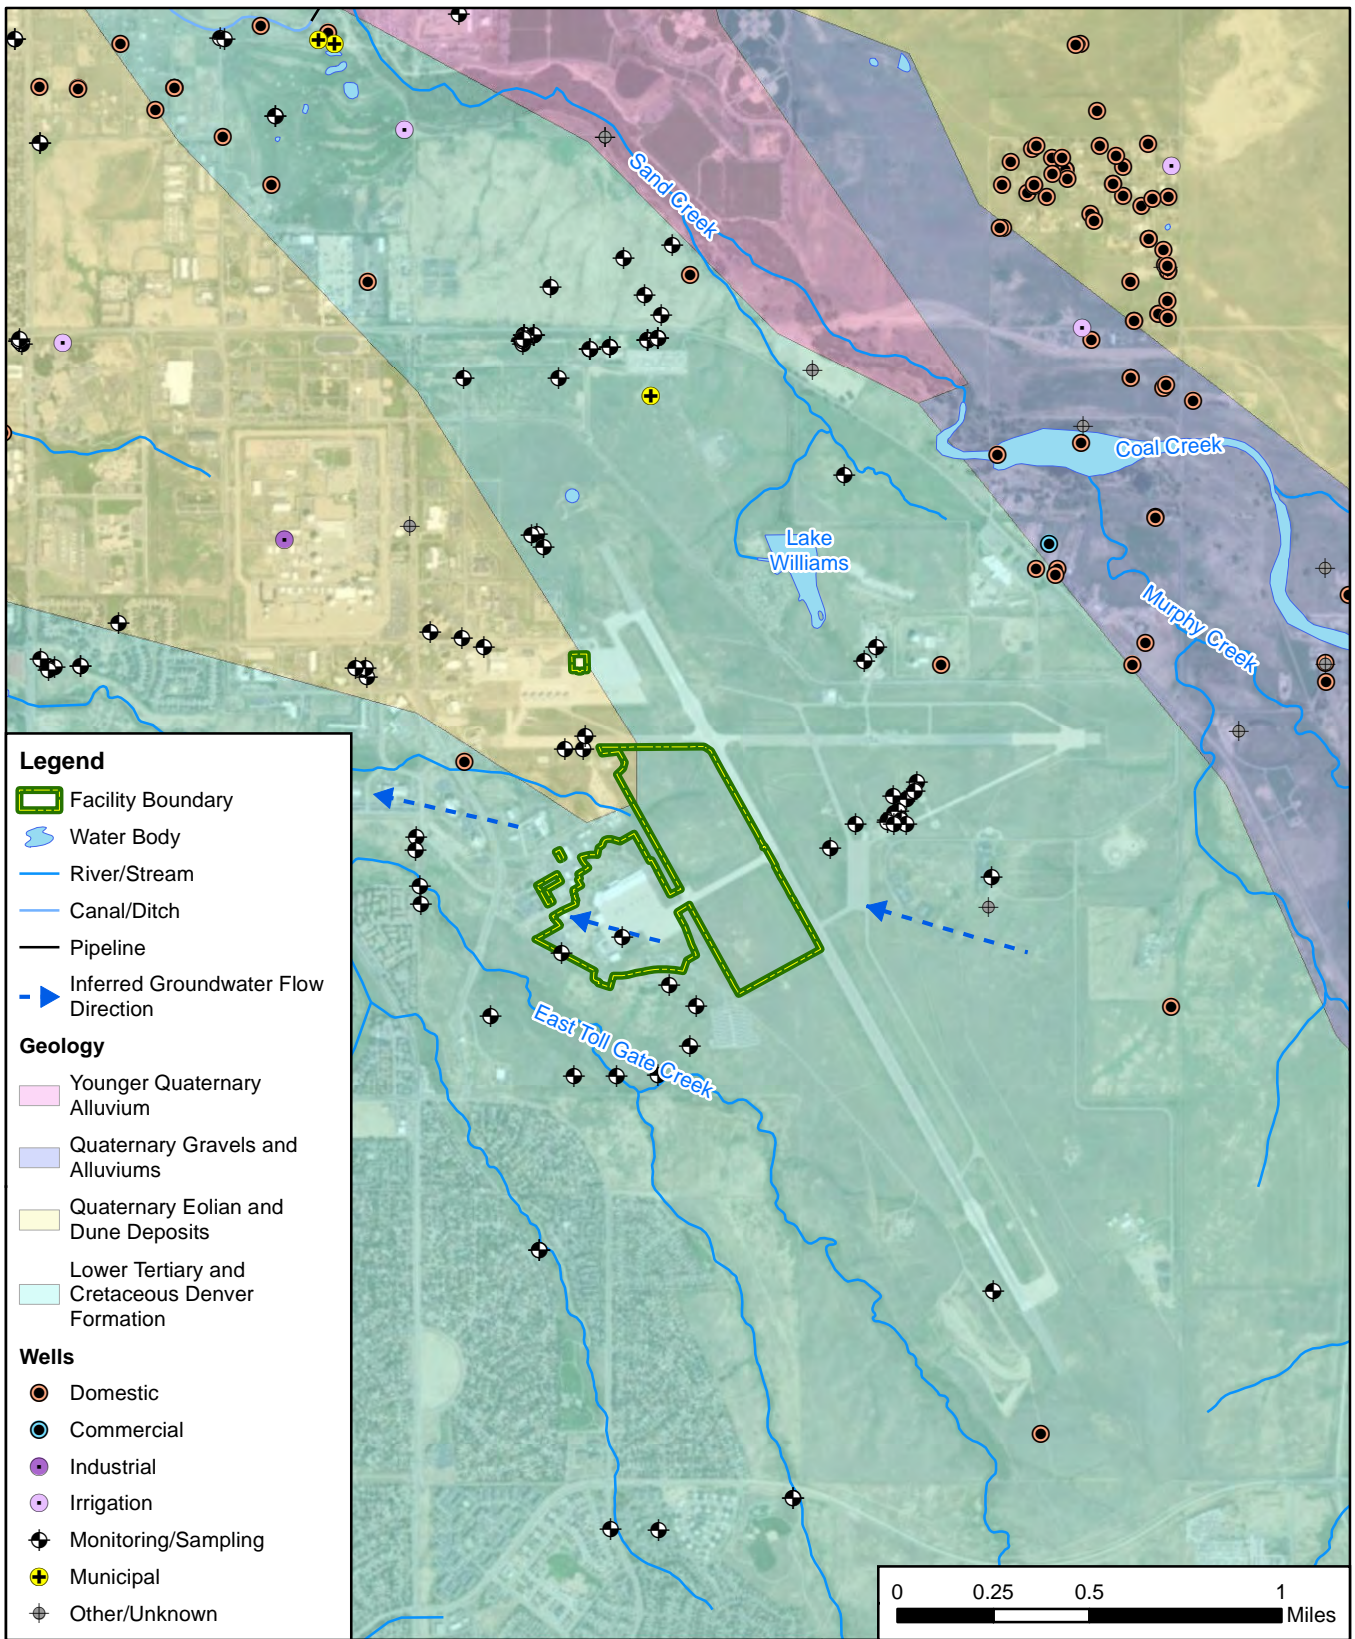
**Figure 1-2**

Regional groundwater flow is generally to the northwest, following the trend of stream drainages toward the South Platte River north of Denver (**Figure 1-2**) (URS, 2007). Groundwater flow direction at a former landfill adjacent to the southwest of the facility is towards the northwest and is presumed to be the same at the facility (USEPA, 2014).

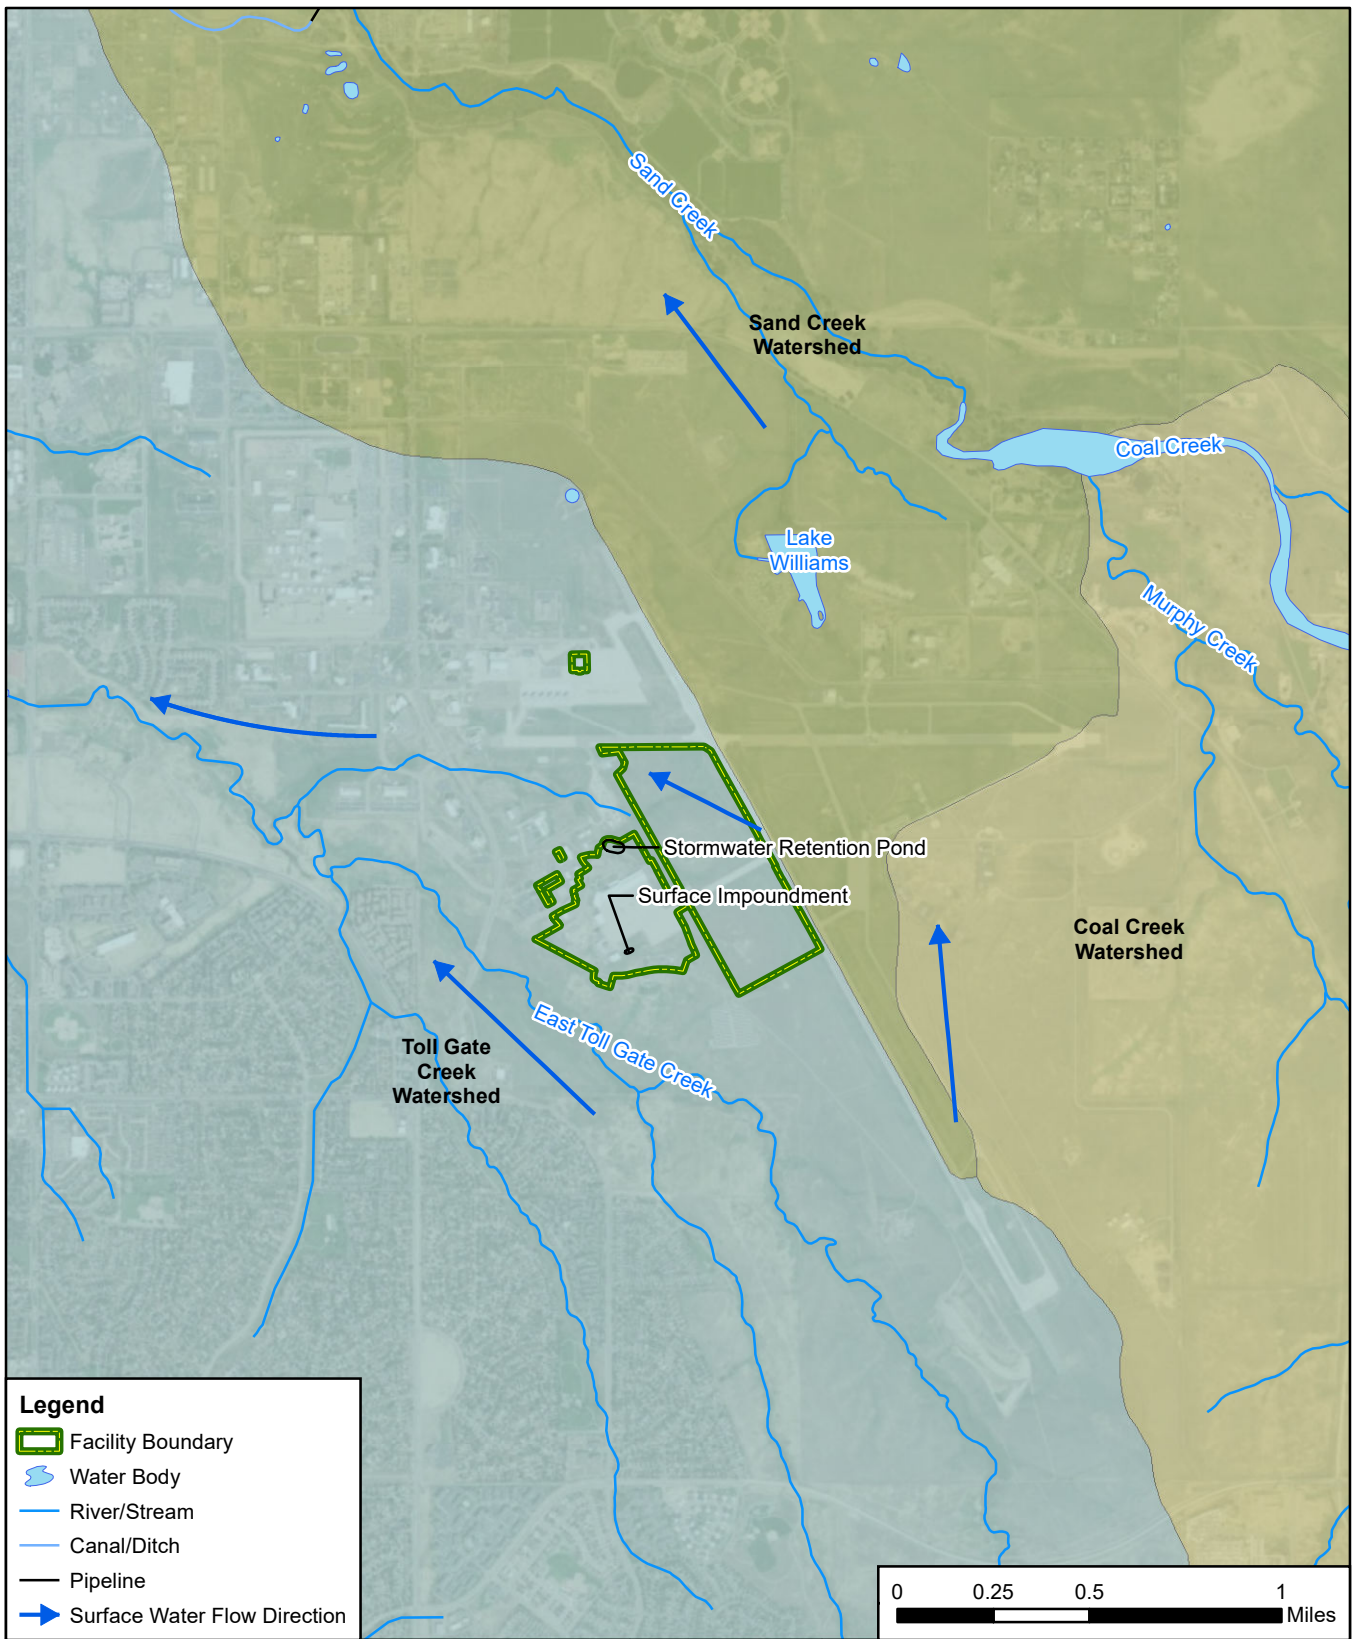
<b>Surface Water Features</b>	
<b>AECOM</b> 12420 Milestone Center Drive Germantown, MD 20876	<b>Figure 1-3</b>

A small stream designated as a freshwater emergent wetland by the US Fish and Wildlife Service (USFWS) National Wetlands Inventory passes through the eastern and northern portions of the facility, and it ultimately discharges to the East Toll Gate Creek west of the facility (USFWS, 2020). The East Toll Gate Creek is located approximately 0.2 miles west of the western AASF boundary and flows to the northwest. East Toll Gate Creek confluences with Sand Creek approximately 5.5 miles northwest of the facility, and it ultimately discharges to the South Platte River further northwest. Lake Williams, a freshwater pond, is also located within the greater Buckley AFB, approximately 1 mile northeast of the AASF property (USFWS, 2020). Overflow from Lake Williams drains through a series of two unnamed tributaries to Sand Creek (USEPA, 2019). Nearby surface water bodies are shown on **Figure 1-3**.

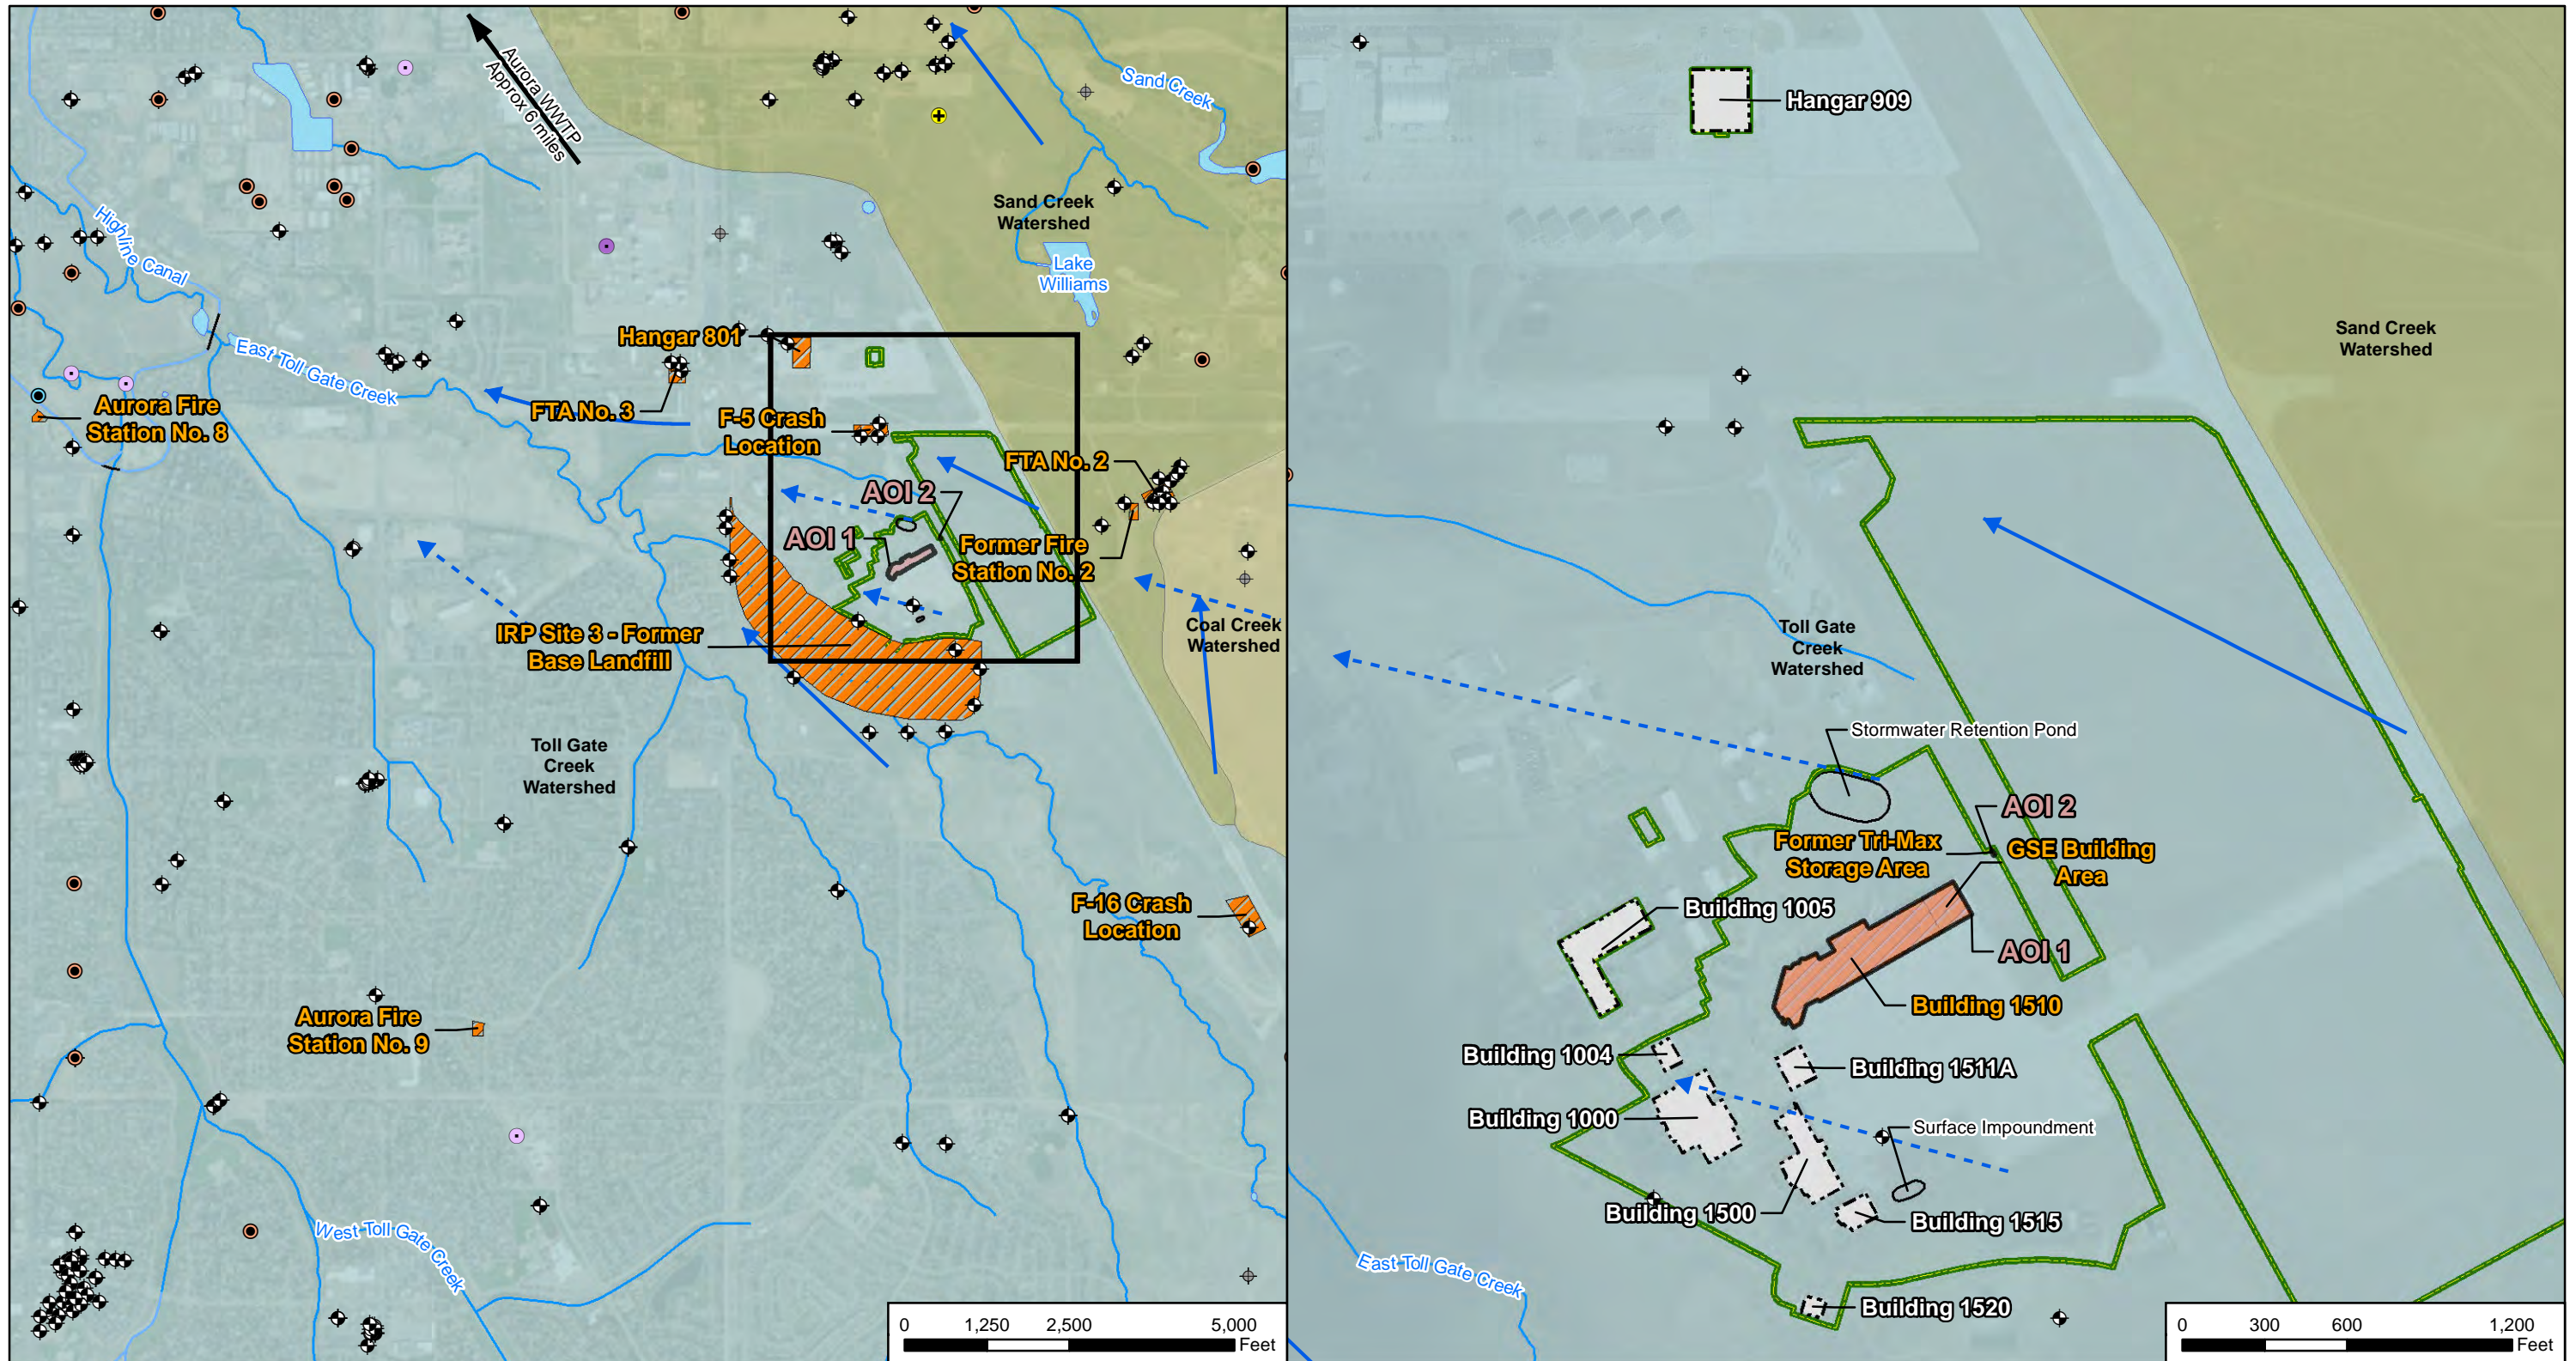
**Figure 6-1**

Based on the PA findings, two AOIs were identified at Buckley AASF, AOI 1 Building 1510 and AOI 2 the Former Tri-Max™ Storage Area. The AOI locations are shown on **Figure 6-1**. The following sections describe the CSM components and the specific preliminary CSM developed for each AOI. The CSMs identify the three components necessary for a potentially complete exposure pathway: (1) source, (2) pathway, (3) receptor. If any of these elements are missing, the pathway is considered incomplete.

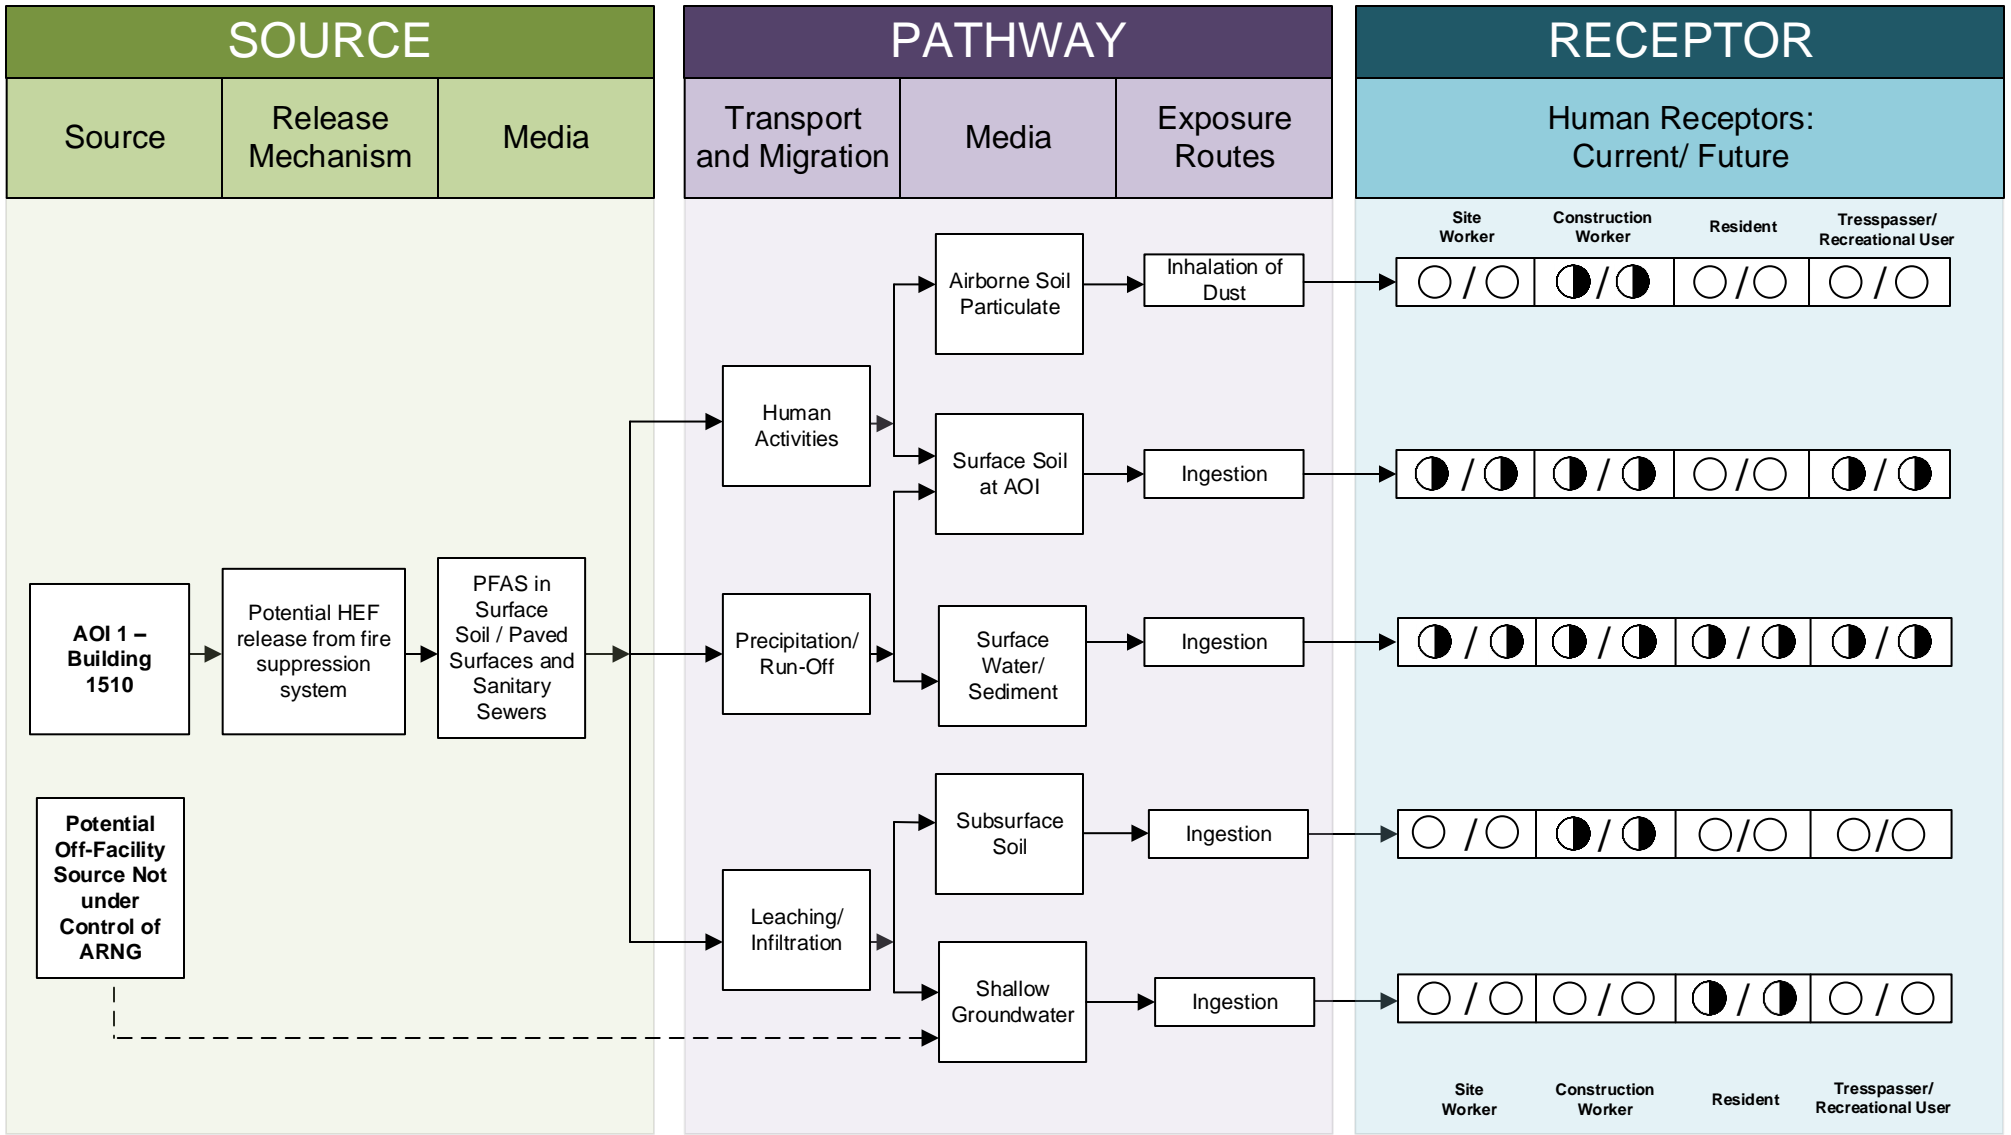
**Figure 6-2**  
 Preliminary Conceptual Site Model  
 AOI 1 – Building 1510 26

Although it is unclear whether the HEF product released at Buckley AASF contains PFAS, it is conservatively assumed to do so for the purpose of this PA. If HEF released from the deluge system test were tracked outside of the building following the test, it may have migrated to the surrounding paved surfaces. Surface water runoff during storm events may have also carried PFAS to the landscaped areas on the north side of Building 1510. As such, it is possible that PFAS infiltrated subsurface soil via cracks in pavement, joints between areas that are paved with different materials on the north and south side of the building, and surface soil in the landscaped areas to the north. If HEF released at the AOI infiltrated surface soil, then surface soil presents a potentially complete pathway for PFAS exposure to site workers, construction workers, and trespassers via ingestion and inhalation. If HEF infiltrated subsurface soil at the AOI, then ground-disturbing activities may result in PFAS exposure to construction workers via ingestion and inhalation. Accidental ingestion of groundwater during ground-disturbing activities is not considered a potentially complete pathway for exposure to PFAS due to the presumed 40-50 ft depth to groundwater.

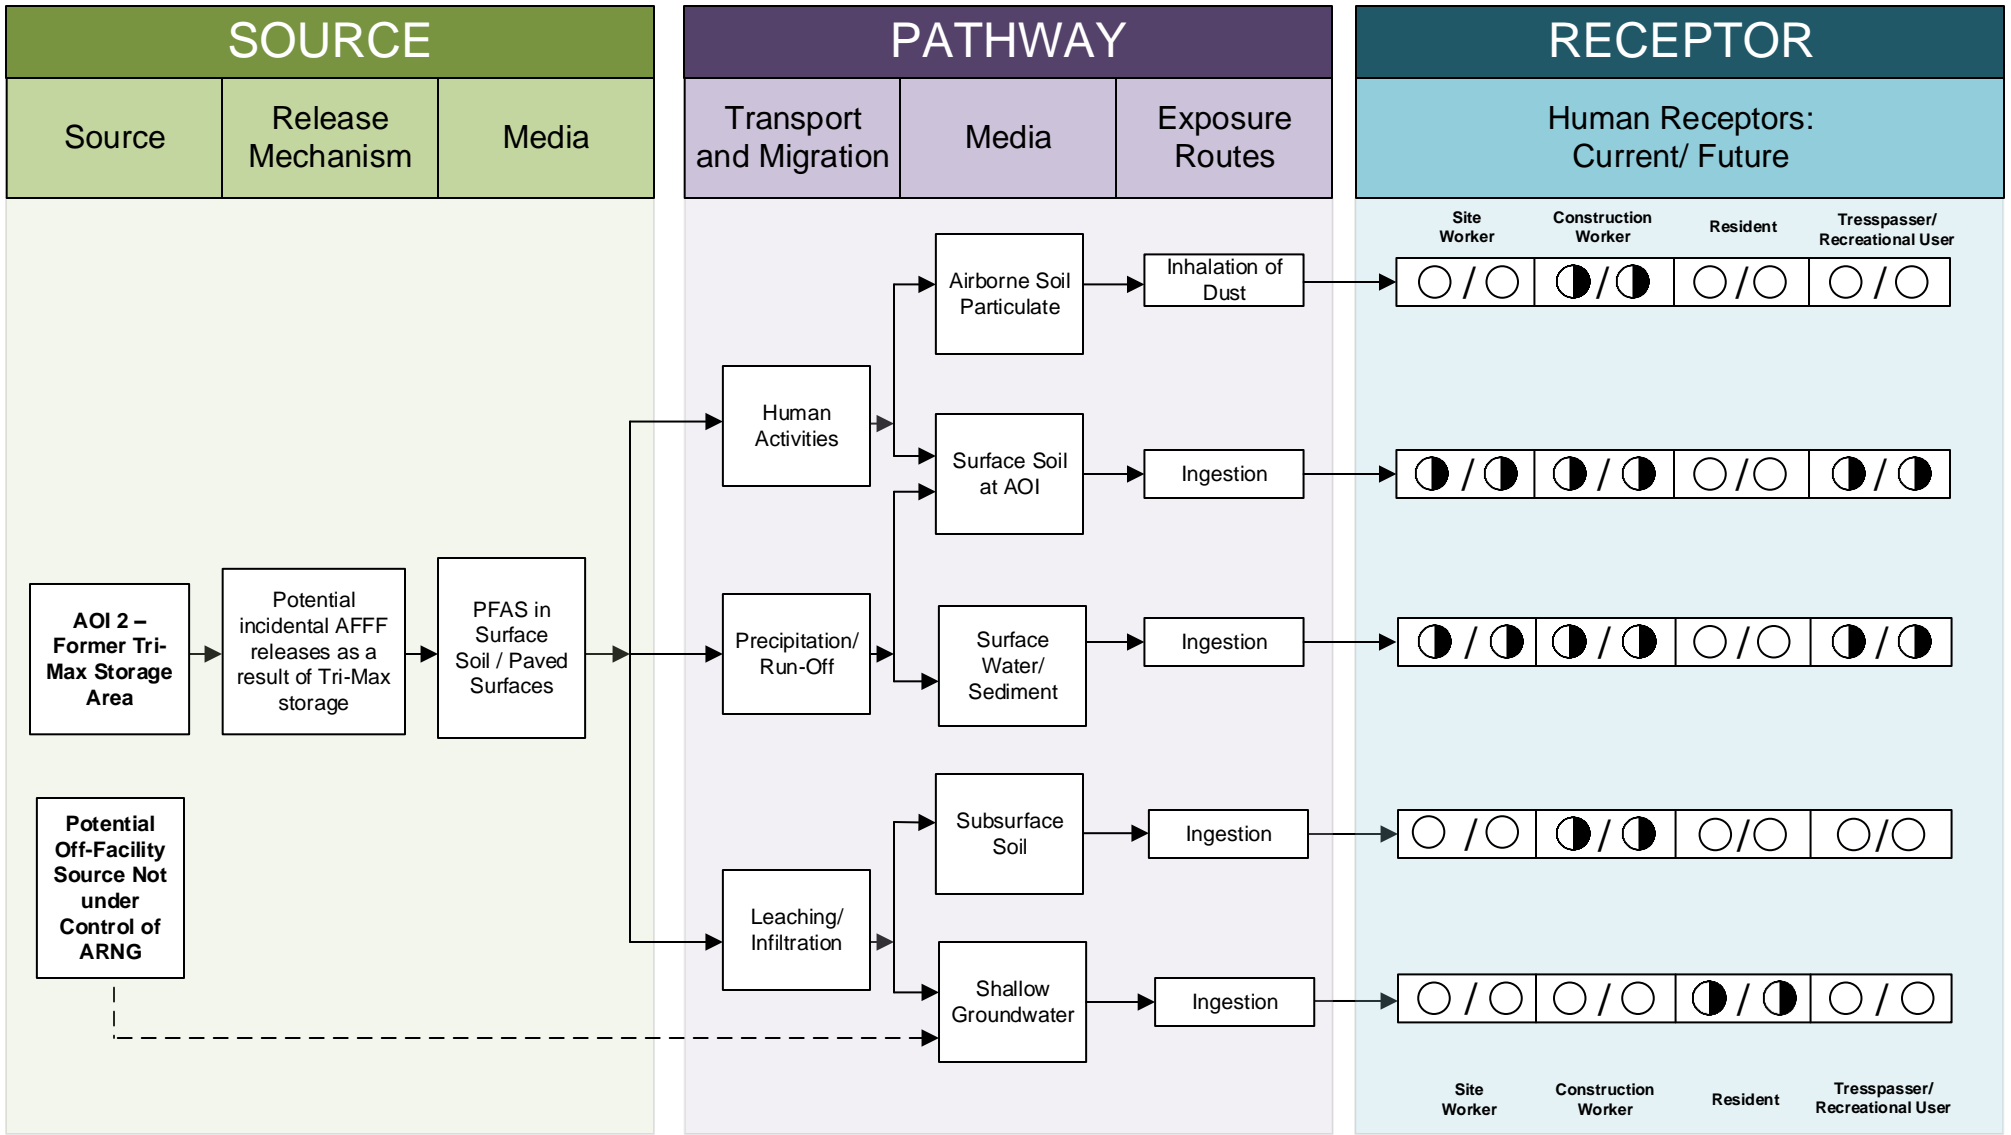
AOI 2 encompasses the area in the northeastern portion of the facility formerly used to store six Tri-Max™ wheeled fire extinguishers containing Chemguard 3% C-303 AFFF concentrate. Although no known PFAS releases have occurred in this area, the outdoor storage of Tri-Max™ and corrosive nature of AFFF may have led to incidental environmental releases of PFAS.

Potential PFAS releases at AOI 2 would most likely have occurred to paved surfaces, but may migrate a short distance to grassy areas. As such, it is possible that PFAS infiltrated surface and subsurface soil adjacent to the Former Tri-Max™ Storage area as well as subsurface soil beneath the storage area via cracks in pavement and joints between areas that are paved with different materials. Surface soil presents a potentially complete pathway for PFAS exposure to site workers, construction workers, and trespassers via ingestion and inhalation. Ground-disturbing activities at the AOI may also result in PFAS exposure to construction workers via ingestion and inhalation of subsurface soil. Accidental ingestion of groundwater during ground-disturbing activities is not considered a potentially complete pathway due to depth to groundwater.

As previously stated, Buckley AASF and the surrounding areas are provided municipal water by the City of Aurora; however, domestic and irrigation wells exist downgradient of the facility (**Appendix A**). Because of the presence of these domestic and irrigation wells, groundwater is considered a potentially complete pathway for PFAS exposure to off-facility residents via ingestion.
