# FINAL Preliminary Assessment Report Buckley Army Aviation Support Facility, Aurora, Colorado

Perfluorooctanesulfonic Acid (PFOS) and Perfluorooctanoic Acid  
(PFOA) Impacted Sites  
ARNG Installations, Nationwide

February 2021

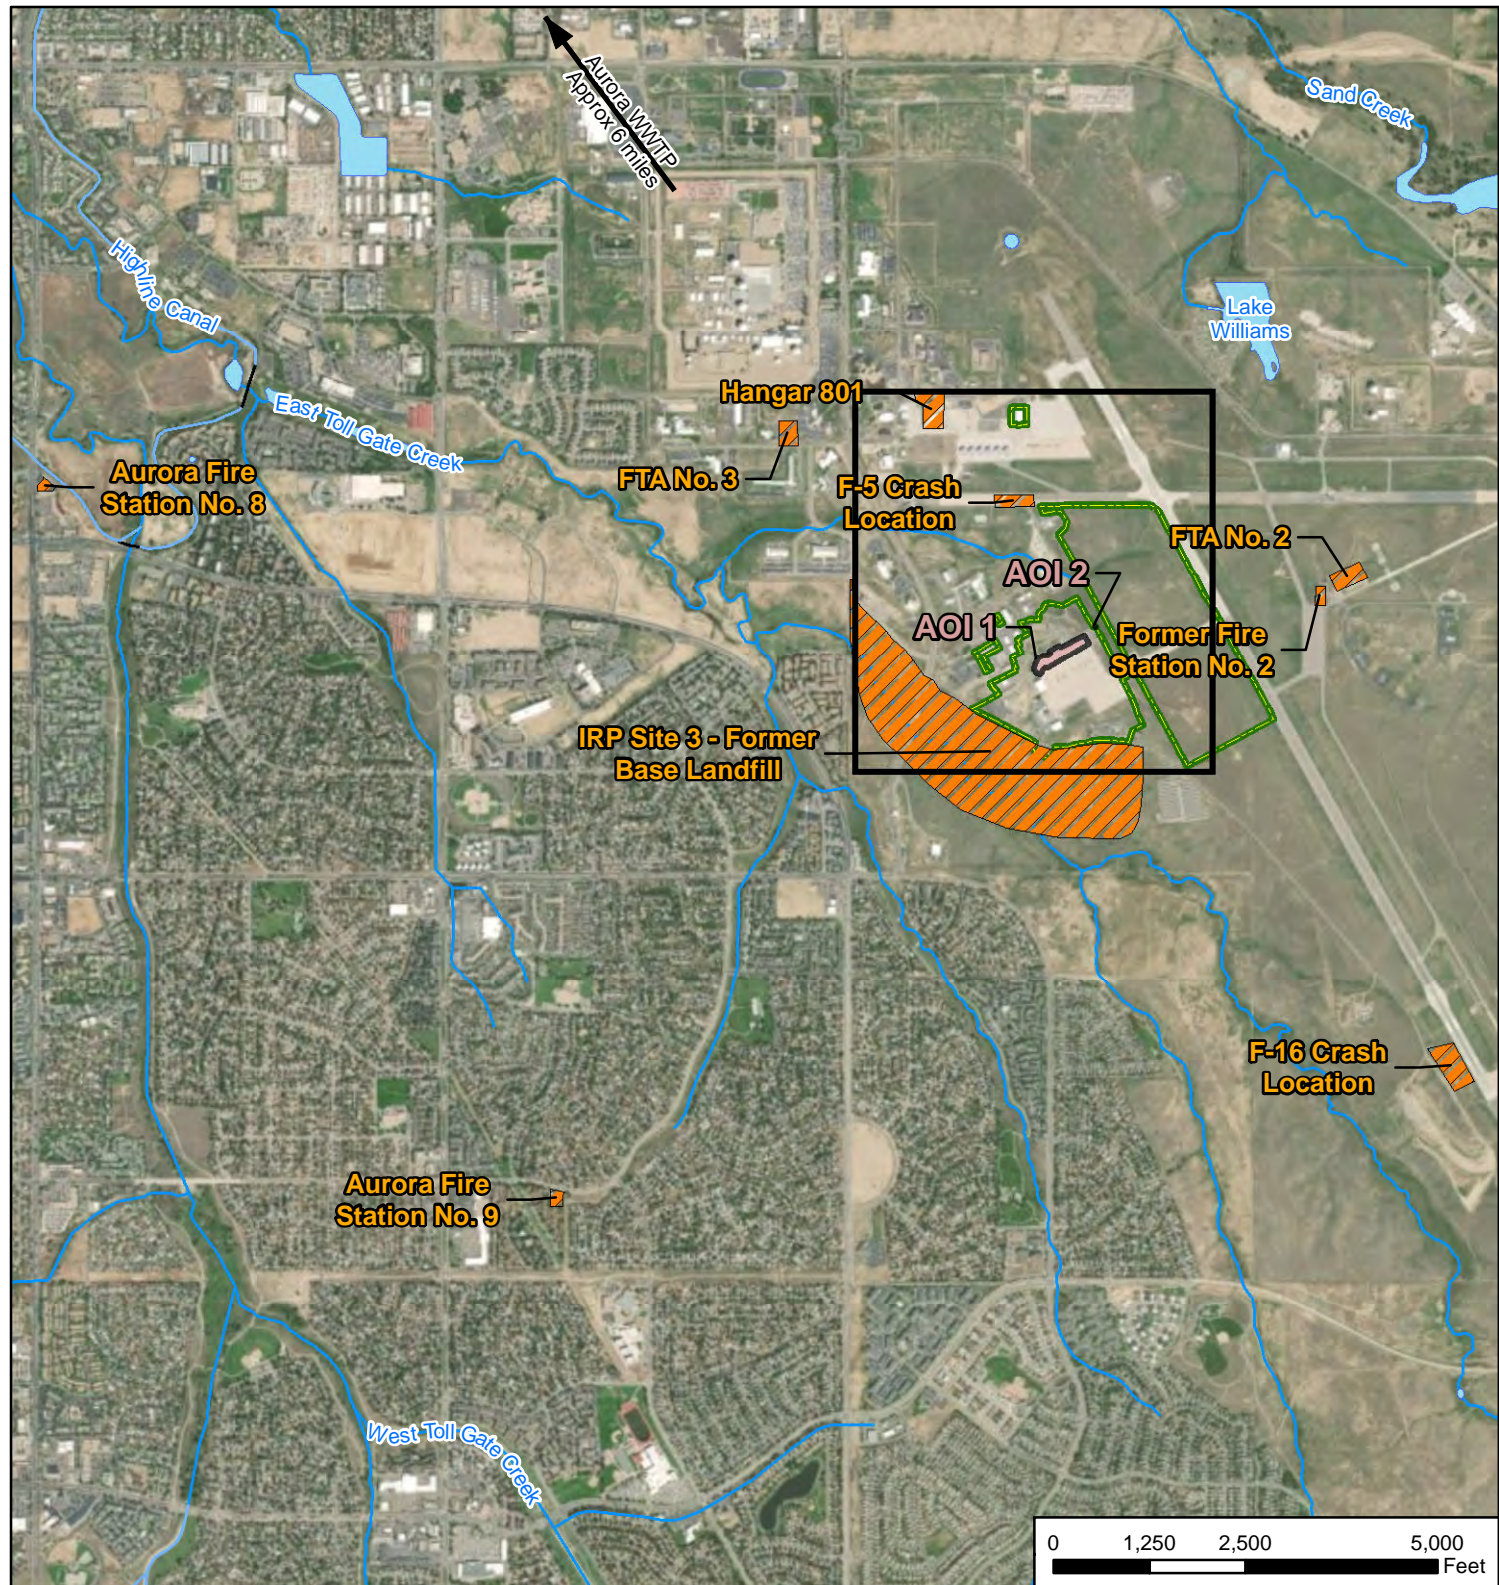
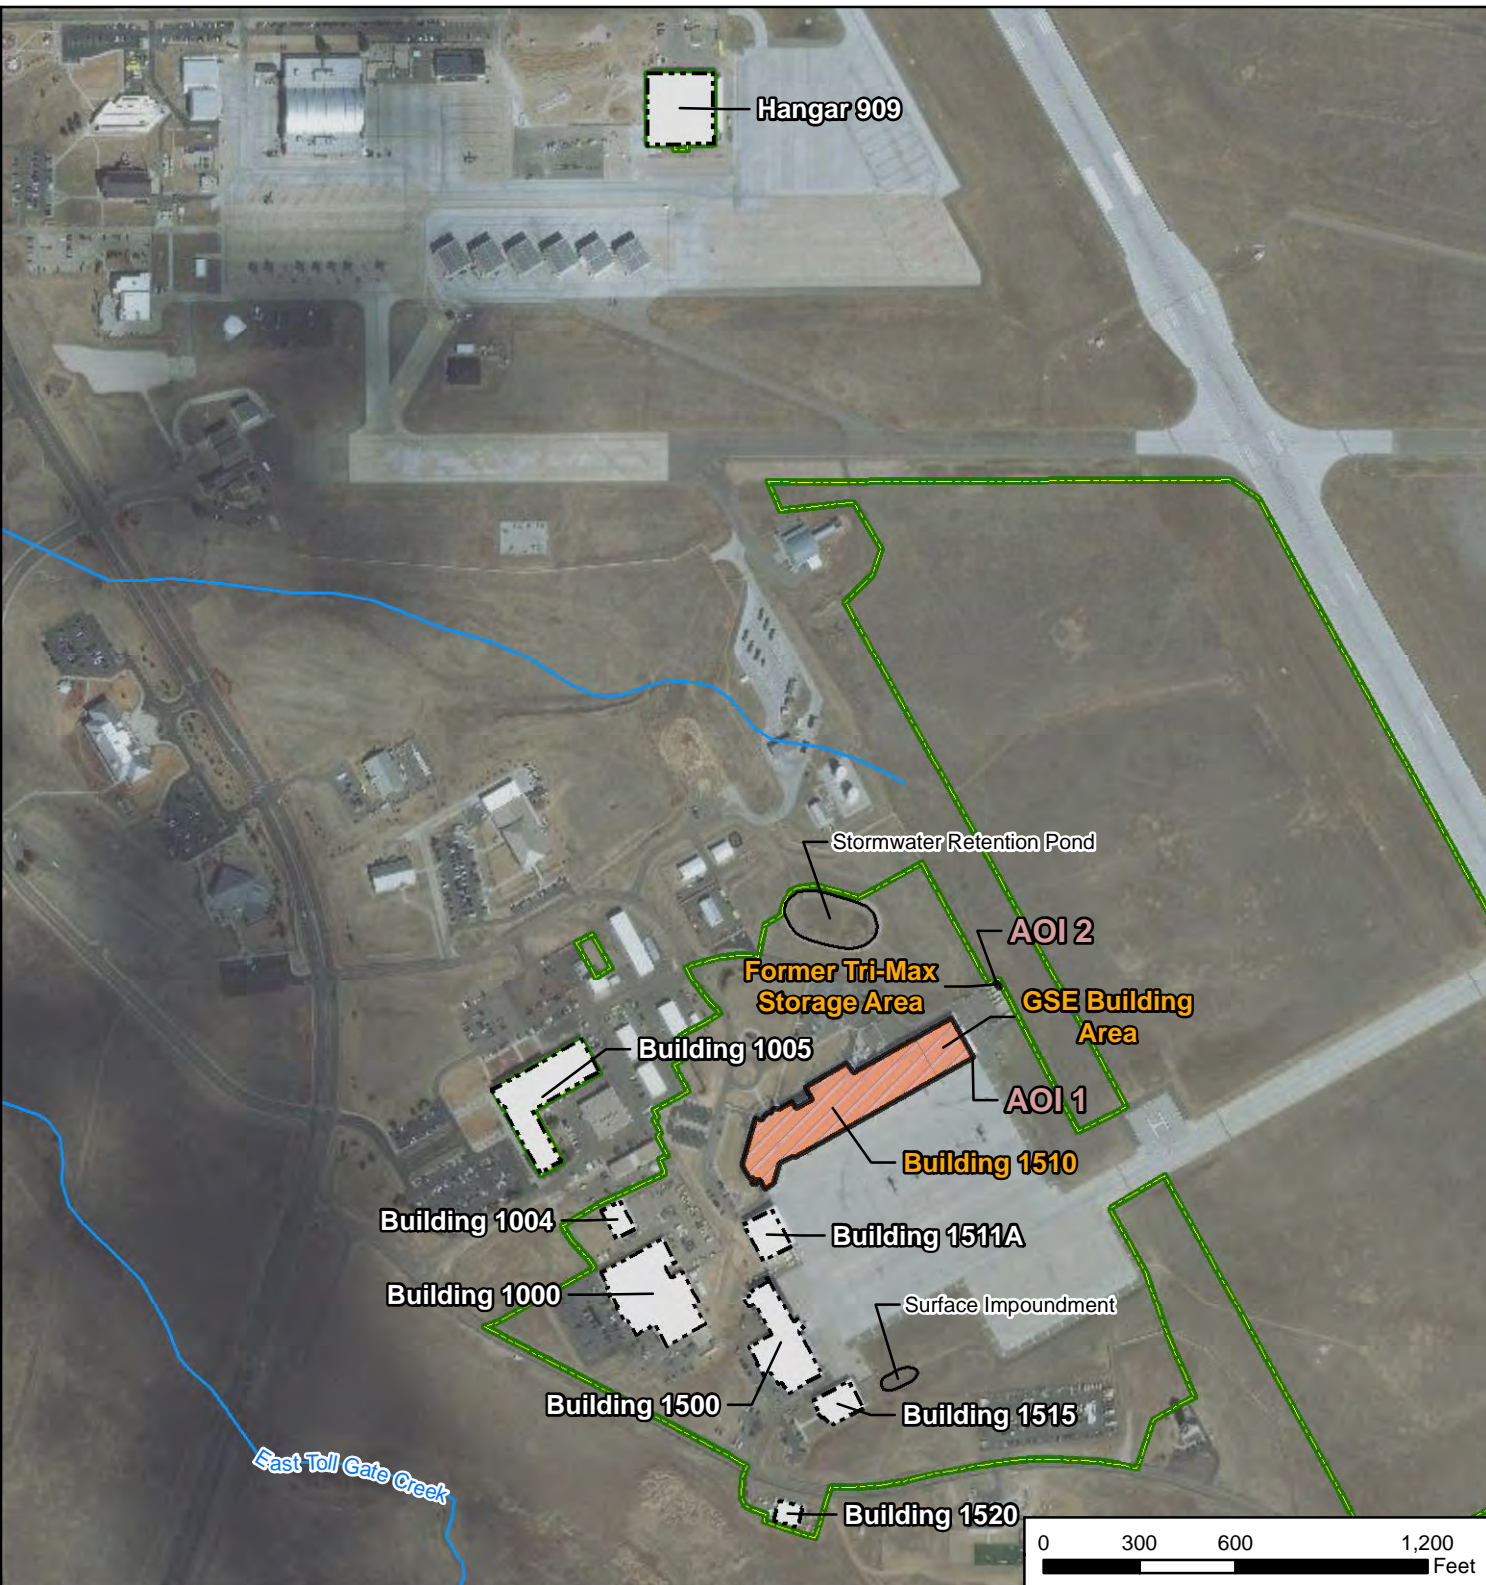
Area of Interest	AOI Location	Rationale	Potential Future Action
AOI 1 Building 1510	39°42'17.21"N; 104°45'42.64"W	HEF suppression system was released during a system test in 2006.	Proceed to an SI, focus on soil, surface water, sediment, and groundwater.
AOI 2 Former Tri-Max™ Storage Area	39°42'19.82"N; 104°45'39.18"W	AFFF was formerly stored outdoors in Tri-Max™ units	Proceed to an SI, focus on soil, surface water, sediment, and groundwater.

ARNG will evaluate the need for an SI at Buckley AASF based on the potential receptors, the potential migration of PFAS contamination off the facility, and the availability of resources.
