FINAL Preliminary Assessment Report Army Aviation Support Facility, Fort Belvoir, Virginia

Perfluorooctanesulfonic Acid (PFOS) and Perfluorooctanoic Acid
(PFOA) Impacted Sites
ARNG Installations, Nationwide

June 2020

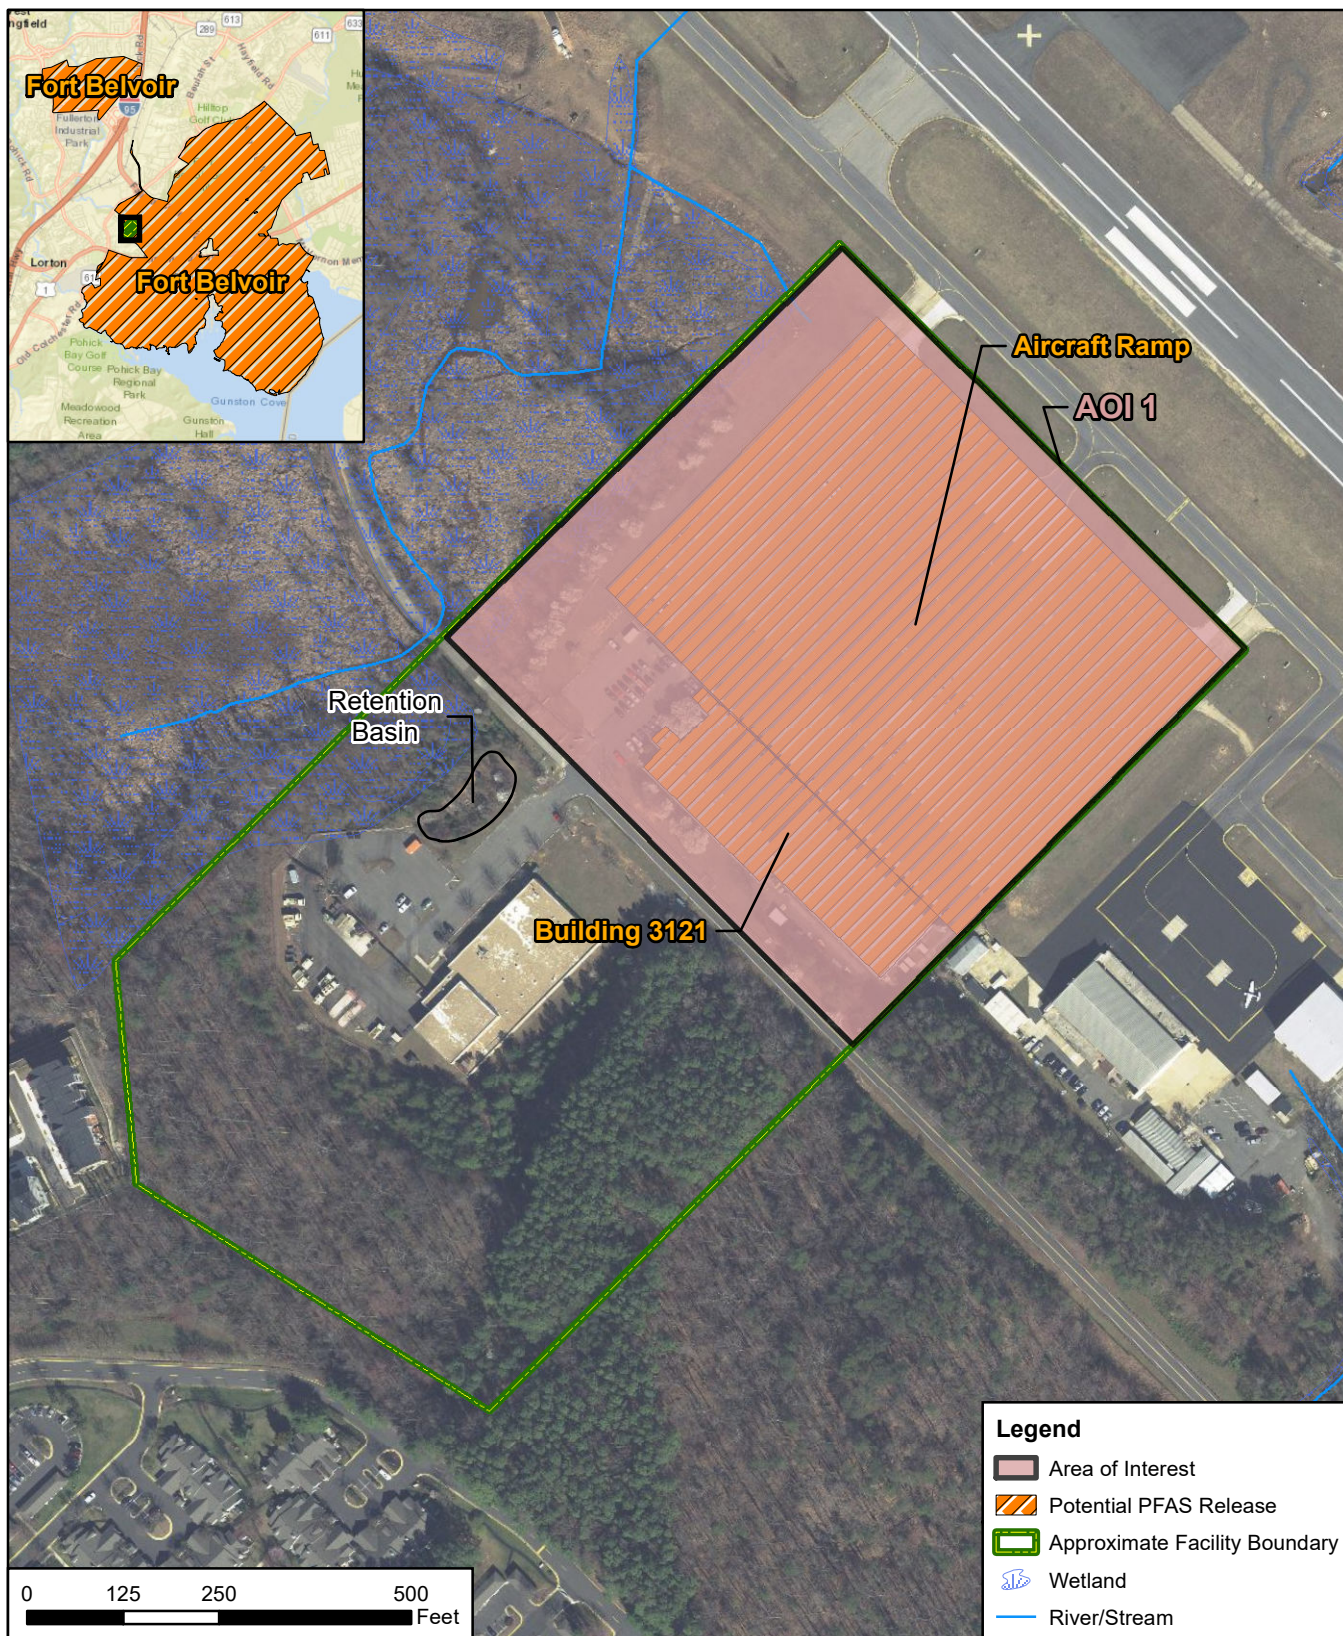
Figure ES-1

One AOI related to a potential PFAS release was identified at the AASF during the PA. The AOI is shown on **Figure ES-1** and described in **Table ES-1** below:

Area of Interest	Name	Used by	Potential Release Date
AOI 1	Building 3121 and Aircraft Ramp	DCARNG	Unknown

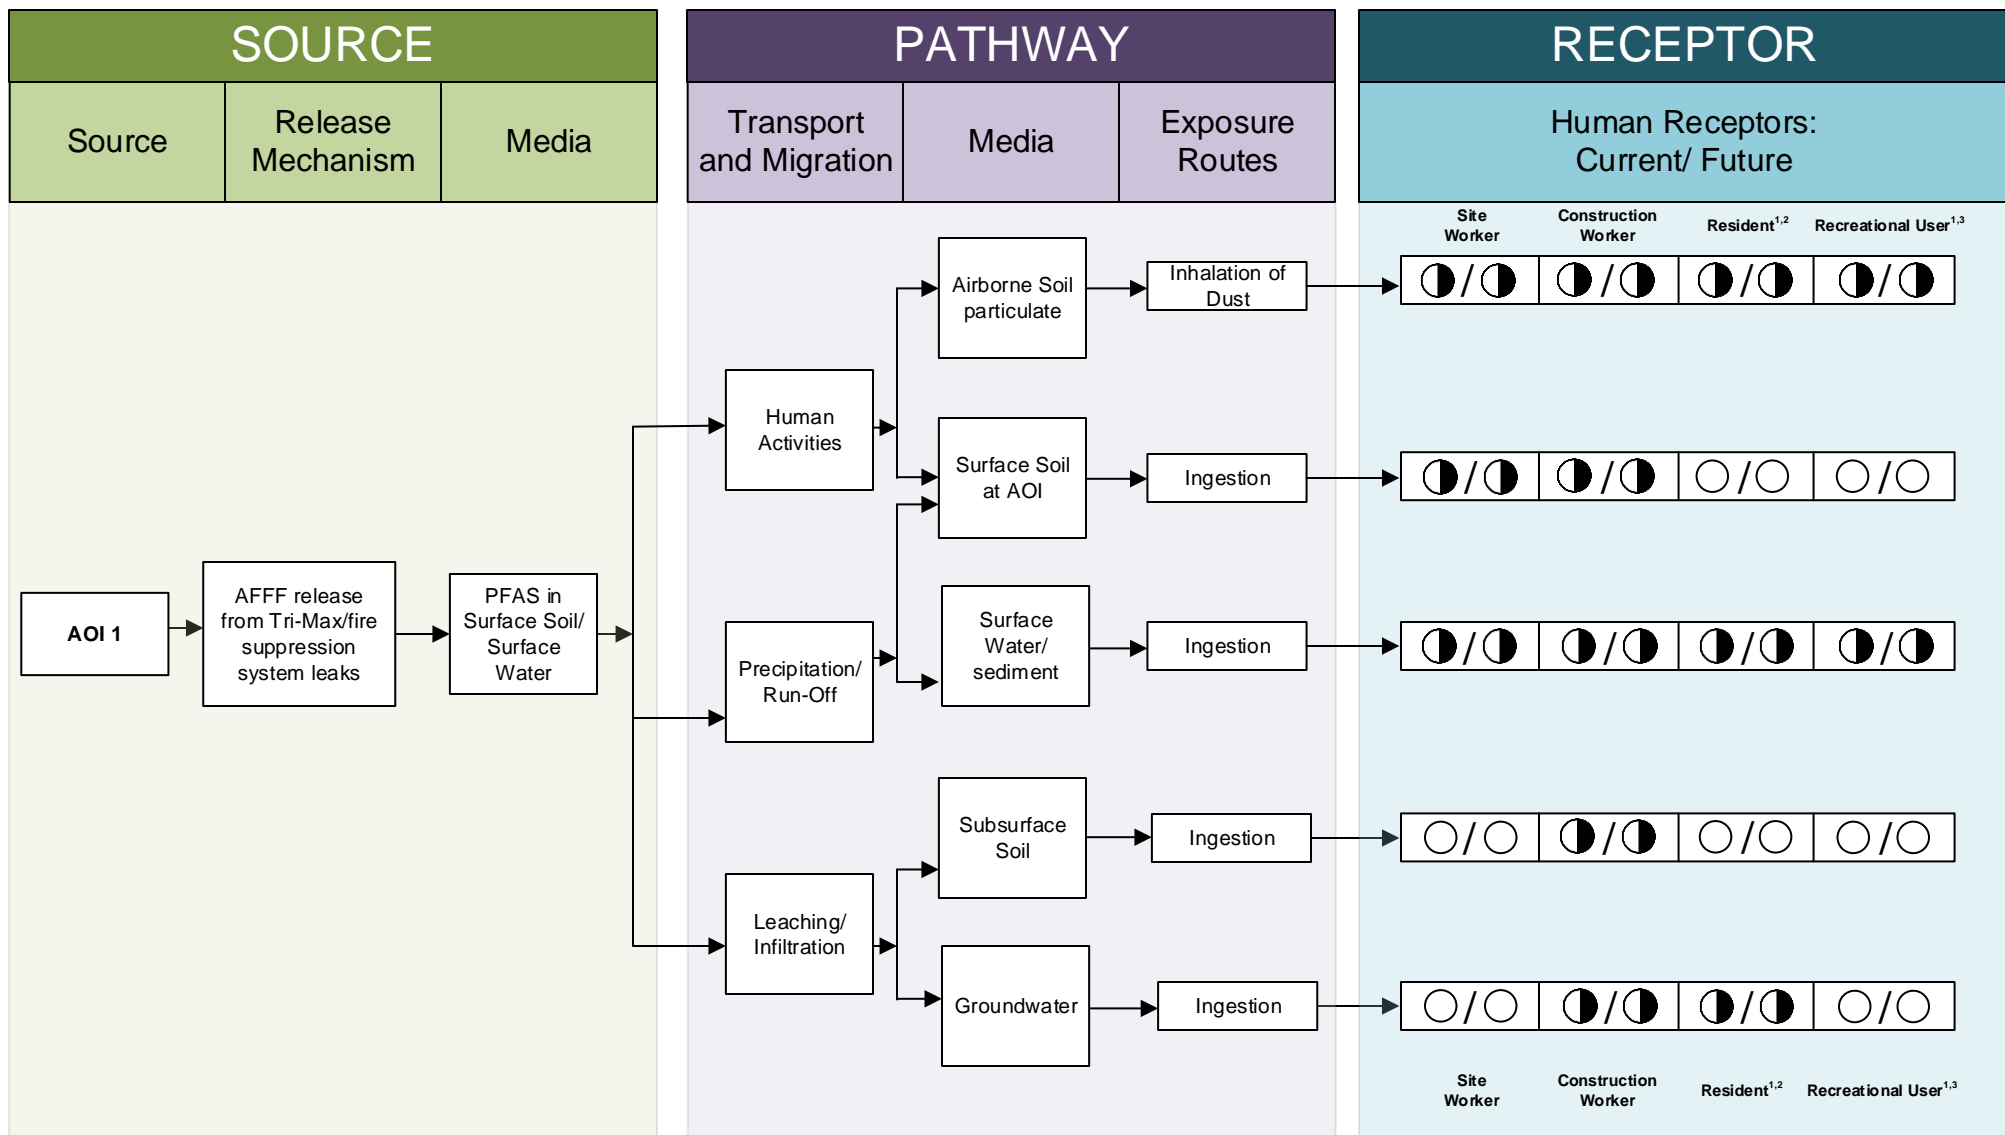
Figure ES-2
Preliminary Conceptual Site Model
AASF, VA

1. The resident and recreational users refer to off-site receptors.
2. Inhalation of dust for off-site receptors is likely insignificant.
3. Human consumption of fish potentially affected by PFAS is possible.

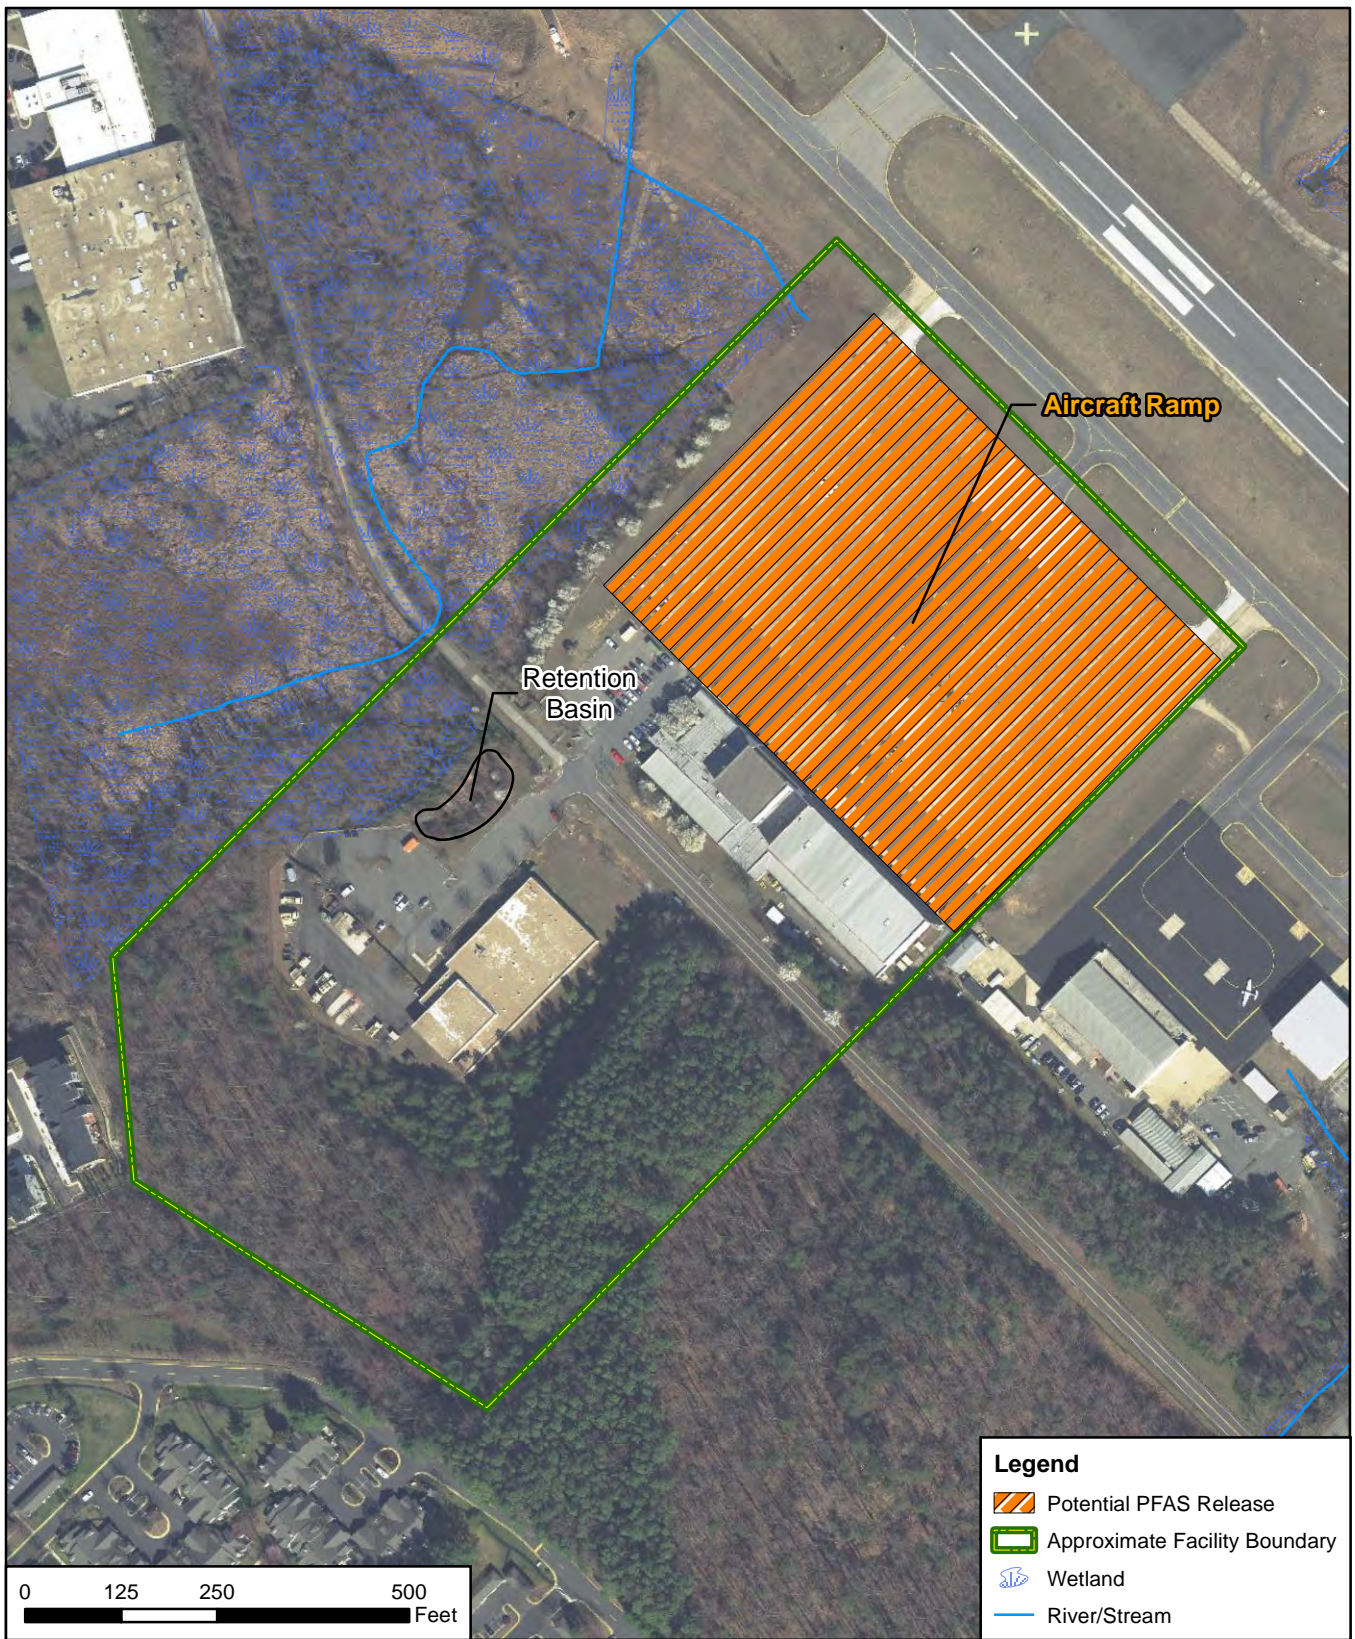
Fire Training Area	
AECOM 12420 Milestone Center Drive Germantown, MD 20876	Figure 2-1

Training sessions where personnel are instructed on how to use Purple K dry chemical fire extinguishers, also referred to as “familiarization training”, are conducted on the aircraft ramp in front of Building 3121. There are currently three Purple K fire extinguishers located on the aircraft ramp. The familiarization training is conducted annually and supervised by the DAAF fire marshal. According to the interviewed DCARNG personnel, smaller, handheld, dry chemical fire extinguishers are discharged in lieu of the Purple K fire extinguishers located on the ramp, and a firebox containing live fire is occasionally used for the training.

Tri-Max™ fire extinguishers were stored on the aircraft ramp prior to being replaced with Purple K fire extinguishers. The Tri-Max™ fire extinguishers were never used or spilled according to the knowledge of the interviewees, which extends from 1989 to present. The DAAF Fire Department was responsible for maintaining the Tri-Max™ fire extinguishers and conducting hydrostatic testing. The Tri-Maxes were turned into the Defense Logistics Agency (DLA) Disposition Services in 2012. Based on the disposal records located in **Appendix A**, there were 14 Tri-Max™ fire extinguishers turned in, and a hydrostatic test was conducted in 2008. A Safety Data Sheet for BlastGuard 6% Synthetic Foam Concentrate was also included with the disposal records; however, it could not be confirmed if this material were used within the Tri-Max™ fire extinguishers and if the material contained PFAS. Although PFAS are not listed on the Safety Data Sheet, the sheet only lists hazardous components and does not definitely state the BlastGuard 6% Synthetic Foam Concentrate does not contain PFAS.

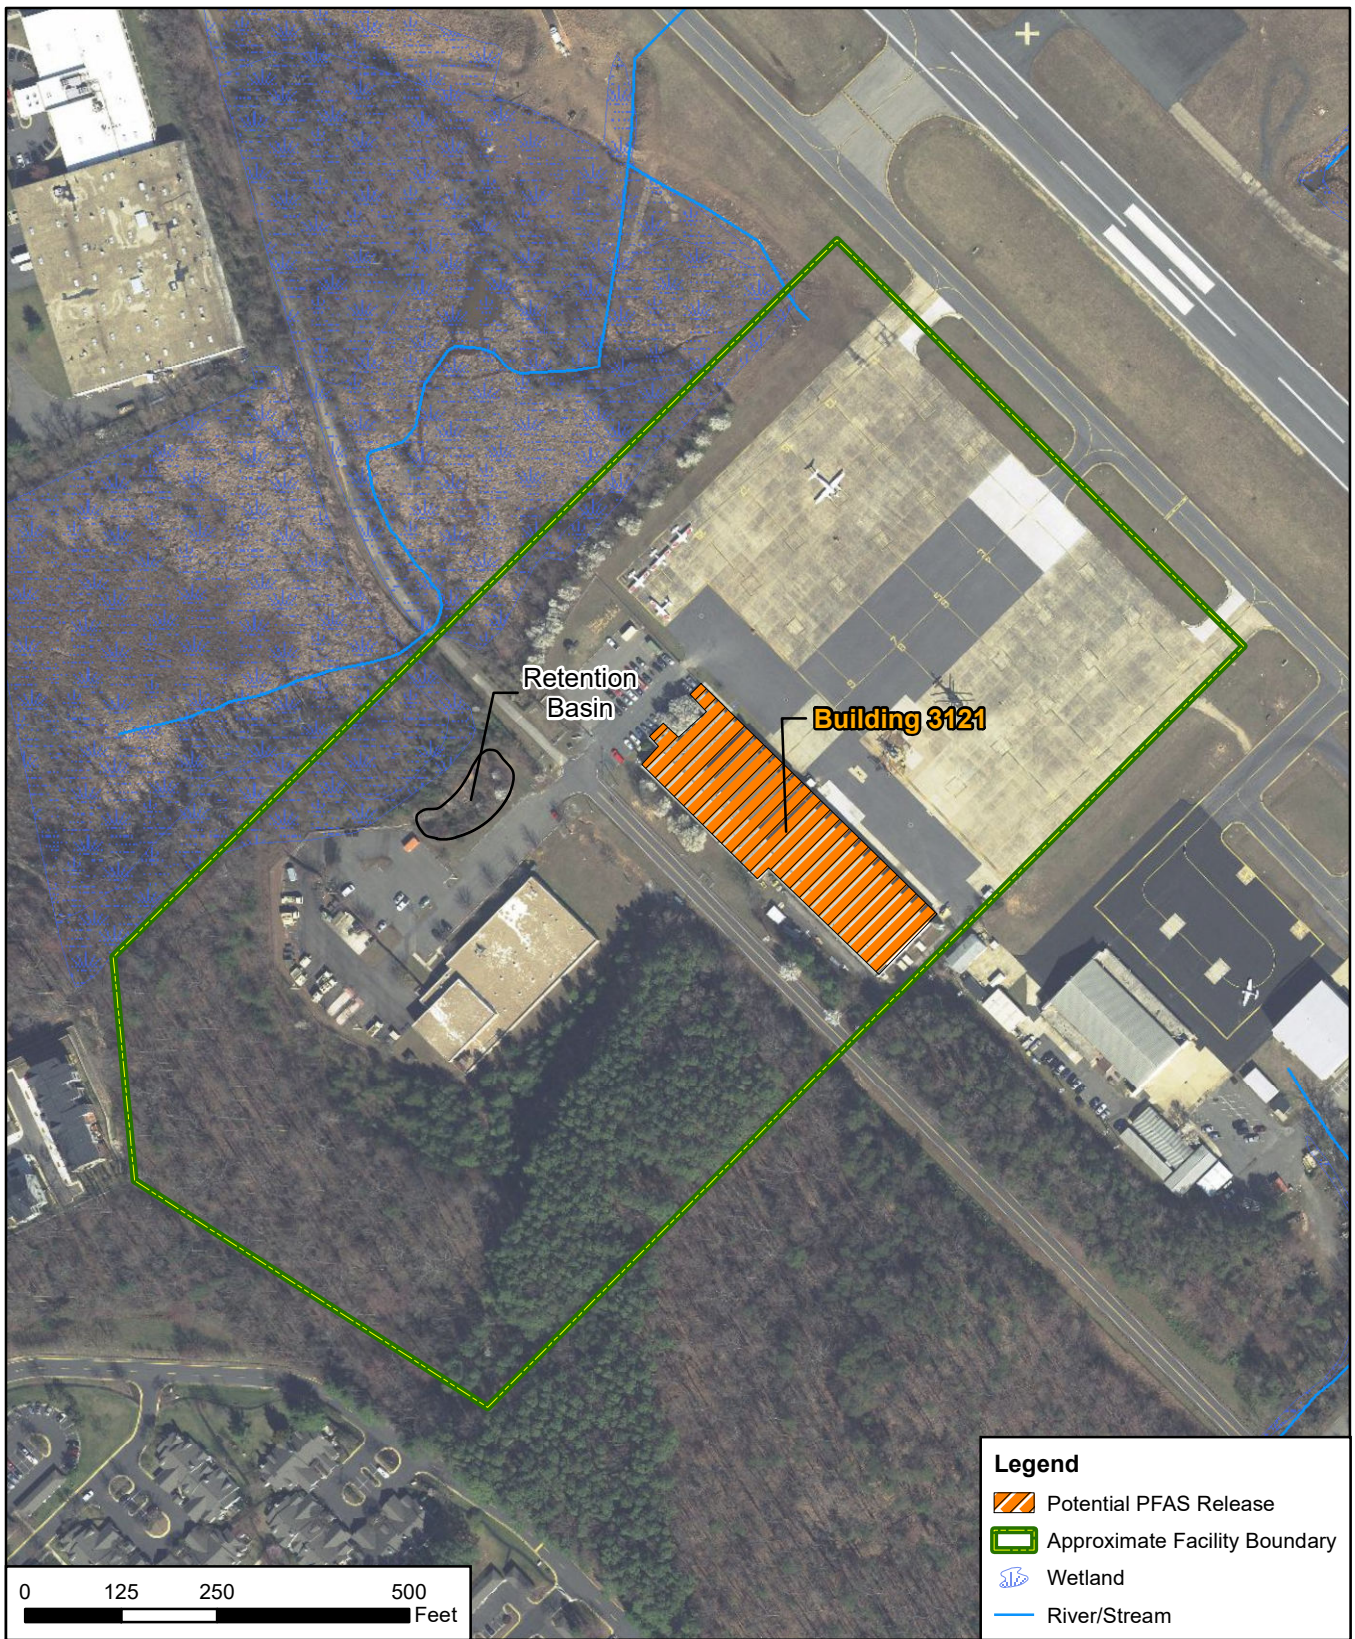
Non-Fire Training Area	
AECOM 12420 Milestone Center Drive Germantown, MD 20876	Figure 3-1

Building 3121 is a 47,000-square foot maintenance hangar. The original section of Building 3121 was constructed in 1981 and later expanded in 1985 (Avatar and AECOM, 2018). The northwestern portion of the hangar contains fixed-wing aircraft, and the southeastern portion contains rotary aircraft. Both portions are connected to an AFFF fire suppression system, which was installed during the original construction for the building.

There are two AFFF tanks for the fire suppression system housed within a tank room in Building 3121. The tanks are marked with dates indicating the levels within the tank to estimate the volume of AFFF leaking. Based on the markings, approximately 50 gallons of AFFF leaked from each tank, with both tanks originally containing about 300 gallons of AFFF. The markings also indicate that the tanks leaked AFFF beginning from August 2012 until June 2014. According to interviewed DCARNG personnel, the AFFF leakage was captured using absorbent mats placed underneath the two tanks; the disposal method for the absorbent mats is unknown. The leaks were caused by a corroded valve, and the valve was subsequently repaired in 2014. The type of AFFF leaked is unknown, but DCARNG personnel stated that the tanks have never been refilled.

Weekly inspections of the AFFF fire suppression system are performed by a state technician, and monthly inspections are performed by a DAAF Fire Department personnel. According to interviewed DCARNG personnel, there have been several repairs to the fire pump and piping due to water leaks. The latest repair occurred in August 2019.

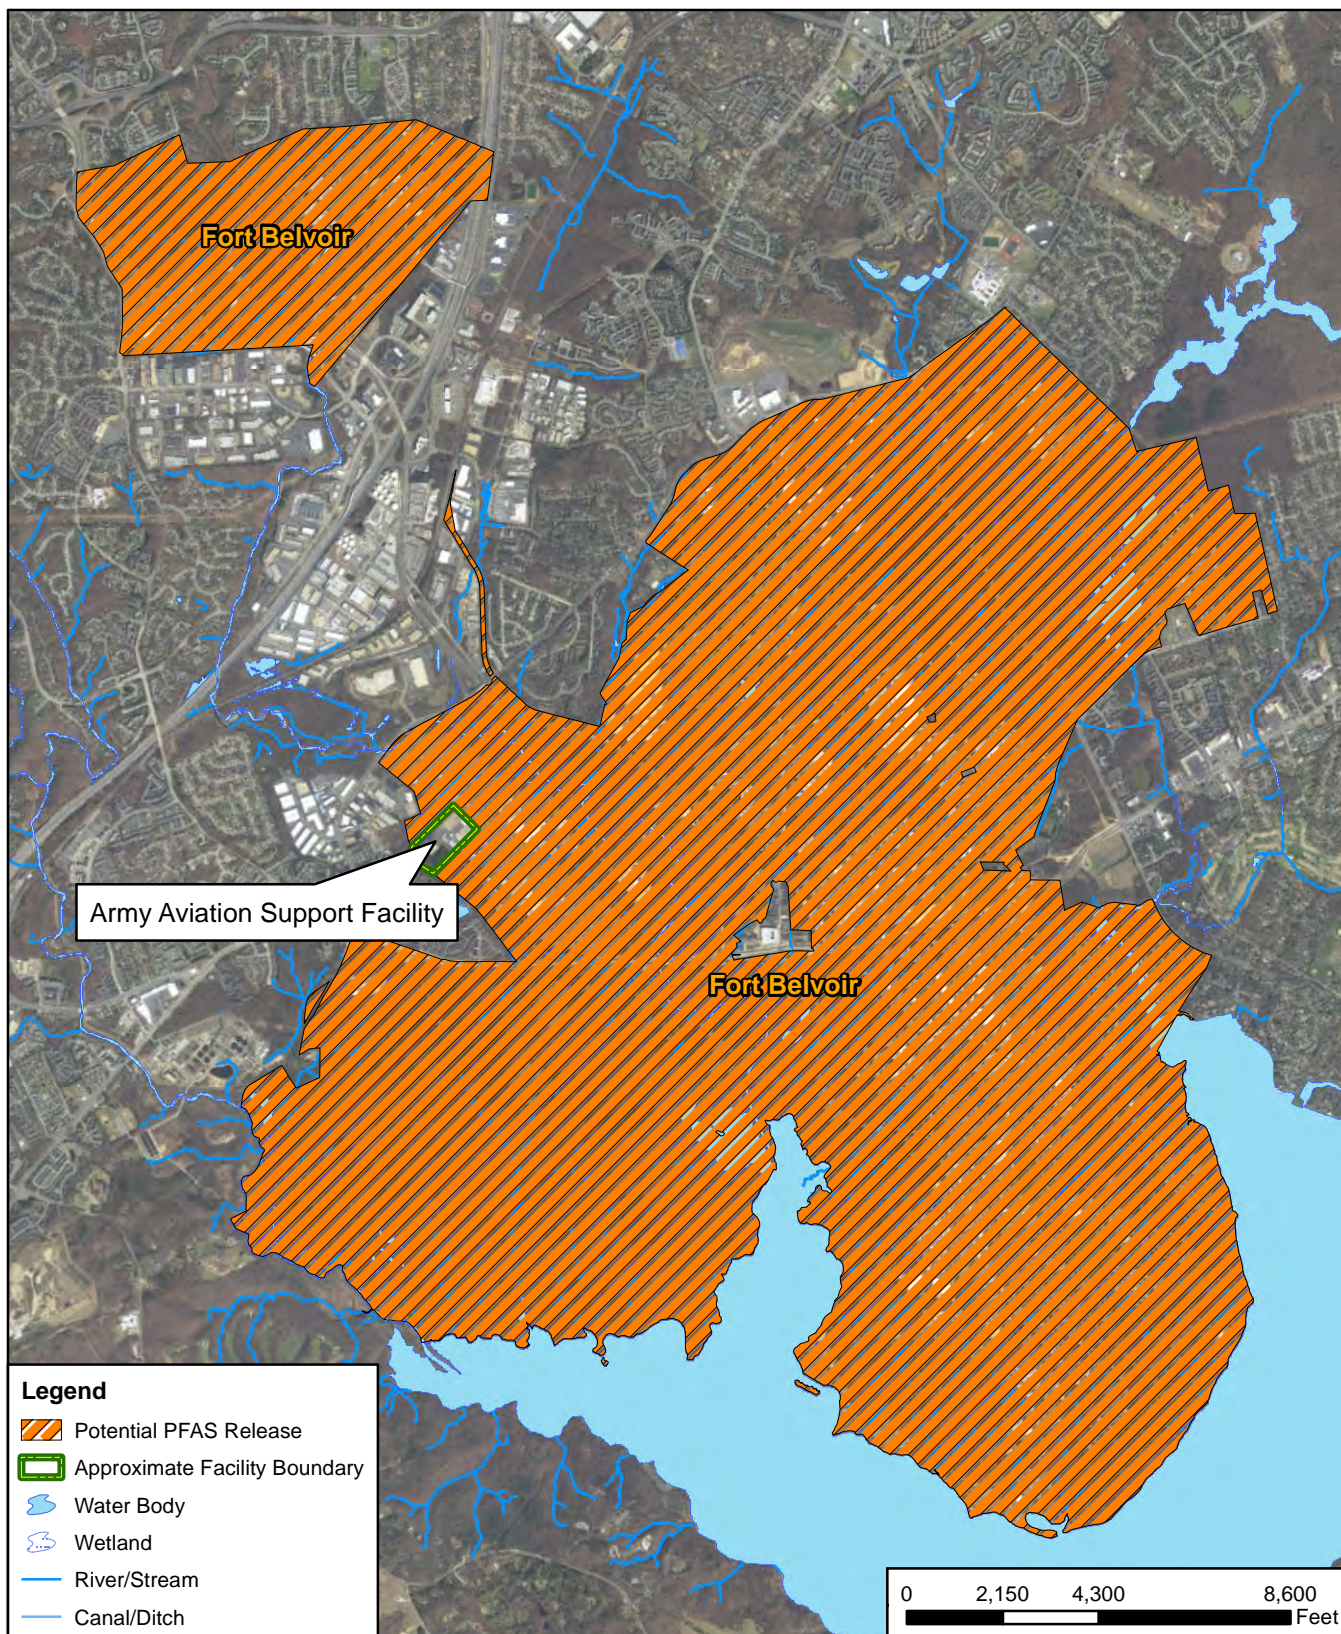
12420 Milestone Center Drive Germantown, MD 20876	Figure 5-1
SCALE	1:51,616	CHK BY	ST	2/11/2020			
Base Map: Virginia Geographic Information Network (VGIN)		PM	RG	2/11/2020

The property surrounding the facility is under the control of US Army Garrison Fort Belvoir, which is being investigated under a separate PFAS PA Program. Notable incidents at US Army Garrison Fort Belvoir that may have resulted in the release of PFAS include the 2018 Lakota Hangar (Building 3140) deluge system release and a 1984 army aircraft crash south of DAAF (UPI Archives, 1984). According to the incident report for the Lakota Hangar deluge system release (**Appendix A**), 324 gallons of Ansul Jet X 2% High Expansion Foam Concentrate were released during an accidental activation of the deluge system on 17 May 2018. The foam ran out of the hangar and into the stormwater conveyance system and runway. The foam was cleaned from the site using vacuum trucks and Frac tanks and was subsequently sent to Waste Management Bethel Landfill in Hampton, Virginia for disposal.

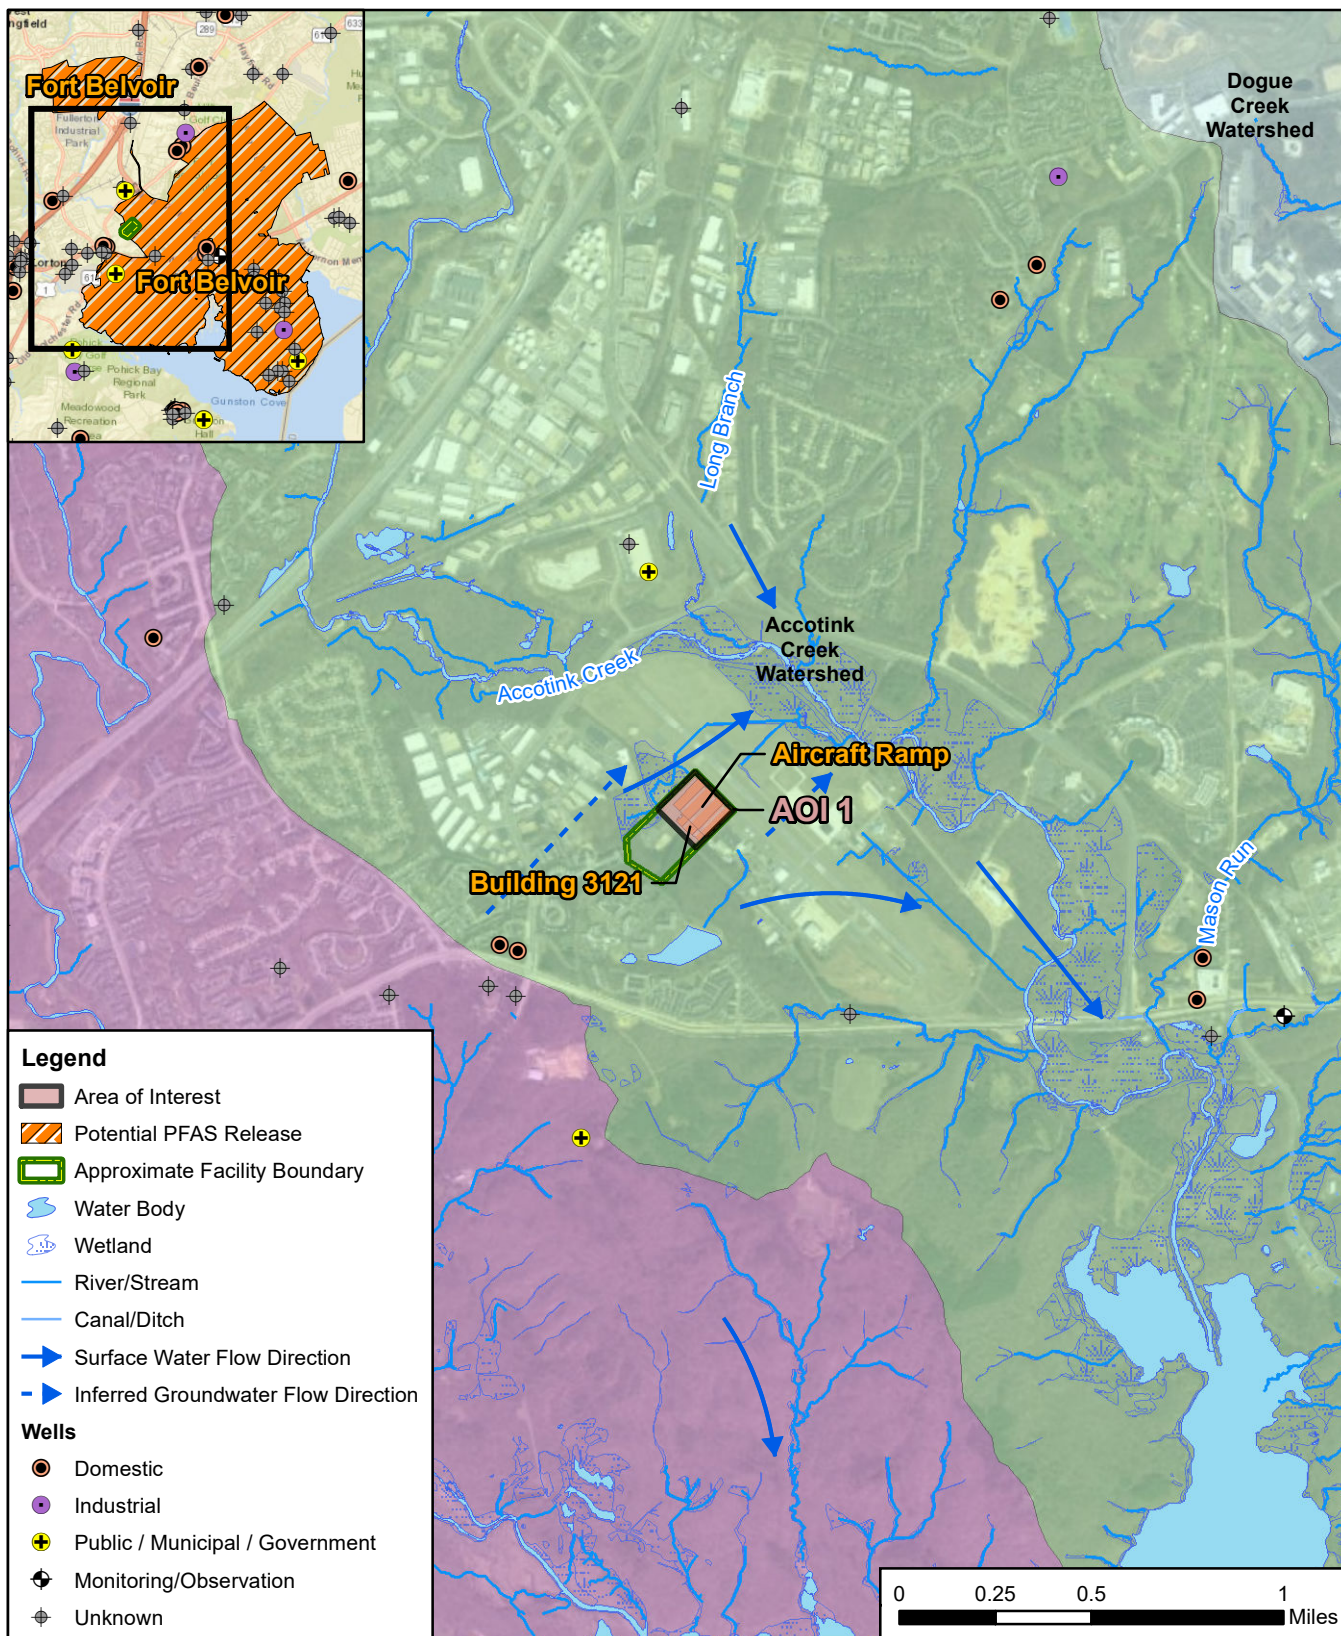
Figure 6-1	
REVISED	2/12/2020	GIS BY	MS	2/12/2020				
SCALE	1:31,680	CHK BY	ST	2/12/2020				
Base Map: Sources: Esri, HERE, Garmin, USGS, Intermap, INCREMENT P, NRCan, Esri Japan, METI,		PM	RG	2/12/2020				12420 Milestone Center Drive Germantown, MD 20876

Based on the PA findings, one area was identified at the facility where AFFF may have been stored or expended: AOI 1 Building 3121 and Aircraft Ramp. As such, this area is determined to be an AOI and may be a potential PFAS source area. The AOI location is shown in **Figure 6-1**.

AOI 1 includes one non-FTA and one FTA: Building 3121 and the aircraft ramp, respectively. AFFF leaked from fire suppression system tanks in Building 3121, and Tri-Max™ fire extinguishers potentially containing AFFF were stored on the aircraft ramp.

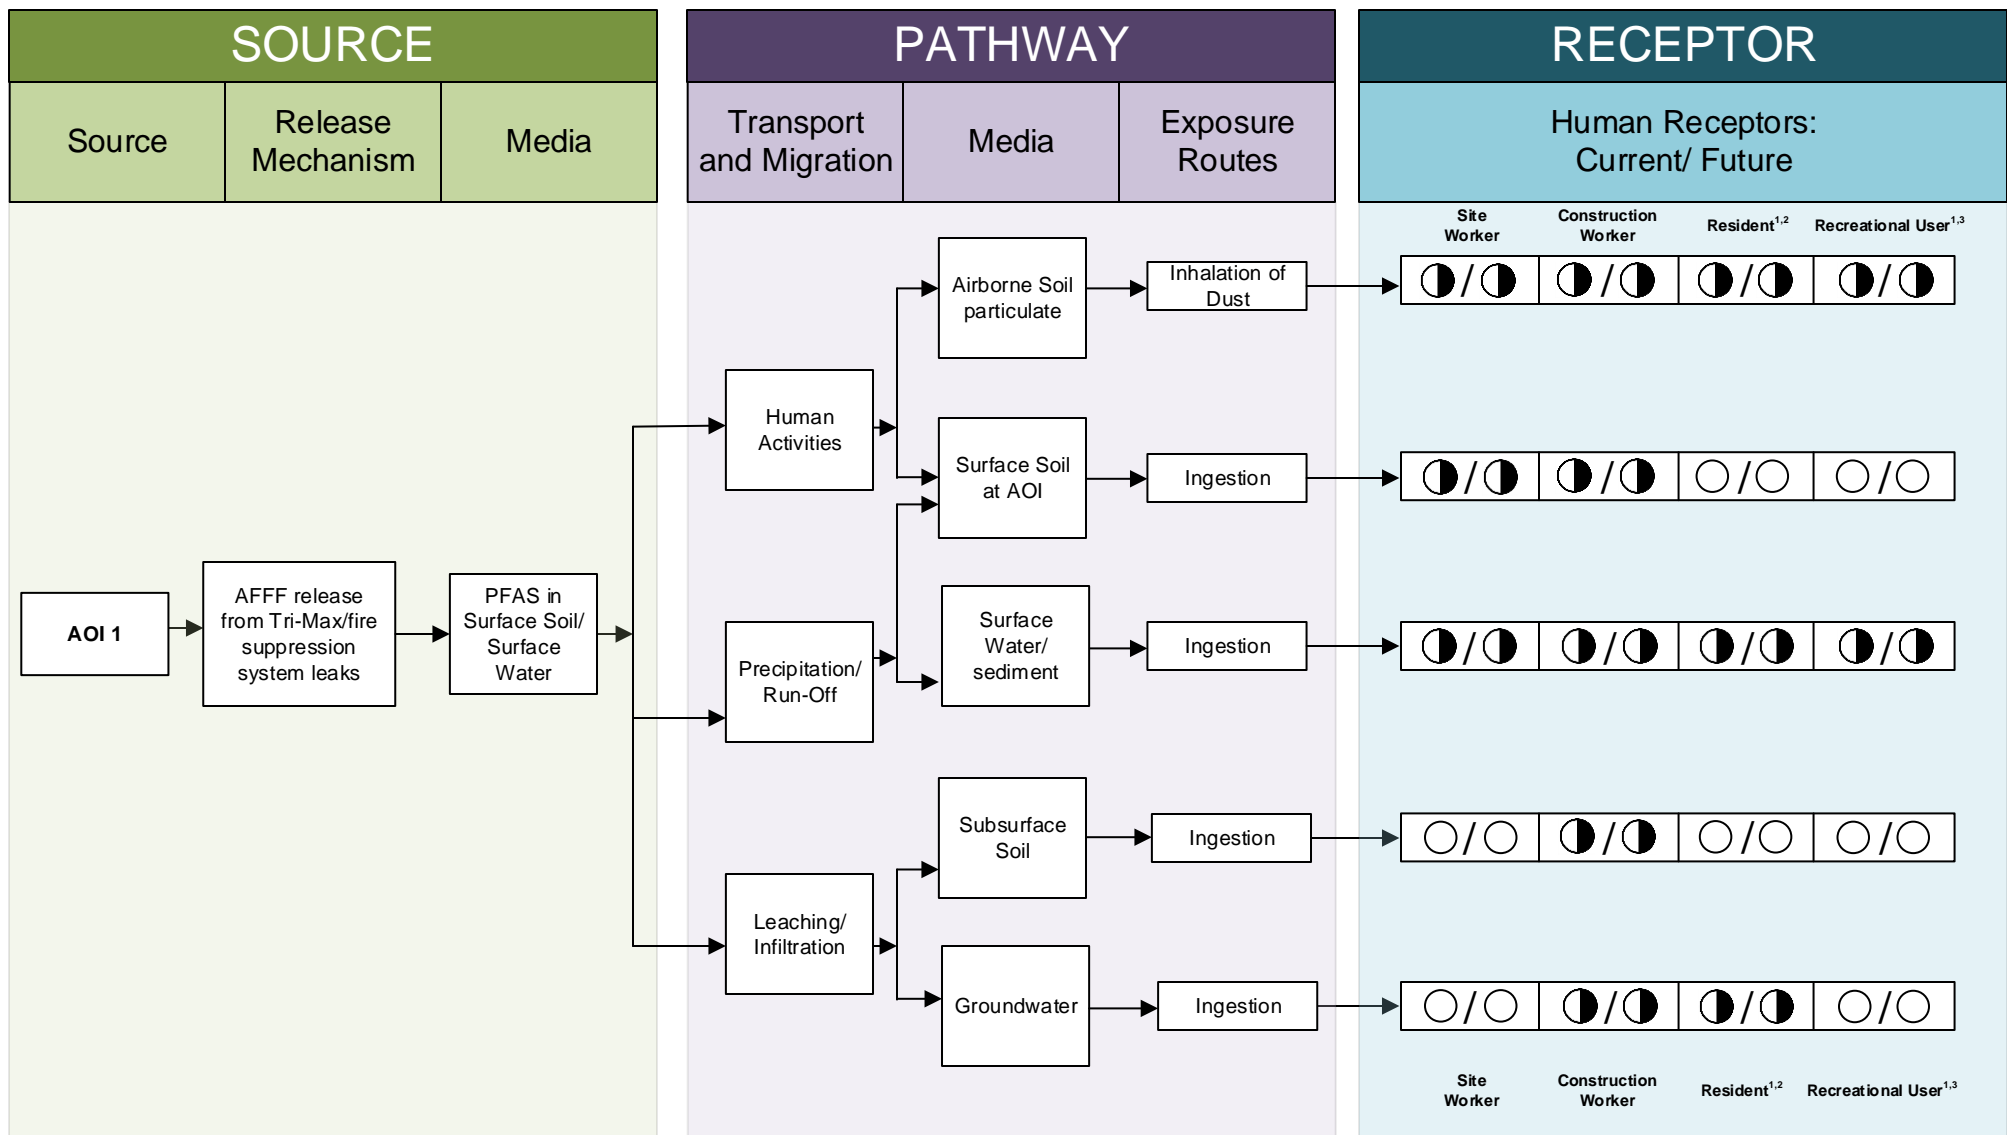
Figure 6-2
Preliminary Conceptual Site Model
AASF, VA

AFFF releases at Building 3121 were captured by absorbent pads that were disposed of in an unspecified manner. There are also trench drains located in Building 3121 that lead into a 2,000-gallon oil water separator. According to interviewed DCARNG personnel, the resulting discharge from the oil water separator leads into the sanitary sewer, and the oil water separator is serviced annually by American Water Company. Direct exposure pathways to receptors are unlikely due to the secondary containment and treatment of wastewater.

Potential AFFF releases on the aircraft ramp would have occurred primarily on paved surfaces but may run-off into unpaved surfaces. PFAS releases carried by run-off into surface soil may have infiltrated the subsurface soil. PFAS releases may have also infiltrated the subsurface soil via cracks in the pavement or in joints between areas that are paved with different materials. Ground-disturbing activities to soil at AOI 1 could result in construction worker exposure to potential PFAS contamination via inhalation of dust or ingestion of surface and subsurface soil. Inhalation of dust or ingestion of surface soil may also occur during the routine activities of site workers. Therefore, the inhalation and ingestion pathways for these receptors are considered potentially complete. The inhalation of dust for off-facility residents and recreational users of Accotink Creek is also a potentially complete pathway, although the exposure is likely insignificant.

PFAS releases carried by run-off likely drain downslope into tributaries of Accotink Creek. Off-facility receptors, such as residents and recreational users, may be exposed to PFAS via ingestion of surface water and sediment in Accotink Creek or via the ingestion of fish affected by PFAS. The on-facility presence of a stormwater basin near Building 3121 presents a potentially complete exposure pathway to site workers and construction workers via ingestion of surface water and sediment.

1. The resident and recreational users refer to off-site receptors.
2. Inhalation of dust for off-site receptors is likely insignificant.
3. Human consumption of fish potentially affected by PFAS is possible.

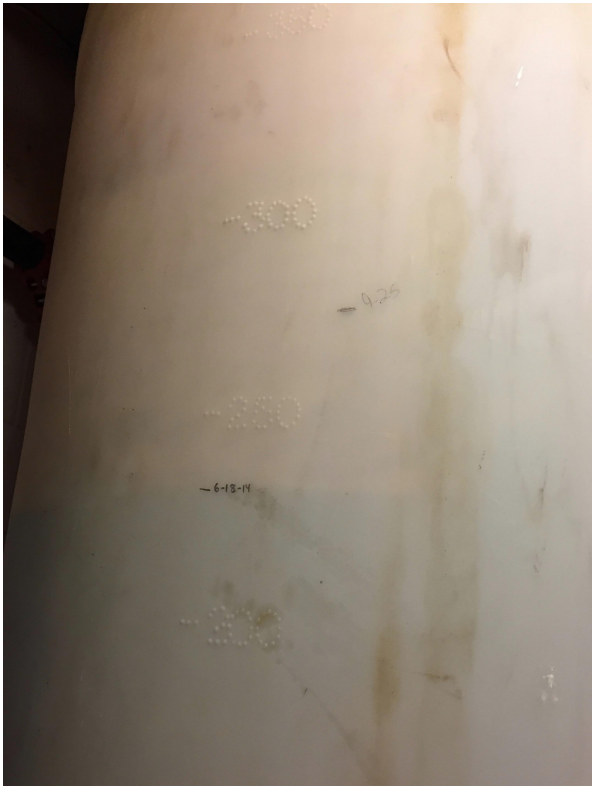
Army National Guard, Preliminary Assessment for PFAS	Army Aviation Support Facility	Fort Belvoir, Virginia
<p>Photograph No. 3</p> <p>Date 10/18/2019 Time 11:14</p> <p>Description: The AFFF tanks have a history of leaking. The AFFF levels in the second tank are marked from September 2012 to June 2014.</p> <p>Orientation: Southeast</p>

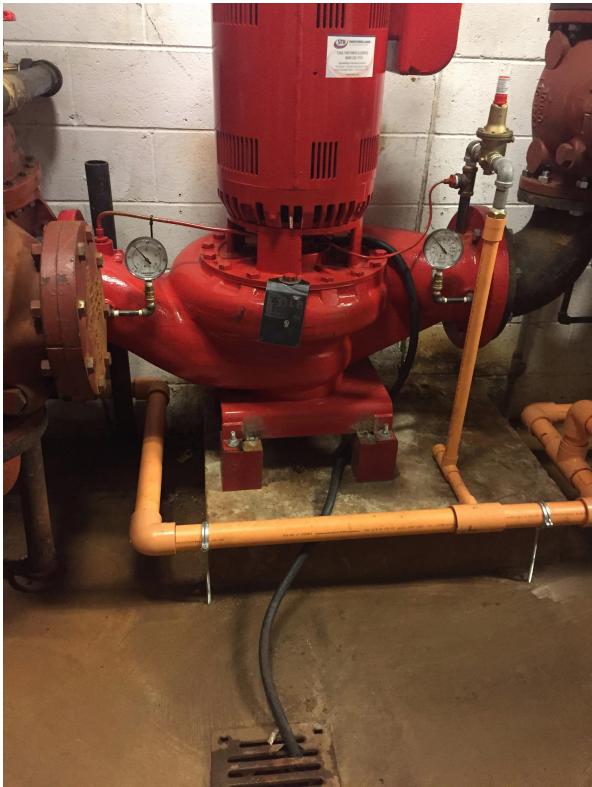
<p>Photograph No. 4</p> <p>Date 10/18/2019 Time 11:14</p> <p>Description: The fire pump has a history of leaking water and is shown in the tank room of Building 3121.</p> <p>Orientation: Northwest</p>

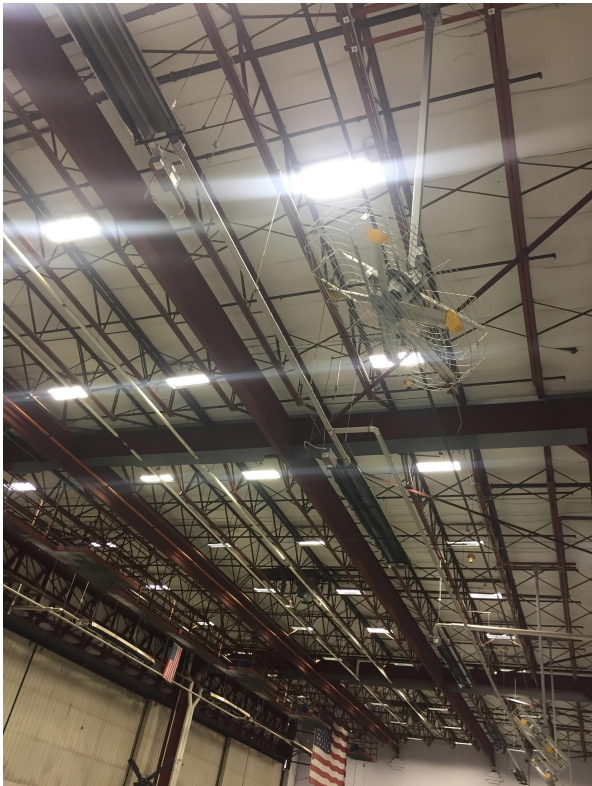
Army National Guard, Preliminary Assessment for PFAS		Army Aviation Support Facility	Fort Belvoir, Virginia
Photograph No. 5 Date 10/18/2019 Time 11:19 Description: Building 3121 has an overhead AFFF fire suppression system in the hangar. Orientation: East

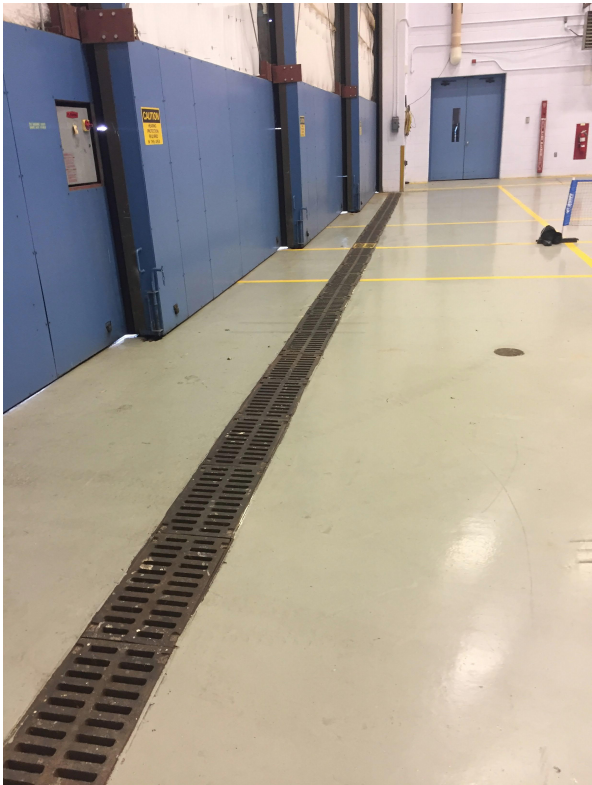
Photograph No. 6 Date 10/18/2019 Time 11:26 Description: Trench drains are located on the perimeter of the hangar floor in Building 3121. The trench drains lead into an oil water separator. Orientation: Southeast
