FINAL Preliminary Assessment Report Brooksville Readiness Center / AASF #2 Spring Hill, Florida

Perfluorooctanesulfonic Acid (PFOS) and Perfluorooctanoic
Acid (PFOA) Impacted Sites
ARNG Installations, Nationwide

August 2020

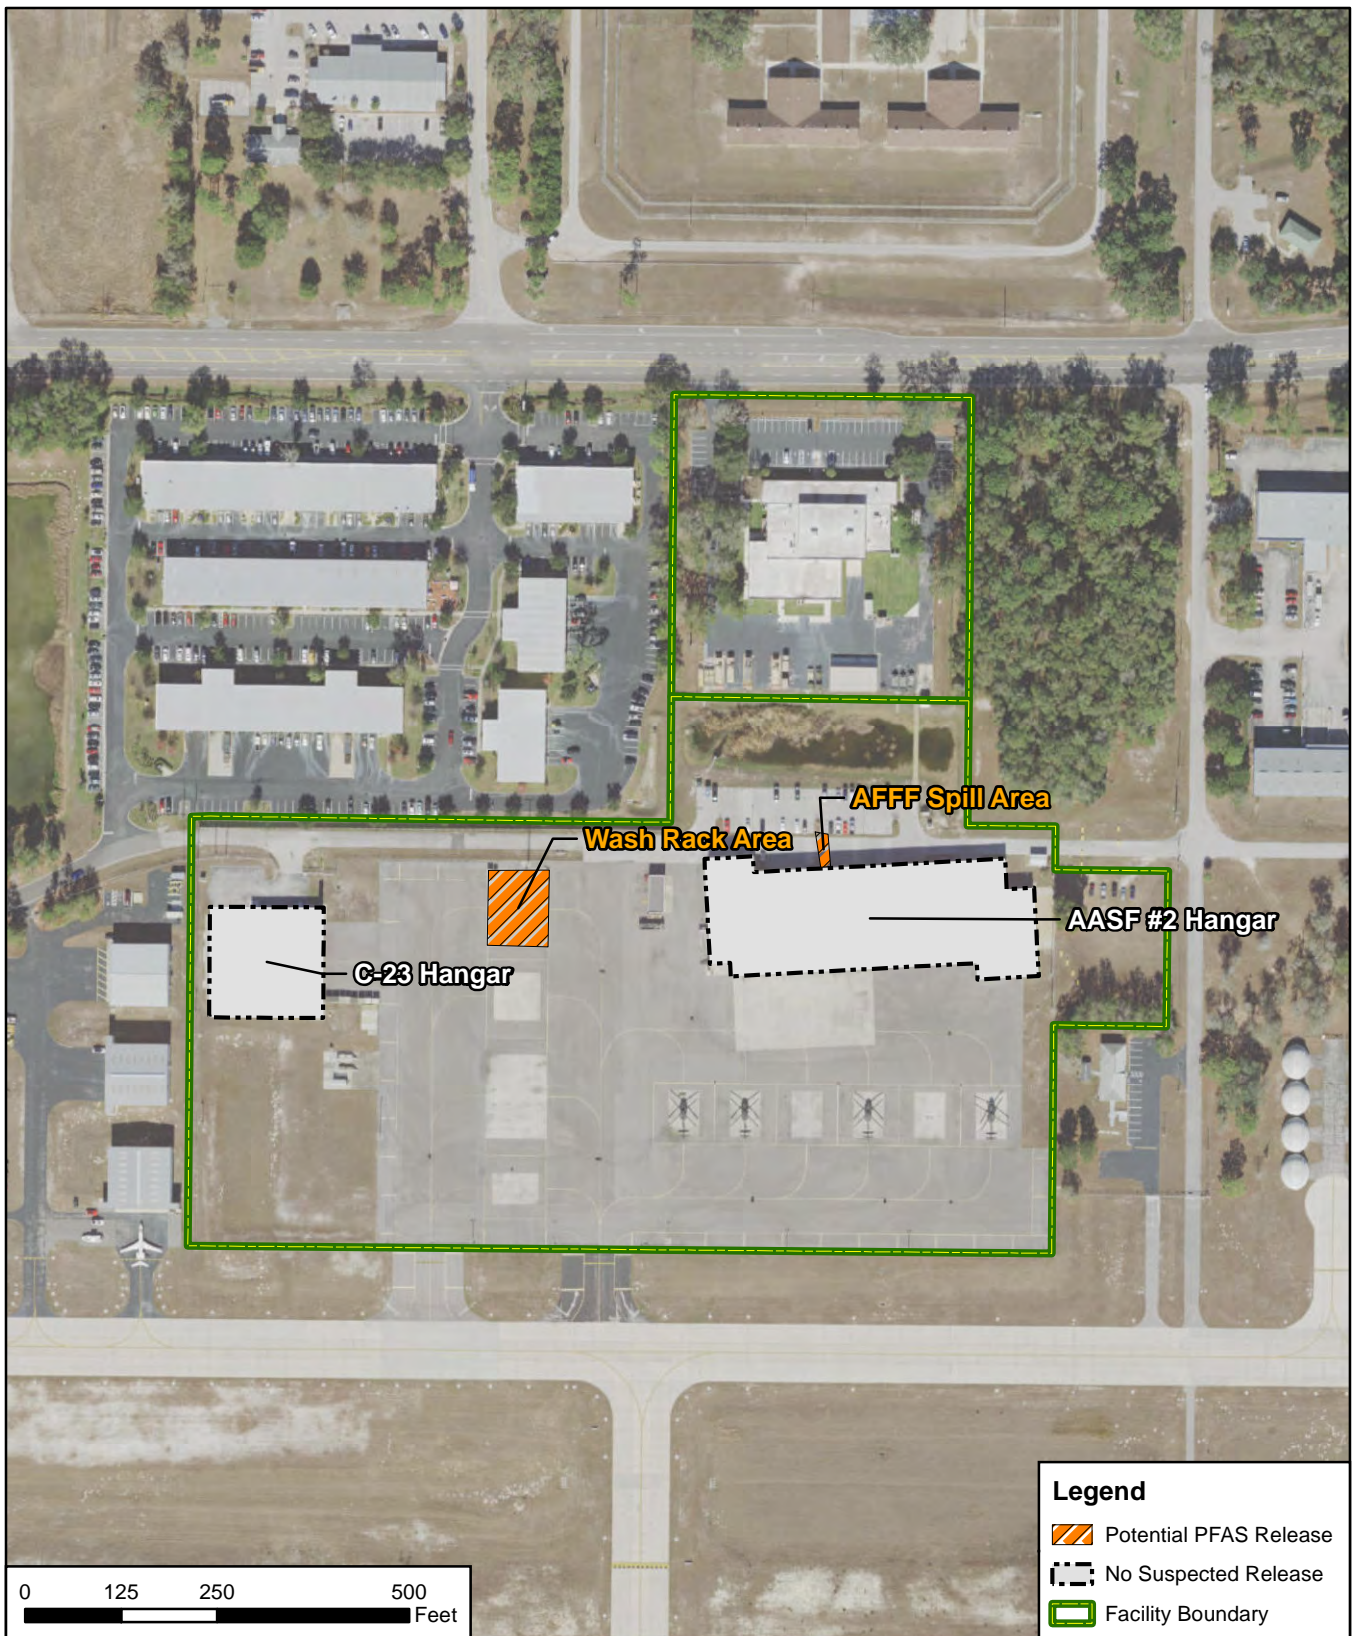
12420 Milestone Center Drive Germantown, MD 20876	Figure 3-1
REVISED	7/29/2019	GIS BY	MS	7/29/2019			
SCALE	1:3,000	CHK BY	MG	7/29/2019			
Base Map: Source: Esri, DigitalGlobe, GeoEye, Earthstar Geographics,		PM	RG	7/29/2019

Several non-FTAs where PFAS was potentially released were identified during the PA. A description of each non-FTA is presented below, and the non-FTAs are shown on **Figure 3-1**. Interview records appear in **Appendix B**. Photographs appear in **Appendix C**.

The wash rack area is located on the northwestern portion of the property (**Figure 3-1**). The geographic coordinates are 28°28'44.31"N; 82°27'20.55"W. According to interviewees and records, annual nozzle testing of the TriMax™ units was conducted at the wash rack in January 2007 and February 2008. The unit tanks were emptied and discharged on the wash rack area. The wash rack drained to an oil/water separator, which then discharges to the sanitary sewer. Four TriMax™ units containing 30 gallons of 3% AFFF were located at the facility. Shortly after the February annual testing, the units were decommissioned and removed from the site. **Photograph 11** of the spill area appears in **Appendix C**.

The AASF #2 hangar is equipped with an AFFF fire suppression system. Interviewees indicated sometime between 2002-2003, during the installation of the fire suppression system by Cox Fire Protection, Inc., 3% AFFF diluted with water was spilled out of the fire suppression tank room (**Figure 3-1**). The geographic coordinates of the AFFF spill area are 28°28'44.96"N; 82°27'16.06"W. The spill was approximately 5 gallons that flowed onto the pavement behind the building and into the grassy area in the adjacent parking lot but did not reach the parking lot itself (see Photographs 8 and 9 in **Appendix C**).

AASF #2 hangar is centrally located within the Brooksville RC boundary (**Figure 3-1**). The geographic coordinates are 28°28'44.35"N; 82°27'16.25"W. The hangar was previously equipped with four TriMax™ 30 foam fire extinguishers in the corners of the hangar. Testing of the TriMax™ units was conducted in the Wash Rack area as discussed in **Section 3.1**. In 2001 the hangar was outfitted with a fire suppression system supplied by two 900-gallon AFFF tanks (**Photographs 5 through 7, and 10**). During the site visit, it was observed that approximately 135 gallons of Ansulite AFFF concentrate for 3% proportioning on reserve were stored in a combination of 5-gallon buckets and 55-gallon drums. Interviewees stated no leaks had been reported, and no signs of leaks from the piping system were observed during the site visit. Interviewees also indicated the AFFF fire suppression system in the hangar has not been tested or used due to water pressure constraints in the area. Currently, a water supply line from the municipality in combination with a water supply line from the Brooksville – Tampa Bay Regional Airport are unable to pressurize the system. An AFFF spill occurred just outside the fire suppression system room in the north portion of the hangar as described in **Section 3.2**.

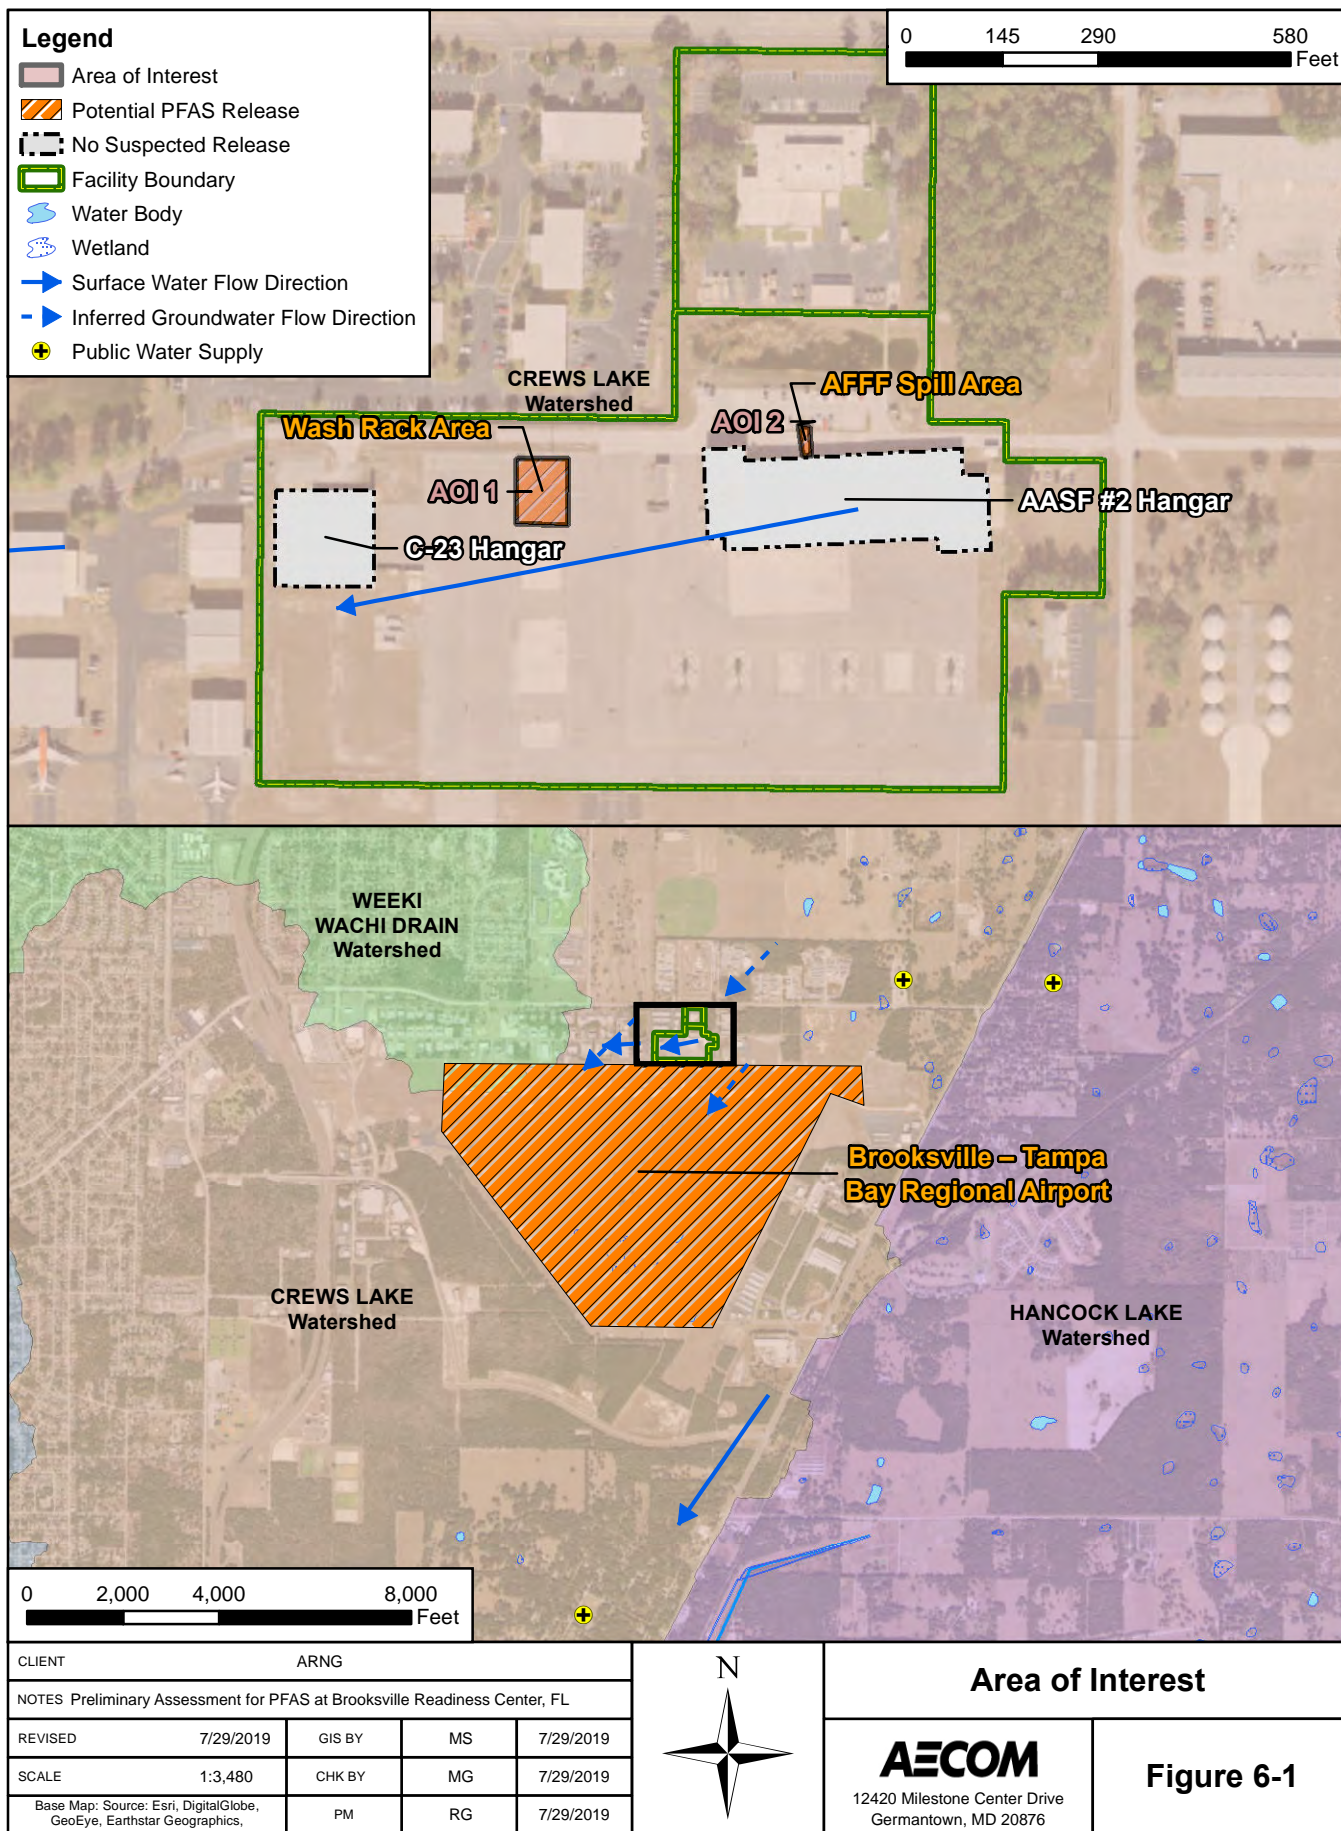
Based on the PA findings, the two distinct potential release areas were identified as AOIs: AOI 1 Wash Rack Area and AOI 2 AFFF Spill Area. The AOI locations are shown on **Figure 6-1**. The following sections describe the CSM components and the specific CSMs developed for each AOI. The CSM identifies the three components necessary for a potentially complete exposure pathway: (1) source, (2) pathway, (3) receptor. If any of these elements are missing, the pathway is considered incomplete.

AOI 1 is the wash rack area. Potential PFAS releases to soil by the FLARNG occurred at AOI 1 during annual testing of the TriMax™ units in January 2007 and February 2008. The units were discharged on the concrete wash rack area and drained to an oil/water separator which then discharges to the sanitary sewer. It is possible the AFFF foam reached the soil area outside of the concrete wash rack during discharges.

AOI 2 is the accidental release of AFFF during the installation of the fire suppression system at AASF #2 hangar, between 2002 and 2003. About 5 gallons of AFFF flowed onto the pavement behind the building and across the road into the grass area adjacently south of the parking lot.

Area of Interest	AOI Location	Rationale	Potential Future Action
AOI 1 Wash Rack Area	28°28'44.33"N and 82°27'20.62"W	Annual TriMax™ unit testing completed at wash rack from 2007 to 2008.	Proceed to an SI, focus on soil and groundwater
AOI 2 AFFF Spill Area	28°28'44.98"N and 82°27'16.07"W	Approximately 5 gallons of 3% AFFF spilled some time in 2002-2003.	Proceed to an SI, focus on soil and groundwater

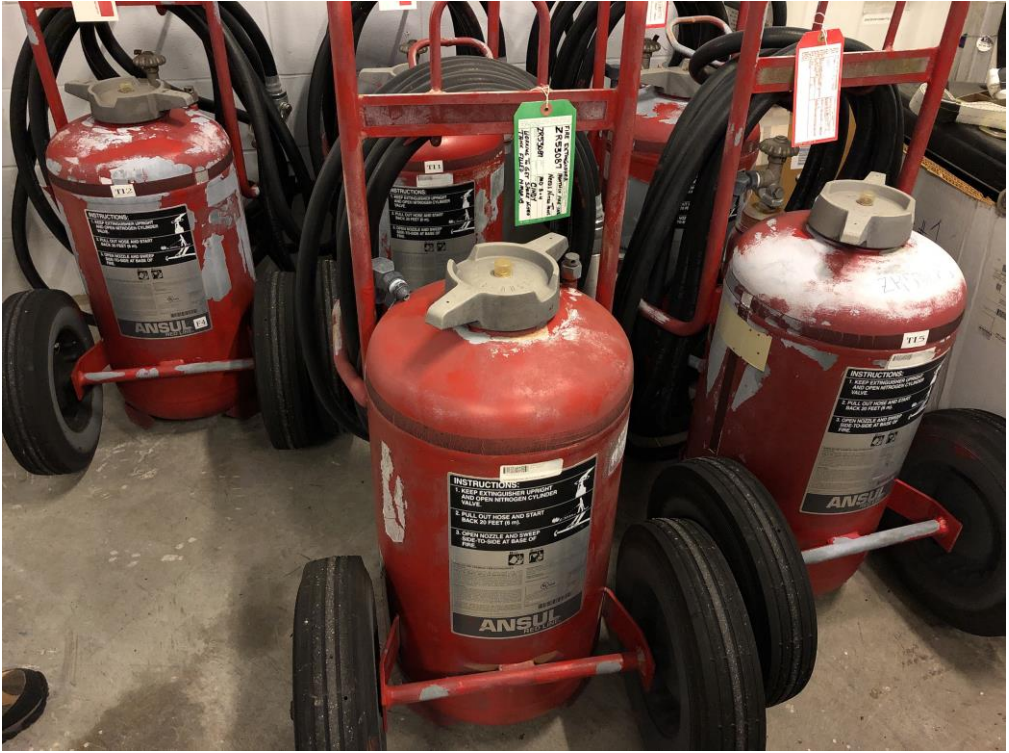
Army National Guard, Preliminary Assessment for PFAS	Brooksville Readiness Center/AASF #2	Spring Hill, Florida
<p>Photograph No. 1</p> <p>Date 2/4/2019 Time 9:11</p> <p>Description: Decomissioned Purple K dry chemical fire extinguishers formerly on the pads.</p> <p>Orientation: East</p>

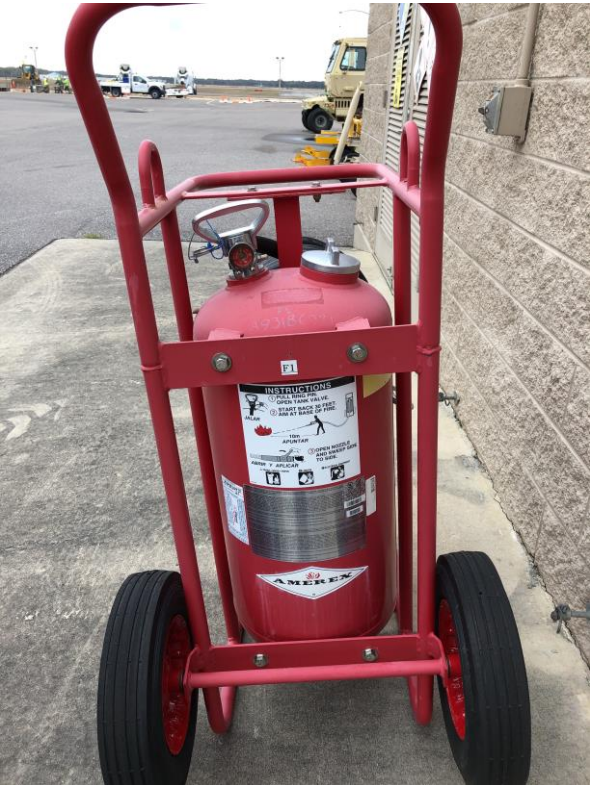
<p>Photograph No. 2</p> <p>Date 2/4/2019 Time 9:15</p> <p>Description: Purple K dry chemical fire extinguishers formerly on the pads.</p> <p>Orientation: South</p>

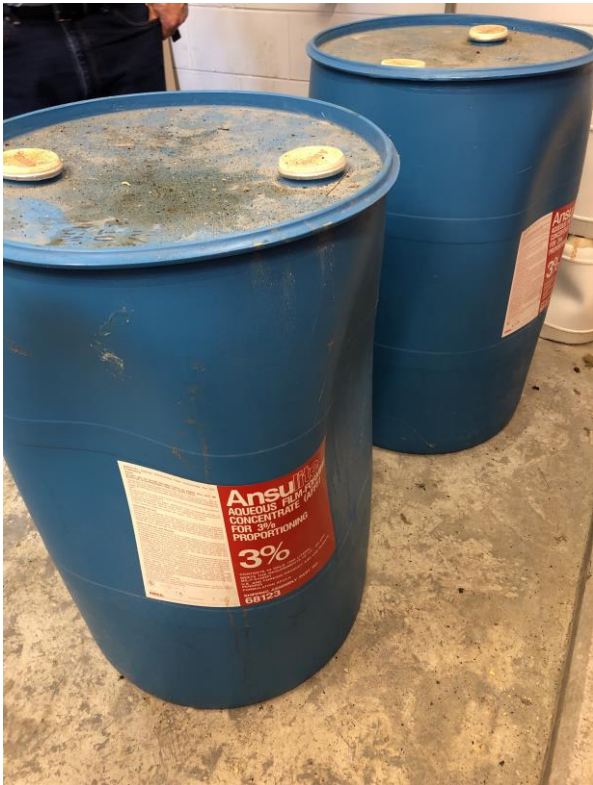
Army National Guard, Preliminary Assessment for PFAS	Brooksville Readiness Center/AASF #2	Spring Hill, Florida
<p>Photograph No. 5</p> <p>Date 2/4/2019 Time 9:44</p> <p>Description: Ansulite AFFF concentrate for 3% proportioning in AASF #2 hangar.</p> <p>Orientation: Southeast</p>	 	
<p>Photograph No. 6</p> <p>Date 2/4/2019 Time 9:44</p> <p>Description: Ansulite AFFF concentrate for 3% proportioning in AASF #2 hangar.</p> <p>Orientation: East</p>

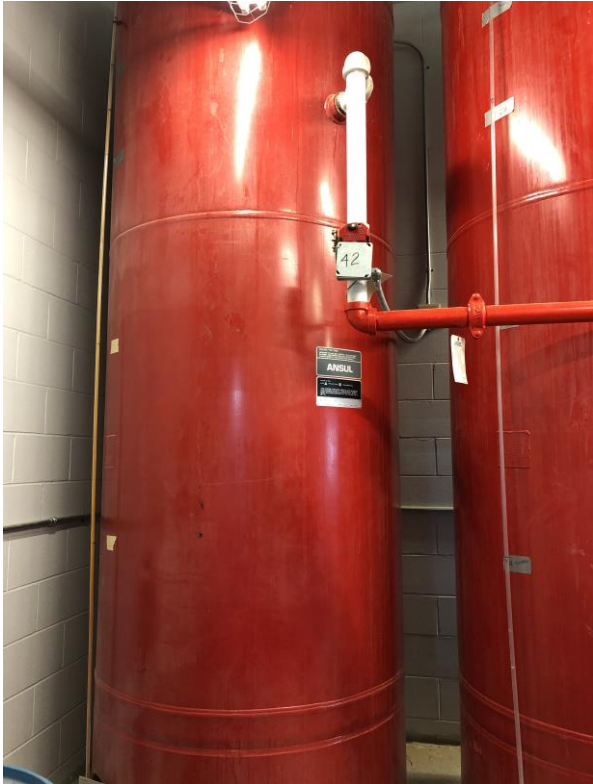
Army National Guard, Preliminary Assessment for PFAS	Brooksville Readiness Center/AASF #2	Spring Hill, Florida
<p>Photograph No. 7</p> <p>Date 2/4/2019 Time 9:46</p> <p>Description: (2) 900-gallon AFFF for AASF #2 hangar fire suppression system.</p> <p>Orientation: Southwest</p>

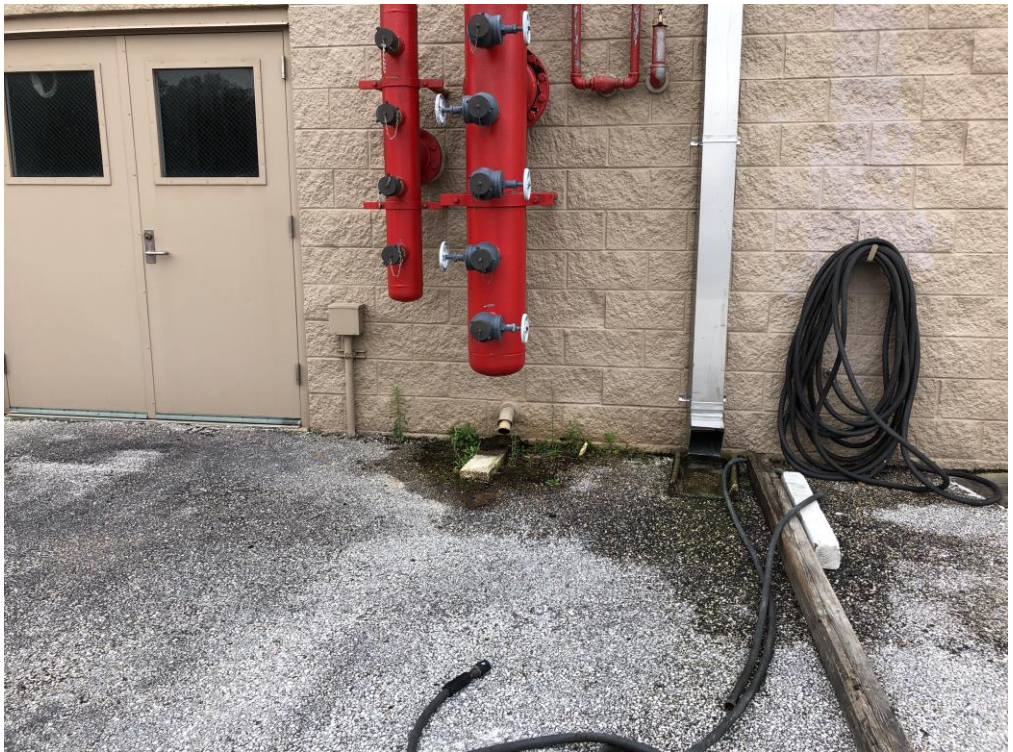
<p>The photograph shows two large, vertical, red cylindrical fire suppression tanks. They are situated indoors against a light-colored brick wall. Various pipes, valves, and a pressure gauge are visible on the tanks. A small white tag with the number '42' is attached to one of the pipes.</p>	
<p>Photograph No. 8</p> <p>Date 2/4/2019 Time 9:55</p> <p>Description: Location of 5 gallon spill of mixed AFFF solution outside of the fire suppression tank room.</p> <p>Orientation: Southeast</p>

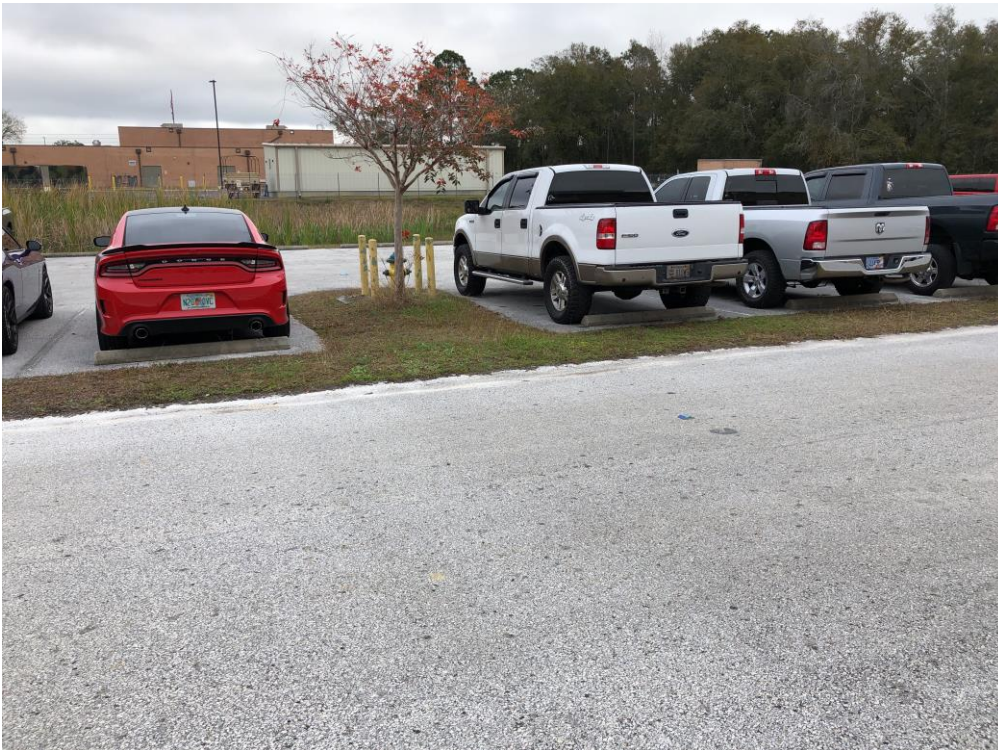
Army National Guard, Preliminary Assessment for PFAS	Brooksville Readiness Center/AASF #2	Spring Hill, Florida
<p>Photograph No. 9</p> <p>Date 2/4/2019 Time 9:56</p> <p>Description: Grass area where approximately 5 gallons of mixed AFFF solution spilled outside of the fire suppression tank room.</p> <p>Orientation:</p>

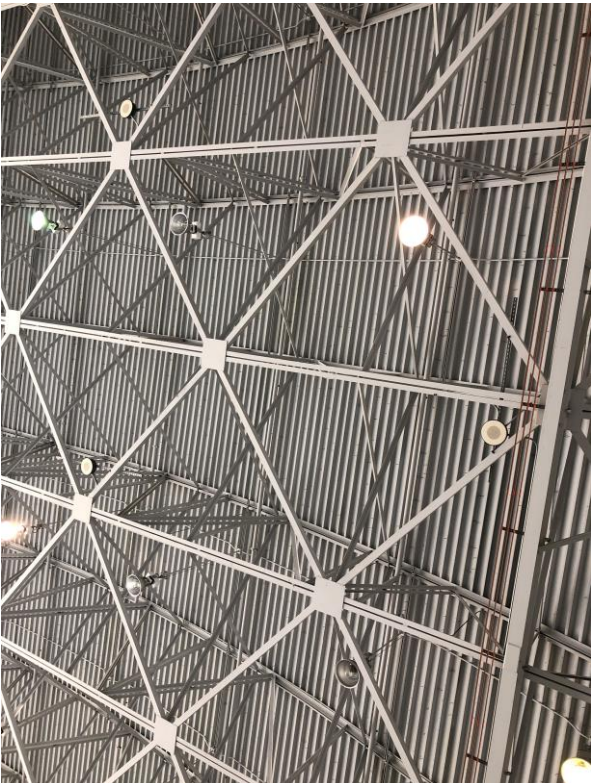
<p>Photograph No. 10</p> <p>Date 2/4/2019 Time 10:03</p> <p>Description: AFFF fire suppression system in AASF #2 hangar.</p> <p>Orientation: Southwest</p>
