FINAL Preliminary Assessment Report Dade City Readiness Center Dade City, Florida

Perfluorooctanesulfonic Acid (PFOS) and Perfluorooctanoic
Acid (PFOA) Impacted Sites
ARNG Installations, Nationwide

August 2020

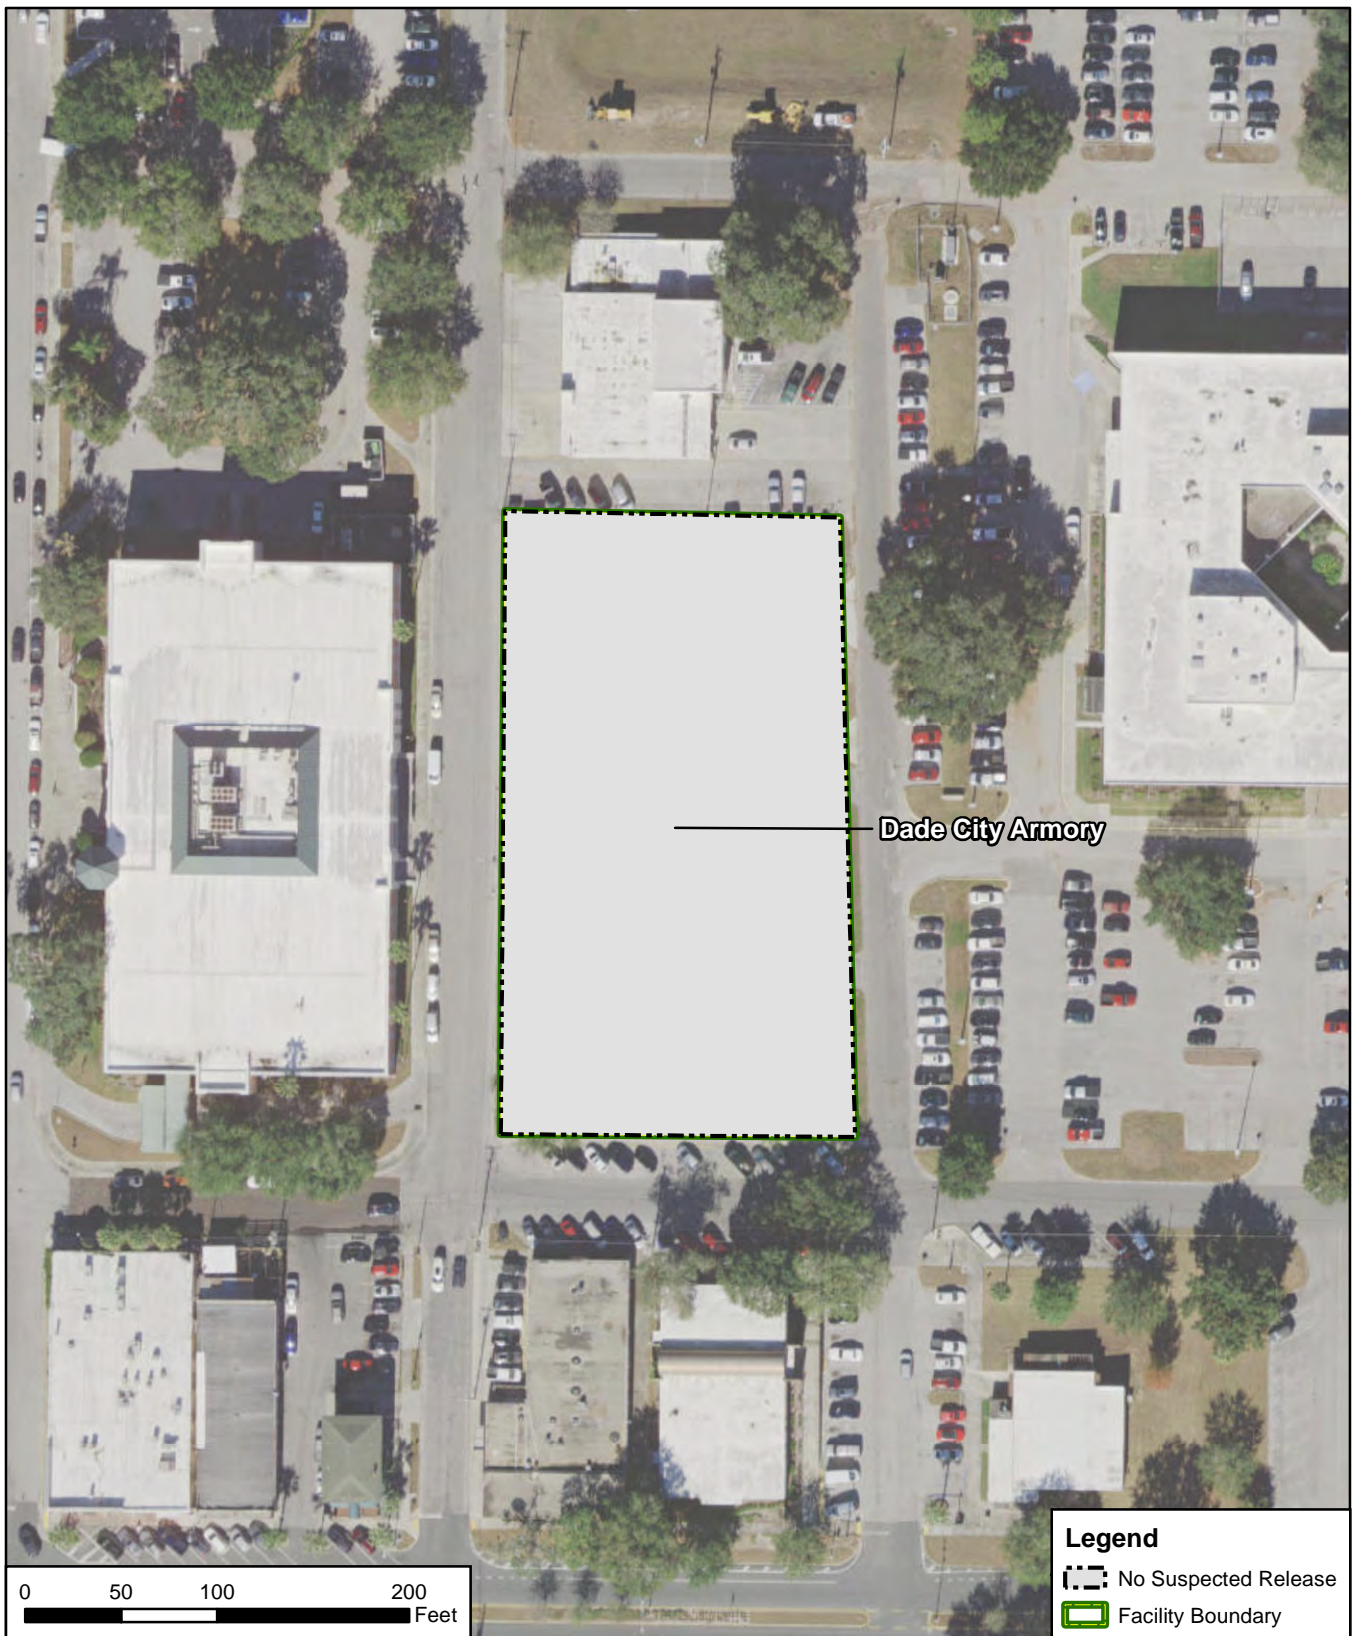
One area, Dade City RC Armory, has been identified as No Suspected Release (**Figure ES-1**). Based on the documented absence (1955-present) of the use or release of PFAS-containing materials at Dade City RC, no areas of interest (AOIs) were identified during the PA. Evidence does not indicate that current or former ARNG activities contributed PFAS contamination to soil, groundwater, surface water, or sediment at the facility or adjacent areas. Dade City RC will not move forward in the Comprehensive Environmental Response, Compensation, and Liability Act (CERCLA) process.

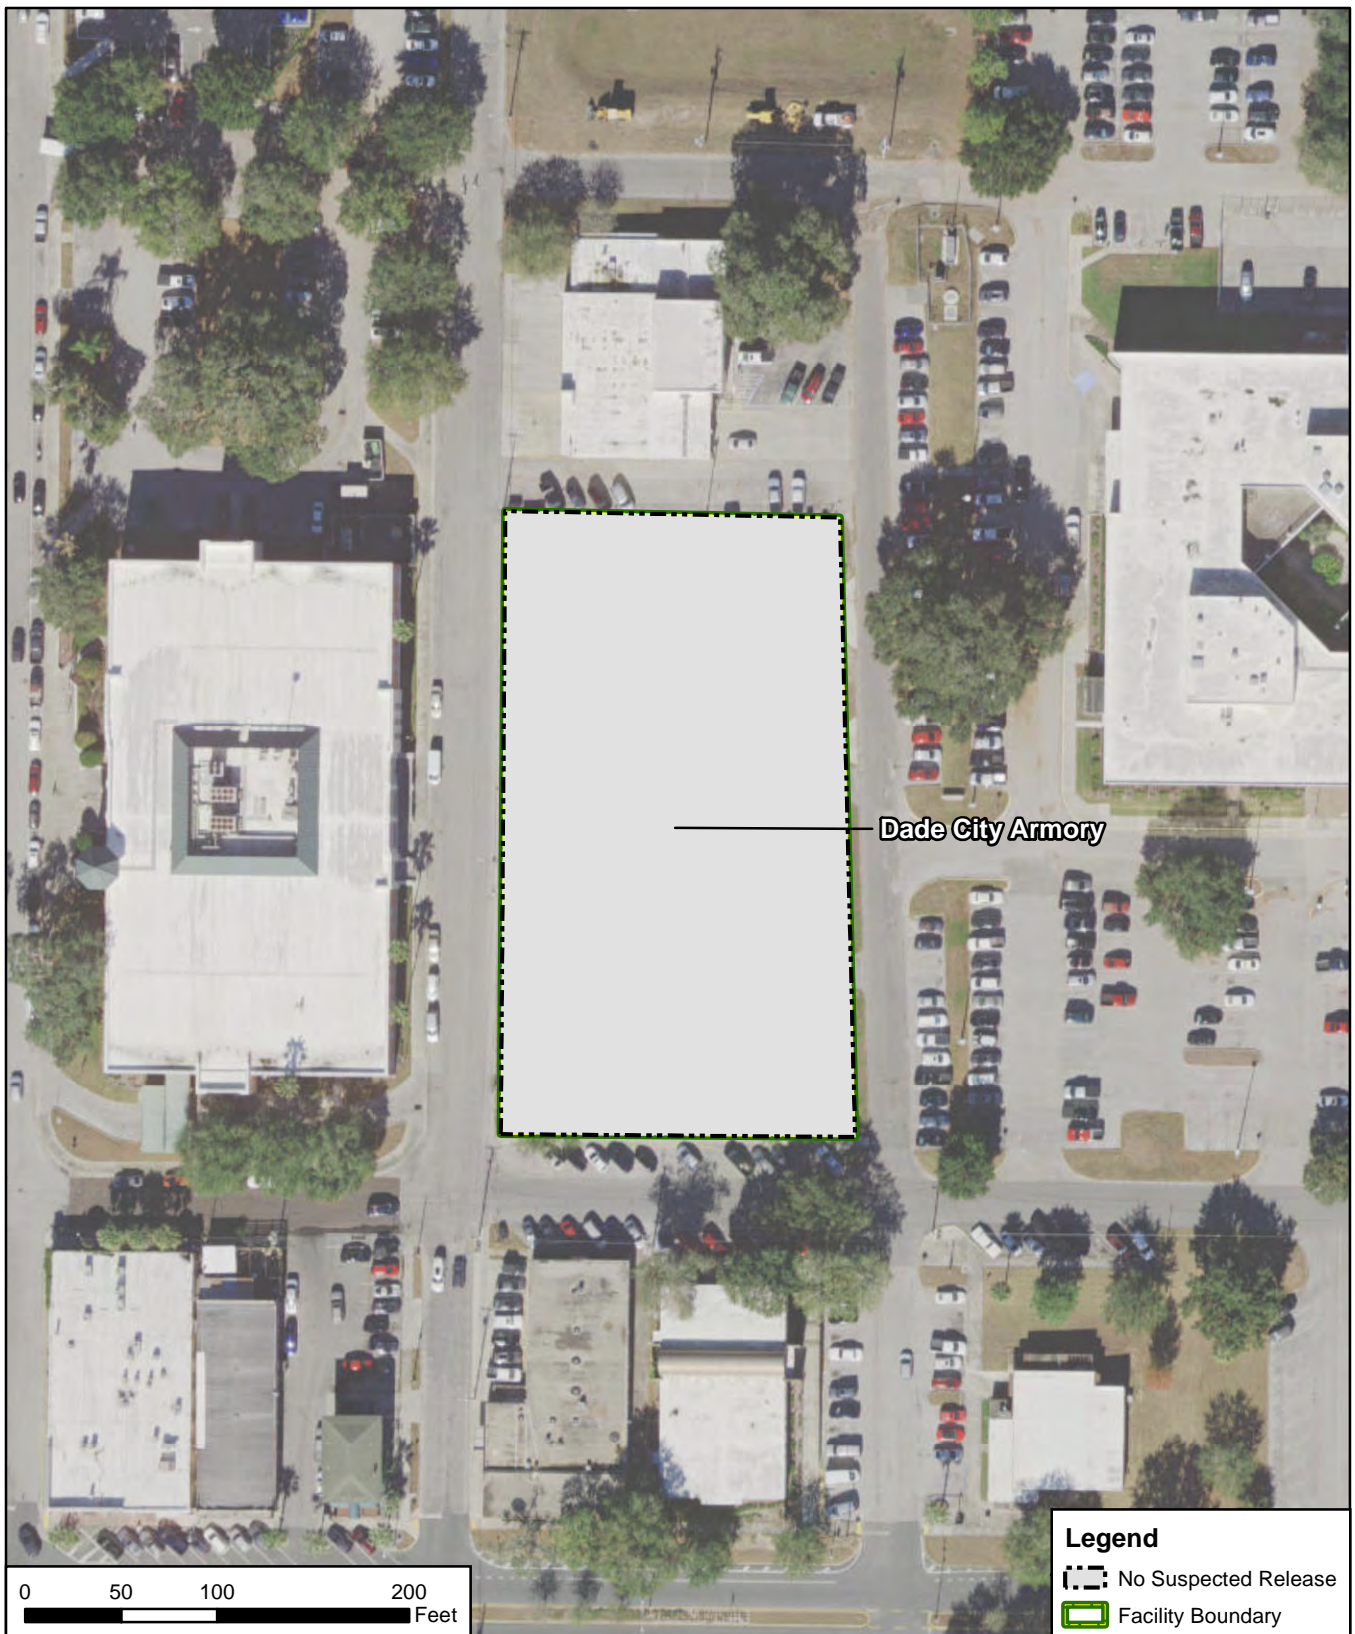
The Armory is located in the center of the facility property (**Figure 3-1**). The geographic coordinates are 28°21'56.59"N; 82°11'13.82"W. The armory is used for drills and is not outfitted with a fire suppression system. During the site visit, ABC Dry chemical extinguishers were found throughout the facility. The kitchen portion of the armory is outfitted with a fire suppression system. At the time of the visit and to interviewee knowledge dating back to 2008, the fire suppression system contained potassium carbonate solution. A potential PFAS release to the environment at the armory is not suspected.

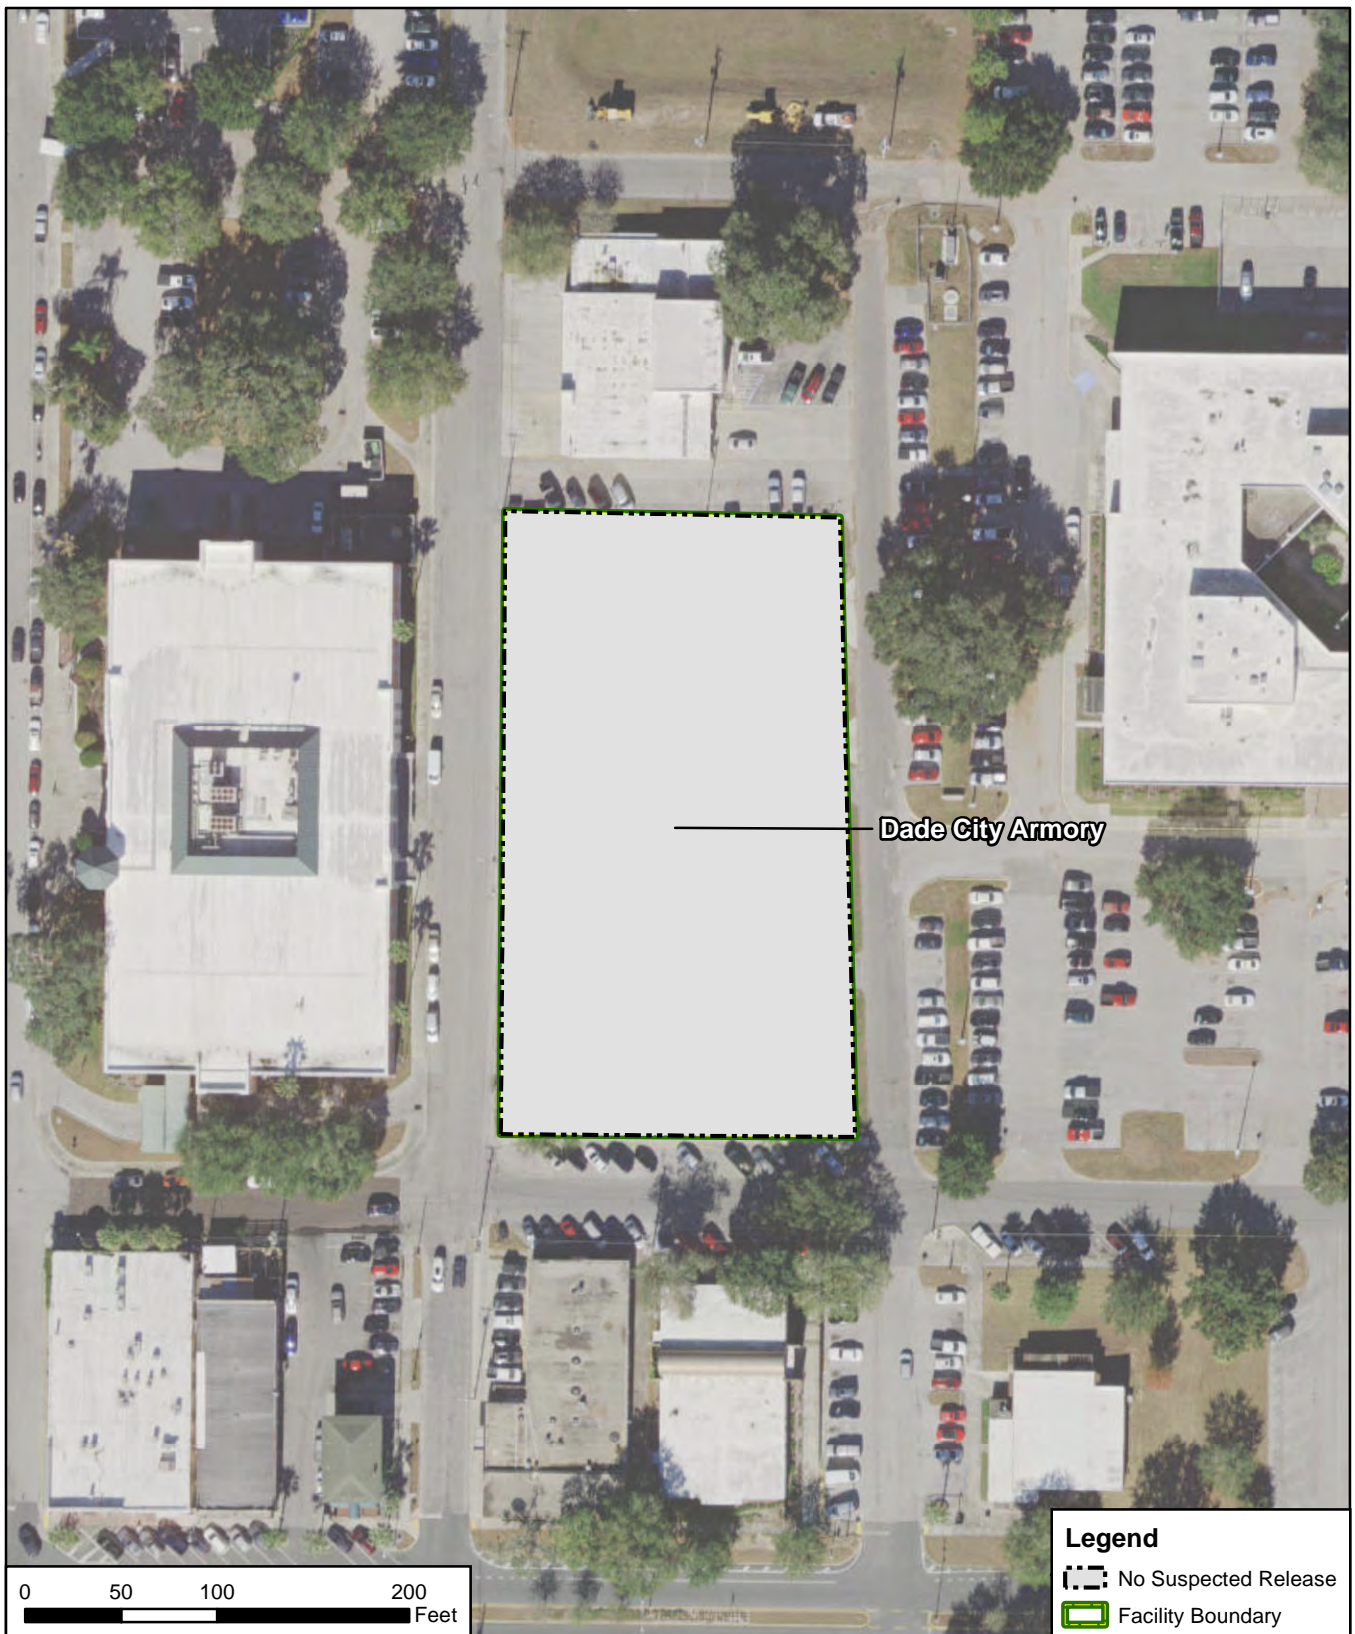
No PFAS releases relating to current or historical activities at Dade City RC were identified during this PA. The following areas discussed in **Section 3 (Figure 7-1)**, and presented in **Table 7-1** below, were determined to have no suspected release:

No Suspected Release Area	Used by	Rationale for No Suspected Release Determination
Armory	FLARNG	Interviewees indicated the fire extinguishers located around the facility have been ABC dry chemical. Fire suppression system installed in the facility kitchen contains potassium carbonate.

Based on the documented absence (1955-present) of the use or release of PFAS-containing materials at Dade City RC, no AOIs were identified during the PA. Evidence does not indicate that current or former ARNG activities contributed PFAS contamination to soil, groundwater, surface water, or sediment at the facility or adjacent areas. Dade City RC will not move forward in the CERCLA process.

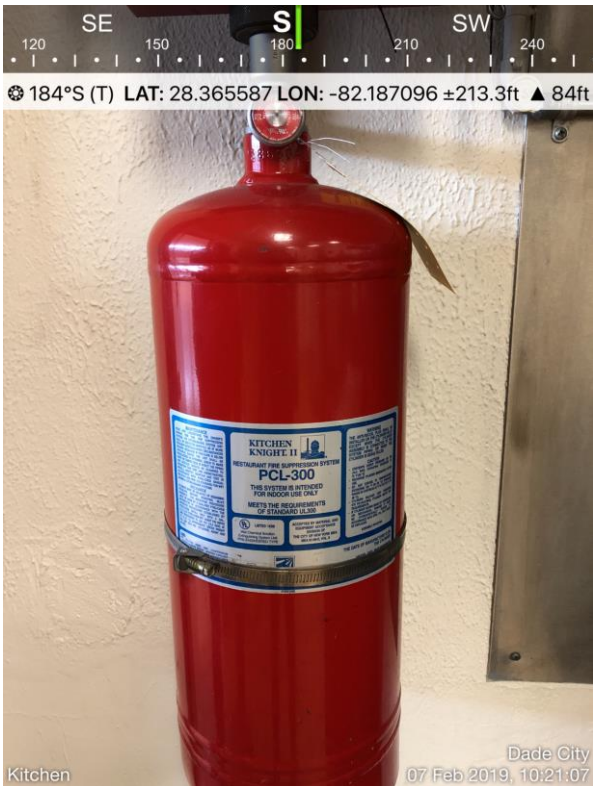
Army National Guard, Preliminary Assessment for PFAS	Dade City Readiness Center	Dade City, Florida
<p>Photograph No. 1</p> <p>Date 2/7/2019 Time 10:21</p> <p>Description: Facility Kitchen fire suppression system chemical, potassium carbonate solution.</p> <p>Orientation: South</p>

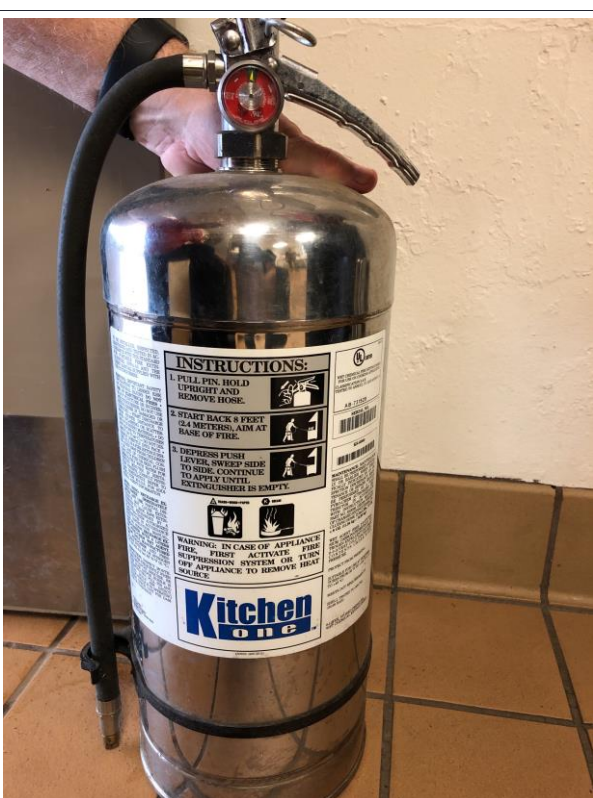
<p>SE S SW 120 150 180 210 240 184°S (T) LAT: 28.365587 LON: -82.187096 ±213.3ft ▲ 84ft</p> <p>Kitchen</p> <p>Dade City 07 Feb 2019, 10:21:07</p>	
<p>Photograph No. 2</p> <p>Date 2/7/2019 Time 10:22</p> <p>Description: Facility Kitchen Fire suppression, Potassium carbonate.</p> <p>Orientation: South</p>
