# FINAL Preliminary Assessment Report Marianna Readiness Center Marianna, Florida

Perfluorooctanesulfonic Acid (PFOS) and Perfluorooctanoic  
Acid (PFOA) Impacted Sites  
ARNG Installations, Nationwide

August 2020

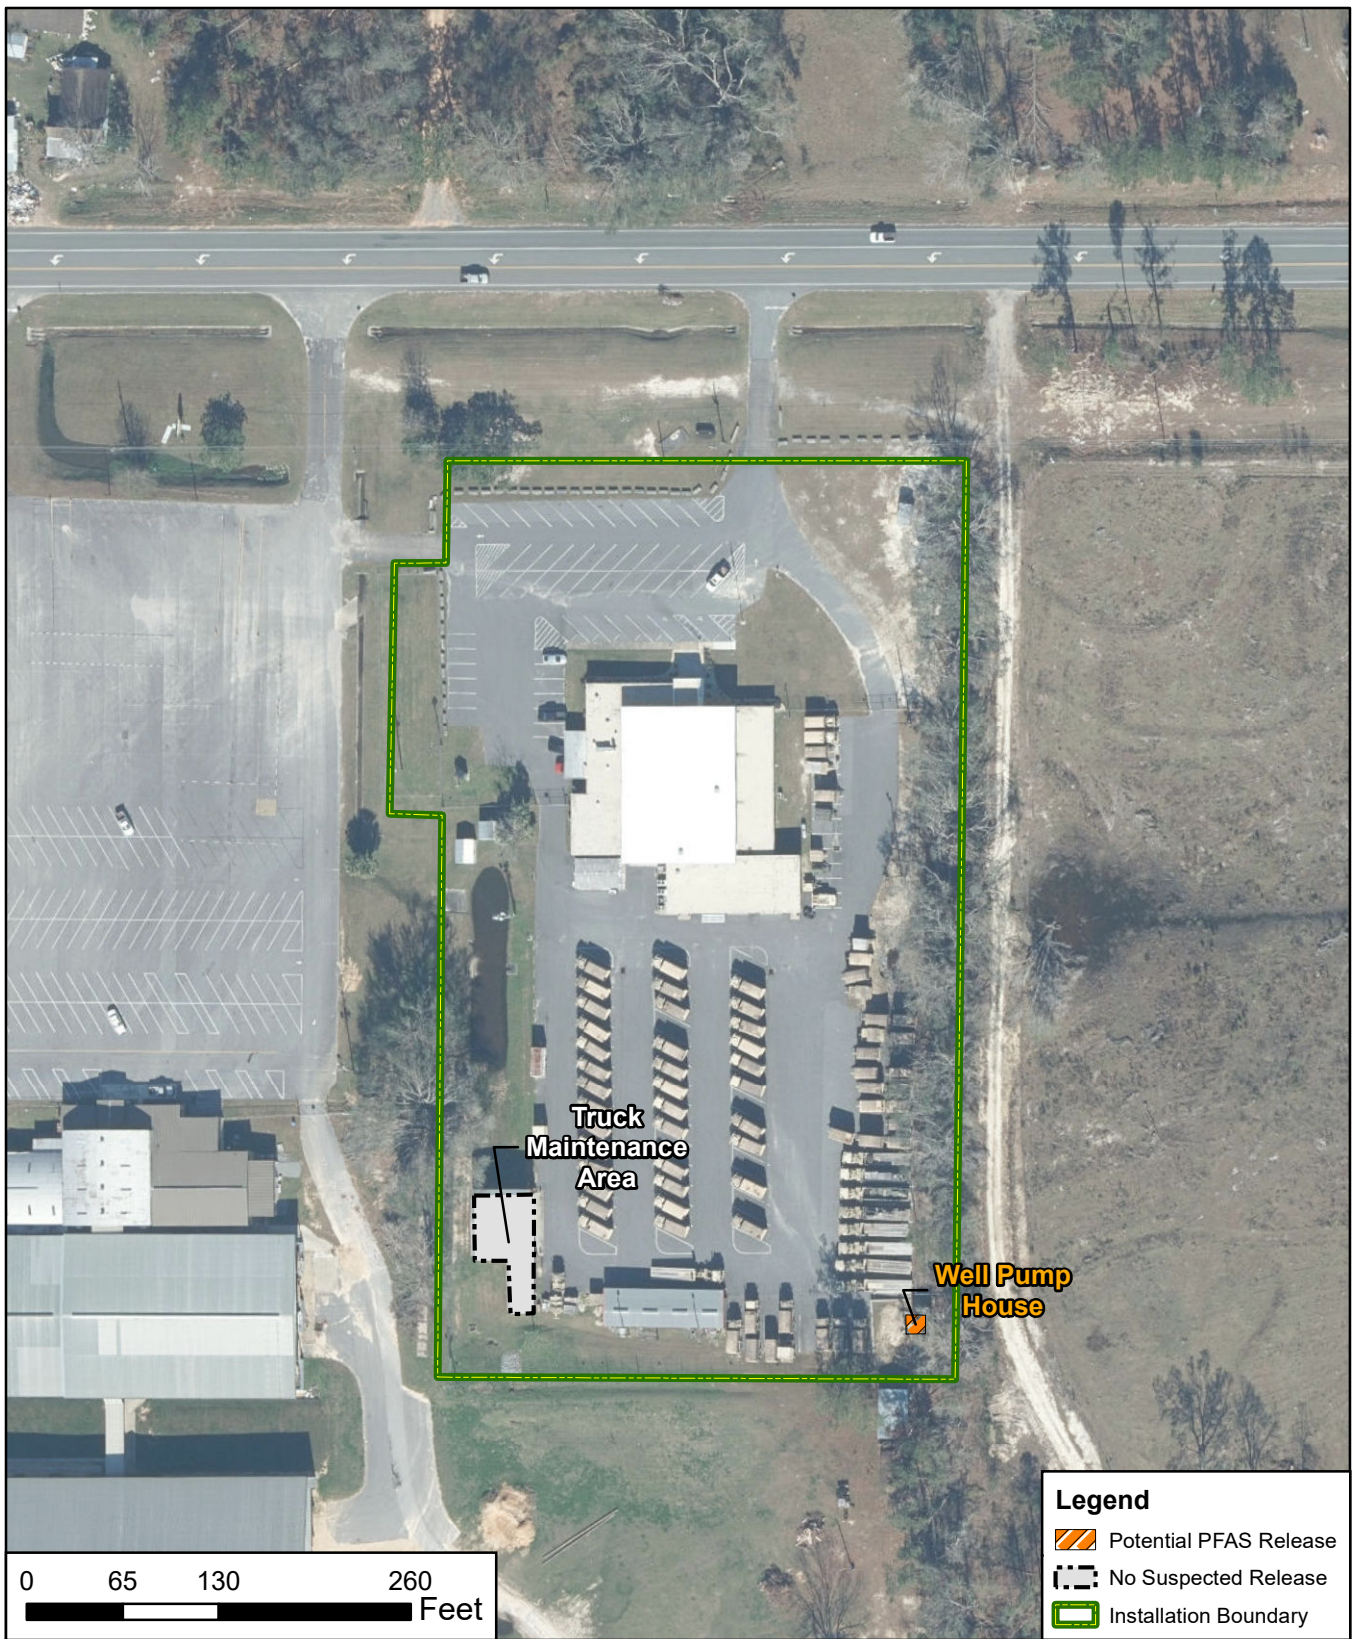
Non-Fire Training Area	
<b>AECOM</b> 12420 Milestone Center Drive Germantown, MD 20876	Figure 3-1

The potable well and pump house are located at the southeast corner of the Marianna Readiness Center property and provides water for the readiness center. The geographic coordinates are 30°46'57.1"N; 85°17'32.7"W. The pump is enclosed in a brick structure and is equipped with a chlorination and filtration system. Prior to the PA site visit, a pre-treatment groundwater sample was collected from the potable well and analyzed for PFAS constituents. Results of this data indicate detections of PFAS constituents; however, these concentrations are reported well below the HA of 70 ppt for PFOA and PFOS, individually or combined. Results of the pre-treatment groundwater sampling are provided in **Appendix A**. According to FLARNG personnel with knowledge of the site since 2007, AFFF has not been used or stored in this area. However, the detections of PFAS within the potable well may be indicative of a PFAS release, so the well pump house is conservatively considered a PFAS release area.

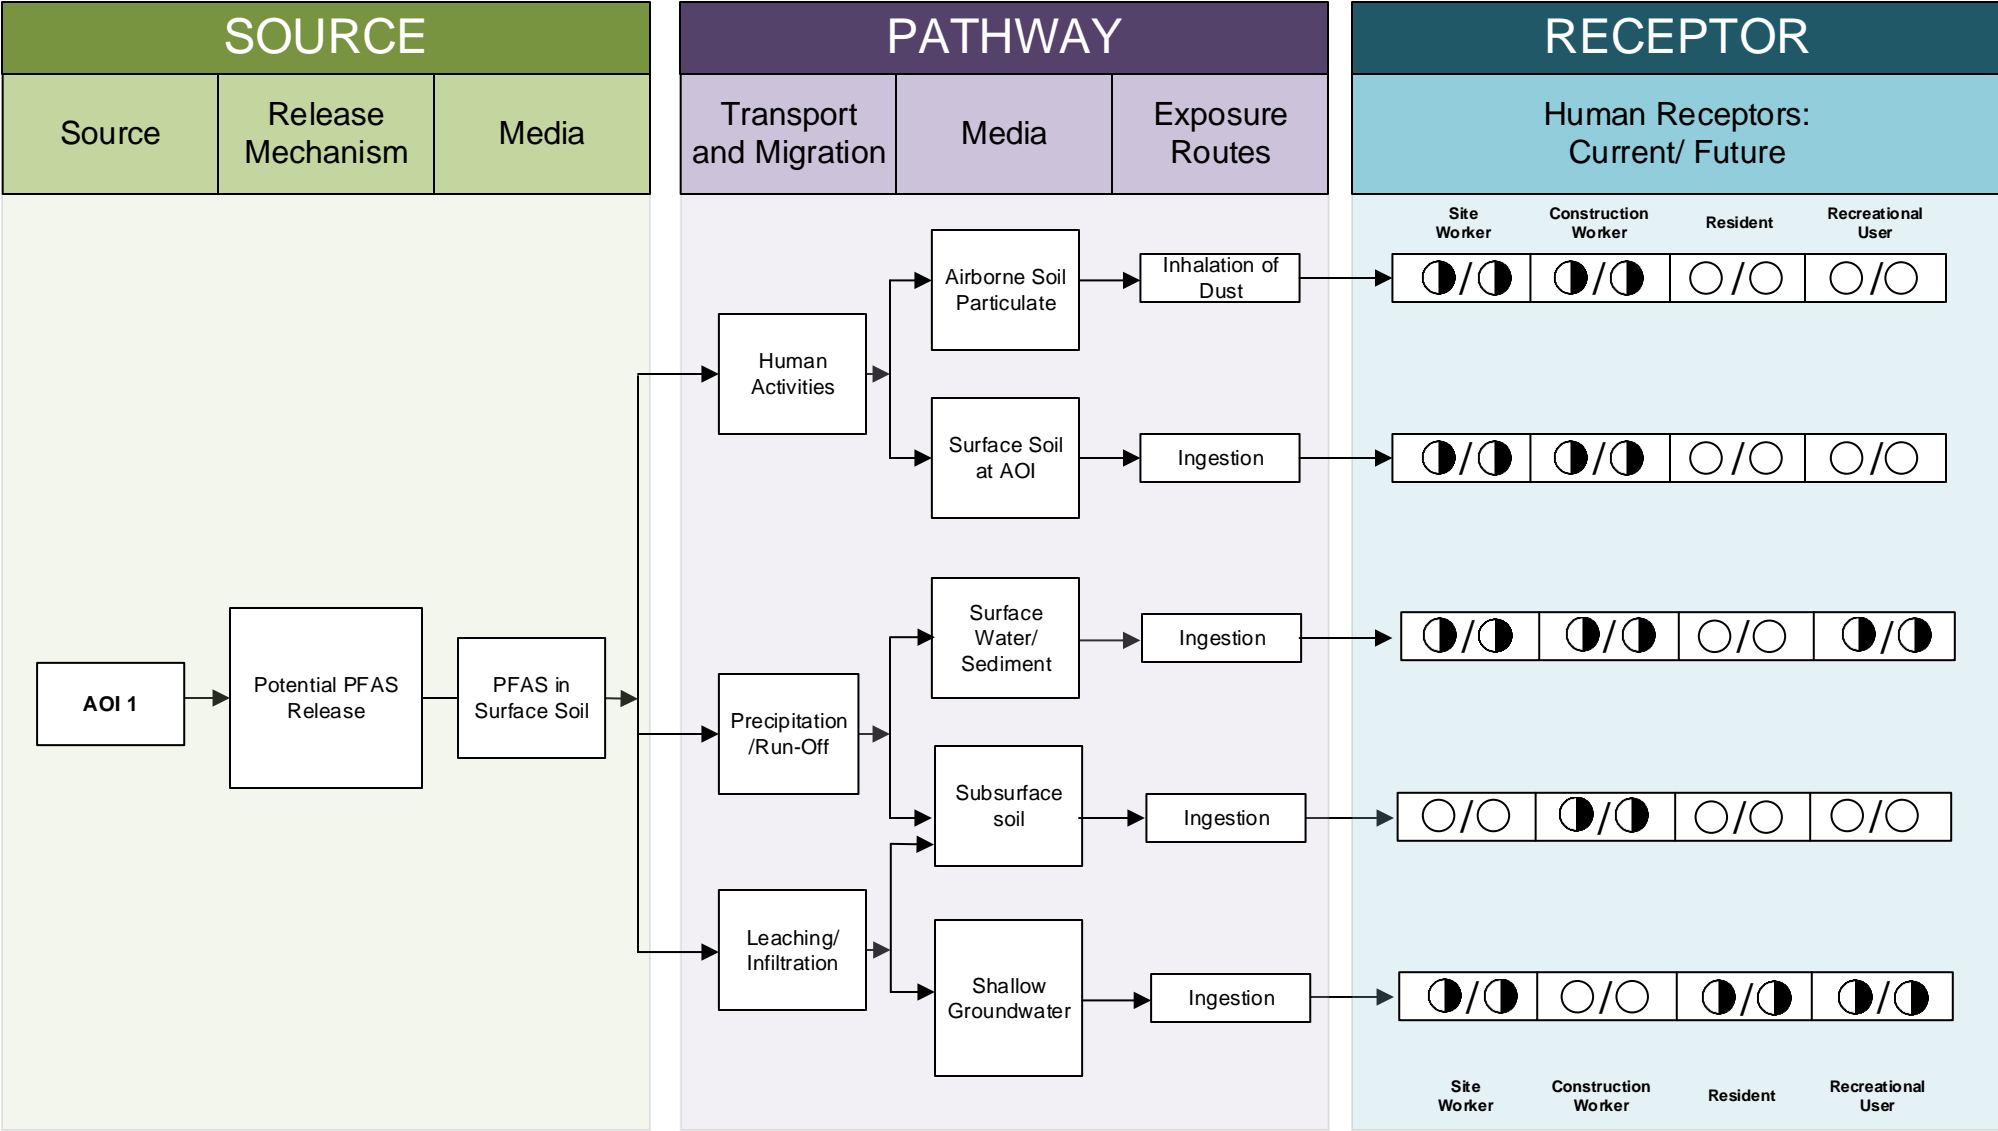
**Figure 6-2**  
Preliminary Conceptual Site Model  
AOI 1 Well Pump House

AOI 1 includes the well pump house containing the facility's water supply well. In 2017, prior to the PA, the potable well was sampled and measured low-level detections of PFAS below the HA. The detections of PFAS may be indicative of a potential PFAS release in the vicinity of the AOI.

AOI 1 is surrounded by paved and grassy areas. If any PFAS releases occurred on these surfaces, ground-disturbing activities may result in potential exposure to PFAS in surface soils via ingestion and inhalation of dust particles for site workers and construction workers. PFAS releases may have also infiltrated the subsurface via cracks in the pavement, so ground-disturbing activities may result in potential exposure via ingestion of subsurface soils for construction workers.

PFAS are water soluble and can migrate readily from soil to groundwater via leaching. Due to the low-level detections of PFAS within the facility's potable well, site workers are potentially exposed to PFAS via ingestion of groundwater. Three public water supply wells are within a 1-mile radius, southeast of AOI 1, in the inferred cross-gradient groundwater direction. It is possible that off-facility residents may also be exposed to PFAS in groundwater from these wells.

Potential PFAS releases in surface water runoff likely drain into the on-facility drainage ditch running east to west, north of the Marianna Readiness Center Building, or into the storm water retention basin located on the west side of the facility. The storm water retention pond is likely connected to local groundwater in the surficial aquifer. Site workers and construction workers performing work in these areas may be potentially exposed to PFAS via ingestion of surface water or sediment. PFAS in surface water runoff or in groundwater may interact with the abundant springs in the surrounding area, so recreational users of local springs may be potentially exposed to PFAS in surface water/sediment or groundwater.

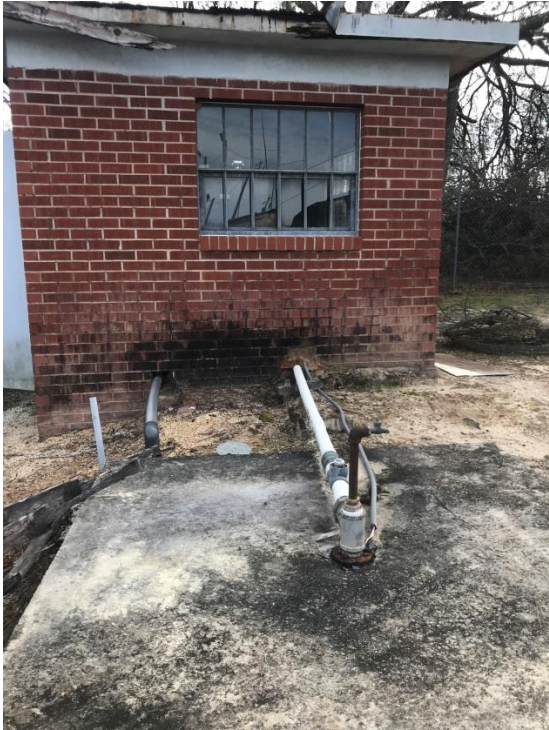
Army National Guard, Preliminary Assessment for PFAS		Mariana Readiness Center	Mariana, Florida
<b>Photograph No. 3</b>  <b>Description:</b> Looking east toward the potable well and pump house. Photo Date: 1/30/19

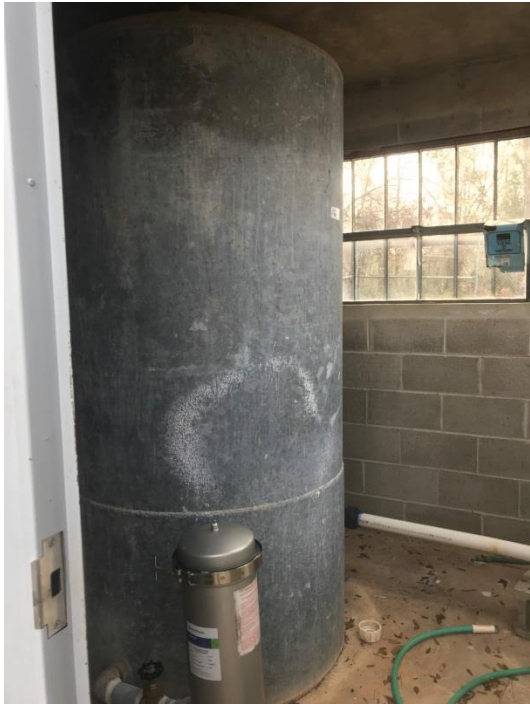
<b>Photograph No. 4</b>  <b>Description:</b> Looking southeast inside the pump house. Photo Date: 1/30/19

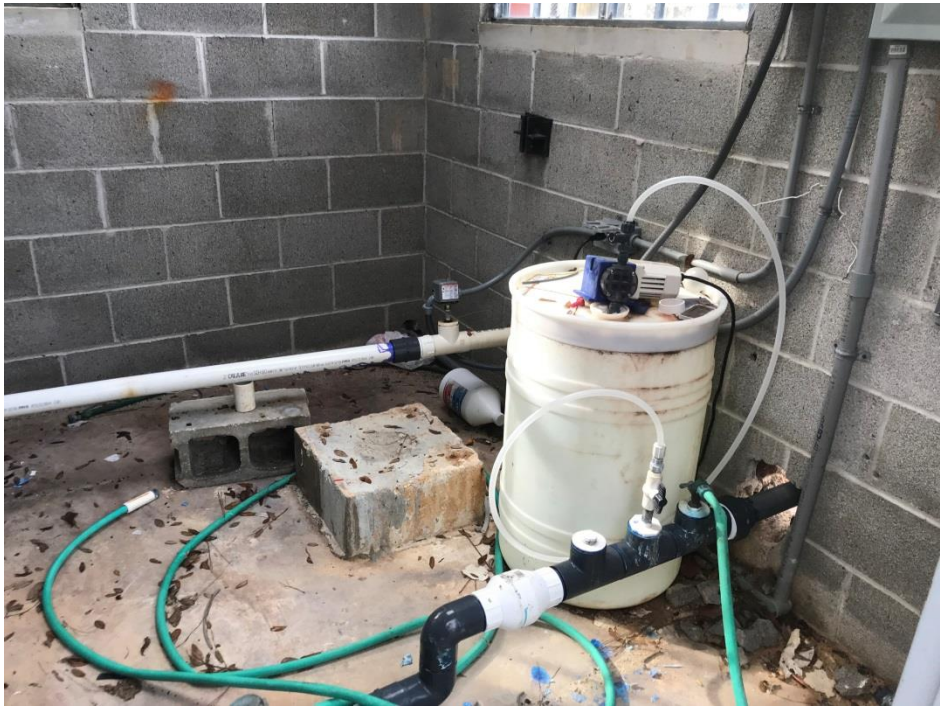
Army National Guard, Preliminary Assessment for PFAS	Mariana Readiness Center	Mariana, Florida
<p><b>Photograph No. 5</b></p> <p><b>Description:</b></p> <p>Looking southwest inside the pump house</p> <p>Photo Date: 1/30/19</p>
