# FINAL Preliminary Assessment Report Ellyson Field Pensacola, Florida

Perfluorooctanesulfonic Acid (PFOS) and Perfluorooctanoic  
Acid (PFOA) Impacted Sites  
ARNG Installations, Nationwide

June 2020

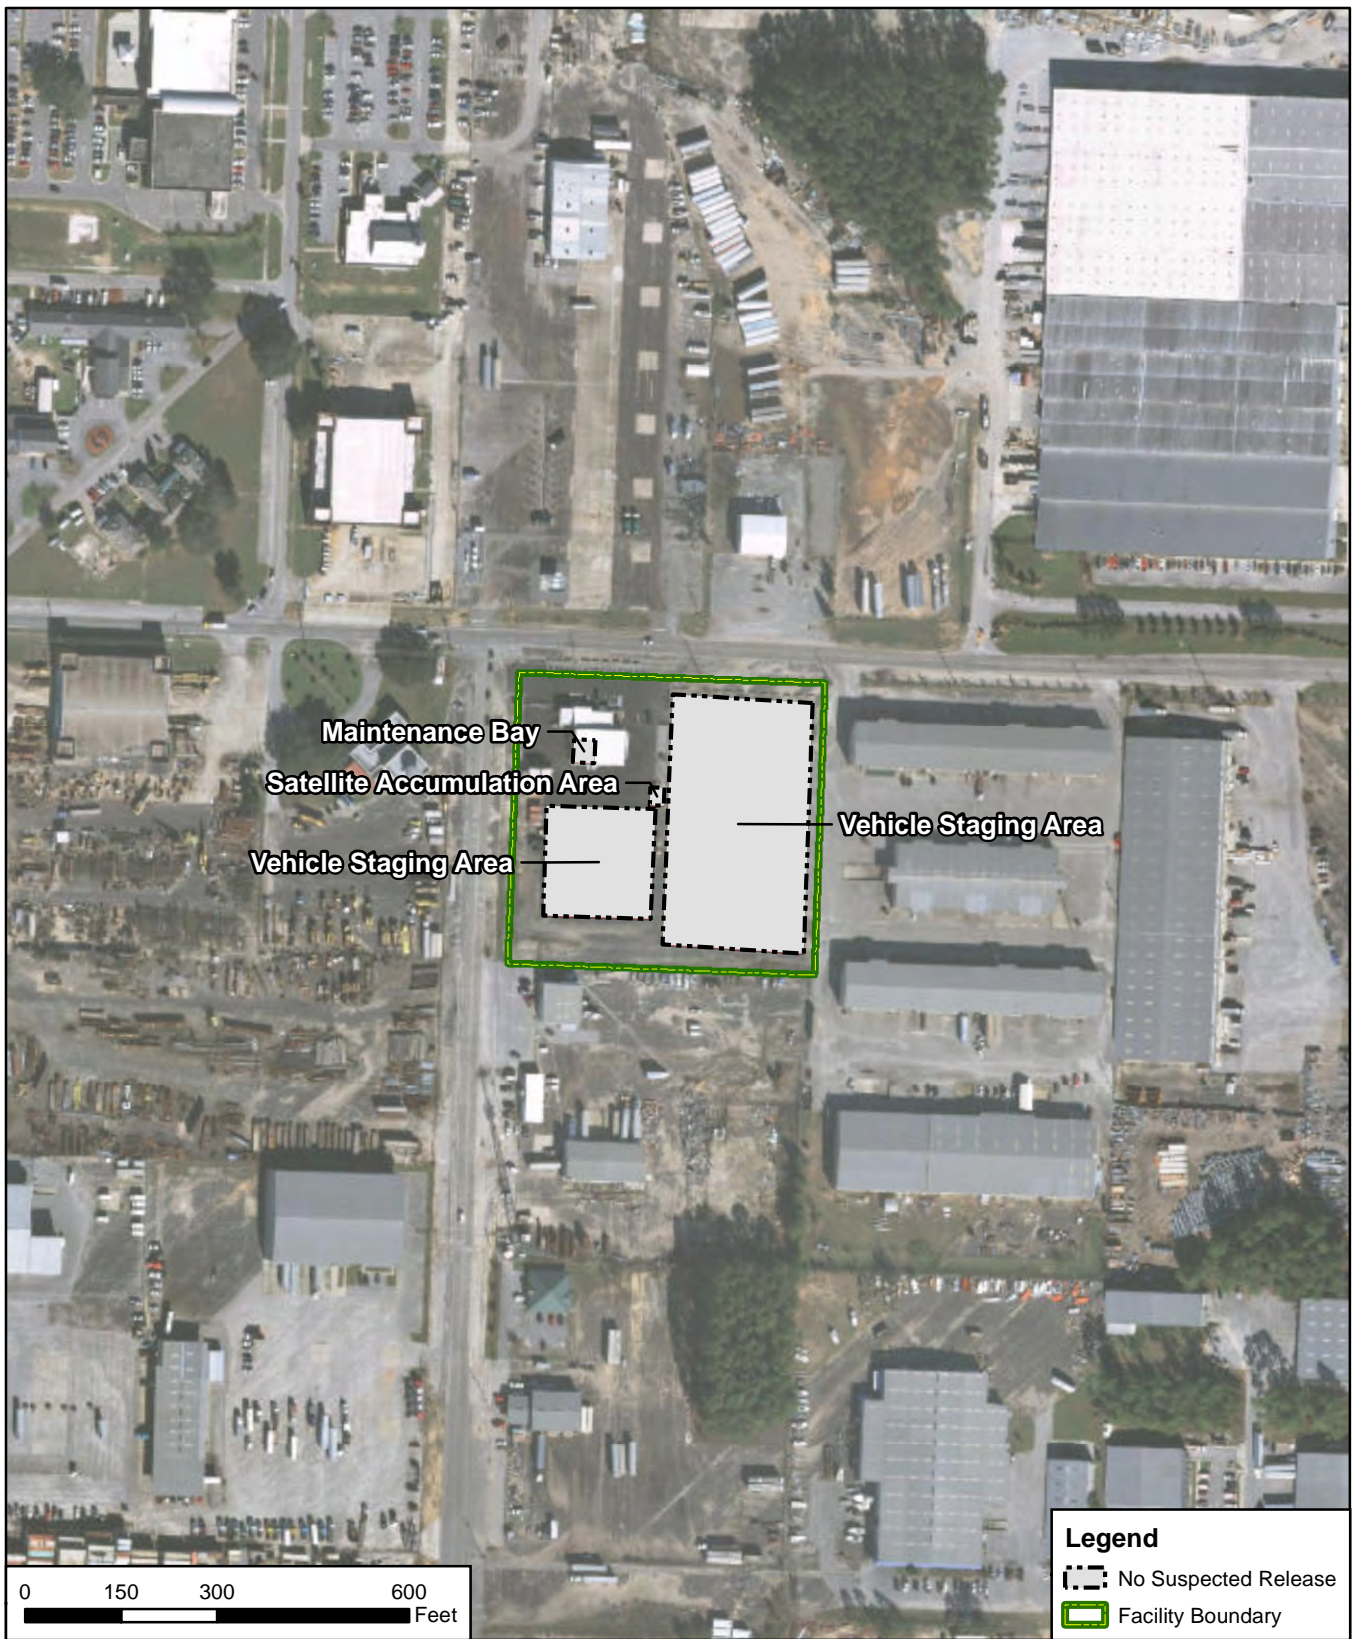
<h3>Non-Fire Training Areas</h3>	
<p>12420 Milestone Center Drive Germantown, MD 20876</p>	<h2>Figure 3-1</h2>

In addition to FTAs, the PA evaluated areas where PFAS-containing materials may have been broadly used, stored, or disposed. This may include buildings with fire suppression systems, paint booths, AFFF storage areas, and areas of compliance demonstrations. Information on these features obtained during the PA are included in **Appendices A and B**. Historically, the US Navy operated an airfield that encompassed the subject property and the surrounding area from after 1940 to about 1981, when the property was sold to Escambia County. Storage or use of AFFF prior to FLARNG occupation circa 1985 was not known, according to FLARNG personnel. FLARNG personnel with knowledge of the Ellyson Field facility dating back to 2000 have confirmed that AFFF has not been used or stored at the Ellyson Field facility during FLARNG occupation of the subject property. Based upon aerial images provided in the EDR™ report (**Appendix A**), no discernable features suggesting FTAs were identified at the location of the current FLARNG facility. Descriptions of these non-FTAs are presented below, and the non-FTAs are shown on **Figure 3-1**, with photographs appearing in **Appendix C**.

The maintenance bay is located in the south side of the Armory building, with bay doors opening at the southern edge of the building. The geographical coordinates are 30°31'37.8"N; 87°11'49.6"W. The maintenance bay was constructed with the armory building in 1998 and is used for general maintenance on ARNG vehicles. The maintenance bay is not equipped with an overhead AFFF fire suppression system. It was noted during the visual inspection that fire protection is provided by wall mounted ABC class fire extinguishers. Based on FLARNG knowledge of the property dating back to 2000, AFFF was not used or stored in the maintenance bay during FLARNG occupation.

ARNG owned vehicles are staged at the south and east side of the Ellyson Field building. The geographical coordinates of the southern staging area are 30°31'36.2"N; 87°11'49.5"W. The geographical coordinates of the western staging area are 30°31'37.2"N; 87°11'46.9"W. It was noted during the visual inspection that fire protection is provided by ABC class fire extinguishers mounted on the exterior wall of the Armory building. Based on FLARNG knowledge of the property dating back to 2000, AFFF was not used or stored in the maintenance bay during FLARNG occupation.

The Satellite Accumulation area is located approximately 80 feet off the southeast corner of the Ellyson Field building. The geographical coordinates of the satellite accumulation area are 30°31'37.3"N; 87°11'48.3"W. This area is used for storing waste associated with ARNG vehicle maintenance such as fuel filters and anti-freeze. Fire protection in this area is provided by a wall mounted sodium fire extinguisher. Based on FLARNG knowledge of the property dating back to 2000, AFFF was not used or stored in the maintenance bay during FLARNG occupation.

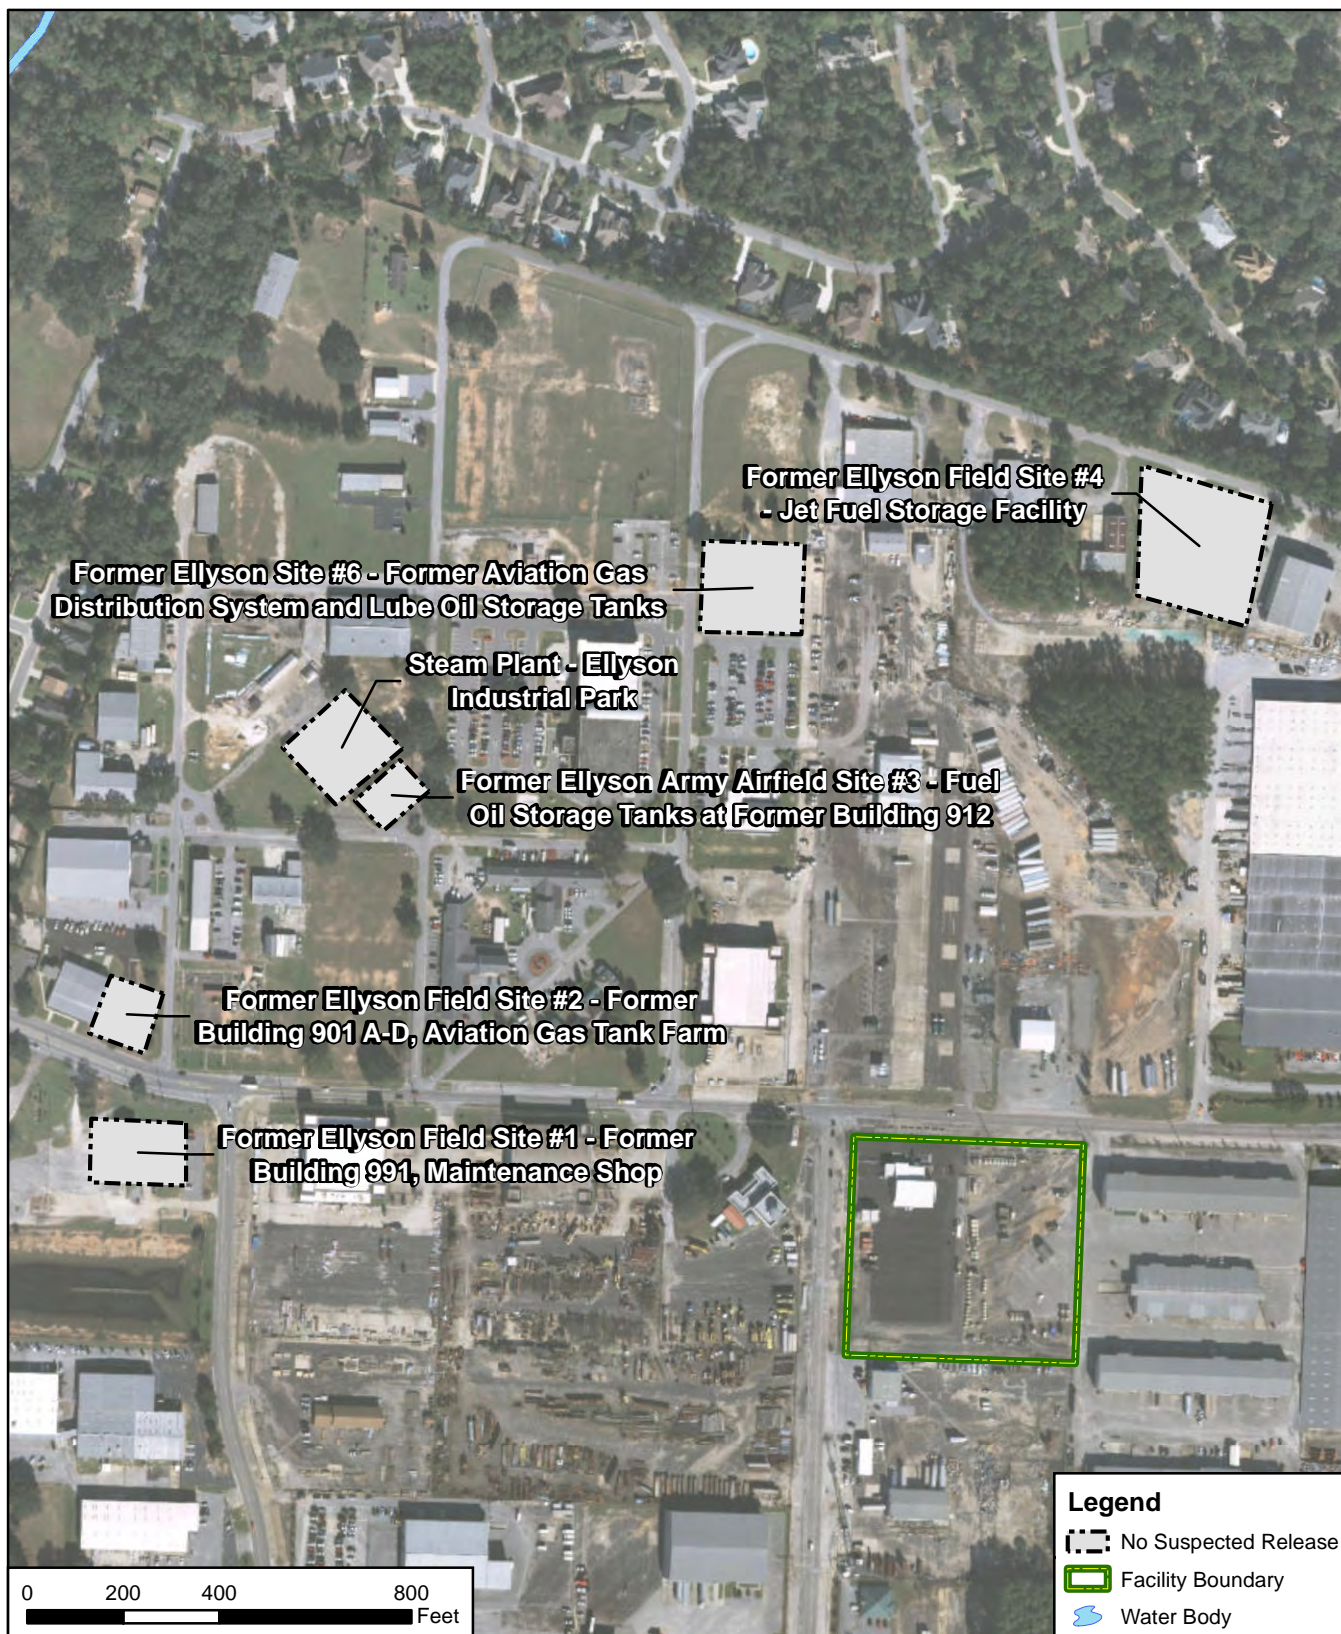
12420 Milestone Center Drive Germantown, MD 20876	Figure 5-1
REVISED	7/3/2019	GIS BY	MS	7/3/2019			
SCALE	1:4,800	CHK BY	BM	7/3/2019			
Base Map: Source: Esri, DigitalGlobe, GeoEye, Earthstar Geographics,		PM	RG	7/3/2019

Based on EDR™ information (**Appendix A**) and the FDEP public record, six areas associated with US Navy activities at the former Ellyson Airfield were reviewed. Locations of these areas are depicted on **Figure 5-1**. An environmental assessment was conducted at each location by USACE, and these assessments are available in the FDEP public record. Summaries of the six areas are provided below:

AFFF could have been stored at the historical firehouse associated with the Steam Plant location. AFFF fire extinguishers could have been used at Site 3 (in the former mess hall) and along the Former Aviation Gas Distribution System (Site #6). Additionally, Navy hangars were likely to have been equipped with suppression systems and the associated ramp areas along the historic flight line were likely to have mobile AFFF extinguishers present. However, based on information provided in the public record, use and storage of AFFF at all of the aforementioned locations could not be ascertained. Therefore, these areas are not considered adjacent off-facility sources of PFAS for the FLARNG Ellyson Field Armory.

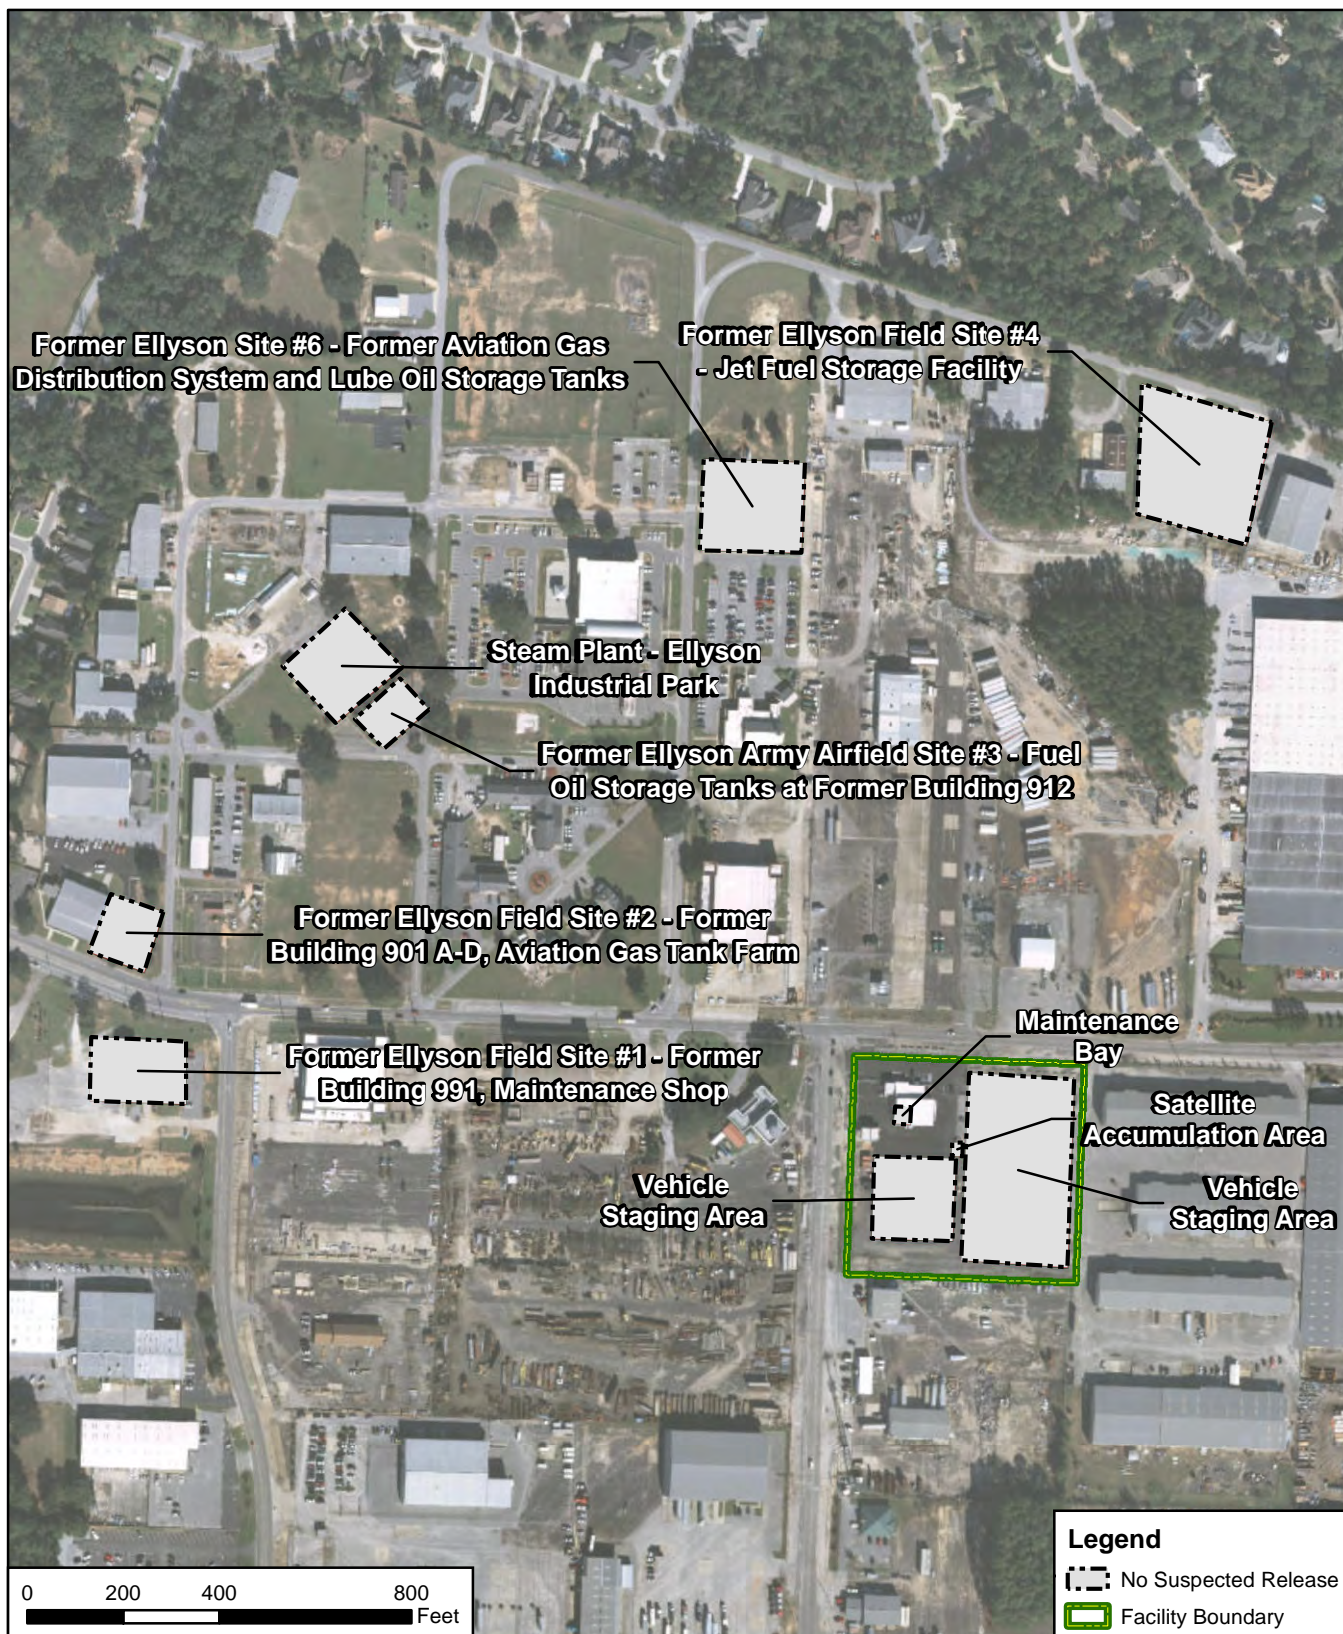
**Figure 7-1**

No PFAS releases relating to current or historical activities at Ellyson Field were identified during this PA. The following areas, which were discussed in **Section 3 (Figure 7-1)** and are presented in **Table 7-1** below, were determined to have no suspected release:

No Suspected Release Area	Used by	Rationale
Maintenance Bay, Vehicle Staging Area, and Satellite Accumulation Area	FLARNG	Based upon FLARNG personnel with knowledge of the site back to 2000, AFFF was not stored or used at the subject site during FLARNG occupation. Evidence of AFFF use was not identified during this PA visual inspection.

Based upon available information, no AOIs were identified during the PA. Evidence does not indicate that current or former ARNG activities contributed PFAS contamination to soil, groundwater, surface water, or sediment at the facility or adjacent areas. The Ellyson Field facility will not move forward in the CERCLA process.

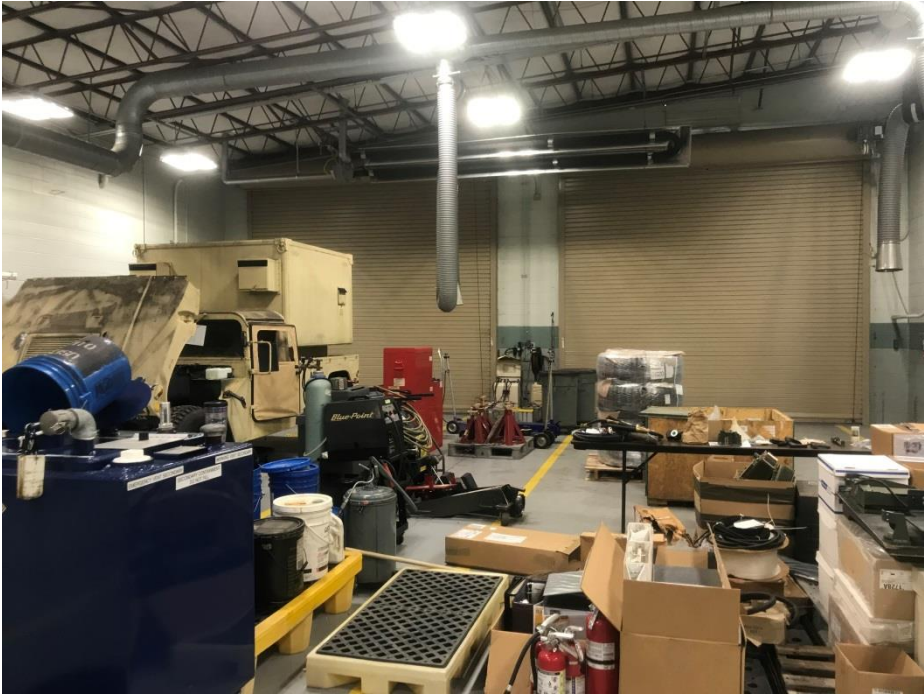
Army National Guard, Preliminary Assessment for PFAS	Ellyson Field	Pensacola, Florida
<p><b>Photograph No. 1</b></p> <p><b>Description:</b></p> <p>Unknown direction of photo.</p> <p>Maintenance bay inside Ellyson Field building</p> <p>Photo date 1/31/19</p>

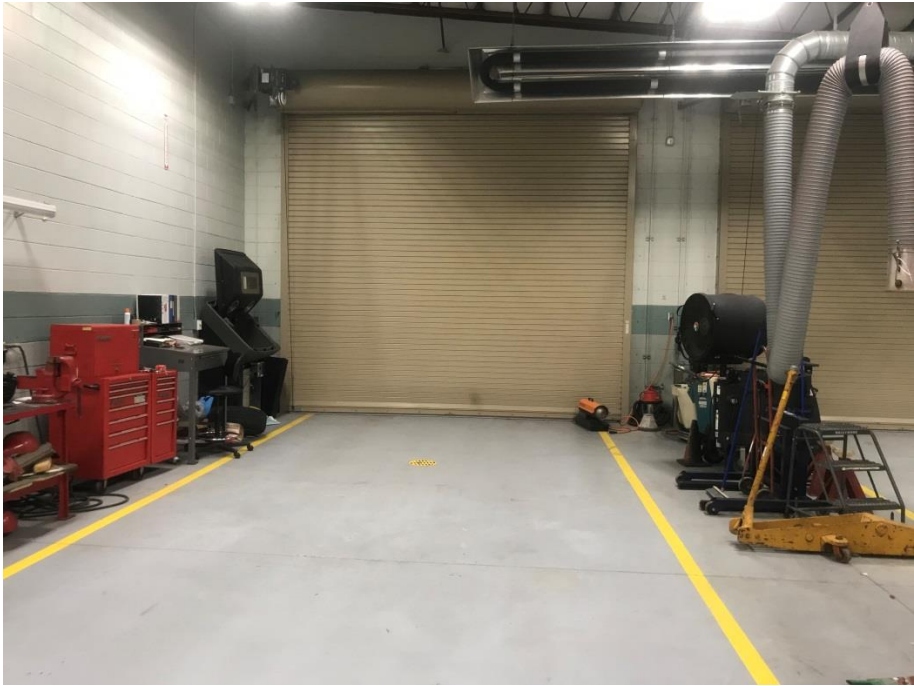
<p><b>Photograph No. 2</b></p> <p><b>Description:</b></p> <p>Unknown direction of photo.</p> <p>Floor drain inside maintenance bay</p> <p>Photo Date: 1/31/19</p>

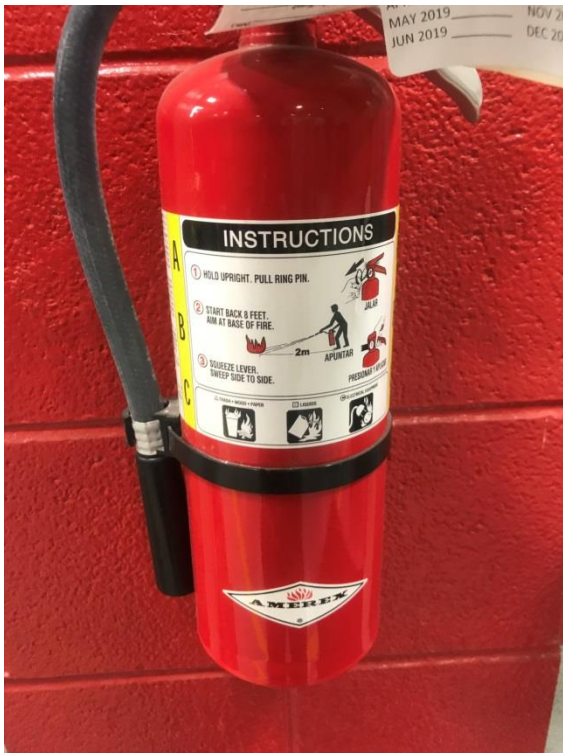
Army National Guard, Preliminary Assessment for PFAS	Ellyson Field	Pensacola, Florida
<p><b>Photograph No. 3</b></p> <p><b>Description:</b></p> <p>Looking north toward the front of the building. ABC fire protection in maintenance bay</p> <p>Photo Date: 1/31/19</p>

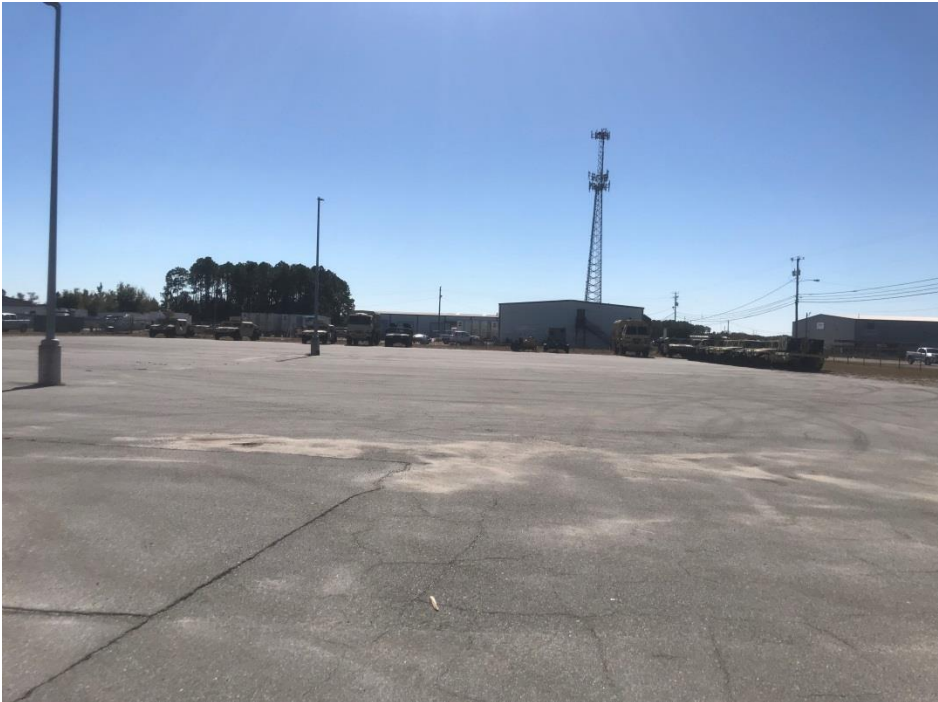
<p><b>Photograph No. 4</b></p> <p><b>Description:</b></p> <p>Looking south. Vehicle staging area south of the Ellyson Field building</p> <p>Photo Date: 1/31/19</p>

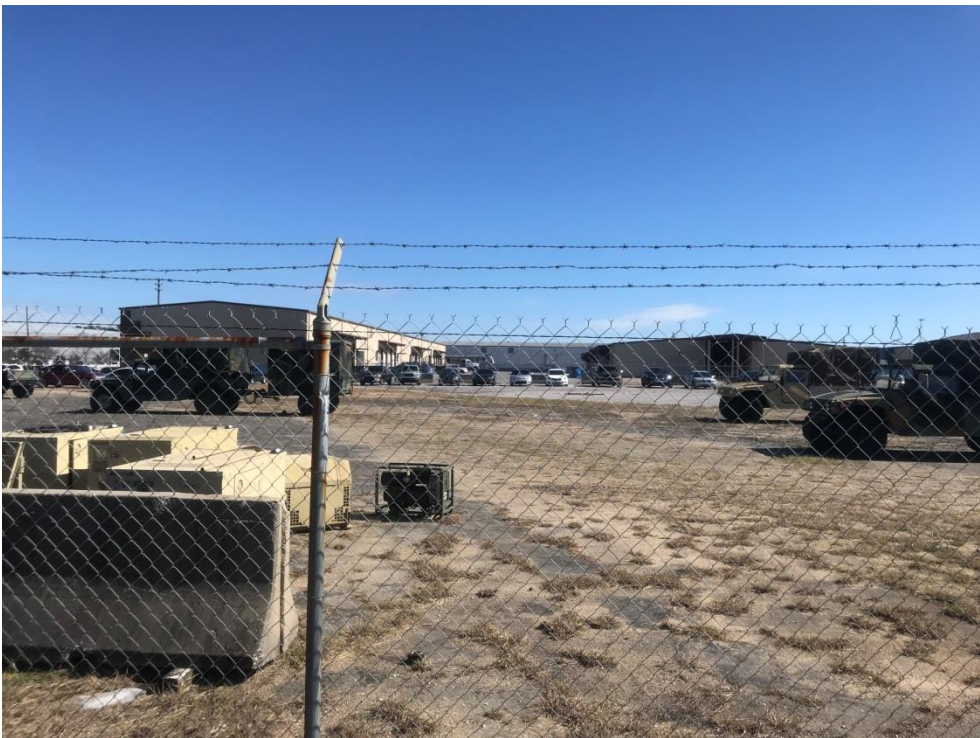
Army National Guard, Preliminary Assessment for PFAS		Ellyson Field	Pensacola, Florida
<b>Photograph No. 5</b>

<b>Description:</b>			
Looking east. Vehicle staging area east of the Ellyson Field building Photo Date: 1/31/19			
<b>Photograph No. 6</b>

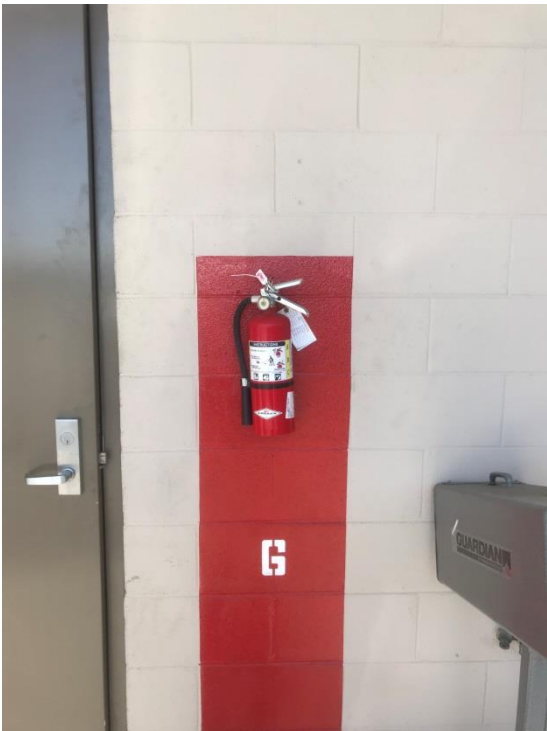
<b>Description:</b>			
Looking north. ABC fire protection used at the vehicle staging areas. Photo Date: 1/31/19

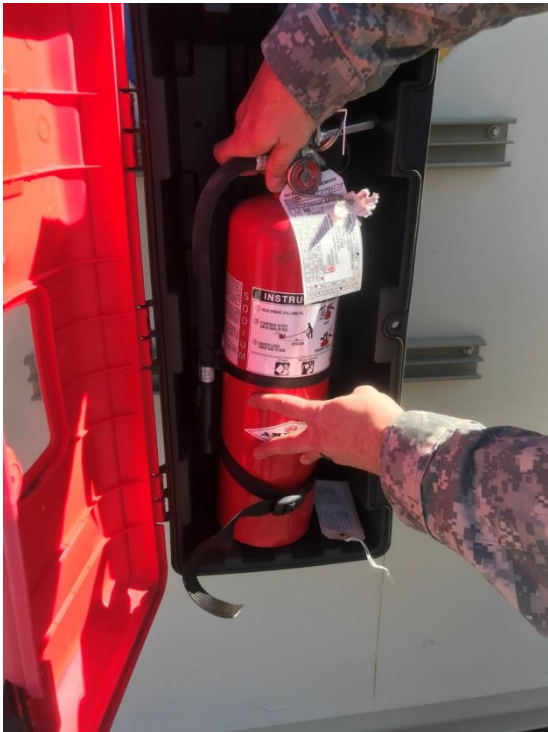
Army National Guard, Preliminary Assessment for PFAS		Ellyson Field	Pensacola, Florida
<b>Photograph No. 7</b>

<b>Description:</b>			
Looking east. Sodium fire extinguisher at the satellite accumulation area.  Photo Date: 1/31/19
