# FINAL Preliminary Assessment Report Barrigada Readiness Center Guam

Perfluorooctanesulfonic acid (PFOS) and Perfluorooctanoic Acid  
(PFOA) Impacted Sites  
ARNG Installations, Nationwide

January 2021

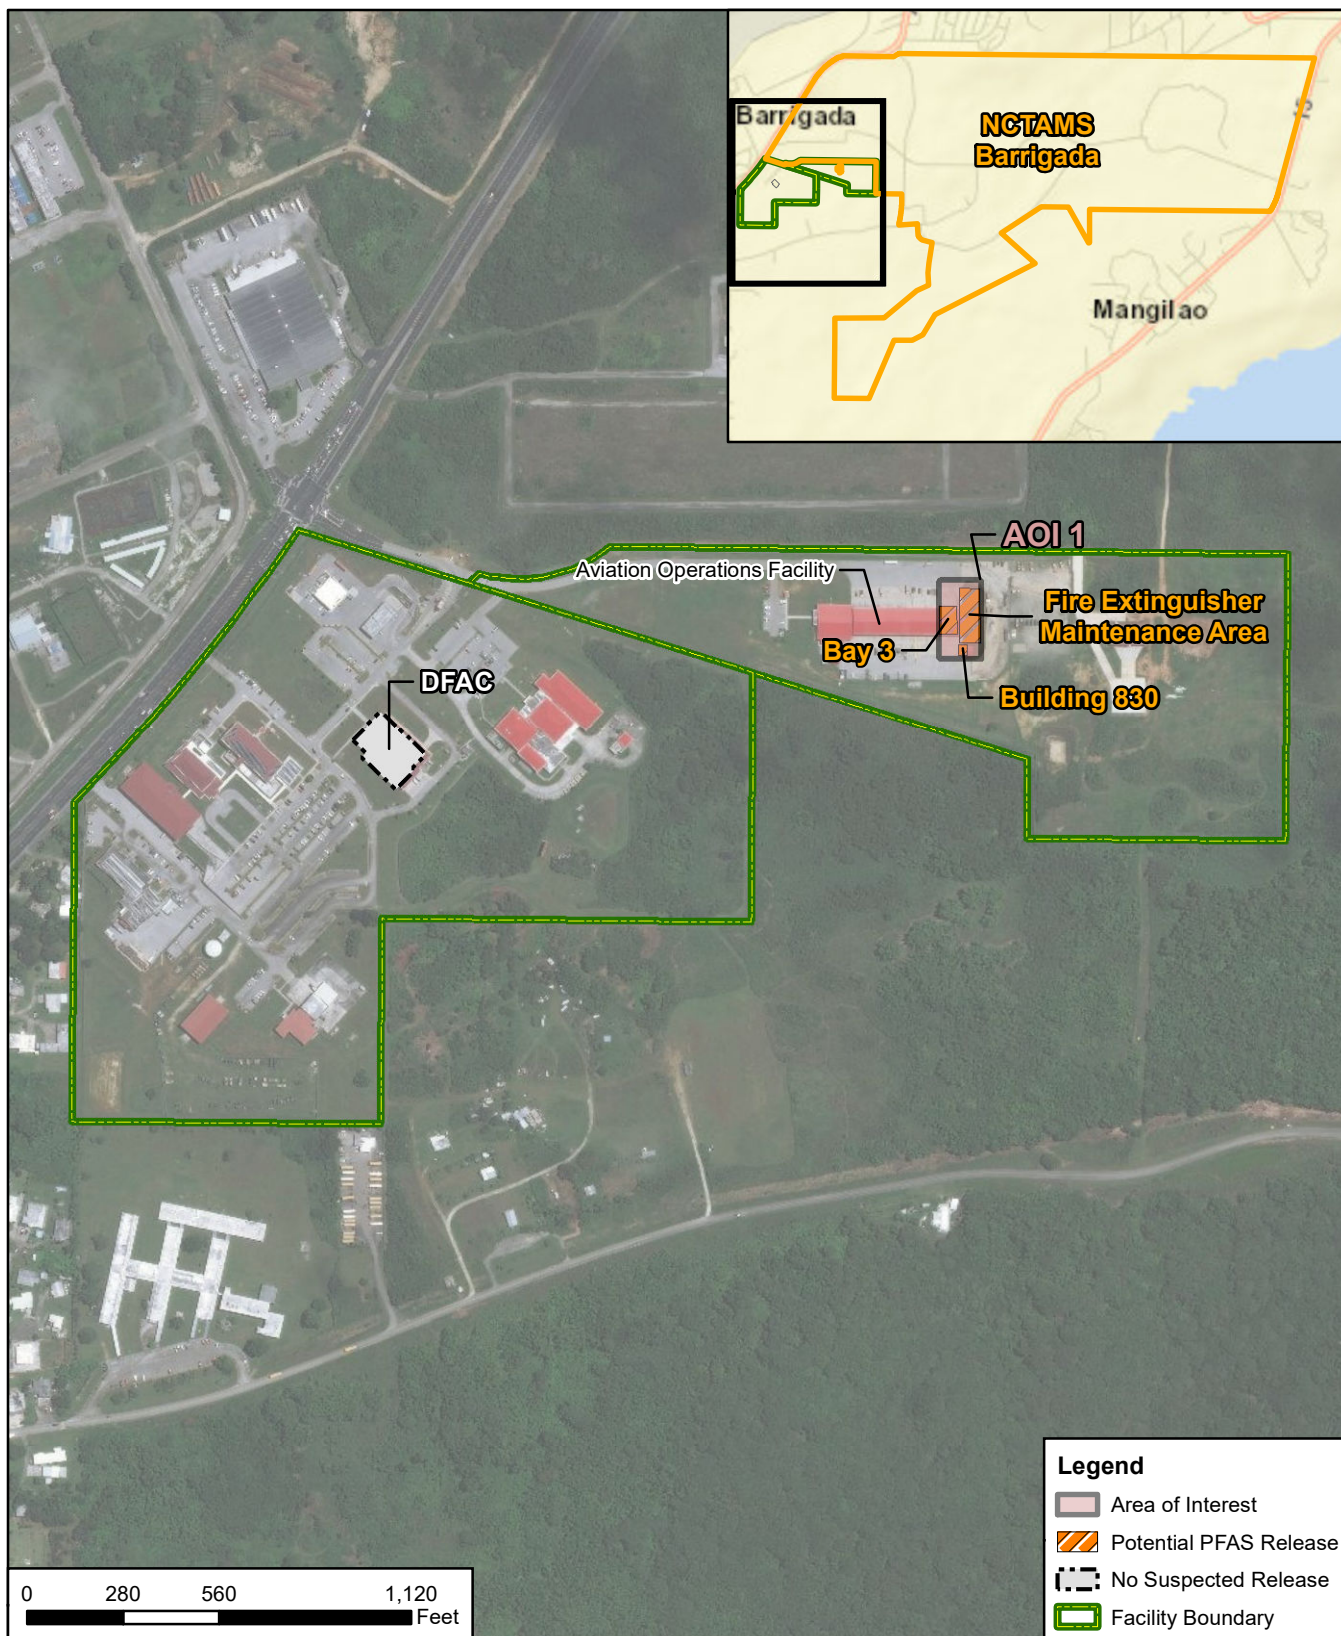
One AOI related to a potential PFAS release was identified at Barrigada Readiness Center. The AOI is shown on **Figures ES-1** and described in **Tables ES-1** below.

Based on the documented release concerning the aqueous film forming foam at the facility, there is potential for exposure to PFAS contamination in media at or near the facility. The preliminary CSM for the Barrigada Readiness Center, which presents the potential receptors and media impacted, is shown on **Figure ES-2**. Based on the US Environmental Protection Agency (USEPA) Unregulated Contaminant Monitoring Rule 3 (UCMR3) data, it was indicated that PFAS were detected in a public water system above the USEPA's lifetime Health Advisory (HA) within 5 miles of the facility. The HA is 70 parts per trillion for PFOS and PFOA, individually or combined. The affected public water system is the GU Waterworks Authority – Northern System, which had detections of PFOS in groundwater ranging from 41 to 410 parts per trillion. The UCMR3 dataset is located in **Appendix A**. PFAS analyses performed in 2016 had method detection limits that were higher than currently achievable. Thus, it is possible that low concentrations of PFAS were not detected during the UCMR3 but might be detected if analyzed today.

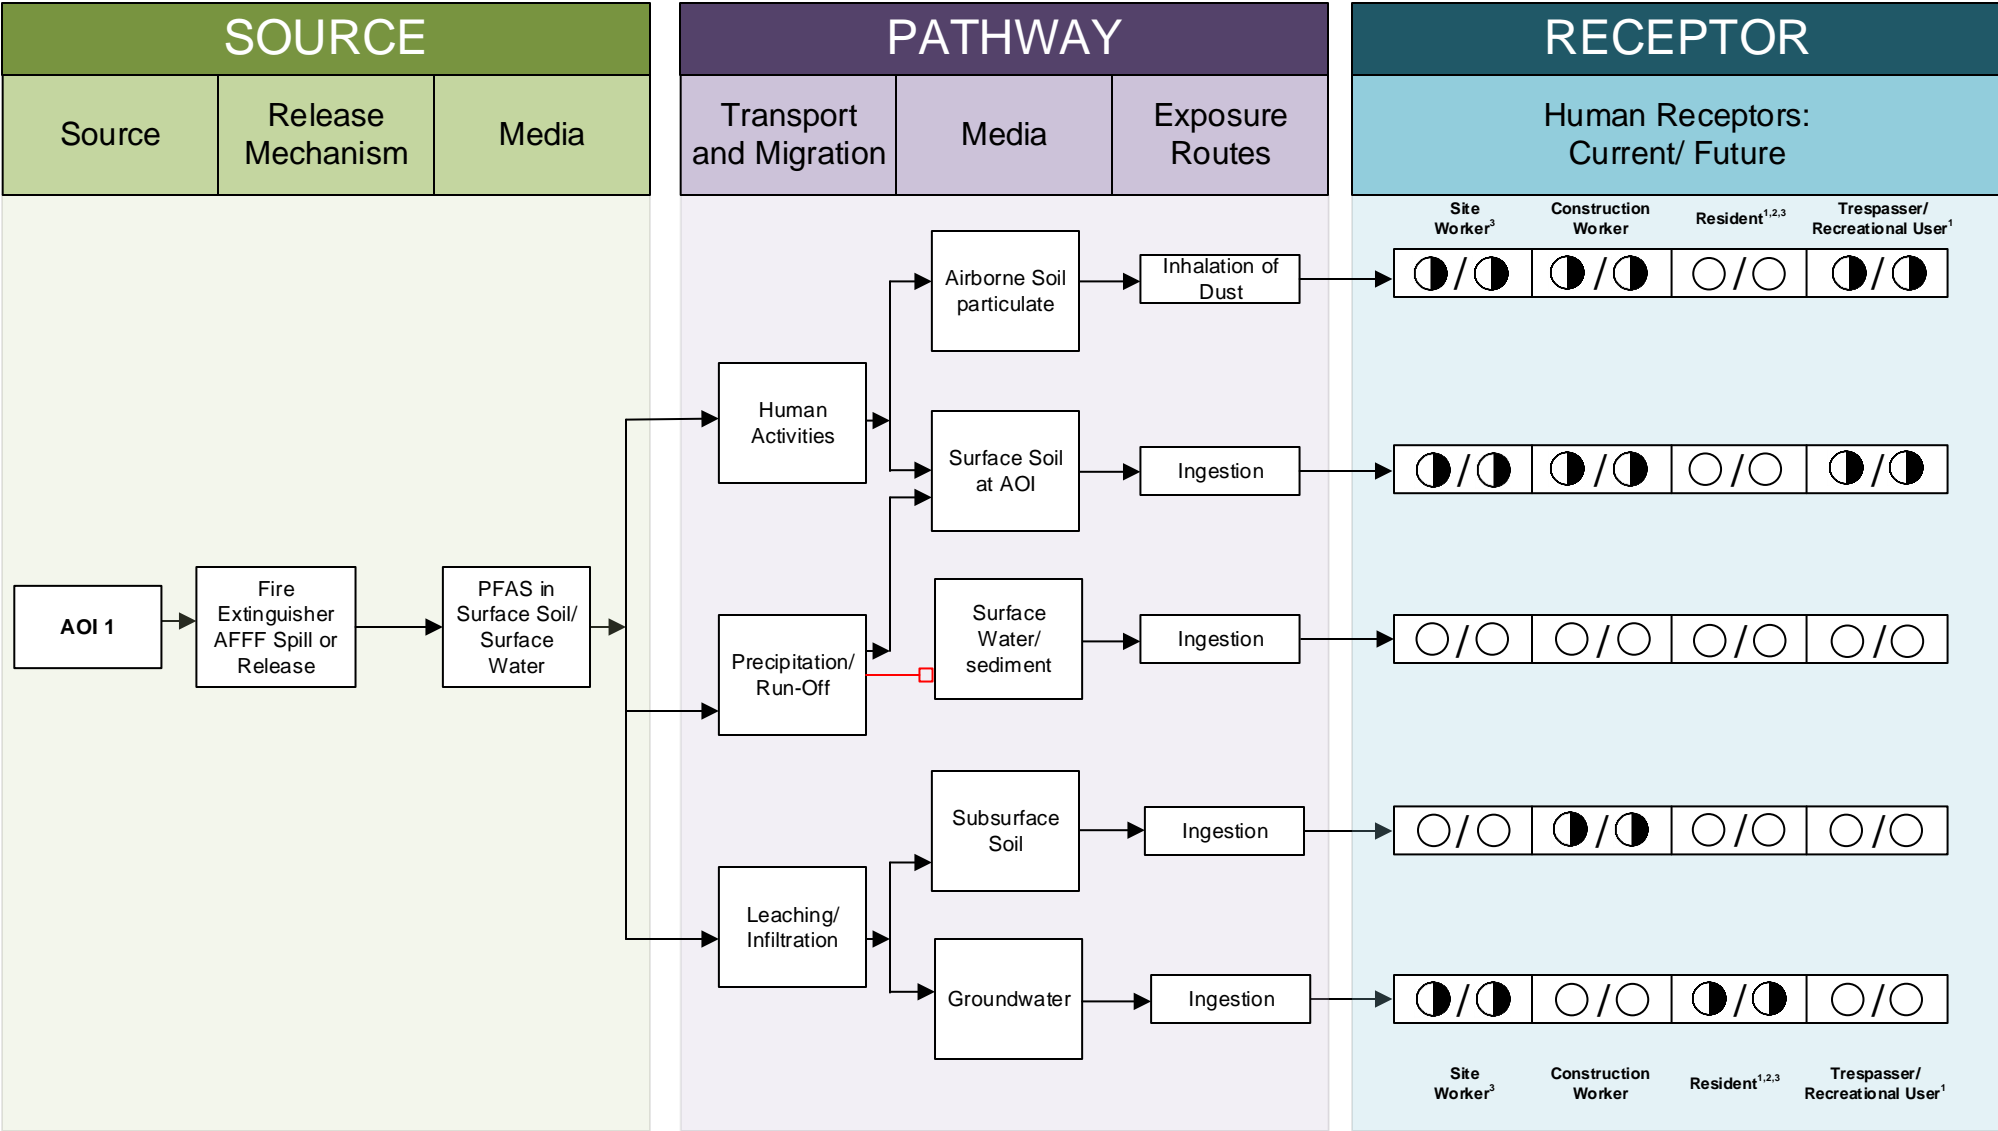
Figure ES-2  
Preliminary Conceptual Site Model  
Barrigada Readiness Center, Guam

1. The resident and recreational users refer to off-site receptors.
2. Inhalation of dust for off-site receptors is likely insignificant.
3. UCMR3 data for municipal drinking water exceeded the HA of 70 parts per trillion for PFOS.

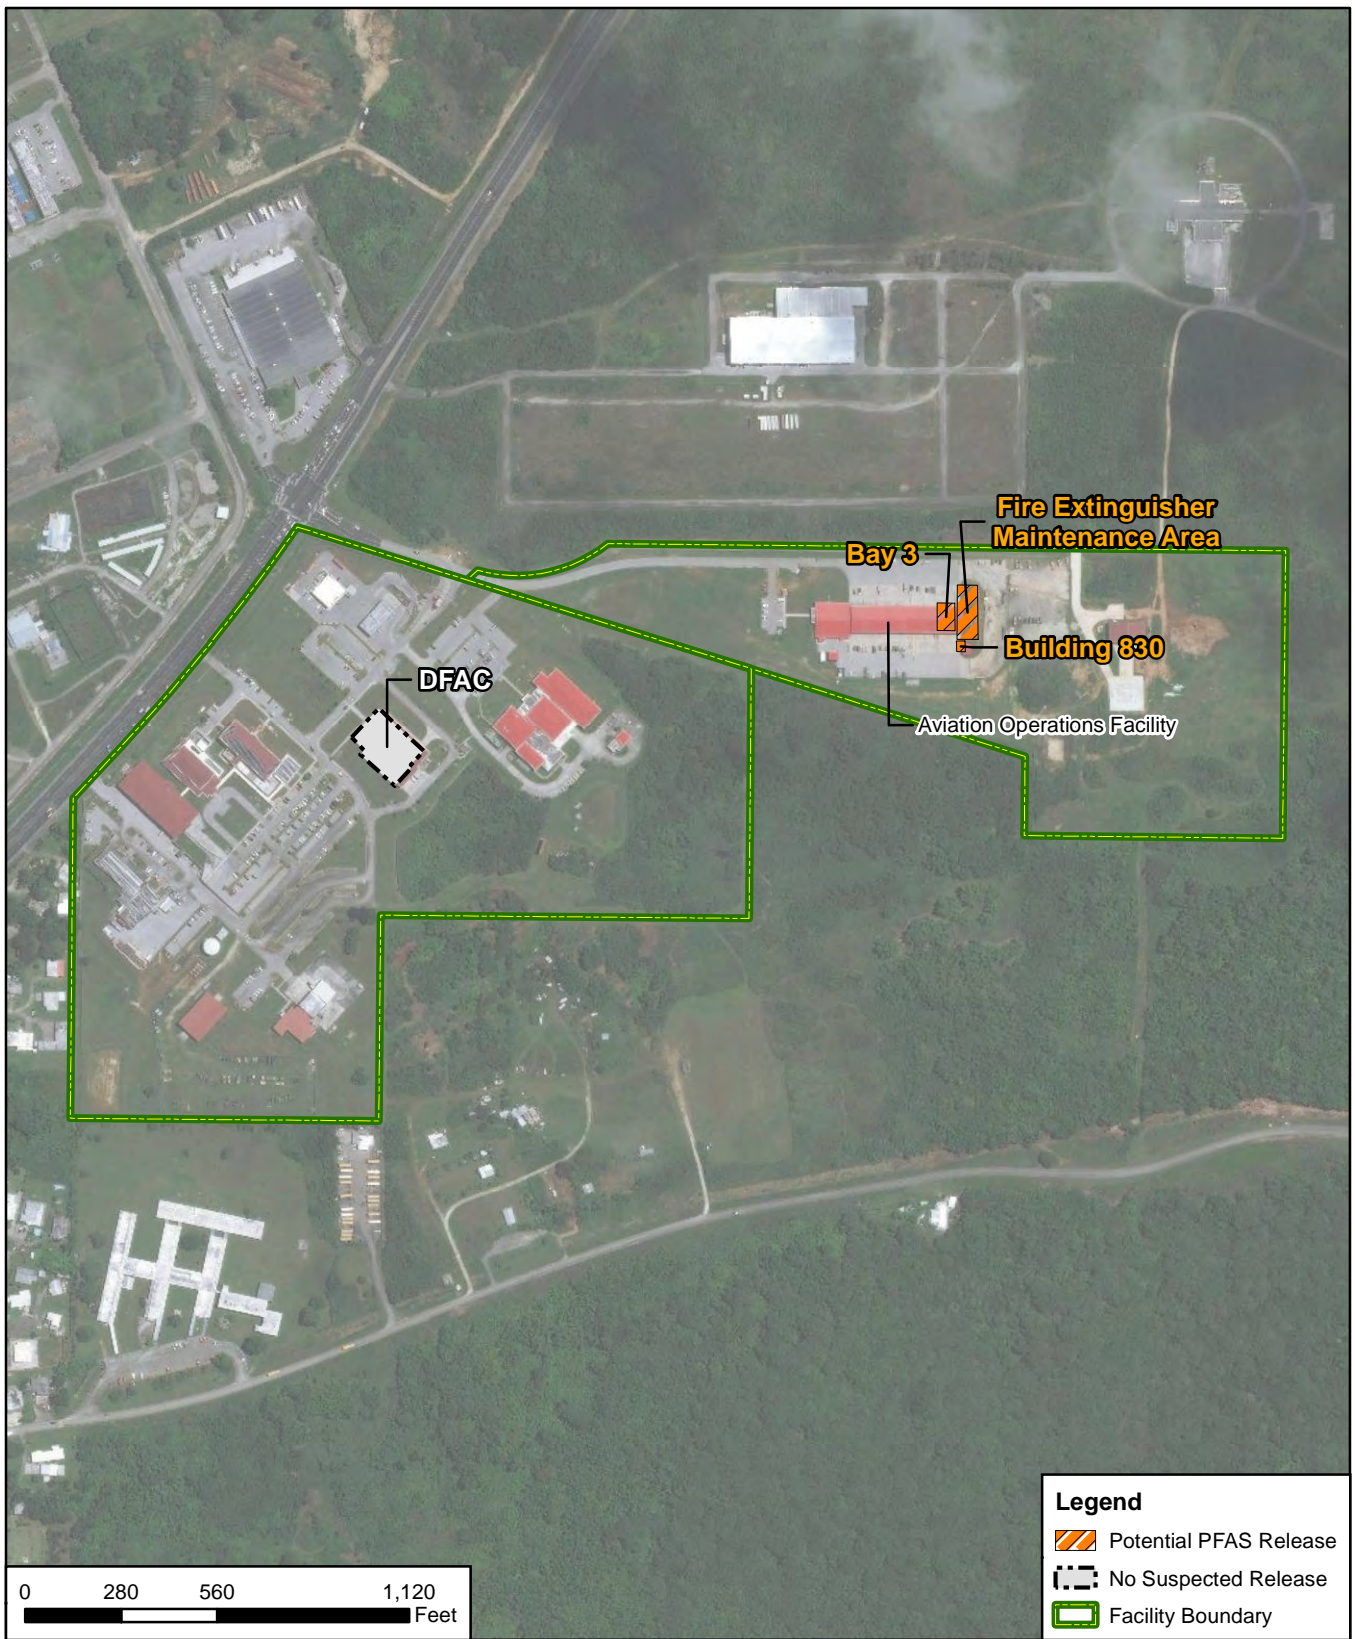
Between the 1<sup>st</sup> and 17<sup>th</sup> of June 2016, new Tri-Max<sup>TM</sup> compressed air foam systems (CAFSs) were issued to GUARNG, and personnel received training on the new systems. Training was conducted in the northern grassy area of the hangar. As part of the training, personnel were instructed on how to load the Tri-Max<sup>TM</sup> and were shown the various parts of the extinguisher. In addition, hands-on demonstrations were conducted on how to properly use the Tri-Max<sup>TM</sup>. Based on interviews, there was a large amount of foam released during the hands-on demonstrations. One of the interviewees maintained that the Tri-Max<sup>TM</sup> CAFSs were filled with soap and not AFFF during the demonstrations because the AFFF material had not yet arrived. According to interviewed personnel, GUARNG did not occupy the hangar, also called “Aviation Operations Facility”, prior to June 2016 and AFFF was only acquired after their arrival. Although it is unclear whether soap or AFFF was used in the training exercises, no other training or use with the Tri-Max<sup>TM</sup> CAFSs was conducted after the DA issued the memorandum “Limiting Use of Aqueous Film Forming Foam” on 29 June 2016 (DA, 2016).

In early 2019, the Tri-Max<sup>TM</sup> CAFSs were emptied of AFFF and moved to a 55-gallon drum plus a 5.5-gallon drum. To empty the Tri-Max<sup>TM</sup>, the personnel interviewed stated that they siphoned the AFFF and then used a shop vac once the siphoning was no longer productive. Absorbent pads were placed around the CAFSs and drums during the siphoning process to catch any AFFF spills. The shop vac was cleaned with the spigot located on the southeast end of the hangar, and the rinse water was allowed to drain naturally. After being cleaned, the shop vac was disposed of in regular municipal waste. The used absorbent pads were placed in a single 55-gallon drum and stored with the AFFF drums inside Building 830, a storage shed located also in the grassy area of the hangar next to where training and maintenance activities were conducted. The AFFF and used absorbent pad drums inside Building 830 were sitting on top of spill containment pallets, and no spills were observed during the VSI (see Photos 5-7 in **Appendix C**). The empty and filled CAFSs were stored in Bay 3 of the hangar when not in use. Two empty CAFSs were observed inside Bay 3 during the VSI (see Photo 1 in **Appendix C**). Both storage locations, Bay 3 and Building 830, are shown on **Figure 3-1**.

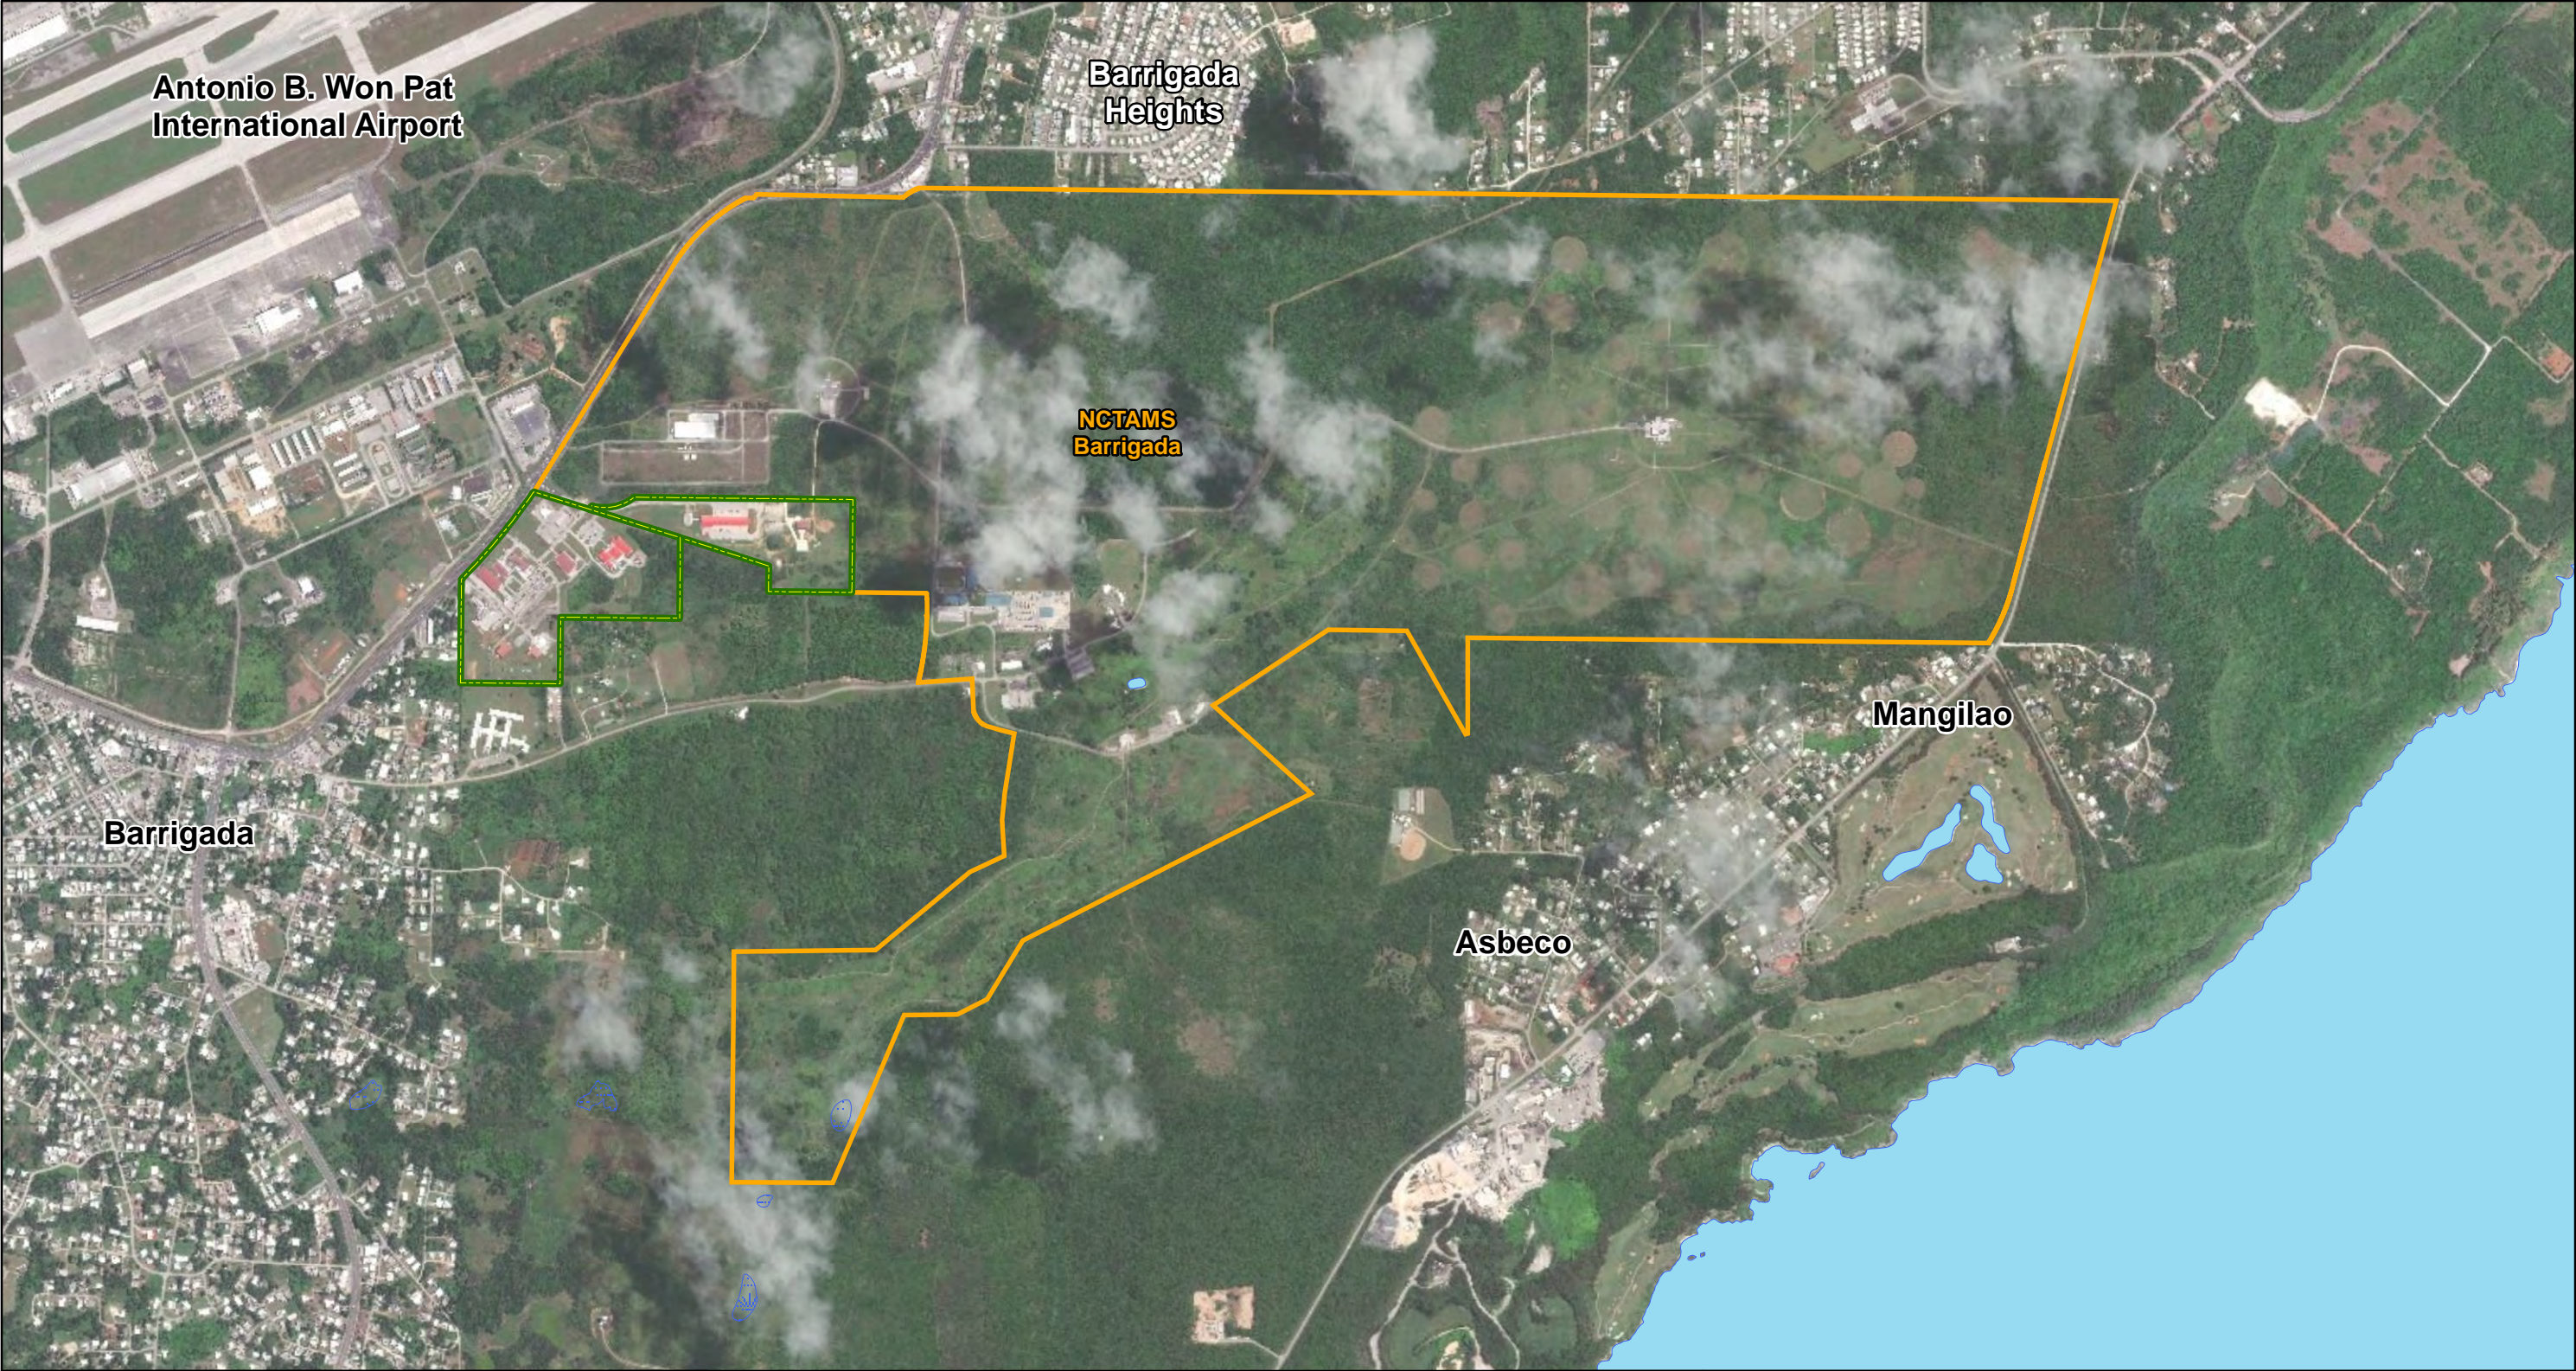
Figure 5-1

NCTAMS Barrigada is located adjacent to the Barrigada Readiness Center. The US Navy is in the process of performing a focused SI for PFAS at NCTAMS; additional information regarding the investigation was not available at the time of the PA report. Because portions of the facility are located both downgradient and side gradient to areas of NCTAMS, it is possible that NCTAMS is a potential off-facility source of PFAS.

During document reviews, a former fire station was identified within a Naval Activities property site (Ogden, 1996). The history and the extent of AFFF use, if any, at the former fire station is unknown, but the approximate location of the former fire station is located about 10 miles southwest of the facility. Review of the EDR™ did not reveal other likely PFAS sources near the facility.

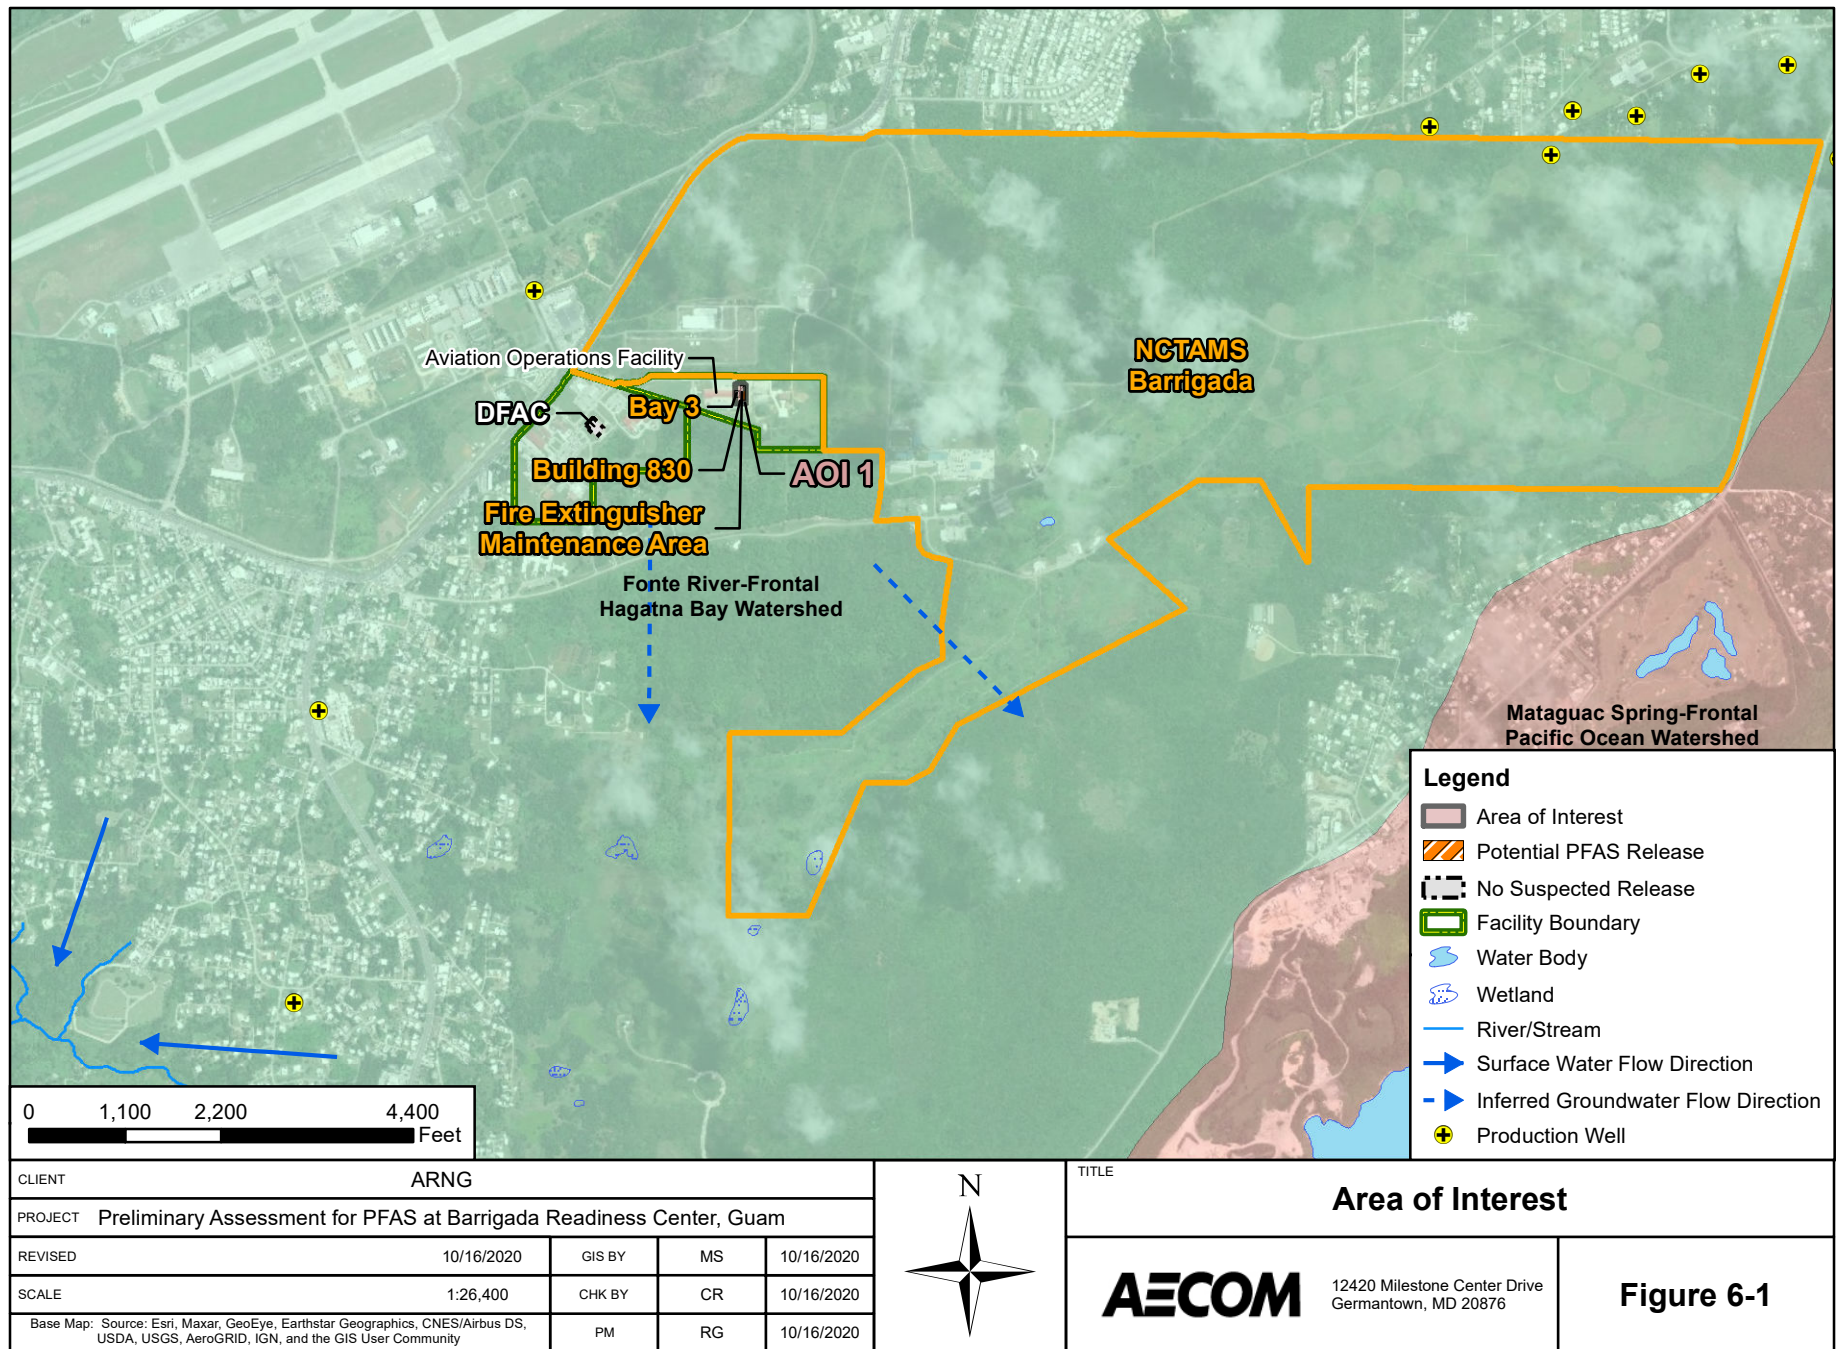
AOI 1 contains the Tri-Max™ training area, Building 830, and Bay 3, where AFFF was stored and/or may have been released during filling and emptying of the Tri-Max™ CAFSSs. The area where the Tri-Max™ training was conducted is grassy, while Building 830 and Bay 3 are paved. Ground-disturbing activities in release areas could result in site worker, construction worker, and trespasser exposure to potential PFAS contamination via inhalation of dust or ingestion of surface soil. PFAS may have also infiltrated from surface soil to the subsurface, and ground-disturbing activities to subsurface soil could result in construction worker exposure.

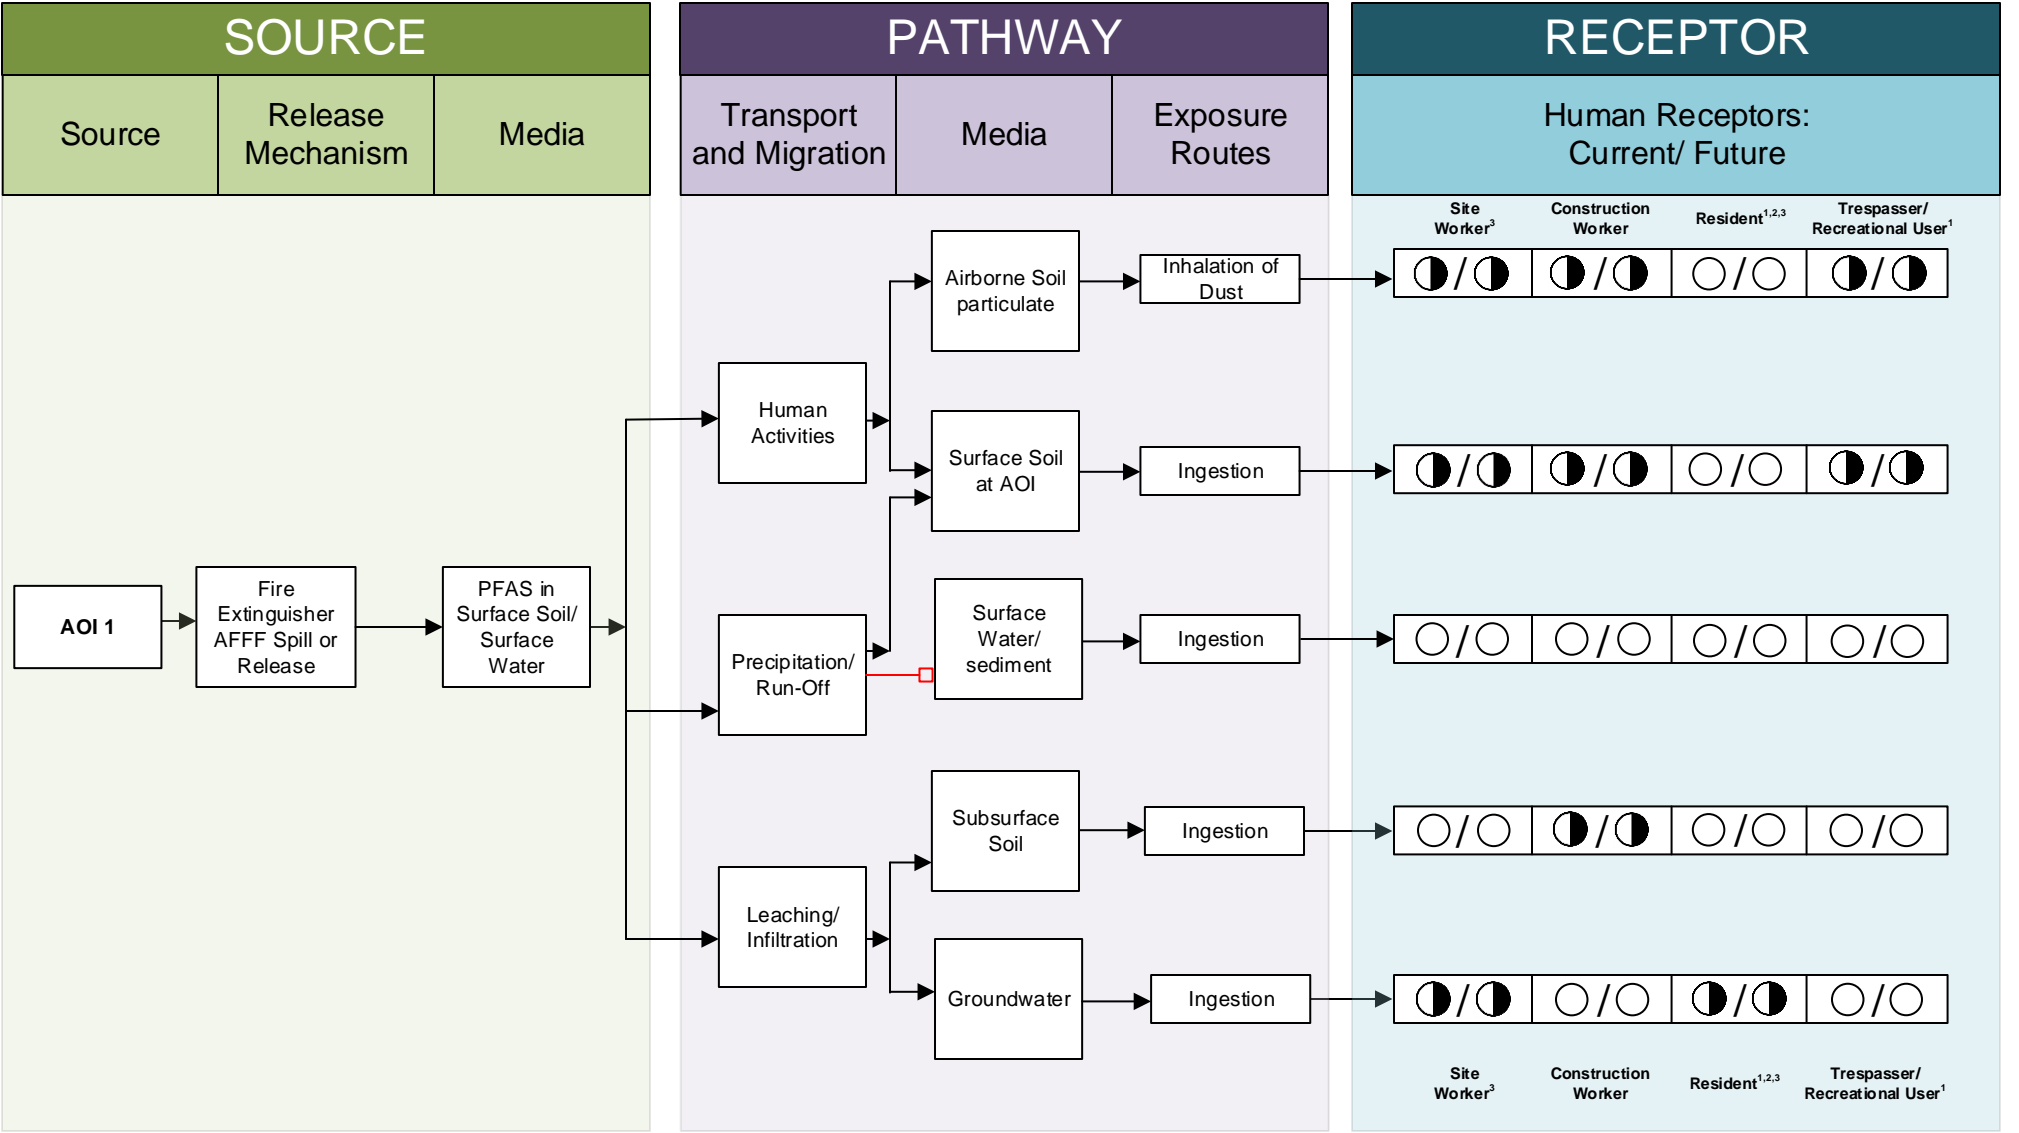
**Figure 6-2**  
Preliminary Conceptual Site Model  
Barrigada Readiness Center, Guam

1. The resident and recreational users refer to off-site receptors.
2. Inhalation of dust for off-site receptors is likely insignificant.
3. UCMR3 data for municipal drinking water exceeded the HA of 70 parts per trillion for PFOS.

Based on the storage and potential AFFF release at the AOI, there is potential for exposure to PFAS contamination in media at or near the facility. The preliminary CSM for Barrigada Readiness Center, which presents the potential receptors and media impacted, is shown on **Figure 6-2**.

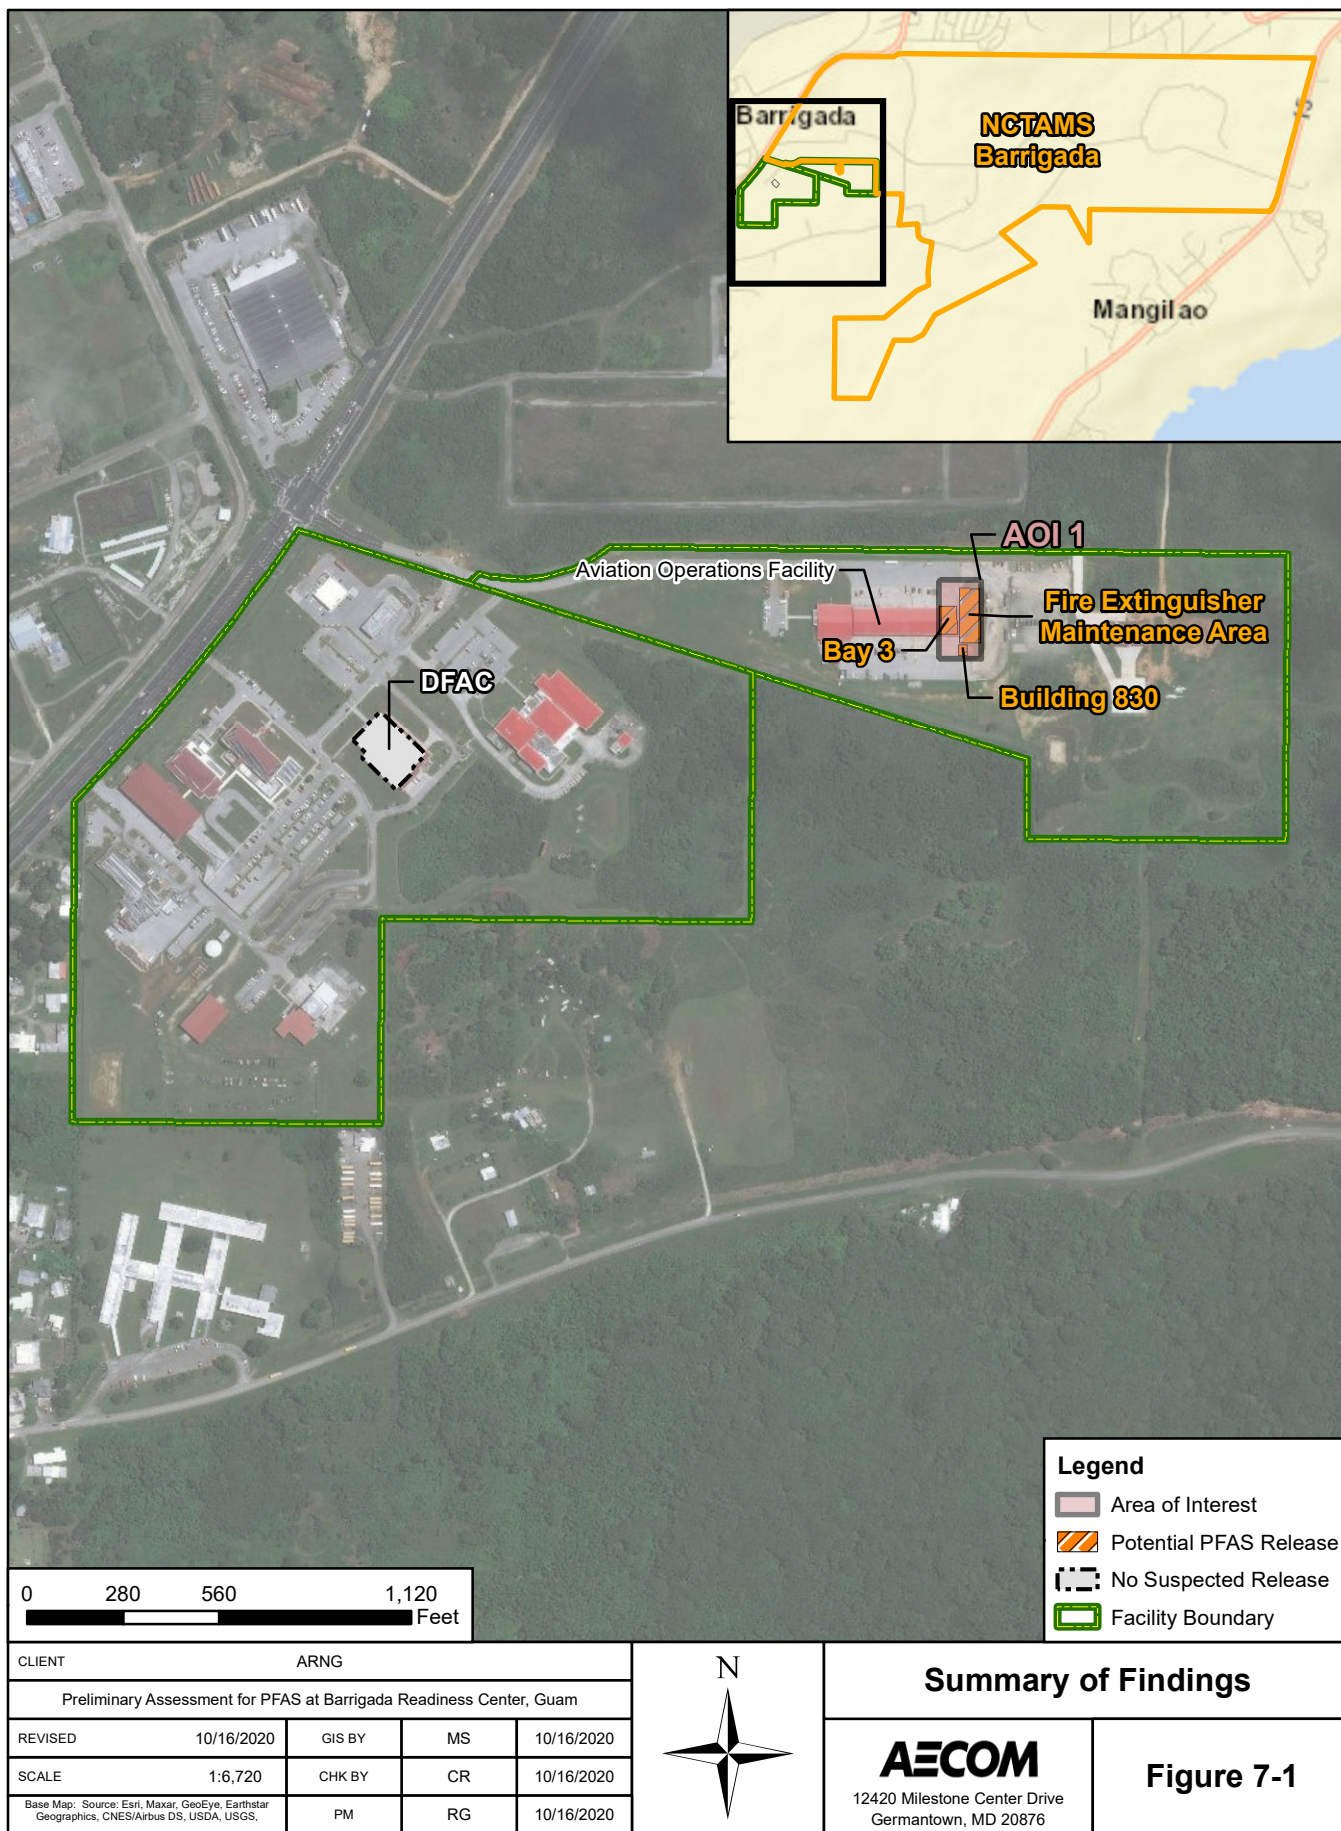
One AOI related to potential PFAS releases was identified at the Barrigada Readiness Center during the PA. **Figure 7-1** and **Table 7-1** present a summary of PA findings.

Area of Interest	AOI Location	Rationale	Potential Future Action
AOI 1 – Fire Extinguisher Maintenance Area	13°28'33.78"N and 144°48'53.11"E	Training and maintenance of Tri-Max™ CAFSSs.	Proceed to an SI; focus on soil and groundwater.

ARNG will evaluate the need for an SI at Barrigada Readiness Center based on the potential presence of a PFAS release, possible receptors, and the migration potential of PFAS contamination to receptors.
