Final Preliminary Assessment Report Edgemoade Mountain Home Training Site Mountain Home, Idaho

Perfluorooctane-Sulfonic Acid (PFOS) and Perfluorooctanoic
Acid (PFOA) Impacted Sites
ARNG Installations, Nationwide

March 2020

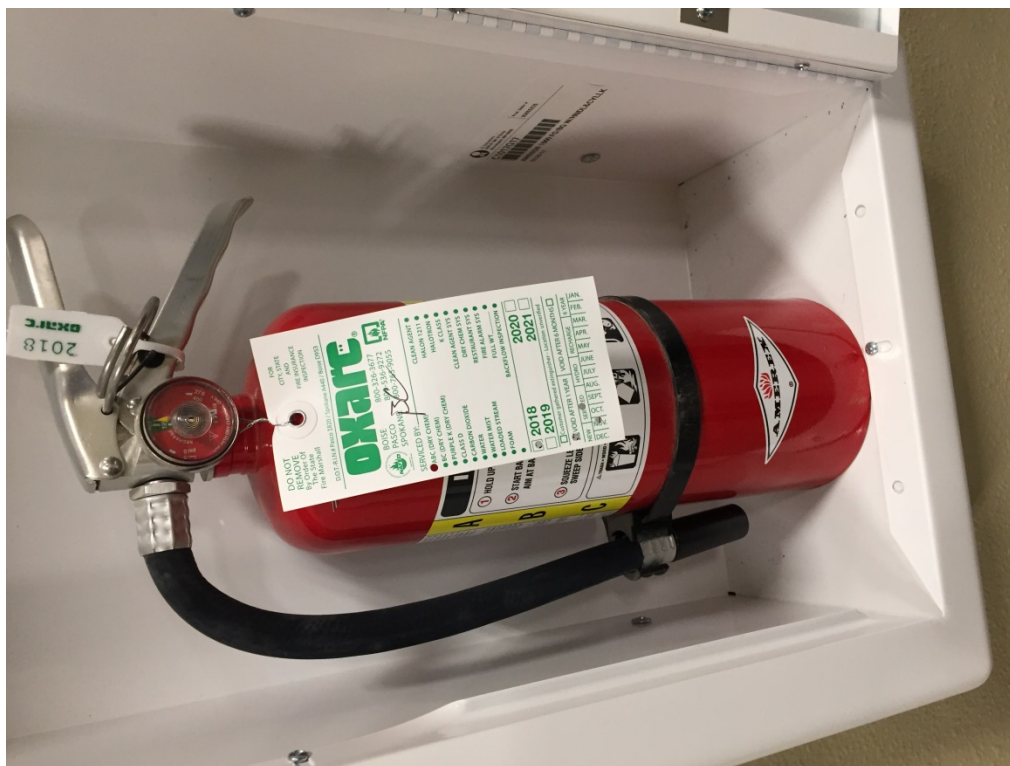
Armory Building ABC fire
extinguisher

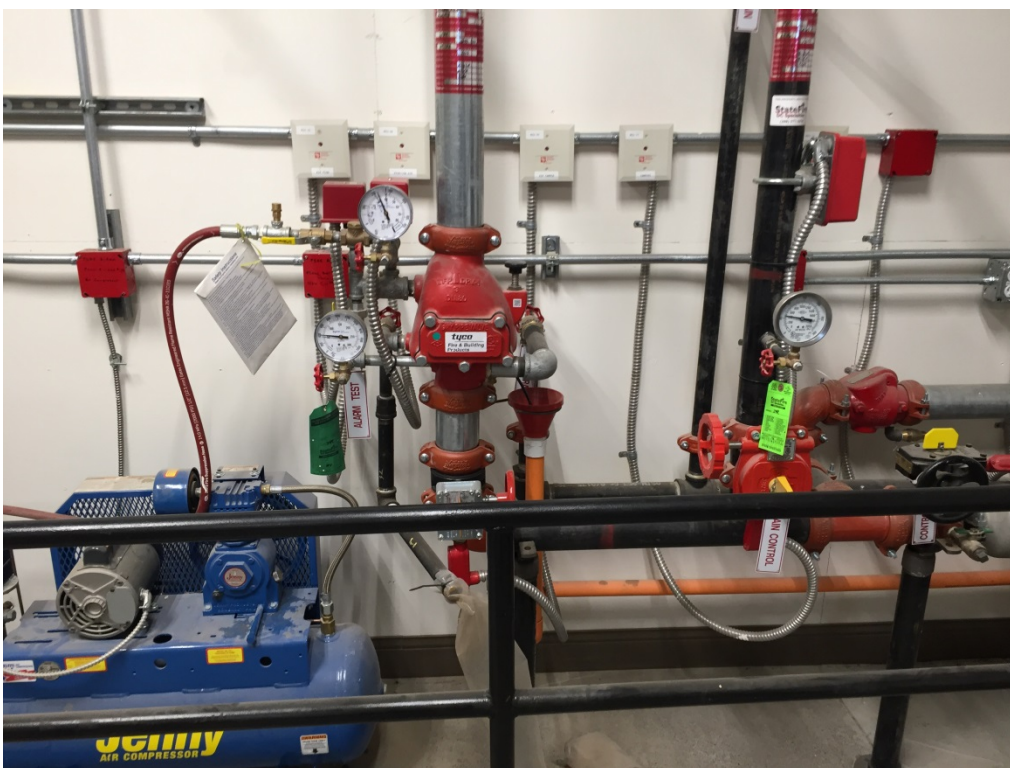
Photograph No. 2

Armory Building water fire
suppression system

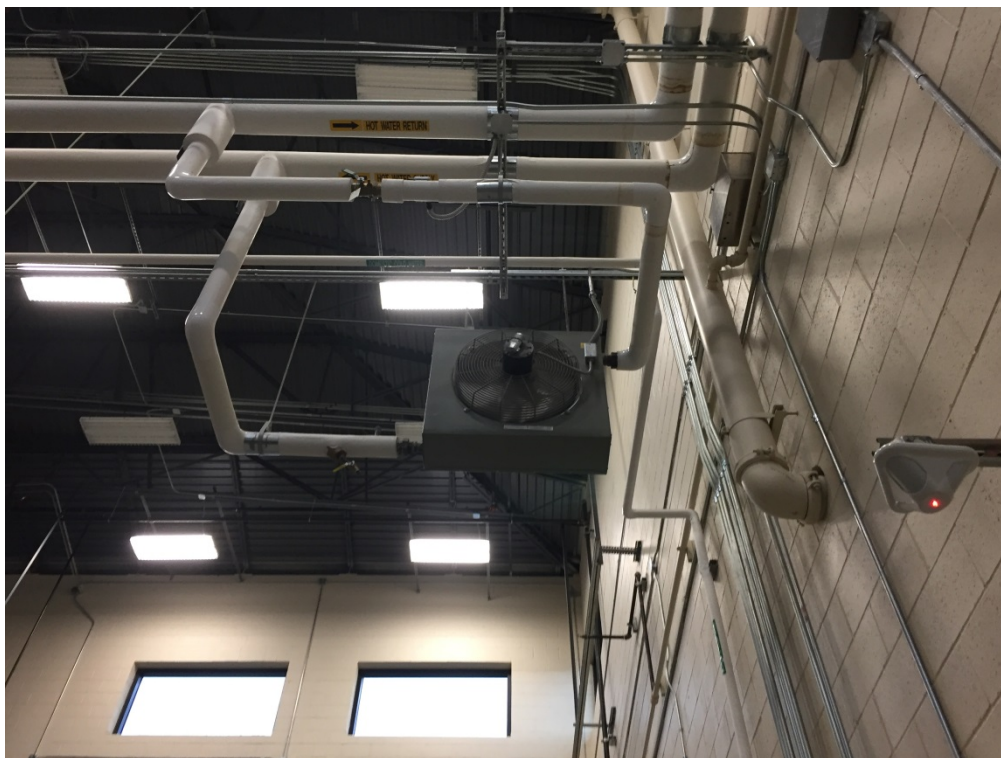
Fire suppression water
sprinklers
