# FINAL Preliminary Assessment Report Army Aviation Support Facility #1, Hammond, Louisiana

Perfluorooctanesulfonic Acid (PFOS) and Perfluorooctanoic  
Acid (PFOA) Impacted Sites  
ARNG Installations, Nationwide

July 2020

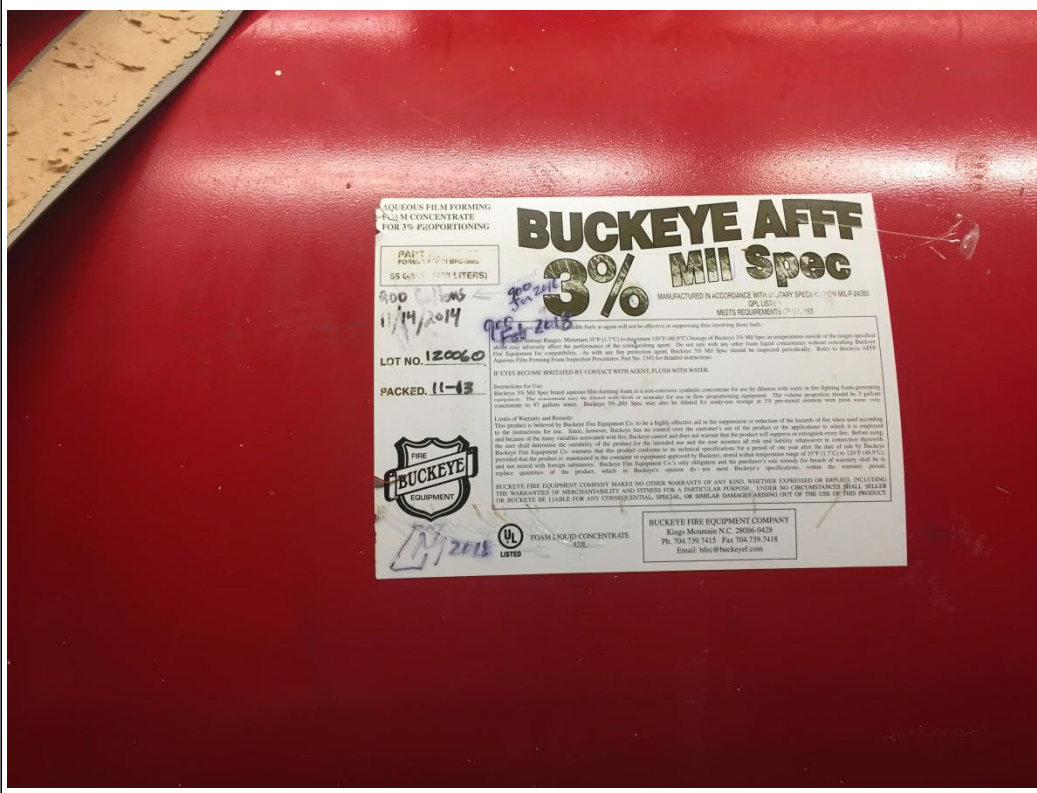
Fire Suppression System  
AFFF tank, Main Hangar.

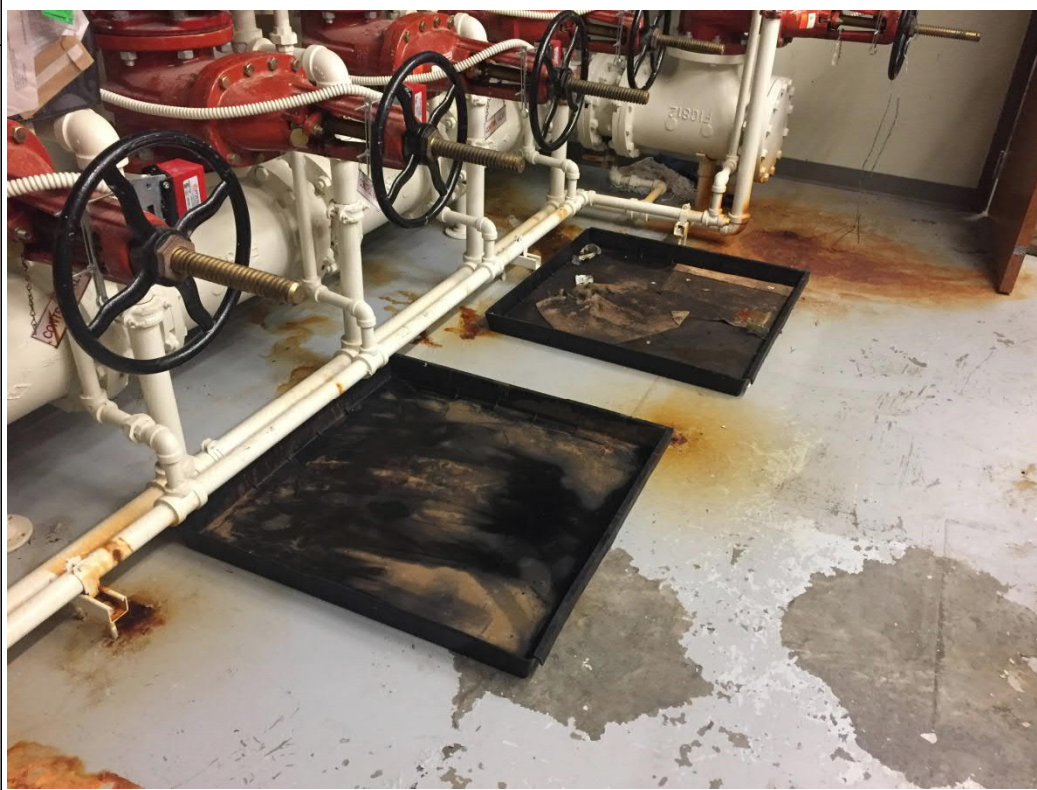
### Photograph No. 2

this activity. Evidence of slight leaking and corrosion/staining was observed underneath the tank on the concrete floor, underneath the feeder pipes to the hangar, and at the joints of the pipes. Drip pans are in place to catch any leaks from the pipes. According to interviews with site personnel, the leaks are intermittent and have never warranted a refill of the AFFF tank. The drip pans have never been full to the point of needing to be emptied. During the VSI, AFFF residue was observed in the drip pans. The utility room has a concrete floor and no floor drains were observed. Photographs are included in **Appendix C**.

Drip pans for AFFF drips  
from Fire Suppression  
System, Main Hangar.

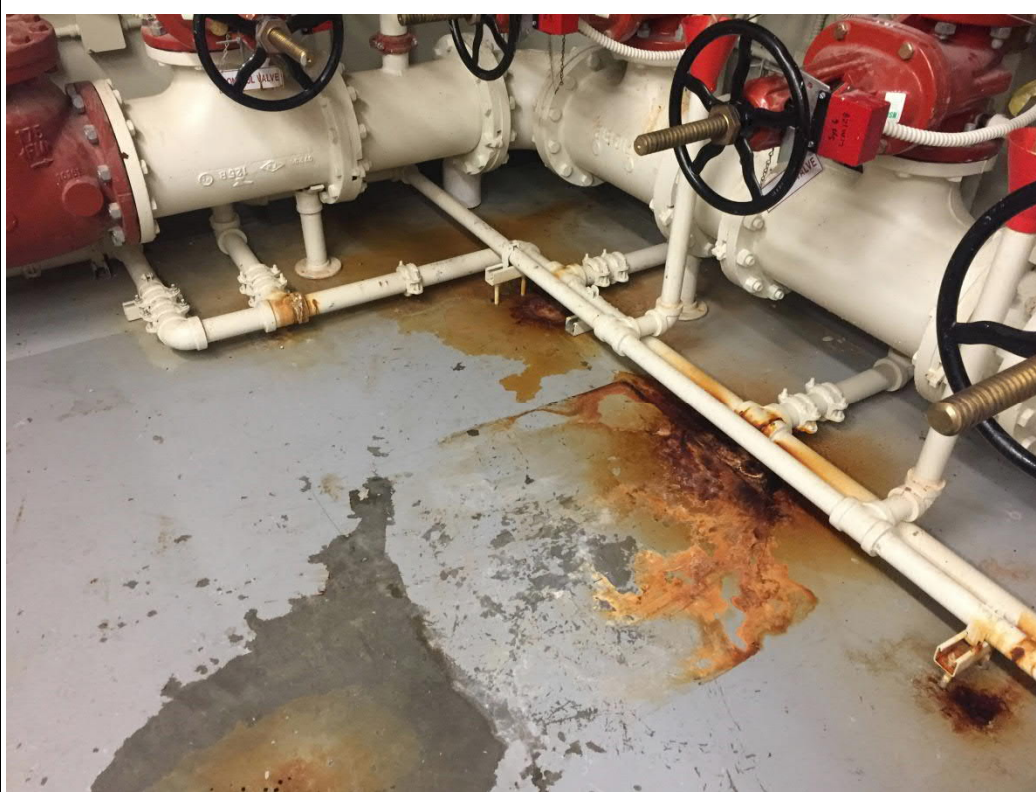
### Photograph No. 4

Corrosion on pipes and  
floor, Fire Suppression  
System tank store room,  
Main Hangar.

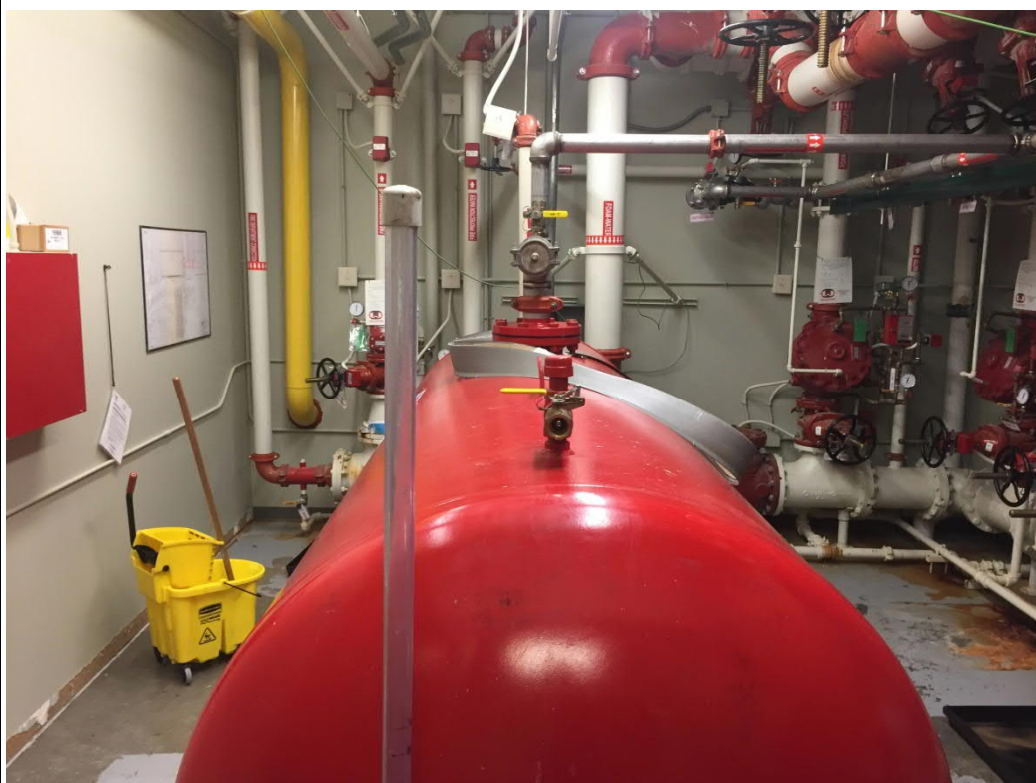
Fire Suppression System  
tank store room, Main  
Hangar.

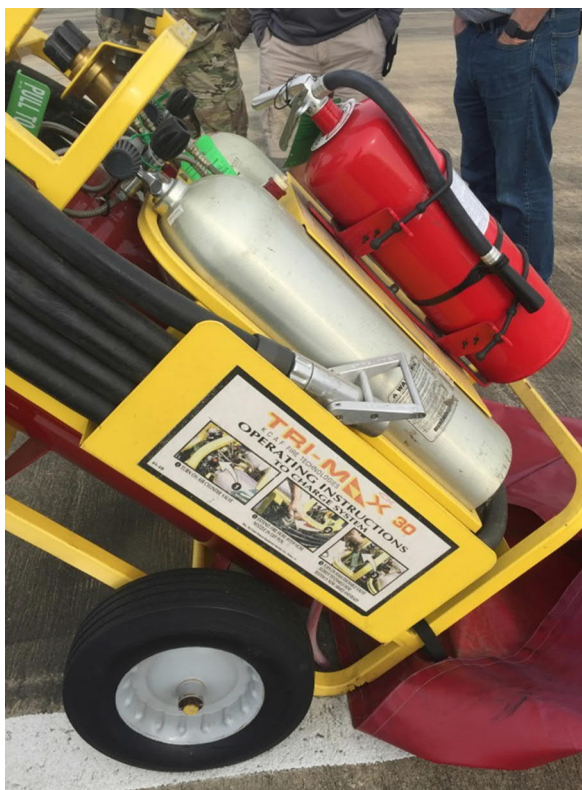
### Photograph No. 6

Trimax unit on Main  
Hangar flight line.

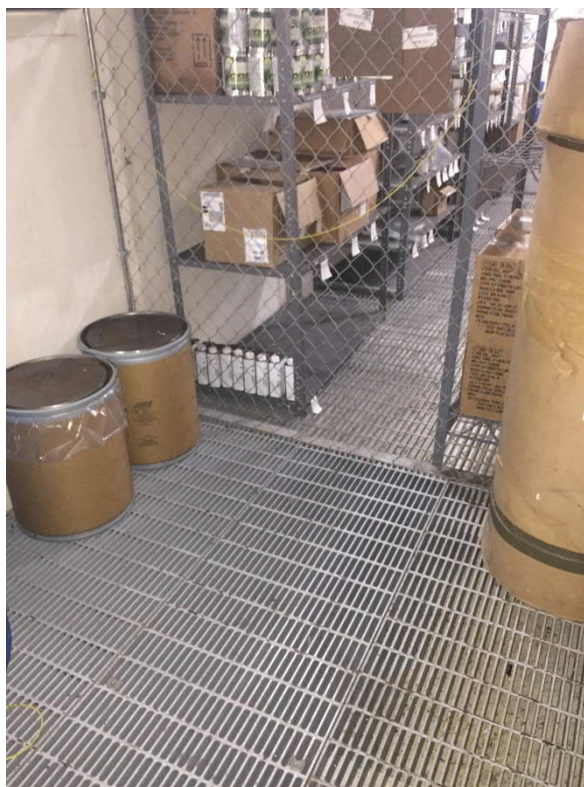
Chemical storage trailer behind Main Hangar with secondary containment system and ABC suppression system. Formerly used for AFFF storage.

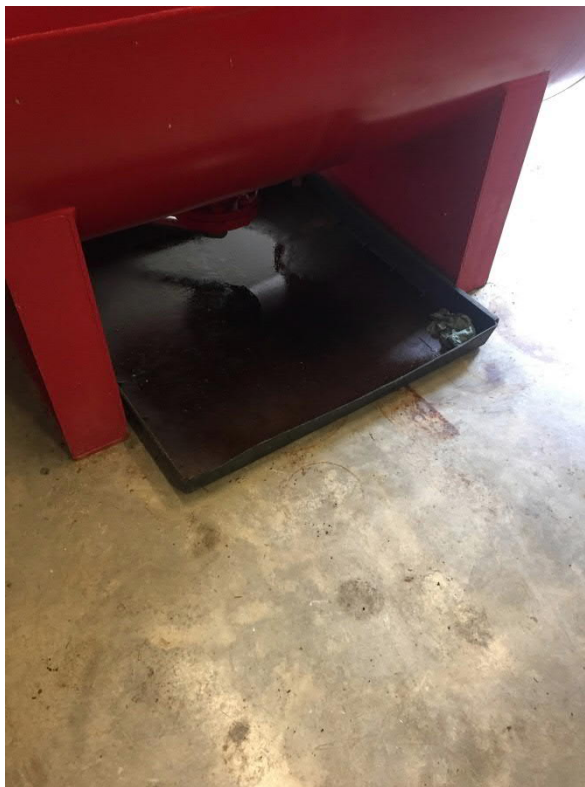
There have been no reported releases of the AFFF suppression system in the C12 Hangar. Evidence of slight leaking was observed underneath the AFFF tank in the utility room. A drip pan was staged underneath the tank. According to information obtained during the site visit, the leak is intermittent, the AFFF tank has not leaked to the extent of needing to be refilled, and the drip pan has never been full to the point of needing to be emptied. During the VSI, AFFF residue was observed in the drip pans. The utility room has a concrete floor, and no floor drains were observed. Photographs are included in **Appendix C**.

Drip pan underneath Fire  
Suppression System AFFF  
tank, C12 Hangar.
