FINAL Preliminary Assessment Report Esler Field Army Aviation Support Facility, Louisiana

Perfluorooctanesulfonic Acid (PFOS) and Perfluorooctanoic
Acid (PFOA) Impacted Sites
ARNG Installations, Nationwide

July 2020

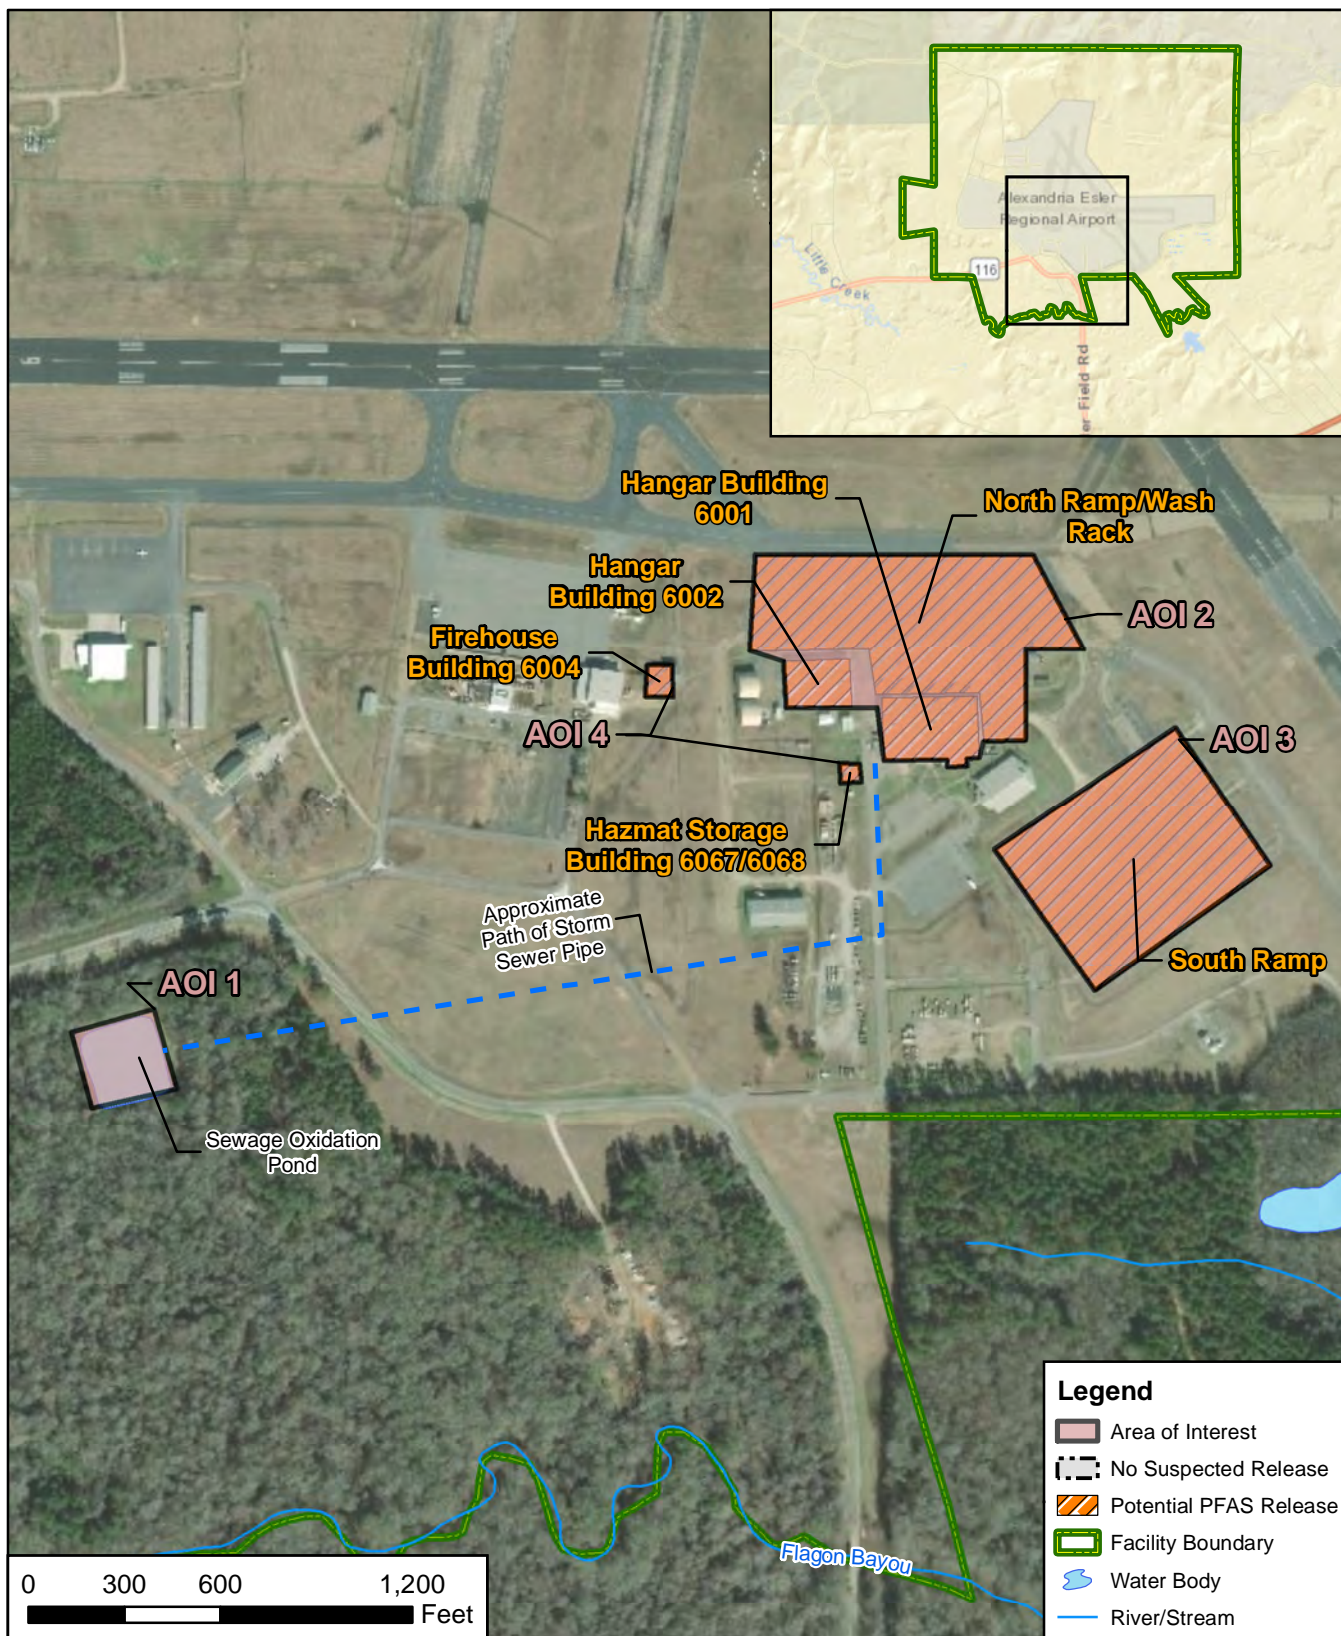
Figure ES-1

Four AOIs related to potential PFAS releases were identified at Esler Field AASF during the PA. The AOIs are shown on **Figure ES-1** and described in **Table ES-1** below.

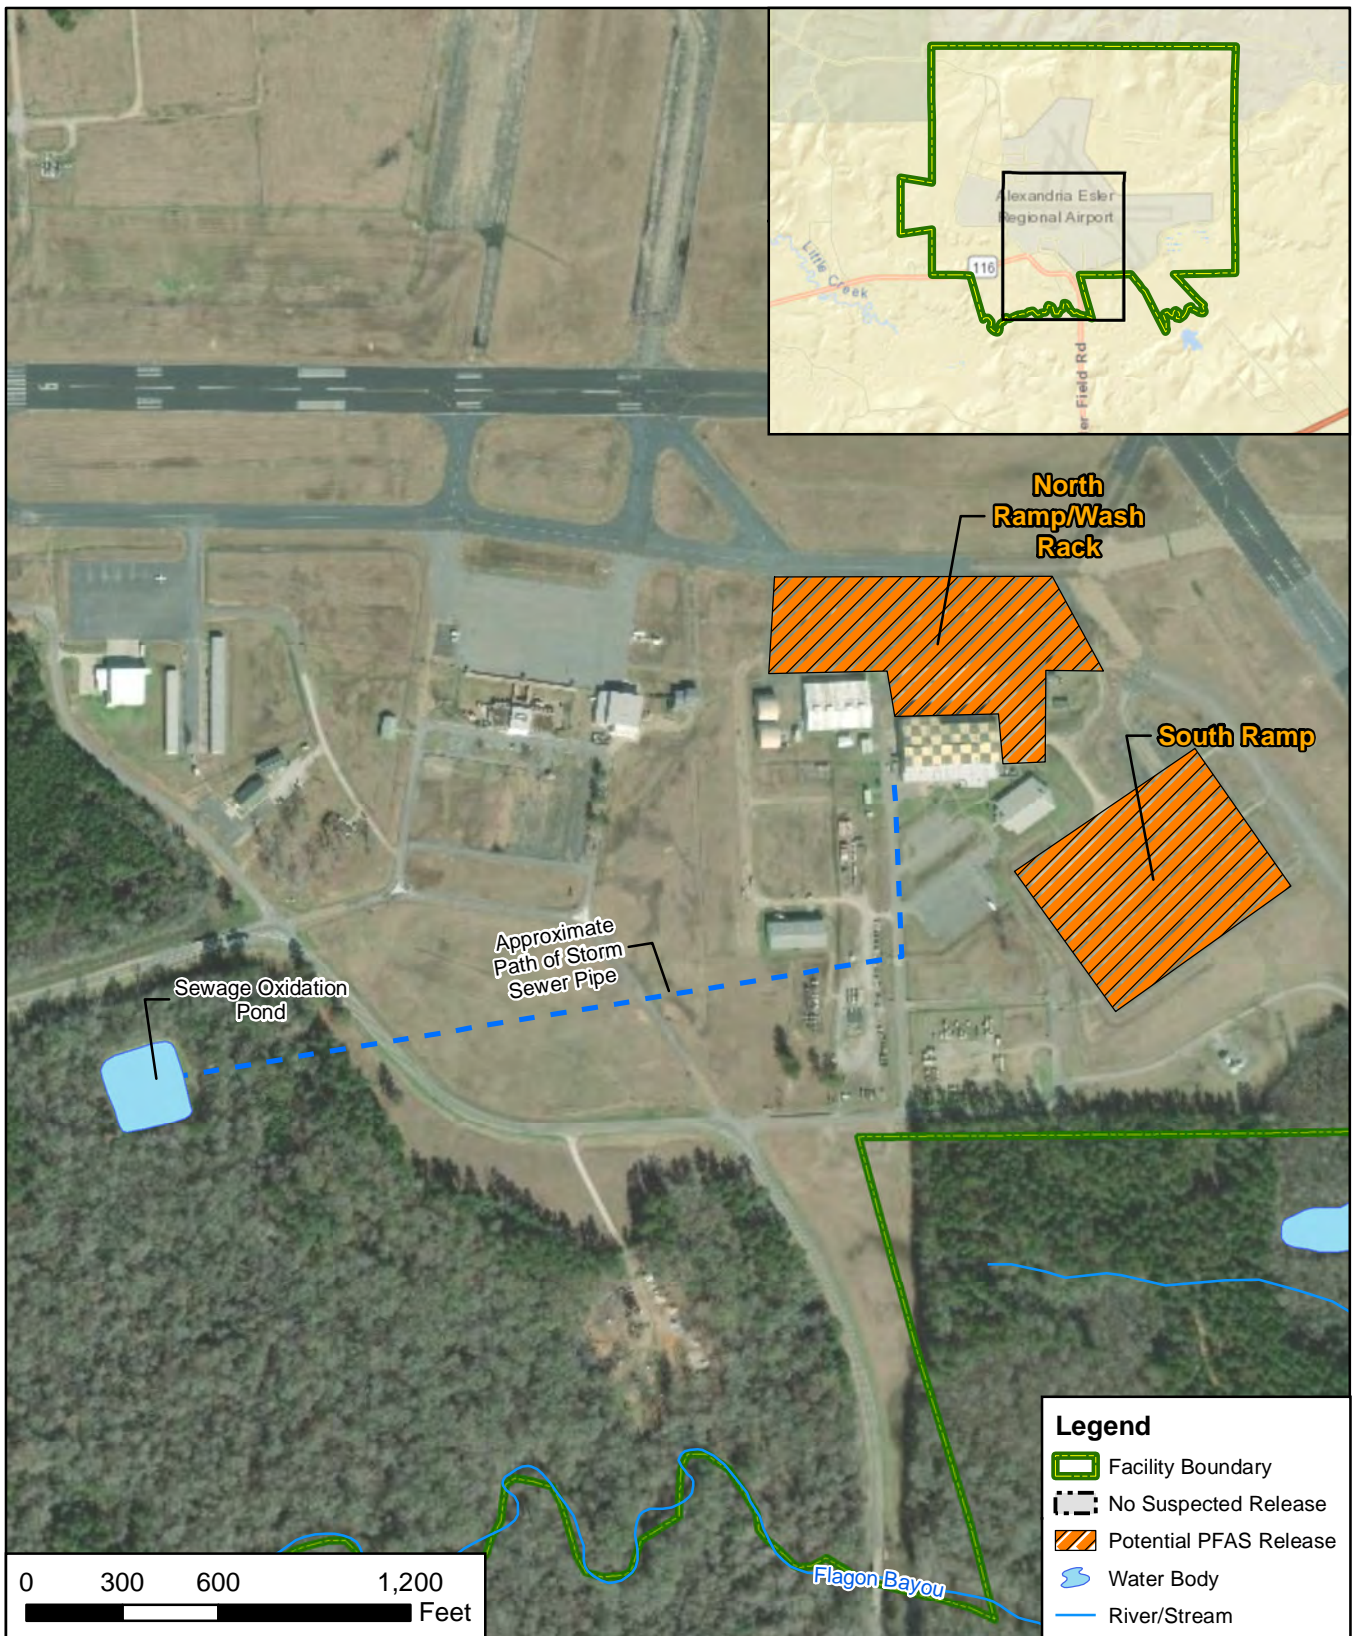
One FTA was identified within the AASF facility during the PA through interviews. This FTA is described below and shown in **Figure 2-1**.

AASF personnel reported fire training at the north ramp/wash rack was conducted annually between 1996 and 2007. After the south ramp was constructed in 2005-2006, fire training also was conducted at the south ramp until 2007. The exact location of the training events held on the ramps varied from year to year. During these drills (held jointly with the local Holloway Volunteer Fire Department [VFD]), expired or near expired Tri MaxTM foam carts were fully expended. After training, the expended carts were recharged with five-gallon buckets stored in the hazmat storage building (discussed in **Section 3.4**). Foam dispensed from Tri-MaxTM carts during training was rinsed from the ramp down into a nearby stormwater drain. Drains convey stormwater southwest (north ramp) and west (south ramp) to an oil water separator and then to a square sewage oxidation pond located on the southwestern portion of the facility (discussed in **Section 3.2**). With the exception of these training exercises, AASF personnel reported no suspected release of AFFF or spill incident at these locations. The geographic coordinates for the north ramp/wash rack are 31° 23'27.15"N; 92°17'45.64"W, and the geographic coordinates for the south ramp are 31° 23'24.84"N; 92°17'38.92"W.

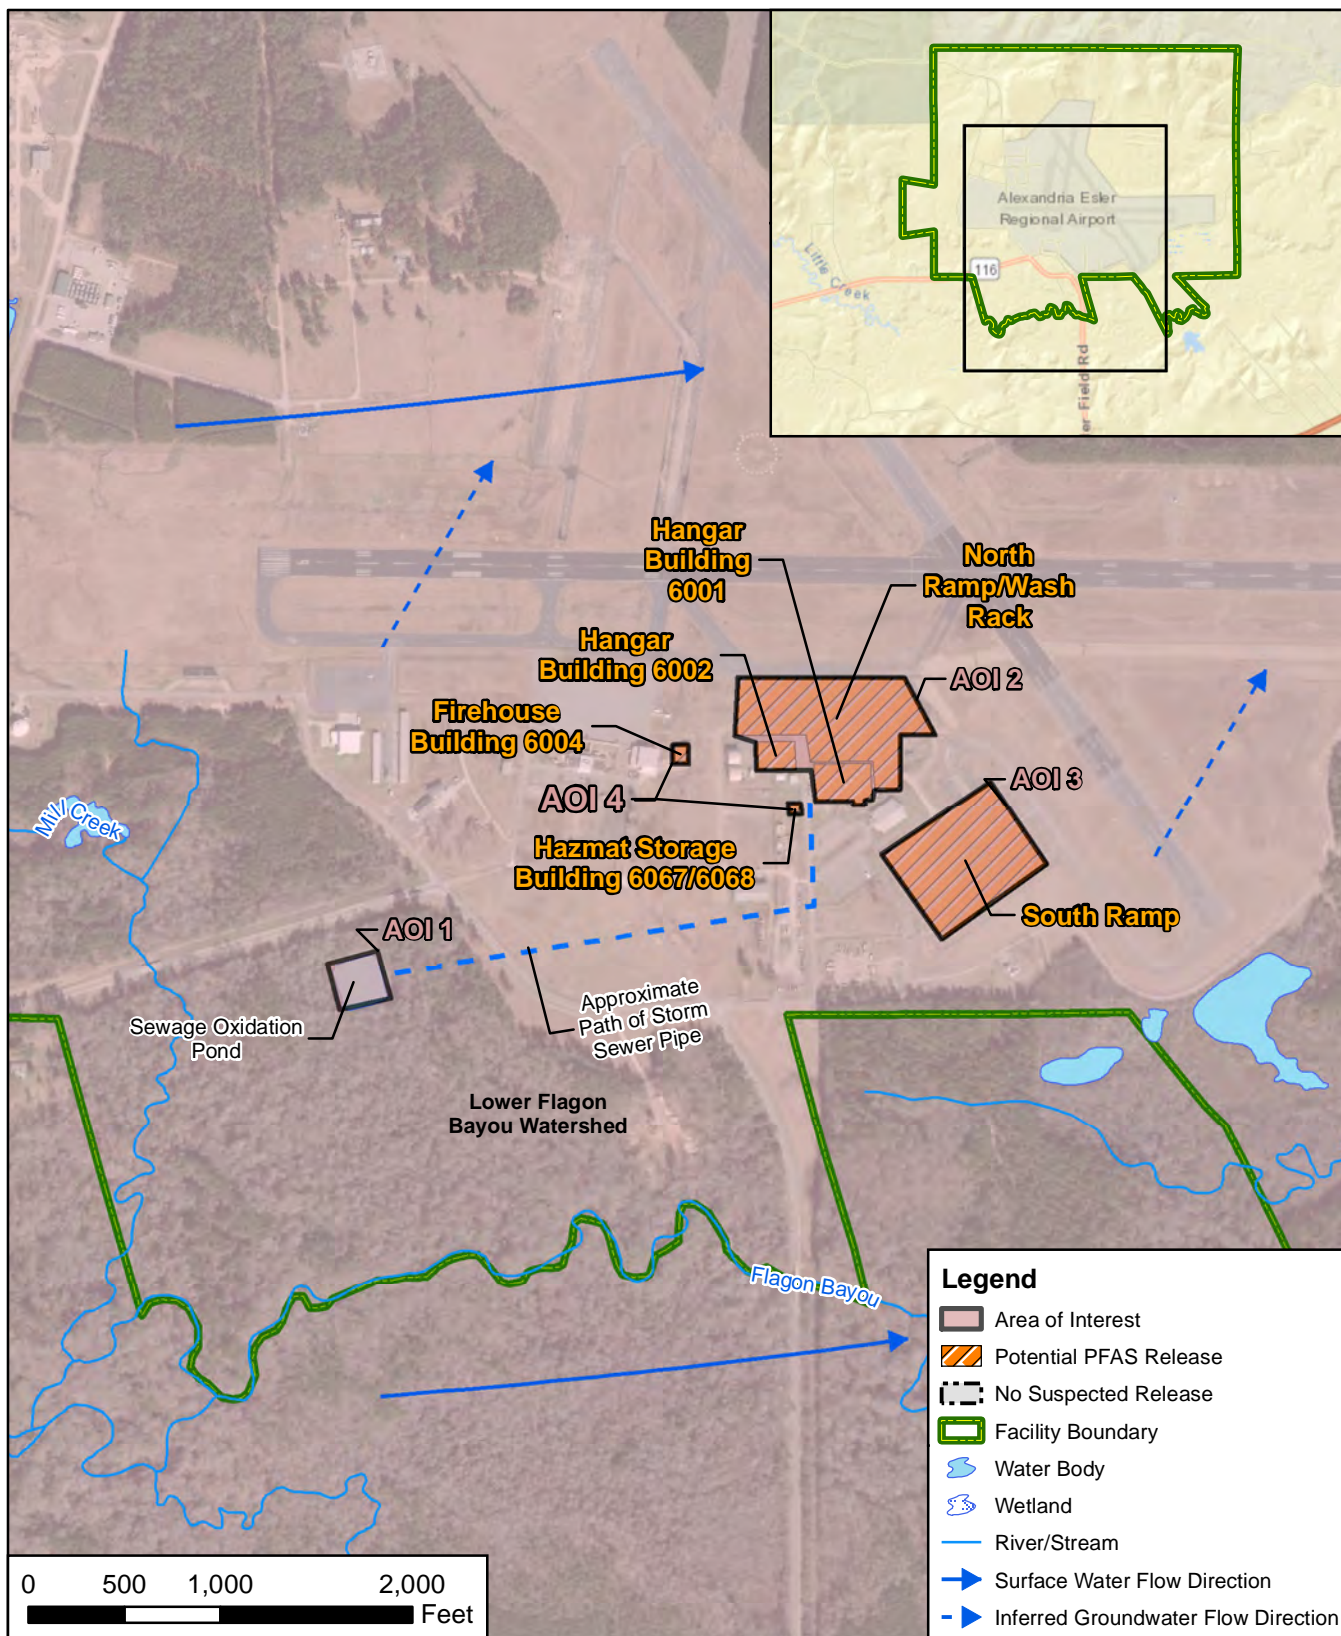
Based on the PA findings, four AOIs were identified at Esler Field AASF: AOI 1 Sewage Oxidation Pond, AOI 2 North Ramp/Wash Rack and Hangar Buildings 6001 and 6002, AOI 3 South Ramp and AOI 4 Firehouse Building 6004 and Hazmat Storage Building 6067/6068. The AOIs are shown on **Figure 6-1**. The following sections describe the CSM components and the specific preliminary CSMs developed for AOIs 1, 2, 3 and 4. The CSM identifies the three components necessary for a potentially complete exposure pathway: (1) source, (2) pathway, (3) receptor. If any of these elements are missing, the pathway is considered incomplete.

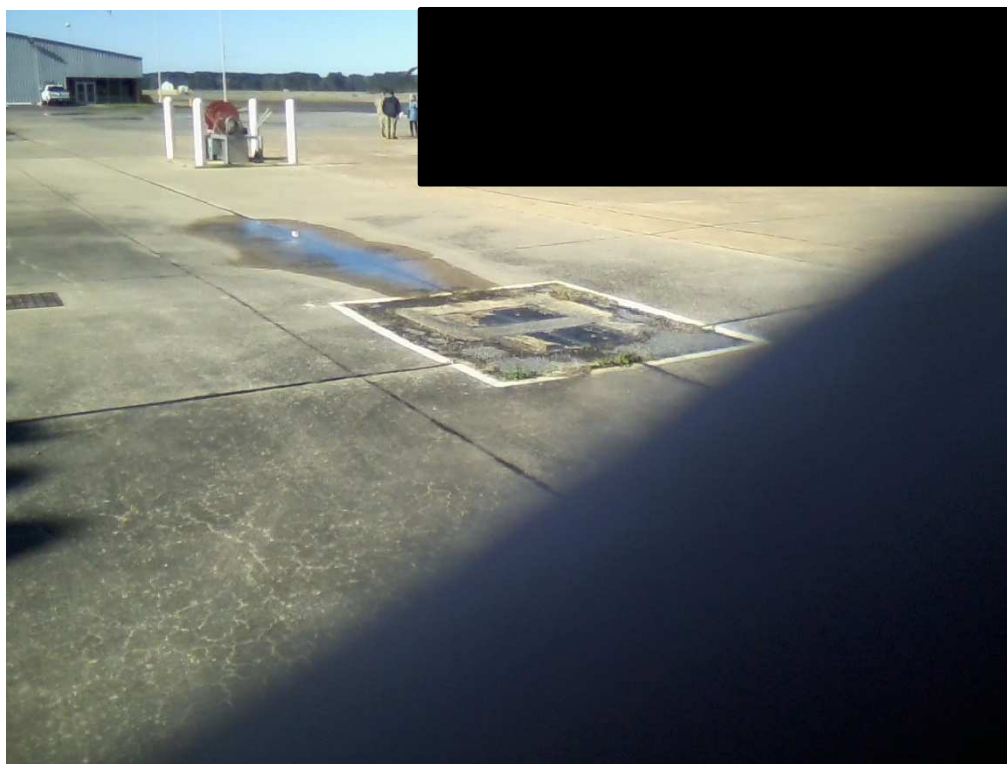
Photo of Wash Rack on north
ramp of Hangar 6001.

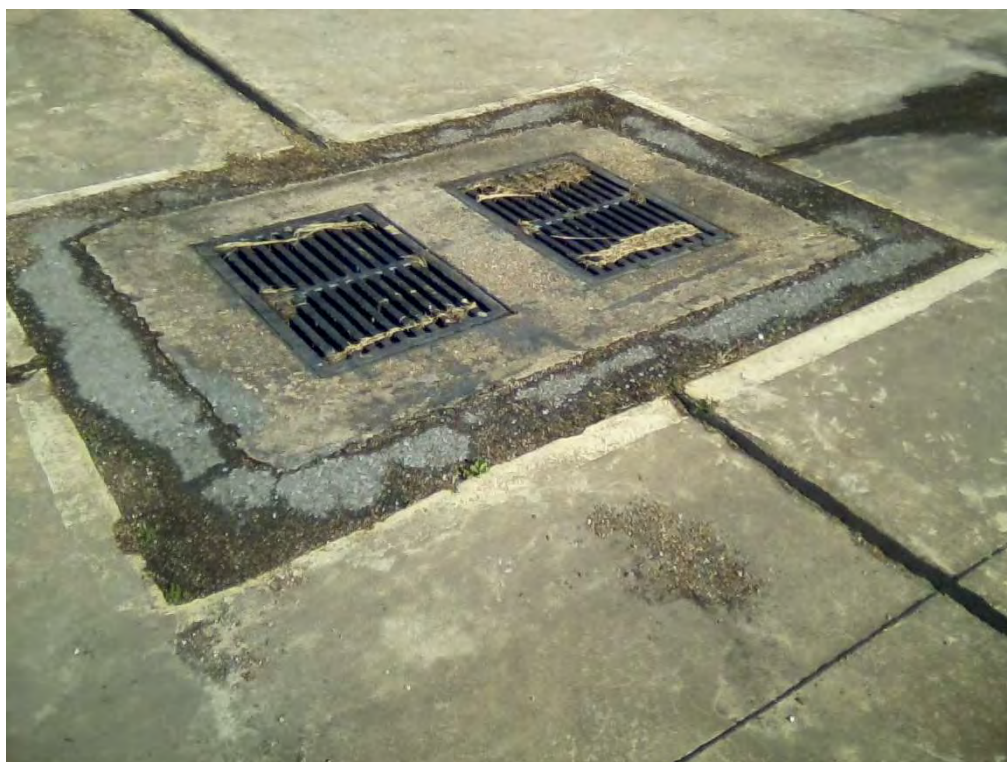
Photograph No. 2

Photo of Wash Rack drains on
north ramp of Hangar 6001.

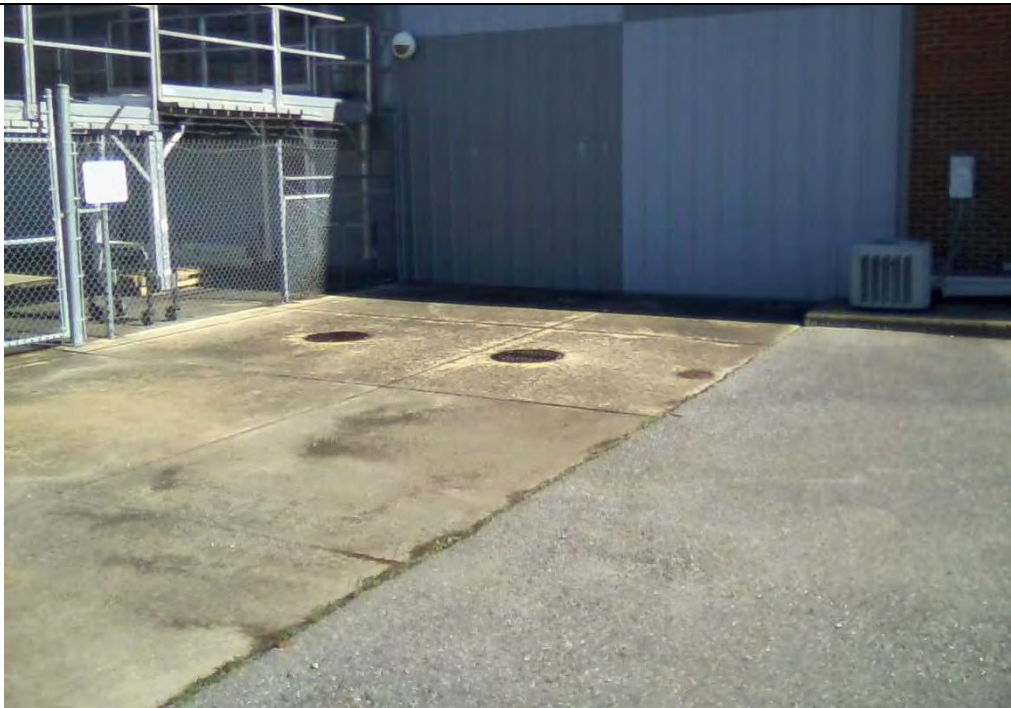
| Photograph No. 3 | |

| Description: Photo of oil/water separator manholes on west-southwest corner of Hangar 6001. Date: 01/24/19 | |

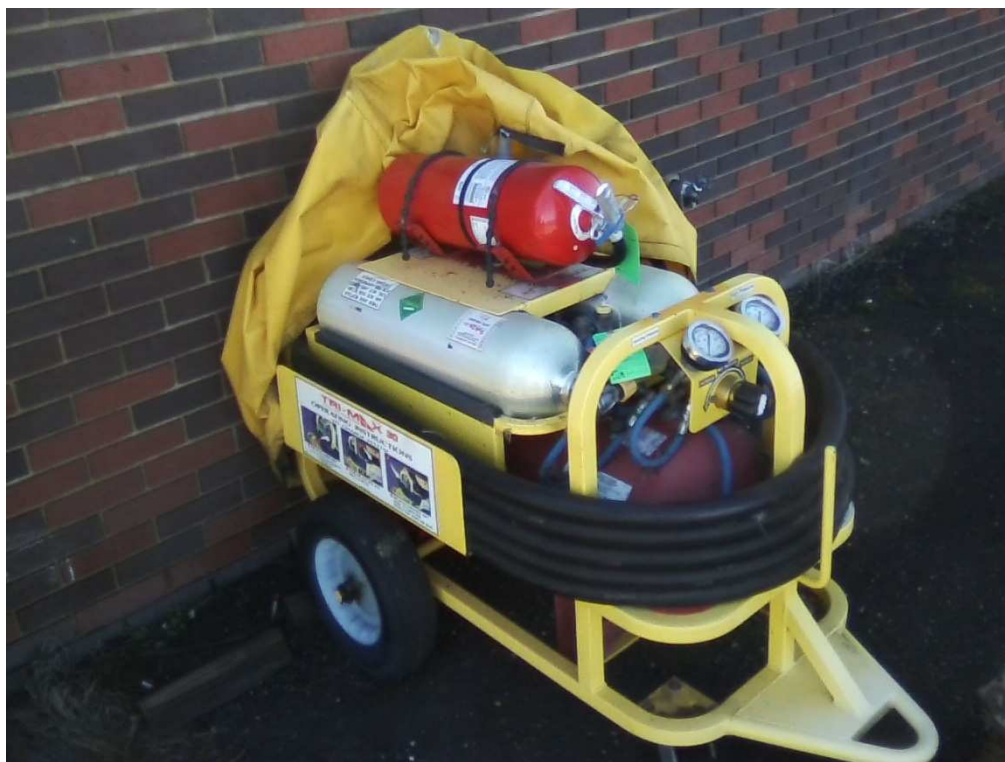
Photo of AFFF fire
extinguisher.

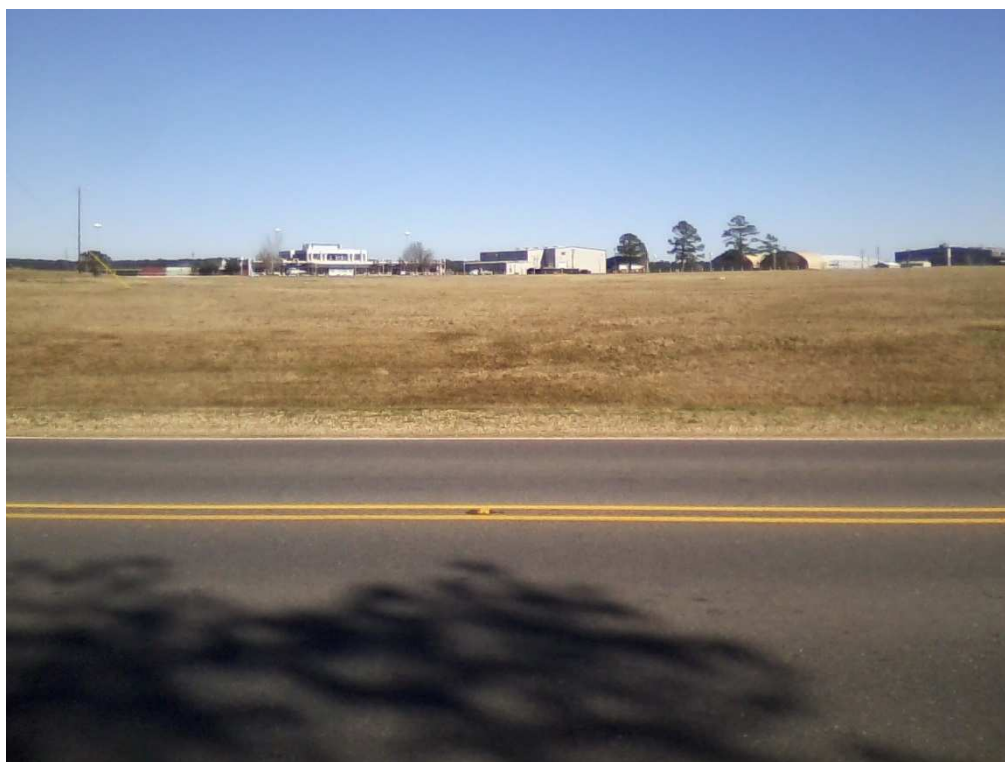
Photograph No. 6

Photo looking west at Esler
Field from entrance to
oxidation pond.
