FINAL Preliminary Assessment Report Weide Army Aviation Support Facility Aberdeen Proving Ground, Maryland

Perfluorooctanesulfonic Acid (PFOS) and
Perfluorooctanoic Acid (PFOA) Impacted Sites
ARNG Installations, Nationwide

September 2020

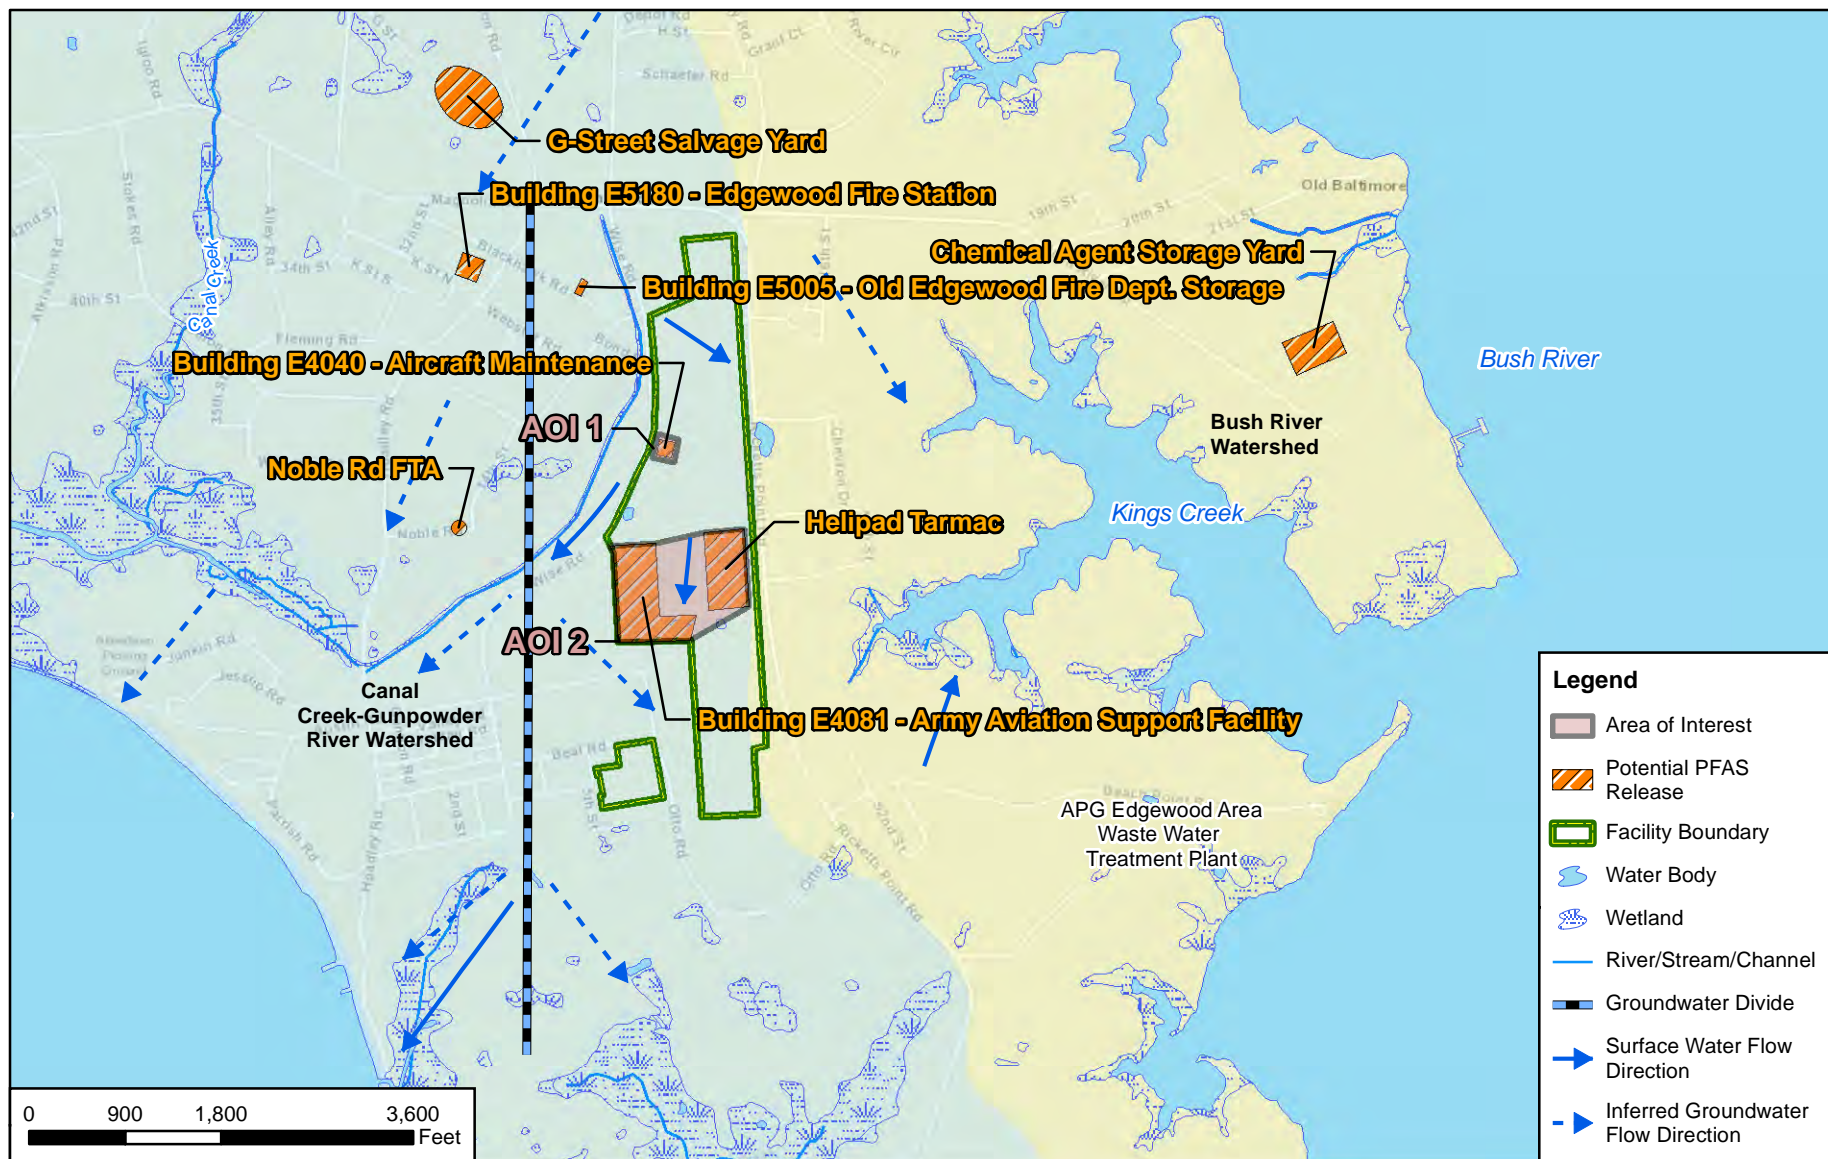
<div>12420 Milestone Center Drive Germantown, MD 20876</div>	Figure 6-1
SCALE	1:21,600	CHK BY	TK	8/26/2019			
Sources: Esri, HERE, Garmin, USGS, Intermap, INCREMENT P, NRCan, Esri Japan, METI, Esri China (Hong Kong), Esri Korea, Esri (Thailand), NGCC, (c) OpenStreetMap		PM	RG	8/26/2019

AOI 1 includes the aircraft maintenance building (hangar), which is located at Building E4040. During interviews, several AFFF releases were reported as this AOI, including a full tank release in 1998, and two pipe leaks in approximately 1998 and 2015. In addition, fire training activities that occurred between the 1970s and 1990s at Building E5005, north of AOI 1, resulted in the release of hundreds to thousands of gallons of AFFF. This off-site source is up-gradient of AOI 1 and may contribute to potential PFAS contamination within this AOI.

During a period from the 1970s until approximately 2012, AFFF was released in several locations surrounding the Weide AASF, including confirmed yearly releases at Building E4081, as well as multiple releases at the heliport tarmac. Based on preliminary data and assumed groundwater and surface water flow directions, these two locations were grouped into one AOI. Thus, AOI 2 comprises both buildings and the space between them.

Area of Interest	AOI Location	Rationale	Potential Future Action
AOI 1 (Aircraft Maintenance, E4040)	39°23'42.50"N; 76°17'36.85"W	Known tank release and pipe leak	Proceed to SI, focus on soil, sediment, and surface water
AOI 2 (Tarmac)	39°23'32.19"N; 76°17'28.90"W (Middle of tarmac)	Historic releases of AFFF across tarmac	Proceed to SI, focus on soil, sediment, and surface water
AOI 2 (AASF, E4081)	39°23'28.69"N; 76°17'38.47"W (Middle of AASF)	Annual releases of AFFF fire suppression system	Proceed to SI, focus on soil, sediment, and surface water

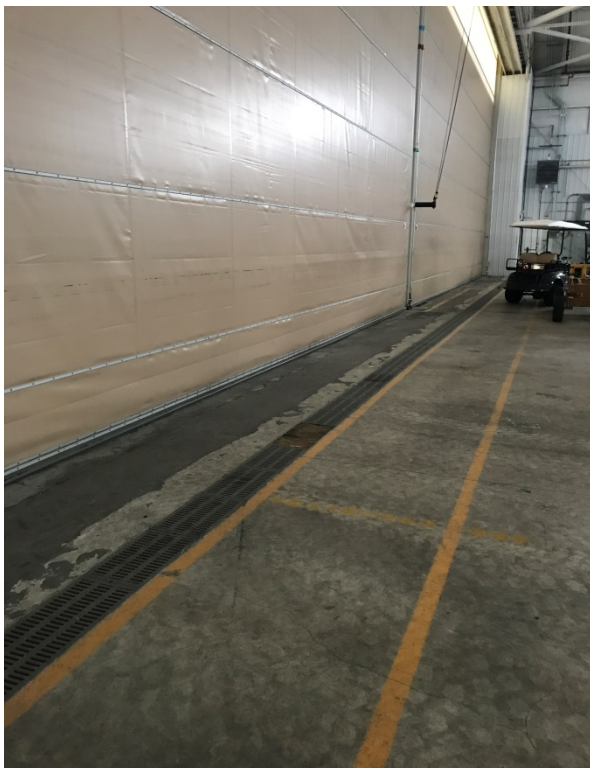
Looking southwest. Closed bay doors located outside of Building E4040.

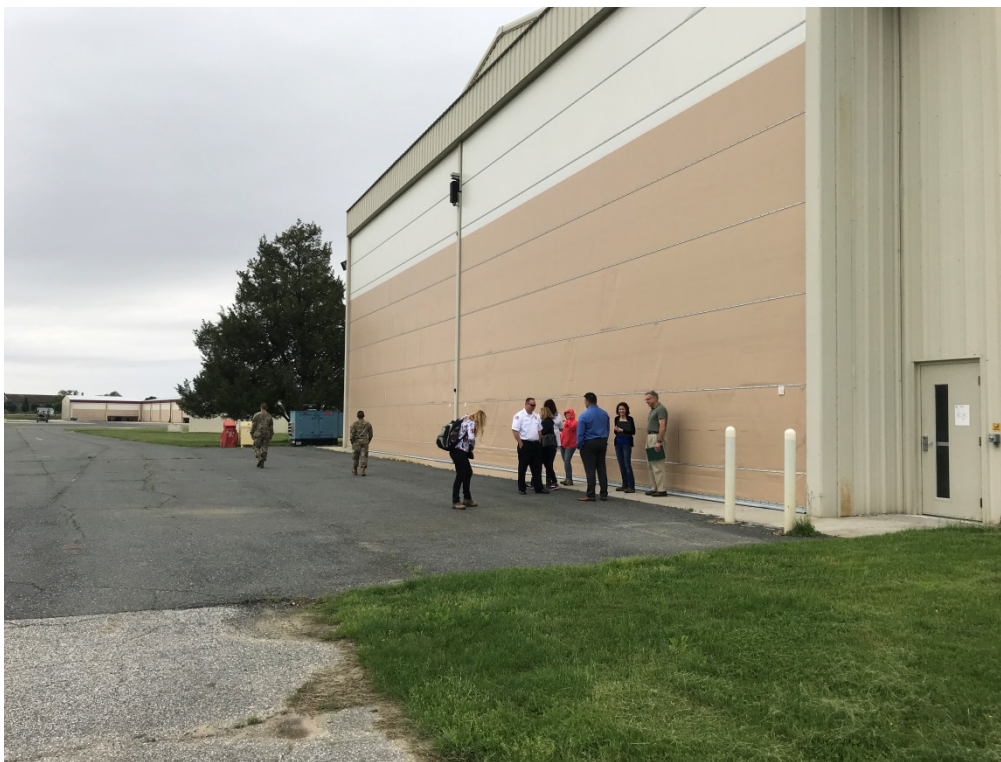
Photograph No. 4

Looking south. Closed bay doors from Building E4040 directly to the right. Arrow in picture indicates location of Building E4081, the other hangar within Weide Army Heliport.

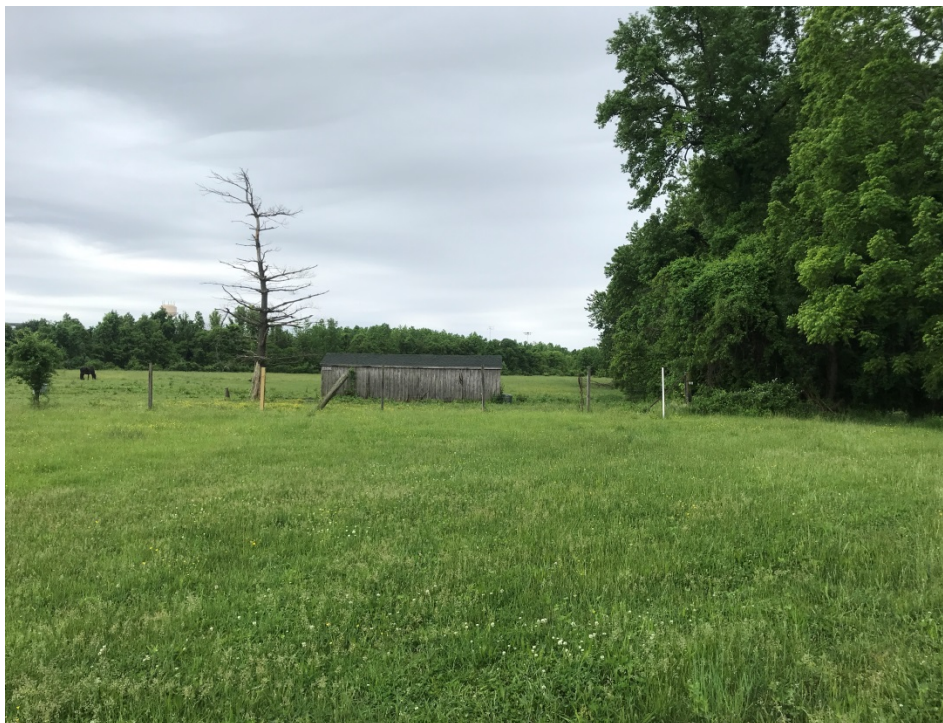
Photograph No. 10

Looking south at location of prior Fire Training Area where two buildings were used at least once a week for fire training when the weather was good. Both buildings and their foundations were removed. Buildings are seen on 2006 aerial photographs; however, they are not seen on the 2013 aerial. Therefore, exact date of removal is unknown.
