Preliminary Assessment Report

Belmont Armory, Michigan

Perfluorooctane-Sulfonic Acid (PFOS) and Perfluorooctanoic Acid (PFOA) Impacted Sites
ARNG Installations, Nationwide

April 2020

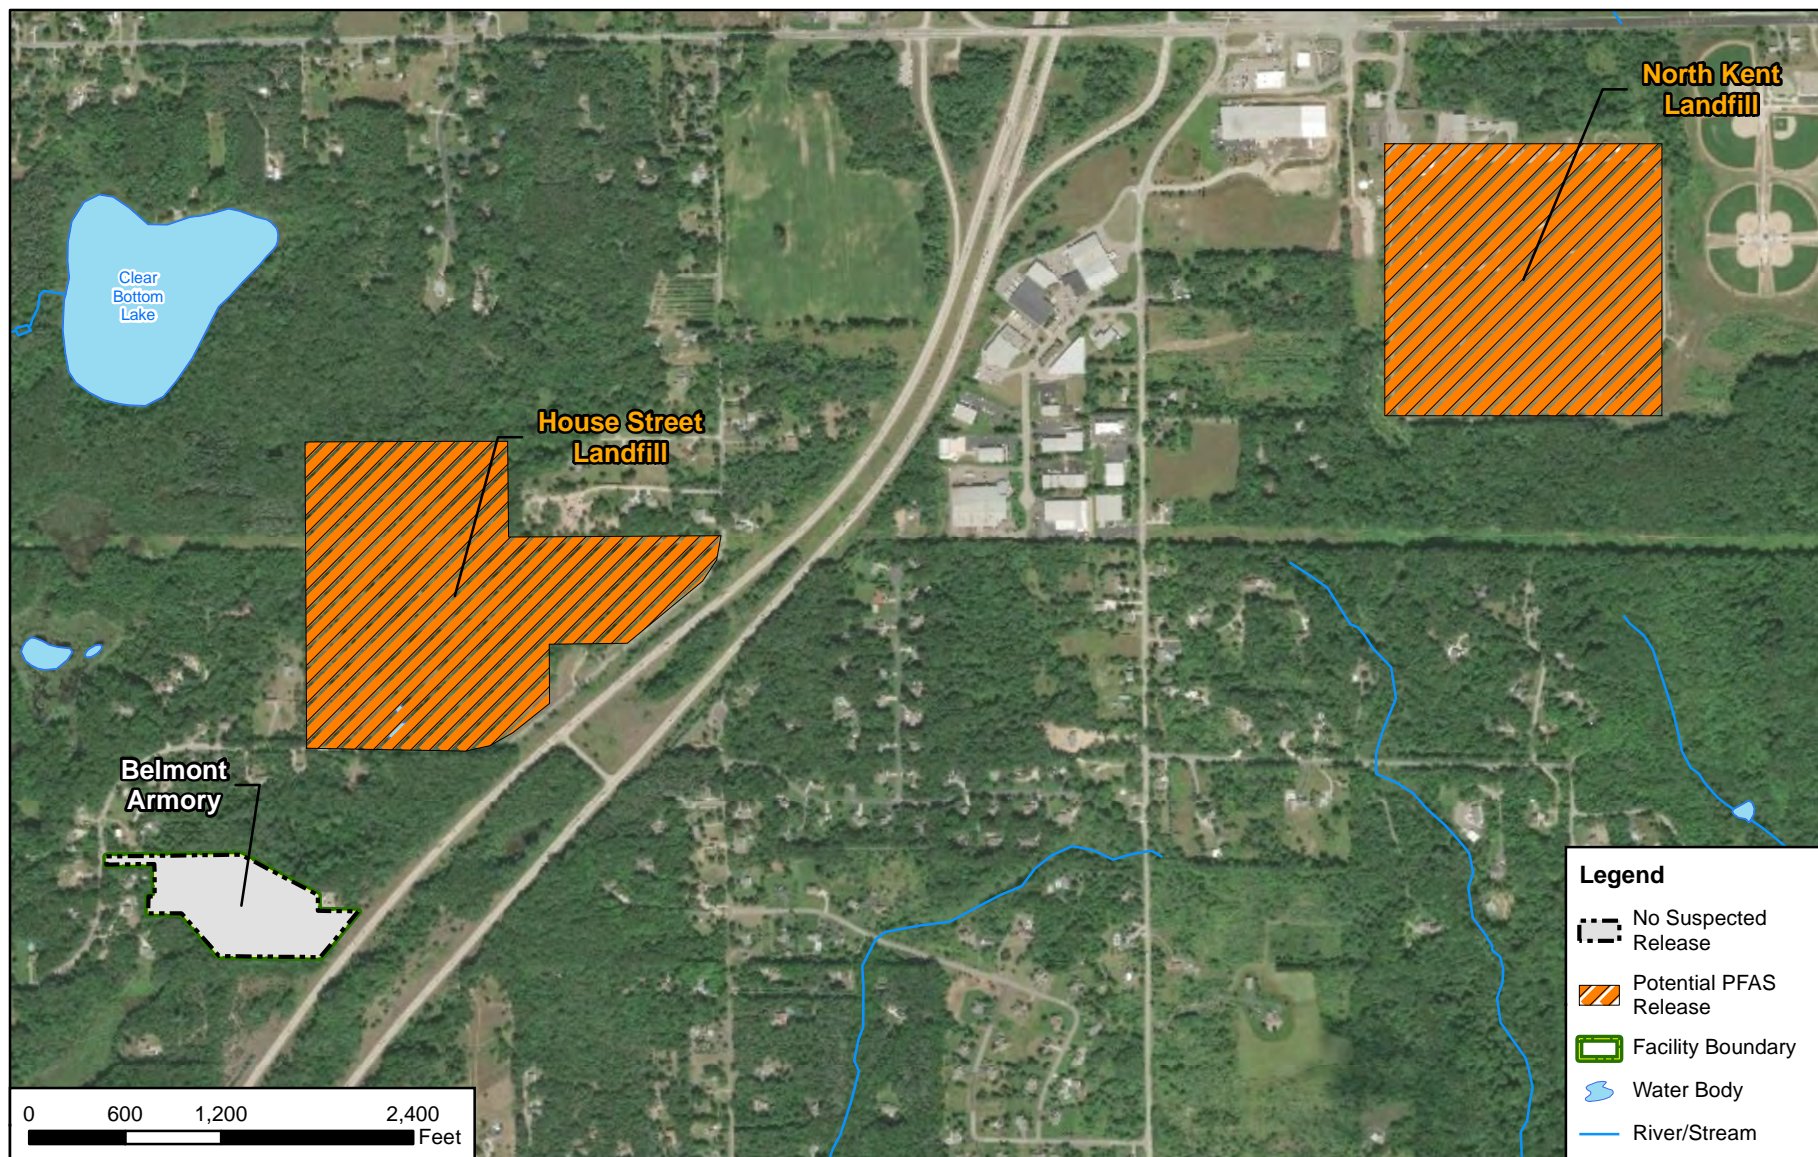
12420 Milestone Center Drive Germantown, MD 20876	Figure ES-1

Two off-facility former landfills located adjacent to the Belmont Armory have been identified as potential PFAS sources (**Figure ES-1**). Both landfills were formerly used by Wolverine World Wide, Inc. to dispose of industrial wastes generated from the production of water resistant consumer products. PFAS have been confirmed in groundwater/drinking water at Belmont Armory and private wells located in adjacent communities and complete exposure pathways exist for PFAS contamination in groundwater in association with the two former off-facility landfills. Both off-facility PFAS sources were identified through interviews with Belmont Armory personnel, independent research, and the 2018 Environmental Data Resource (EDR) Report. Interviews were not conducted with landfill staff and the site visit did not include visiting the landfills.

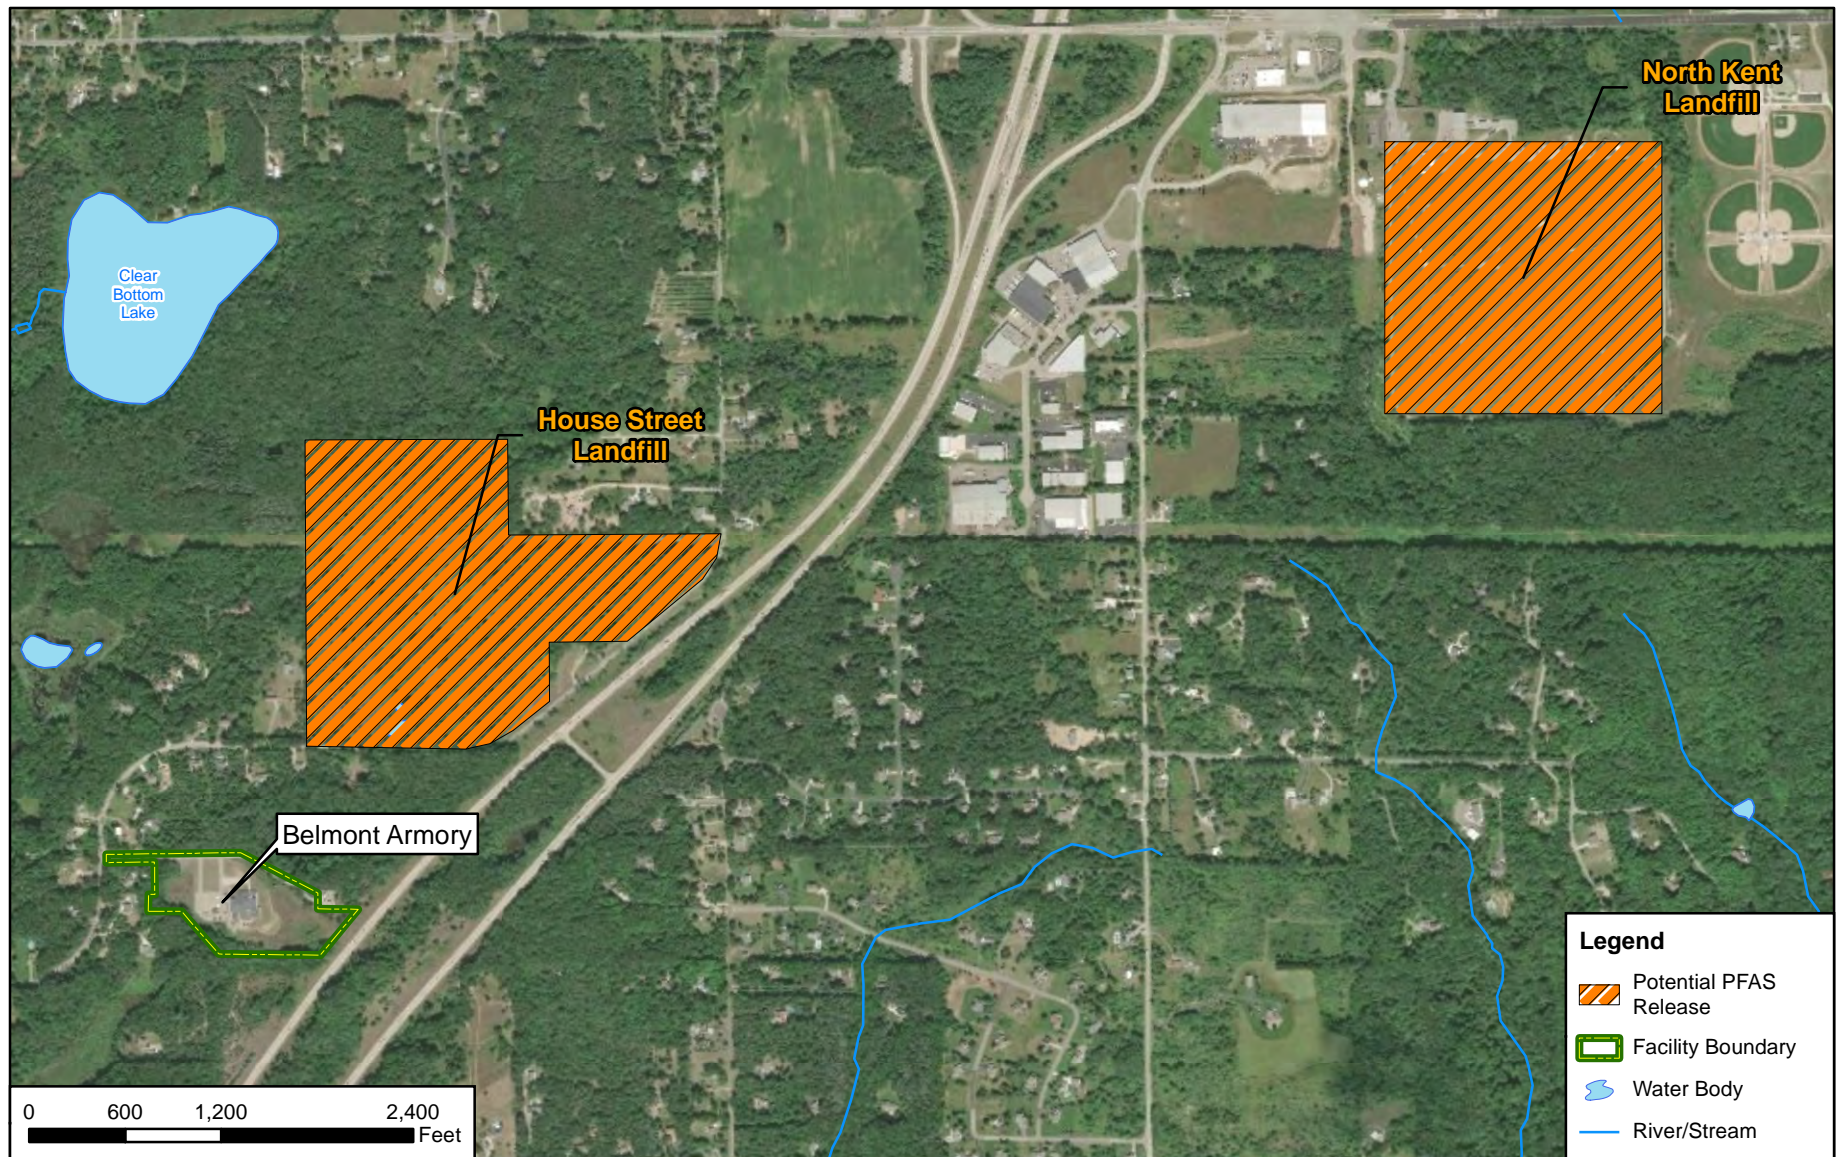
12420 Milestone Center Drive Germantown, MD 20876		Figure 5-1

Located approximately 2,000 feet northeast of Belmont Armory is a landfill formerly used by Wolverine Worldwide, Inc. (Wolverine). This property was used during the mid-1960s as a licensed landfill for the disposal of solid waste. Wolverine disposed of industrial wastes generated from the production of water resistant consumer products, specifically, lime-sludge wastes from the treatment of tanning wastes generated by the nearby Rockford tannery. Lime slurry wastes were also disposed of in trenches dug across the property; seepage pits, on the property were used for disposing of lime liquor (a mixture of lime, water, dissolved protein, and fat), and other liquid wastes (State of Michigan, 2018). The landfill is located hydraulically upgradient of the armory, at the following geographic coordinates 43° 6'24.47"N and 85°37'17.96"W.

Wolverine and the Michigan Department of Environmental Quality (MDEQ) began sampling drinking water in April 2017 after citizens expressed concern regarding landfill impacts (State of Michigan, 2018). During PA interviews, a former armory manager confirmed that the drinking water well for the armory was tested for PFAS in May 2017. Well water at the armory was found to contain PFAS compounds above the combined USEPA health advisory level of 70 ppt. The combined concentration of PFOA and PFOS was 96.9 ppt and total PFAS was 421.5 ppt; the armory was switched to bottled water at that time. Wolverine and MIARNG worked in conjunction with MDEQ to install a two-stage activated carbon treatment system for the armory's groundwater well, which has been in operation since October 2018 and is currently being monitored for effectiveness. Wolverine and MDEQ have subsequently expanded drinking water sampling within the surrounding communities; PFAS has been found in drinking water above the combined USEPA health advisory level in private wells at numerous homes.

The North Kent (Ten Mile) Landfill, located approximately 1.5 miles northeast of the Armory (geographic coordinates 43° 6'45.76"N and 85°35'44.53"W), was also identified as having received several years' worth of tannery sludge from the Wolverine facility during the 1980s. Monitoring wells at the sampled in December 2017 by MDEQ found PFAS compounds above the combined USEPA health advisory level. An investigation of the area surrounding the landfill is currently being led by MDEQ (Kent County Health Department, 2018).

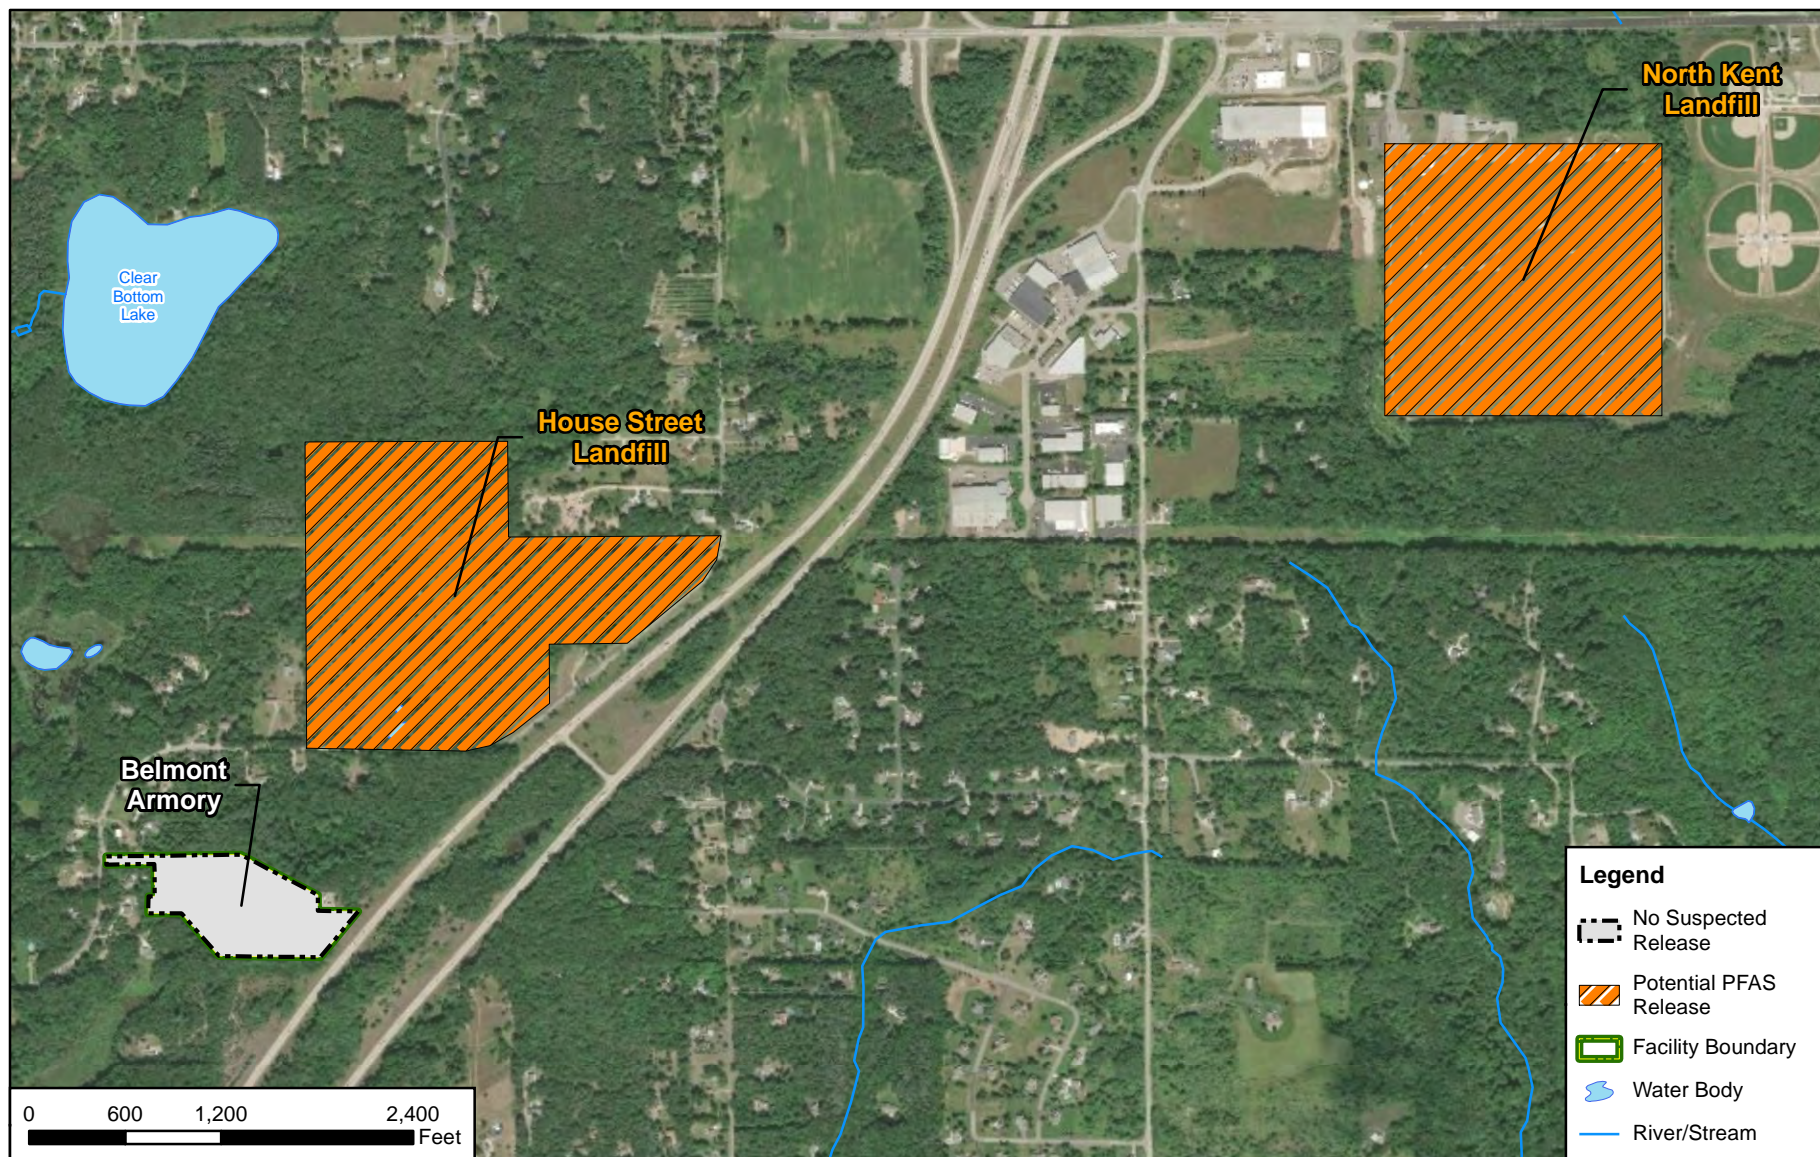
12420 Milestone Center Drive Germantown, MD 20876	Figure 7-1

Two off-facility former landfills located adjacent to the Belmont Armory have been identified as potential PFAS sources (**Figure 7-1**). Both landfills were formerly used by Wolverine World Wide, Inc. to dispose of industrial wastes generated from the production of water resistant consumer products. PFAS have been confirmed in groundwater/drinking water at Belmont Armory and private wells located in adjacent communities and complete exposure pathways exist for PFAS contamination in groundwater in association with the two former off-facility landfills. Both off-facility PFAS sources were identified through interviews with Belmont Armory personnel, independent research, and the EDR Report. Interviews were not conducted with landfill staff and the site visit did not include visiting the landfills. Off-site investigations at these adjacent sources are ongoing by others.

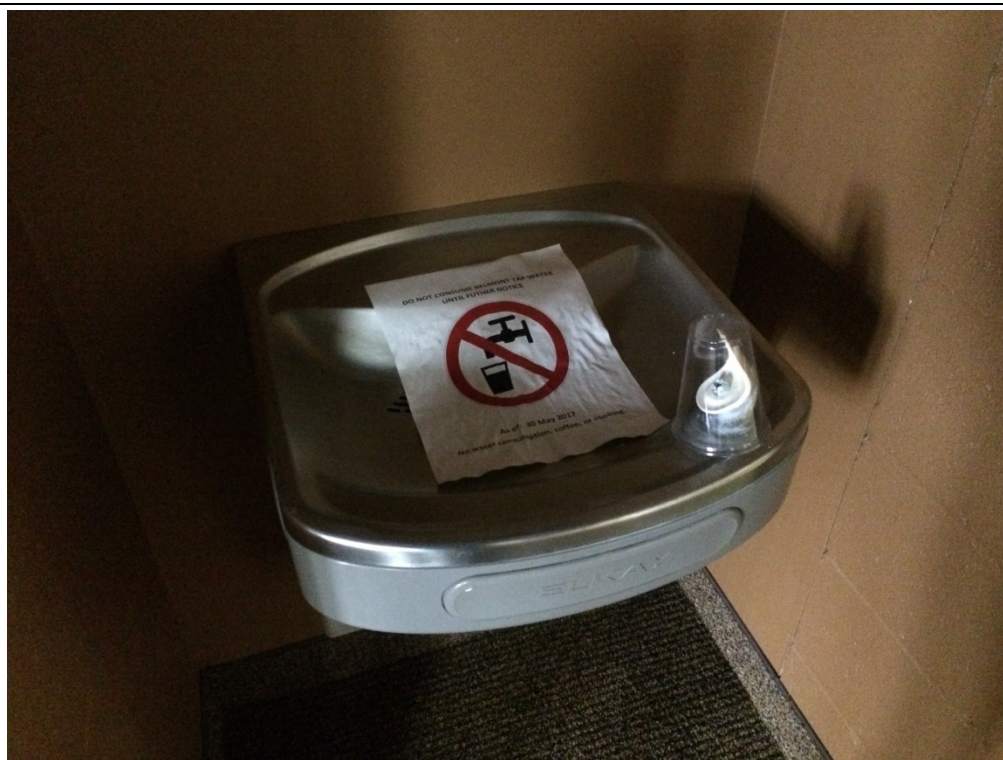
No drinking sign posted to water fountain inside Belmont Armory. Sign reads:

“Do Not Consume Belmont Tap Water Until Further Notice; As of: 30 May 2017; No water consumption, coffee, or cooking.”

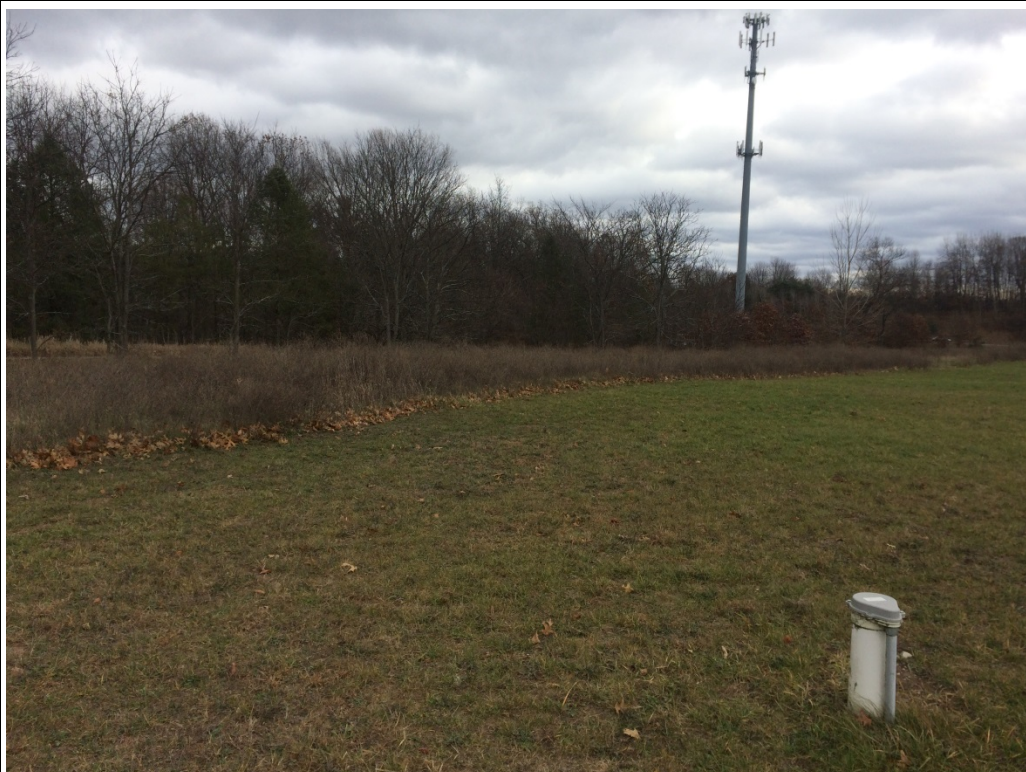
Photograph No. 2

Potable well at the Belmont Armory facility located north of the armory building. View facing east.

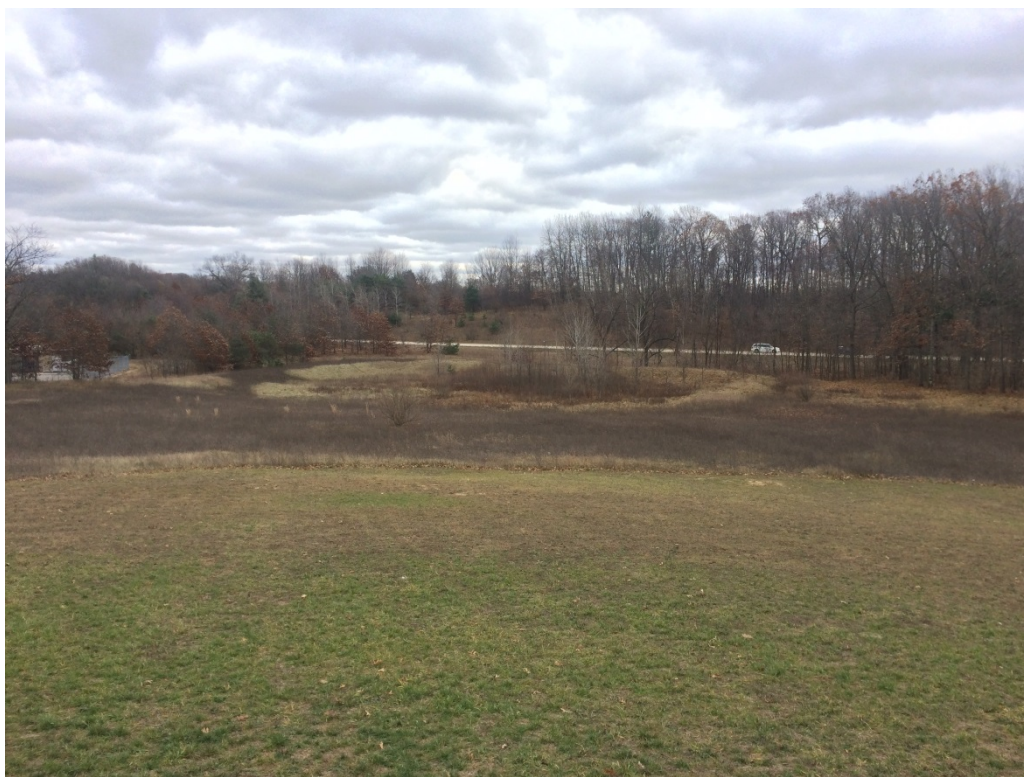
Stormwater retention pond
east of Belmont Armory.
Highway (US-131) visible in
background.

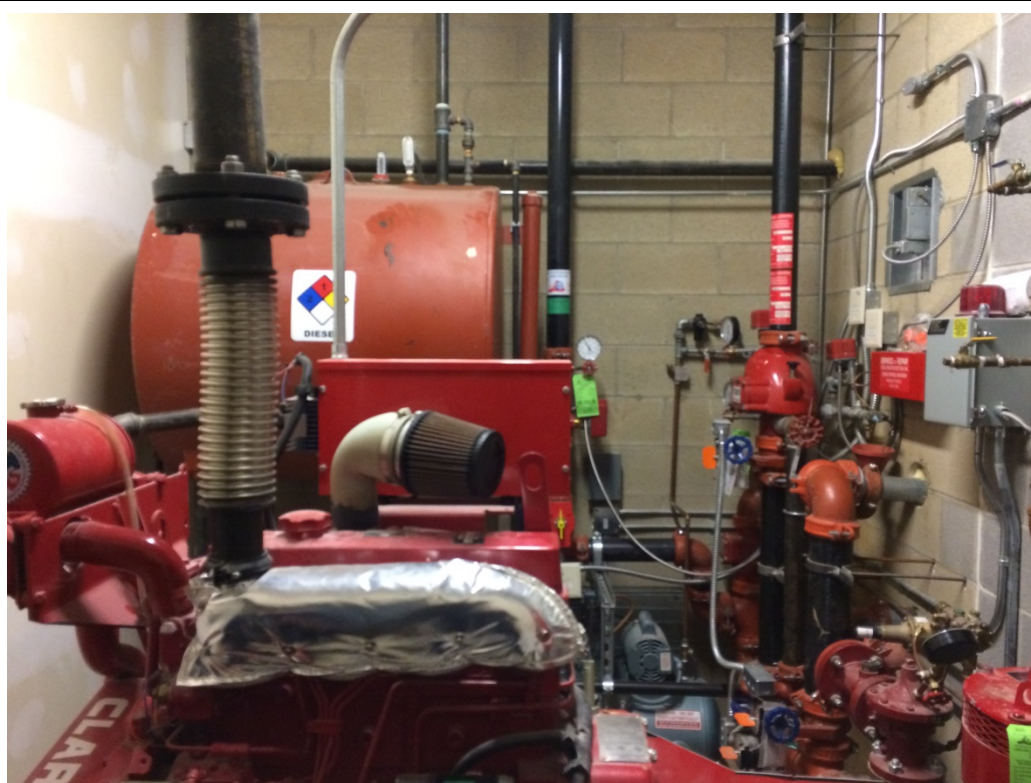
Photograph No. 4

Diesel generator powered
water sprinkler system at
Belmont Armory.
