Preliminary Assessment Report

1108th Theatre Aviation Sustainment Maintenance Group (TASMG), Gulfport, Mississippi

Perfluorooctanesulfonic Acid (PFOS) and Perfluorooctanoic Acid
(PFOA) Impacted Sites
ARNG Installations, Nationwide

September 2020

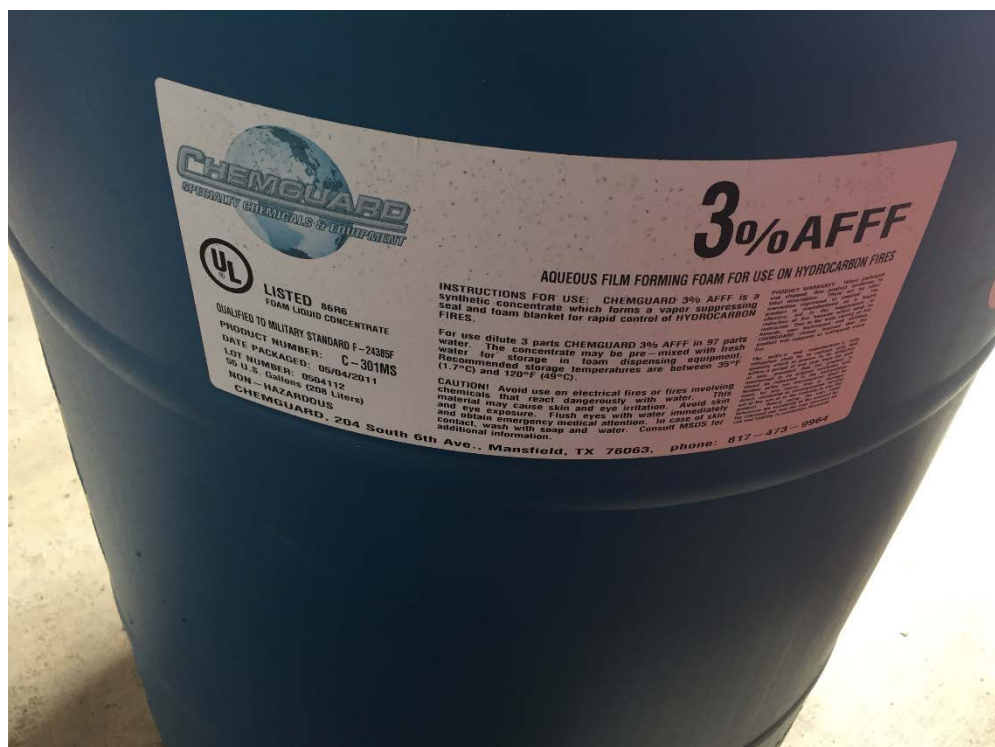
55-gallon drum of AFFF staged
 in the Main Hangar Fire
 Suppression System utility
 room.

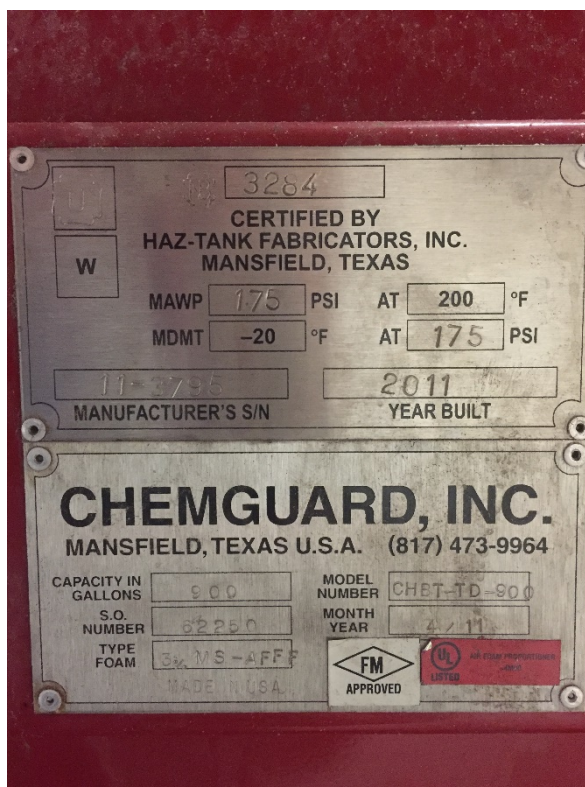
Photograph No. 2

Label on Main Hangar Fire
 Suppression System tank.

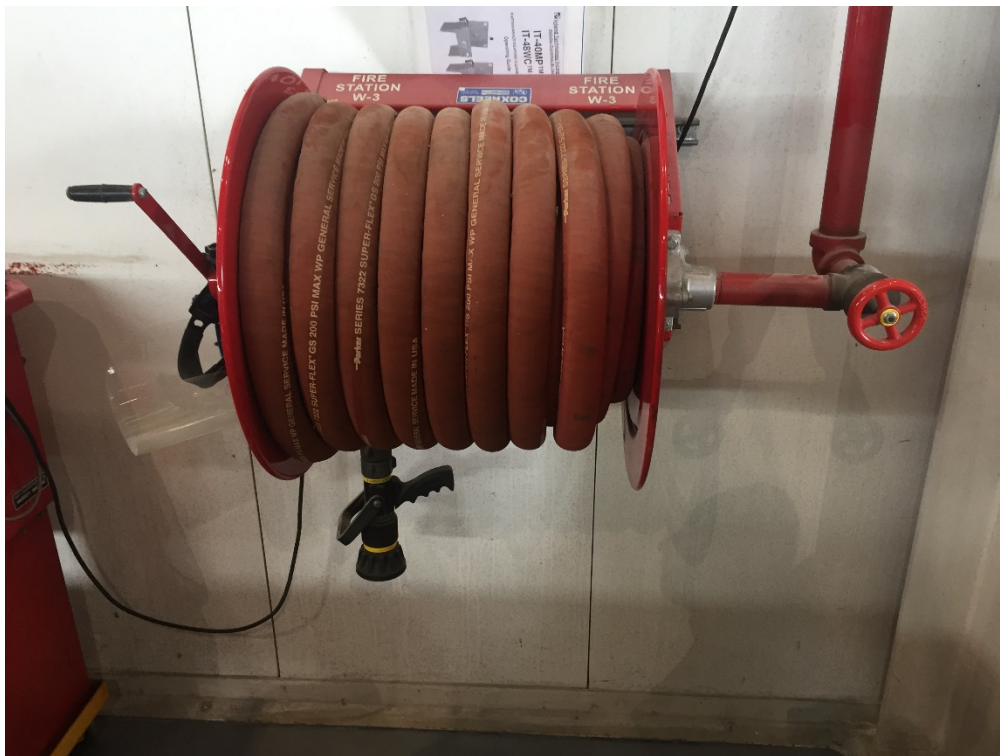
Hose for Fire Suppression
System in Main Hangar.

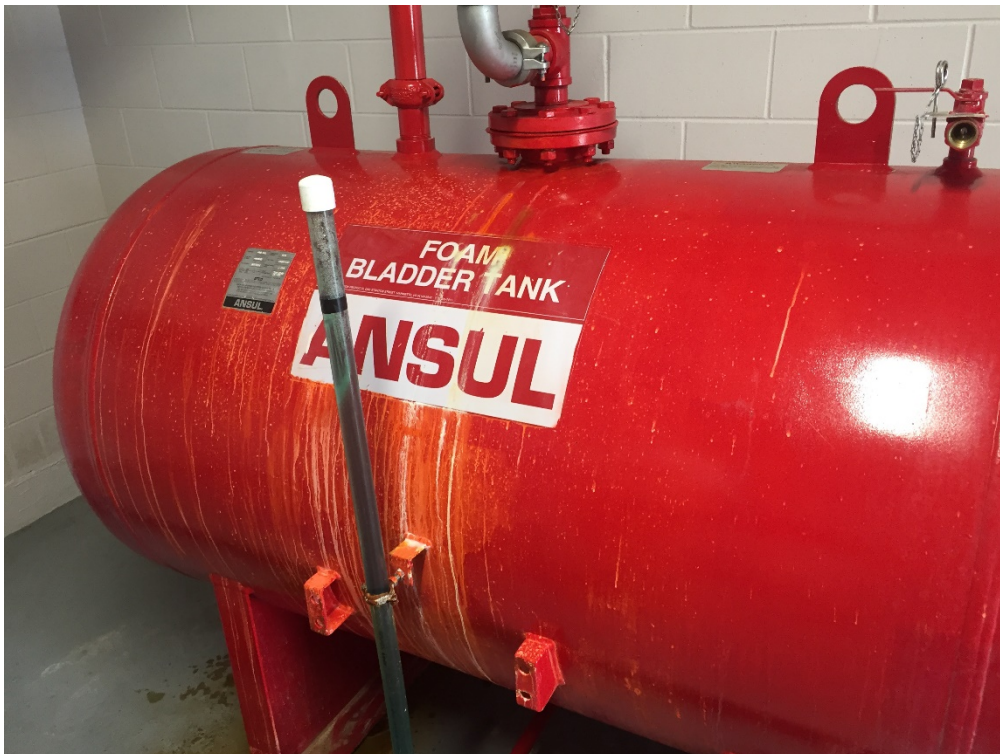
Photograph No. 4

400-gallon tank of Ansul
Jet-X foam which charges
the Paint Hangar Fire
Suppression System.

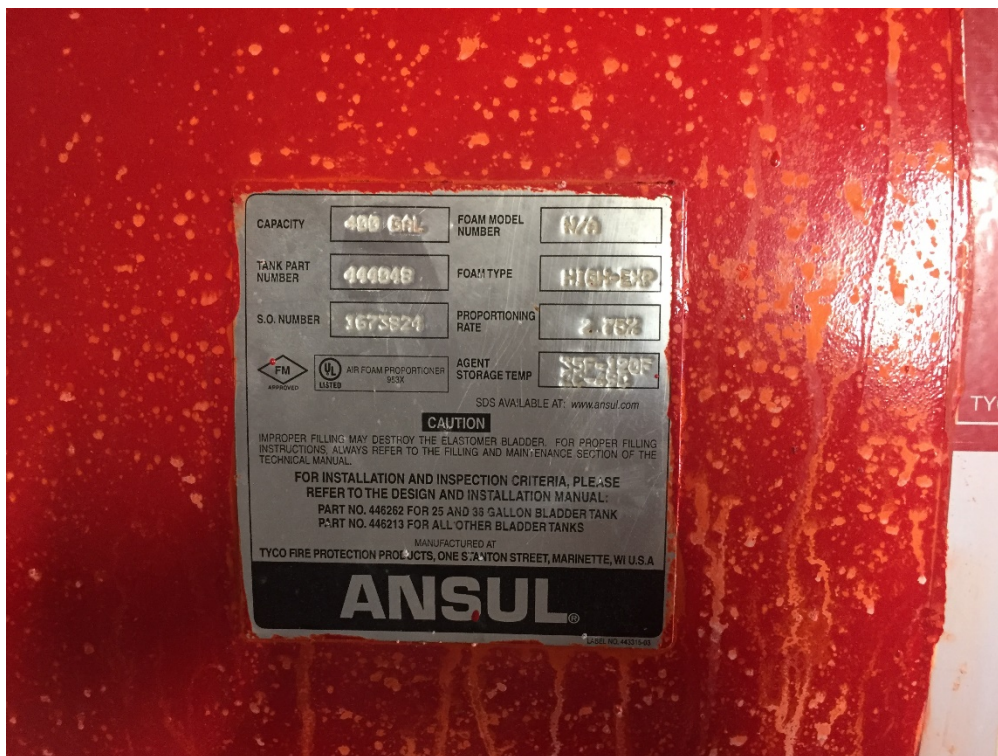
Label on Paint Hangar Fire Suppression System tank.

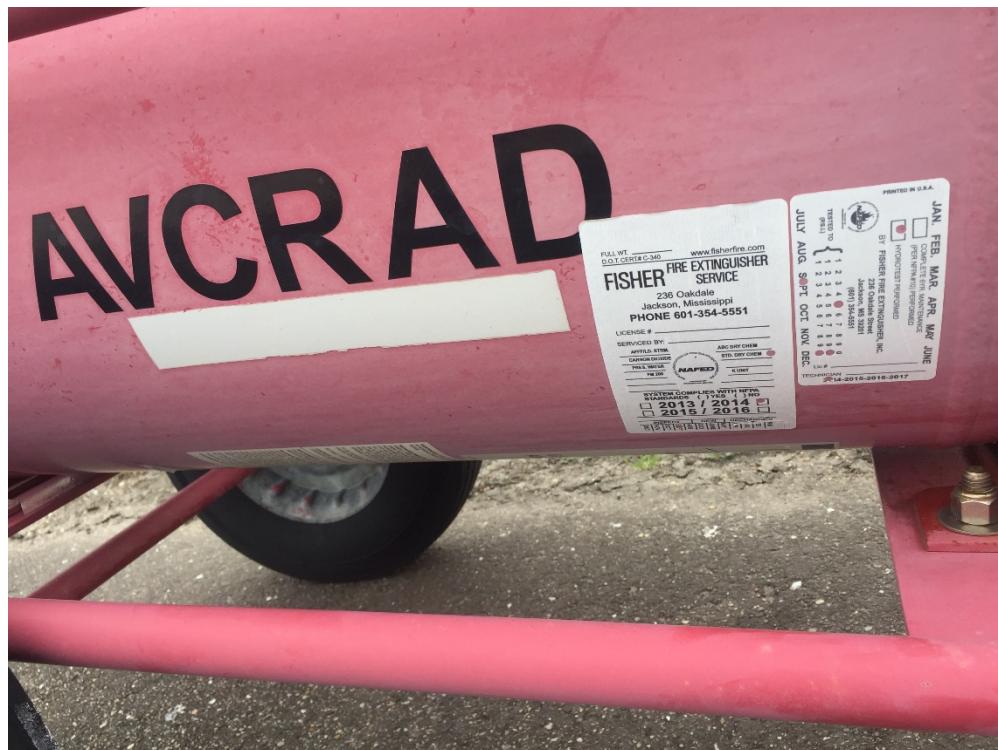
Photograph No. 6

Dry chemical extinguishers on the flight line outside the Main Hangar.
