# FINAL Preliminary Assessment Report Army Aviation Support Facility, Helena, Montana

Perfluorooctane-Sulfonic Acid (PFOS) and Perfluorooctanoic Acid (PFOA) Impacted Sites ARNG Installations, Nationwide

October 2018

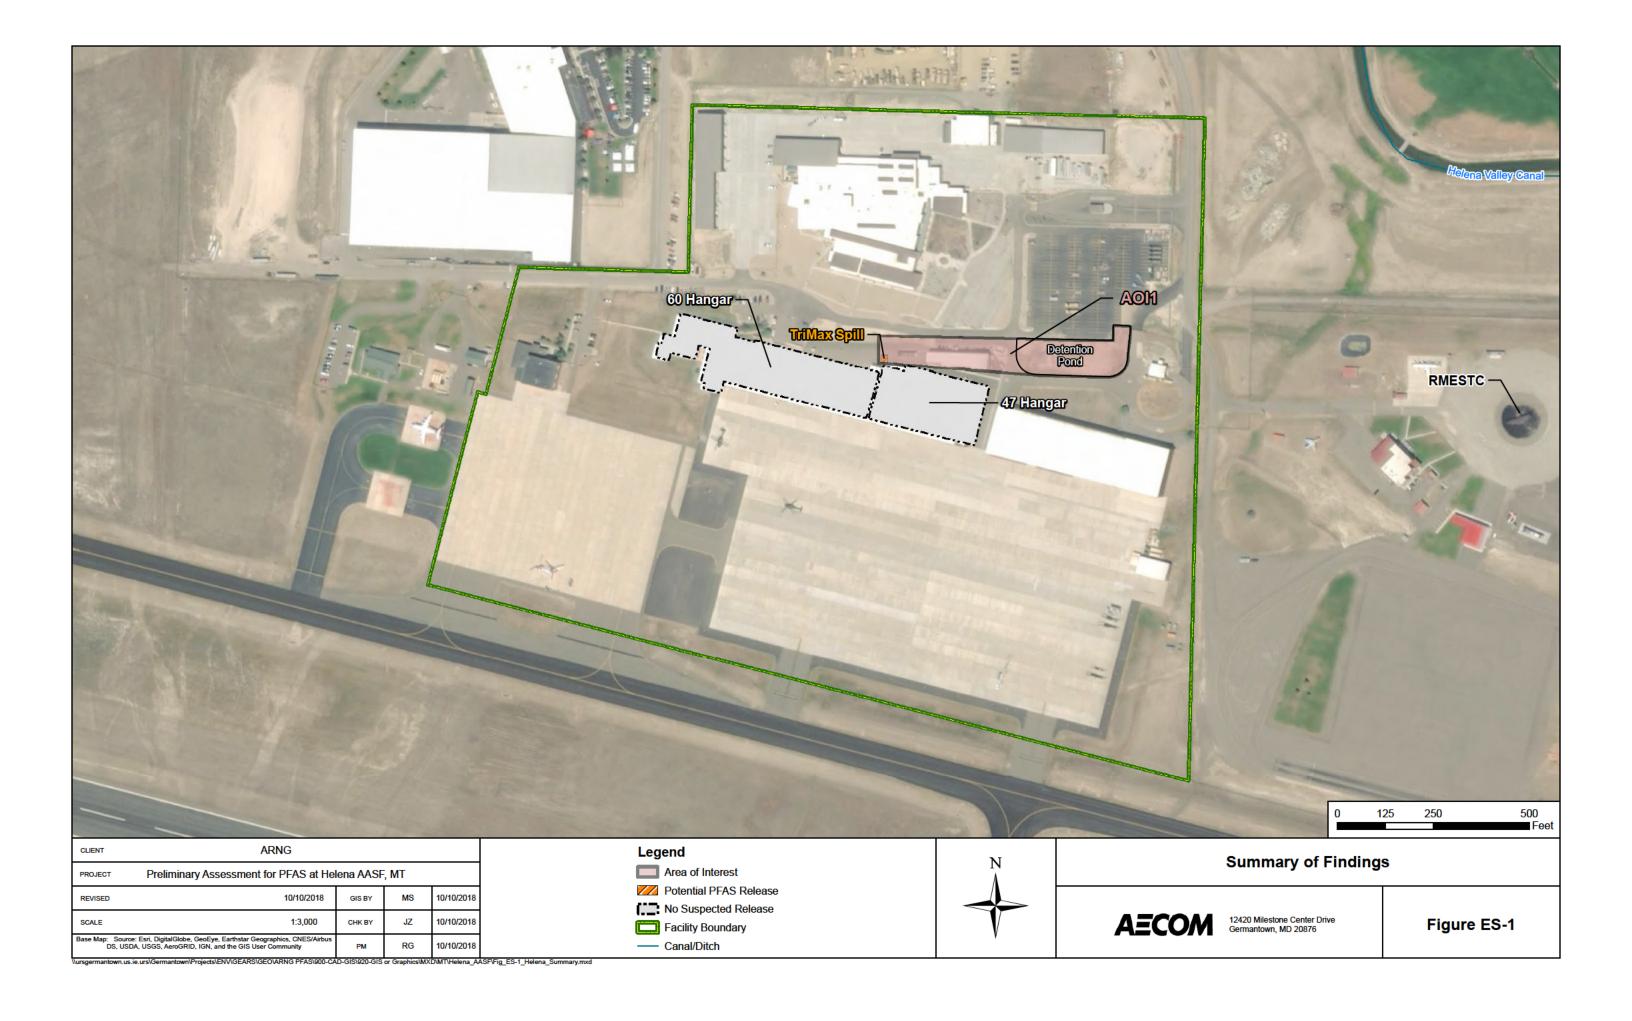
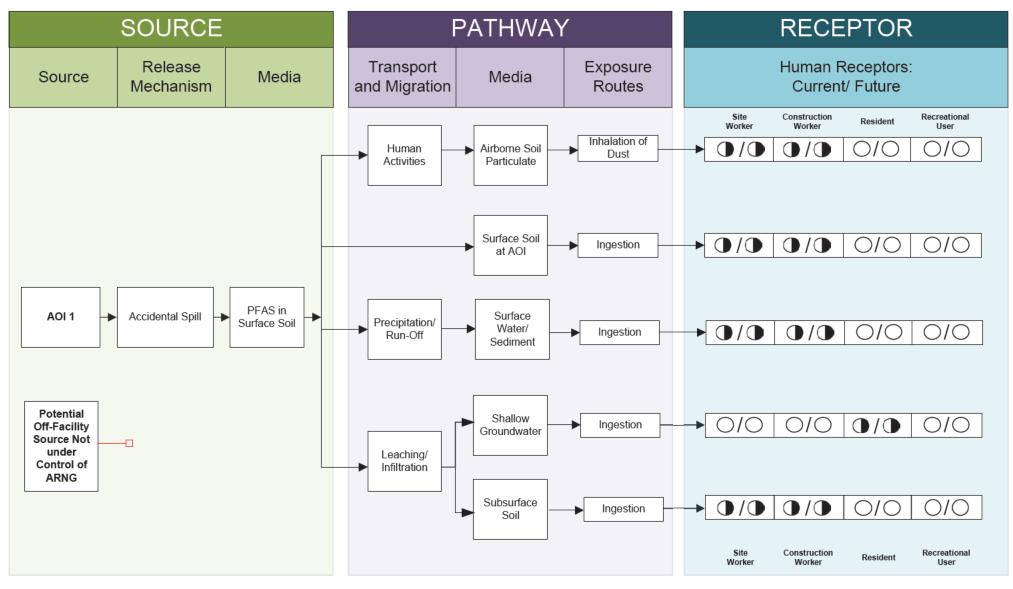
Figure ES-2
Conceptual Site Model
Current Helena AASF

Based on a potential PFAS release at this AOI, there is potential for exposure to PFAS contamination in surface soil and intermittent surface water and sediments to site and construction workers via ingestion and inhalation of dust, subsurface soil to site and construction workers via ingestion, and groundwater to off-facility residents via ingestion. Potential off-facility PFAS release areas exist adjacent to the current Helena AASF. Because these areas include property upgradient of the facility, it is unknown whether or not the off-facility sources effect the current Helena AASF. The CSM for the current Helena AASF is shown on Figure ES-2.

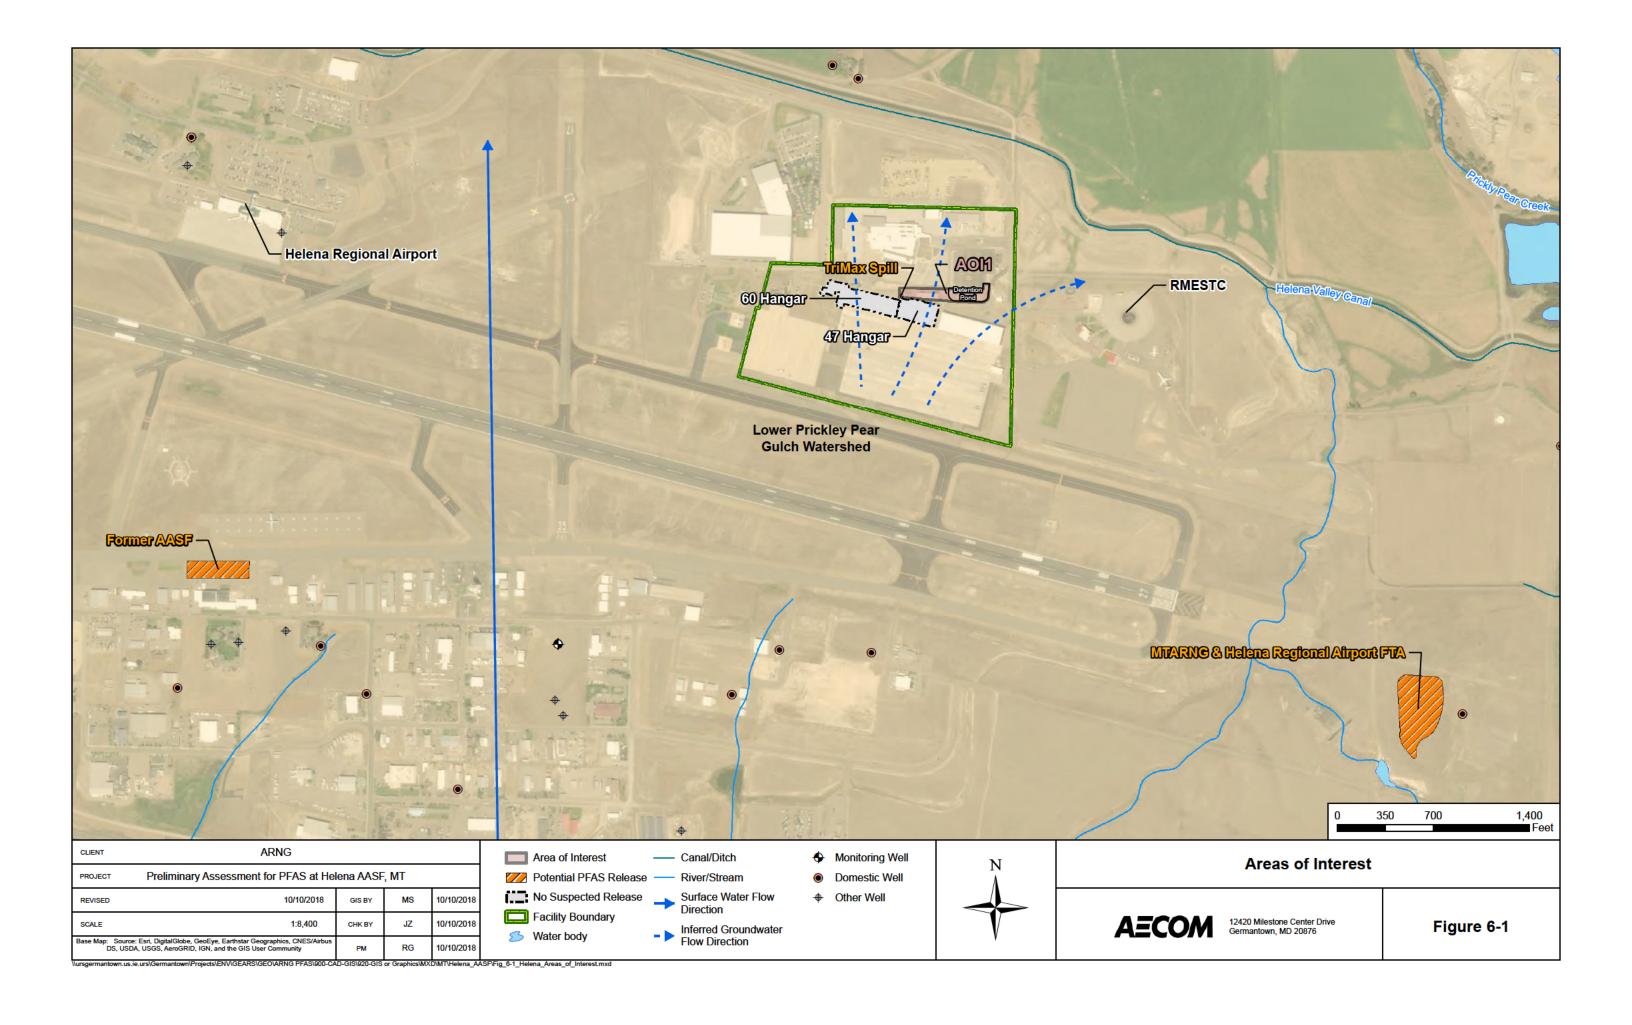
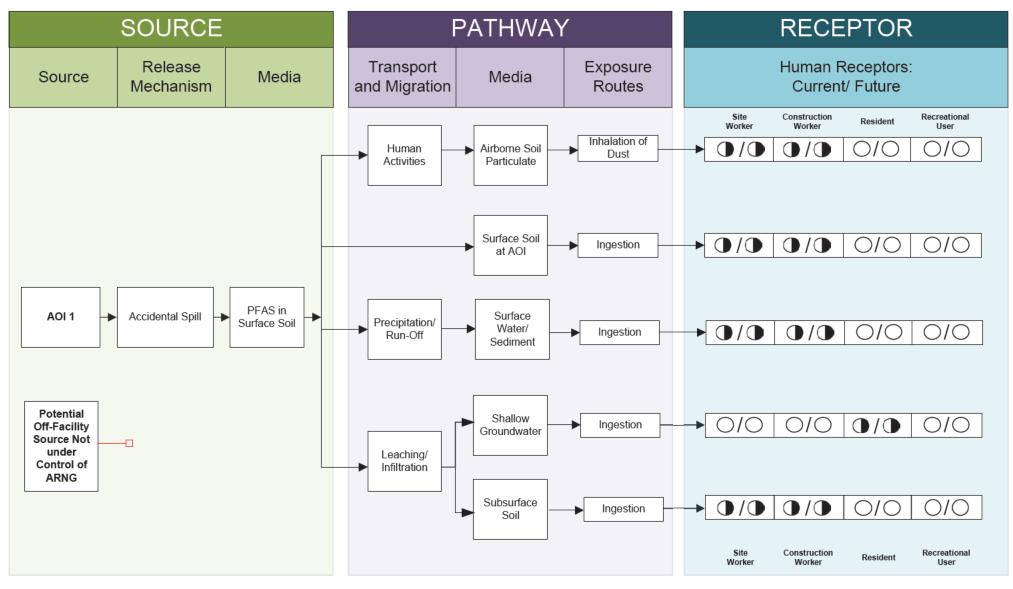
Figure 6-2
Conceptual Site Model
AOI 1 TriMax Spill Area

AOI 1 is the TriMax Spill Area. PFAS was potentially released once to the concrete surface at AOI 1 by the MTARNG in the early 2000s. During filling of fire extinguishers, a 5-gallon jug of TriMax 30 spilled onto the concrete behind the most eastern end of the 60 Hangar. The spilled TriMax 30 possibly ran into a drain that empties into a detention pond to the northeast of the 47 Hangar.

The detention pond is approximately 3 feet deep and collects runoff from most of the facility, including industrial stormwater runoff. Drainages have been diverted around the current AASF and unprocessed surface water is not used in the area, except for irrigation. Drinking water is supplied by the City of Helena; however, domestic wells are located downgradient of AOI 1 within four miles of the current AASF.

Ground-disturbing activities to surface soil and intermittent surface water and sediment at AOI 1 in and construction worker exposure site to potential contamination. Therefore, the exposure pathways for inhalation of soil particles and ingestion of soil, surface water, and sediment are potentially complete for these receptors. Grounddisturbing activities to subsurface soil could result in site and construction worker exposure via ingestion of subsurface soil. Therefore, the inhalation and ingestion pathways for these receptors are considered potentially complete. The current Helena AASF drinking water is supplied by the City of Helena; however, domestic water supply wells are present to the north and northeast. Groundwater flow at the current Helena AASF is predominantly to the north-northeast; therefore, these wells are downgradient of AOI 1, and the exposure pathway for groundwater to residents through domestic drinking water ingestion is potentially complete. The CSM for the current AASF is shown on Figure 6-2.

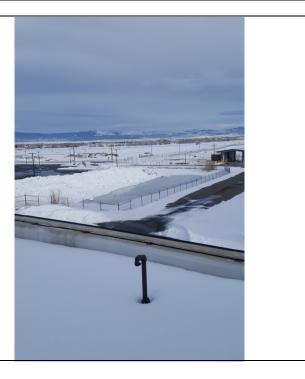
Looking northeast. Detention pond. The white material in the photograph is snow.
