Preliminary Assessment Report

Joint Base McGuire-Dix-Lakehurst

Lakehurst, New Jersey

Perfluorooctane-Sulfonic Acid (PFOS) and Perfluorooctanoic Acid (PFOA) Impacted Sites
ARNG Installations, Nationwide

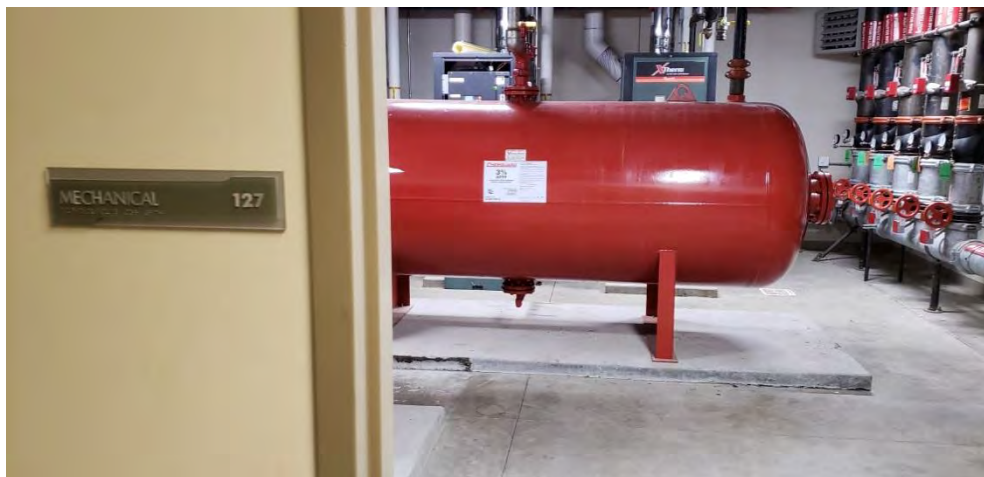
Photograph No. 2

Inside Building 780 (Warm Storage Hangar). The bladder inside the tank was pulled out and replaced during the retrofill event.

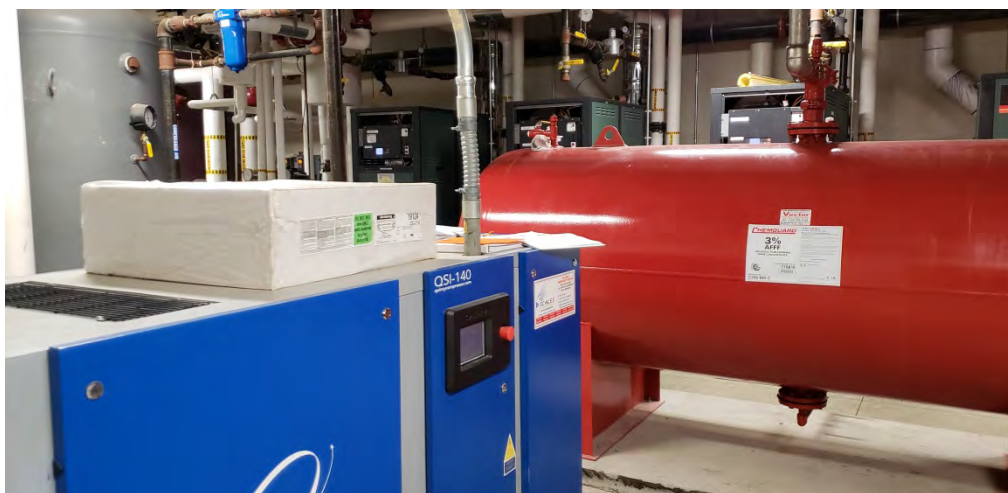
Inside Building 780 (Warm Storage Hangar). AFFF stains are visible due to a valve leak during the replacement of the bladder.

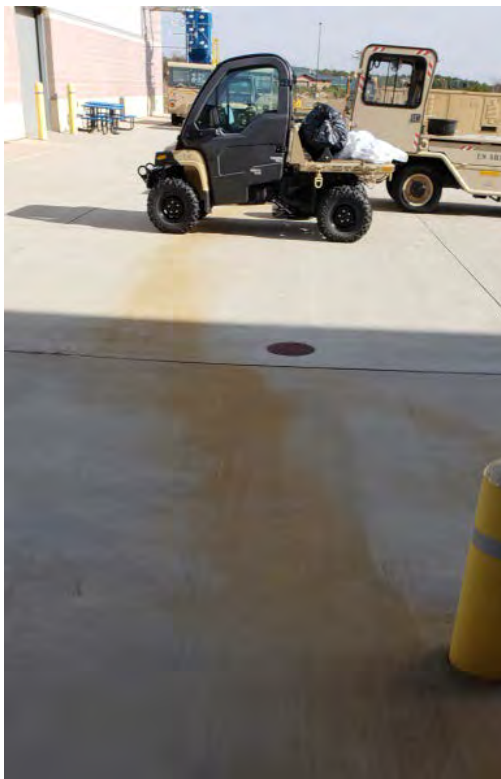
Photograph No. 6

East of Inside Building 780
(Warm Storage Hangar)
location of spill from
retrofitting truck carrying
foam. Extent of foam was
approximately the outline of
two vehicles.

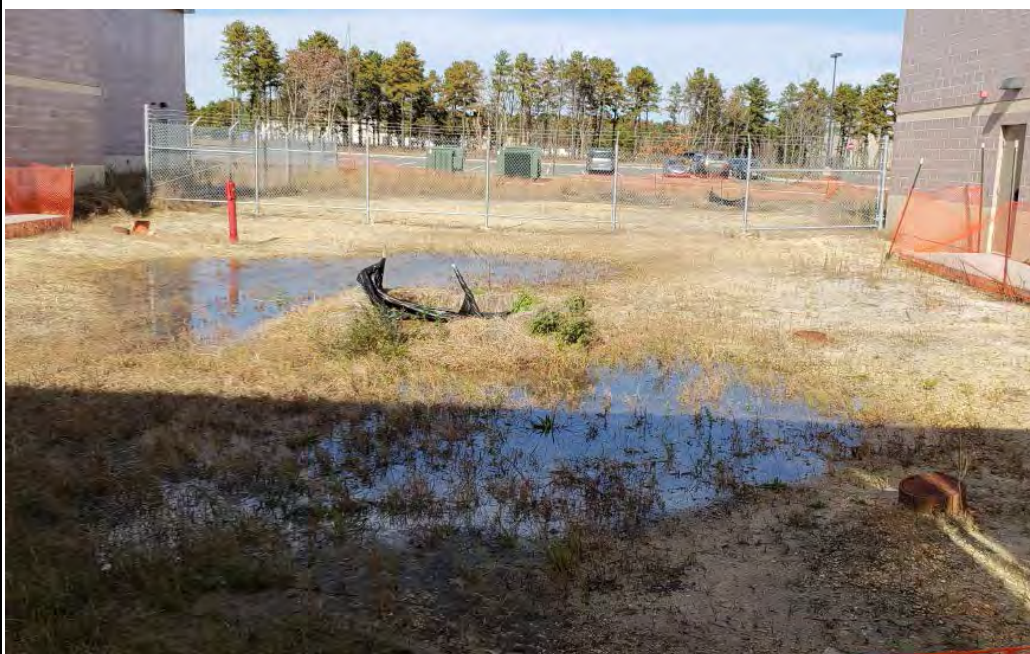
Location of AFFF discharge from spill area between Building 780 (Warm Storage Hangar) and Building 790 (Cold Storage Hangar). AFFF spilled out of storm drain.

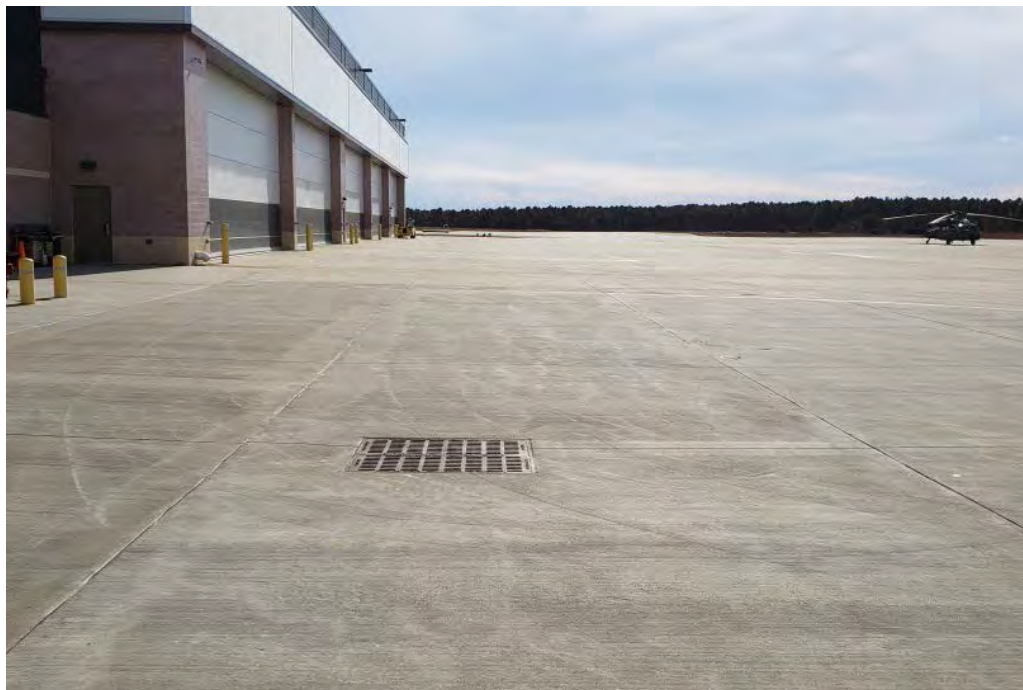
Photograph No. 10

Outside south entrance of Building 790 (Cold Storage Hangar) where the AFFF spill originated from.

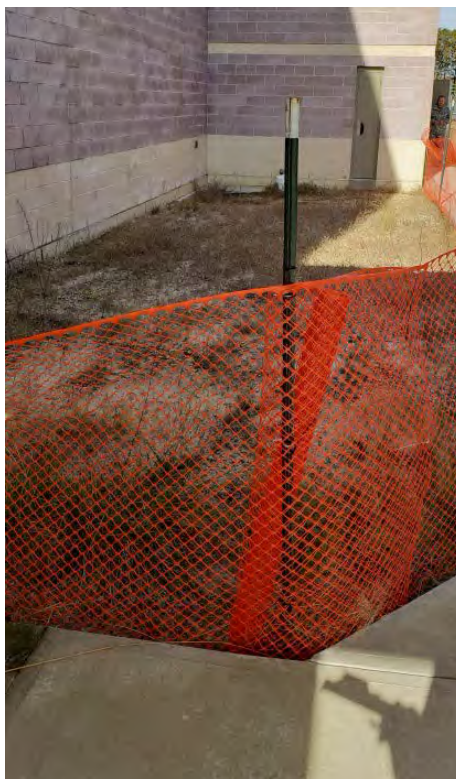
| Photo ID/Name | Date & Location | Photograph Description |
|---|---|--|
| Photograph No. 12 | AFFF Valve outside of 790 | Location of second spill directly east of Building 790 (Cold Storage Hangar). AFFF leaked out of valve (indicated by white bucket underneath). |

Location of second spill directly east of Building 790 (Cold Storage Hangar). AFFF leaked out of valve (indicated by white bucket underneath).

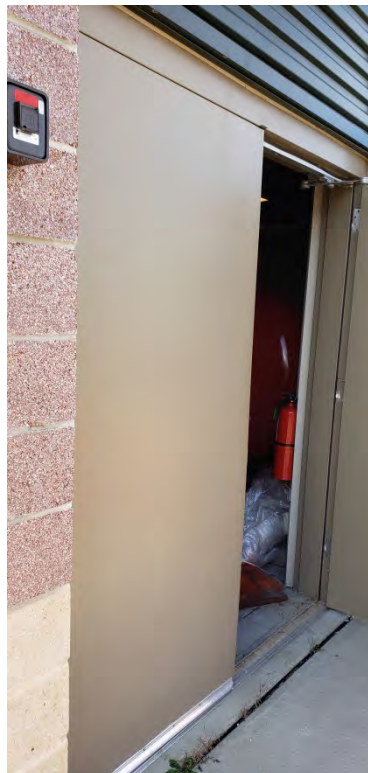
Inside Building 790 (Cold Storage Hangar) maintenance room that holds AFFF tank. Cap featured is what malfunctioned causing the discharge. New sheetrock pictured after spill damaged original wall.

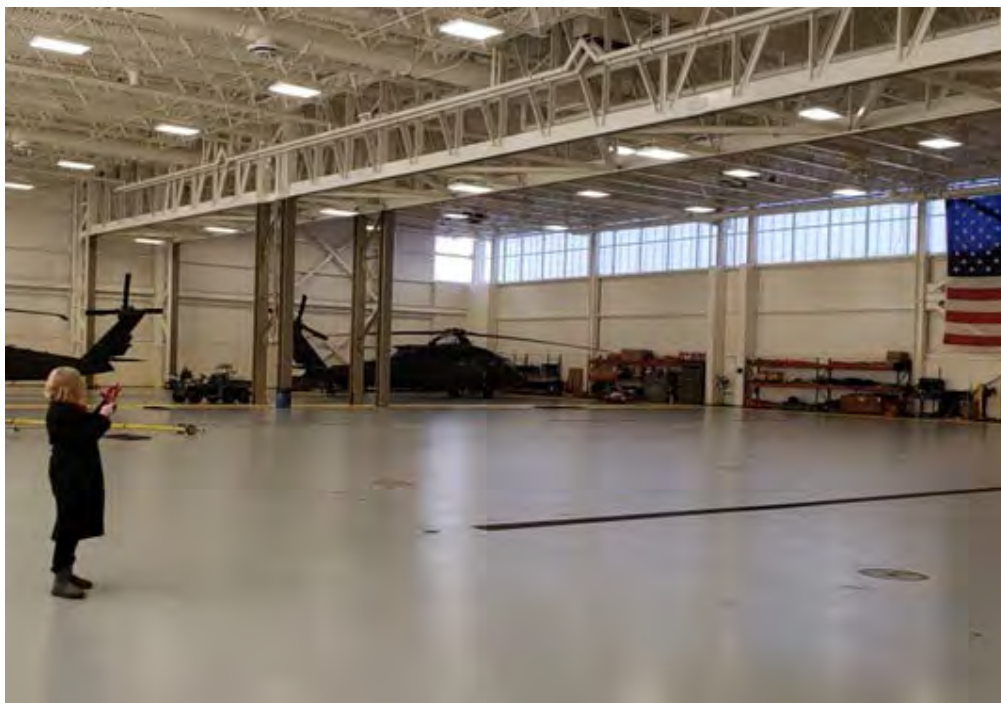
Photograph No. 22

Building 790 (Cold Storage Hangar) inside Hangar adjacent to AFFF maintenance room. During discharge event AFFF knocked the dry wall out and leaked onto the hangar floor. New sheetrock is indicated by different coloring from the floor up.

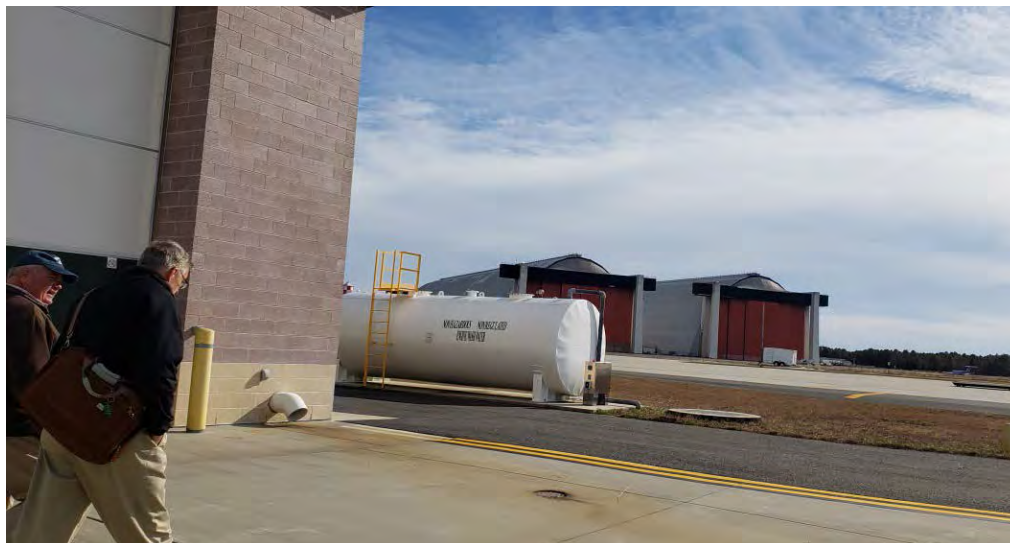
Outfall located south of Building 790 (Cold Storage Hangar). AFFF discharged from the Outfall during the first spill event and was later excavated.
