FINAL Preliminary Assessment Report Santa Fe Army Aviation Support Facility Santa Fe, New Mexico

Perfluorooctane-Sulfonic Acid (PFOS) and Perfluorooctanoic
Acid (PFOA) Impacted Sites
ARNG Installations, Nationwide

August 2020

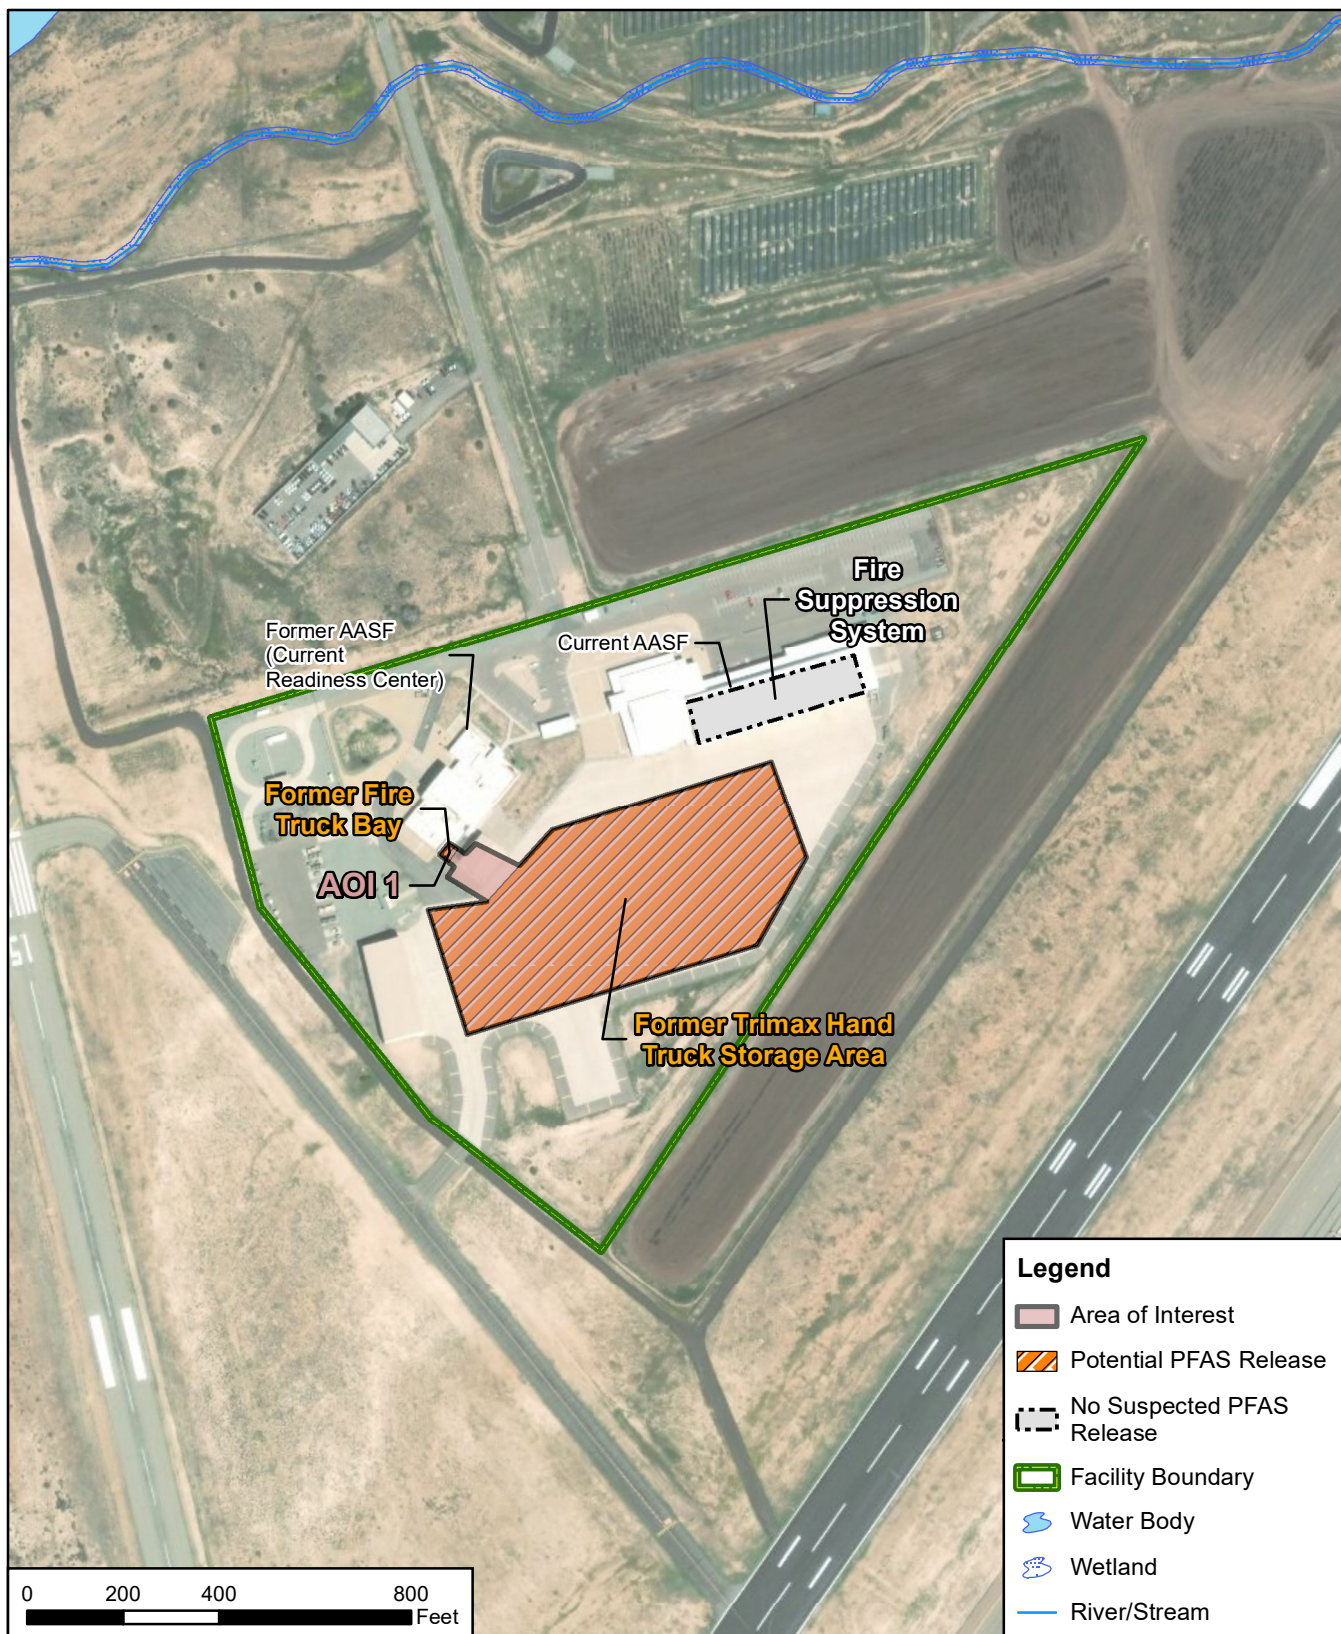
During the PA, one AOI related to potential PFAS release was identified at Santa Fe AASF based on PA data. The AOI is shown on **Figure ES-1** and described in **Table ES-1** below:

One adjacent off-facility potential PFAS release area was identified that includes an emergency response area from two plane crashes in 2018 and 2019. As a result of adjacent PFAS releases, it is possible PFAS contamination exists in site media surrounding the AASF.

Potential PFAS releases may have occurred at Santa Fe AASF based on the storage and potential use of AFFF at the facility. Based on the possible PFAS releases at the AOI, there is potential for exposure to PFAS contamination in media at or near of the facility. The preliminary CSM for Santa Fe AASF is shown on **Figure ES-2**.

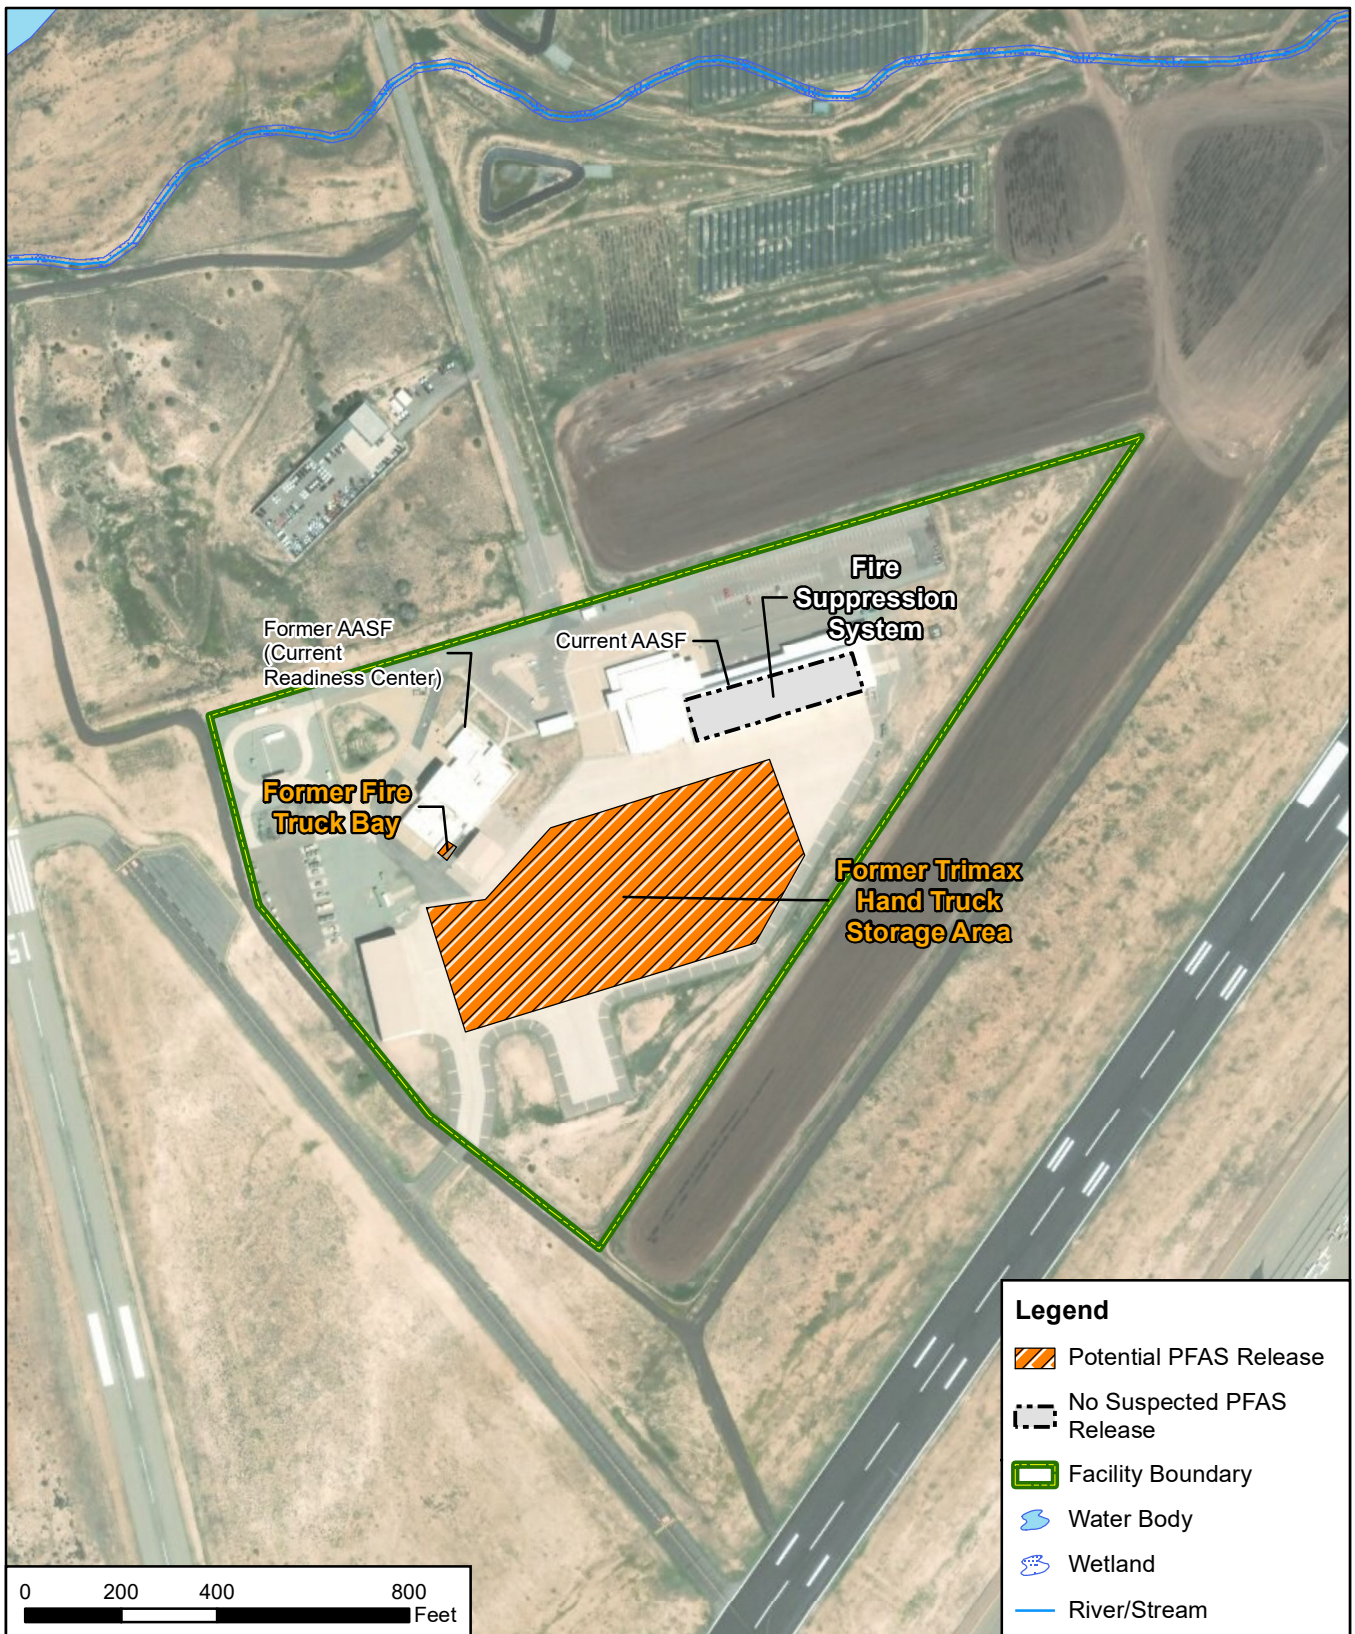
Figure 3-1

The flight line and paved parking apron at the facility currently stretch across the majority of the facility and are directly adjacent to both the current and former AASF buildings. The area was expanded and repaved in 2012 during the construction and renovation of the facility. Prior to the 2012 renovation, Tri-Max™ 70/30 hand trucks were stored in various places around the flight line and parking apron and were regularly serviced. According to personnel, the Tri-Max™ hand trucks were only used for 4 to 5 years in the mid-2000s and were turned in because they were too expensive to maintain. There is no recollection or record of any training conducted with these units or nozzle testing performed. Interviewees were unsure about when or where specifically the

Tri-Max™ units were turned in, but they no longer exist at the facility and have since been replaced with fire extinguishers that do not contain PFAS. The primary area where the hand trucks were stored is presented in **Figure 3-1**.

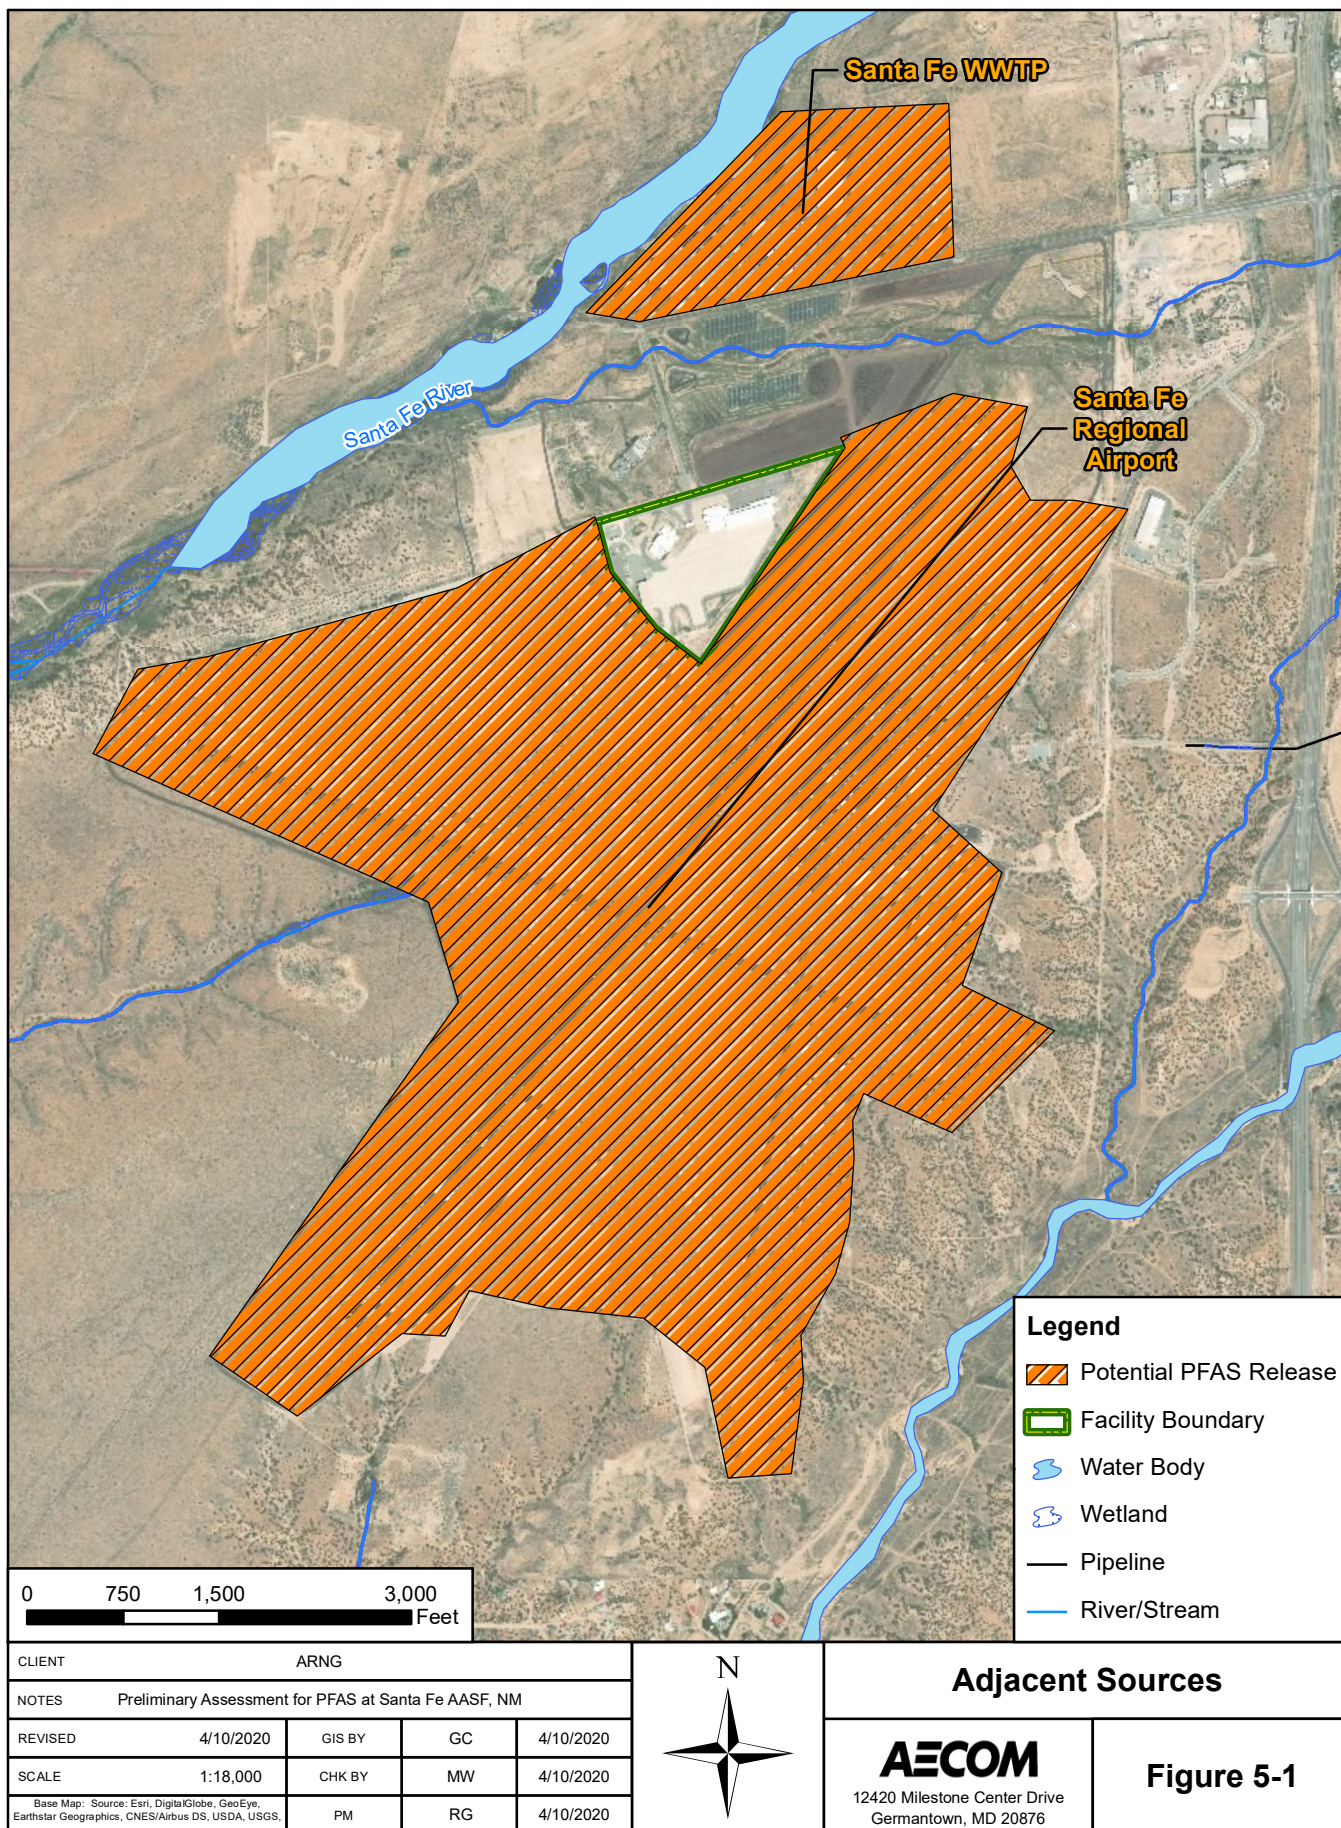
One off-facility site was identified as a possible PFAS source adjacent to Santa Fe AASF during the PA and is discussed below. **Figure 5-1** presents the location of the suspected adjacent PFAS sources.

The Santa Fe Regional Airport (SAF) is a public airport that opened in 1941 and covers 2,128 acres. SAF has three active asphalt runways (GCR, 2019). Interviews with NMARNG facility staff and a historical records search provided little information regarding use of AFFF at Santa Fe Regional Airport; however, the records search detailed two emergency incidents that happened on or near the runway – one on 27 November 2018, and another on 8 April 2019. According to a local news source, the first crash occurred when a single-engine Mooney M20 crashed just short of the runway and burst into flames (Edge, 2018). The second crash happened several months after, when a two-seater aircraft crashed and burst into flames at the airport on a secondary runway just south of the AASF facility (Mullan, 2019). It is unknown if AFFF were used as part of the emergency response to either of these incidents. This possible adjacent source is presented on **Figure 5-1**.

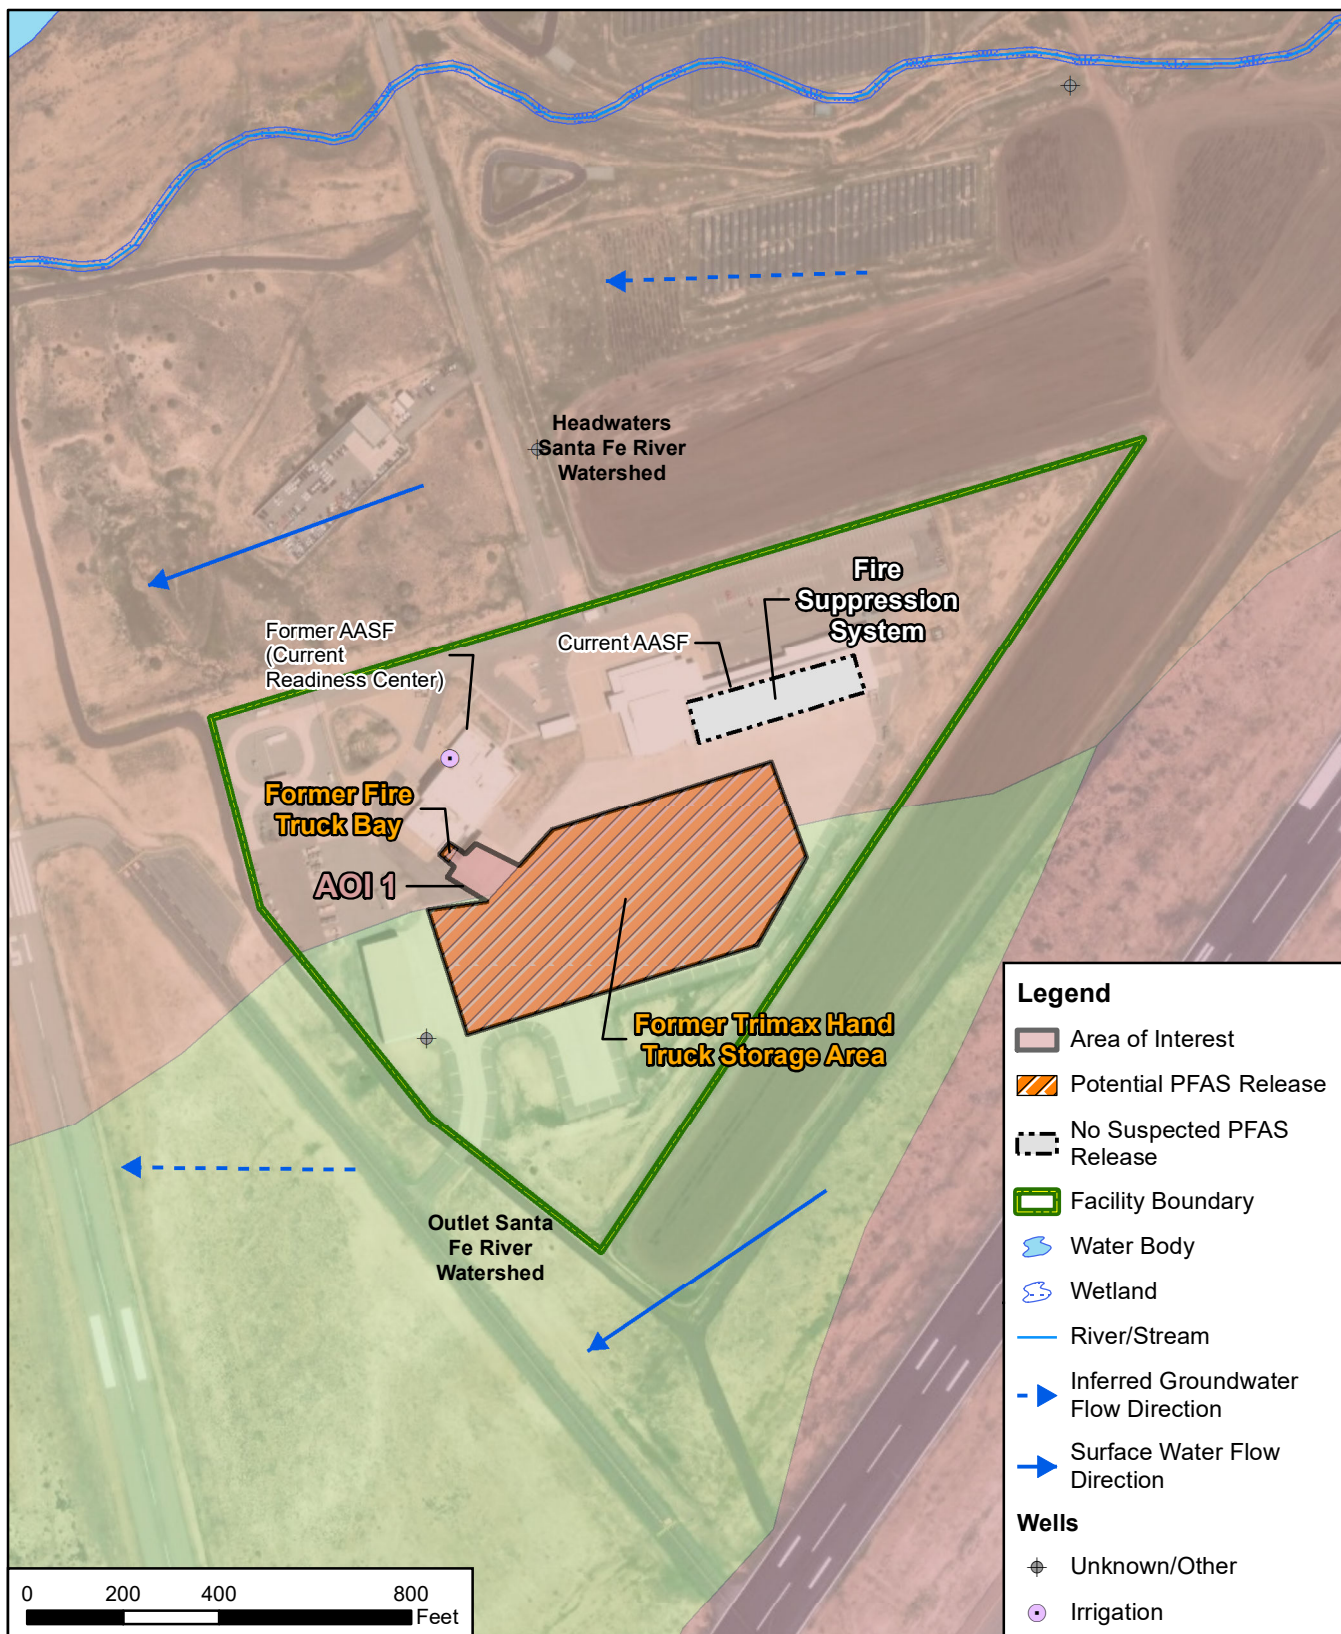
Figure 6-1

Based on the PA findings, one potential release area was identified at Santa Fe AASF as a result of NMARNG actions and will be considered an AOI. The AOI location is shown on **Figure 6-1**. The following sections describe the CSM components and the specific preliminary CSM developed for the AOI. The CSM identifies the three components necessary for a potentially complete exposure pathway: (1) source, (2) pathway, and (3) receptor. If any of these elements are missing, the pathway is considered incomplete.

The AOI encompasses the building that is the former AASF. There is a possibility that the firetruck stored inside the may have leaked AFFF or may have had its AFFF tank flushed out during maintenance. If a release occurred, ground disturbing activities in this area could result in construction worker, site worker, and trespasser exposure to suspected PFAS contamination via inhalation of dust or ingestion of surface soil. A construction worker could also be exposed to subsurface soil affected by AFFF. PFAS are water soluble and can migrate readily from soil to groundwater or surface water via leaching and run-off. However, groundwater beneath the facility ranges from 900 to 1200 feet bgs, and the city sources roughly half of its drinking water from both the Santa Fe and Buckman Well Fields approximately 12 miles northwest and northeast of the facility. Groundwater flows generally southwest and away from the well fields. There are no known drinking water sources downgradient of the facility; therefore, groundwater does not appear to be a likely exposure pathway. Due to the arid desert climate, the pathway for surface water is considered incomplete; however, it is possible that historic deposition of AFFF could occur during rain events carrying into nearby ditches or recessed areas off-site. Given the high rates of evapotranspiration, any such event would result in a quick evaporation of water, leaving the AFFF on the surface soil and possibly sediment. Thus, soil and sediment pathways to site worker, construction worker, and trespasser receptors are potentially complete. The preliminary CSM for the AOI is shown on **Figure 6-2**.

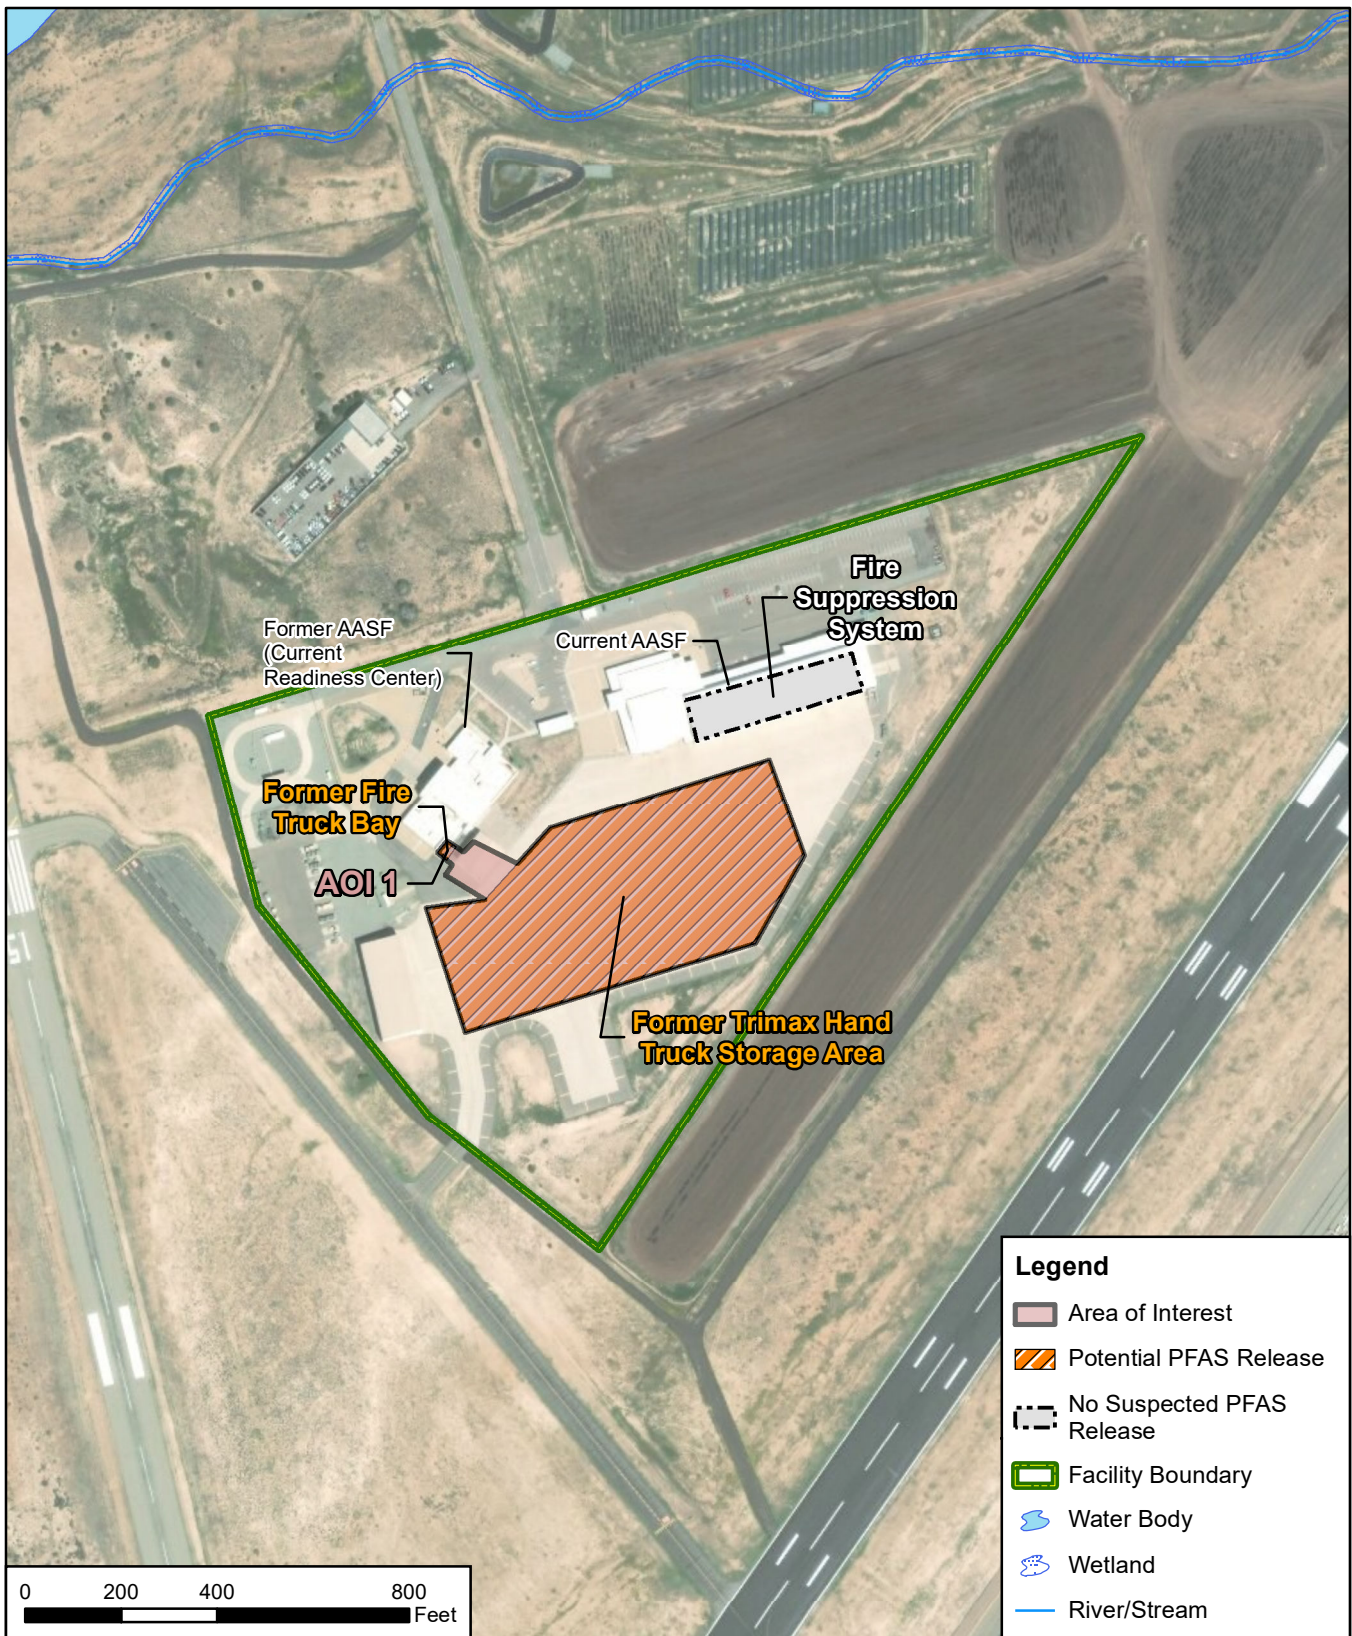
One AOI related to suspected PFAS release was identified at Santa Fe AASF during the PA (**Figure 7-1**) and is described in **Table 7-1** below:

An adjacent potential PFAS release area was identified within the vicinity of the NMARNG facility. Santa Fe Regional Airport had two plane crashes on the runway in 2018 and 2019, though it is unknown whether AFFF were used to respond to these situations.

Based on documented potential PFAS release at the AOI, there is potential for exposure to PFAS contamination in media at or near the facility. The preliminary CSM for Santa Fe AASF is shown on **Figure 6-2**, which presents the potential receptors and media impacted. A summary of PA findings is presented in **Figure 7-1**.

Records review and interviews with NMARNG facility staff indicate that current or former ARNG activities may have resulted in PFAS releases at the AOI at Santa Fe AASF. PFAS have the potential to be present in the soil and surface water pathways. Based on the preliminary CSM developed for the AOI, there is potential for receptors to be exposed to PFAS contamination in soil and sediment. **Table 7-3** summarizes the rationale used to determine if the AOI should be considered for further investigation under the CERCLA process and undergo an SI.

Area of Interest	AOI Location	Rationale	Potential Future Action
Former Firetruck Bay	35°37'27.66"N; 106°05'18.35"W	Potential release from a former fire truck that carried AFFF	Proceed to an SI focusing on soil, and potentially water/sediment

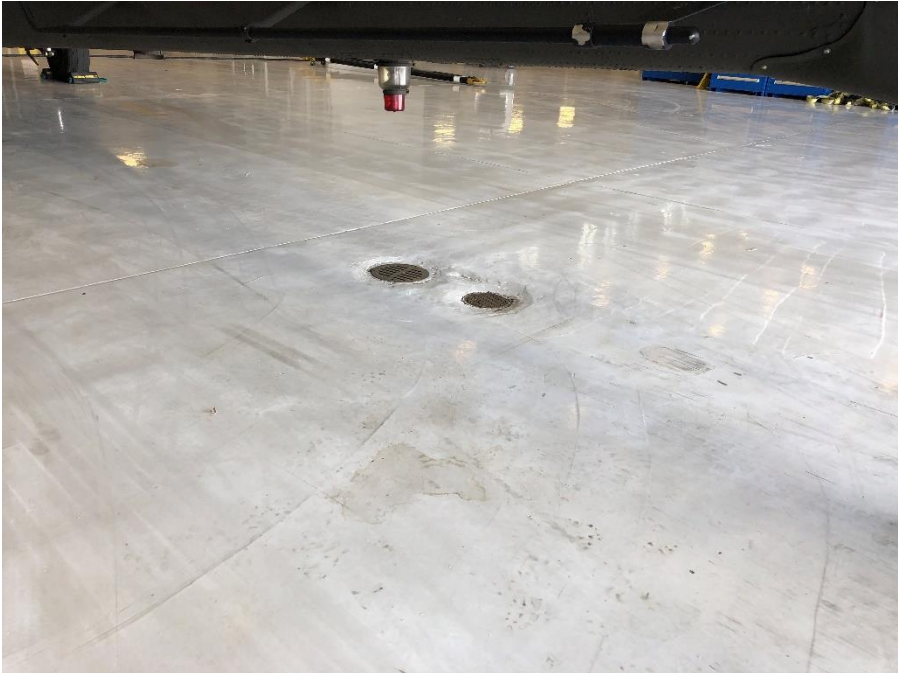
Description: Facing North. Drains in new AASF hangar through which AFFF drained during test of fire suppression system. Photo Date: 10/01/2019 0949			
Photograph No. 2

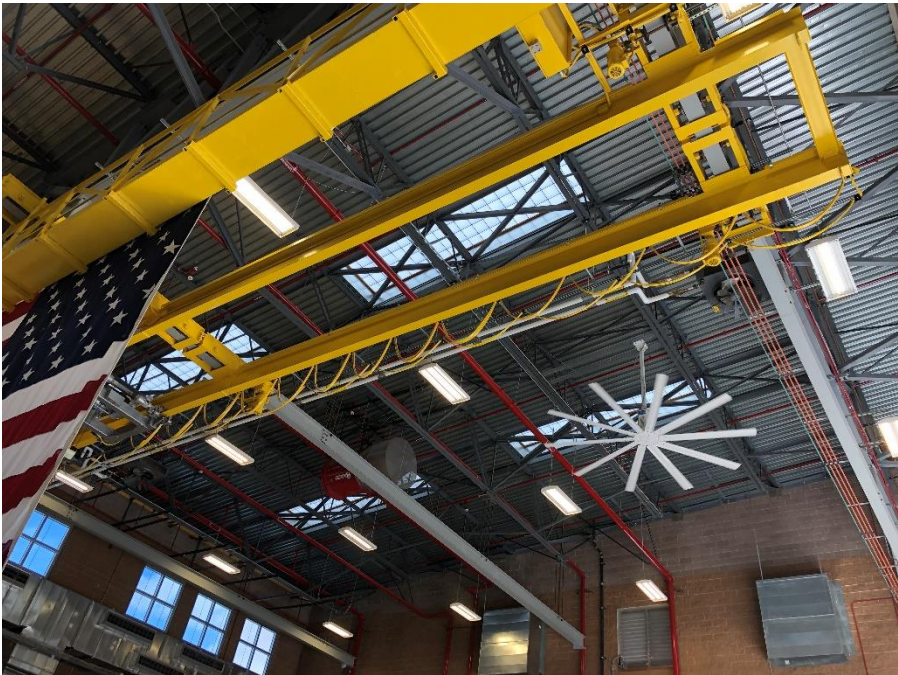
Description: Facing Northeast. Fire suppression system in new AASF hangar. Photo Date: 10/01/2019 0950

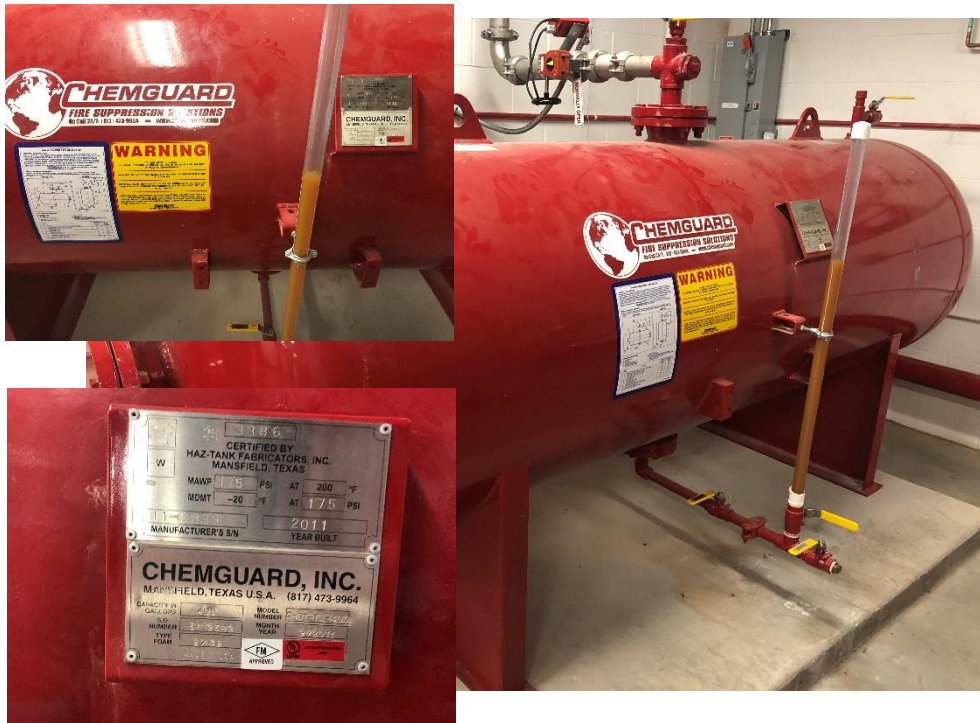
Army National Guard, Preliminary Assessment for PFAS	Santa Fe Army Aviation Support Facility	Santa Fe, New Mexico
Photograph No. 3		
Description: Facing Southeast. Fire Suppression System tank in new AASF building. Callouts contain detailed information on specs. Photo Date: 10/01/2019 0954

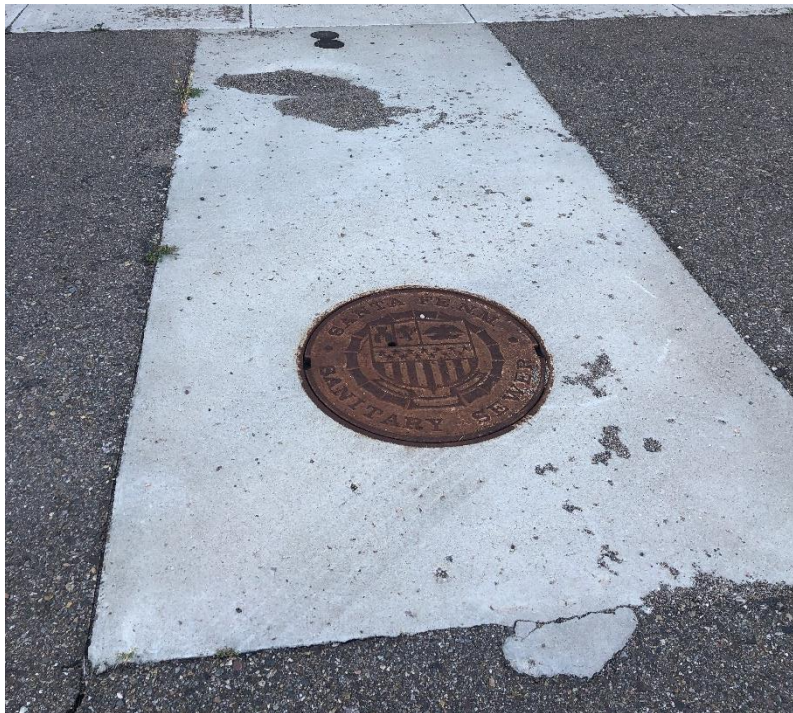
Photograph No. 4		
Description: Facing South. Where drain meets switchbox. Flows WSW towards O/W separator. Photo Date: 10/01/2019 0957

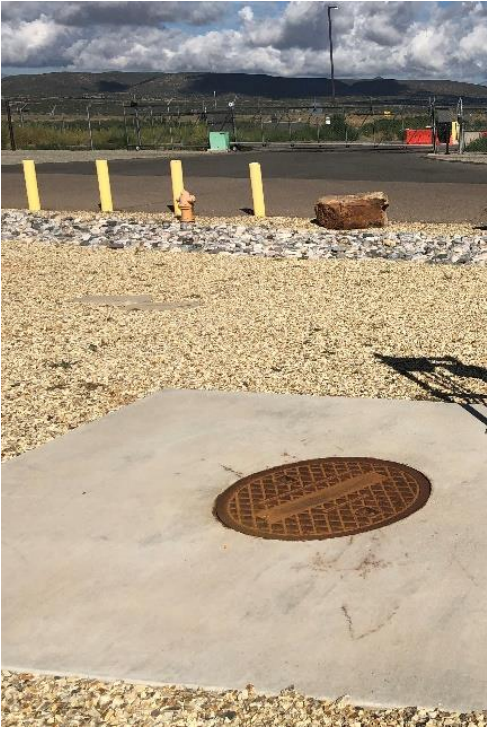
APPENDIX C – Photographic Log		
Army National Guard, Preliminary Assessment for PFAS	Santa Fe Army Aviation Support Facility	Santa Fe, New Mexico
Photograph No. 5 Description: Facing Northwest. O/W Separator. Flows west through pipes to city sanitation center across the street. Photo Date: 10/01/2019 1000

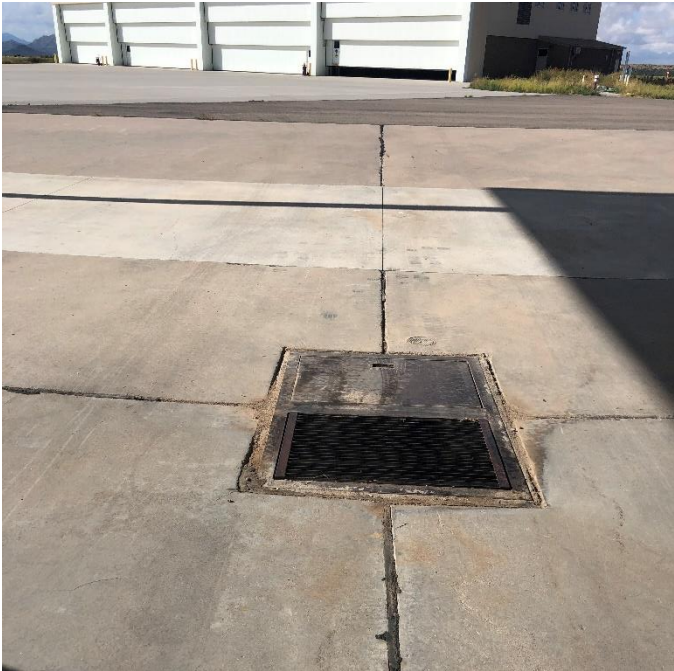
Photograph No. 6 Description: Facing Southwest. Former wash rack and drain near former AASF building. Photo Date: 10/01/2019 1009

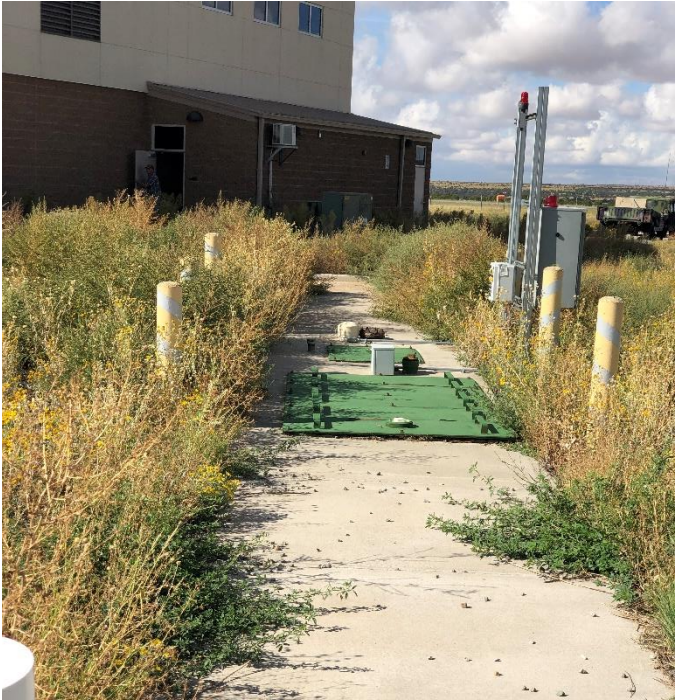
Army National Guard, Preliminary Assessment for PFAS	Santa Fe Army Aviation Support Facility	Santa Fe, New Mexico
<p>Photograph No. 7</p> <p>Description:</p> <p>Facing Southwest. Former O/W separator near former AASF building.</p> <p>Photo Date: 09/18/2019 1011</p>

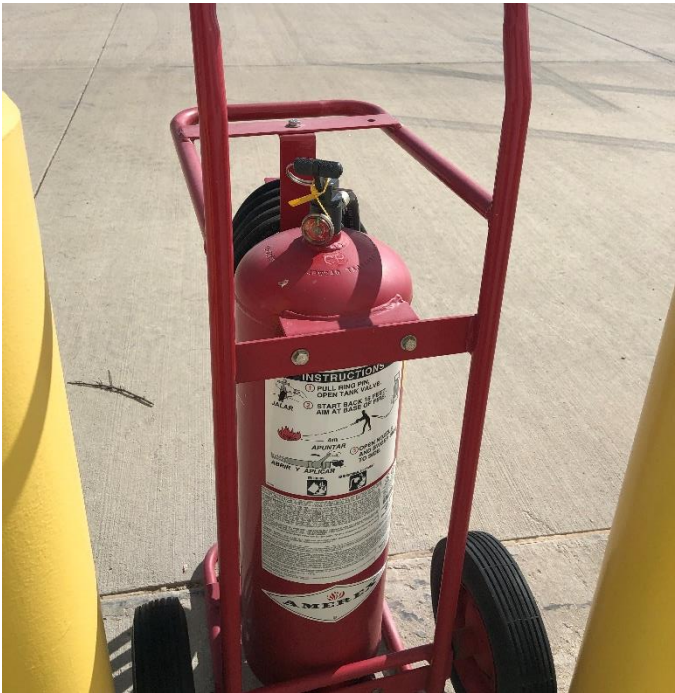
<p>Photograph No. 8</p> <p>Description:</p> <p>Facing East. New fire extinguishers which do not contain AFFF.</p> <p>Photo Date: 10/01/2019 1012</p>

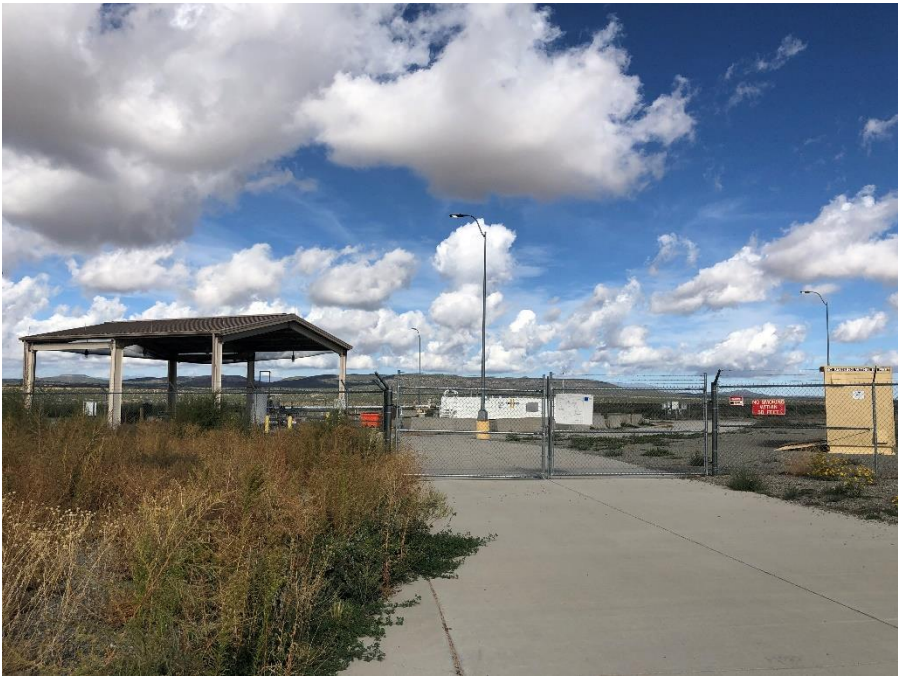
Army National Guard, Preliminary Assessment for PFAS	Santa Fe Army Aviation Support Facility	Santa Fe, New Mexico
<p>Photograph No. 9</p> <p>Description:</p> <p>Facing Northwest. 5000 gallon O/W separator as safety feature safeguard for stormwater.</p> <p>Photo Date: 10/01/2019 1018</p>

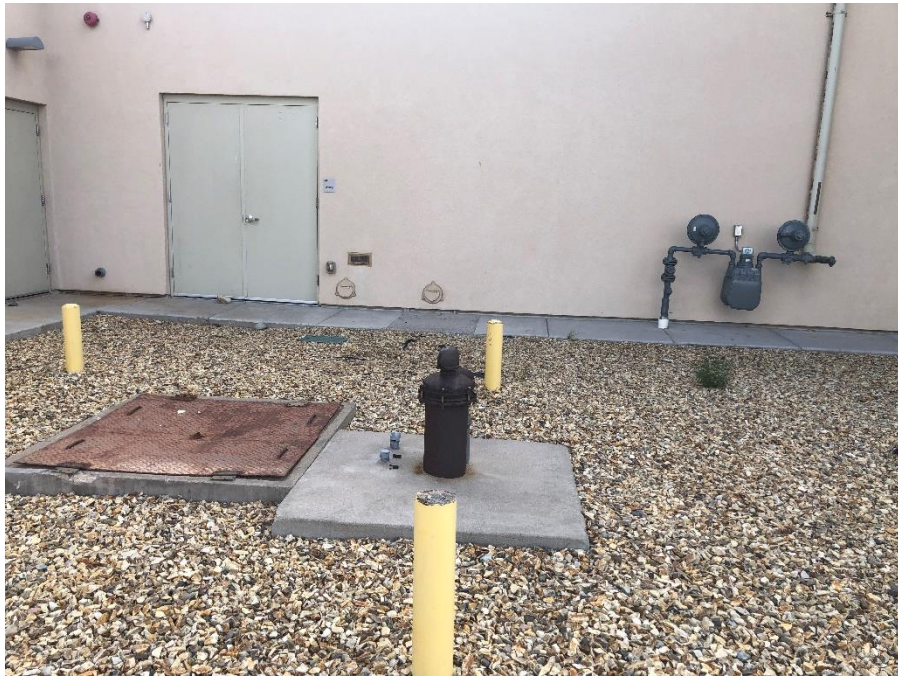
<p>Photograph No. 10</p> <p>Description:</p> <p>Facing East. Groundwater well on site that is no longer being used.</p> <p>Photo Date: 10/01/2019 1022</p>

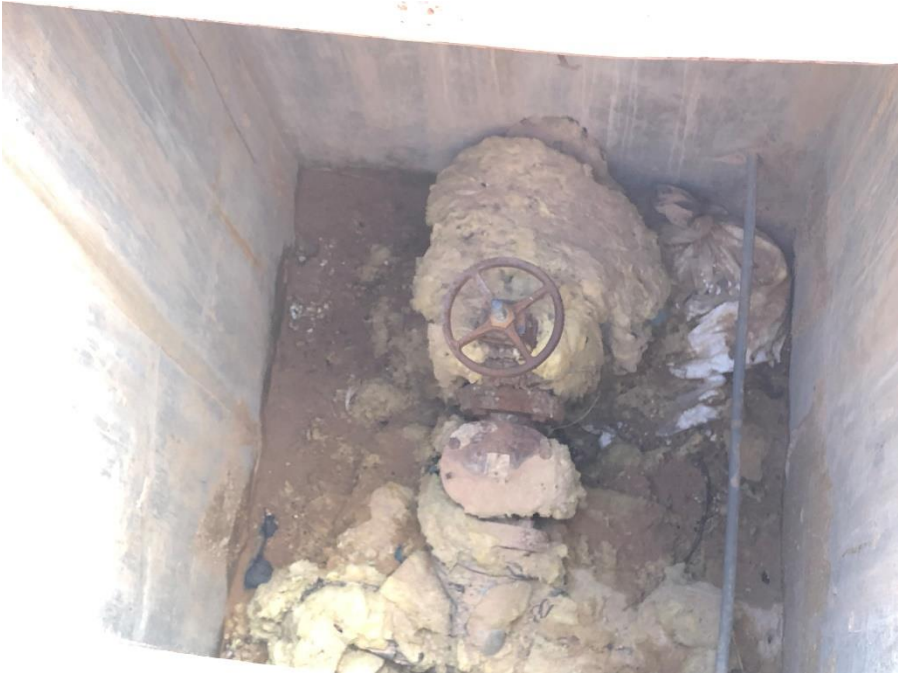
Description: Facing East. Shutoff valve for groundwater well on site that is no longer being used. Photo Date: 10/01/2019 1023
