# FINAL Preliminary Assessment Report Rio Rancho Rio Rancho, New Mexico

Perfluorooctanesulfonic Acid (PFOS) and Perfluorooctanoic  
Acid (PFOA) Impacted Sites  
ARNG Installations, Nationwide

August 2020

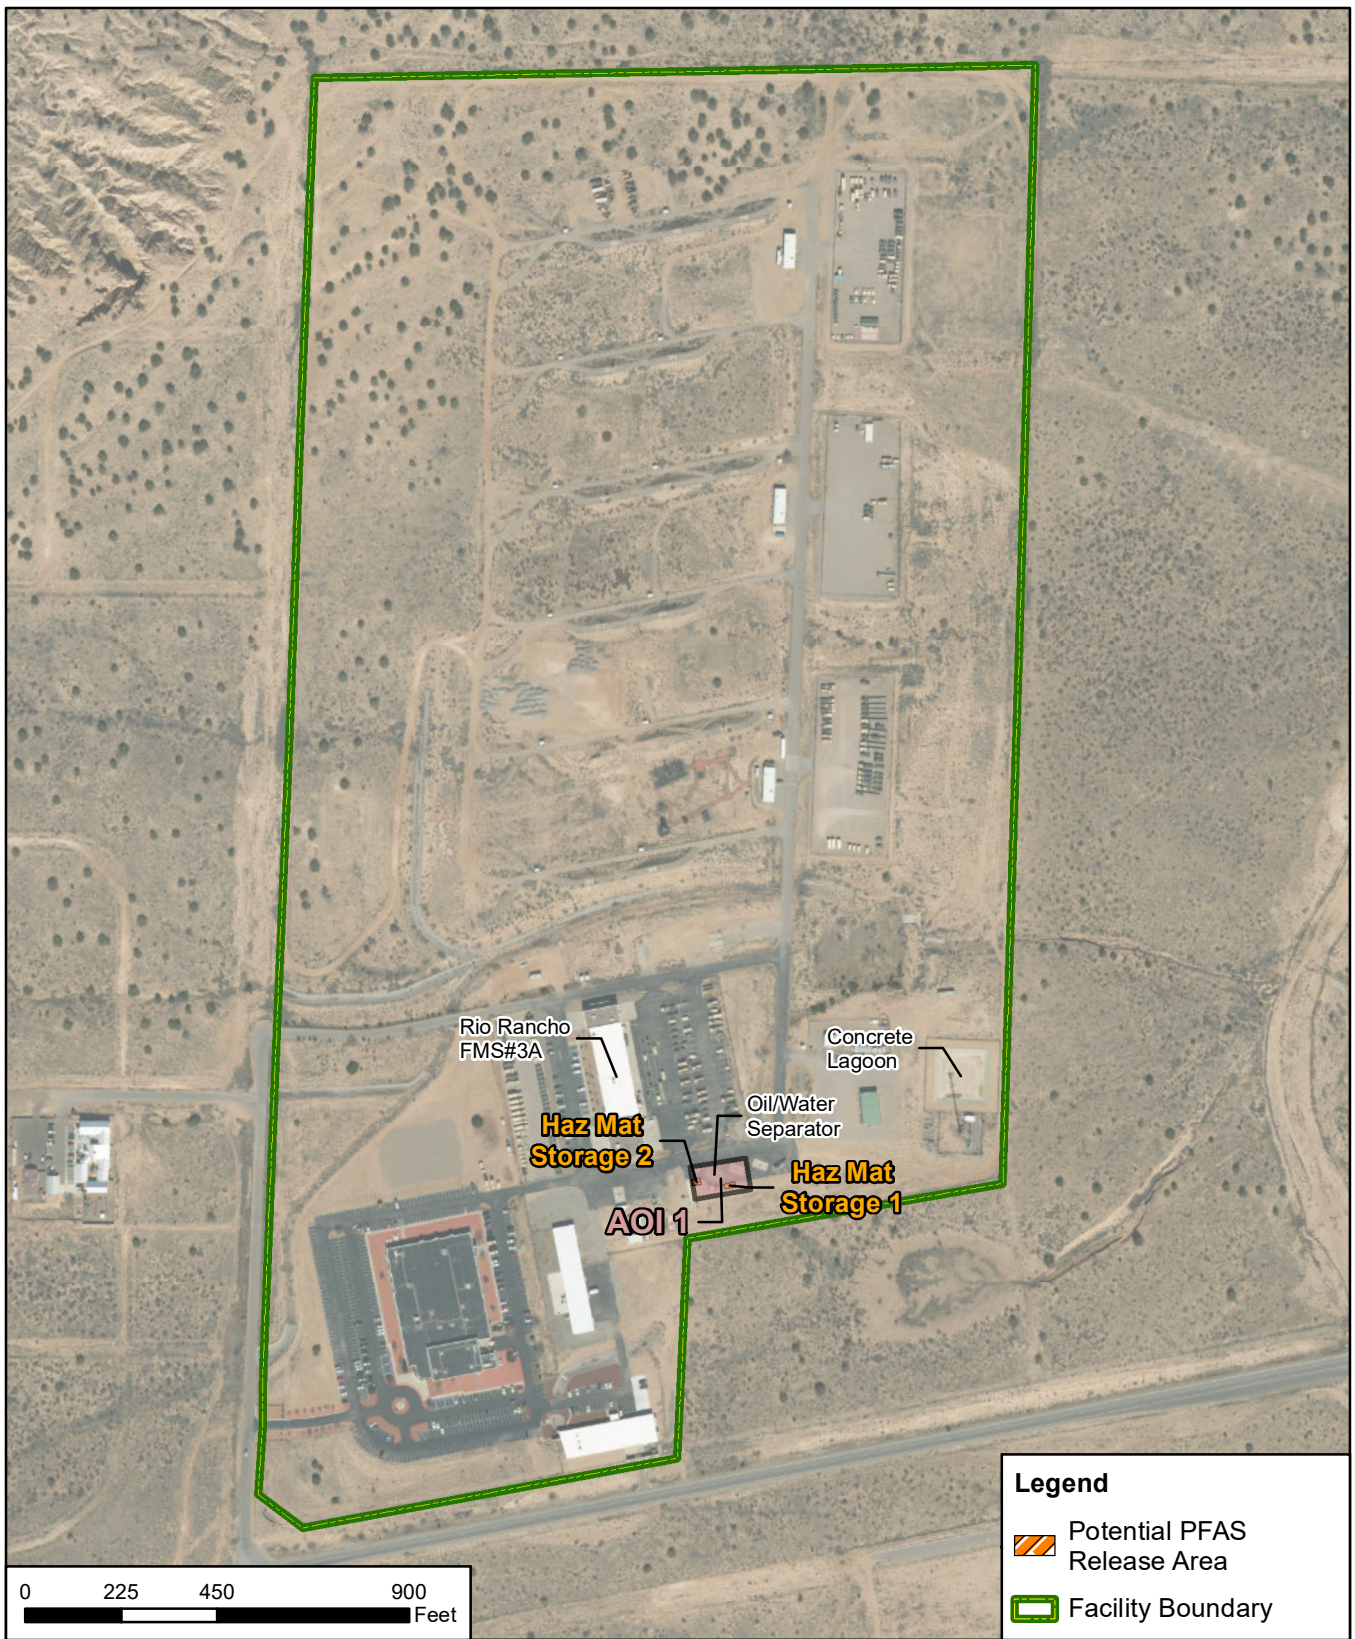
<b>Summary of Findings</b>	
 12420 Milestone Center Drive Germantown, MD 20876	<b>Figure ES-1</b>

During the PA, one AOI related to potential PFAS release was identified at Rio Rancho based on PA data. The AOI is shown on **Figure ES-1** and described in **Table ES-1** below:

Based on the PA findings, direct interviewee knowledge of releases at this facility, and a lack of robust institutional knowledge regarding historical activities concerning AFFF use and storage at the facility, there is potential for exposure to PFAS contamination in media at or near the facility. A summary of PA findings is shown on **Figure ES-1**, and the preliminary CSM for Rio Rancho is shown on **Figure ES-2**.

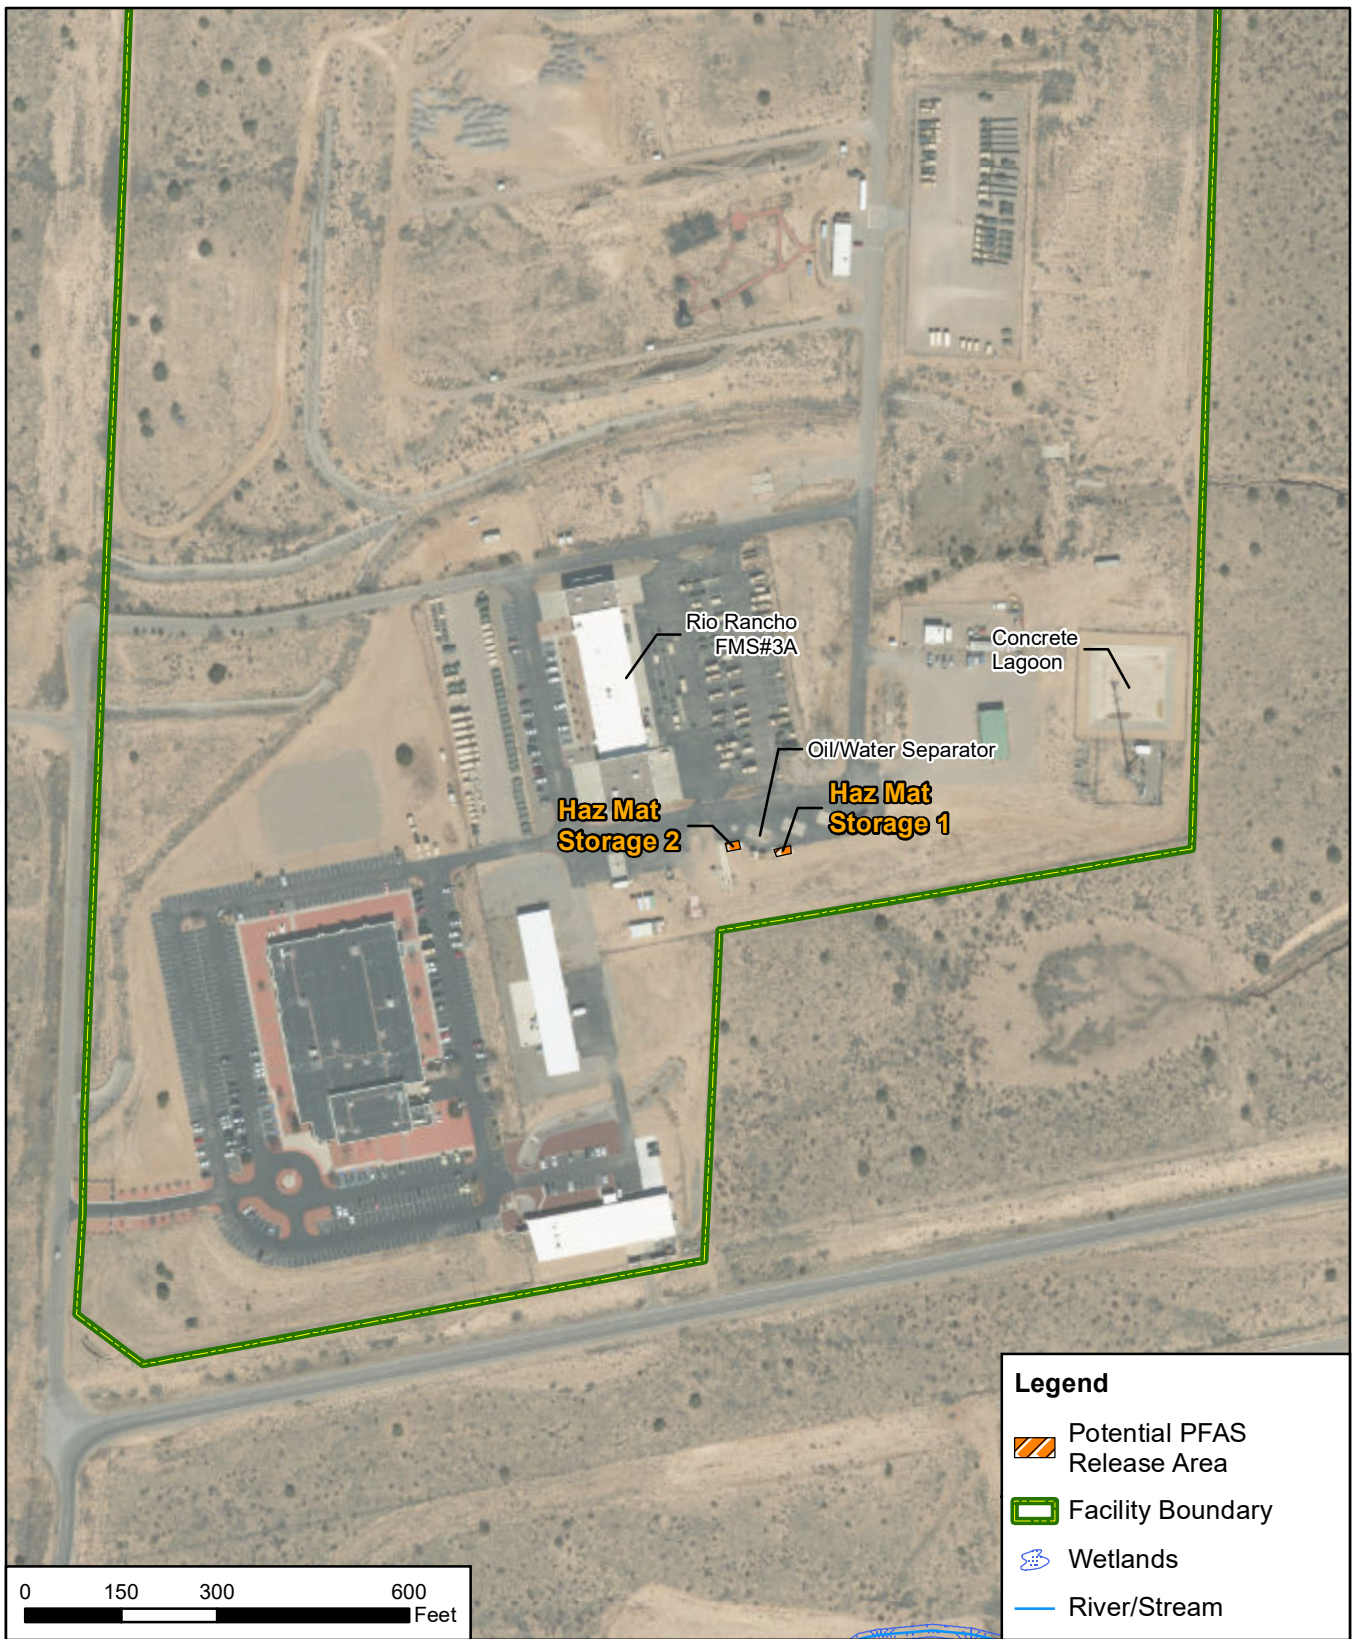
**Figure 3-1**

The hazardous materials storage lockers, located in the southern portion of the facility, housed two containers of AFFF for an unknown period of time (**Figure 3-1**). The lockers are located in the segment of the facility designated as the FMS-3. According to personnel interviews, two 10-gallon containers of AFFF were found in hazardous waste storage locker 1 sometime in early 2019. Both containers, which are classified as Fiberboard or plastic drums, barrels, or kegs (DF) in the Uniform Hazardous Waste Manifest (**Appendix A**), were found half empty with evidence of a small amount of product around the cap. There is no evidence or recollection of these containers being used or transported to the site, and no leaks or spills have been reported. The containers were described as small high-density polyethylene (HDPE) “poly” 10-gallon closed head drums by interviewed personnel and were stored in a hazmat storage locker that was in good condition, with no evidence or corrosion or damage that would compromise the integrity of the locker. Once these containers were discovered, they were moved to an adjacent hazmat storage locker (hazardous waste storage locker 2) designated for transport through the Defense Logistics Agency (DLA) as non-Resource Conservation and Recovery Act (RCRA) non-hazardous waste. This secondary storage locker was also in good condition, with no evidence of corrosion or damage that would compromise the integrity of the locker. The containers of AFFF were dispatched via a third-party carrier (Envirokleen – EPA ID Number: TXR000084068), with the waste code N/H Out54091, on 08 April 2019. The weight of the product listed on the Uniform Hazardous Waste Manifest is 60 pounds. There was no evidence of PFAS-containing substances ever having been stored or used within the FMS-3 building itself, and the fire sprinkler system within the FMS uses water only as seen in the attached photo log (**Appendix C**).

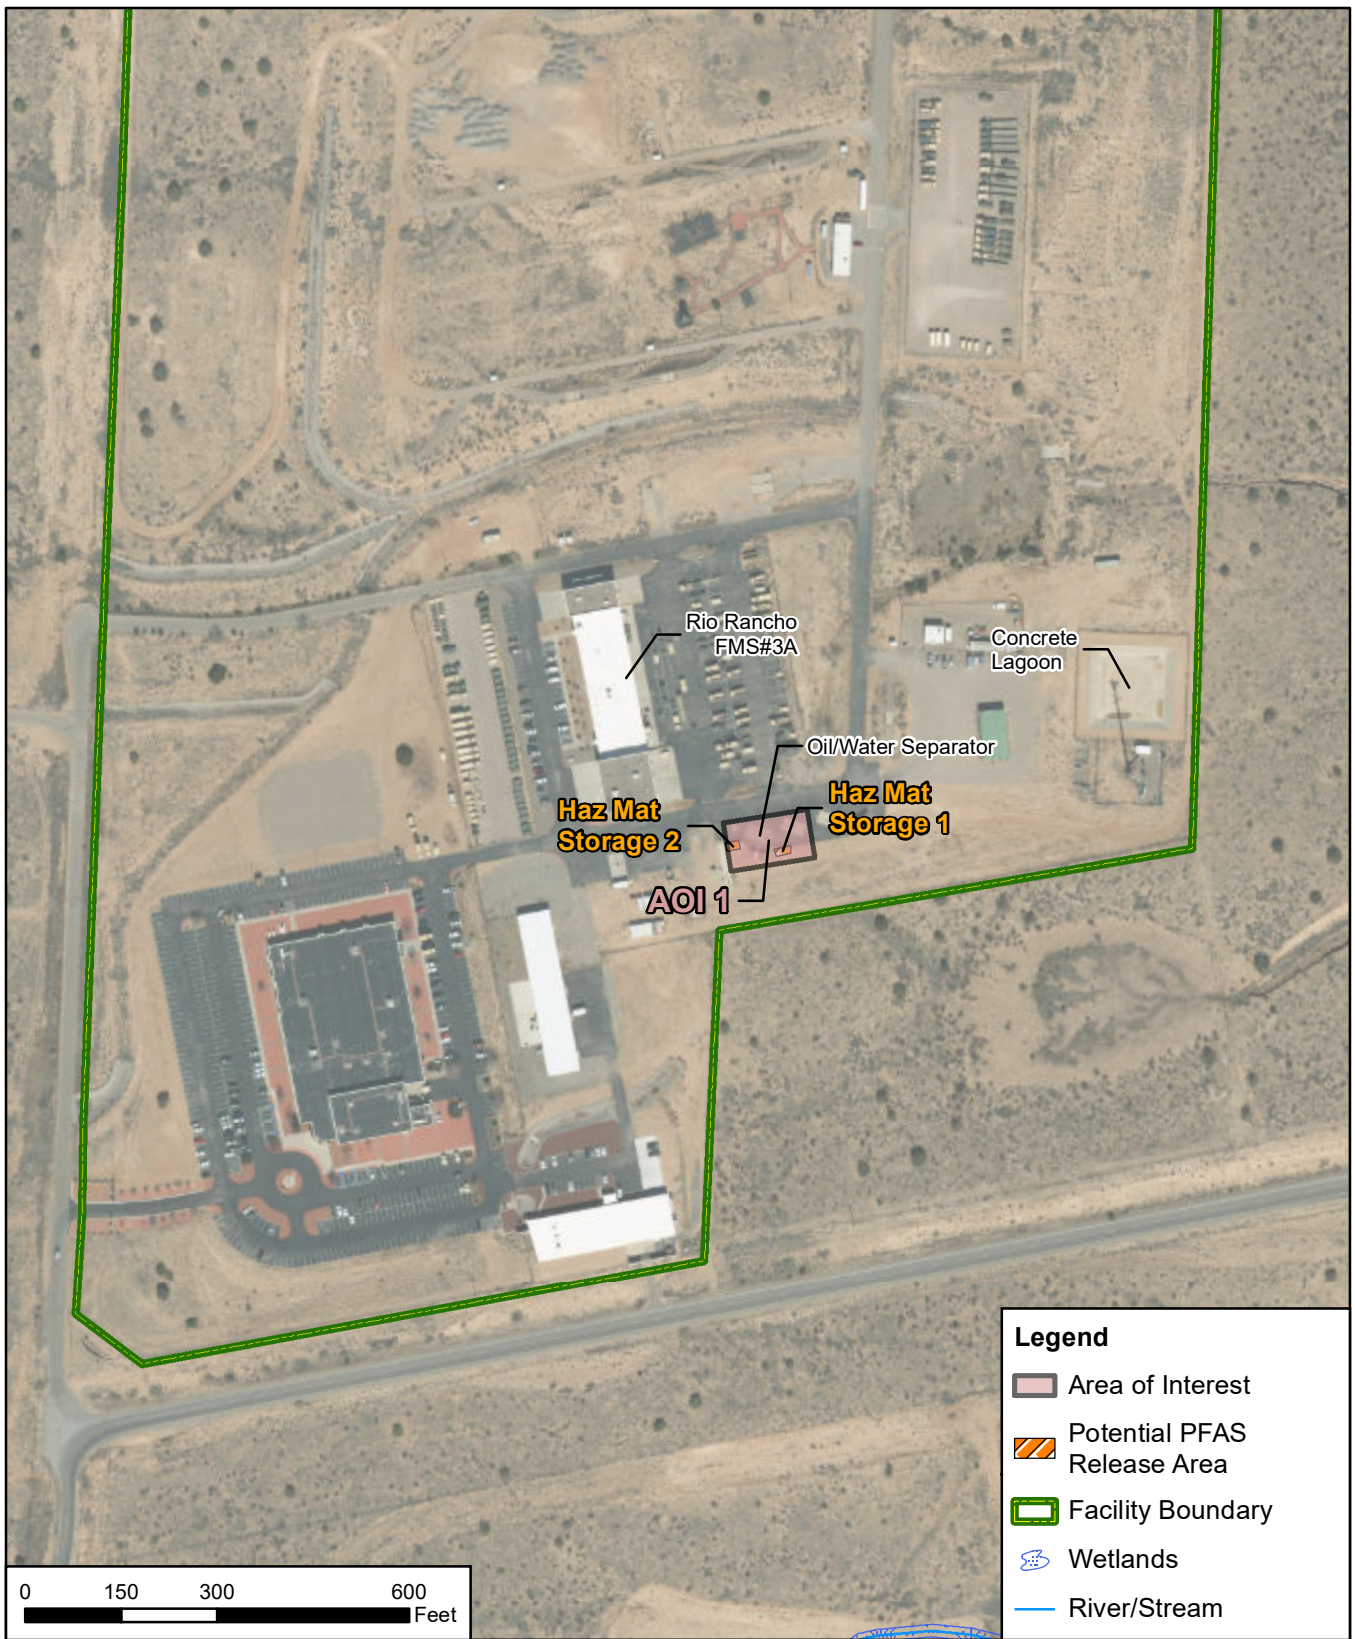
**Figure 6-1**

The hazardous materials storage lockers, located in the southern portion of the facility, near the FMS-3 building, housed two containers of a PFAS-containing substance for an unknown period of time (**Figure 6-1**). Personnel indicated that two 10-gallon HDPE “poly” drums of PFAS-containing substance were found in hazardous waste storage locker 1 sometime in early 2019. Both of these containers, which are classified as Fiberboard or plastic drums, barrels, or kegs (DF) in the Uniform Hazardous Waste Manifest (**Appendix A**), were found half empty, with evidence of a small amount of product around the cap. Interview information can be found in **Appendix B**. There are no records indicating when or from whom these containers of AFFF product were acquired. Additionally, there is no evidence or recollection of these containers being used or transported to the site, and no leads as to the extent of the use of this product. No leaks or spills concerning AFFF have been reported at the facility. The containers were stored in a hazmat storage locker that was in good condition, with no evidence or corrosion or damage that would compromise the integrity of the locker. Once these containers were discovered, they were moved to an adjacent hazmat storage locker (hazardous waste storage locker 2) designated for transport through DLA as non-RCRA non-hazardous waste. This secondary storage locker was also in good condition, with no evidence of corrosion or damage that would compromise the integrity of the locker. The containers of AFFF were dispatched via a third-party carrier (Envirokleen – EPA ID Number: TXR000084068), with the waste code N/H Out54091, on 08 April 2019. The weight of the product listed on the Uniform Hazardous Waste Manifest is 60 pounds.

The AOI encompasses the hazardous materials lockers, which are within close proximity to one another, and the immediate area in between and surrounding these two lockers. If AFFF were used or spilled within the containers, the spill would have been considered entirely contained, as both hazardous materials storage lockers are in good condition, with no signs of leaks or damage. If the AFFF containers were used or spilled outside of the hazardous materials storage lockers, then the product may have traveled to an oil water separator, which leads to the concrete lagoon located on the southeast corner of the facility, and evaporated. If there were any leakage in this chain of transport, ground disturbing activities in this area could result in construction worker, site worker, and trespasser exposure to potential PFAS contamination via inhalation of dust or ingestion of surface soil. PFAS are water soluble and can migrate readily from soil to groundwater or surface water via leaching and run-off. Groundwater depth in the area is approximately 1000 feet below ground surface (Bartolino & Cole 2002). The city of Rio Rancho currently sources its water supply entirely from groundwater and the Aquifer Injection Project and has 17 wells currently in operation. Groundwater flows southeast, and surface water flows generally east-northeast.

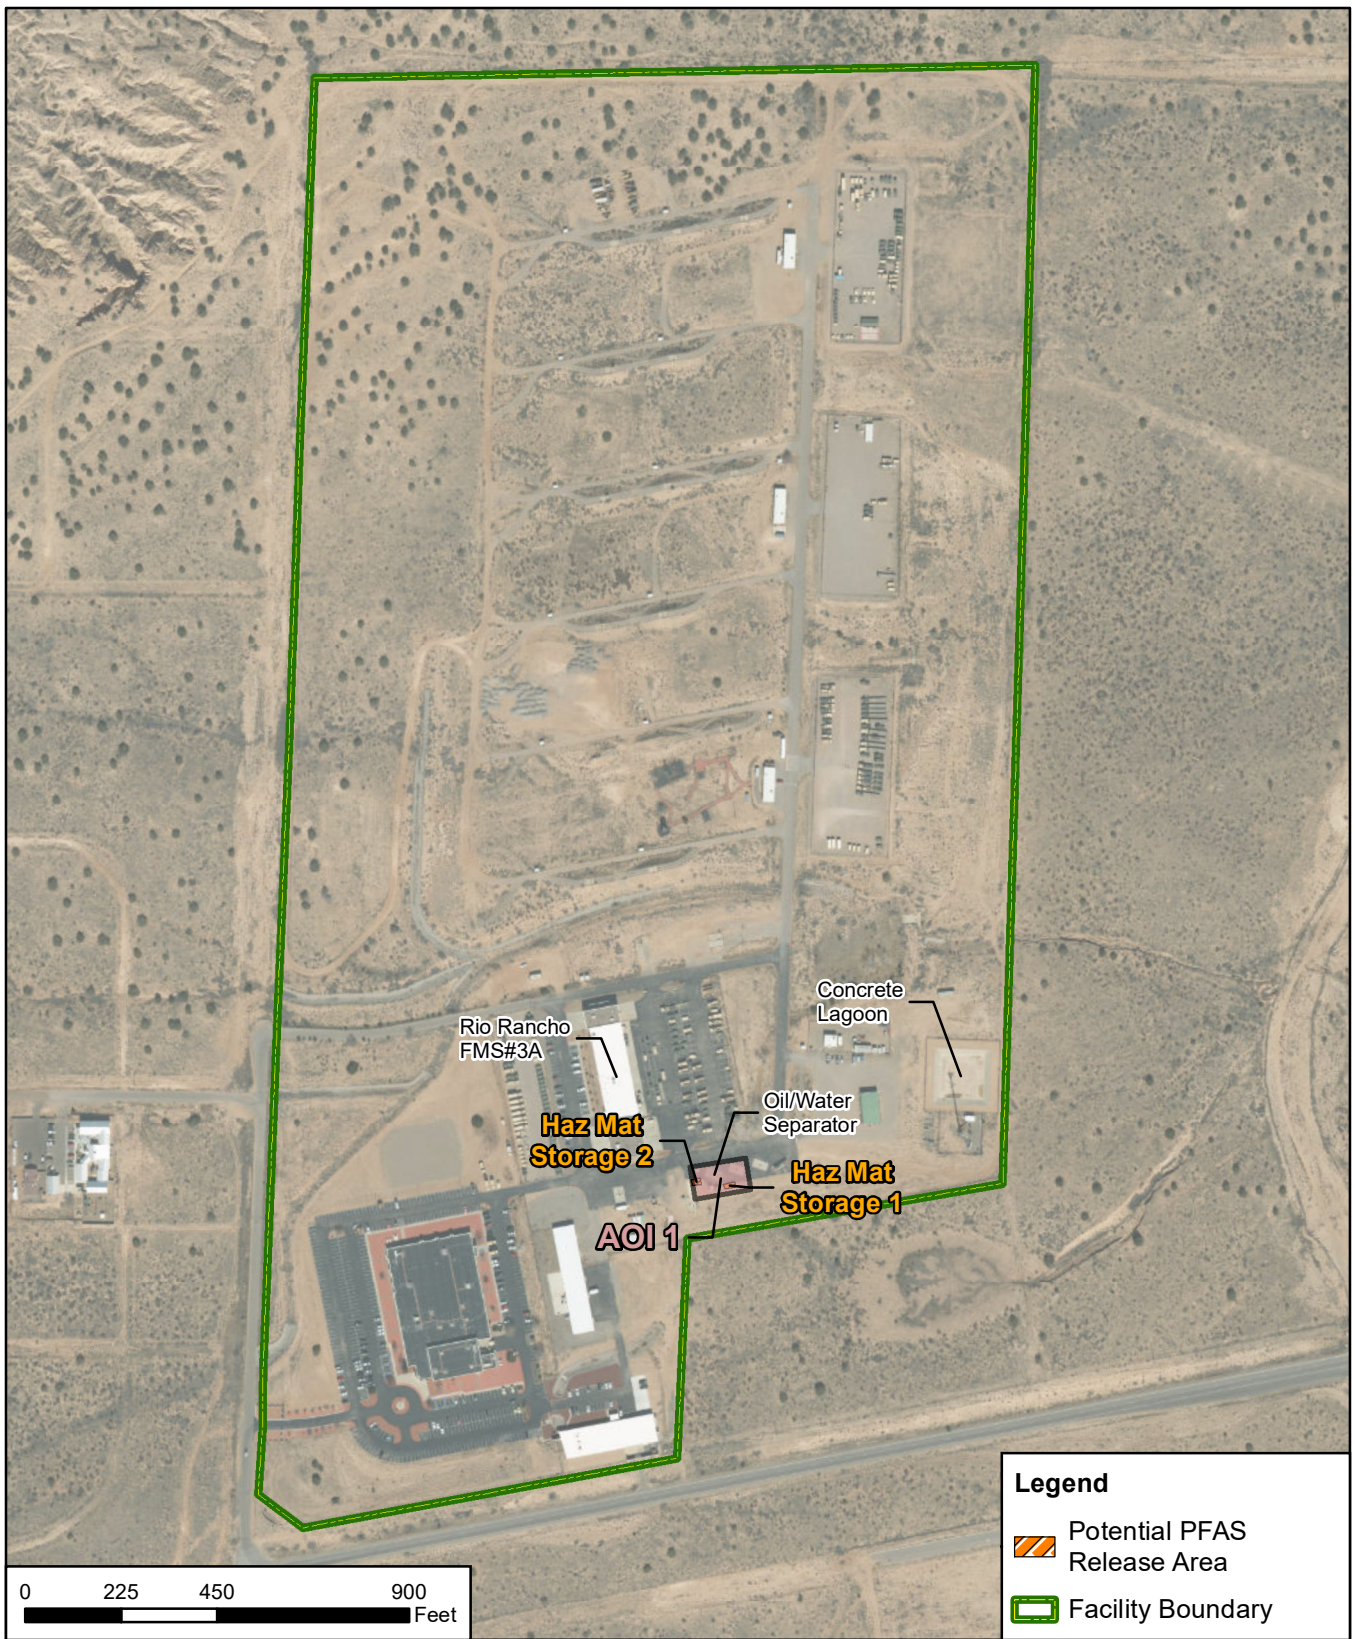
<b>Summary of Findings</b>	
 12420 Milestone Center Drive Germantown, MD 20876	<b>Figure 7-1</b>

The AOI is the hazardous materials storage lockers 1 & 2, where NMARNG discovered two previously opened 10-gallon containers of PFAS-containing substance were found in hazardous waste storage locker 1 sometime in early 2019 and then moved to hazardous waste storage locker 2 to be transported. Both of these containers, which are classified as Fiberboard or plastic drums, barrels, or kegs (DF) in the Uniform Hazardous Waste Manifest, were found half empty, with evidence of a small amount of product around the cap. Based on the PA findings and interviews with employees whose knowledge spans from 2014 to present, data gaps exist regarding historical activities concerning AFFF use and storage at the facility from when the facility opened to 2014. As such, there is potential for exposure to PFAS contamination in soil and airborne soil particulate in the event that releases occurred.

Area of Interest	AOI Location	Rationale	Potential Future Action
AOI 1 Hazardous Materials Storage Lockers 1 & 2	35°22'14.00"N; 106°39'04.49"W	Potential release from two 10-gallon containers of AFFF discovered half full, with product on around the cap.	Proceed to an SI focusing on soil.

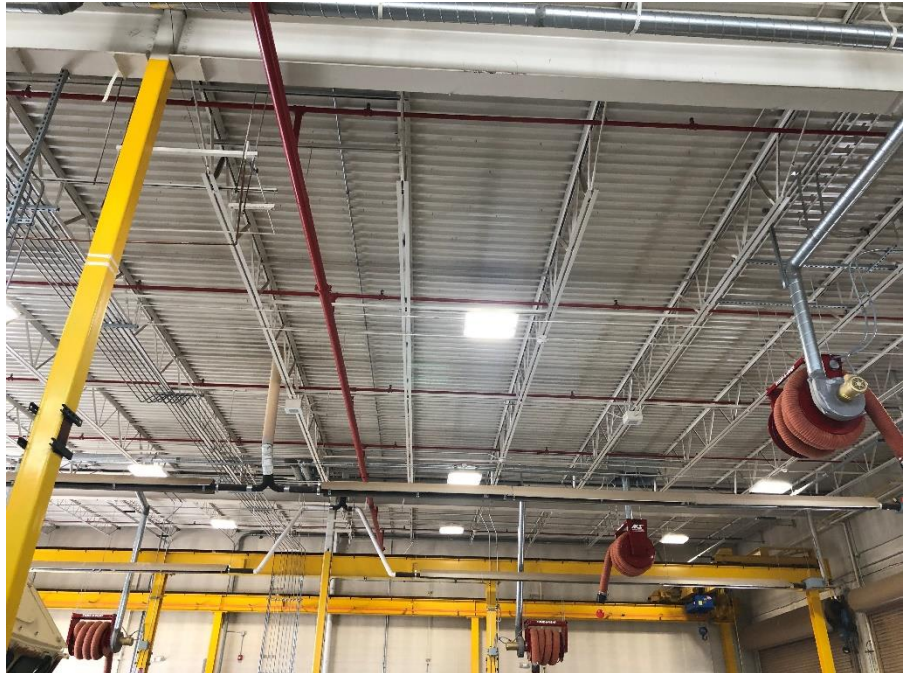
Facing South. Water sprinkler  
system in FMS.

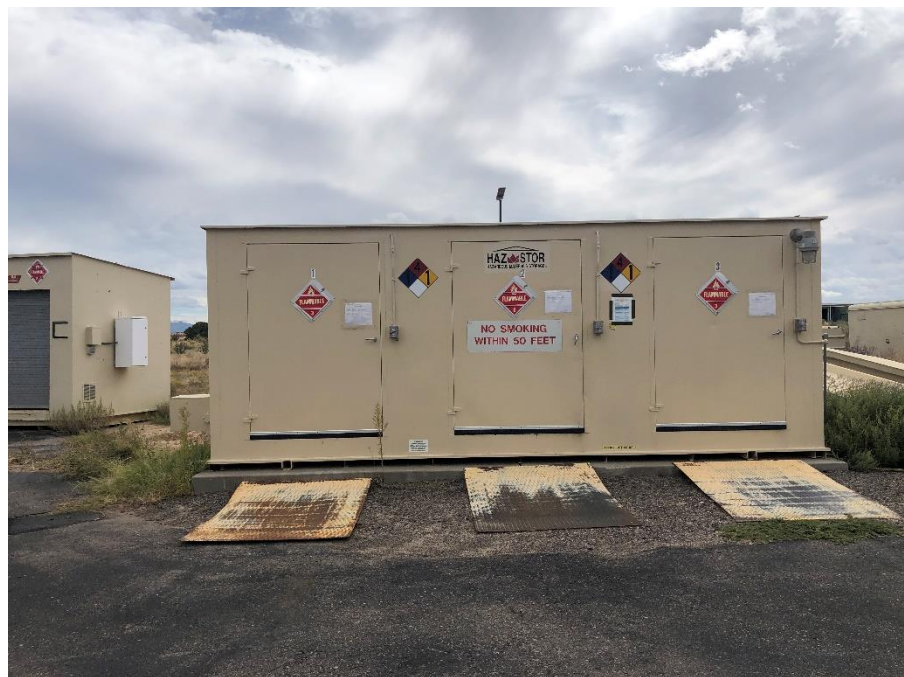
### Photograph No. 2

Facing South. Hazmat Storage  
Locker 1 where PFAS  
containers were found.

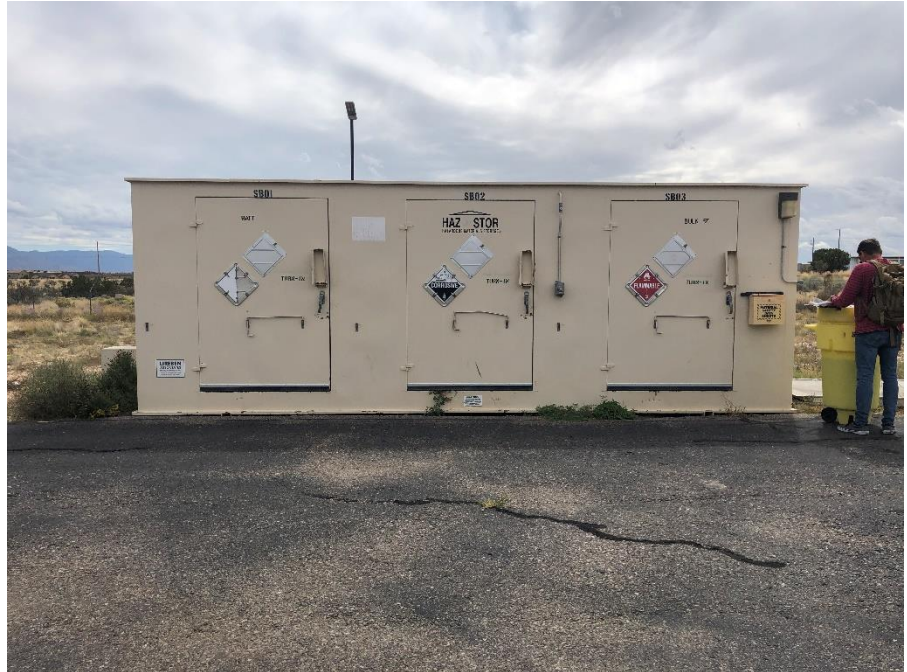
Facing Southeast. Hazmat  
Storage Locker 2 where PFAS  
containers were moved to be  
picked up by Envirokleen.

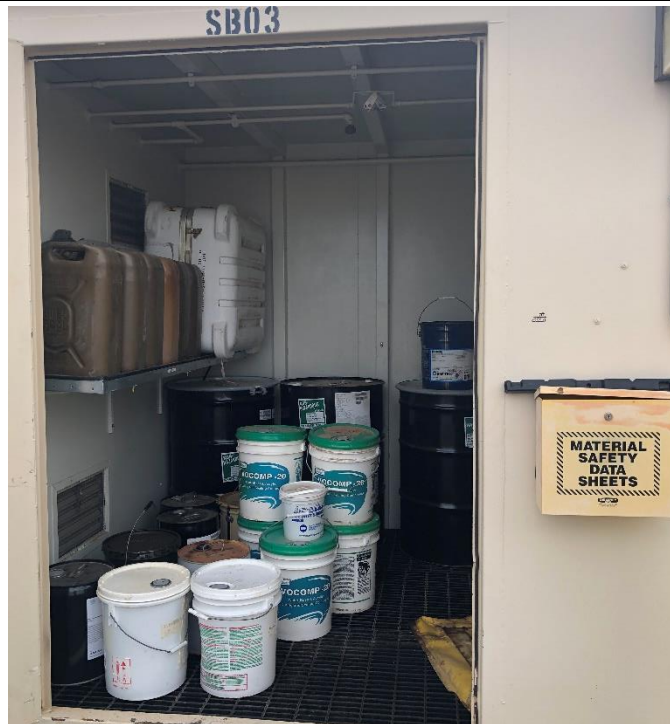
### Photograph No. 4

Facing Southeast. Inside of  
Hazmat Storage Locker 2.
