# FINAL Preliminary Assessment Report Albany Army Aviation Support Facility #3 Latham, New York

Perfluorooctanesulfonic Acid (PFOS) and Perfluorooctanoic  
Acid (PFOA) Impacted Sites  
ARNG Installations, Nationwide

April 2020

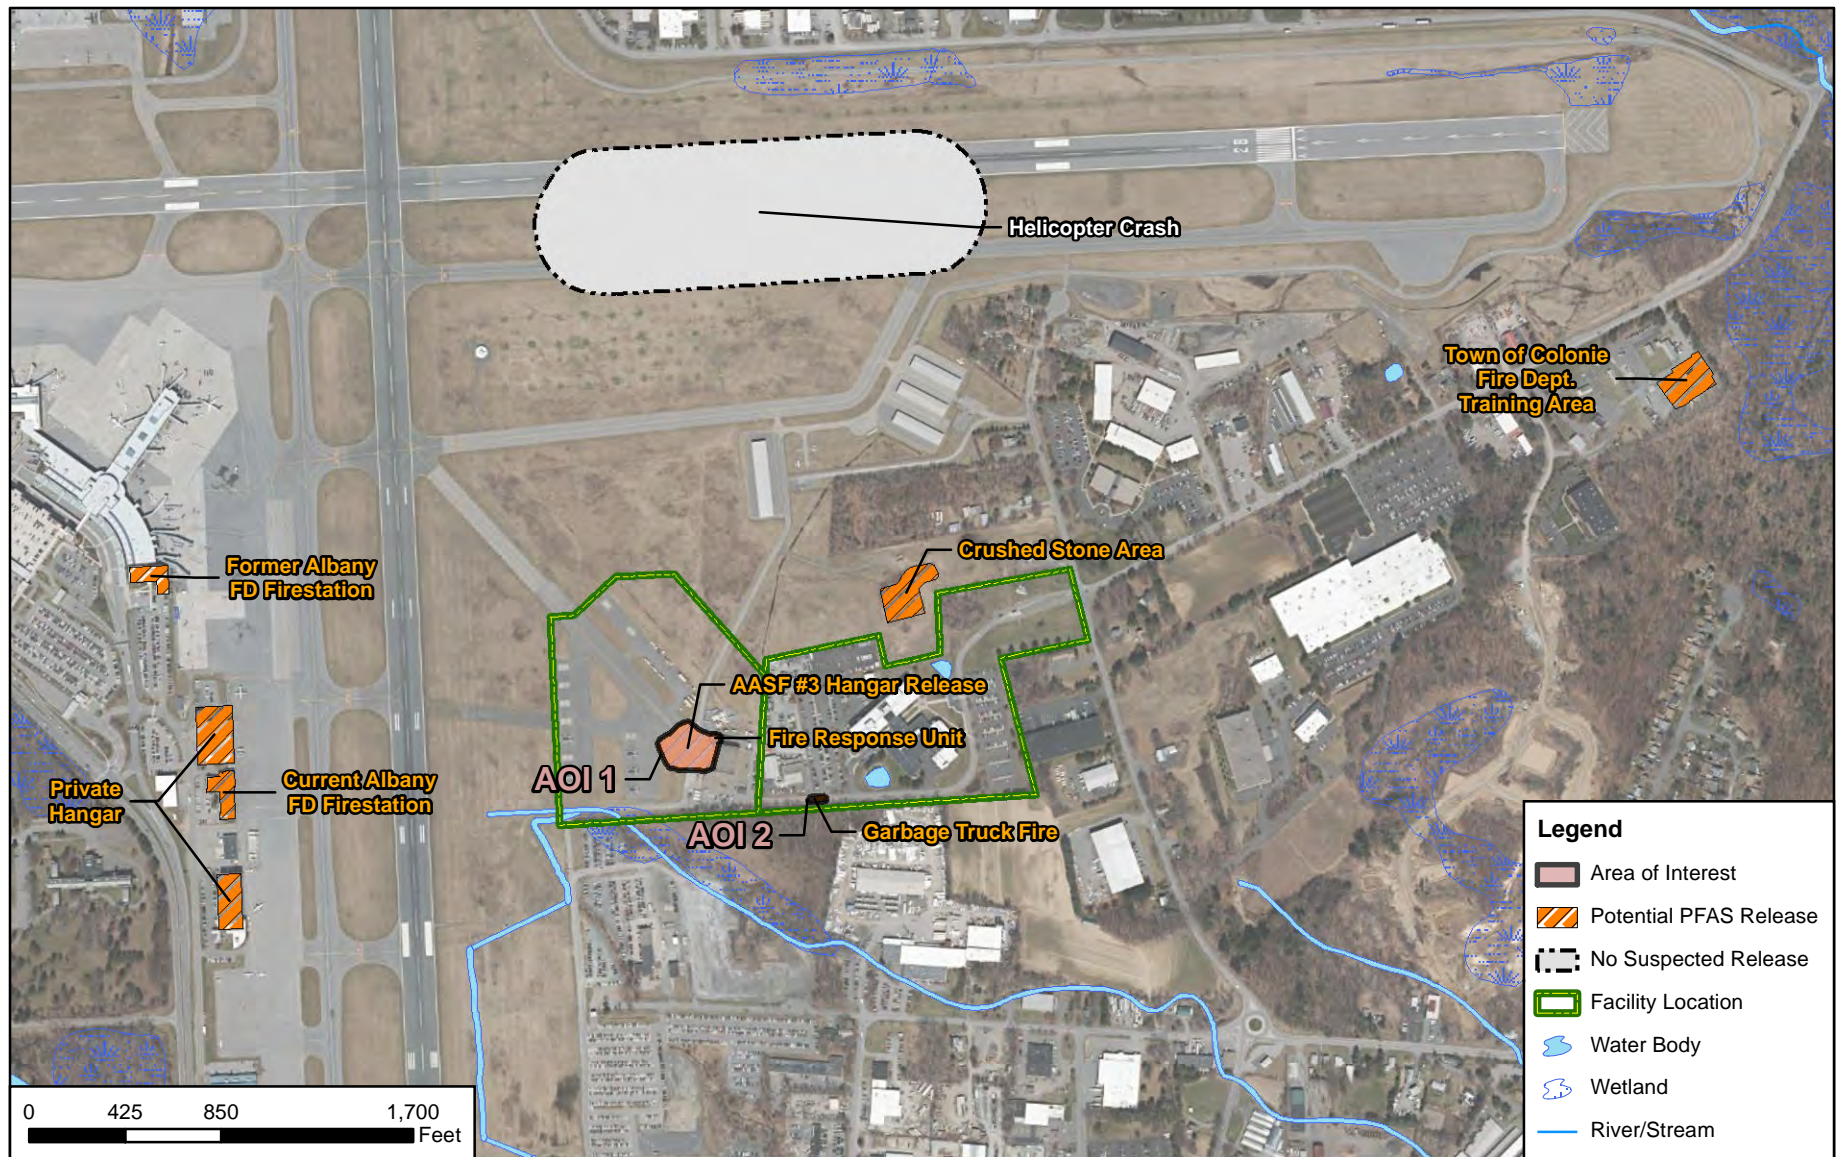
12420 Milestone Center Drive Germantown, MD 20876	Figure ES-1
SCALE	1:10,200	CHK BY	MB	1/31/2020			
Base Map: National Agricultural Imagery Program, 2016 Well Data: VT Dept of Environmental Conservation, Water Resource Section; ARNG		PM	RG	1/31/2020

Two AOIs related to potential PFAS releases was identified at the Albany AASF #3 during the PA. The AOIs are shown on **Figure ES-1** and described in the **Table ES-1** below.

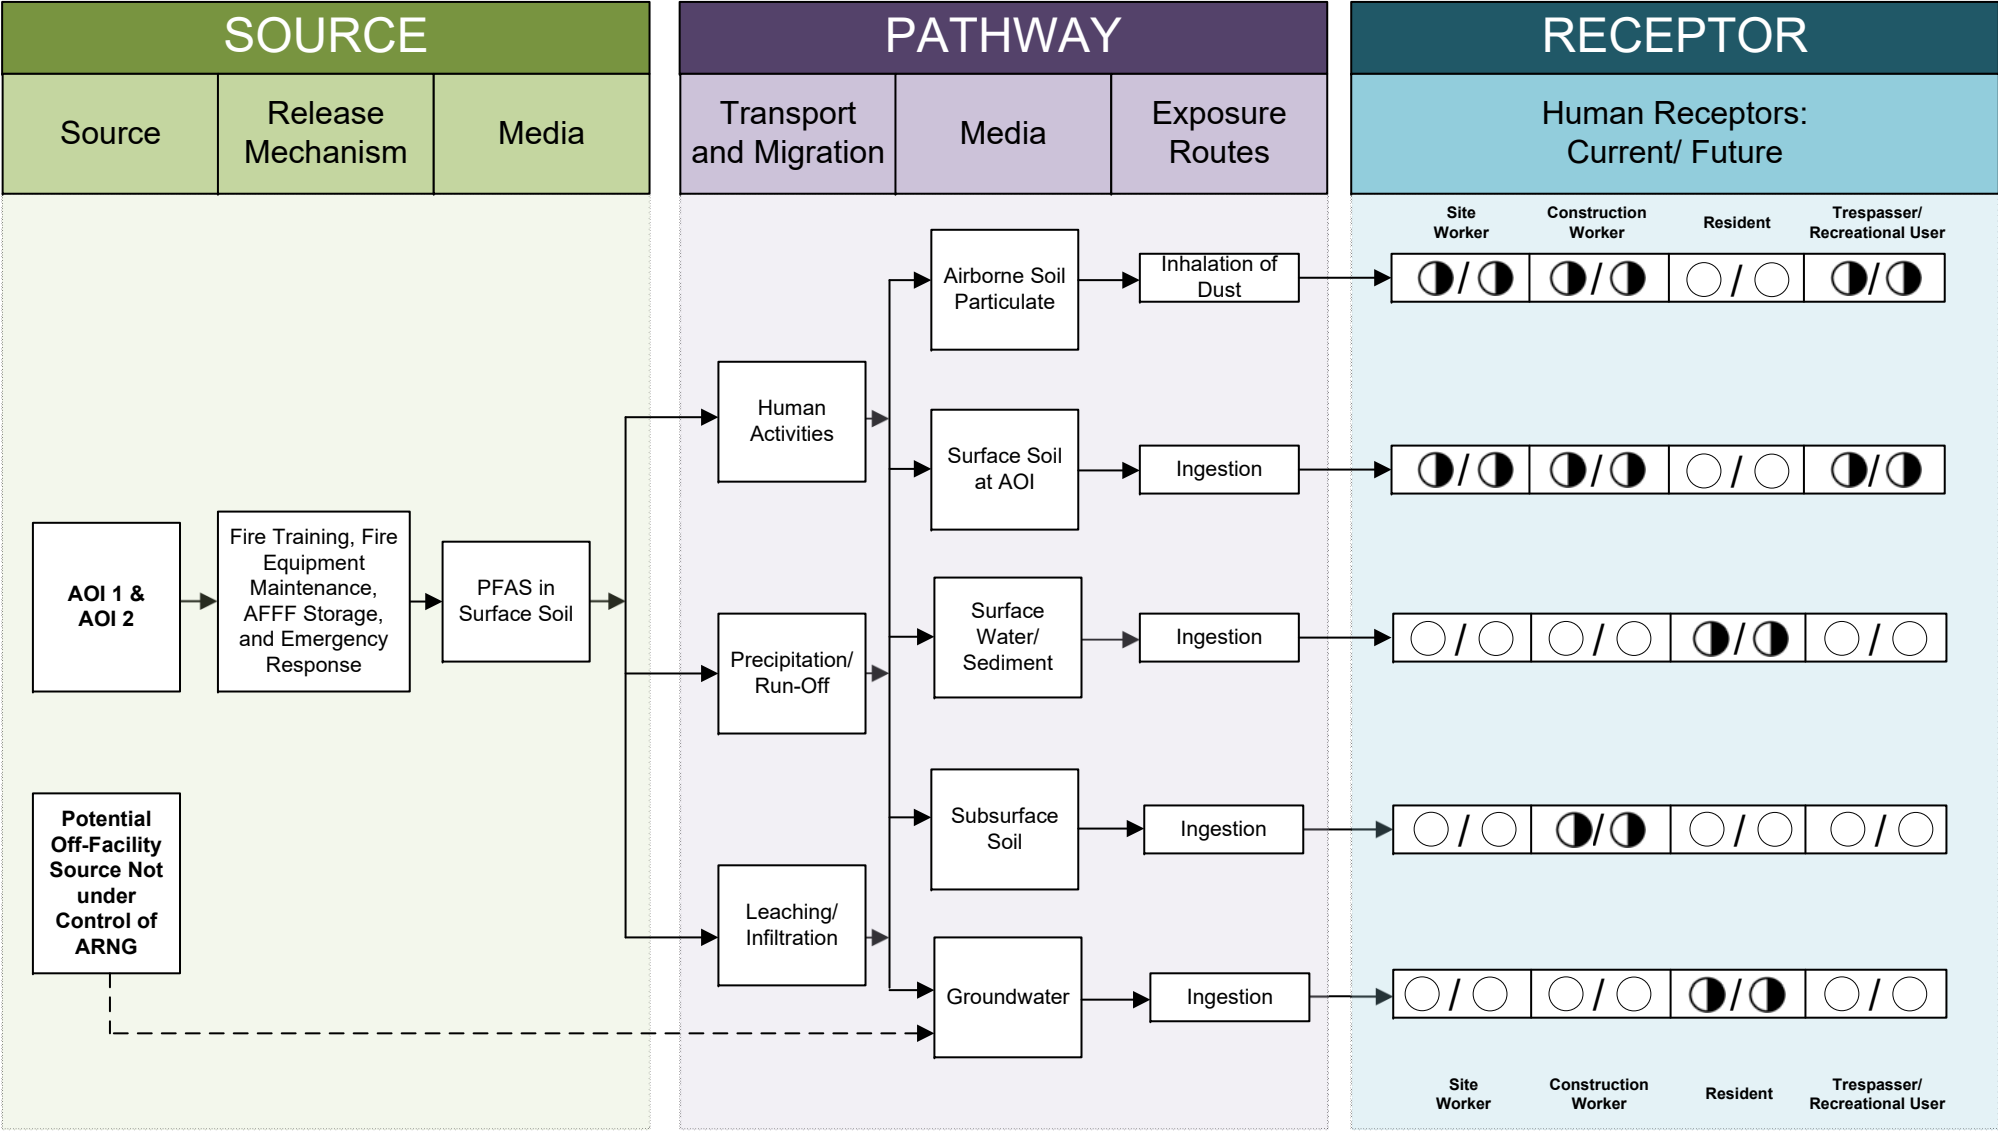
**Figure ES-2**  
Conceptual Site Model  
Albany AASF #3

Based on potential PFAS releases at these AOIs, there is potential for exposure to PFAS contamination in media at or near the facility. The preliminary CSM for Albany AASF #3, which presents the potential receptors and media impacted, is shown on **Figure ES-2**.

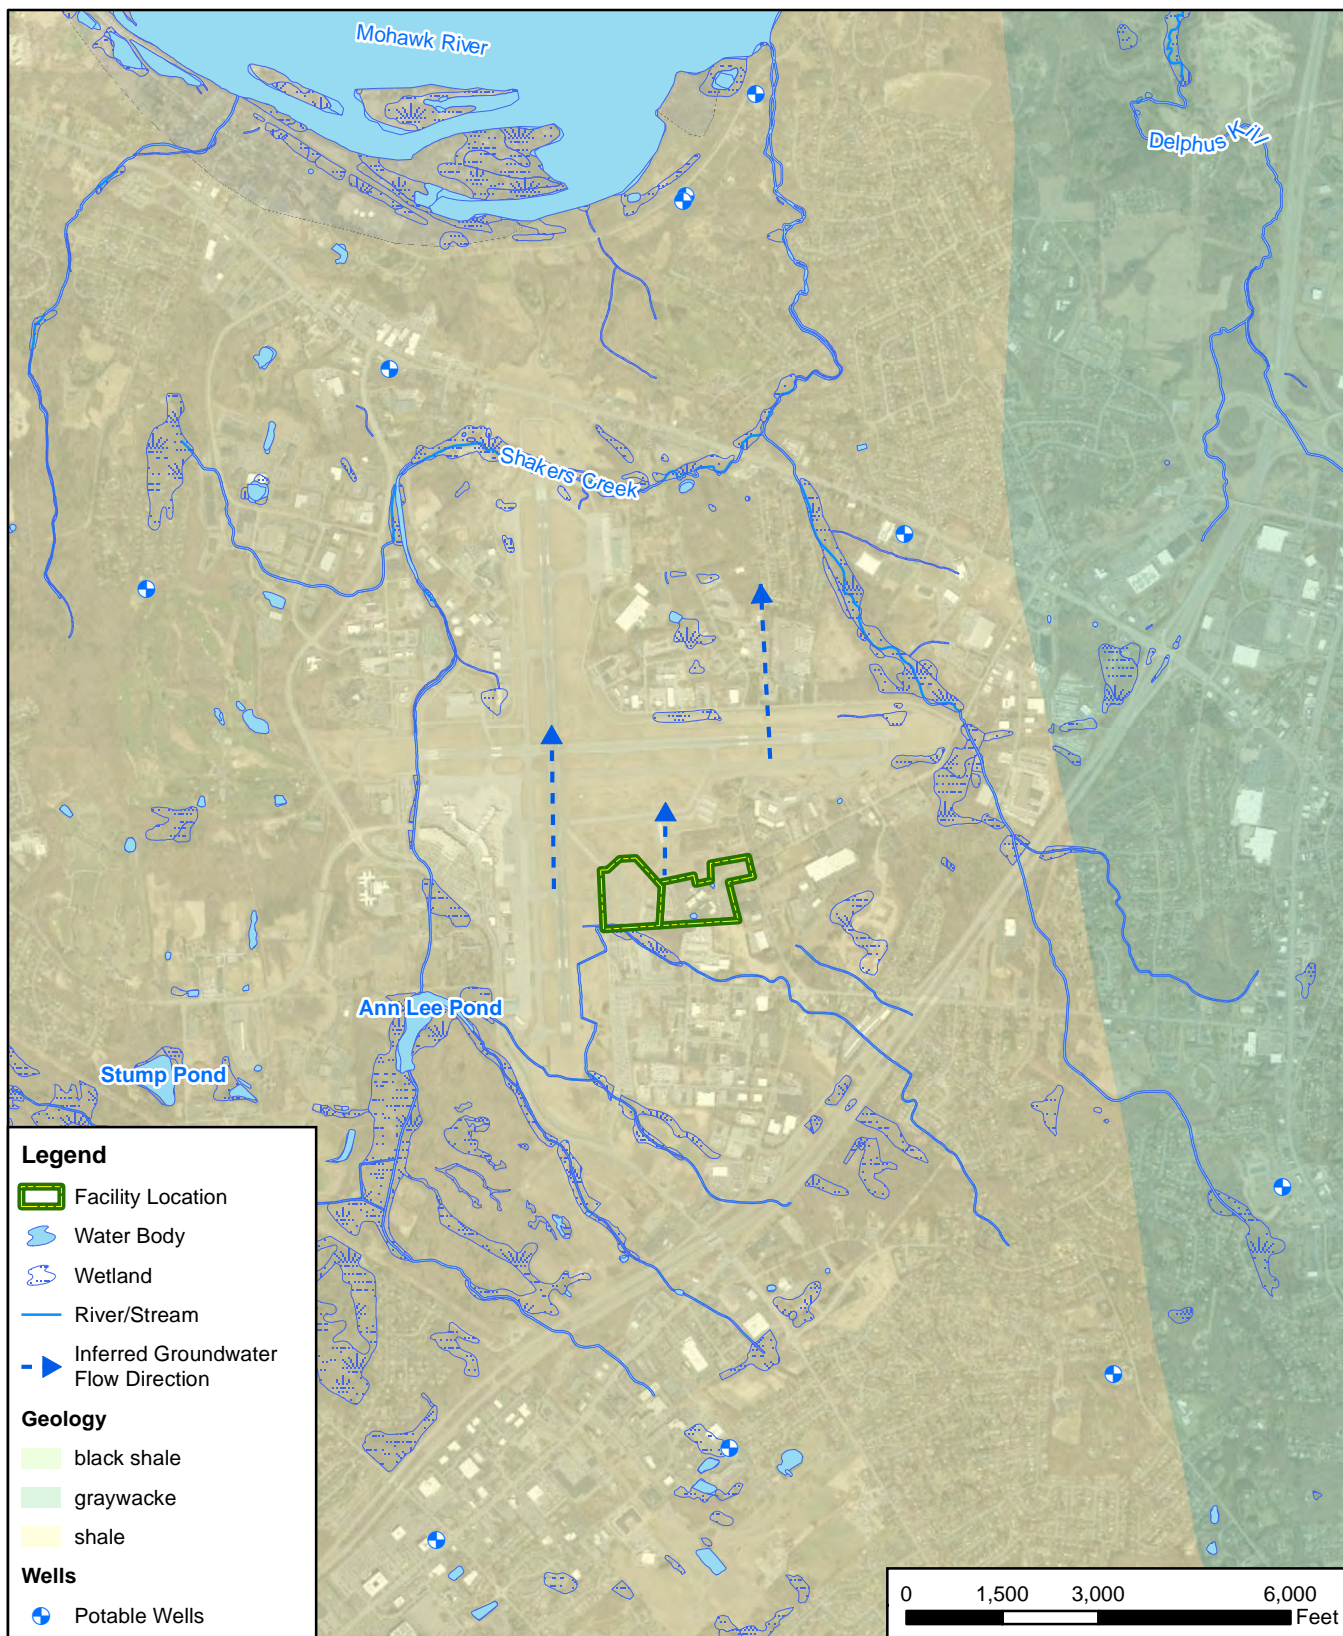
12420 Milestone Center Drive Germantown, MD 20876	Figure 1-2	
SCALE	1:36,000	CHK BY	MB	1/31/2020				
Base Map: NYS Digital Ortho-imagery Program (NYSDOP), 2016		PM	RG	1/31/2020

Groundwater direction in the cantonment area is generally from north towards the Mohawk River (**Figure 1-2**). There are several potable wells located within 1.5 miles to the southeast, northwest, and northeast of the facility (**Figure 1-2**). The depth to groundwater ranges between 4.5 and 150 feet below ground surface (bgs), with well depths ranging anywhere from 30 to 900 feet bgs and yield anywhere from 0.5 to 120 gallons per minute.

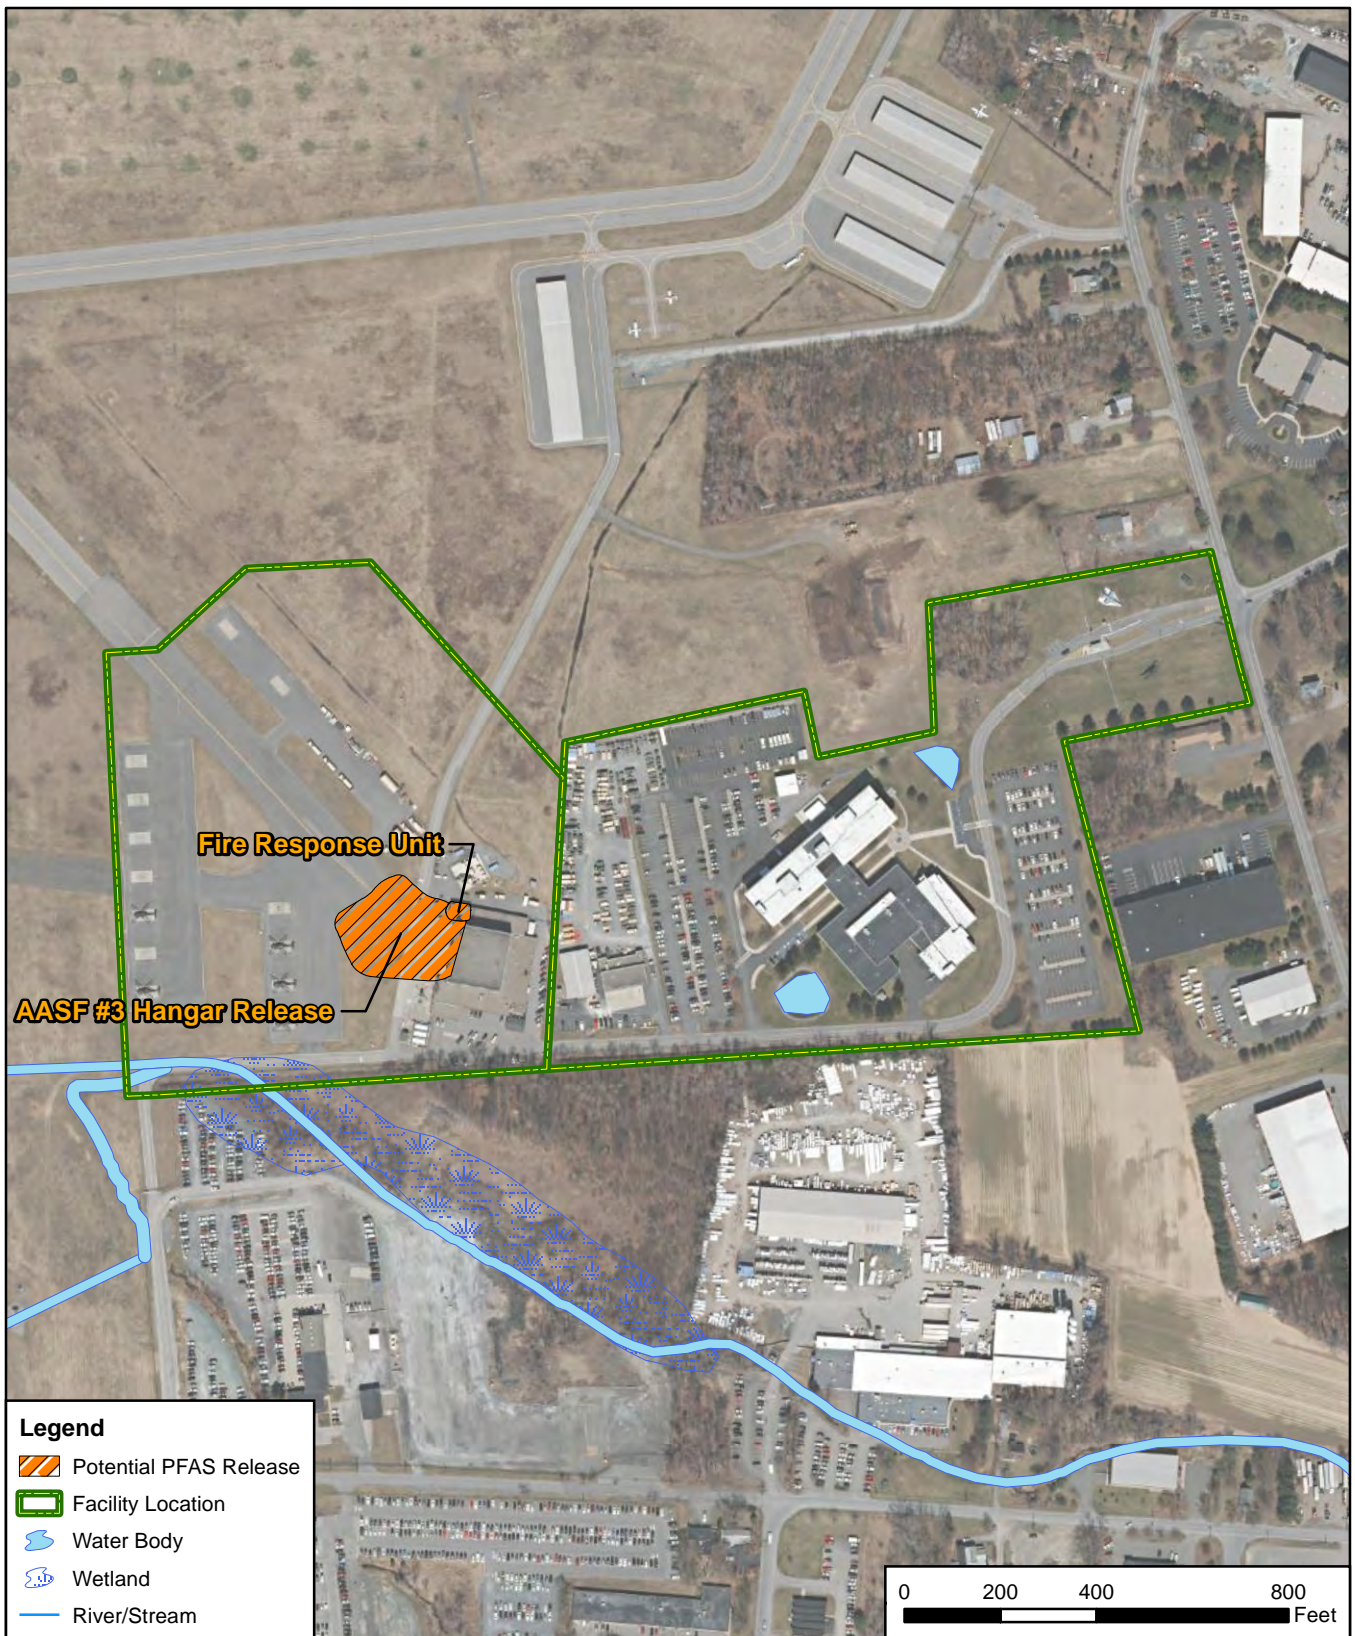
Non-Fire Training Areas	
 12420 Milestone Center Drive Germantown, MD 20876	<h2 style="margin: 0;">Figure 3-1</h2>

The NYARNG Albany AASF #3 is located 0.45 miles southeast from the end of Runway 1, at geographic coordinates 42°44'32.16"N; 73°47'57.83"W. AASF #3 was built sometime between 1977 and 1985. A 1987 lease agreement (**Appendix A**) states the facility and an adjacent 8.2-acre parcel of land used for certain aircraft and vehicle parking was leased to NYARNG in 5-year increments for a period not to extend beyond 40 years. The AASF #3 Hangar (**Figure 3-1**) had a 3% AFFF fire suppression deluge system installed in 2012. An initial testing of the system caused AFFF to completely fill the hangar. The hangar bay doors were opened, allowing the AFFF to spill out onto the tarmac and into the grass. The release was cleaned up and disposed of by a contractor. It is unknown how much AFFF was used during the testing or spilled outside of the hangar. Annual testing of the deluge system is conducted using only water. One 35-gallon 3% AFFF tank is located inside the hangar on the southern wall (**Appendix C**).

The former Fire Response Unit was housed in a room attached to the northern side of the AASF #3 Hangar (**Figure 3-1**). This unit existed between 1983 and 1992 and responded to all fire and emergency related incidents that occurred at the Albany AASF #3 and Albany International Airport in conjunction with the AFD. The Fire Response Unit had one firetruck with a 150-gallon dual line of 3% AFFF and water tank and a 400-gallon Purple K tank. It is unknown where the firetruck was filled, washed, or if it ever leaked within the Fire Response Unit room. This room now contains the 500 gallon 3% AFFF tank, which is connected to the hangar deluge system and sits on a raised platform against the wall (**Appendix C**). Annual testing of the deluge system is conducted using only water.

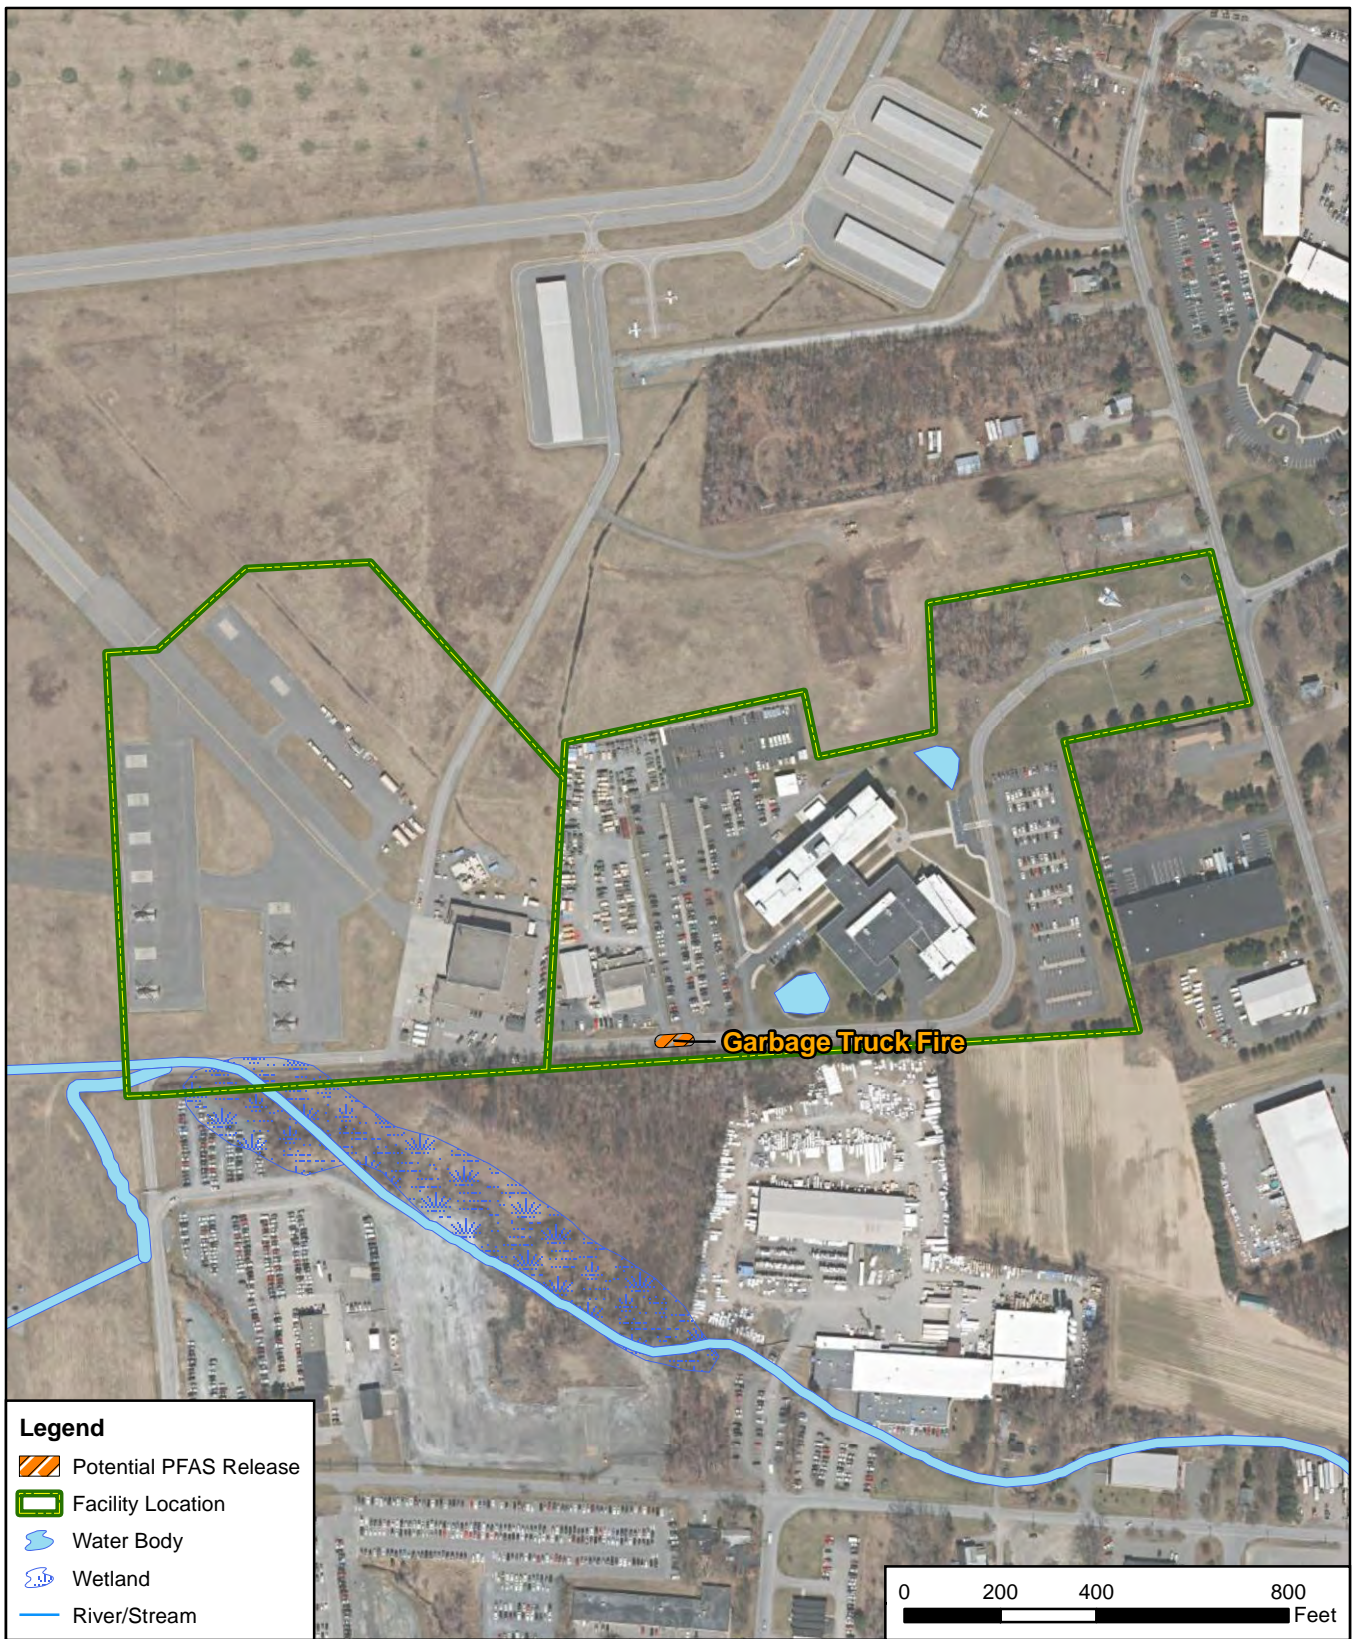
**Figure 4-1**

During the VSI, NYARNG staff stated that there was a fire in the back of a garbage truck in May 2017. The fire occurred southeast of the hangar. The CFD responded to the incident, but it is unknown if any AFFF were used during the emergency response.

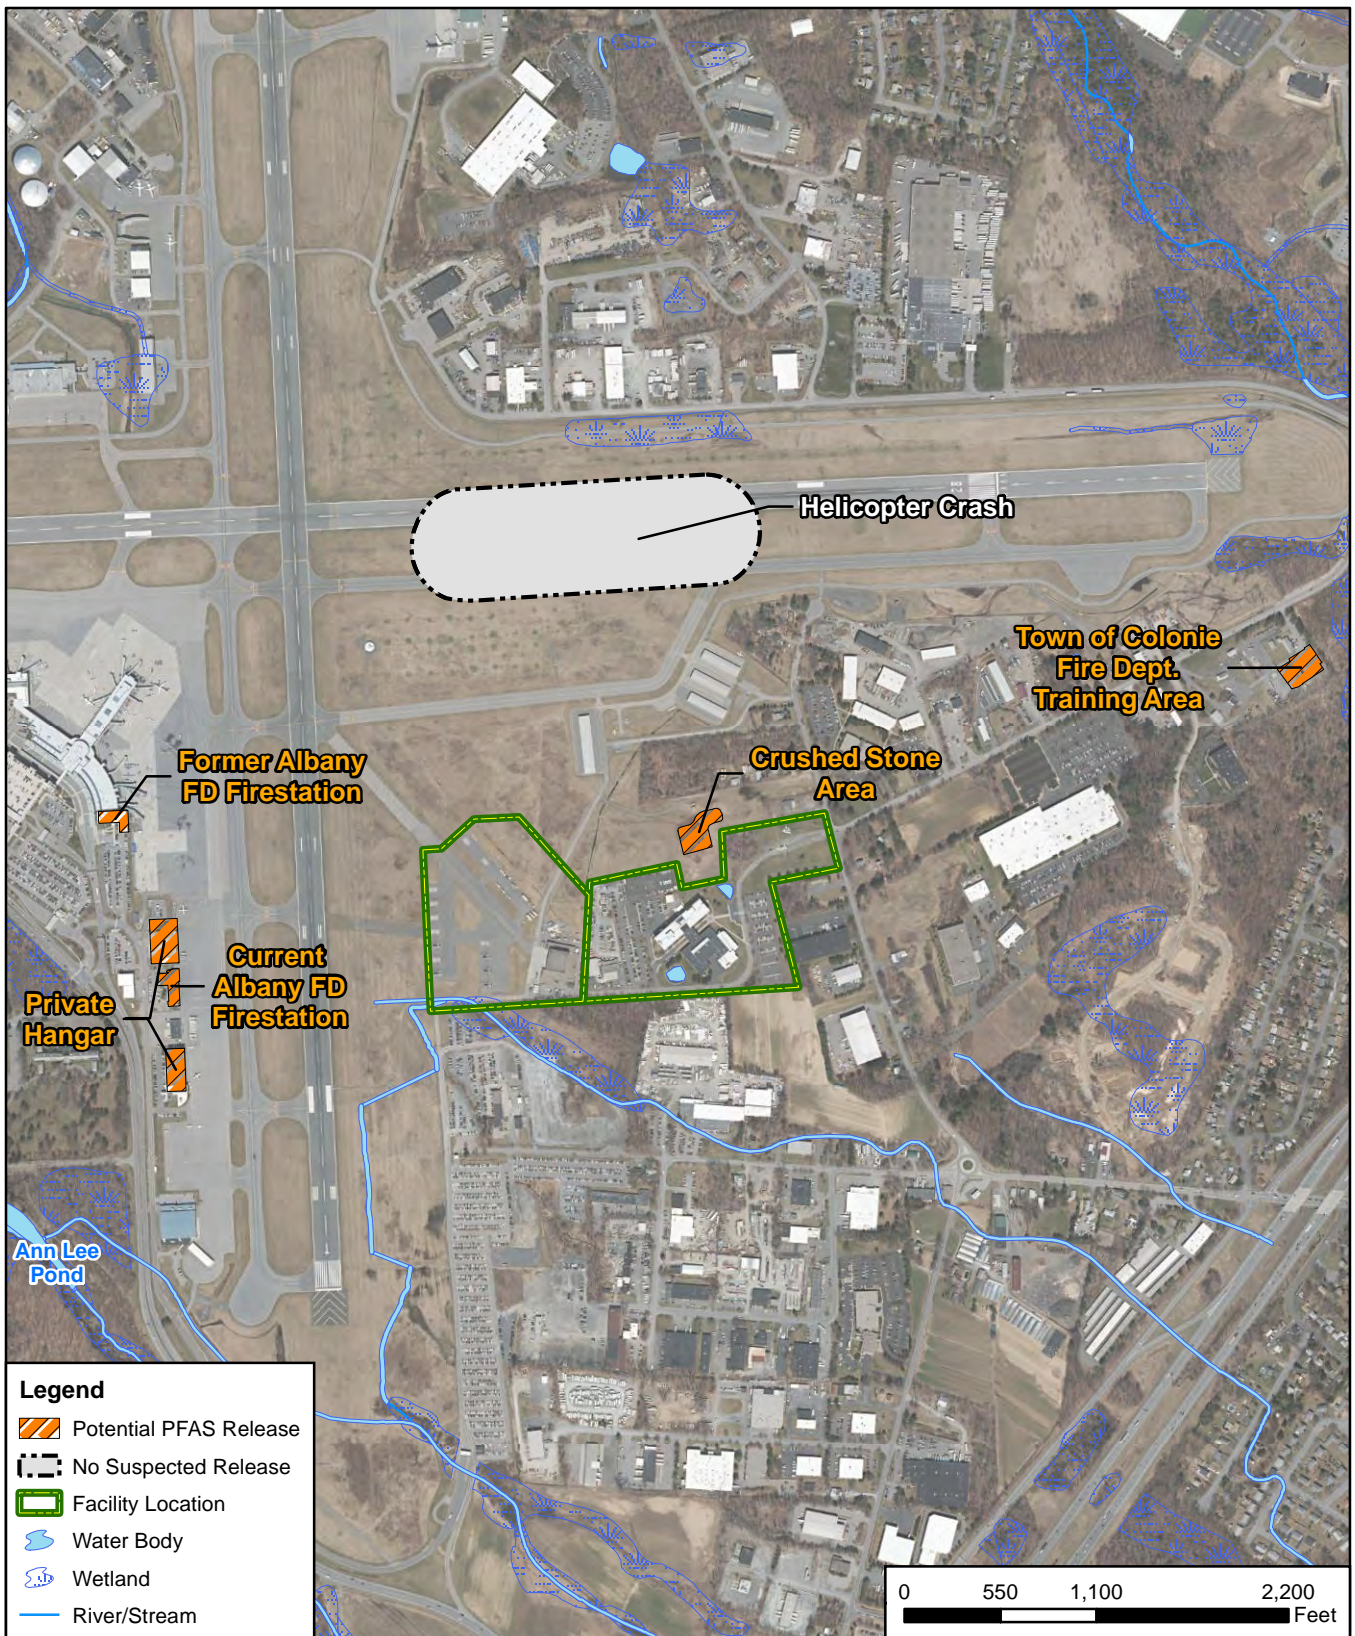
Roughly 0.20 miles northeast of the facility is the Crushed Stone Area, where the AFD and the NYARNG Fire Response Unit conducted joint live burn fire training once per year between 1983 and 1992 (**Figure 5-1**). There is some discrepancy regarding whether diesel fuels were used for the fire; however, more than one source said fuels were used during the training events. Interviews with NYARNG and AFD staff stated that during and after fire training activities, the AFFF used for training was left to dissipate on the grass and soil. Joint nozzle testing also occurred during this period twice per year. Records indicate 20 gallons of 3% AFFF were used during the activities. The Crushed Stone Area is downgradient from the facility, and based on northern groundwater flow direction, it is possible that potential PFAS contamination from these fire training activities is being carried into the residential and industrial areas to the north of Albany AASF #3.

A helicopter reportedly crashed sometime in the early 1980s, possibly 1983-1984, on Albany International Airport property roughly 0.45 miles north of the Albany AASF #3. The AFD responded to the incident. Based on an interview with the AFD chief, no AFFF was used at the crash site (**Appendix B**), and therefore has been identified as an area of “No Suspected Release” on **Figure 5-1**

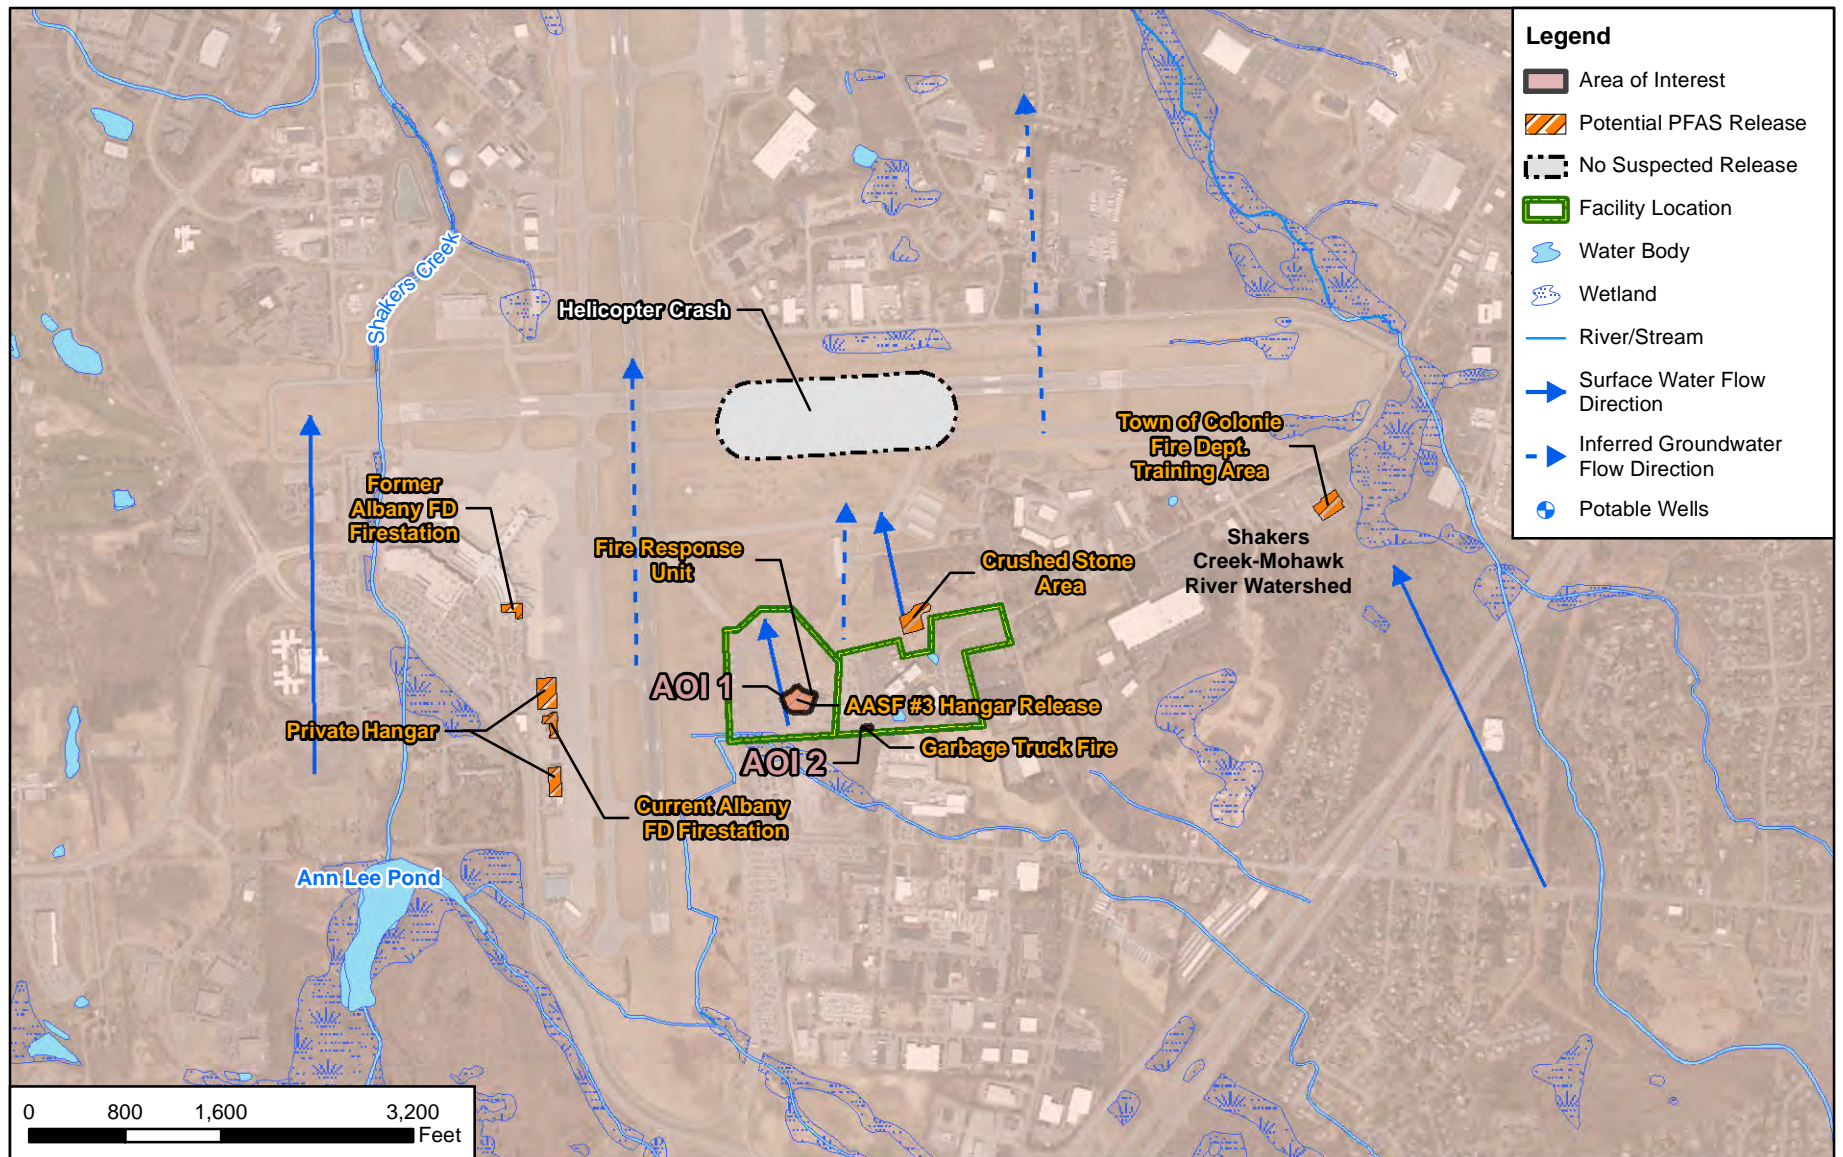
12420 Milestone Center Drive Germantown, MD 20876</div>	Figure 6-1	
SCALE	1:19,200	CHK BY	MB	1/31/2020				
Base Map: National Agricultural Imagery Program, 2016			PM	RG				1/31/2020
Well Data: VT Dept of Environmental Conservation, Water Resource Section; ARNG

AOI 1 encompasses the release of AFFF from the AASF #3 Hangar and the former Fire Response Unit room. The area surrounding the AOI is predominantly paved with a few grassy areas between paved areas. A 500-gallon 3% AFFF fire suppression system is stored in the AASF #3 Hangar. The tank is located in the former Fire Response Unit building. An initial testing of the system caused AFFF to completely fill the hangar. The hangar bay doors were opened, allowing the AFFF to spill out onto the tarmac and into the grass. The release was cleaned up and disposed of by a contractor. Knowledge regarding the fire suppression system is based solely on the recollections of interviewed personnel from the AFD and NYARNG.

AFFF releases at AOI 1 occurred on both paved areas and grassy surfaces. Some AFFF releases occurred directly onto surface soil but may also have infiltrated subsurface soil via cracks in pavement or joints between areas that are paved with different materials. If AFFF released at the AOI infiltrated the subsurface, then ground-disturbing activities in the grassy areas as well as beneath the pavement may result in potential PFAS exposure to construction workers.

Area of Interest	AOI Location	Rationale	Potential Future Action
AOI 1 – AASF #3 Hangar Release / Former Fire Response Unit	42°44'32.16"N, 73°47'57.83"W	Full fire suppression system release of 3% AFFF. It is unknown if the fire truck leaked or was filled inside or outside the building.	Proceed to an SI, focus on soil and groundwater
