# Final Preliminary Assessment Report Salisbury Army Aviation Support Facility #2, North Carolina

Perfluorooctane-Sulfonic Acid (PFOS) and Perfluorooctanoic  
Acid (PFOA) Impacted Sites  
ARNG Installations, Nationwide

August 2020

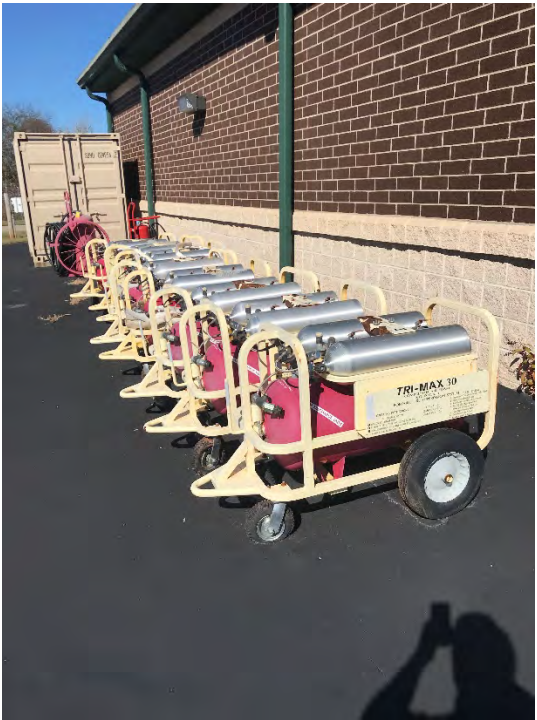
APPENDIX C – Photographic Log		
Army National Guard, Preliminary Assessment for PFAS		Salisbury AASF
		Salisbury, North Carolina
<b>Photograph No. 1</b>  <b>Description:</b> Eight Tri-Max 30™ extinguishers stored along the southern wall of the firehouse.  Date Taken: 23 October 2019

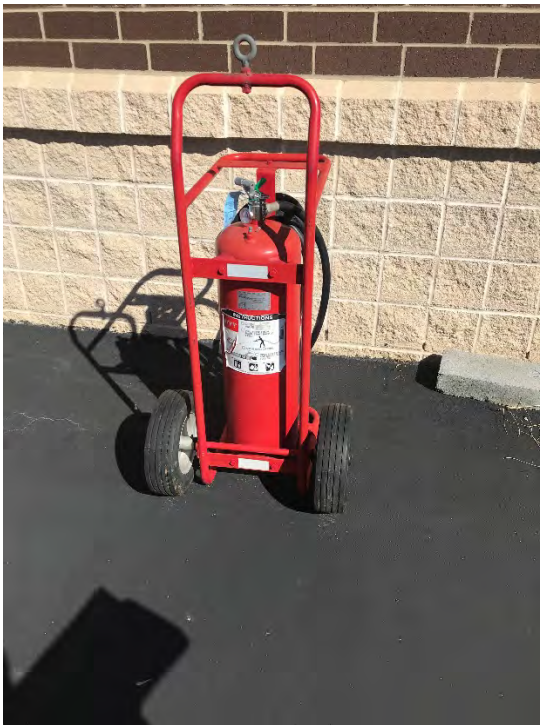
<b>Photograph No. 2</b>  <b>Description:</b> An additional AFFF extinguisher stored with the Tri-Max 30™ extinguishers. This unit is also assumed to contain PFAS agents.  Date Taken: 23 October 2019

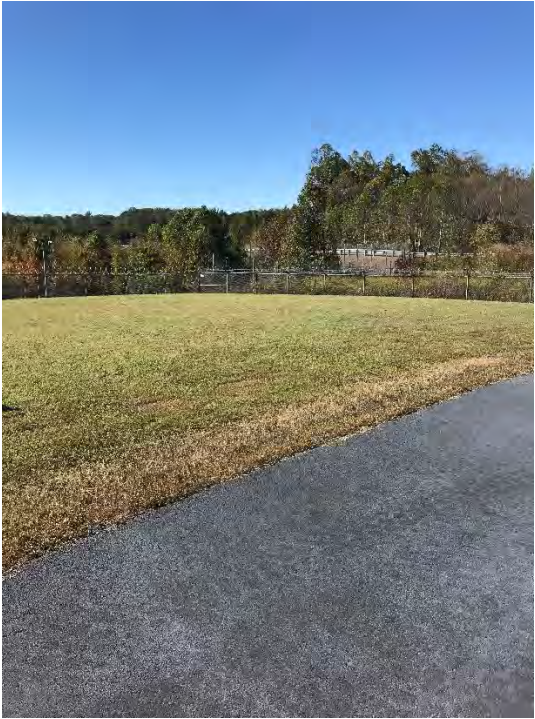
APPENDIX C – Photographic Log		
Army National Guard, Preliminary Assessment for PFAS		Salisbury AASF
		Salisbury, North Carolina
<b>Photograph No. 3</b>  <b>Description:</b> Current Aircraft Apron FTA taken from the southwest corner of the apron looking southwest.  Date Taken: 23 October 2019

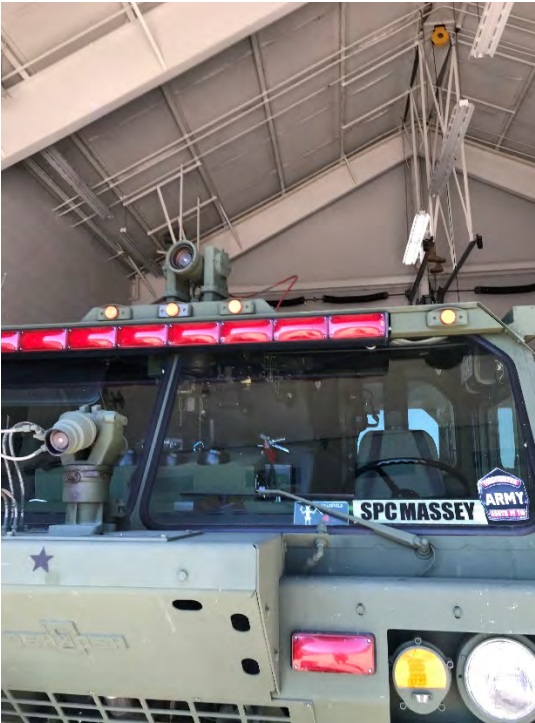
<b>Photograph No. 4</b>  <b>Description:</b> Front view of the TFFT parked in the firehouse vehicle bay.  Date Taken: 23 October 2019

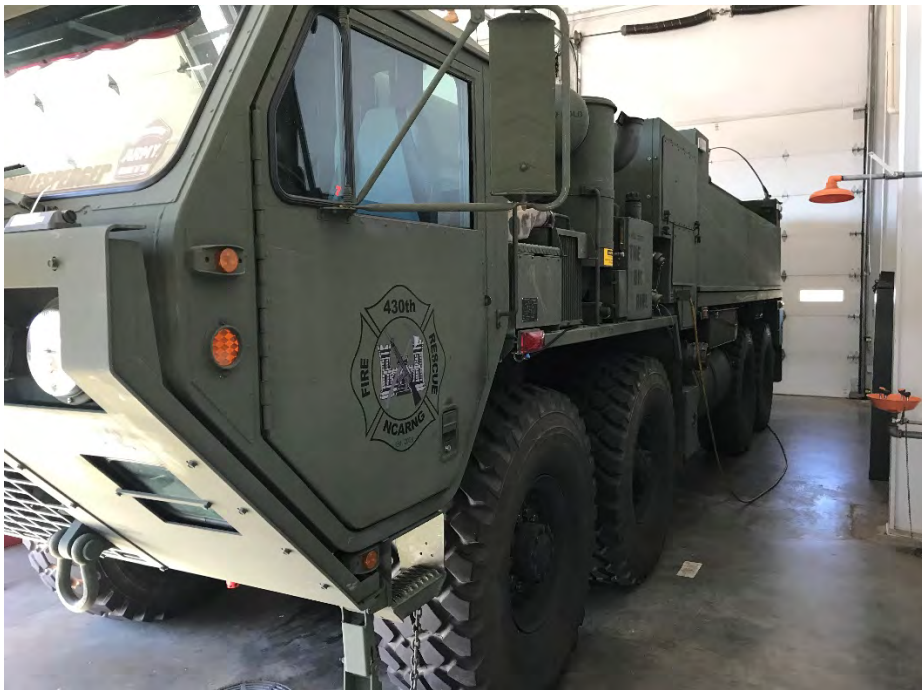
Army National Guard, Preliminary Assessment for PFAS		Salisbury AASF	Salisbury, North Carolina
<b>Photograph No. 5</b> <b>Description:</b> <p>The second firetruck parked inside the firehouse, known as the tanker.</p> <p>Date Taken: 23 October 2019</p>

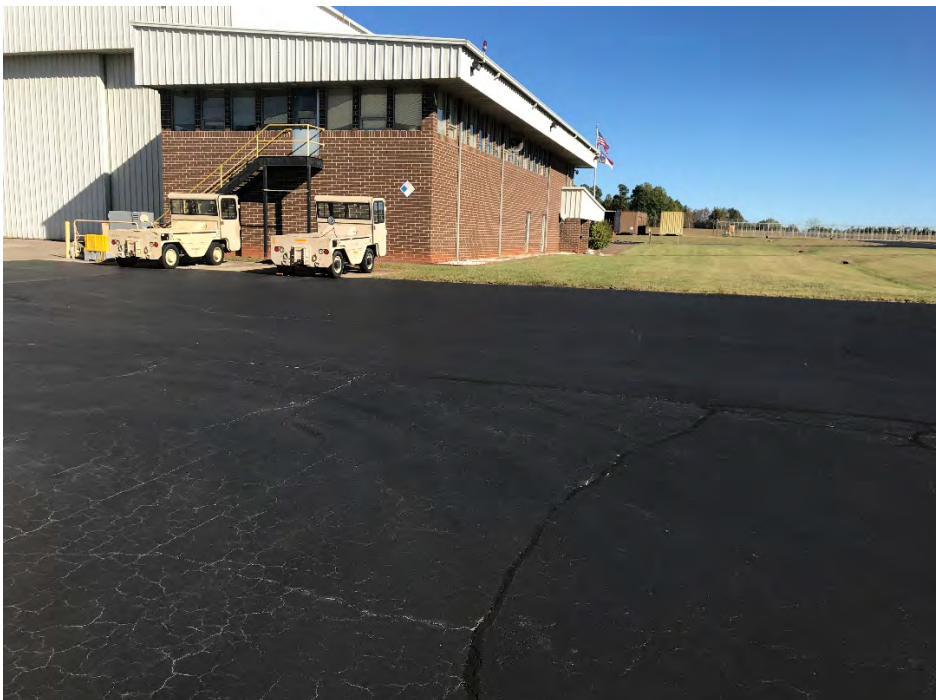
A former firetruck parking area was also described by interviewees on the paved area just north of the Aircraft Apron adjacent to the flight operations building. It is possible that firetrucks parked here contained AFFF and had the potential to leak.

<b>Photograph No. 6</b> <b>Description:</b> <p>The former firetruck parking area outside the Flight Ops Building, taken from the northern end of the aircraft apron looking east.</p> <p>Date Taken: 23 October 2019</p>

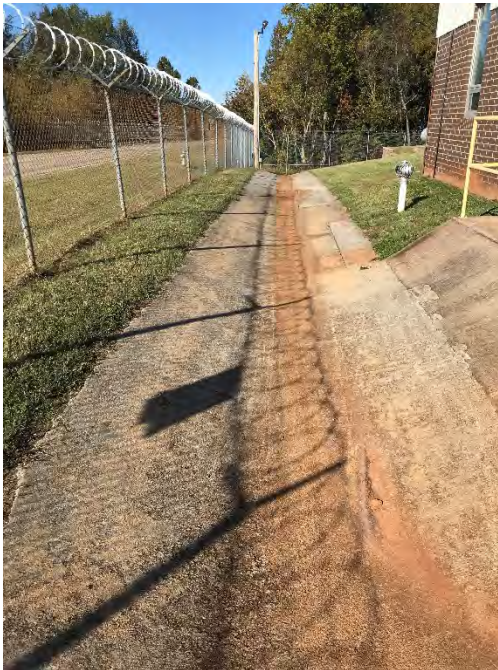
APPENDIX C – Photographic Log		
Army National Guard, Preliminary Assessment for PFAS	Salisbury AASF	Salisbury, North Carolina
<b>Photograph No. 9</b> <b>Description:</b> <p>The drainage swale located adjacent to the former firehouse (1989-2000s). Taken looking to the north in the same direction as drainage flow.</p> <p>Date Taken: 23 October 2019</p>

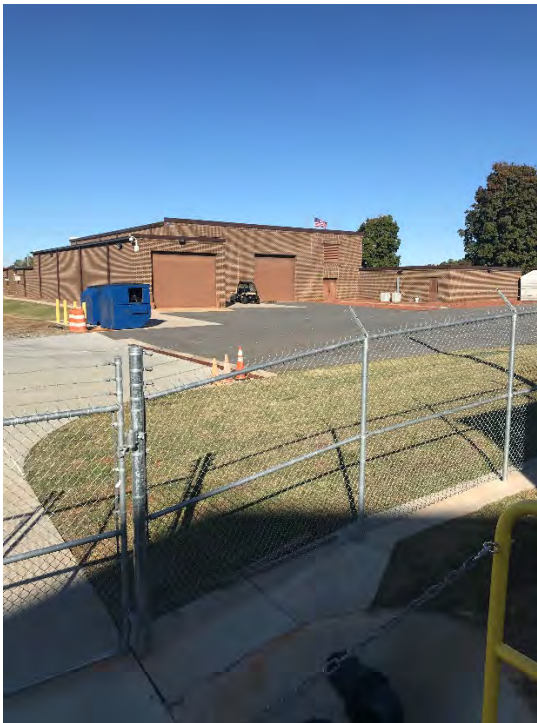
<b>Photograph No. 10</b> <b>Description:</b> <p>Looking north at the Armory. This building stands in the approximate area where the first firehouse had once existed (1979-1989).</p> <p>Date Taken: 23 October 2019</p>

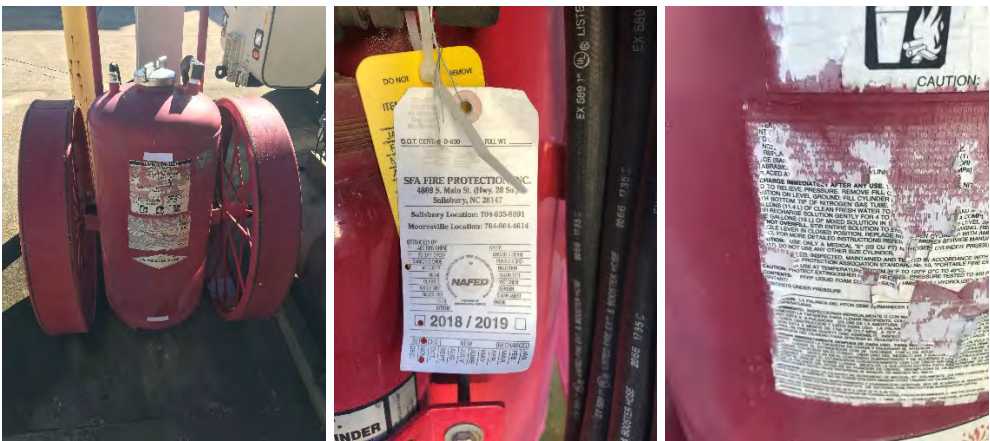
Army National Guard, Preliminary Assessment for PFAS	Salisbury AASF	Salisbury, North Carolina
<p><b>Photograph No. 11</b></p> <p><b>Description:</b></p> <p>Various images taken of a film forming fluoroprotein (FFFP) foam extinguisher located near the center of the flightline. The labels indicate the presence of fluorinated compounds in a mixture of hydrolyzed proteins. These extinguishers are found throughout the aircraft apron.</p> <p>Date Taken: 23 October 2019</p>

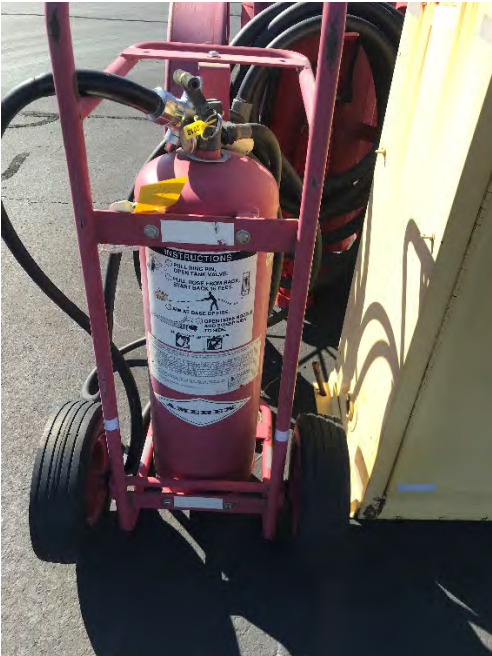
<p><b>Photograph No. 12</b></p> <p><b>Description:</b></p> <p>Located next to the FFP extinguisher, this Amerex extinguisher is visibly smaller and is charged with Purple K. These extinguishers are found throughout the aircraft apron.</p> <p>Date Taken: 23 October 2019</p>

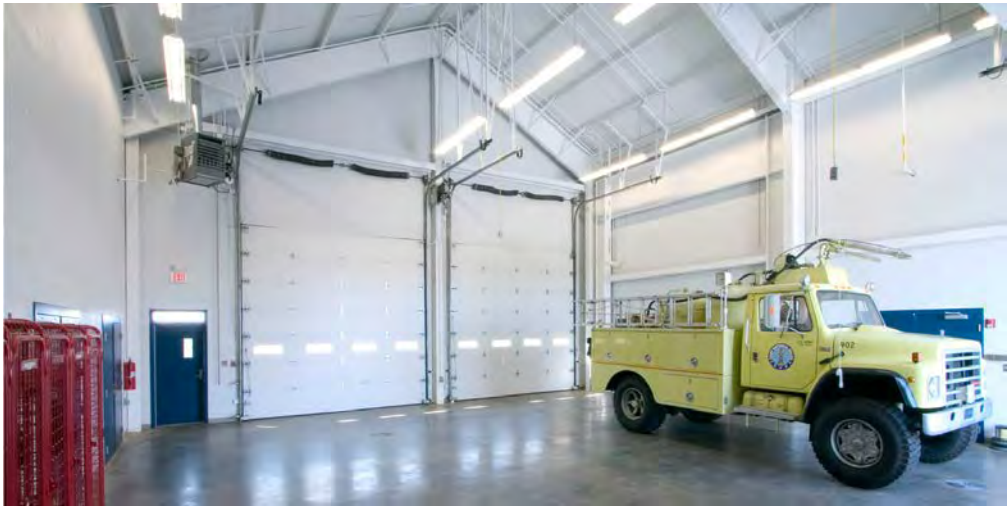
APPENDIX C – Photographic Log		
Army National Guard, Preliminary Assessment for PFAS	Salisbury AASF	Salisbury, North Carolina
<b>Photograph No. 13</b> <b>Description:</b> Looking east to the parking area adjacent to the fuel point at the former firetruck.  Date Taken: 23 October 2019	 	
<b>Photograph No. 14</b> <b>Description:</b> Photograph accessed from the architect's website after construction of the current firehouse showing the former firetruck in the vehicle bay.  Date Taken: 2006

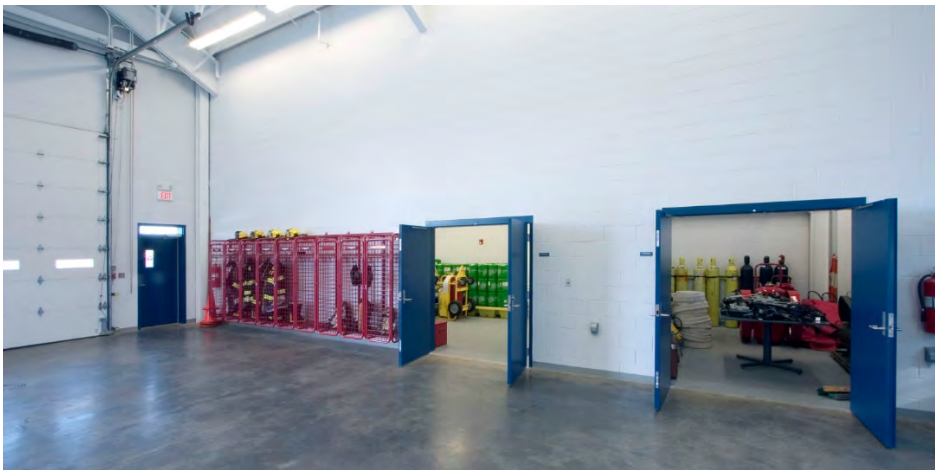
APPENDIX C – Photographic Log		
Army National Guard, Preliminary Assessment for PFAS	Salisbury AASF	Salisbury, North Carolina
<b>Photograph No. 15</b> <b>Description:</b> Photograph accessed from the architect's website after construction of the current firehouse showing AFFF stored in 5-gallon buckets inside the office room. Date Taken: 2006
