# Final Preliminary Assessment Report Morrisville Army Aviation Support Facility #1, North Carolina

Perfluorooctanesulfonic Acid (PFOS) and Perfluorooctanoic  
Acid (PFOA) Impacted Sites  
ARNG Installations, Nationwide

August 2020

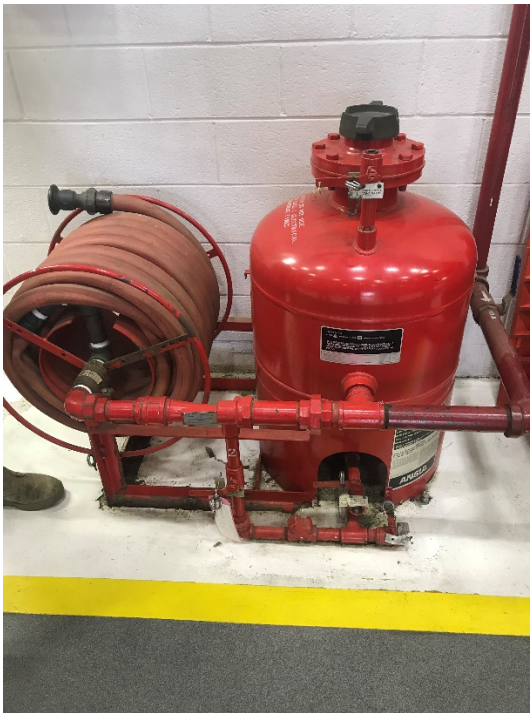
Sometime around 2016 or 2017, a small AFFF leak developed near the proportioner of the pump located along the southwestern wall of the hangar, at approximate geographic coordinates are 35°51'58.33"N; 78°46'45.44"W. The leak was described as a small puddle confined to the area immediately surrounding the pump, with a total volume of less than 5 gallons. The puddle was mopped up and emptied into a receptacle in the janitorial storage room that is connected to the sanitary sewer. The pump was turned off and subsequently serviced by a contractor. No leaks or seeps have been observed since the repair. During the VSI, the Ansul pump located along the southeastern wall of the hangar was marked as "Out of Order" and was reportedly left unrepaired to avoid replacing the foam. No leaks or other issues with this pump were known; however, the contractor for the AFFF dispensing system performs periodic inspections, and it is suspected that the contractor identified a maintenance issue during a recent inspection.

| Army National Guard, Preliminary Assessment for PFAS | Morrisville AASF | Morrisville, North Carolina |
|---|---|---|
| <p><b>Photograph No. 1</b></p> <p><b>Description:</b></p> <p>Ansul unit that leaked in 2015. Less than 5 gallons leaked. Pump located along Southwestern wall of the hangar. All Ansul pumps in the hangar have a 35 gal AFFF capacity</p> <p>Date Taken:<br/>22 October 2019</p> | | |

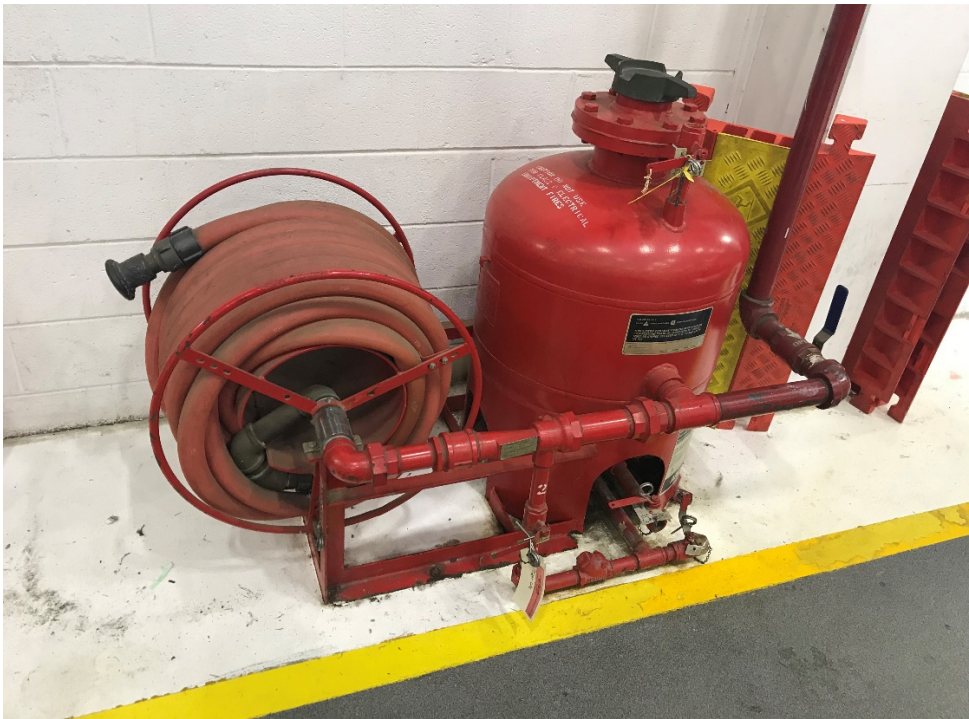
| Army National Guard, Preliminary Assessment for PFAS | Morrisville AASF | Morrisville, North Carolina |
|---|---|---|
| <p><b>Photograph No. 2</b></p> <p><b>Description:</b></p> <p>Second Ansul pump, located along northwestern wall of the hangar. No history of leaking.</p> <p>Date Taken:<br/>22 October 2019</p> | | |

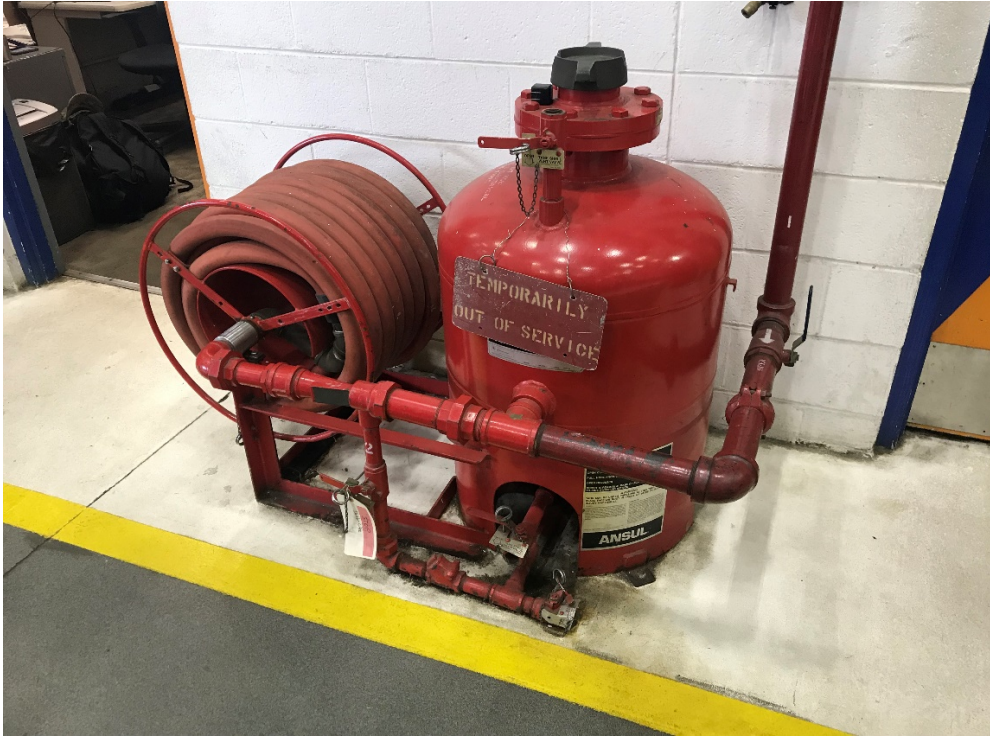
| Army National Guard, Preliminary Assessment for PFAS | Morrisville AASF | Morrisville, North Carolina |
|---|---|---|
| <p><b>Photograph No. 3</b></p> <p><b>Description:</b></p> <p>Third Ansul pump located along the southeastern wall of the hangar. Not operational, reason unknown. No history of leaking.</p> <p>Date Taken:<br/>22 October 2019</p> | <p>A red Ansul fire suppression pump is mounted on a metal frame. A red fire hose is coiled on a reel to the left of the pump. The pump has a black cap on top and a label that reads "TEMPORARILY OUT OF SERVICE". The pump is located in a room with white cinder block walls and a concrete floor with a yellow safety line.</p> | |

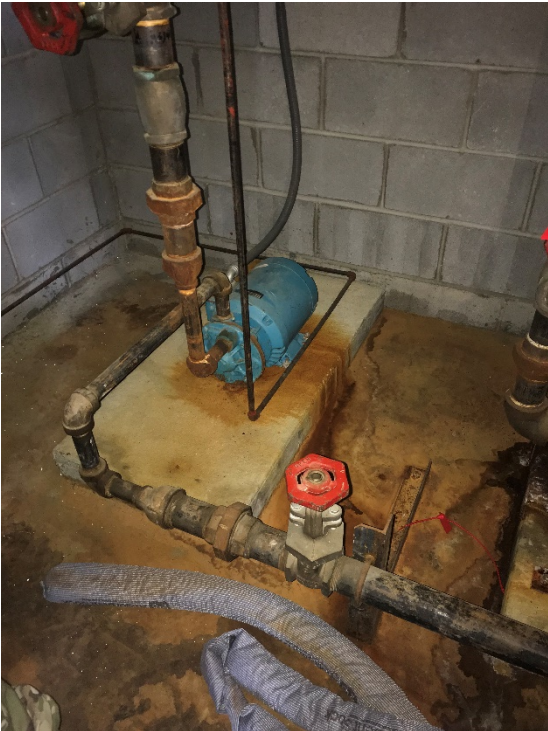
There is evidence of several leaks around the AFFF dispensing system in the GSE Building. Interviewees confirmed that two of the jockey pumps began leaking around the same time in 2018. The leak is described as a slow seep coming from each pump. The valve to each pump

was shutoff immediately when the leak was discovered; however, small damp areas of corrosion were visible around the pumps during the VSI. Additionally, a vertical trail of corrosion originates from the top of the poly tank. All leaks and spills that have occurred in the utility room of the GSE Building would have drained into the single floor drain located about 2 feet from the AFFF storage tank. The floor drain is connected to an oil-water separator before flowing to the Town of Cary sanitary sewer.

| Army National Guard, Preliminary Assessment for PFAS | Morrisville AASF | Morrisville, North Carolina |
|---|---|---|
| <p><b>Photograph No. 4</b></p> <p><b>Description:</b></p> <p>GSE Building, looking at first pump in AFFF dispensing system. Evidence of leaking around the base of the pump. Valve to the AFFF tank has been closed.</p> <p>Date Taken:<br/>22 October 2019</p> | <p>A blue pump is located in a concrete pit. The pump is surrounded by a pool of brown liquid, indicating a leak. A red valve is visible on the pipe leading from the pump. The background shows a white cinder block wall.</p> | |

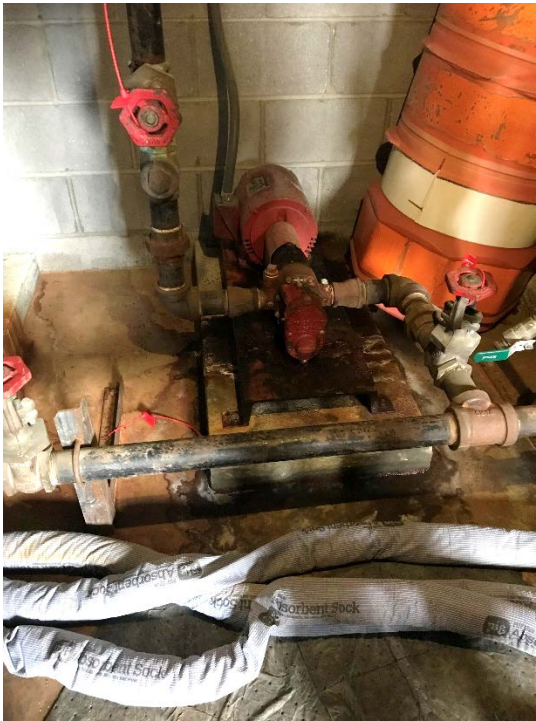
| Army National Guard, Preliminary Assessment for PFAS | Morrisville AASF | Morrisville, North Carolina |
|---|---|---|
| <p><b>Photograph No. 5</b></p> <p><b>Description:</b></p> <p>GSE Building, looking at second pump in AFFF dispensing system. Evidence of leaking around the base of the pump. Valve to the AFFF tank has been closed. Booms present from initial leak incident.</p> <p>Date Taken:<br/>22 October 2019</p> | | |

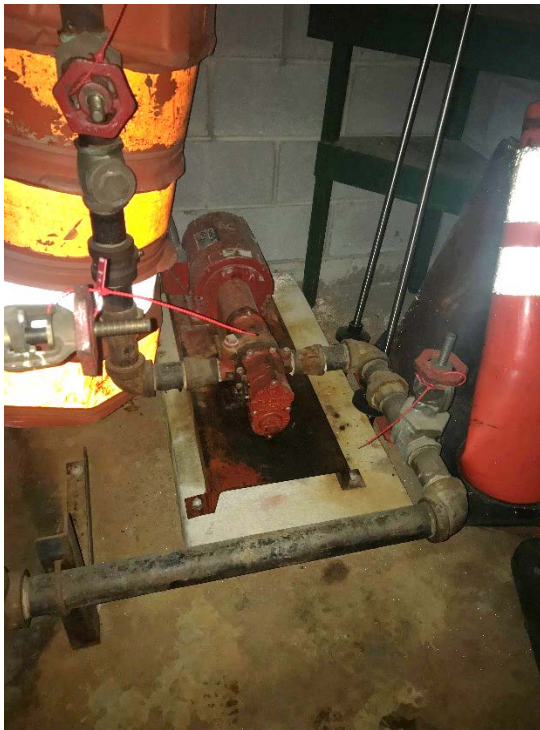
| Army National Guard, Preliminary Assessment for PFAS | Morrisville AASF | Morrisville, North Carolina |
|---|---|---|
| <p><b>Photograph No. 6</b></p> <p><b>Description:</b></p> <p>GSE Building, looking at third pump in AFFF dispensing system. No evidence of leaking, the pump is considered to be operational.</p> <p>Date Taken:<br/>22 October 2019</p> | | |

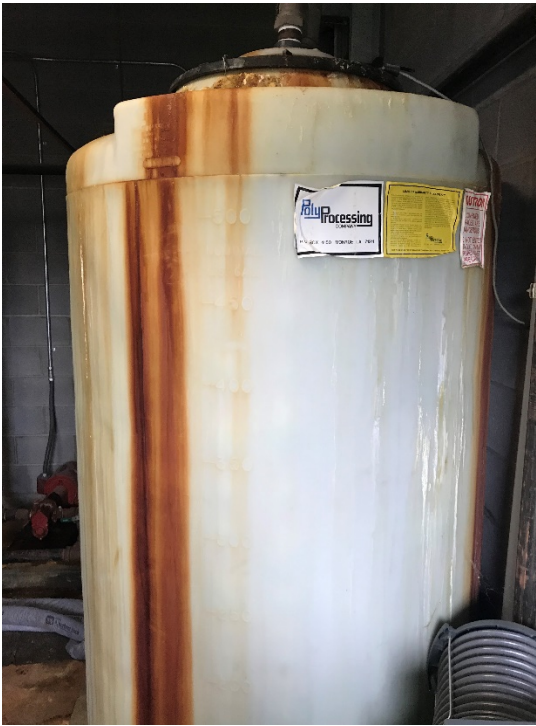
| Army National Guard, Preliminary Assessment for PFAS | | Morrisville AASF | Morrisville, North Carolina |
|---|---|---|---|
| <b>Description:</b><br><br>AFFF tank located in the GSE building, supplying the AFFF dispensing system in the building. The tank has a 550 gallon capacity and is assumed to be full. Evidence of leaks/spills visible near the top of the tank and the pressure valve.<br><br>Date Taken:<br>22 October 2019 | | | |

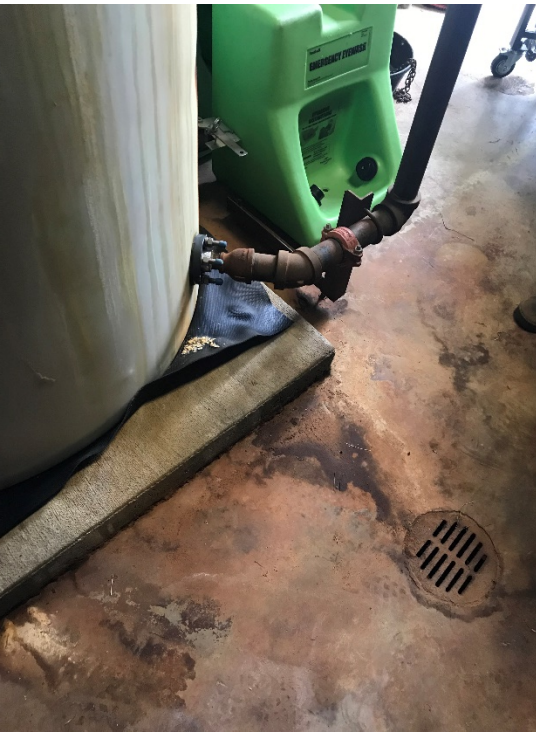
| Army National Guard, Preliminary Assessment for PFAS | | Morrisville AASF | Morrisville, North Carolina |
|---|---|---|---|
| <b>Description:</b><br><br>Floor drain located near the AFFF tank in the GSE building. Evidence of leaks and drainage can be seen on the floor.<br><br>Date Taken:<br>22 October 2019 | | | |

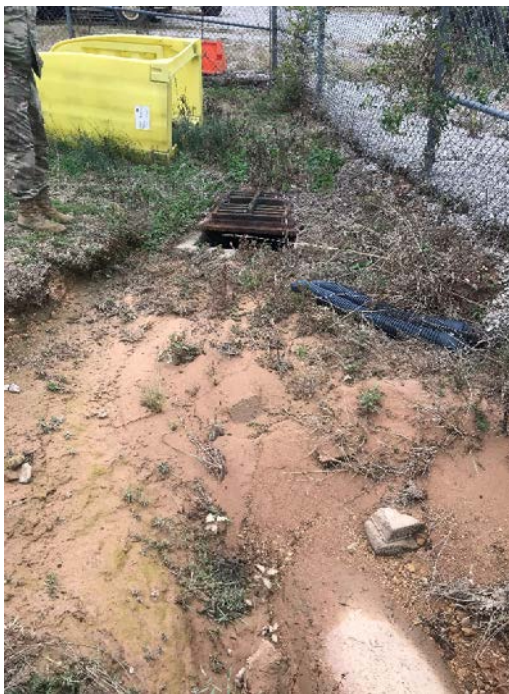
| APPENDIX C – Photographic Log | | |
|---|---|---|
| <b>Photograph No. 14</b><br><b>Description:</b><br>Looking south at the Delta Row FTA stormwater inlet. Erosion is visible around the structure.<br><br>Date Taken:<br>22 October 2019 | | |

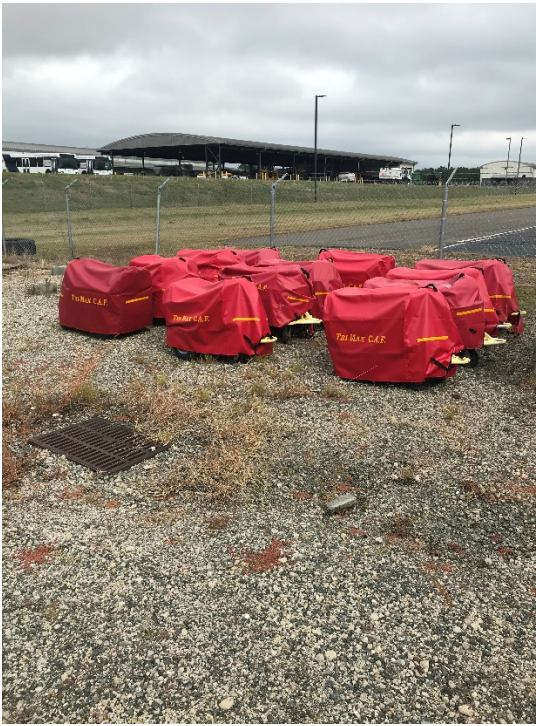
| Army National Guard, Preliminary Assessment for PFAS | Morrisville AASF | Morrisville, North Carolina |
|---|---|---|
| <p><b>Photograph No. 15</b></p> <p><b>Description:</b></p> <p>12 TriMax30™ carts in long term storage yard. Storm drain pictured in the foreground, while the RDU Maintenance Shop is visible in the background.</p> <p>Date Taken:<br/>22 October 2019</p> | | |

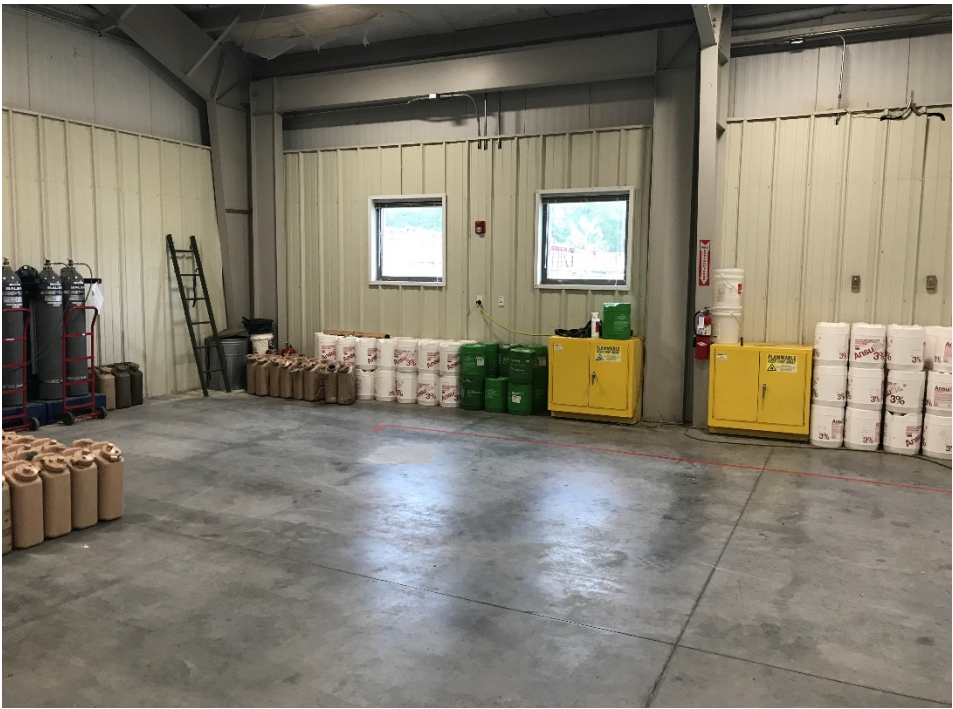
| Army National Guard, Preliminary Assessment for PFAS | Morrisville AASF | Morrisville, North Carolina |
|---|---|---|
| <p><b>Photograph No. 16</b></p> <p><b>Description:</b></p> <p>AFFF storage area inside the Fire Station. In total 42 five-gallon buckets of 3% AFFF are stored here.</p> <p>Date Taken:<br/>22 October 2019</p> | | |
