# FINAL Preliminary Assessment Report Tulsa Army Aviation Support Facility #2 Oklahoma

Perfluorooctanesulfonic Acid (PFOS) and Perfluorooctanoic  
Acid (PFOA) Impacted Sites  
ARNG Installations, Nationwide

October 2020

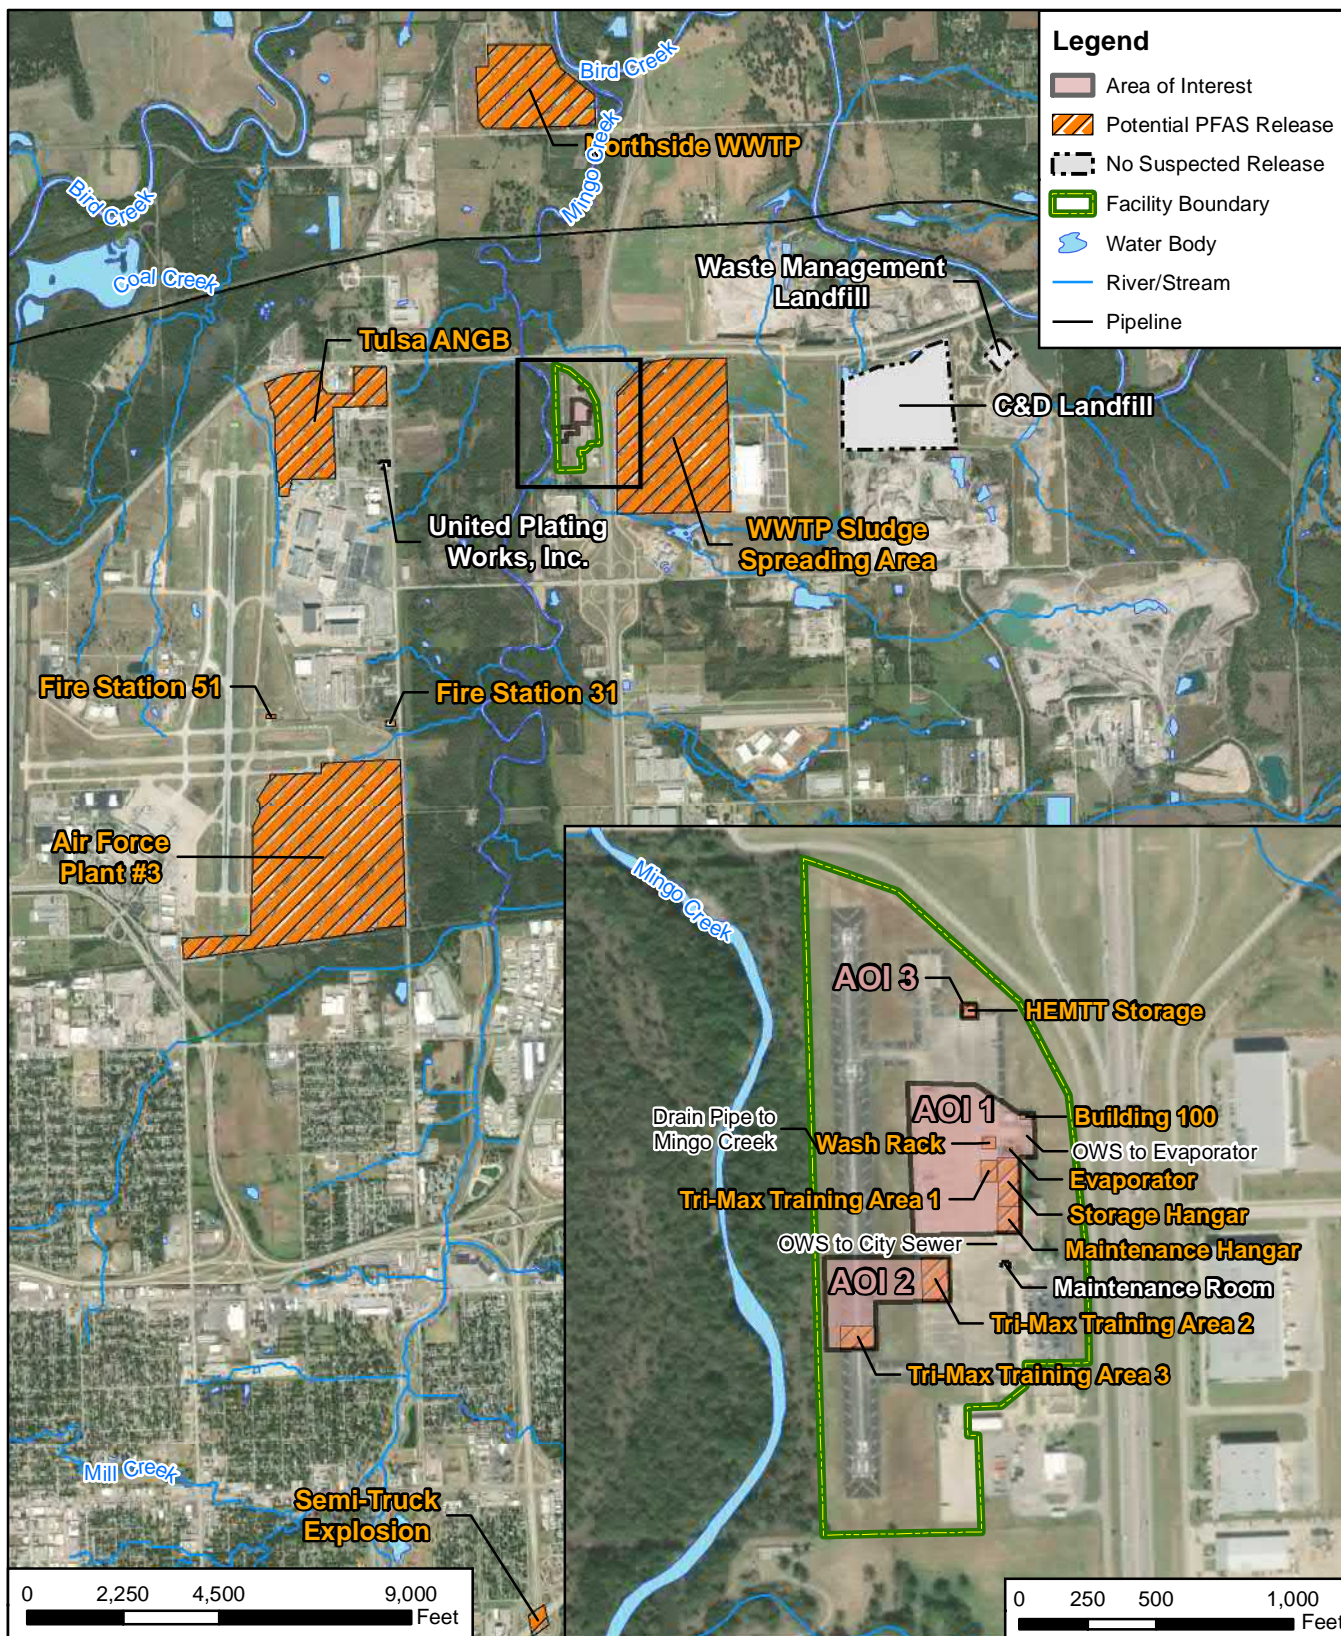
Nine potential PFAS source areas were identified during the PA. These source areas constitute three Areas of Interest (AOIs) identified at the Tulsa AASF #2. The AOIs are shown in **Figure ES-1** and summarized in **Table ES-1**.

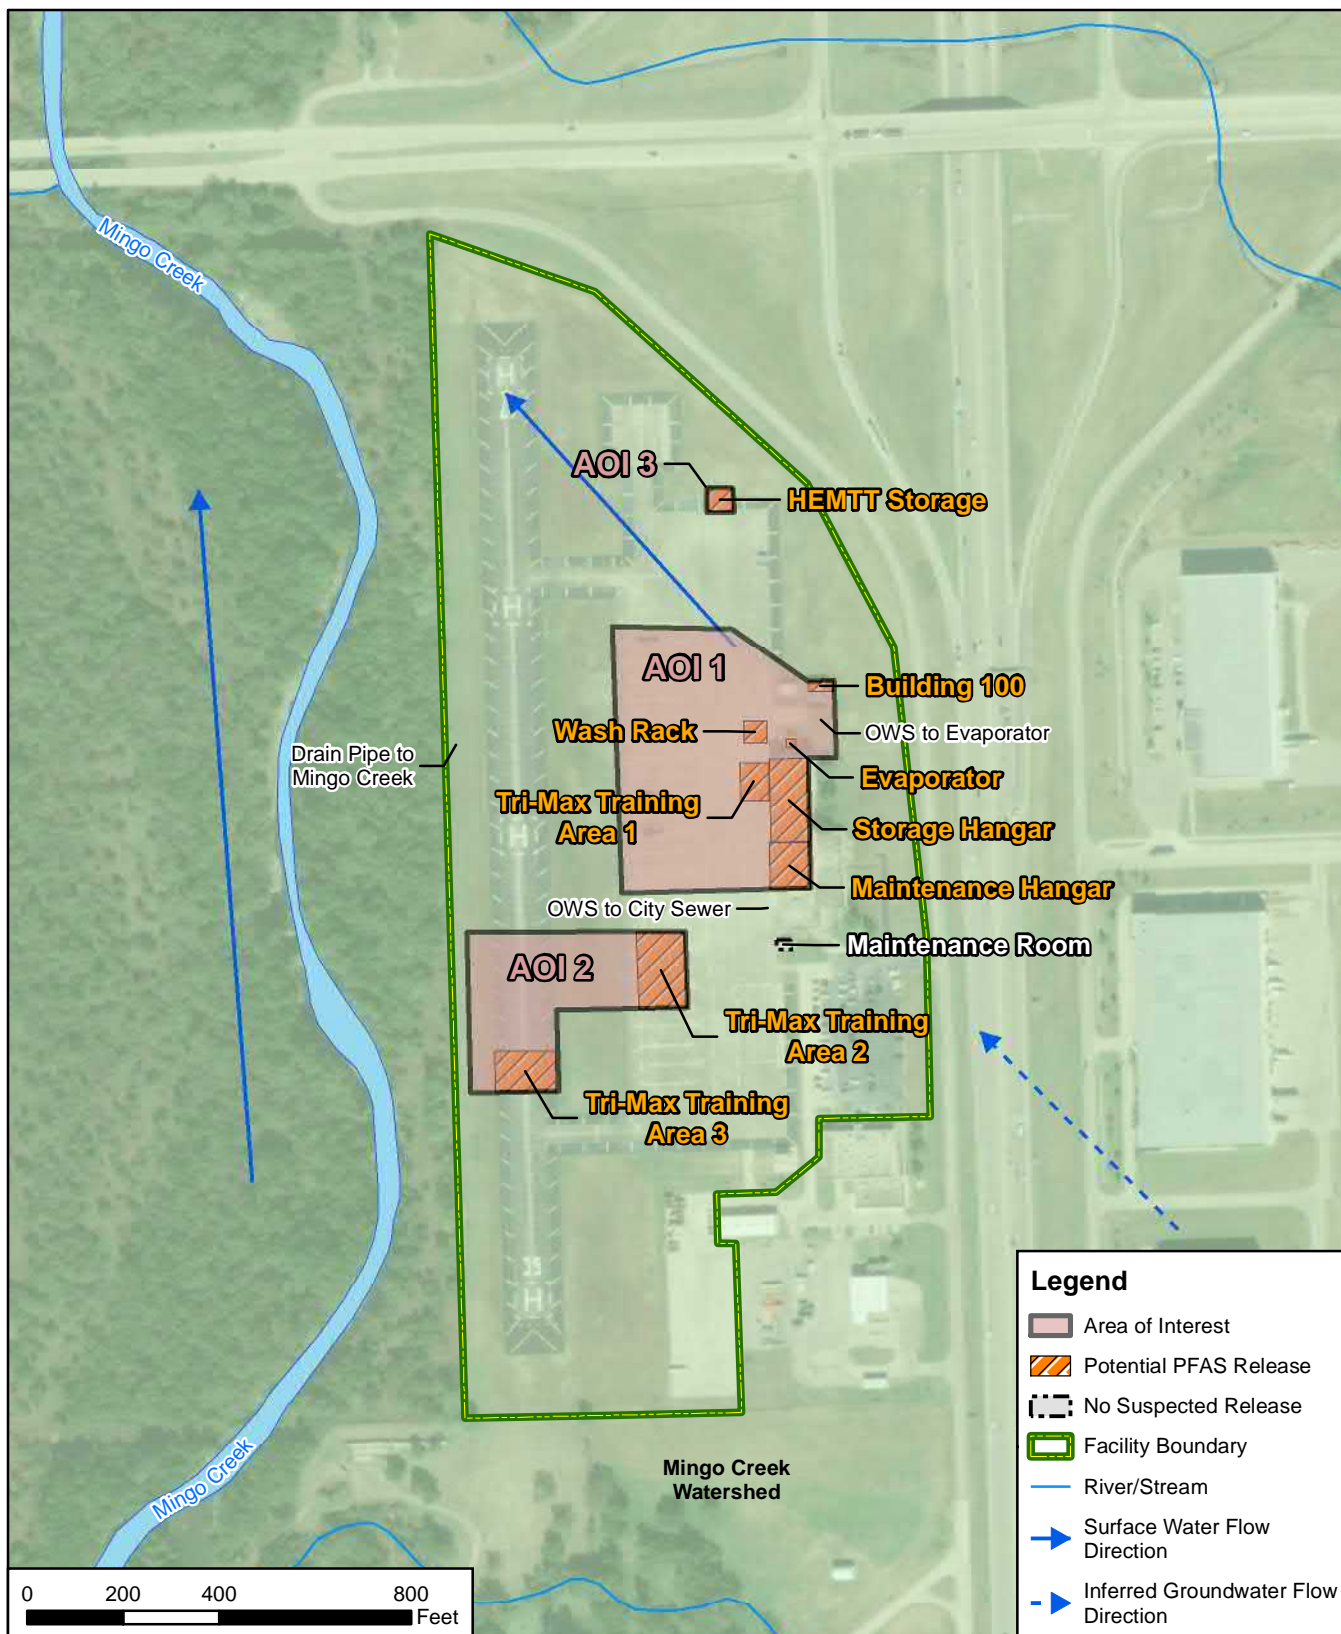
Based on the PA findings, three AOIs were identified at the Tulsa AASF #2: AOI 1 Eastern Release Areas, AOI 2 Western FTAs, and AOI 3 HEMTT Storage. Locations of the AOIs are shown on **Figure 6-1**. The preliminary CSM for AOIs 1, 2, and 3 is shown on **Figure 6-2**. The following sections describe the CSM components and the specific preliminary CSMs developed for each AOI. The CSM identifies the three components necessary for a potentially complete exposure pathway: (1) source, (2) pathway, (3) receptor. If any of these elements are missing, the pathway is considered incomplete.

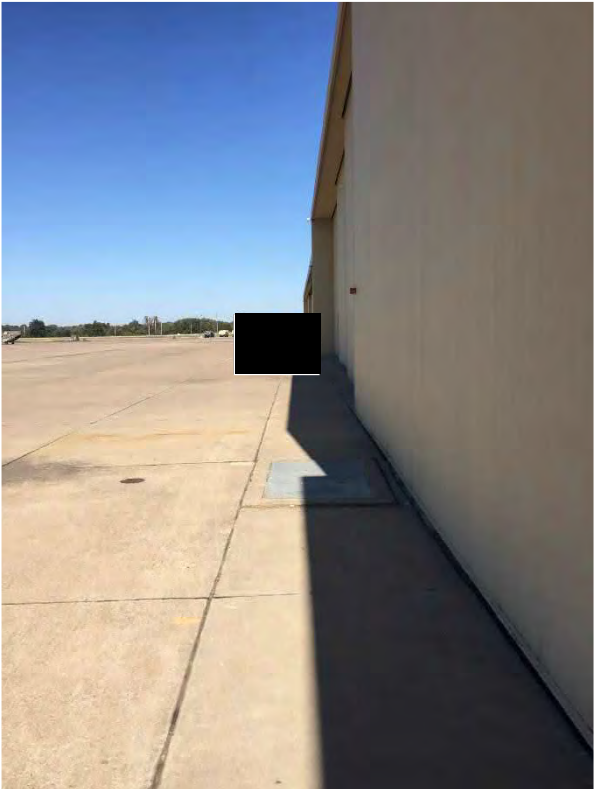
Army National Guard, Preliminary Assessment for PFAS	Tulsa AASF #2 (October 17, 2019)	Tulsa, Oklahoma
<p><b>Photograph No. 1</b></p> <p><b>Description:</b></p> <p>Photo facing north of oil/water separator that is located on the west side of the facility. This OWS receives wastewater from the trench drains in the hangars.</p>

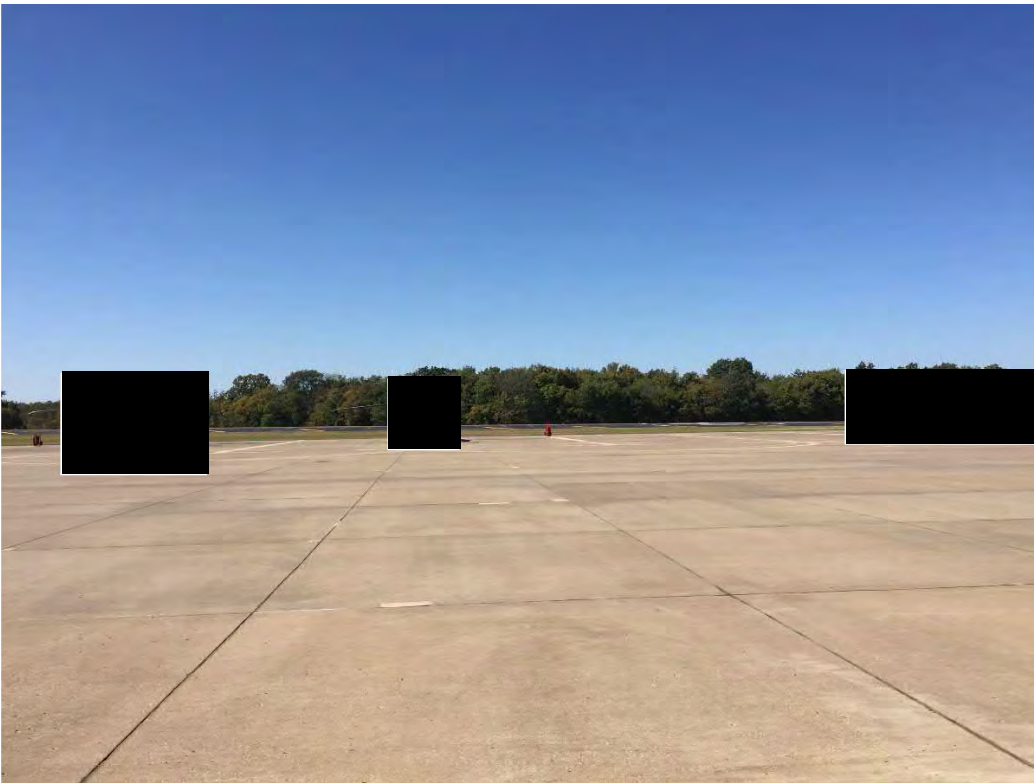
<p><b>Photograph No. 2</b></p> <p><b>Description:</b></p> <p>Photo facing west of the flight line. Helicopters and mobile firefighting units (Purple-K) shown. Location of historic Tri-Max™ Training Area 1.</p>

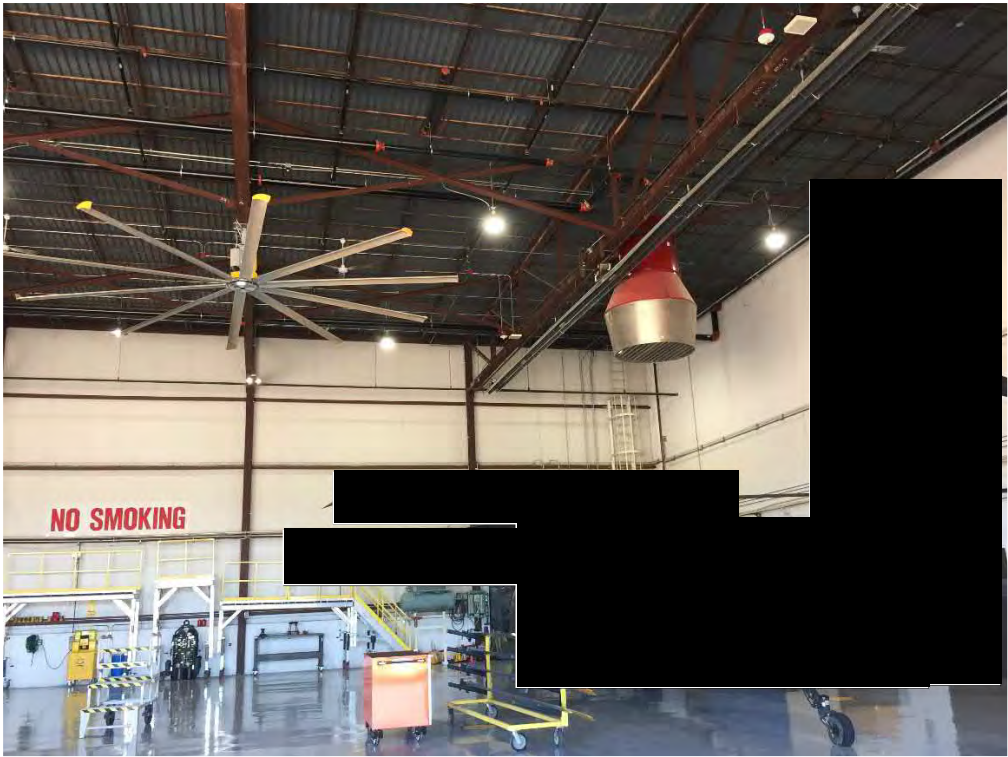
Army National Guard, Preliminary Assessment for PFAS	Tulsa AASF #2 (October 17, 2019)	Tulsa, Oklahoma
<p><b>Photograph No. 3</b></p> <p><b>Description:</b></p> <p>Photo facing east of Storage Hangar. This hangar has a fire suppression system and three overhead foam sprayers (red unit attached to the ceiling on right side of photo). This is the location of the 2014 accidental triggering of the fire suppression system.</p>

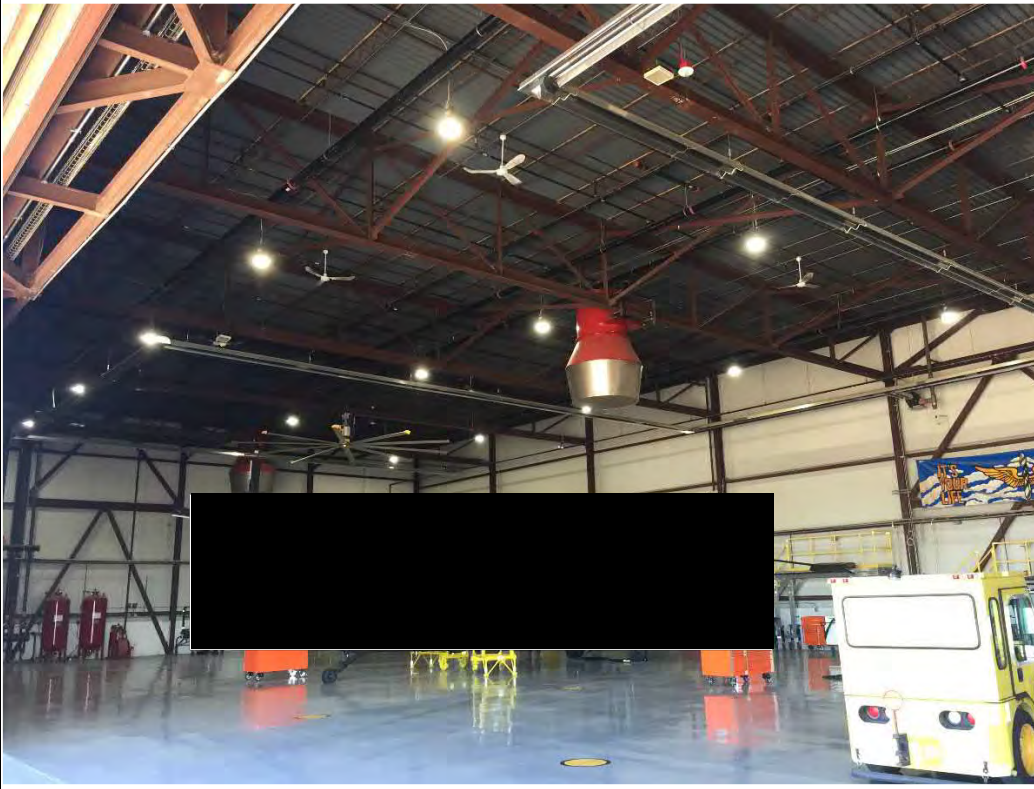
<p><b>Photograph No. 4</b></p> <p><b>Description:</b></p> <p>View of the Storage Hangar facing northeast. Two foam ceiling spray nozzles are visible, as well as the two 300-gallon foam tanks and one 36-gallon manual AFFF tank along the north wall.</p>

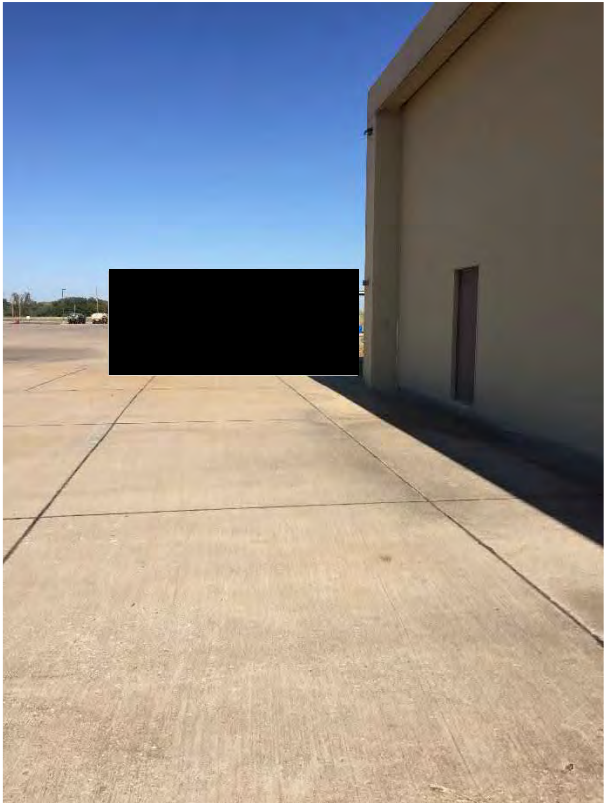
Army National Guard, Preliminary Assessment for PFAS		Tulsa AASF #2 (October 17, 2019)	Tulsa, Oklahoma
<b>Photograph No. 5</b>

<b>Description:</b>  Photo facing north of the historic Tri-Max™ Training Area 1 located west of the Storage Hangar.			
<b>Photograph No. 6</b>

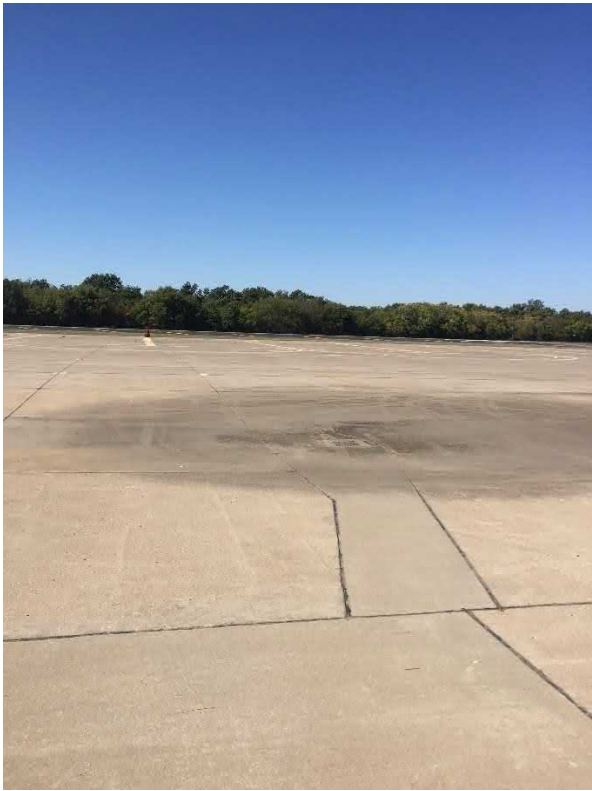
<b>Description:</b>  Photo facing west of the historic and current wash rack.

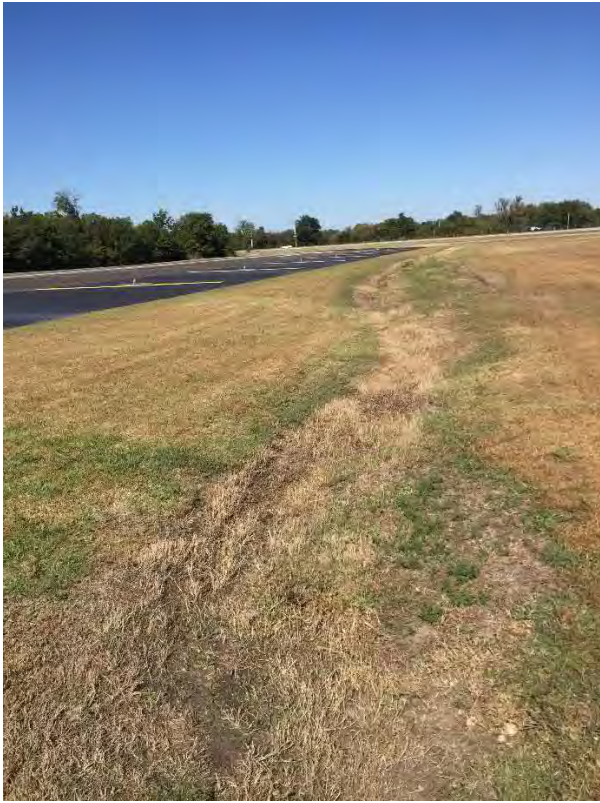
Army National Guard, Preliminary Assessment for PFAS		Tulsa AASF #2 (October 17, 2019)	Tulsa, Oklahoma
<b>Photograph No. 15</b>

<b>Description:</b>  Ditch along the east side of the flightline.			
<b>Photograph No. 16</b>

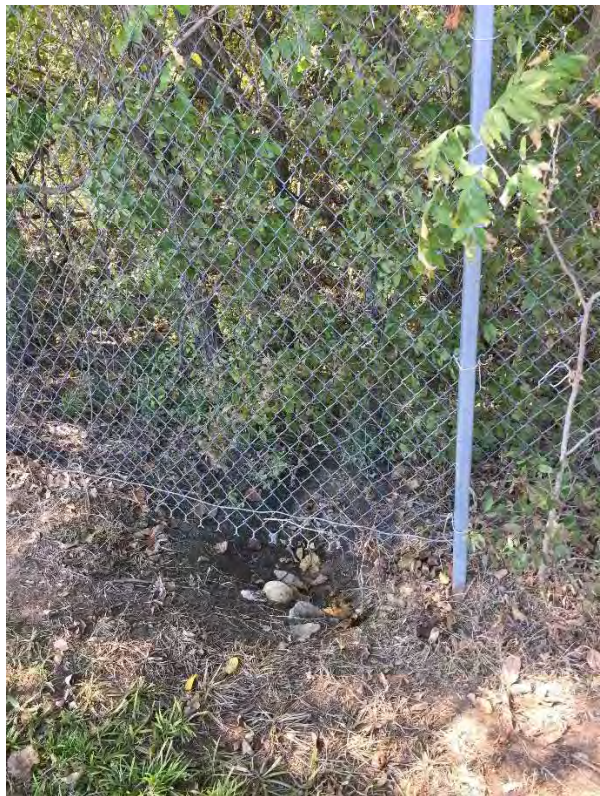
<b>Description:</b>  Photo facing west. Drainage from the OWS to Mingo Creek.

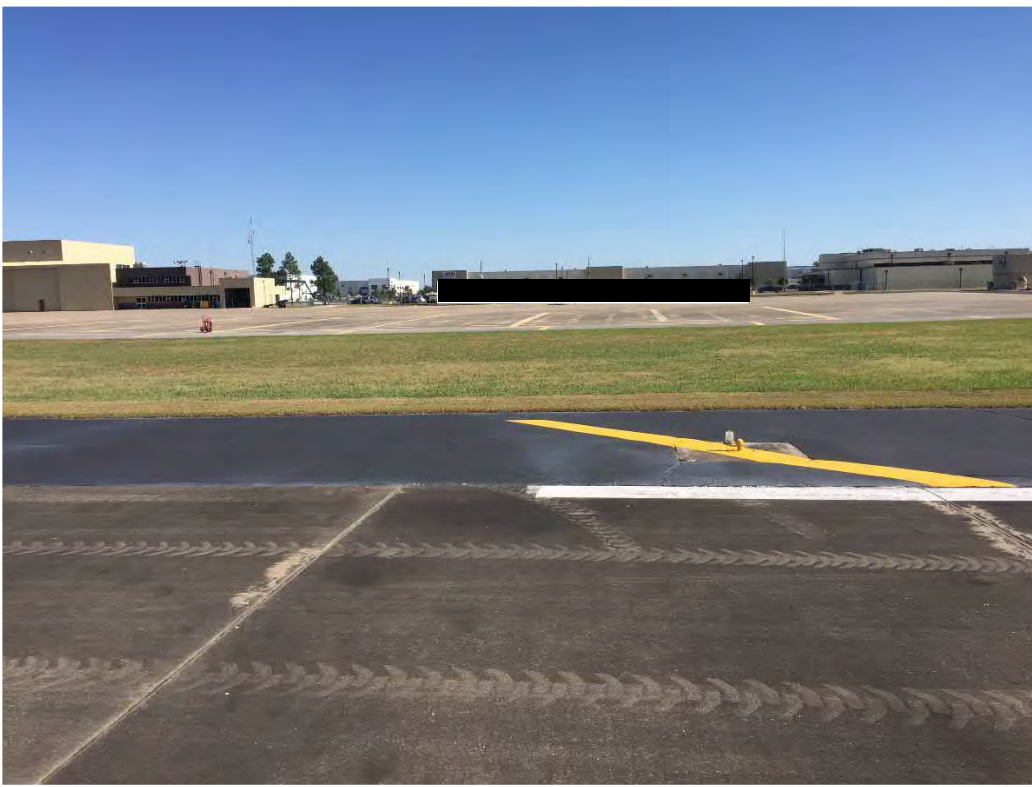
Army National Guard, Preliminary Assessment for PFAS	Tulsa AASF #2 (October 17, 2019)	Tulsa, Oklahoma
<p><b>Photograph No. 17</b></p> <p><b>Description:</b></p> <p>Photo facing east. Photo of historic Tri-Max™ Training Area 3, which is located on the western flight line.</p>

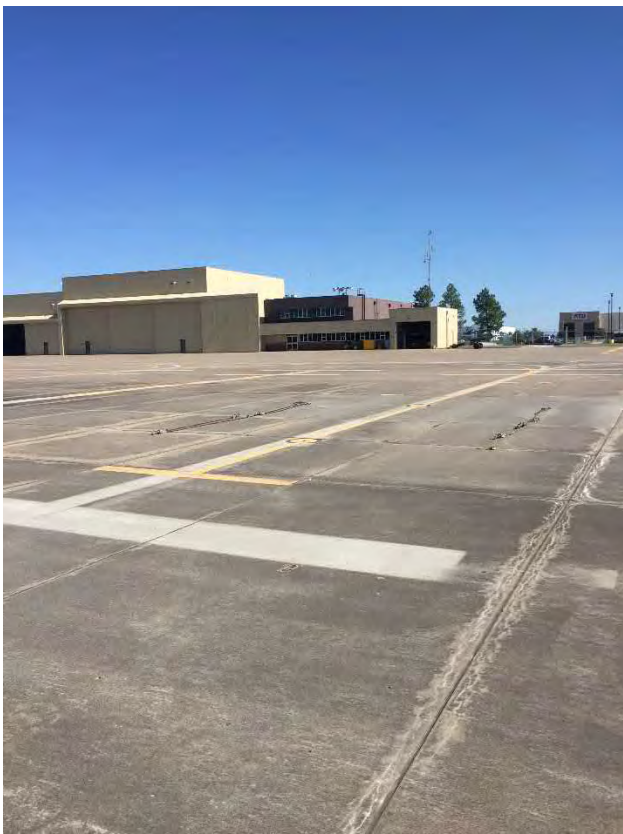
<p><b>Photograph No. 18</b></p> <p><b>Description:</b></p> <p>Photo facing northeast of location of historic Tri-Max™ Training Area 2.</p>

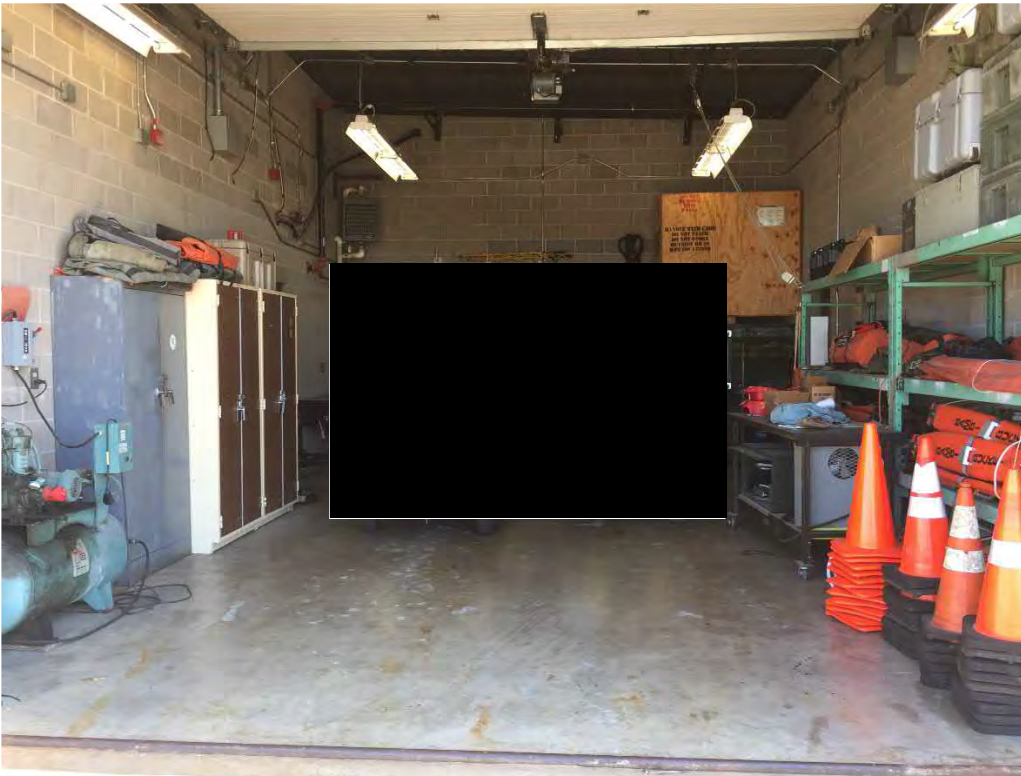
Army National Guard, Preliminary Assessment for PFAS		Tulsa AASF #2 (October 17, 2019)	Tulsa, Oklahoma
<b>Photograph No. 19</b>

<b>Description:</b> Historic firetruck location, facing south.			
<b>Photograph No. 20</b>

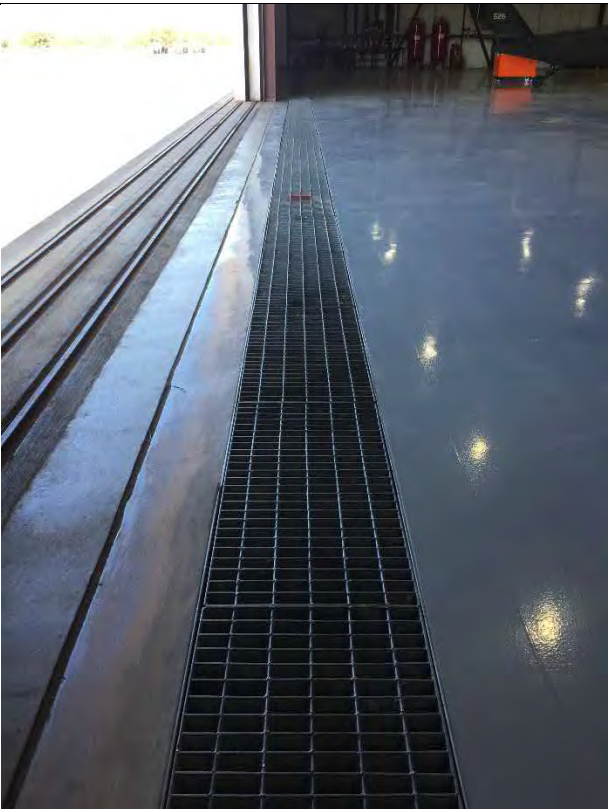
<b>Description:</b> Trench drain along west side of Storage Hangar and Maintenance Hangar.

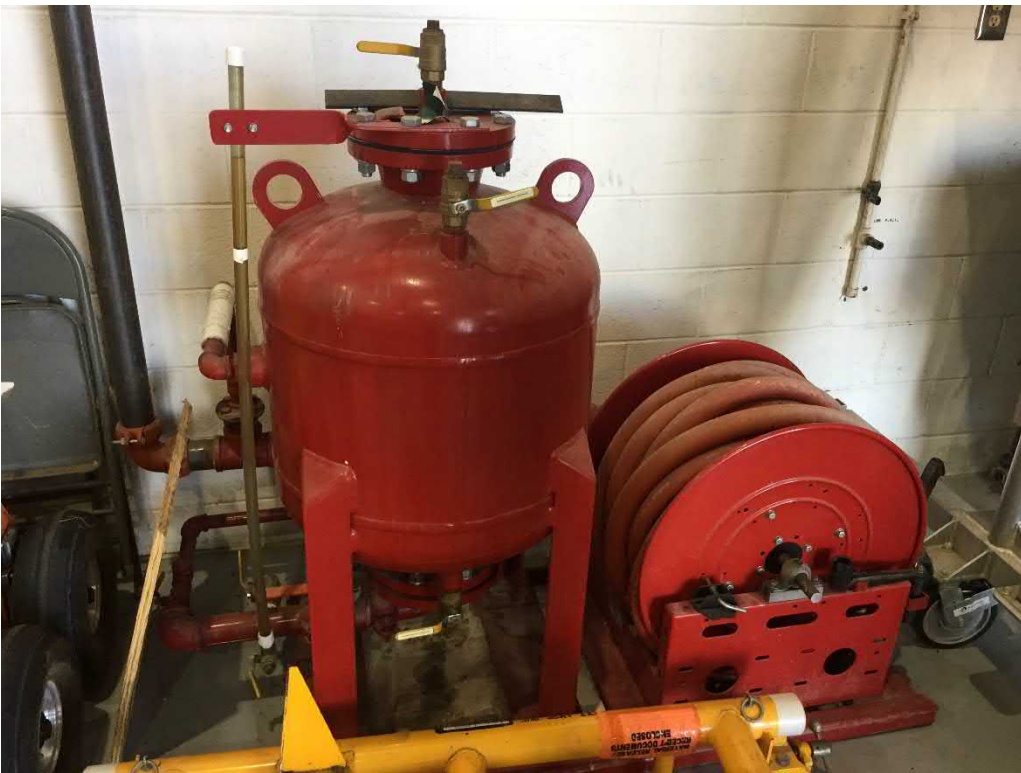
Army National Guard, Preliminary Assessment for PFAS	Tulsa AASF #2 (October 17, 2019)	Tulsa, Oklahoma
<p><b>Photograph No. 21</b></p> <p><b>Description:</b></p> <p>36-gallon AFFF tank (built in 2013) for manual fire fighting in the hangars. Three of these tanks located in the Storage Hangar, and two are located in the Maintenance Hangar.</p>
