# Final Preliminary Assessment Report Vega Baja Readiness Center, Vega Baja, Puerto Rico

Perfluorooctane-Sulfonic Acid (PFOS) and Perfluorooctanoic  
Acid (PFOA) Impacted Sites  
ARNG Installations, Nationwide

March 2020

AECOM  
12420 Milestone Center Drive, Suite 150  
Germantown, MD 20876  
aecom.com

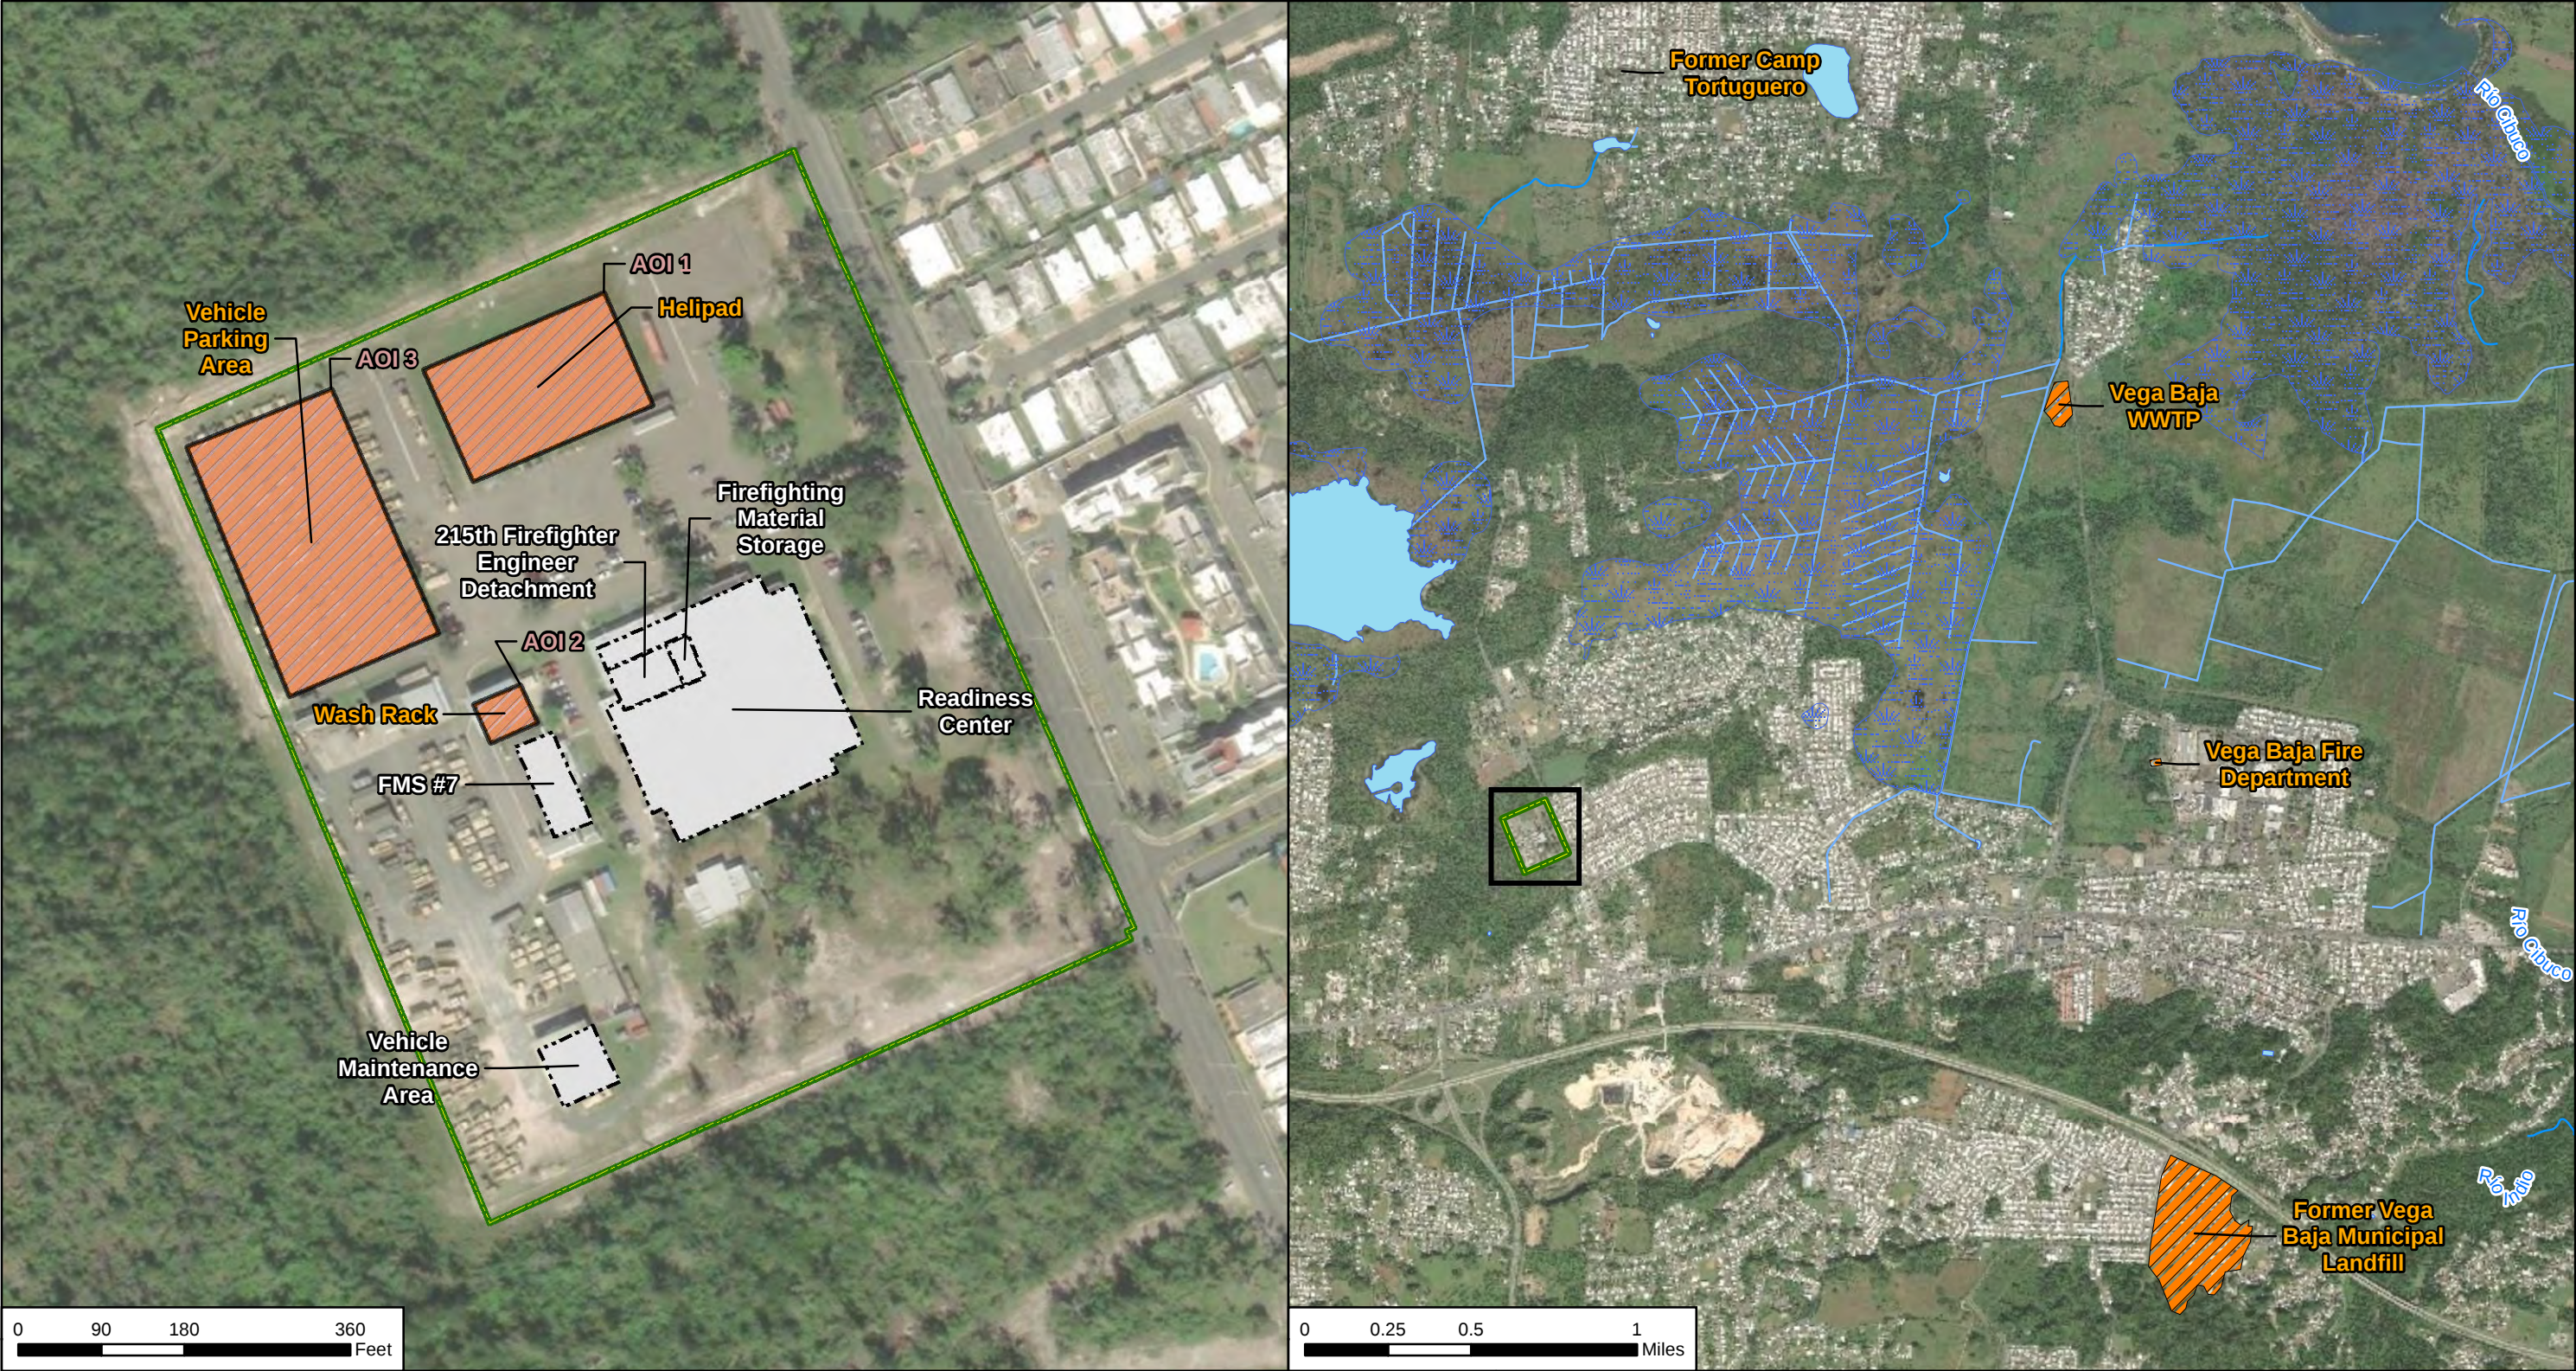
Three AOIs related to potential PFAS release were identified at Vega Baja Readiness Center based on PA data (**Figure ES-1**) and are summarized in **Table ES-1** below:

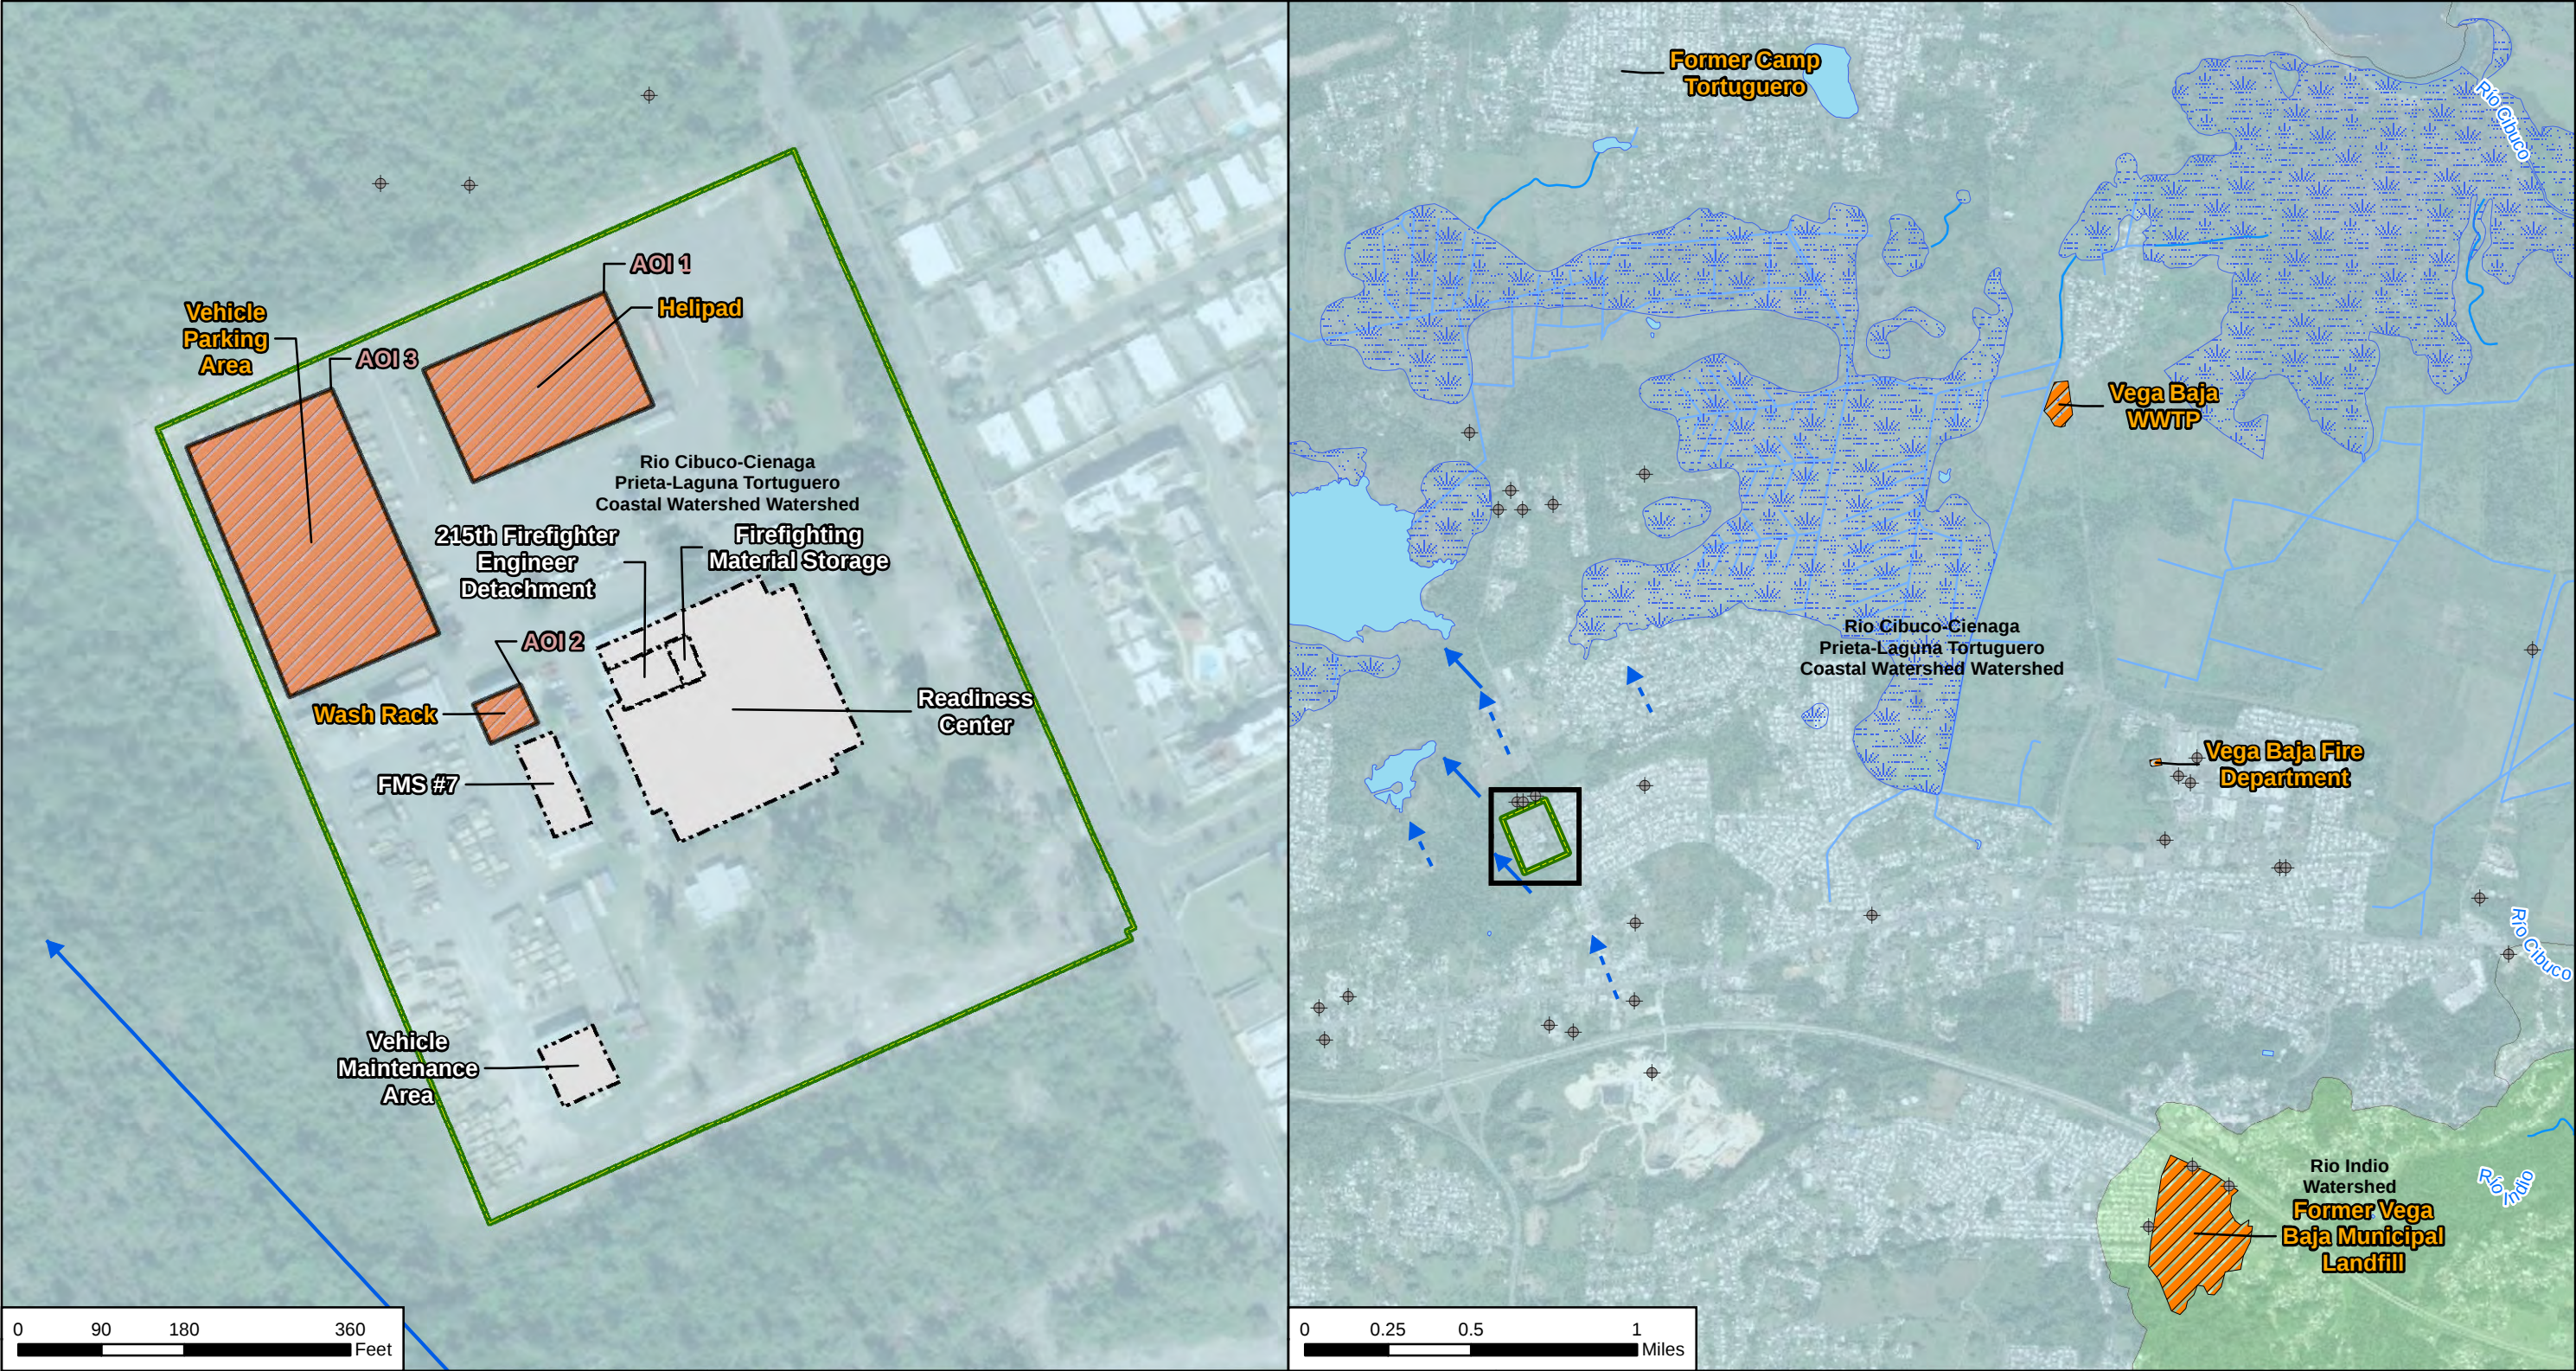
Figure 6-1

Based on the PA findings, three areas of interest (AOIs) were identified at Vega Baja Readiness Center: the Helipad, the Wash Rack, and the Vehicle Parking Area. The AOI locations are shown on **Figure 6-1**. The following sections describe the CSM components and the specific preliminary CSMs developed for each AOI. The CSM identifies the three components necessary for a potentially complete exposure pathway: (1) source, (2) pathway, (3) receptor. If any of these elements are missing, the pathway is considered incomplete.

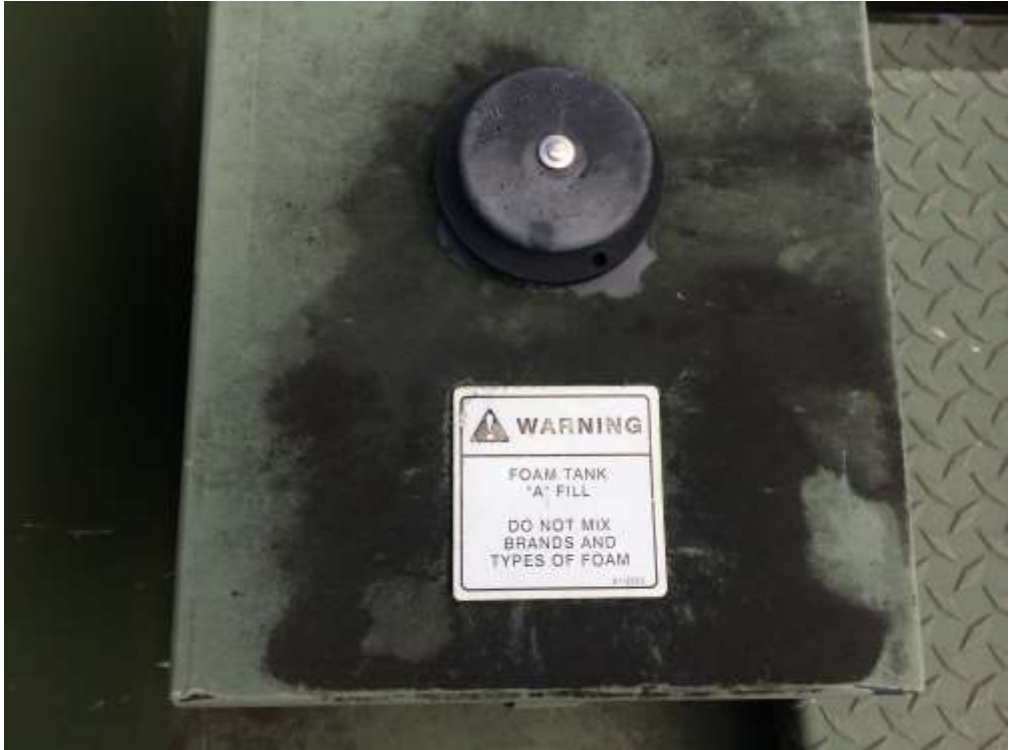
| Army National Guard, Preliminary Assessment for PFAS | | Vega Baja - FMS #7 | Vega Baja, Puerto Rico |
|---|---|---|---|
| <b>Photograph No. 1</b> | | | |

| Army National Guard, Preliminary Assessment for PFAS | | Vega Baja - FMS #7 | Vega Baja, Puerto Rico |
|---|---|---|---|
| <b>Description:</b><br>AFFF tank cap on the 1984 Osh Kosh Water Tanker Truck | | | |

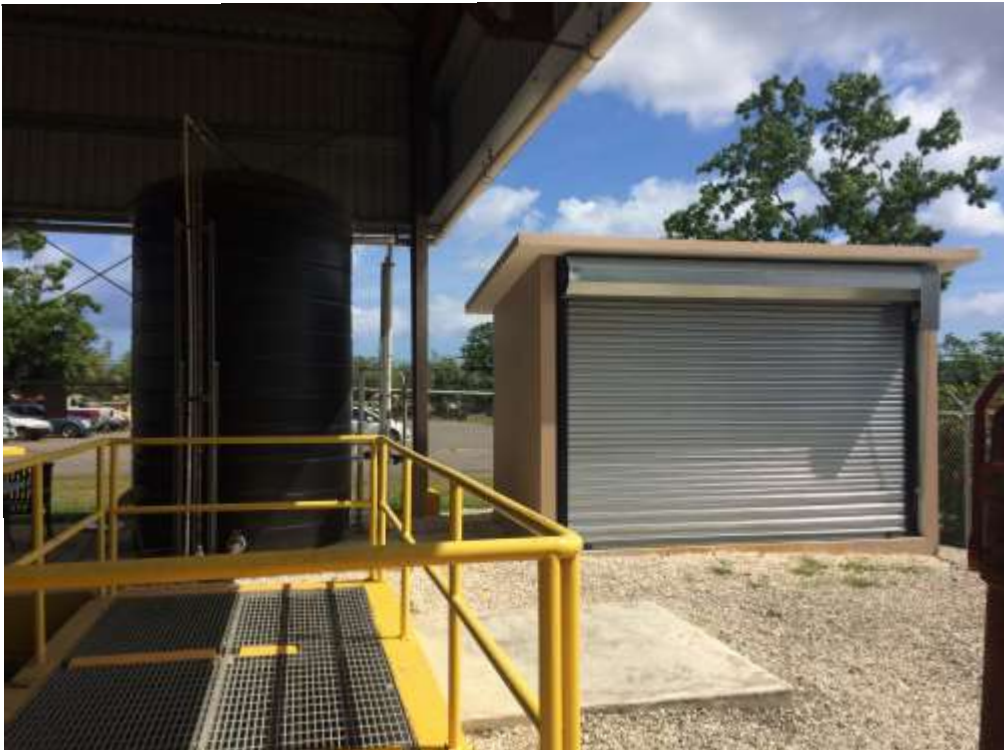
The facility Wash Rack is located adjacent to FMS #7 to the north (18°26'59.16"N; 66°25'14.10"W). The Wash Rack is also used to perform maintenance on PRARNG vehicles, including firefighting vehicles. Despite the Wash Rack's use to perform maintenance on firefighting vehicles, PRARNG personnel stated during interviews that no AFFF releases have occurred as a result of nozzle testing or general maintenance at the Wash Rack. Based on the reported corrosion of firefighting vehicle nozzles however, it is possible that the integrity of tanks and lines in the vehicles has been compromised. As such, AFFF may potentially migrate into the vehicle bulk tanks, or remain present in vehicle nozzle during nozzle testing and fire training. Based on the reported corrosion of vehicle nozzles, vehicle maintenance at the Wash Rack may have resulted in PFAS releases to the environment. The Wash Rack is considered a potential PFAS release area.

AOI 2 is the Wash Rack located near the center of the facility. Based on the reported corrosion of firefighting vehicle nozzles, it is possible that vehicle maintenance performed at the Wash Rack may have resulted in PFAS-laden water releases to the environment.

Potential PFAS-laden water releases at AOI 2 may have occurred on paved surfaces or on grassy surfaces surrounding the Wash Rack. If PFAS has been released at the AOI, it may have infiltrated subsurface soil beneath the grassy surfaces or via cracks in pavement and joints between areas paved with different materials. As a result, PFAS may be present in surface soil and subsurface soil at the AOI.

| Army National Guard, Preliminary Assessment for PFAS | | Vega Baja - FMS #7 | Vega Baja, Puerto Rico |
|---|---|---|---|
| <b>Photograph No. 3</b><br><br><b>Date</b> 5/21/2019<br><b>Time</b> 9:20<br><br><b>Description:</b><br>Wash rack at the Vega Baja ARNG facility<br><br><br><br><br><br><br><br><br><br><b>Orientation:</b><br>East | | | |

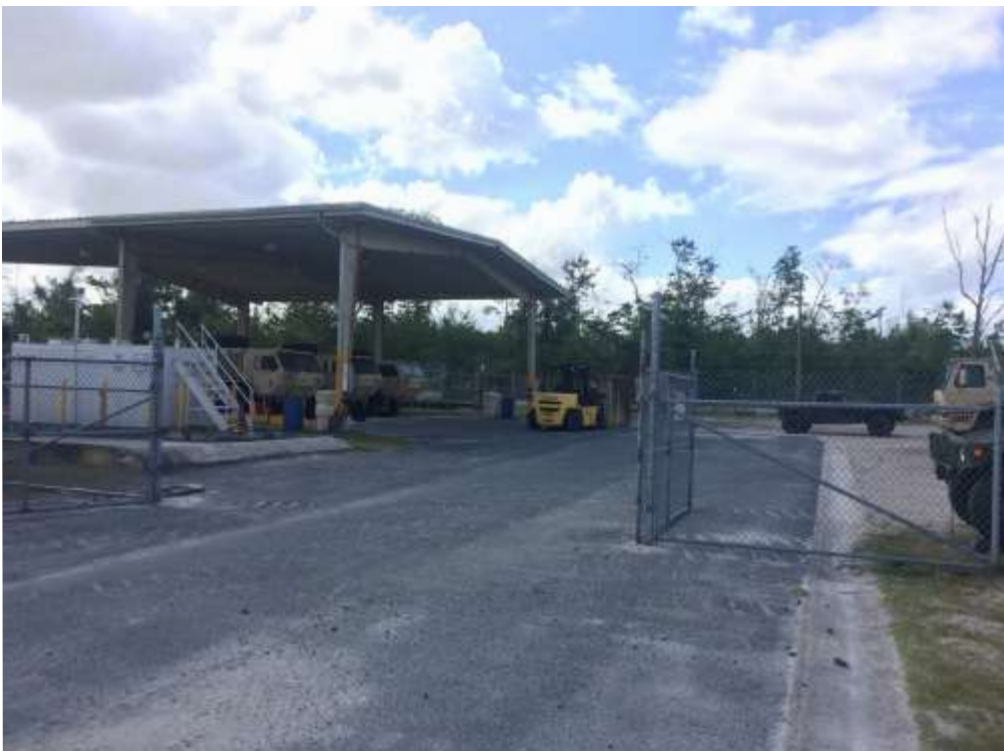
There is no affixed fire suppression system at the Vehicle Maintenance Area, and no AFFF has been stored in any capacity in the area during the tenure of PRARNG personnel interviewed. One of the firefighting vehicles typically stored at the Vega Baja Readiness Center has regularly been staged in front of the Vehicle Maintenance Area; however, facility staff stated that no known AFFF leaks have ever occurred. No accidents have occurred requiring the use of AFFF fire suppression at the Vehicle Maintenance Area. No known activities resulting in the release PFAS-containing materials are known to have occurred in the area, and the Vehicle Maintenance Area is not considered a potential PFAS release area.

| Army National Guard, Preliminary Assessment for PFAS | | Vega Baja - FMS #7 | Vega Baja, Puerto Rico |
|---|---|---|---|
| <b>Photograph No. 4</b><br><br><b>Date</b> 5/21/2019<br><b>Time</b> 9:15<br><br><b>Description:</b><br>Vehicle maintenance area at the ARNG Vega Baja facility. Firetrucks have been maintained in this location.<br><br><br><br><br><br><br><br><br><br><b>Orientation:</b><br>Southeast | | | |

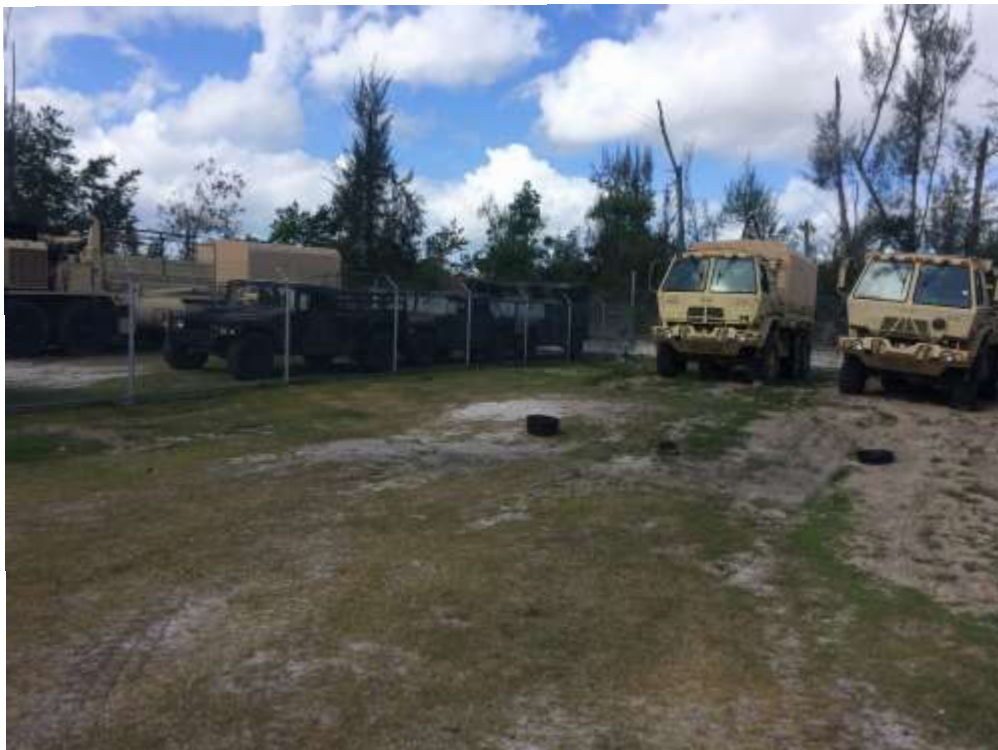
| Army National Guard, Preliminary Assessment for PFAS | | Vega Baja - FMS #7 | Vega Baja, Puerto Rico |
|---|---|---|---|
| <b>Photograph No. 5</b> | | | |

| Army National Guard, Preliminary Assessment for PFAS | | Vega Baja - FMS #7 | Vega Baja, Puerto Rico |
|---|---|---|---|
| <b>Description:</b><br>Former firetruck parking area at the Vega Baja ARNG facility | | | |

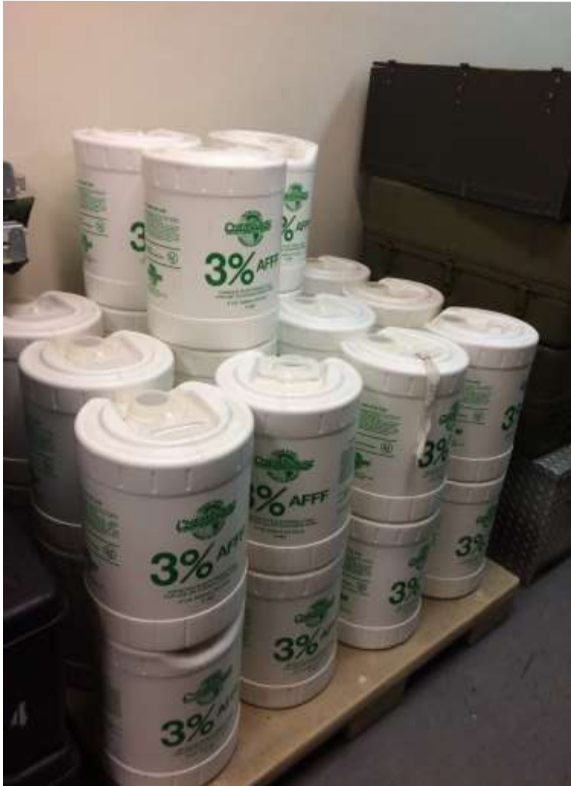
| Army National Guard, Preliminary Assessment for PFAS | Vega Baja - FMS #7 | Vega Baja, Puerto Rico |
|---|---|---|
| <p><b>Photograph No. 7</b></p> <p><b>Date</b> 5/21/2019<br/> <b>Time</b> 9:00</p> <p><b>Description:</b><br/> Chemguard 3% AFFF stored within the Vega Baja ARNG facility firefighting materials storage area</p> <p><b>Orientation:</b><br/> NA</p> | | |
