Final Preliminary Assessment Report Mayagüez Readiness Center, Mayagüez, Puerto Rico

Perfluorooctane-Sulfonic Acid (PFOS) and Perfluorooctanoic
Acid (PFOA) Impacted Sites
ARNG Installations, Nationwide

March 2020

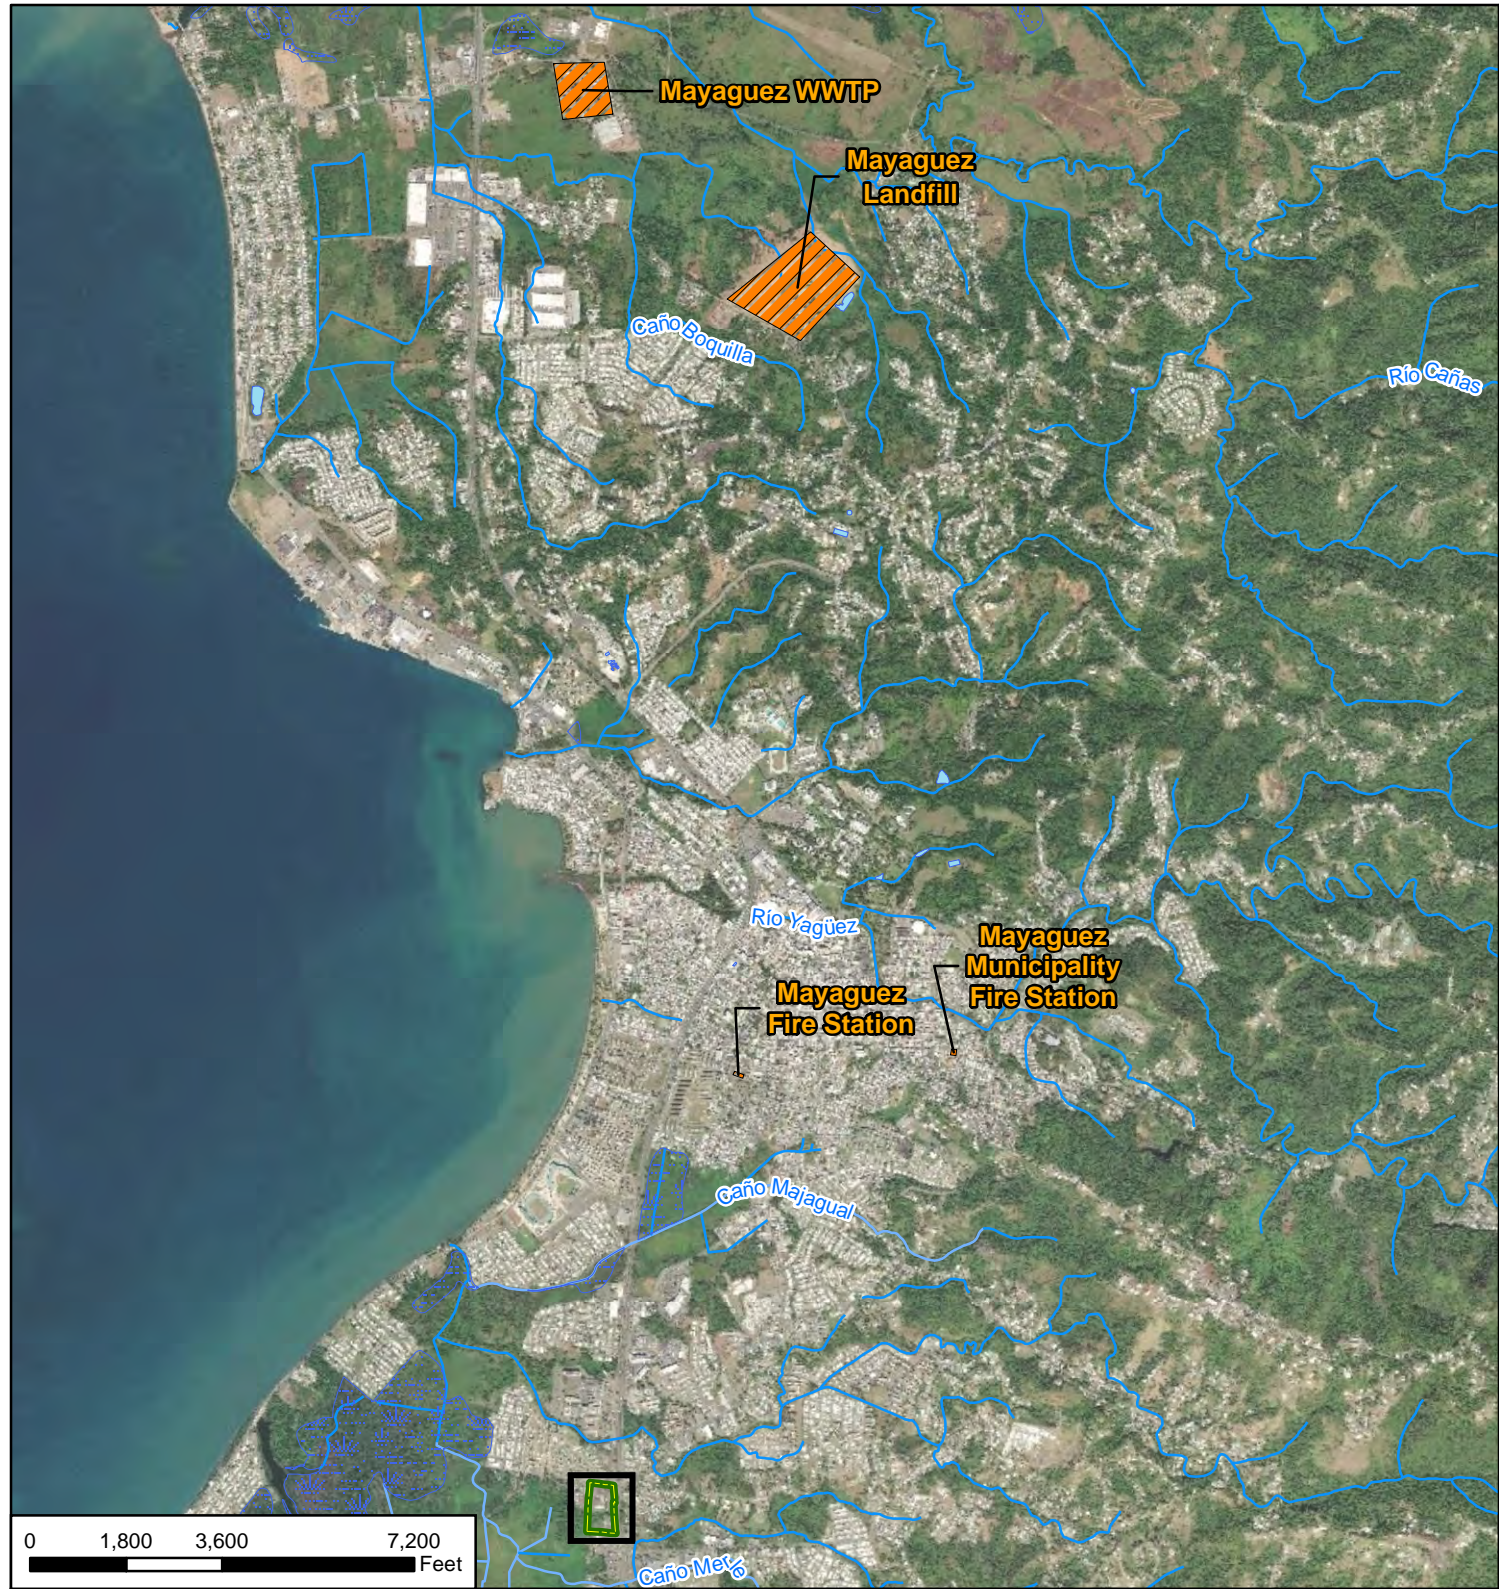
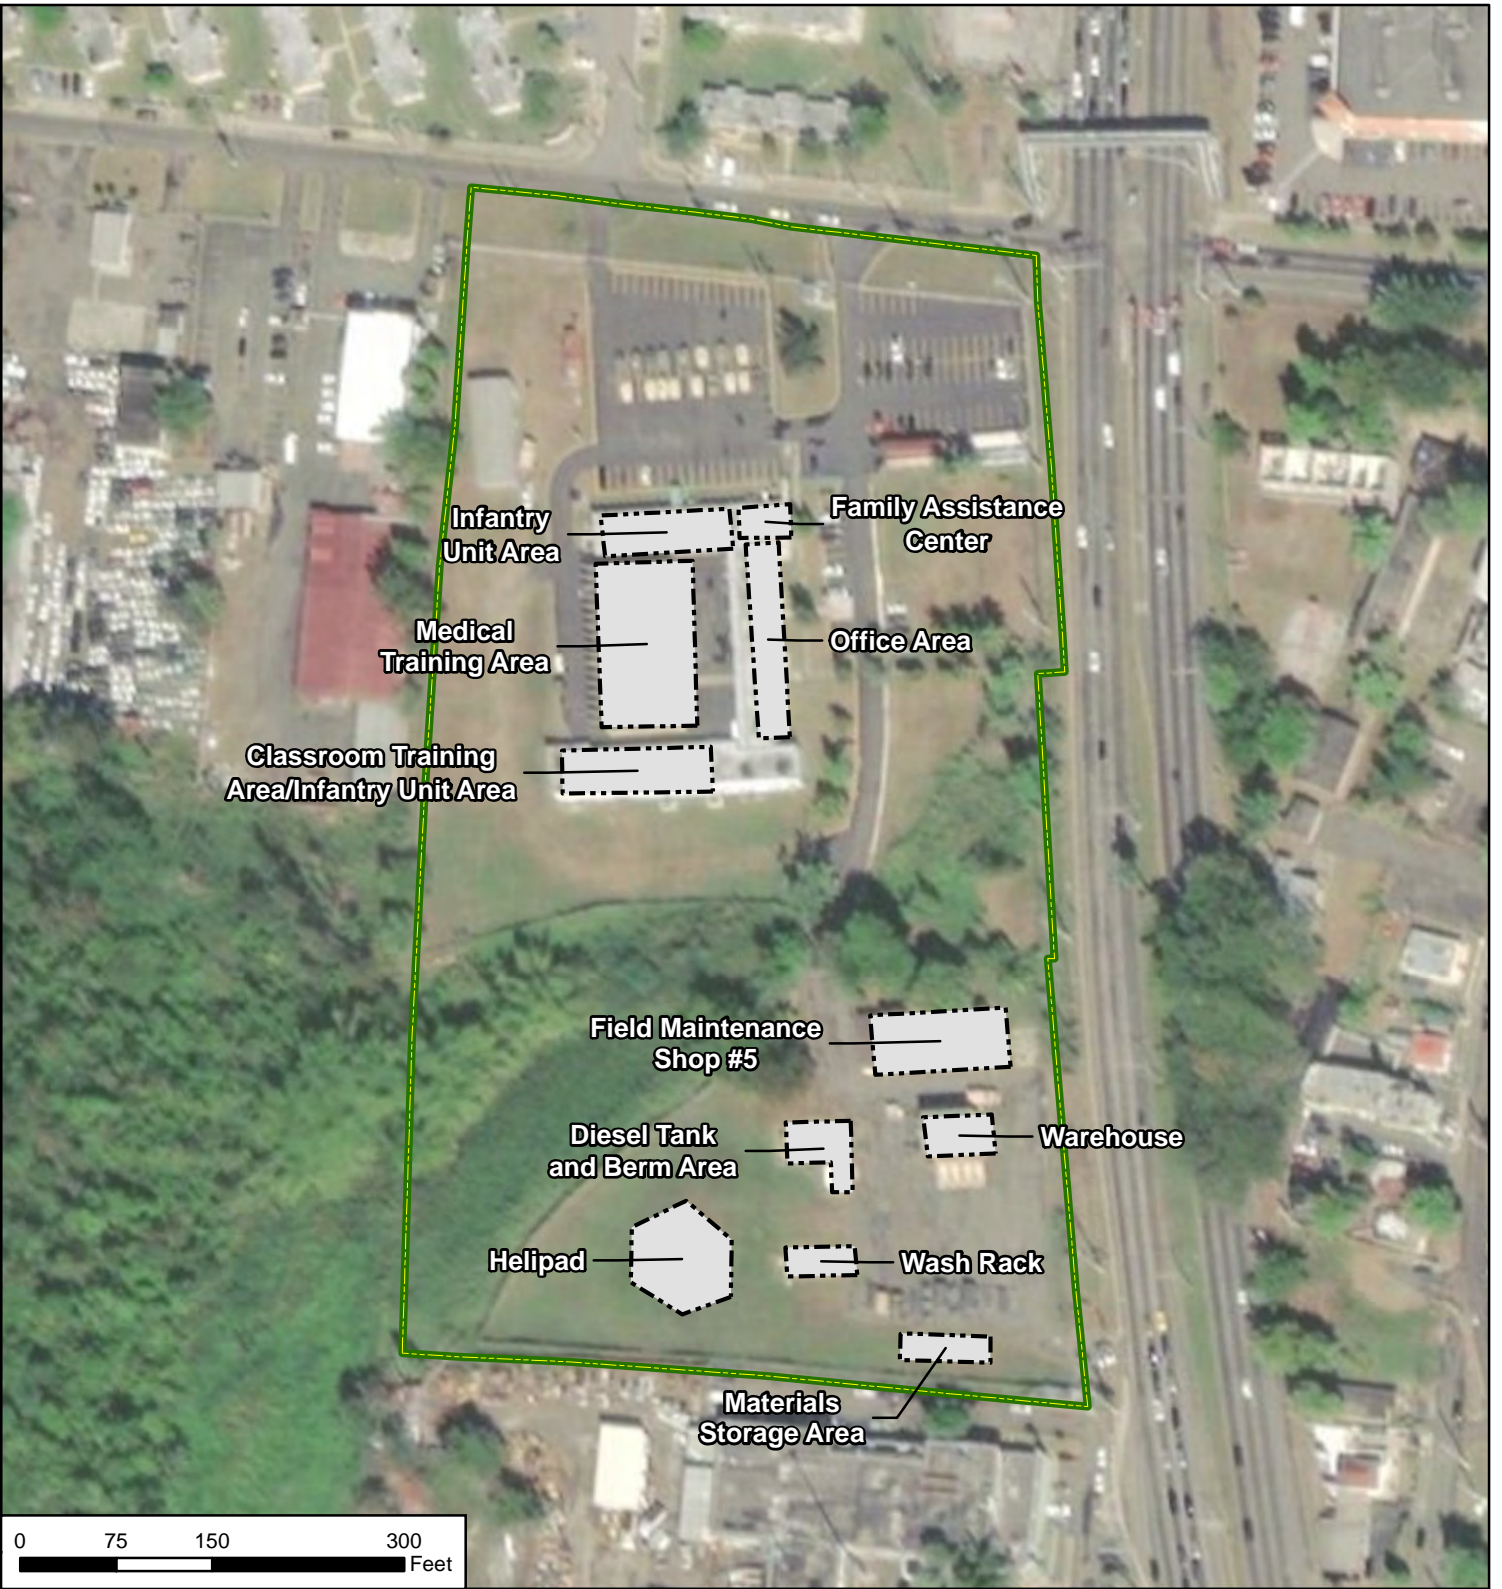
Summary of Findings	
AECOM	12420 Milestone Center Drive Germantown, MD 20876
Figure ES-1

Based on the absence of the use or release of PFAS-containing materials at Mayagüez Readiness Center, evidence does not support current or former ARNG activities having contributed to PFAS contamination in soil, groundwater, surface water, or sediment. Additionally, no adjacent sources of potential PFAS release were identified within the vicinity of the facility. No AOIs related to PFAS release were identified at the PRARNG facility based on PA data. A summary of PA findings is shown on **Figure ES-1**. The Mayagüez Readiness Center will not move forward in the CERCLA process.

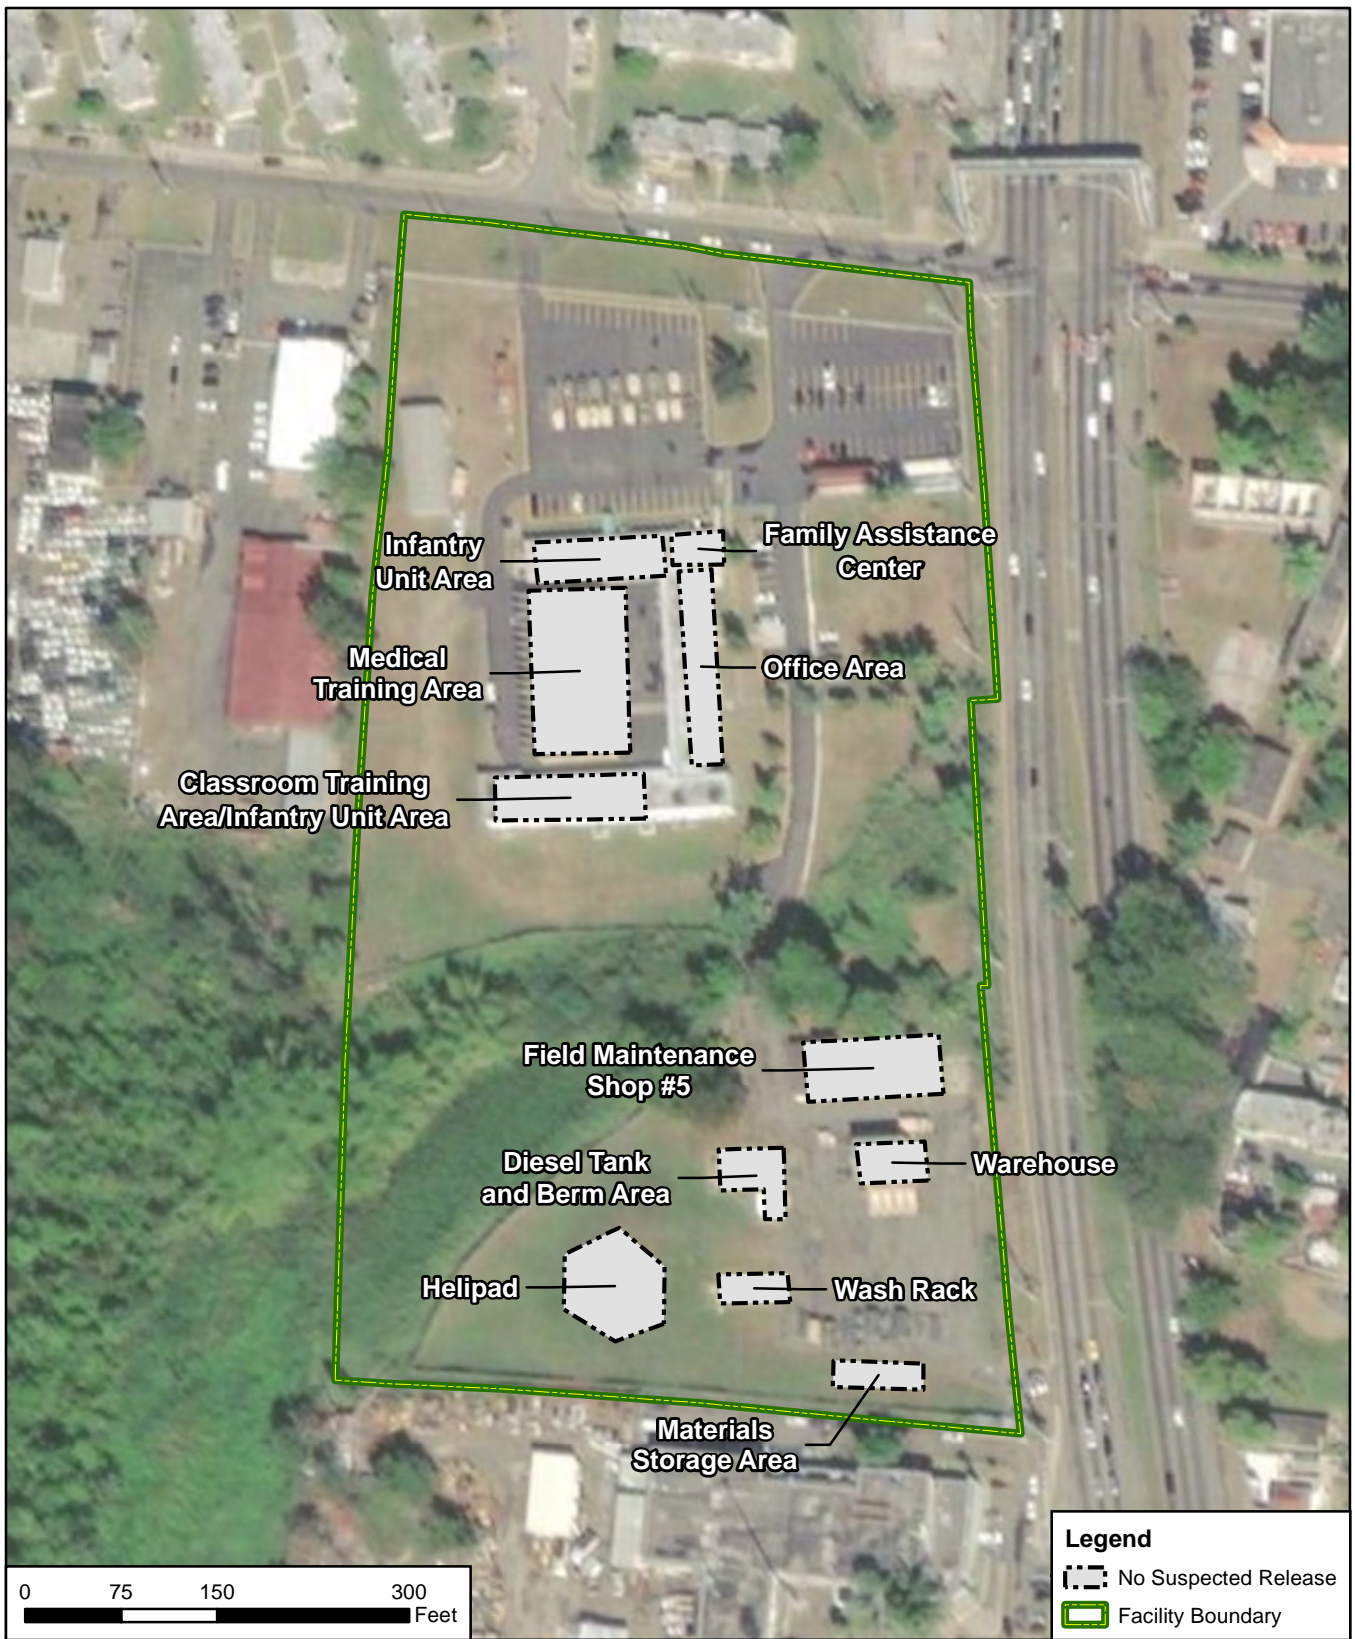
Non-Fire Training Area	
	Figure 3-1
12420 Milestone Center Drive Germantown, MD 20876

An FMS #5 diagram provided by Mayagüez Readiness Center personnel is included in **Appendix A**. No evidence indicates that AFFF was ever stored or used at FMS; FMS#5 is not considered a potential PFAS release area.

The Mayagüez Readiness Center includes a warehouse located in the southern portion of the facility property adjacent to FMS #5 (18°10'29.76"N; 67°9'6.17"W). The warehouse includes storage space, a tool room, and a welding area. According to facility staff, no AFFF has ever been stored or used within the warehouse. Dry chemical fire extinguishers are staged within the warehouse, and there is no fire suppression system at the warehouse. No evidence indicates that AFFF was ever stored or used at the warehouse; the warehouse is not considered a potential PFAS release area.

The Wash Rack is located in the southern portion of the Mayagüez Readiness Center (18°10'28.72"N; 67°9'7.27"W). The Wash Rack is located adjacent to the facility oil-water separator (OWS) and is used for to wash facility vehicles and equipment. No AFFF is stored or used at the Wash Rack, and no AFFF-capable vehicles are washed at the Wash Rack. Dry chemical fire extinguishers are staged at the Wash Rack in case of emergency. There is no fire suppression system at the Wash Rack. The OWS connects to municipal sanitary sewer systems. No evidence indicates that AFFF was ever stored or used at the Wash Rack; the Wash Rack is not considered a potential PFAS release area.

No evidence indicates that AFFF was ever stored or used at the Helipad; it is not considered a potential PFAS release area.

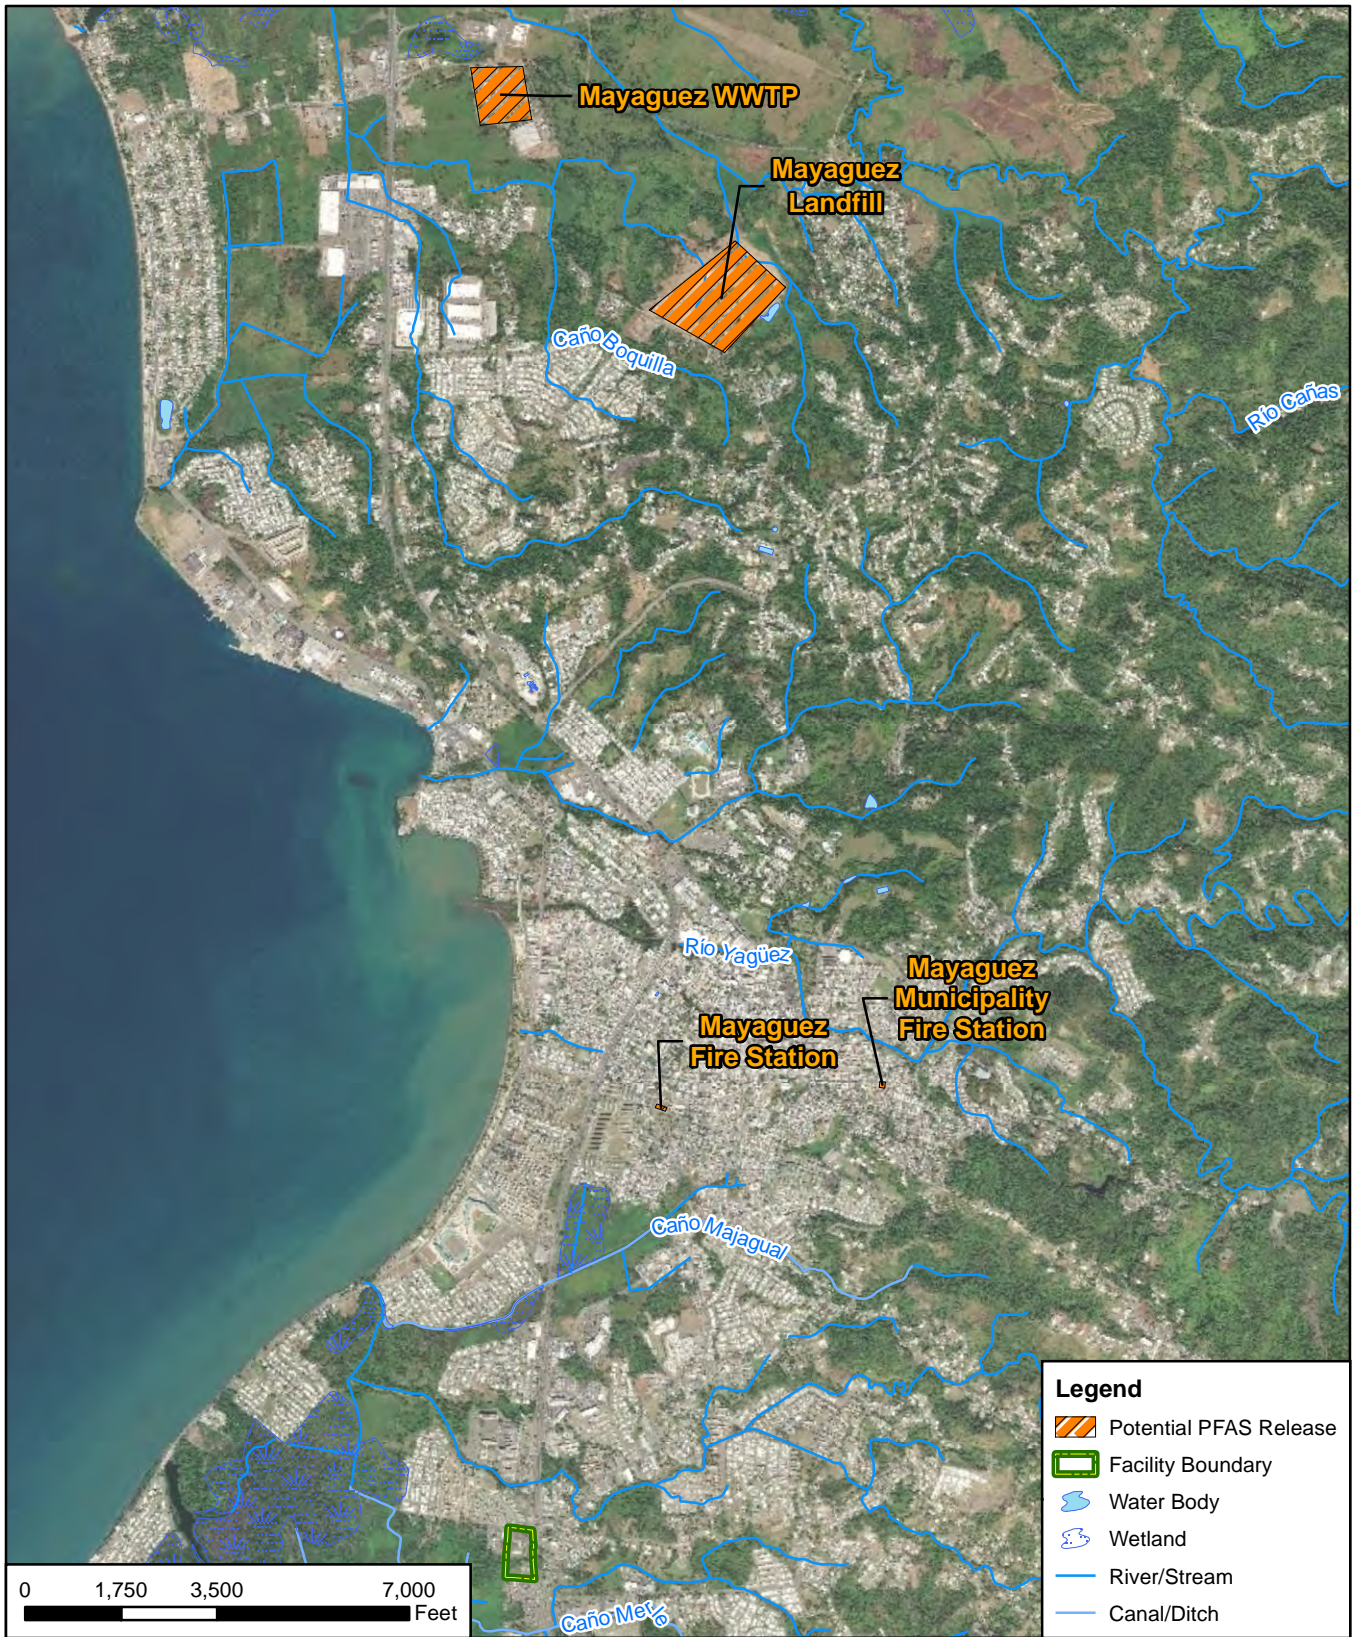
Adjacent Sources	
AECOM 12420 Milestone Center Drive Germantown, MD 20876	Figure 5-1

Two fire stations are located in the city of Mayagüez, north of the Mayagüez Readiness Center: the Mayagüez Fire Station is about 1.6 miles to the north and the Mayagüez Municipality Fire Station is about 2 miles to the northeast. The Mayagüez Fire Department responds to emergencies at the Mayagüez Readiness Center; however, no emergencies requiring fire suppression emergency response have occurred at the facility. According to Mayagüez Readiness Center personnel, the fire department also performs annual inspections of the water supply at the Mayagüez Readiness Center for capabilities during an emergency, and they also inspect the dry chemical fire extinguishers. It is unknown whether either Fire Department stores AFFF at the fire stations, trains with AFFF, or maintains firefighting vehicles capable of using AFFF.

There are no Waste Water Treatment Plants (WWTPs) at the Mayagüez Readiness Center. The nearest WWTP is located approximately 5 miles north of the facility and is operated by the Puerto Rico Aqueduct and Sewer Authority. WWTPs are not usually a primary potential release area of PFAS, but sludges and liquids from areas of potential release that are treated at WWTPs may create a secondary source of contamination. No information obtained during the PA that indicated PFAS-related materials from the Mayagüez Readiness Center were treated at a WWTP.

There are no landfills at the Mayagüez Readiness Center. The nearest landfill is the Mayagüez Landfill, located approximately 4.4 miles north of the facility. Landfills are not usually a primary potential release area of PFAS, but materials disposed of in landfills may create a secondary source of contamination. Such materials, to name a few, may include sludge from a WWTP that processes PFAS-laden water, used AFFF storage containers, or products associated with waterproofing uniforms or boots. At the PRARNG Mayagüez Readiness Center, no information obtained indicates PFAS-related materials were disposed of in a landfill.

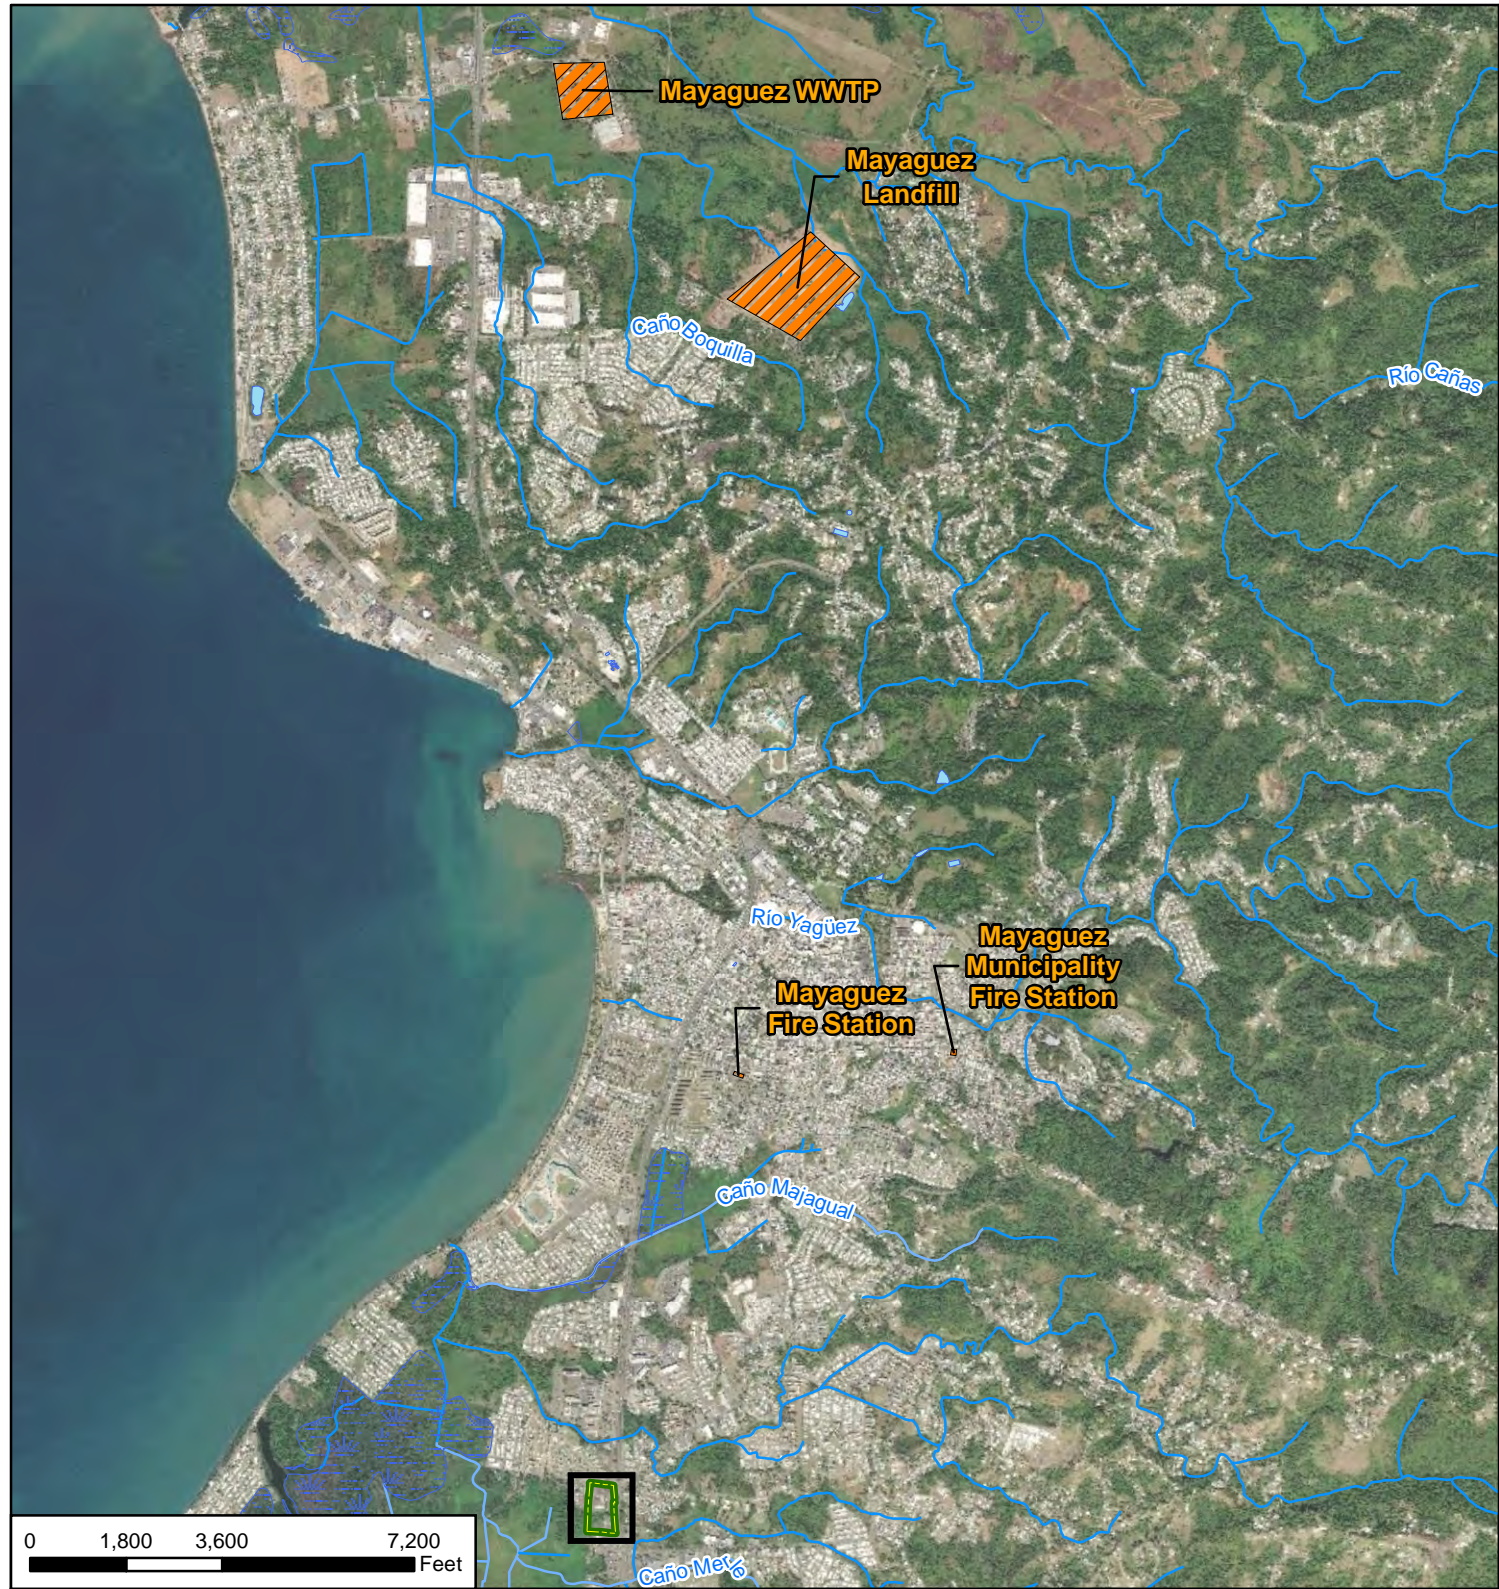
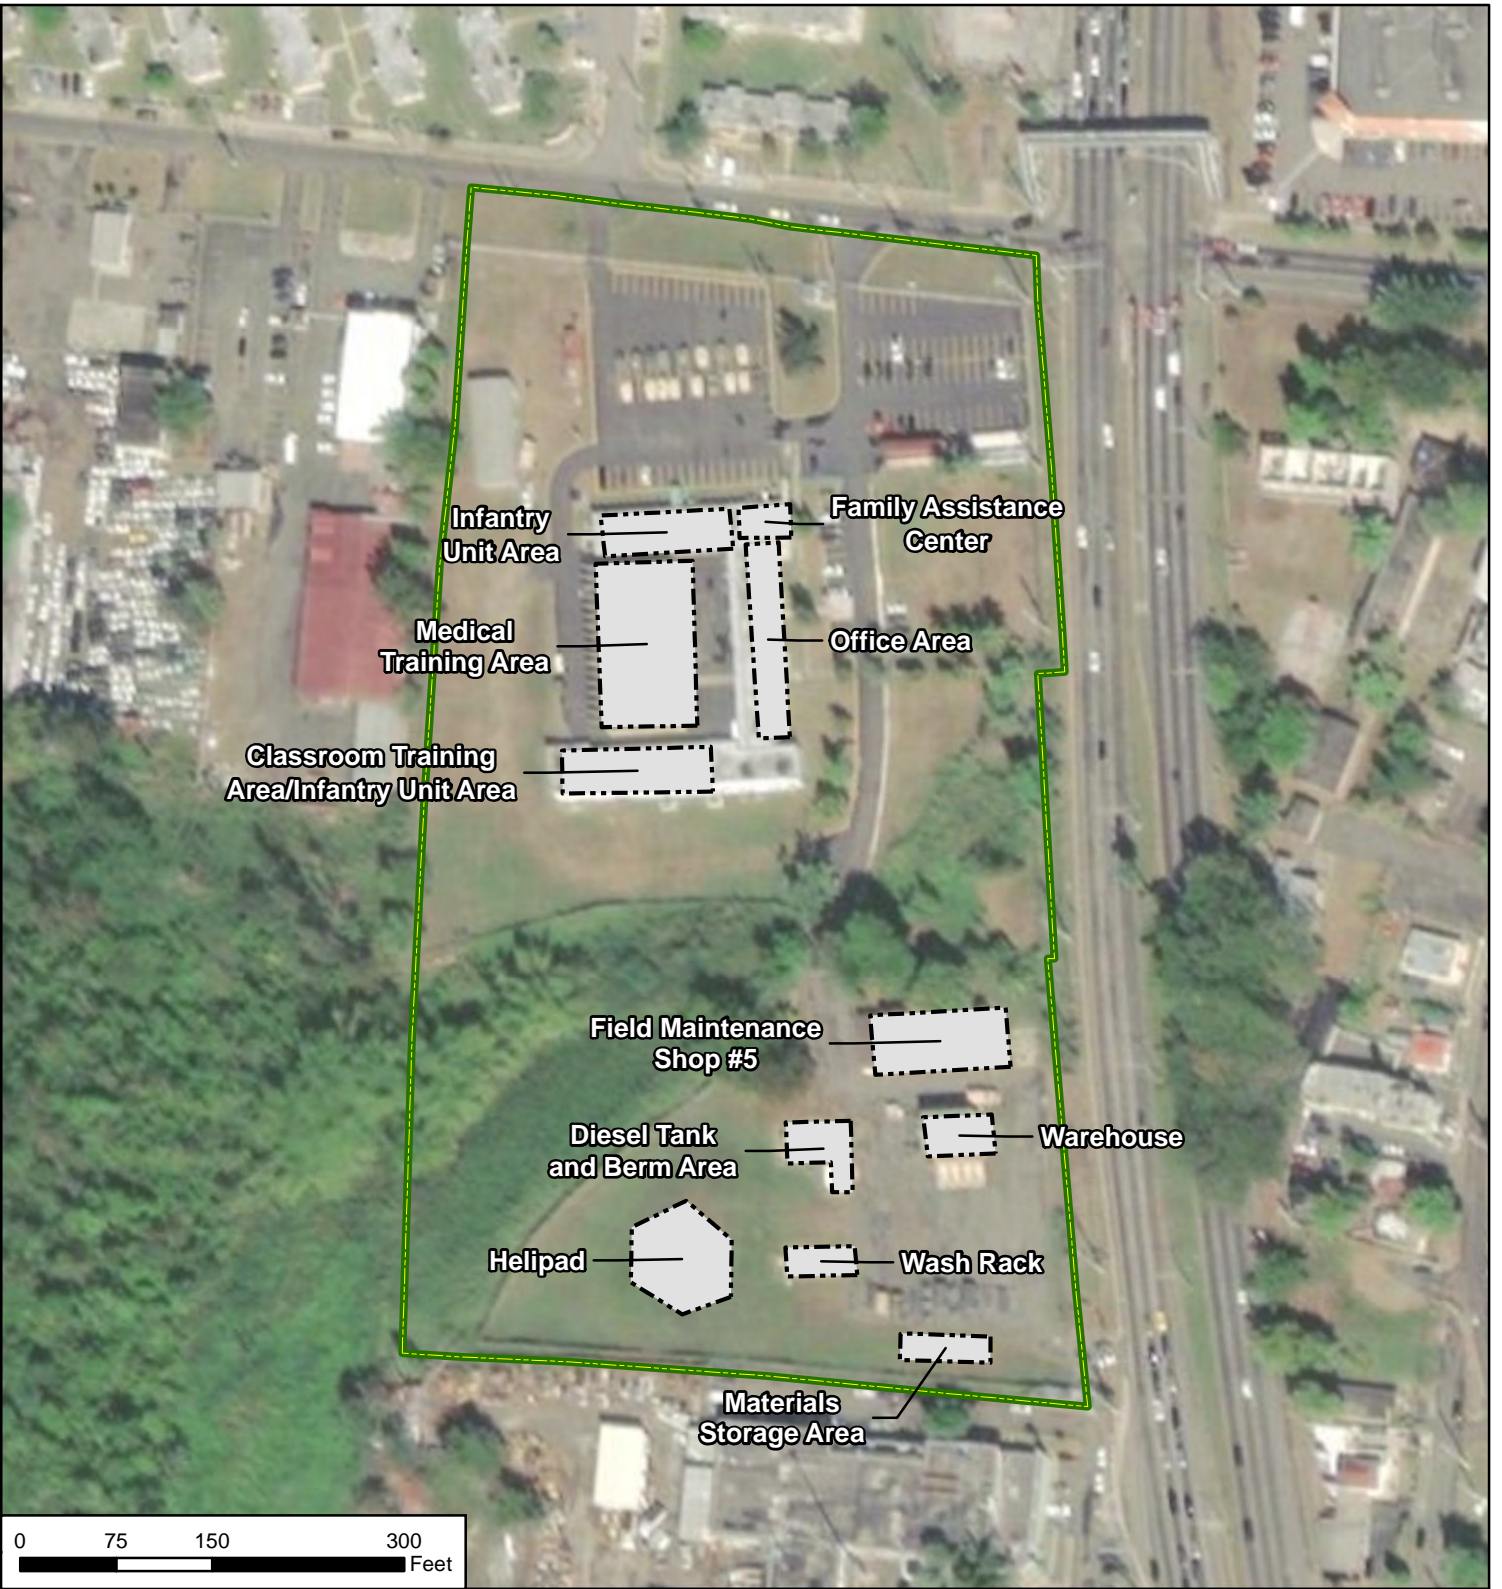
Summary of Findings	
AECOM	12420 Milestone Center Drive Germantown, MD 20876
Figure 7-1

No AOIs related to potential PFAS release were identified at the Mayagüez Readiness Center based on information gathered as part of this PA (**Figure 7-1**). Based on the documented absence of the use/release of PFAS-containing materials, evidence does not support current or former ARNG activities at the facility having contributed to PFAS contamination in soil, groundwater, surface water, or sediment at the facility or adjacent areas. Adjacent potential PFAS release areas were identified in the city of Mayagüez, but it is unknown if any PFAS releases have occurred at these locations.

The PRARNG Mayagüez Readiness Center will not move forward in the CERCLA process.

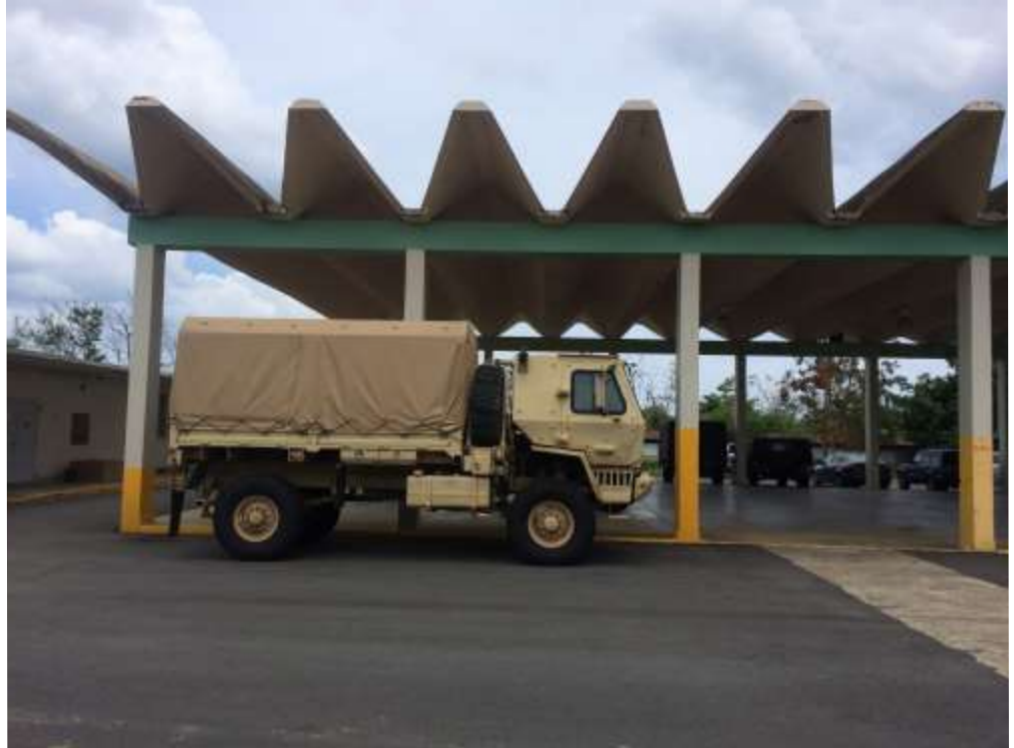
The Medical Training Area in the courtyard at the center of the office and administrative areas at Mayaguez Readiness Center

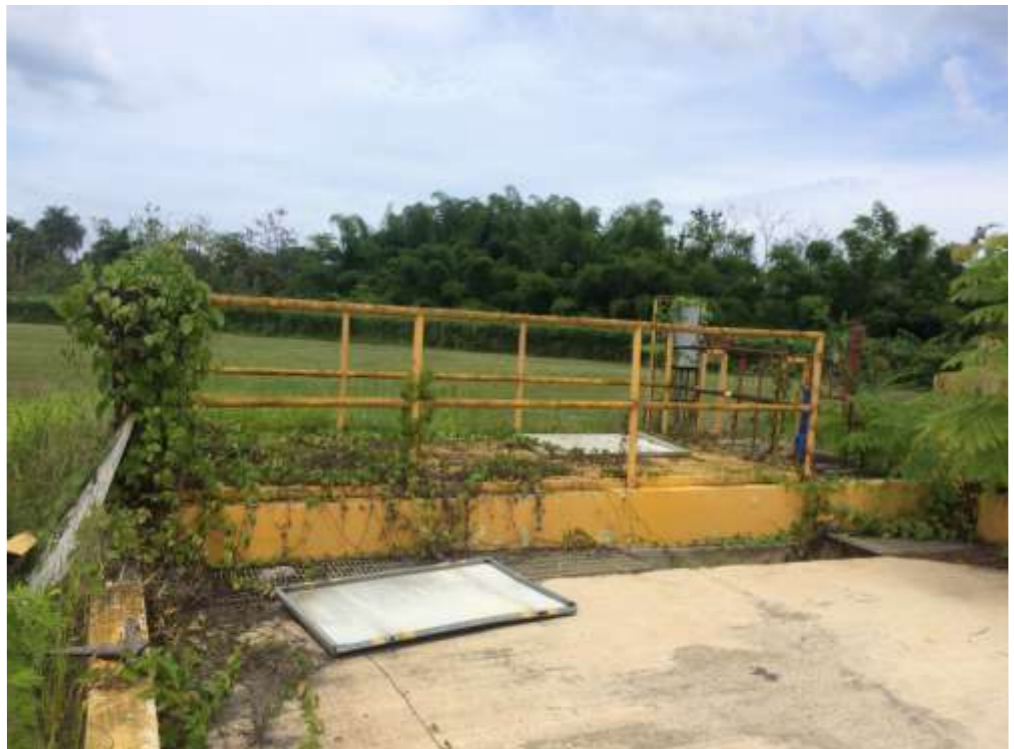
The oil water separator at the Wash Rack at the Mayaguez Readiness Center.
