FINAL Preliminary Assessment Report Allendale Armory, Allendale, South Carolina

Perfluorooctanesulfonic Acid (PFOS) and Perfluorooctanoic Acid
(PFOA) Impacted Sites
ARNG Installations, Nationwide

October 2020

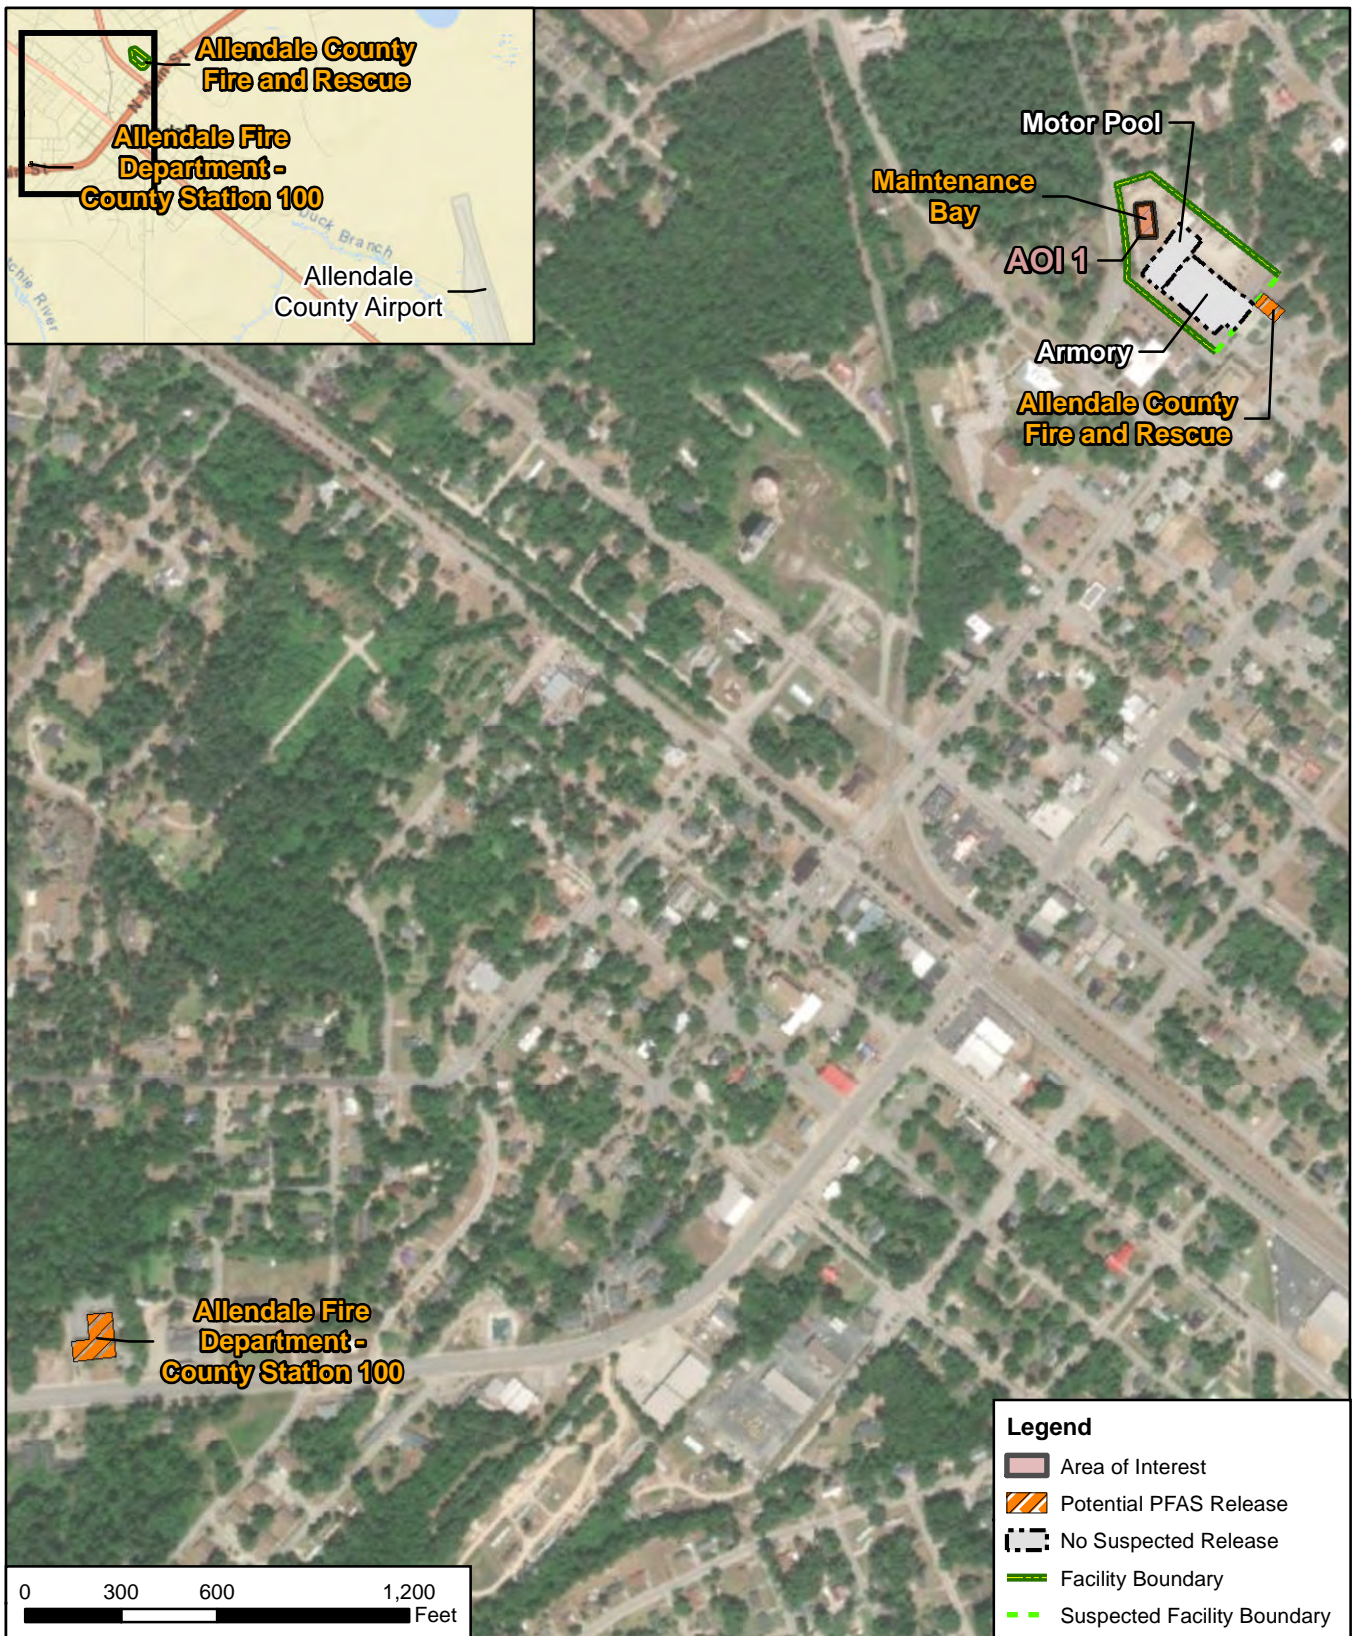
One AOI related to a potential PFAS release was identified at Allendale Armory during the PA. The AOI is shown on **Figure ES-1** and in **Table ES-1** below:

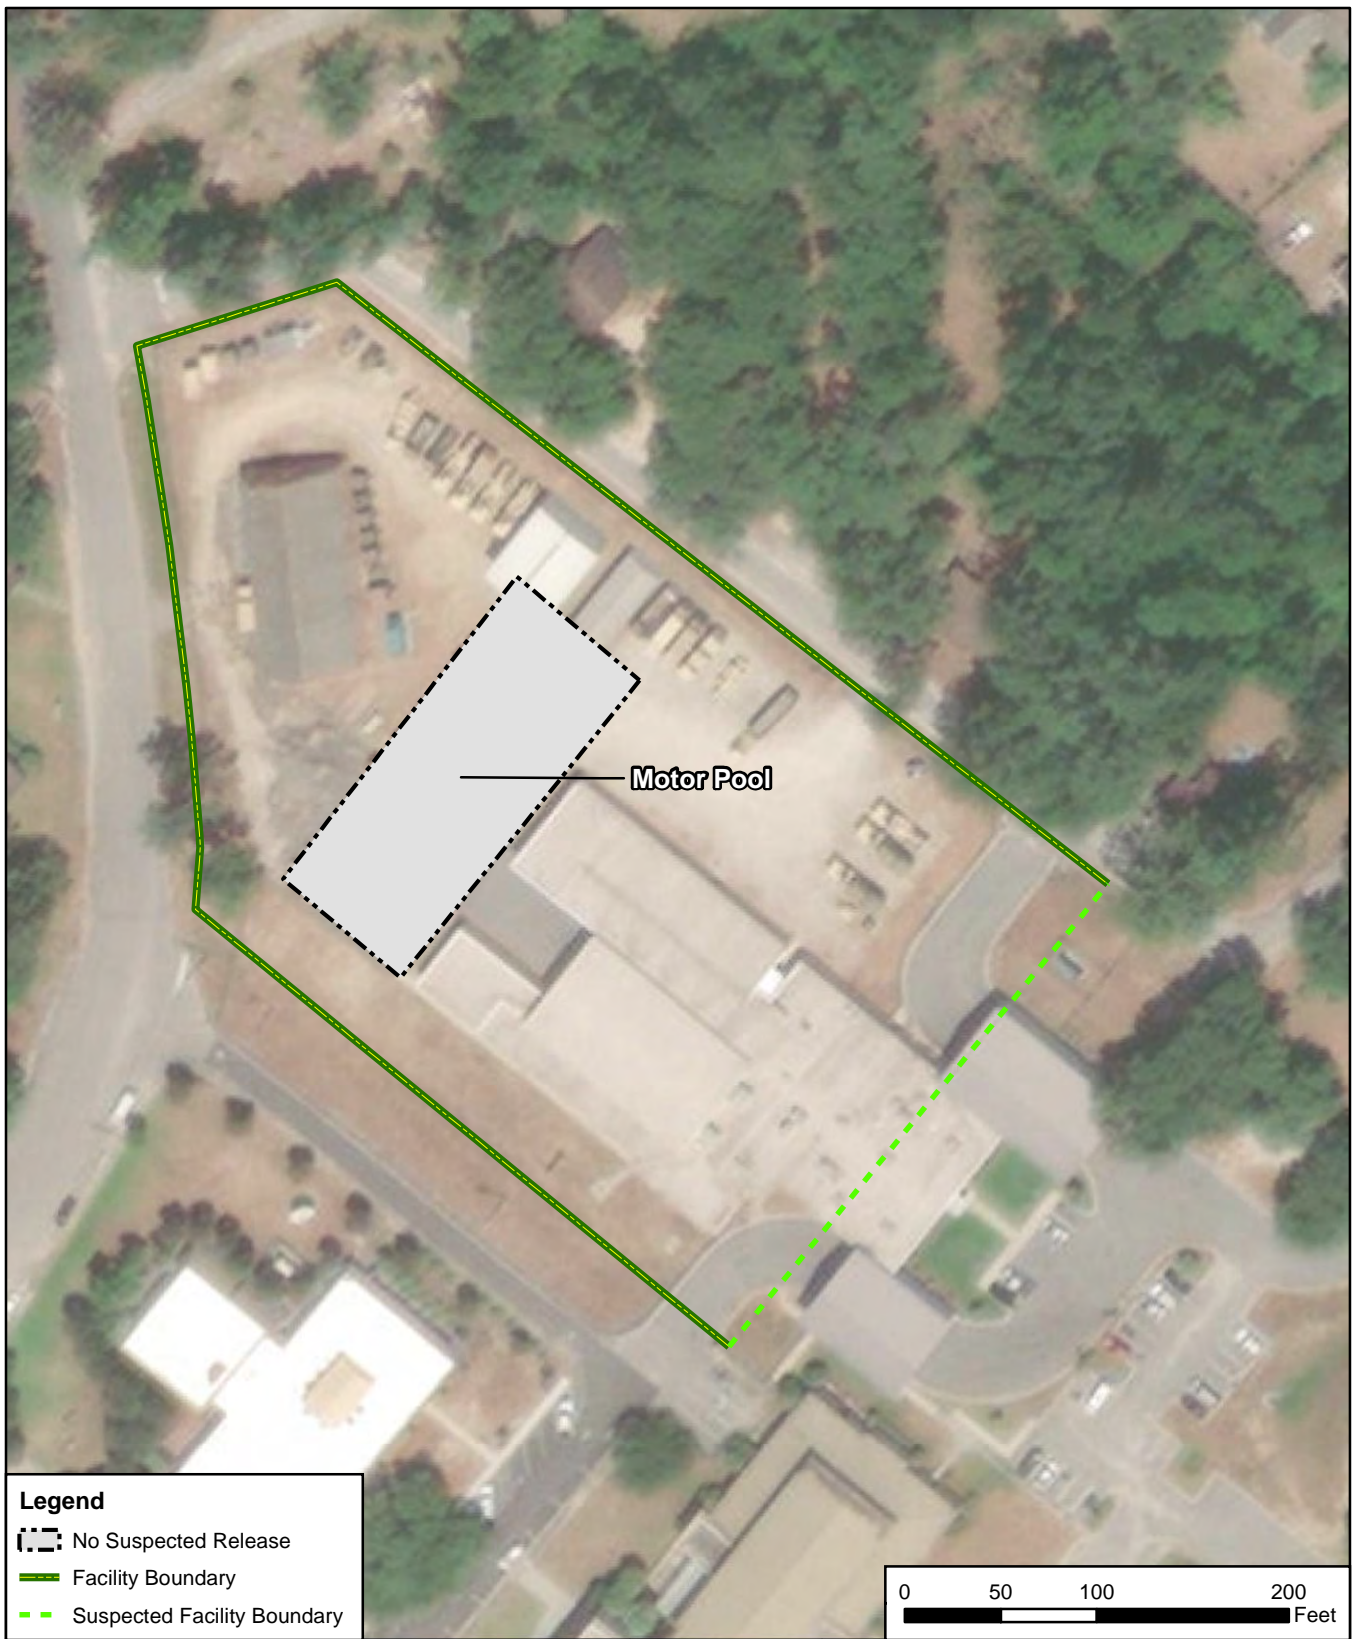
Figure 2-1

One FTA was identified through record reviews and interviews during the PA as described below. The FTA is shown on **Figure 2-1**.

Fire training activities involving portable ABC fire extinguishers (non-AFFF) by SCARNG have taken place at the motor pool. Training fires are created by igniting either paper or diesel in a pan; ABC extinguishers are then used to extinguish the fires. No exact dates for when the fire training took place could be recalled by interviewees; however, the interviewed SCARNG personnel recalled at least one fire training event occurring during his tenure of 24 years at the facility.

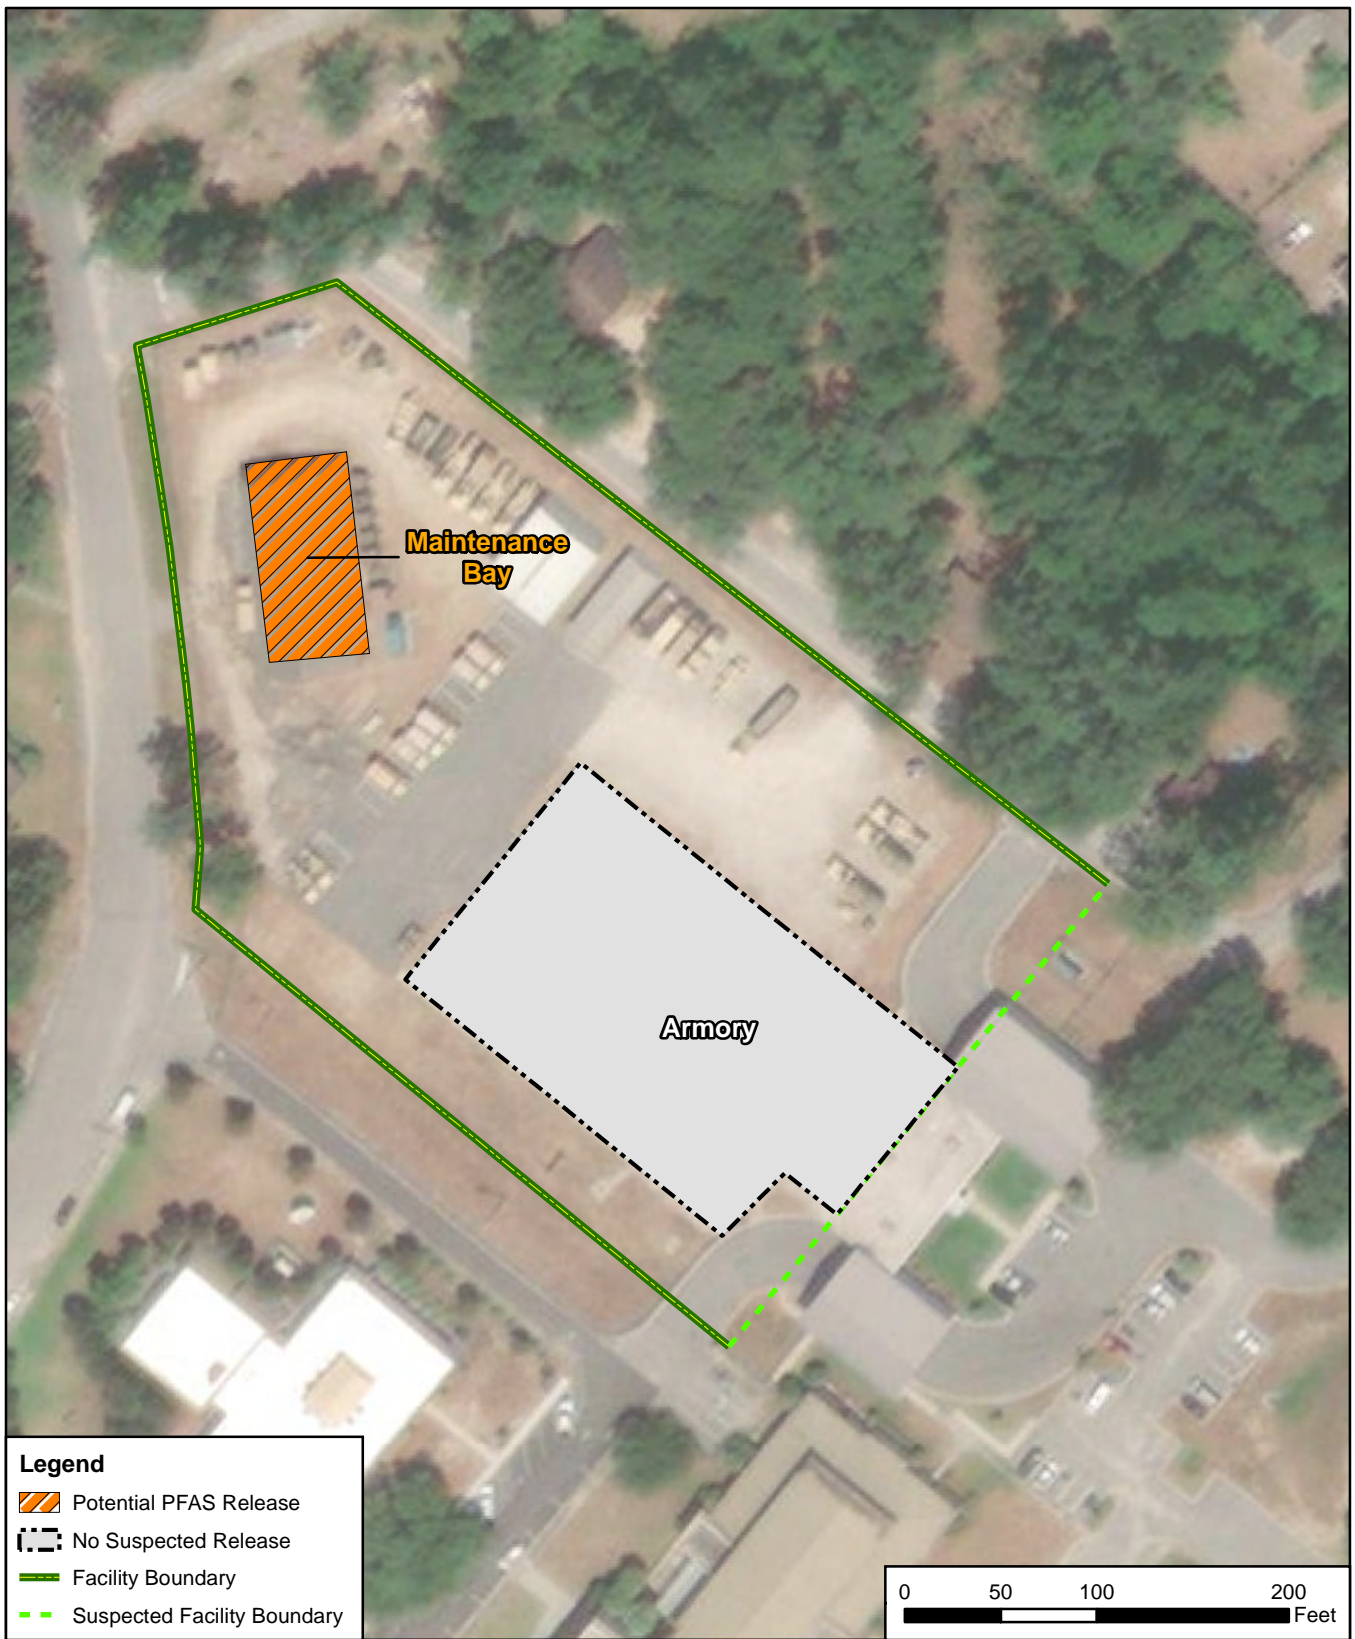
In addition to FTAs, the PA evaluated areas where PFAS-containing materials may have been broadly used, stored, or disposed. This may include buildings with fire suppression systems, paint booths, AFFF storage areas, and areas of compliance demonstrations. Information on these features obtained during the PA are included in **Appendices A** and **B**. Two non-FTAs where AFFF was stored and/or potentially released were identified during the PA. A description of each non-FTA is presented below, and the non-FTAs are shown on **Figure 3-1**.

Prior to the 264th and 268th Engineer Detachments (firefighting units) moving to McCrady Training Center in the early 2000s, firetrucks and 5-gallon buckets of AFFF were stored in the vehicle maintenance bay at the facility. According to interviewed SCARNG personnel, the firetrucks were foam capable but never leaked AFFF, and AFFF was never otherwise spilled during the personnel's years of experience at the facility (1986 to 2005). Fire training and nozzle testing of the firetrucks were only conducted with water, although the exact location of these activities was not specified. Older firetrucks were historically present at the facility prior to 1990 but were not foam capable. However, newer firetrucks with foam tanks were received around 1990 but were reportedly never used to expel AFFF. Currently, the only fire extinguishing agents located within the maintenance bay are portable ABC fire extinguishers (non-AFFF).

It is unknown when the 264th and 268th Engineer Detachments were established at the facility; interviewed SCARNG personnel's knowledge dates back to 1986. A data gap exists between the establishment of the facility in 1950 and the earliest tenure of PA interviewees in 1986. The maintenance bay is considered a potential PFAS release area.

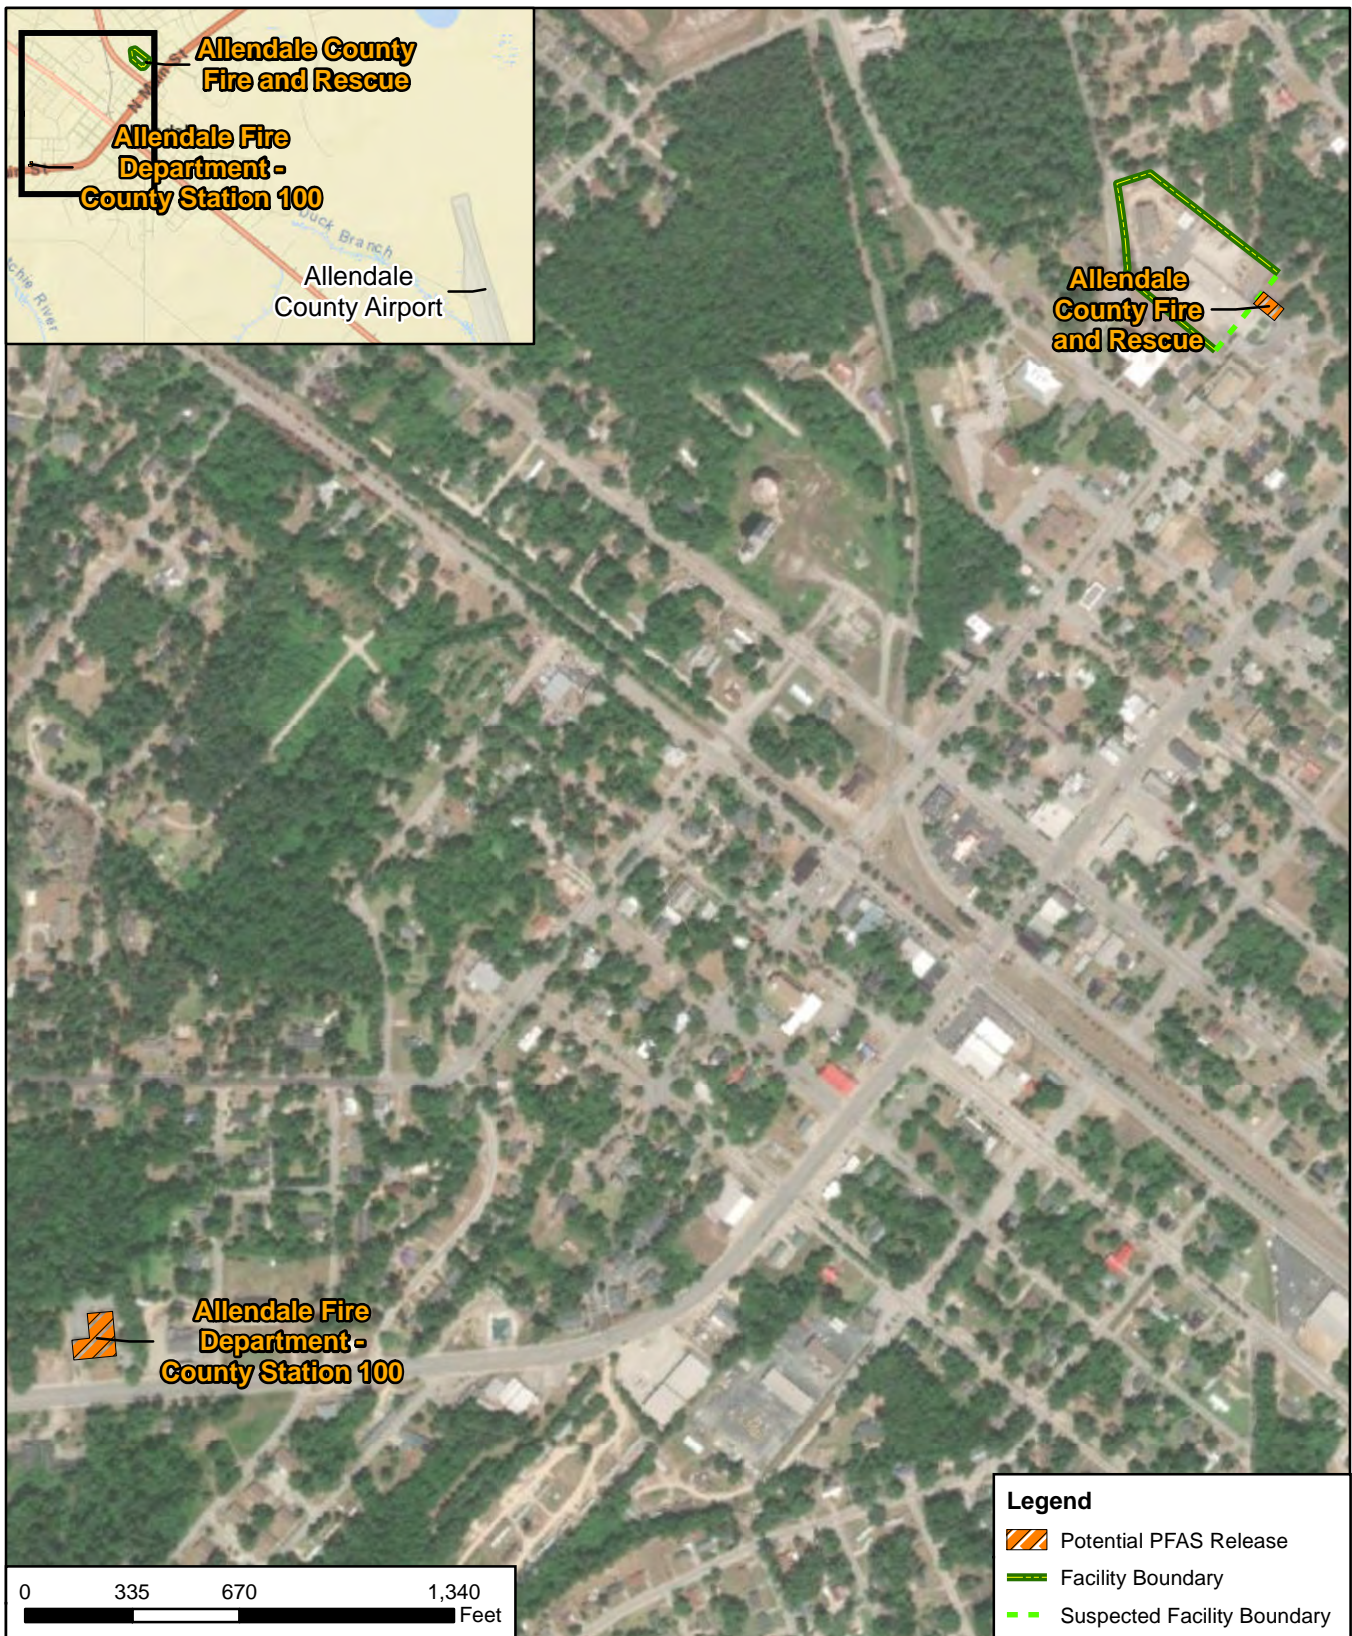
Two potential sources of PFAS adjacent to the facility, not under the control of the SCARNG, were identified during the PA. A description of each adjacent source is presented below, and the adjacent sources are shown on **Figure 5-1**.

A VSI was conducted at the Allendale County Fire and Rescue fire station during the PA; four 5-gallon buckets of AFFF were found in storage at the fire station. According to the Allendale County Fire and Rescue personnel, the AFFF has never been used or carried within the firefighting vehicles in her 23 years of experience. The fire department also has two pumper stations with foam capabilities and one rescue firetruck. None of the firefighting vehicles currently carry AFFF. Only an unknown formulation of Flame Freeze™, a firefighting wetting agent, is stored within the firefighting vehicles and is used for vehicle washing in front of the fire station. It is unclear if Flame Freeze contains PFAS, as certain formulations of the product describe it as fluorine-free, while others describe it as a C6 Class B foam in compliance with 2010/2015 USEPA PFOA/PFOS Stewardship Requirements (Momar, Inc., 2020). Safety data sheets for various formulations of Flame Freeze are included in **Appendix A**.

Although County Station 100 was not visited during the VSI, because the Allendale County Fire and Rescue was previously located with the station and has historically had AFFF, County Station 100 was also identified as a potential adjacent source of PFAS by association.

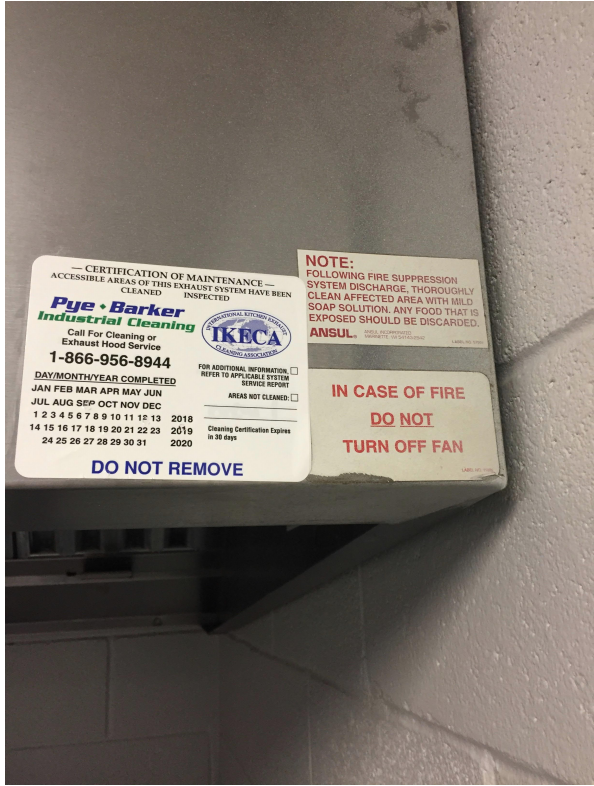
Army National Guard, Preliminary Assessment for PFAS	Allendale Armory	Allendale, South Carolina
<p>Photograph No. 1</p> <p>Date 10/2/2019 Time 9:28</p> <p>Description: An Ansul R-102 wet chemical fire suppression system is located in the kitchen of the armory. The ventilation hood where the wet chemical agent is discharged is shown.</p> <p>Orientation: Northeast</p>

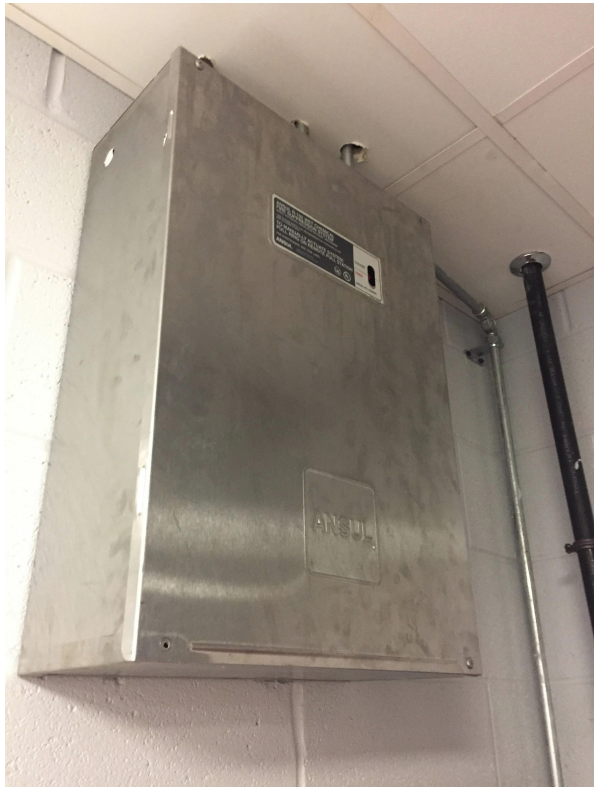
<p>Photograph No. 2</p> <p>Date 10/2/2019 Time 9:30</p> <p>Description: An Ansul R-102 wet chemical fire suppression system is located in the kitchen of the armory. The enclosure where the wet chemical agent is contained is shown.</p> <p>Orientation: Northeast</p>

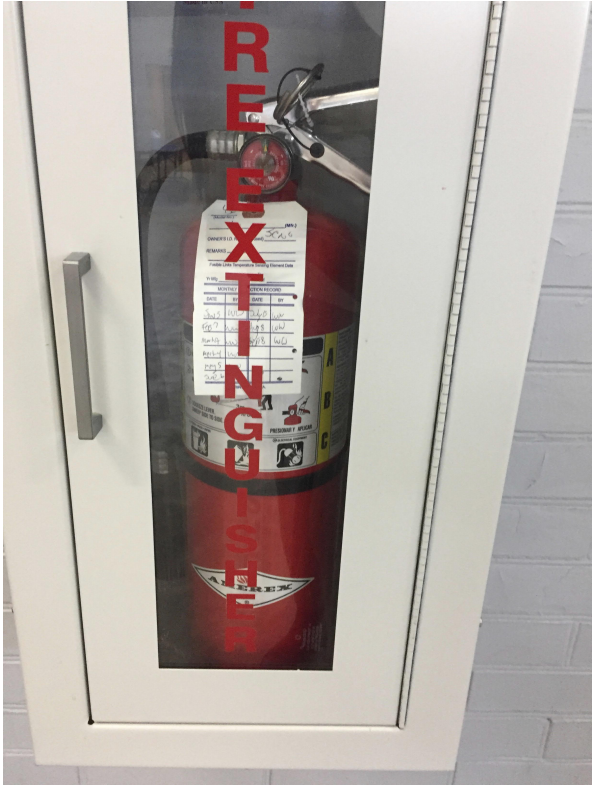
Army National Guard, Preliminary Assessment for PFAS	Allendale Armory	Allendale, South Carolina
<p>Photograph No. 3</p> <p>Date 10/2/2019 Time 10:38</p> <p>Description: Portable ABC fire extinguishers (non-AFFF) are stored within the armory.</p> <p>Orientation: Southwest</p>

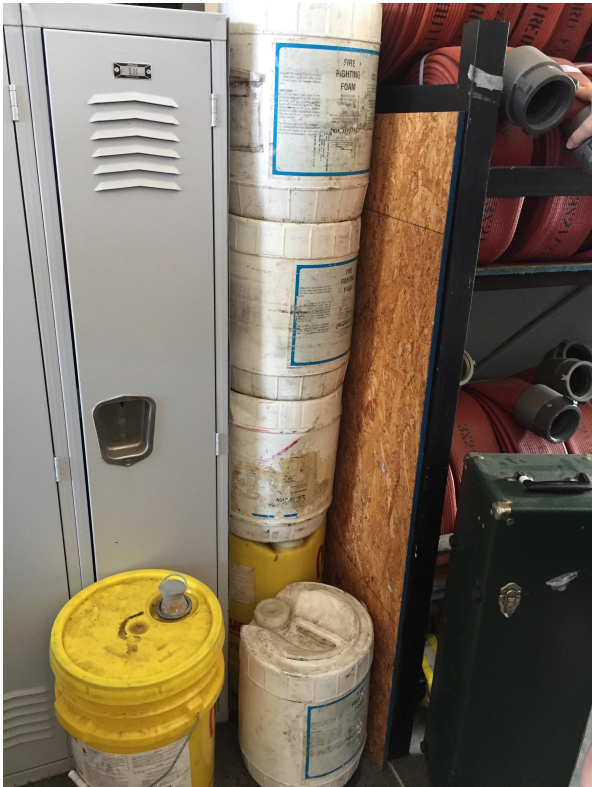
<p>Photograph No. 4</p> <p>Date 10/2/2019 Time 10:41</p> <p>Description: Four 5-gallon buckets of AFFF are stored at the adjacent Allendale County Fire and Rescue.</p> <p>Orientation: Northeast</p>
