Preliminary Assessment Report

Army Aviation Support Facility #2, Louisville, Tennessee

Perfluorooctanesulfonic Acid (PFOS) and Perfluorooctanoic
Acid (PFOA) Impacted Sites
ARNG Installations, Nationwide

October 2020

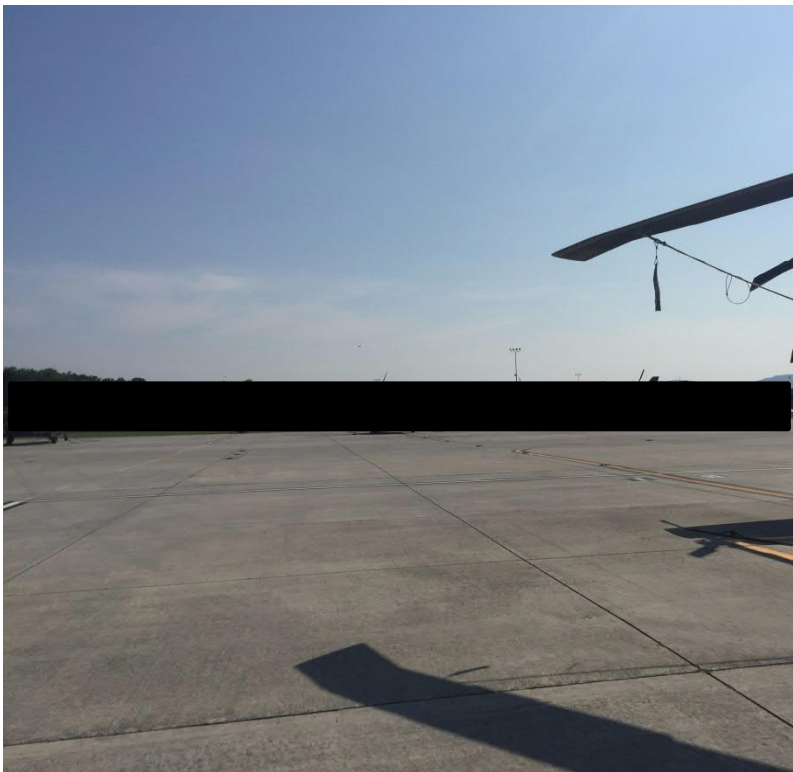
Photograph No. 1

Description: Flight line looking Northeast, mobile cart between helicopters 24 May 2019

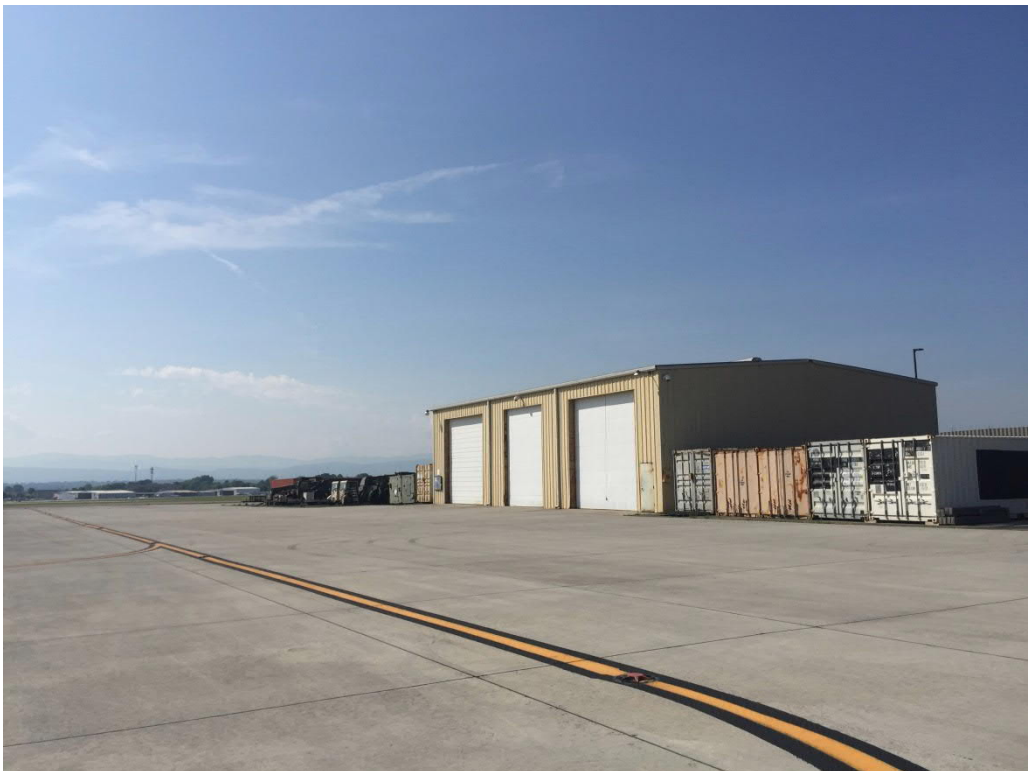
Photograph No. 2

Description: Old hangar exterior, looking South 24 May 2019

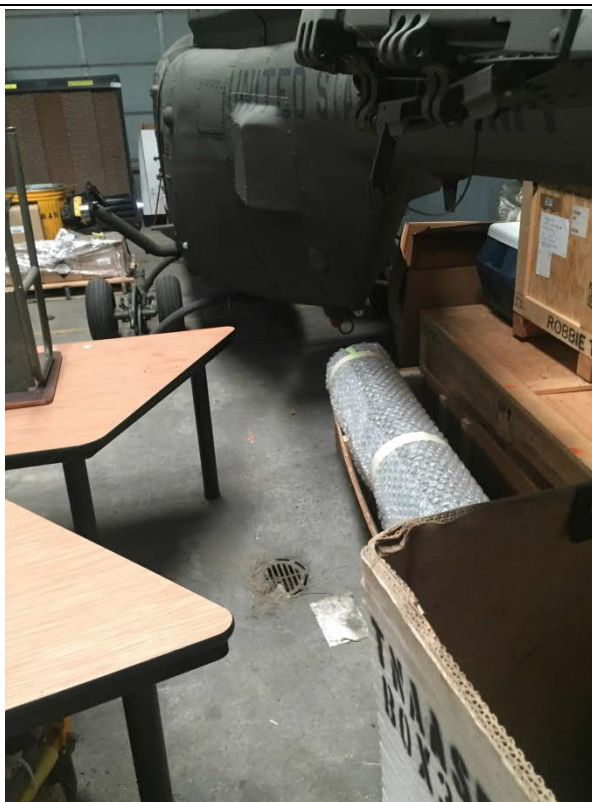
Old hangar interior floor drain

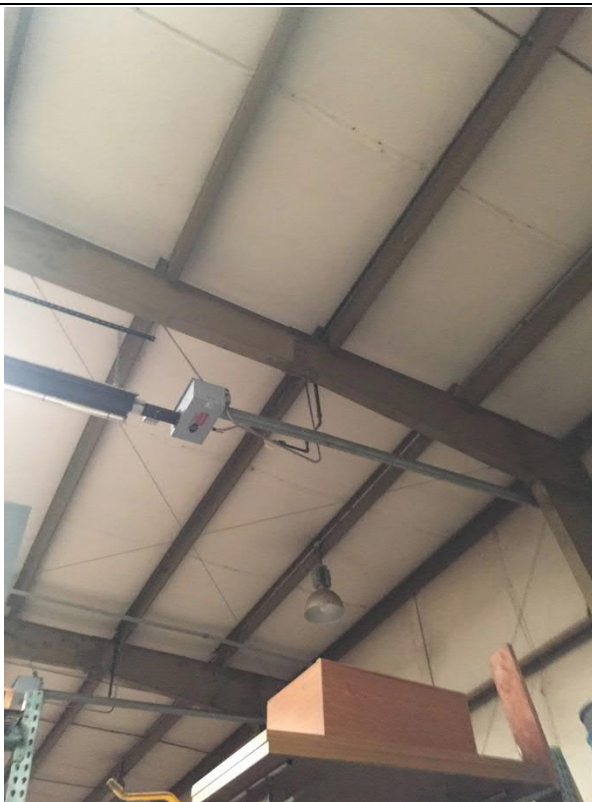
Photograph No. 4

Old hangar no ceiling fire
suppression system

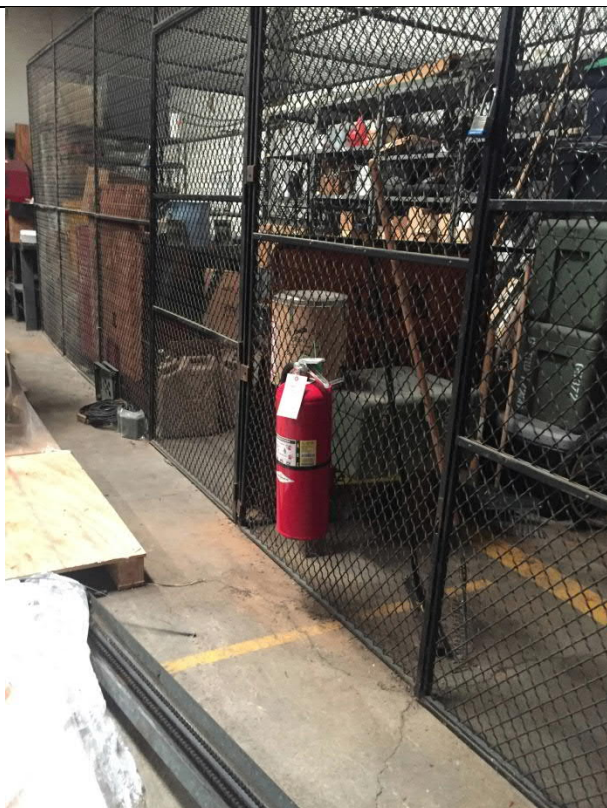
Old hangar wall mount fire
extinguisher

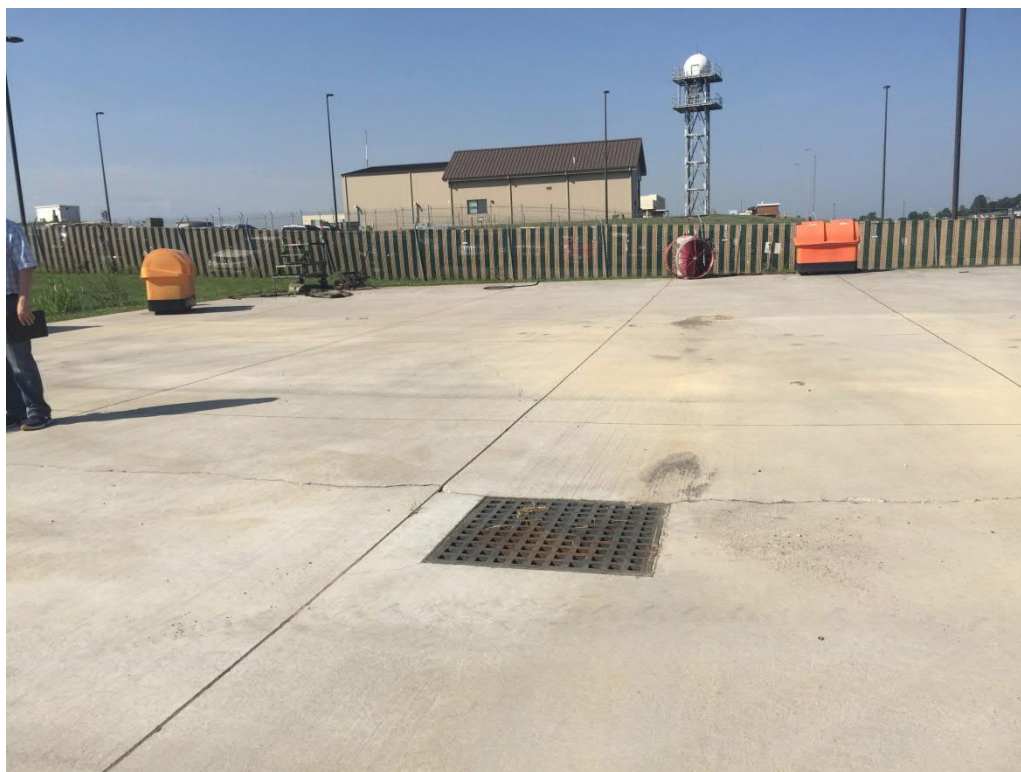
Photograph No. 6

Looking Southwest, wash
rack, drain in foreground,
Ansul cart in background
along fence

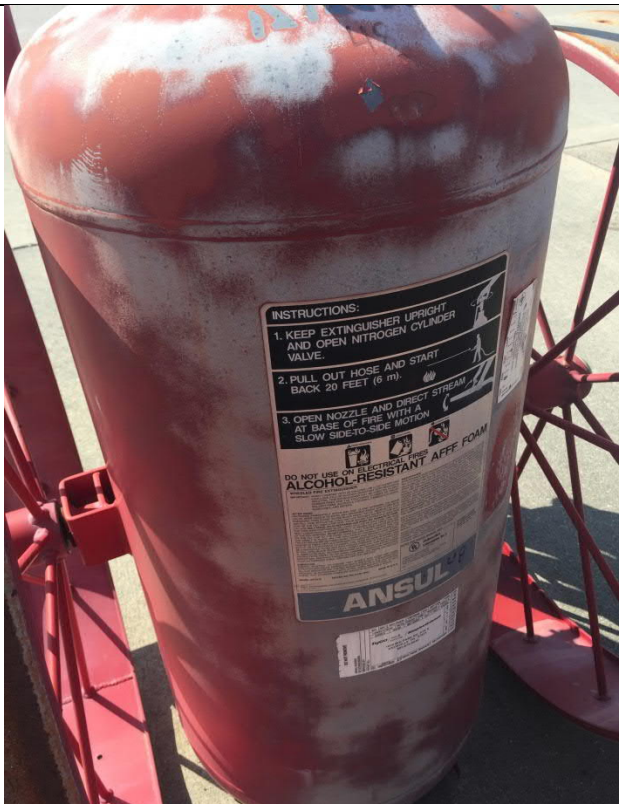
Photograph No. 7 Description: Label on Ansul AFFF fire extinguisher, SimplexGrinnell 24 May 2019

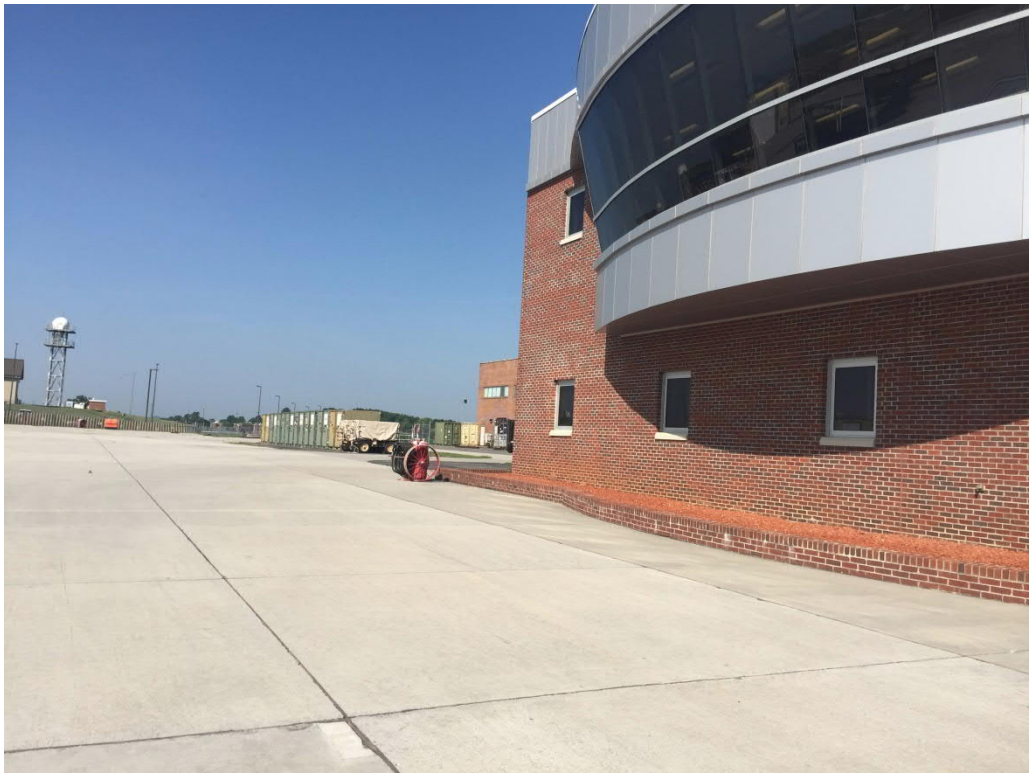
Photograph No. 8 Description: Looking Southwest, Ansul AFFF mobile cart fire extinguisher 24 May 2019

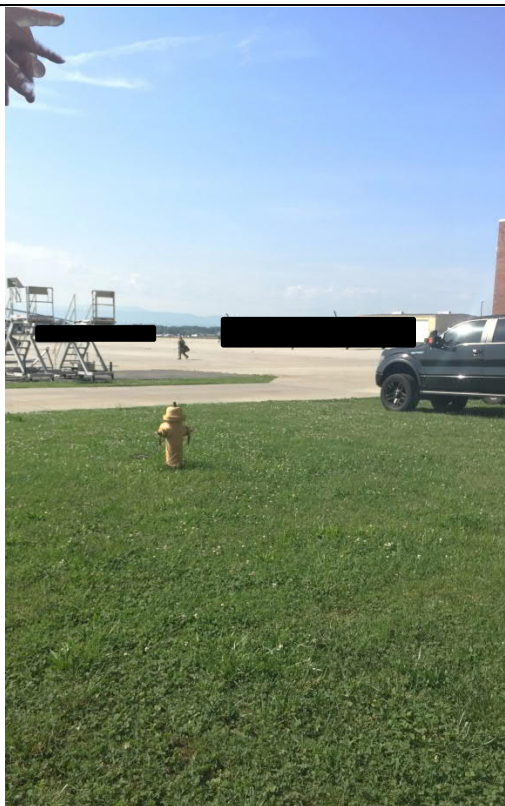
No
There is a known sewer blockage caused by bldg construction on / near flight line, unlikely to be repaired due to cost to replace flight line pad (concrete)

View South toward flight line
and damaged sewer blockage
beneath concrete pad

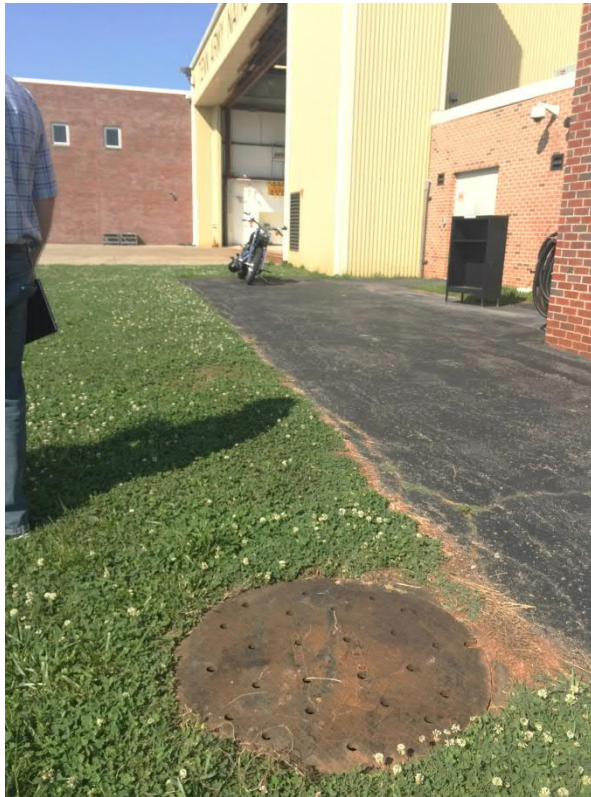
Photograph No. 10

Manhole to sewer system,
looking South

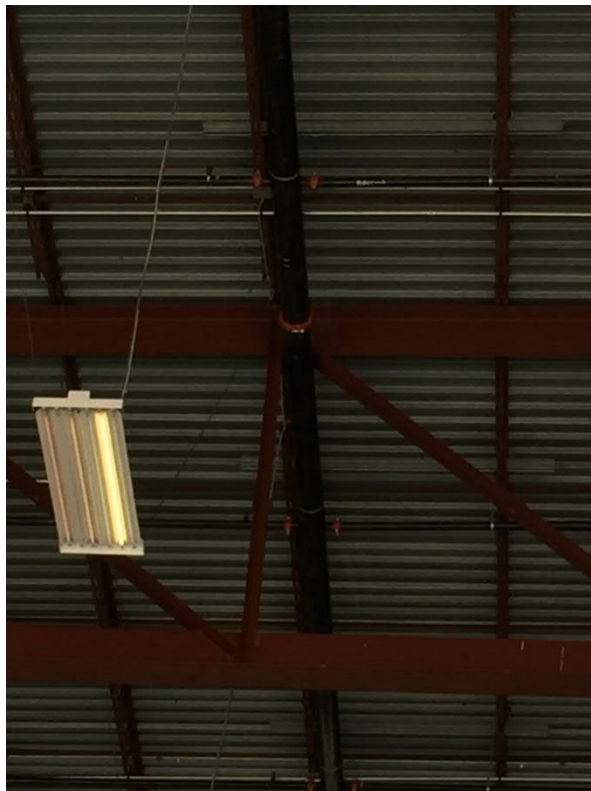
Photograph No. 11

Black fire suppression piping
in hangar ceiling, above lights

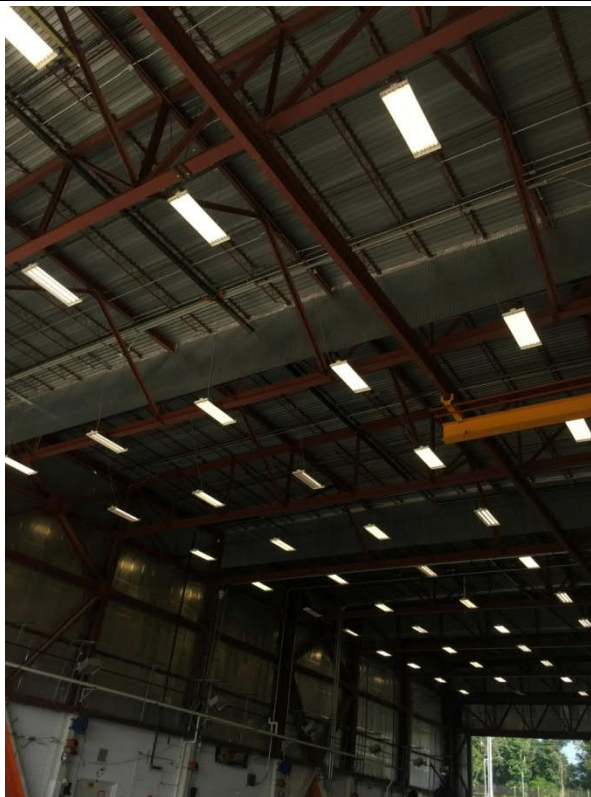
Photograph No. 12

Black fire suppression piping
in hangar ceiling, above lights

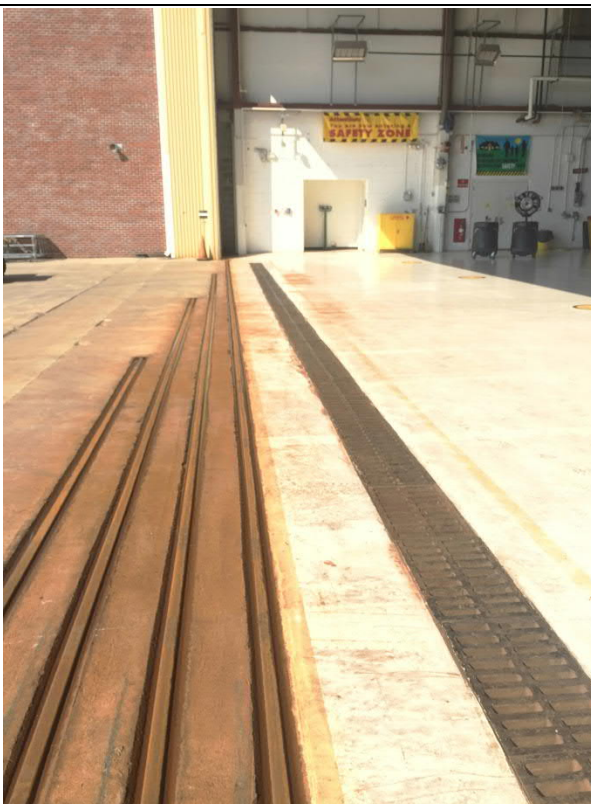
Photograph No. 13

Floor drains inside hangar
door

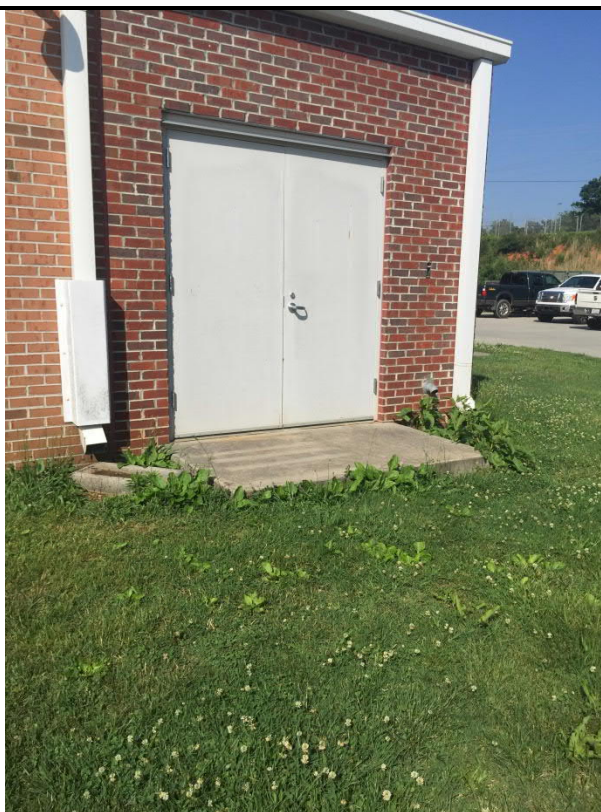
Photograph No. 14

AFFF storage, accessible
outside Northeast corner of

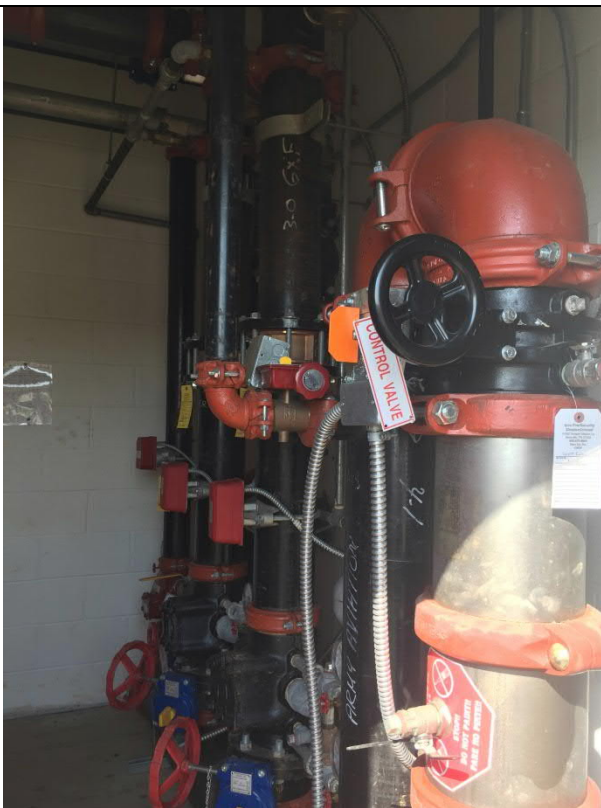
Photograph No. 15

AFFF piping in storage room
adjacent to hangar

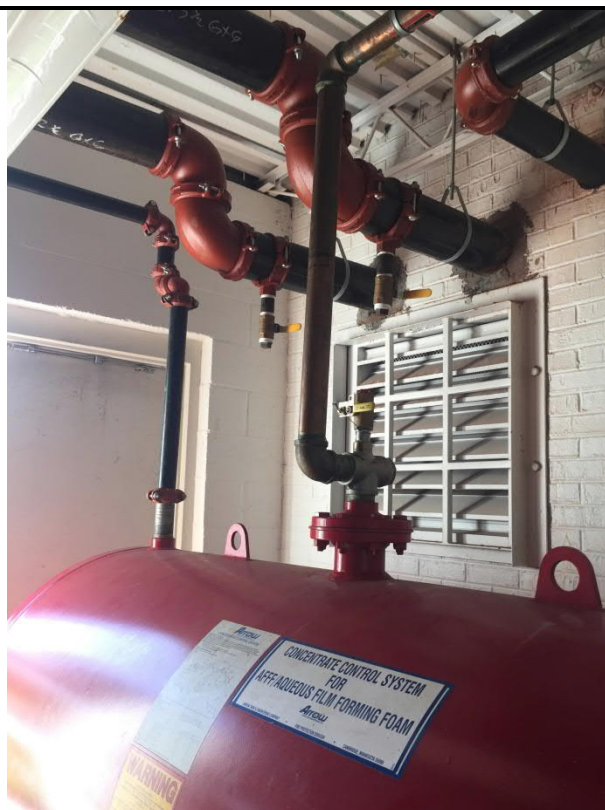
Photograph No. 16

AFFF tank piping in storage
 room adjacent to hangar

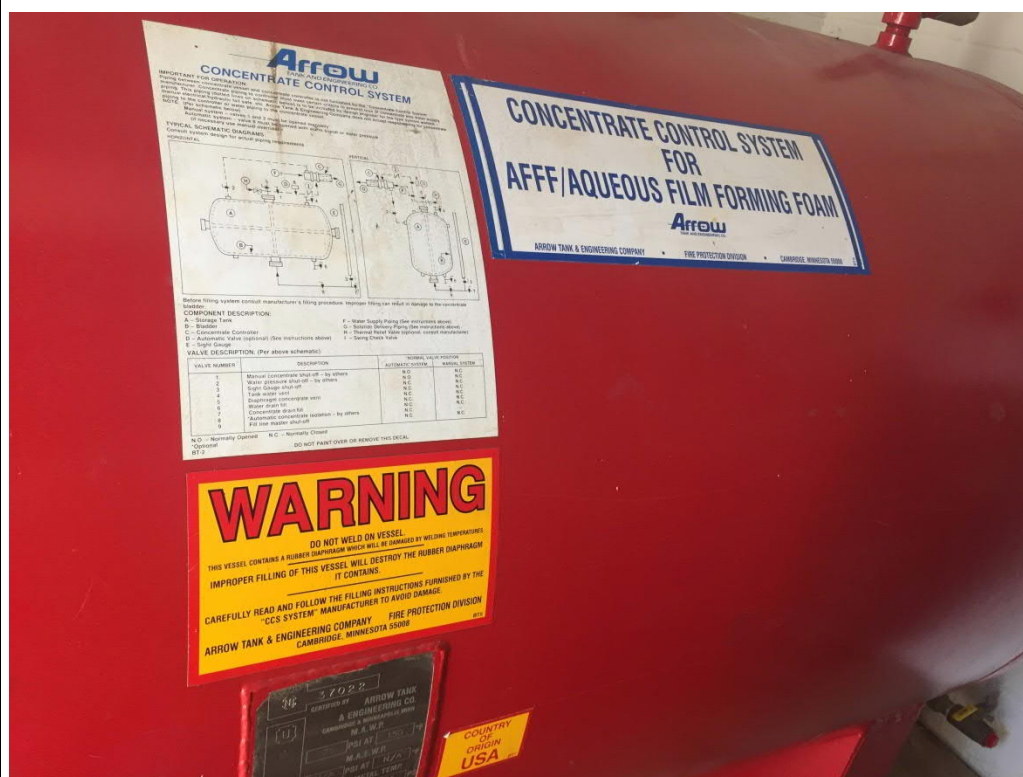
Photograph No. 17

500 gallon AFFF tank
 installed in 2008
