FINAL Preliminary Assessment Report Martindale Army Aviation Support Facility San Antonio, Texas

Perfluorooctanesulfonic Acid (PFOS) and Perfluorooctanoic
Acid (PFOA) Impacted Sites
ARNG Installations, Nationwide

July 2020

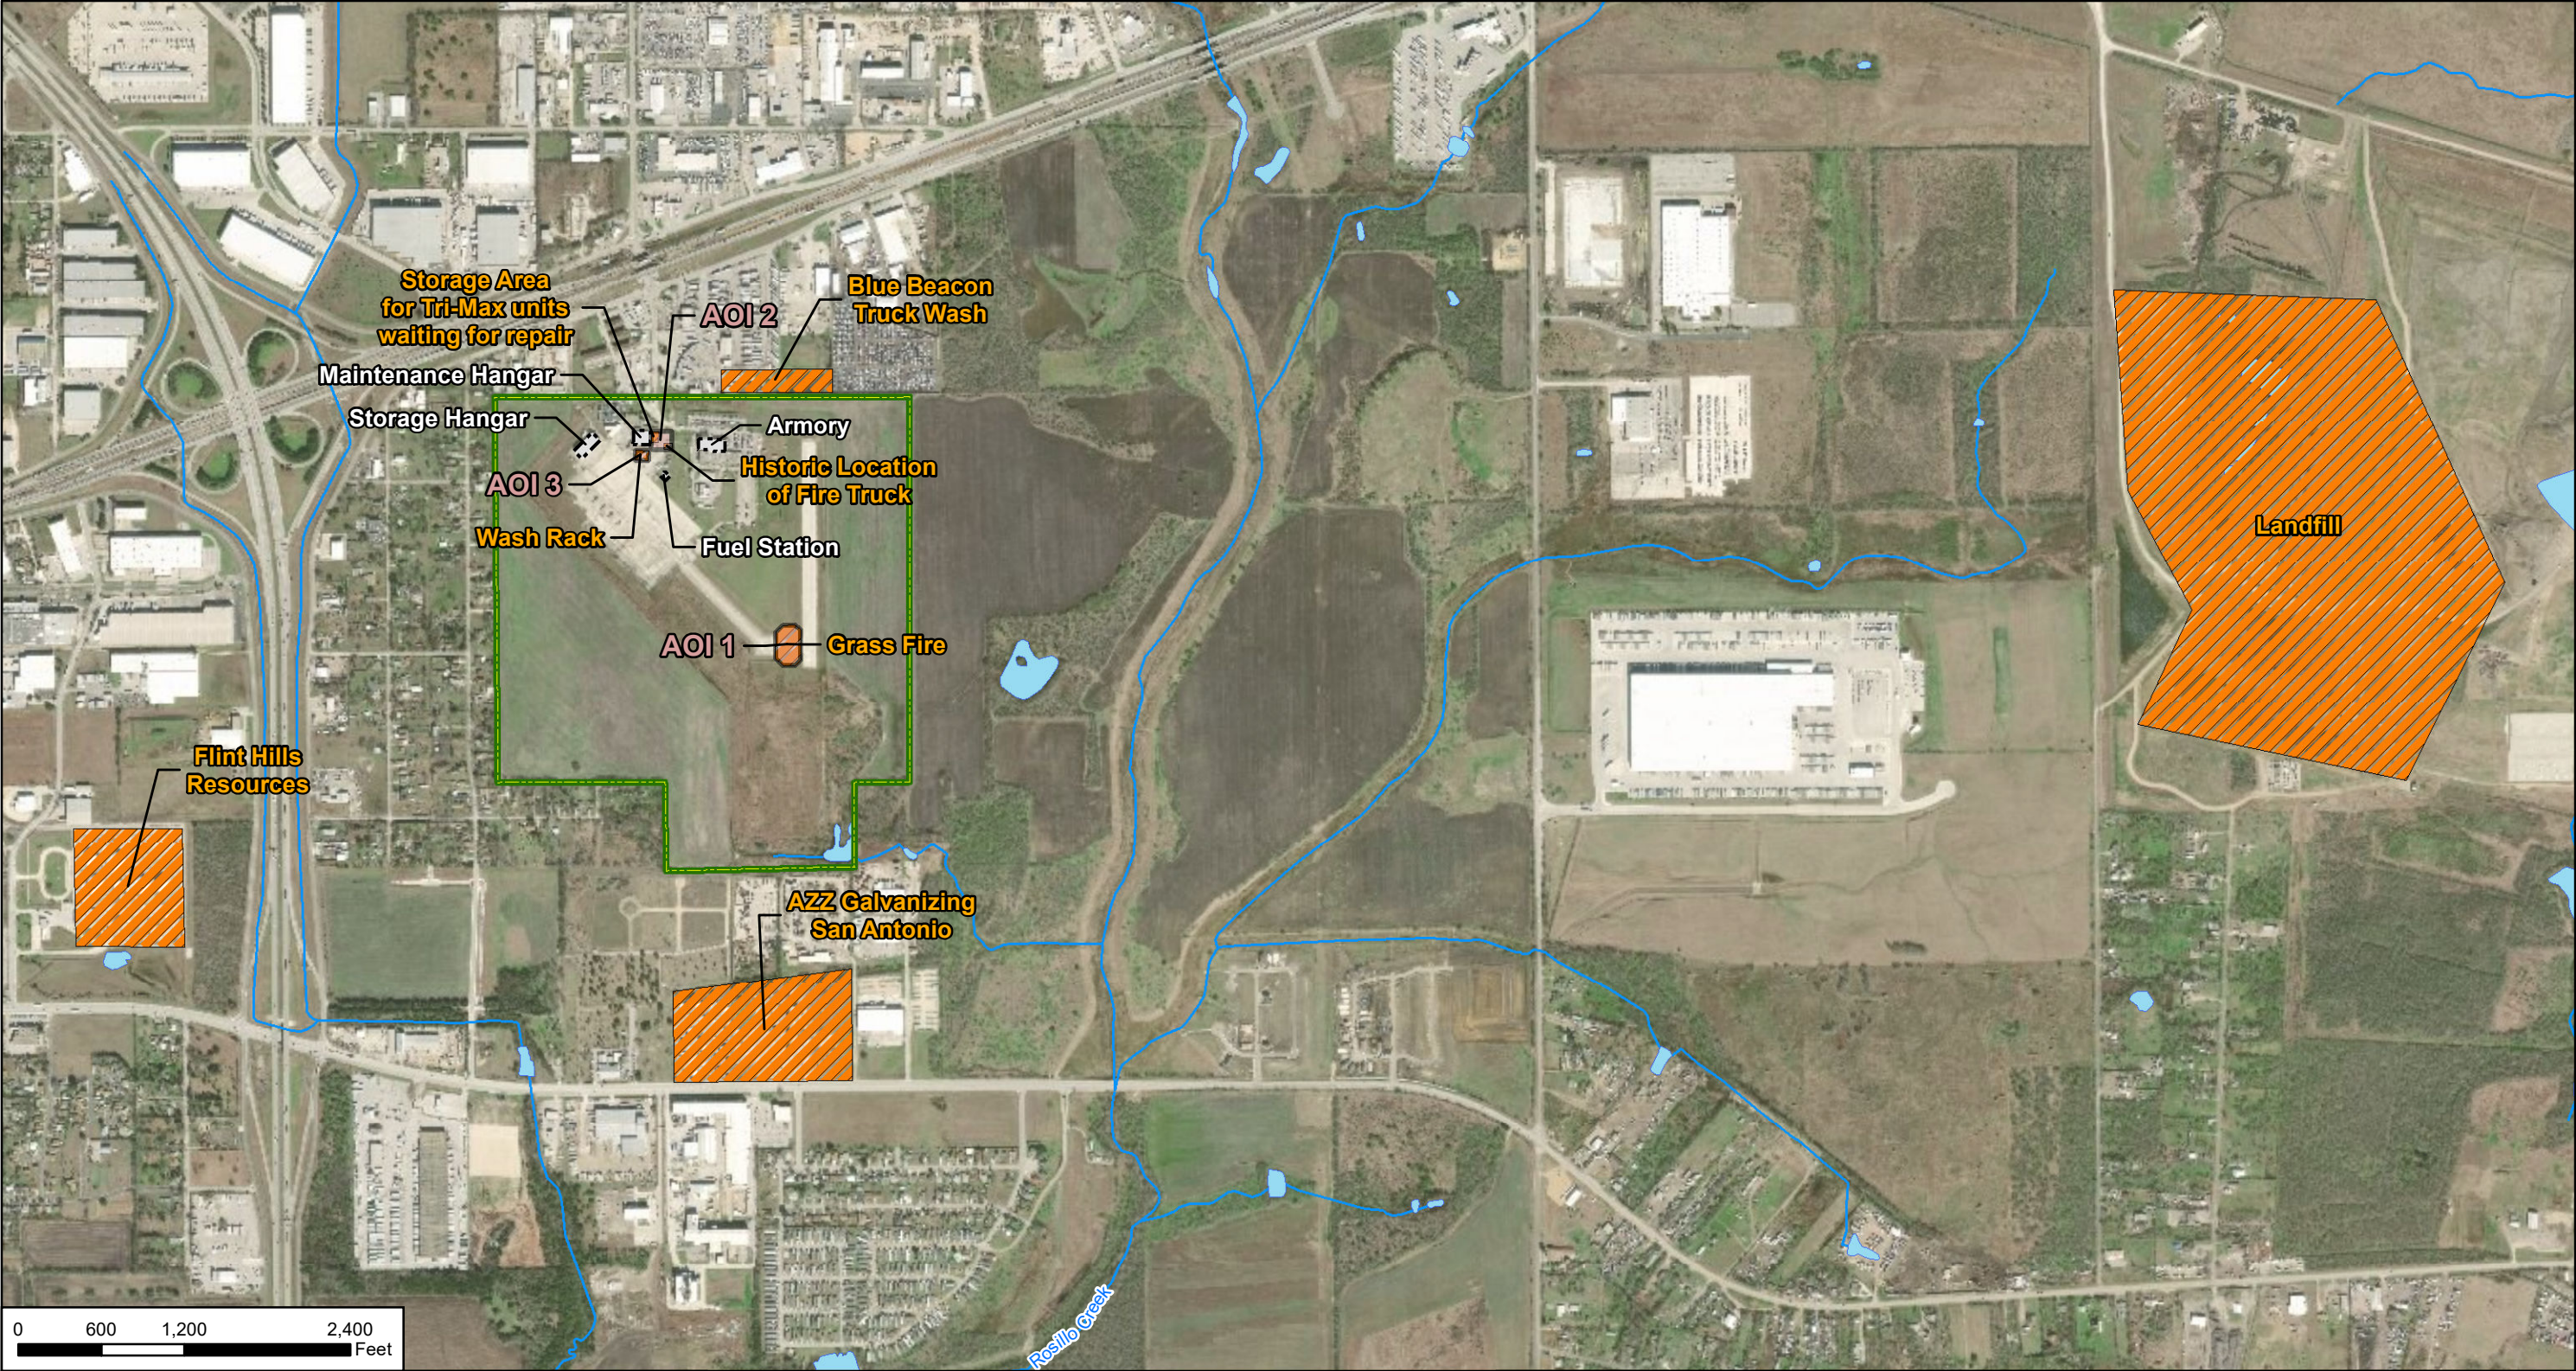
Figure ES-1

Three PFAS releases were identified during the PA, as described below. These releases constitute three AOIs identified at Martindale AASF. The AOIs are shown in **Figure ES-1** and summarized in **Table ES-1** below.

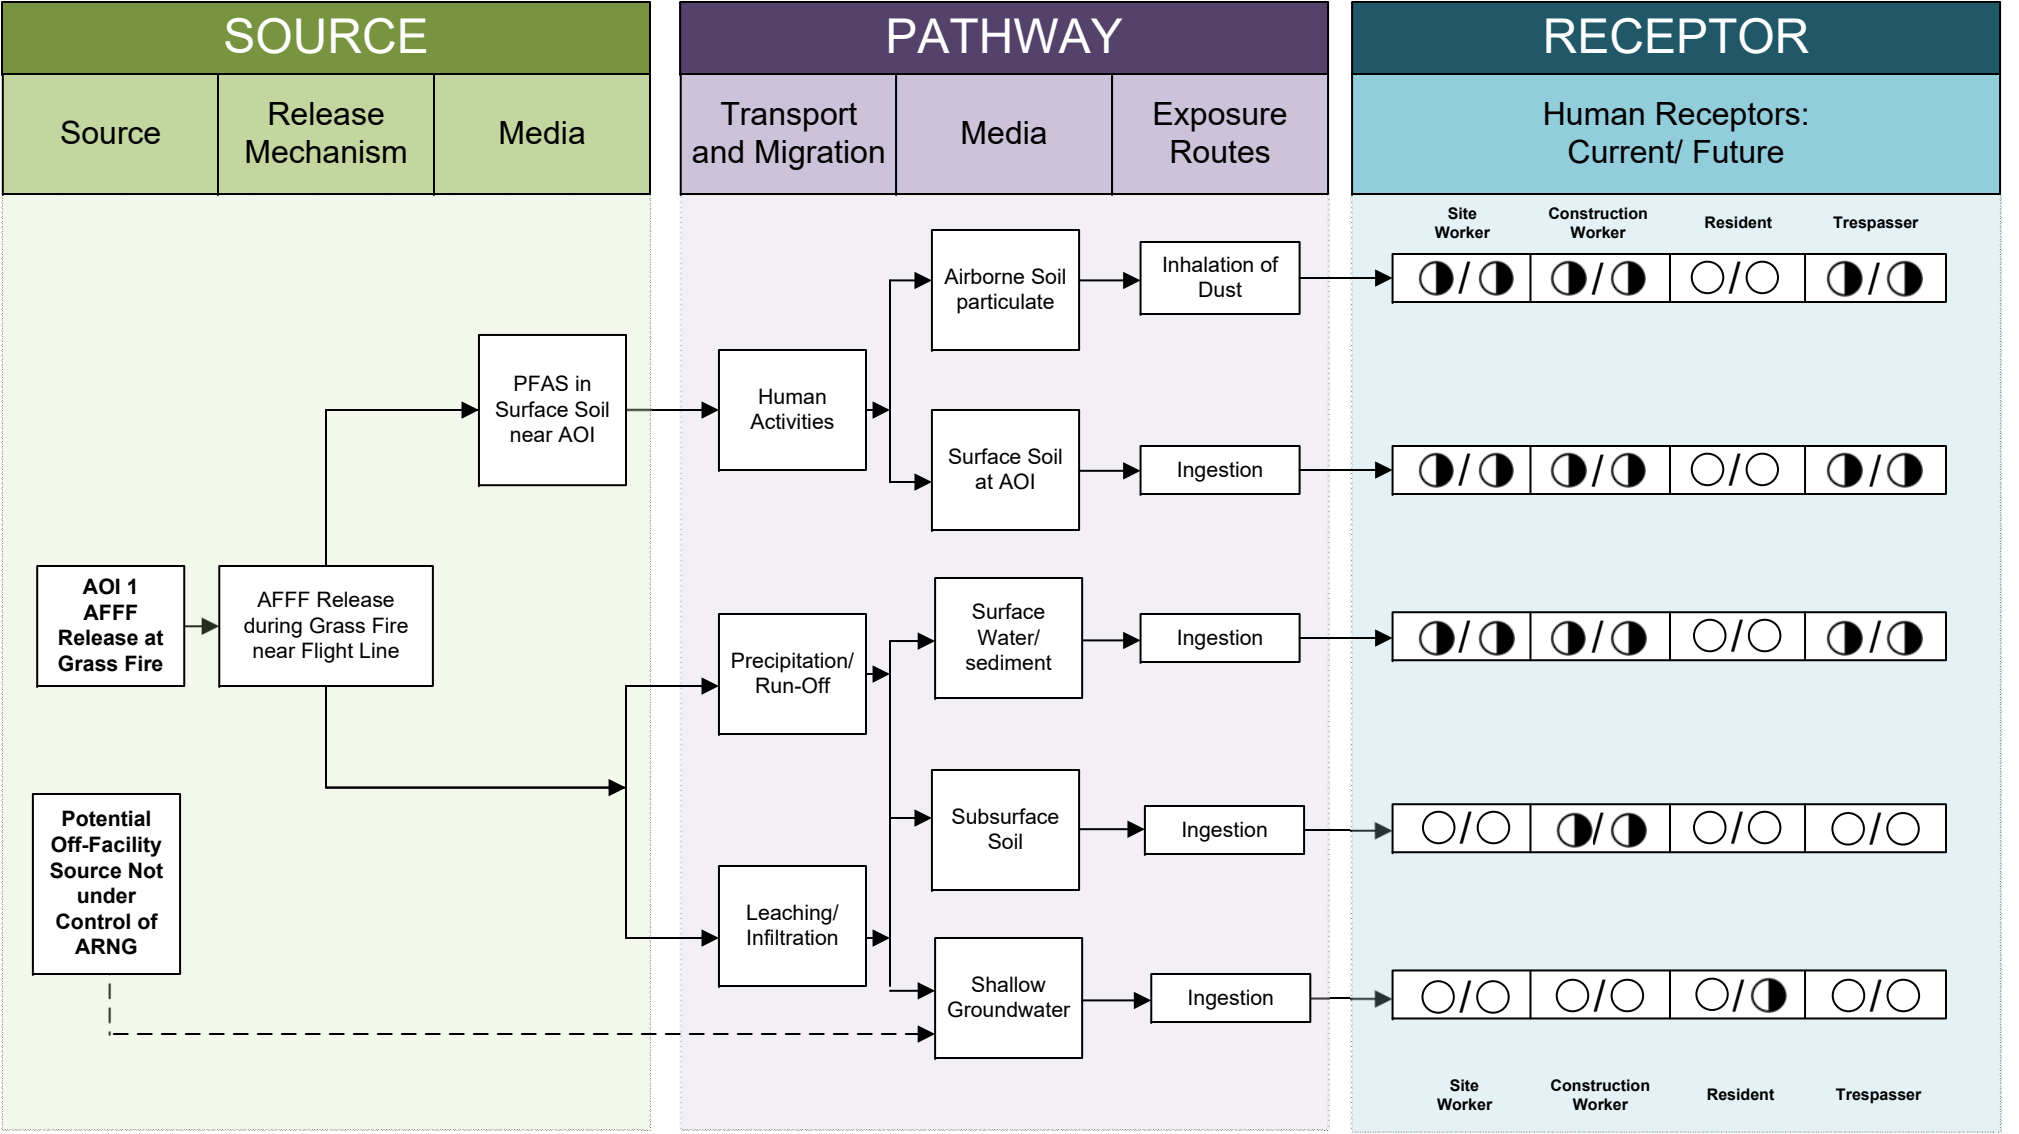
Figure ES-2
Preliminary Conceptual Site Model
AOI 1 AFFF Release at Grass Fire near Flight Line at Martindale AASF 4

Releases at the grassy areas on either side of the flight line would eventually infiltrate into the soil and potentially infiltrate to the subsurface and groundwater via rainwater infiltration. Under such scenarios, ground disturbing activities in these areas could result in site or construction worker exposure to PFAS via inhalation of dust or ingestion of exposed soil. PFAS contamination may have further infiltrated to shallow groundwater; however, there are no groundwater receptors identified within a 1-mile radius of the facility, so the groundwater exposure pathway is incomplete. PFAS may have accumulated in nearby storm water ditches, located both north and south of the flight line, creating an exposure pathway to site workers, construction workers, and trespassers from surface water/sediment in this area.

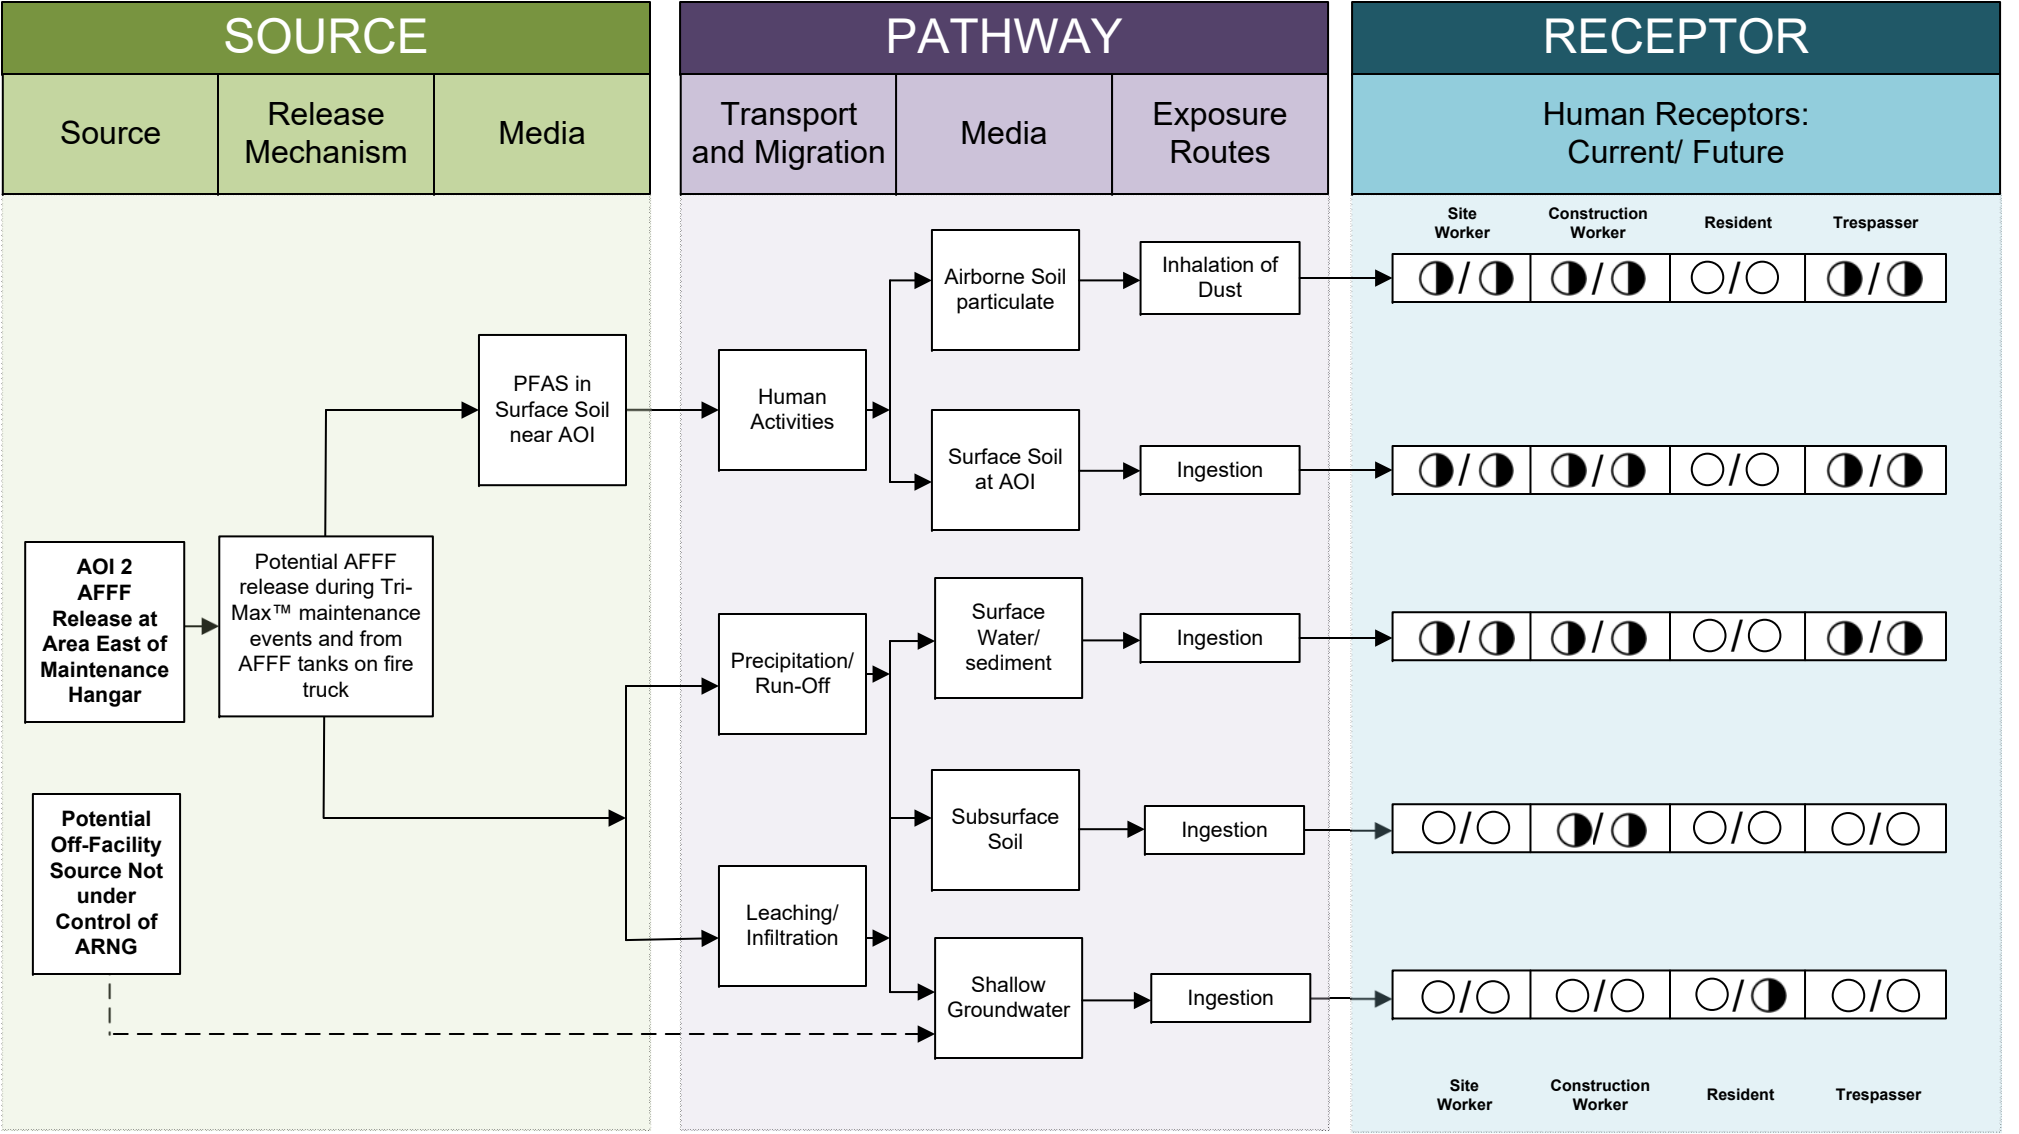
Figure ES-3
Preliminary Conceptual Site Model
AOI 2 AFFF Release at Area East of Maintenance Hangar at Martindale AASF

AFFF was potentially released at the area east of the Maintenance Hangar during Tri-MaxTM maintenance events performed by an outside contractor. The AFFF fluids stored in the Tri-MaxTM units were disposed during these maintenance events. Additionally, the fire truck, which was historically stored further east of the Maintenance Hangar, likely contained AFFF tanks, and AFFF could have leaked on to the gravel surface beneath the truck.

Releases at the area east of the Maintenance Hangar may have infiltrated into surrounding grassy areas when washed off the concrete surface, and potential releases at the fire truck may have infiltrated into the gravel and soil beneath it. Releases in either area have the potential to infiltrate into soil and further into the subsurface via rainwater infiltration. Under such scenarios, ground disturbing activities in these areas could result in site or construction worker exposure to PFAS via inhalation of dust or ingestion of exposed soil. PFAS contamination may have further infiltrated to shallow groundwater; however, there are no groundwater receptors identified within a 1-mile radius of the facility, so the groundwater exposure pathway is incomplete.

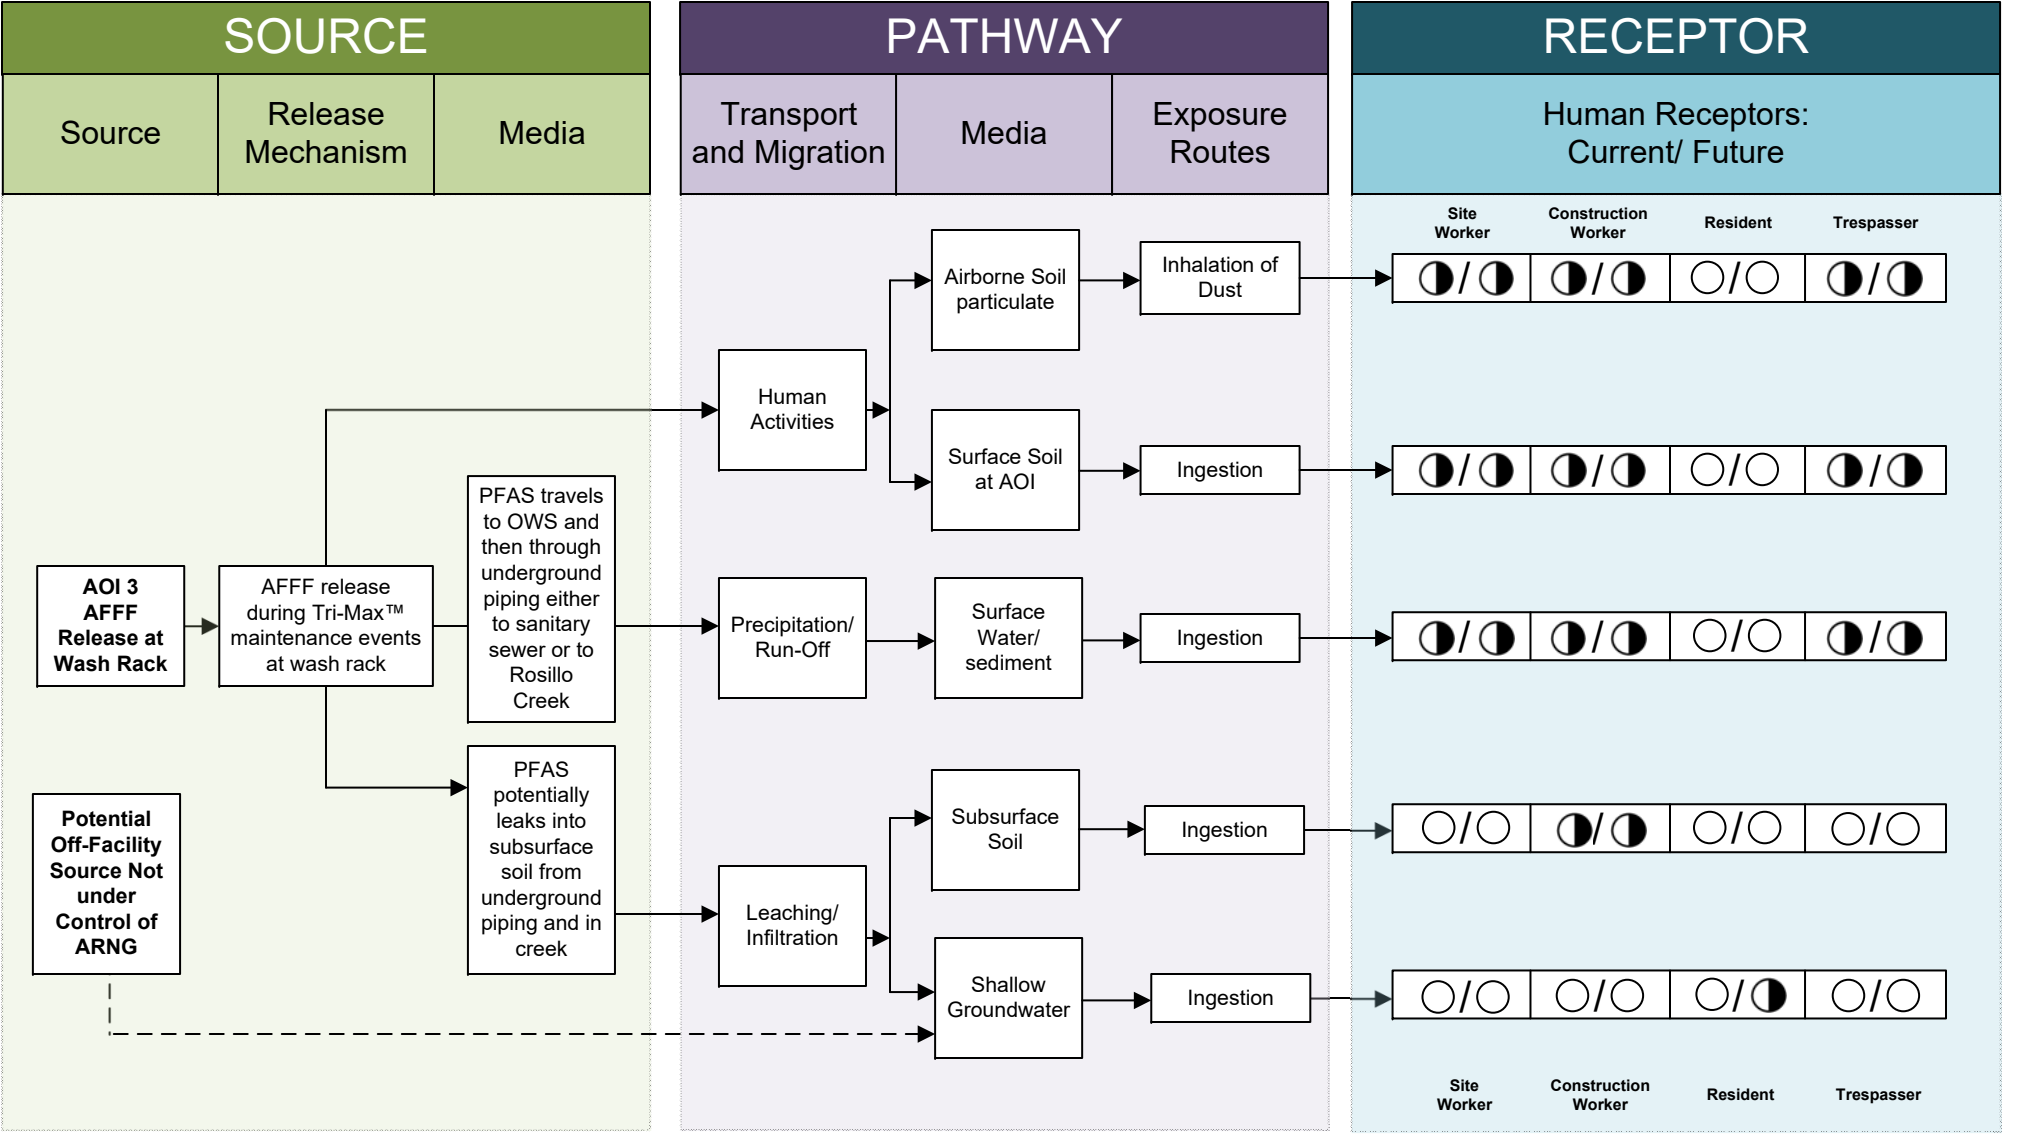
Figure ES-4
Preliminary Conceptual Site Model
AOI 3 AFFF Release at Wash Rack at Martindale AASF

AFFF was potentially released at the wash rack during Tri-Max™ maintenance events performed by an outside contractor. The AFFF fluids stored in the Tri-Max™ units would have been disposed during these maintenance events.

Releases at the wash rack would have traveled to the OWS and then, depending on the position of a diverter valve, either traveled through underground piping to the sanitary sewer, or traveled through a series of manholes and then discharged to Rosillo Creek and then to Salado Creek. Releases at the wash rack have the potential to infiltrate into soil and further into the subsurface via leaks in underground piping. Under such scenarios, ground disturbing activities in this area could result in site or construction worker exposure to PFAS via inhalation of dust or ingestion of exposed soil. PFAS contamination may have further infiltrated to shallow groundwater; however, there are no groundwater receptors identified within a 1-mile radius of the facility, so the groundwater exposure pathway is incomplete.

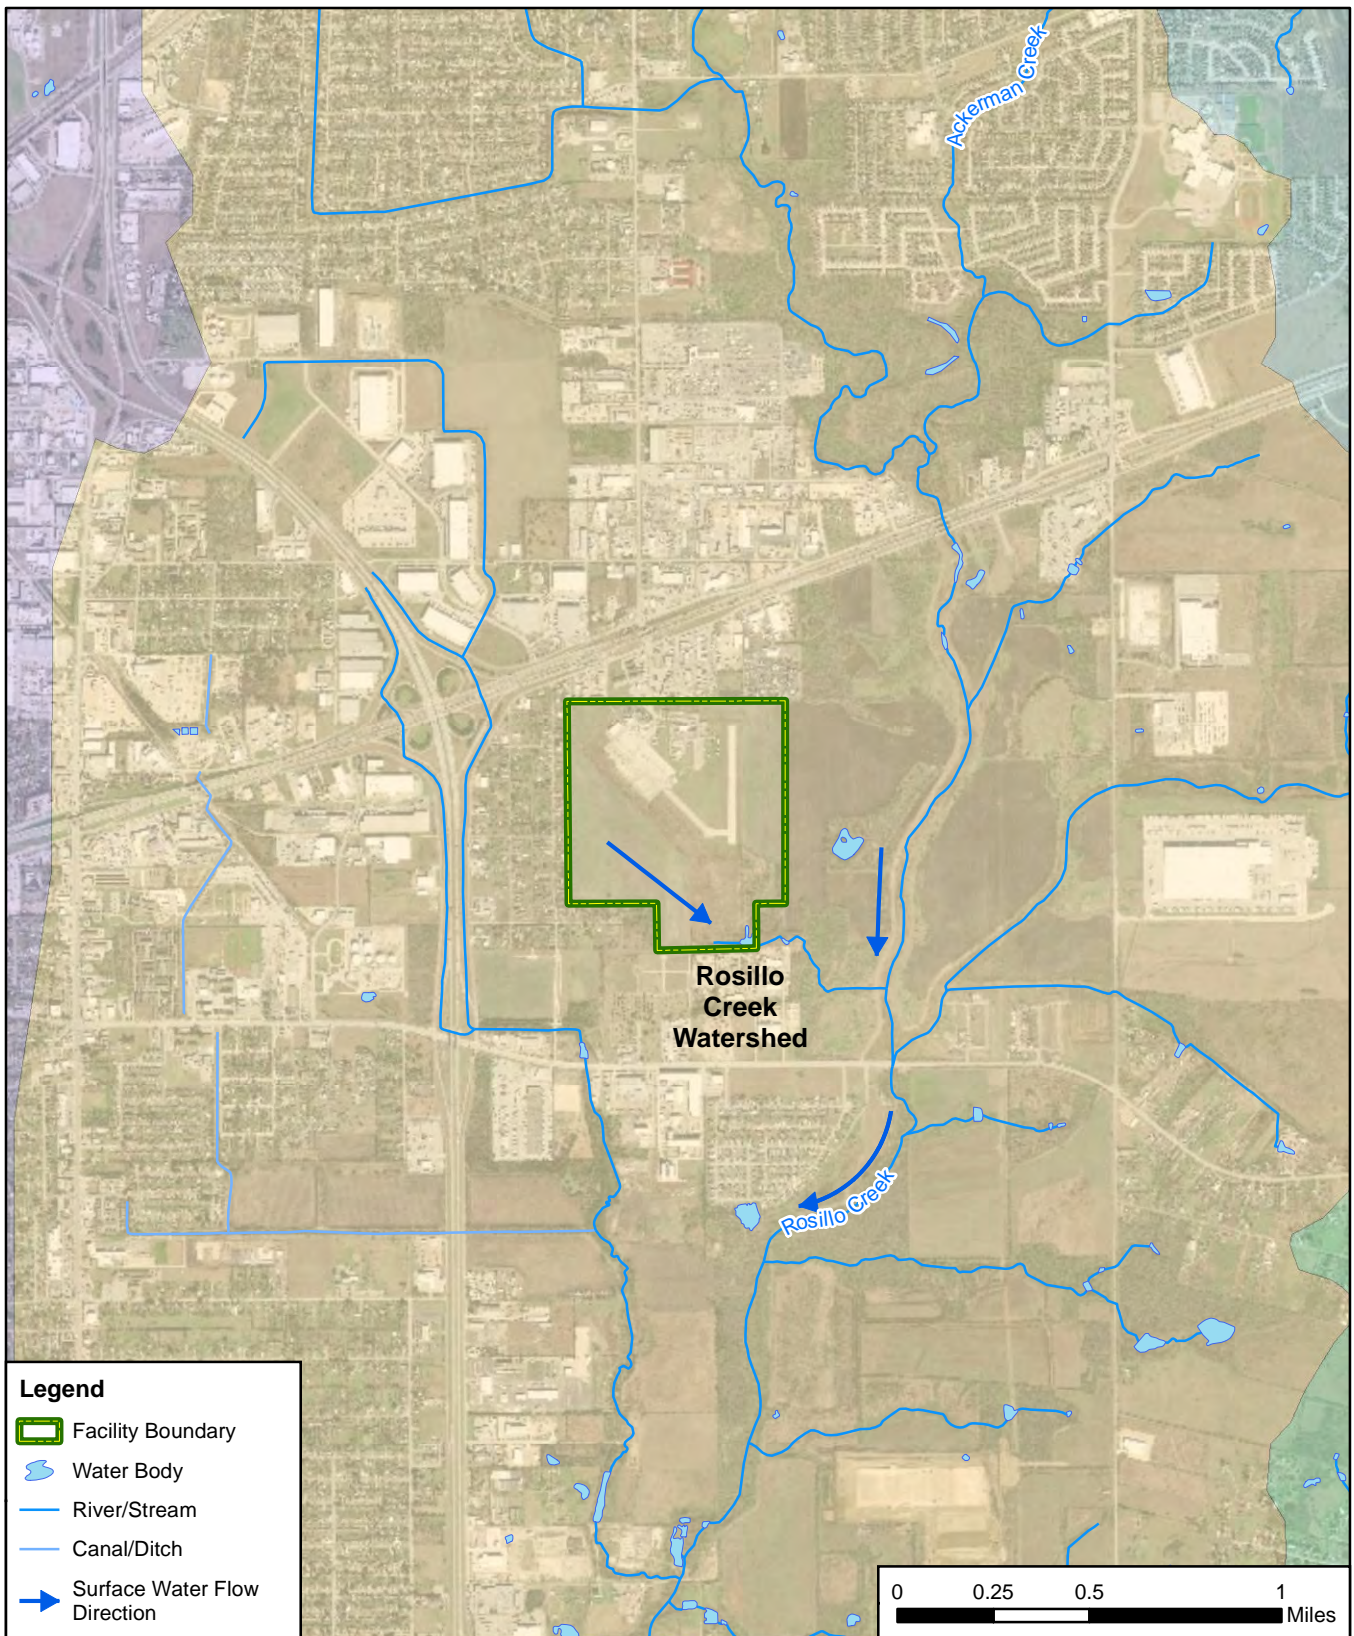
Figure 1-3

Surface water at the facility flows through ditches around the perimeter of the flight line to the southeast and settles in a retention pond (**Figure 1-3**). The retention pond in the southeast corner of the facility is less than 2,000 feet from Rosillo Creek, so it is likely that surface water flows from the retention pond to the creek under heavy rain conditions.

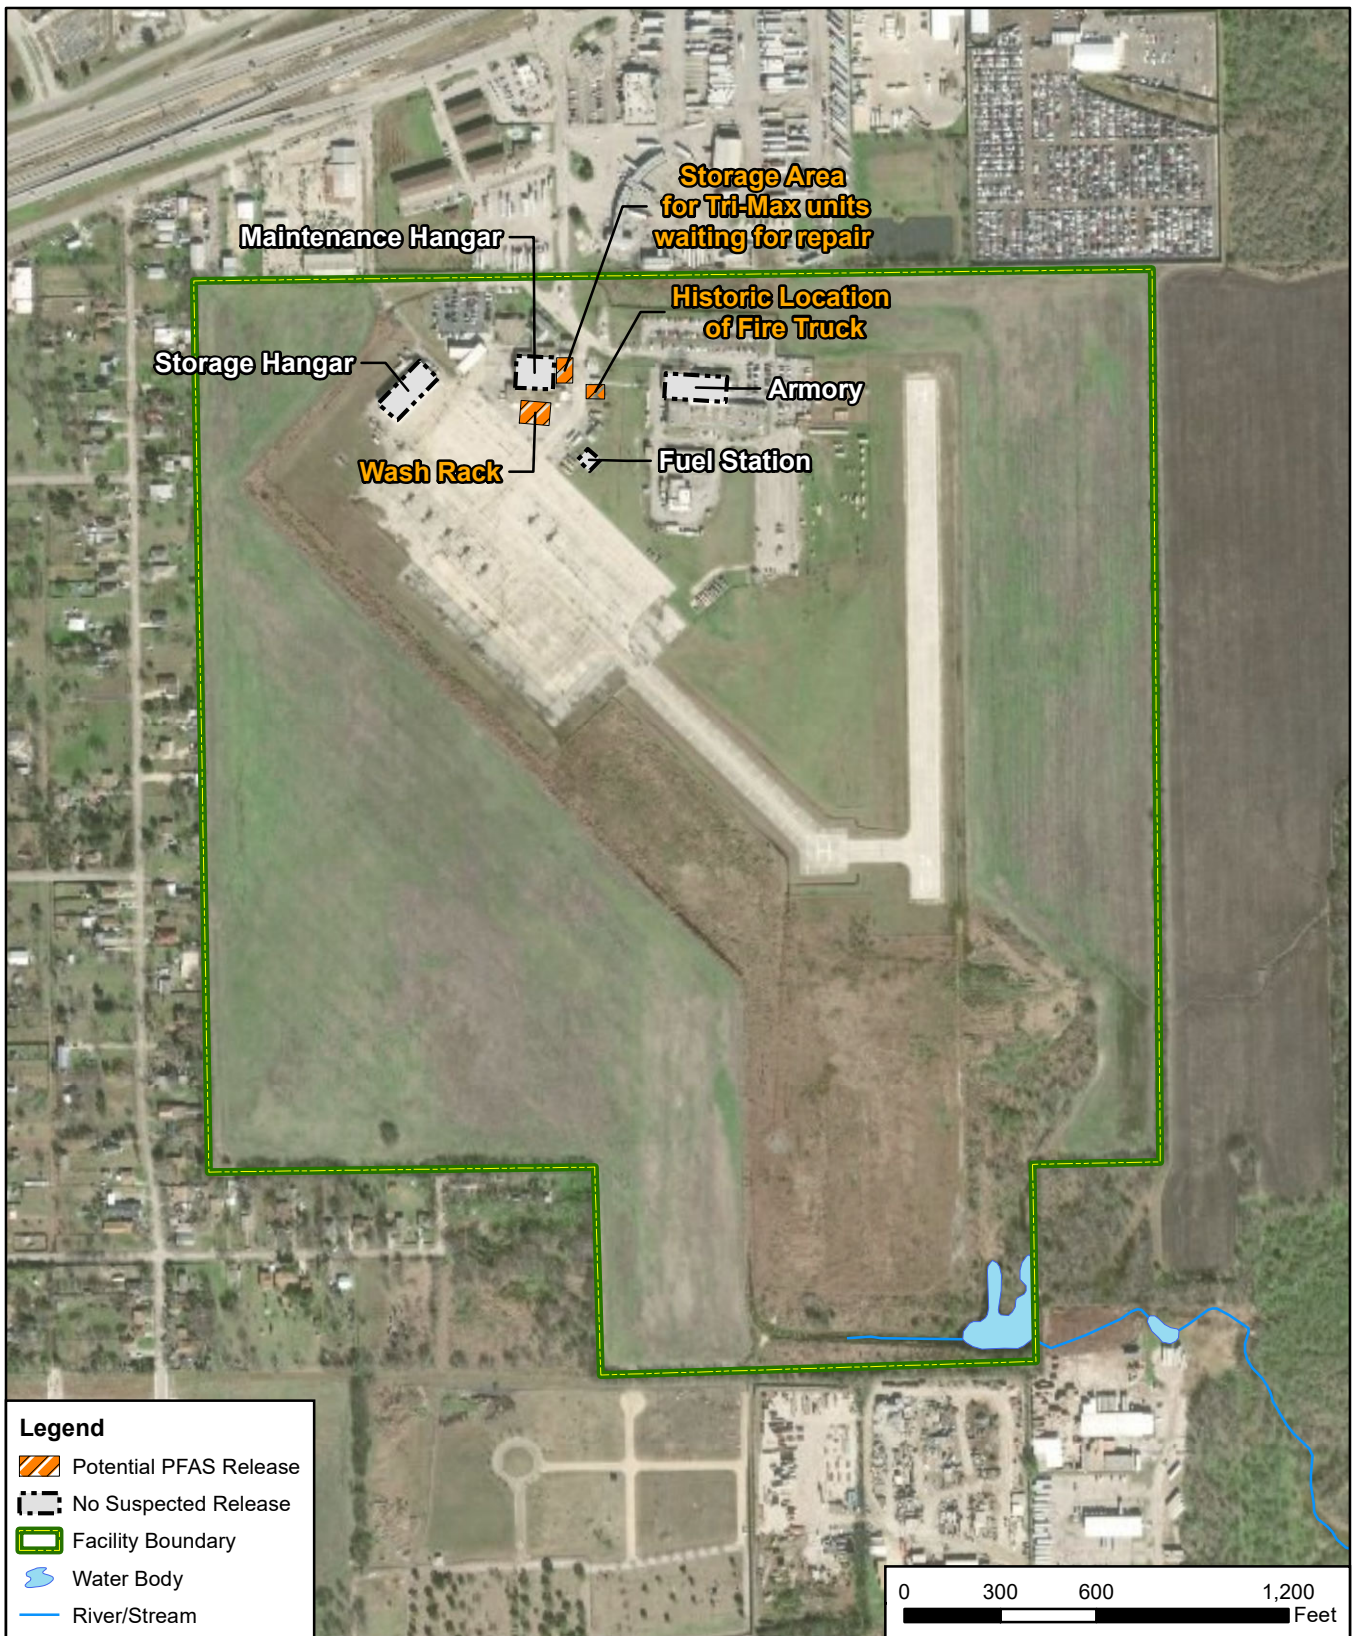
Figure 3-1	
					12420 Milestone Center Drive Germantown, MD 20876

In addition to FTAs, the PA evaluated areas where PFAS-containing materials may have been broadly used, stored, or disposed. This may include buildings with fire suppression systems, paint booths, AFFF storage areas, and areas of compliance demonstrations. Information on these features obtained during the PA are included in **Appendices A and B**. The Martindale AASF comprises a flight line, several buildings (two hangars, an armory, administrative buildings, and storage), and a wash rack area. These non-FTAs were investigated during the PA. These and other areas are described below and shown on **Figure 3-1**, with photographs provided in **Appendix C**.

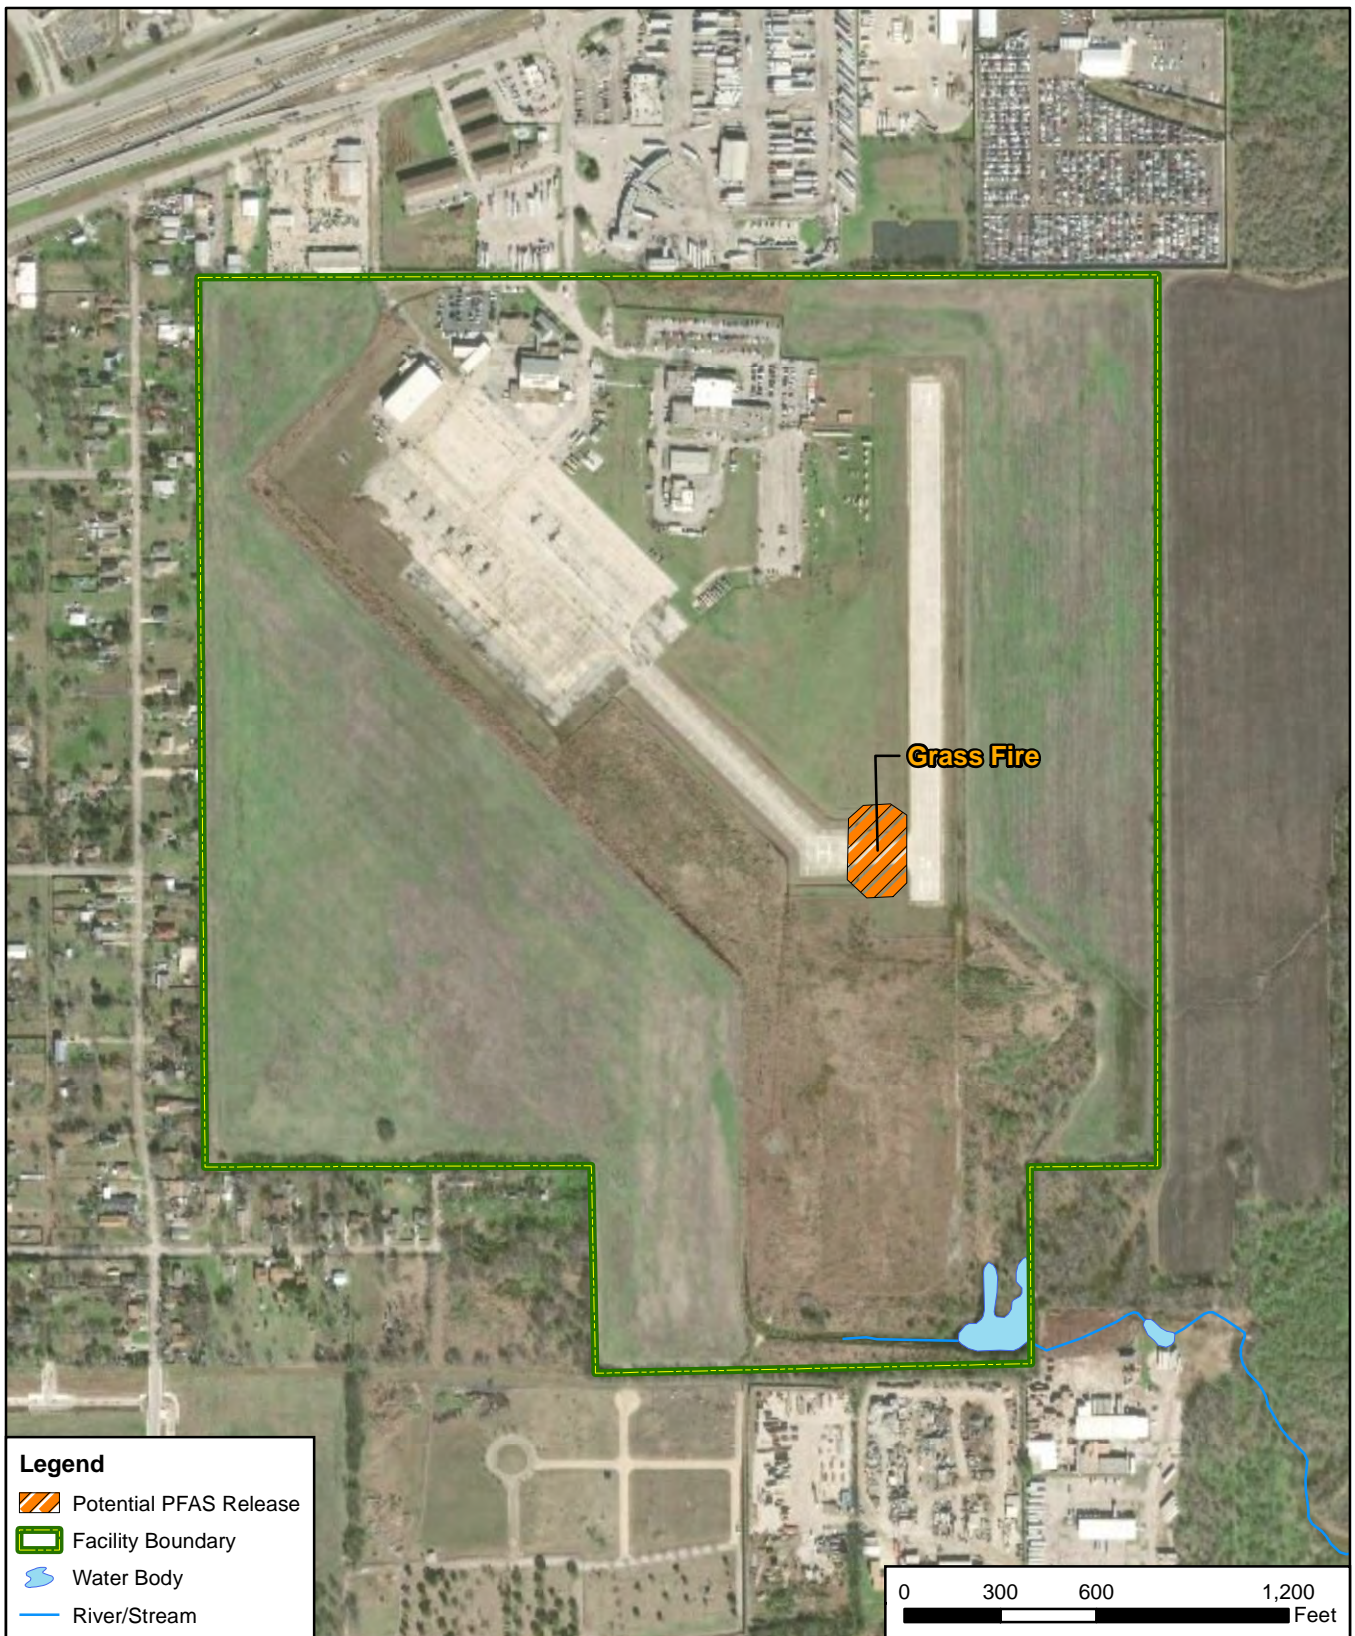
Figure 4-1

During personnel interviews, it was revealed that Tri-Max™ units were used to fight a grass fire on the flight line. The date of the incident is unknown, but it happened sometime between 1999 and 2014, when Tri-Max™ units were present at the facility. The approximate location of the grass fire is shown on **Figure 4-1**. Three or four Tri-Max™ units were historically located along the flight line for firefighting purposes. The City of San Antonio fire department came out to fight the grass fire as well and used water (not AFFF) to put out the remaining fire.

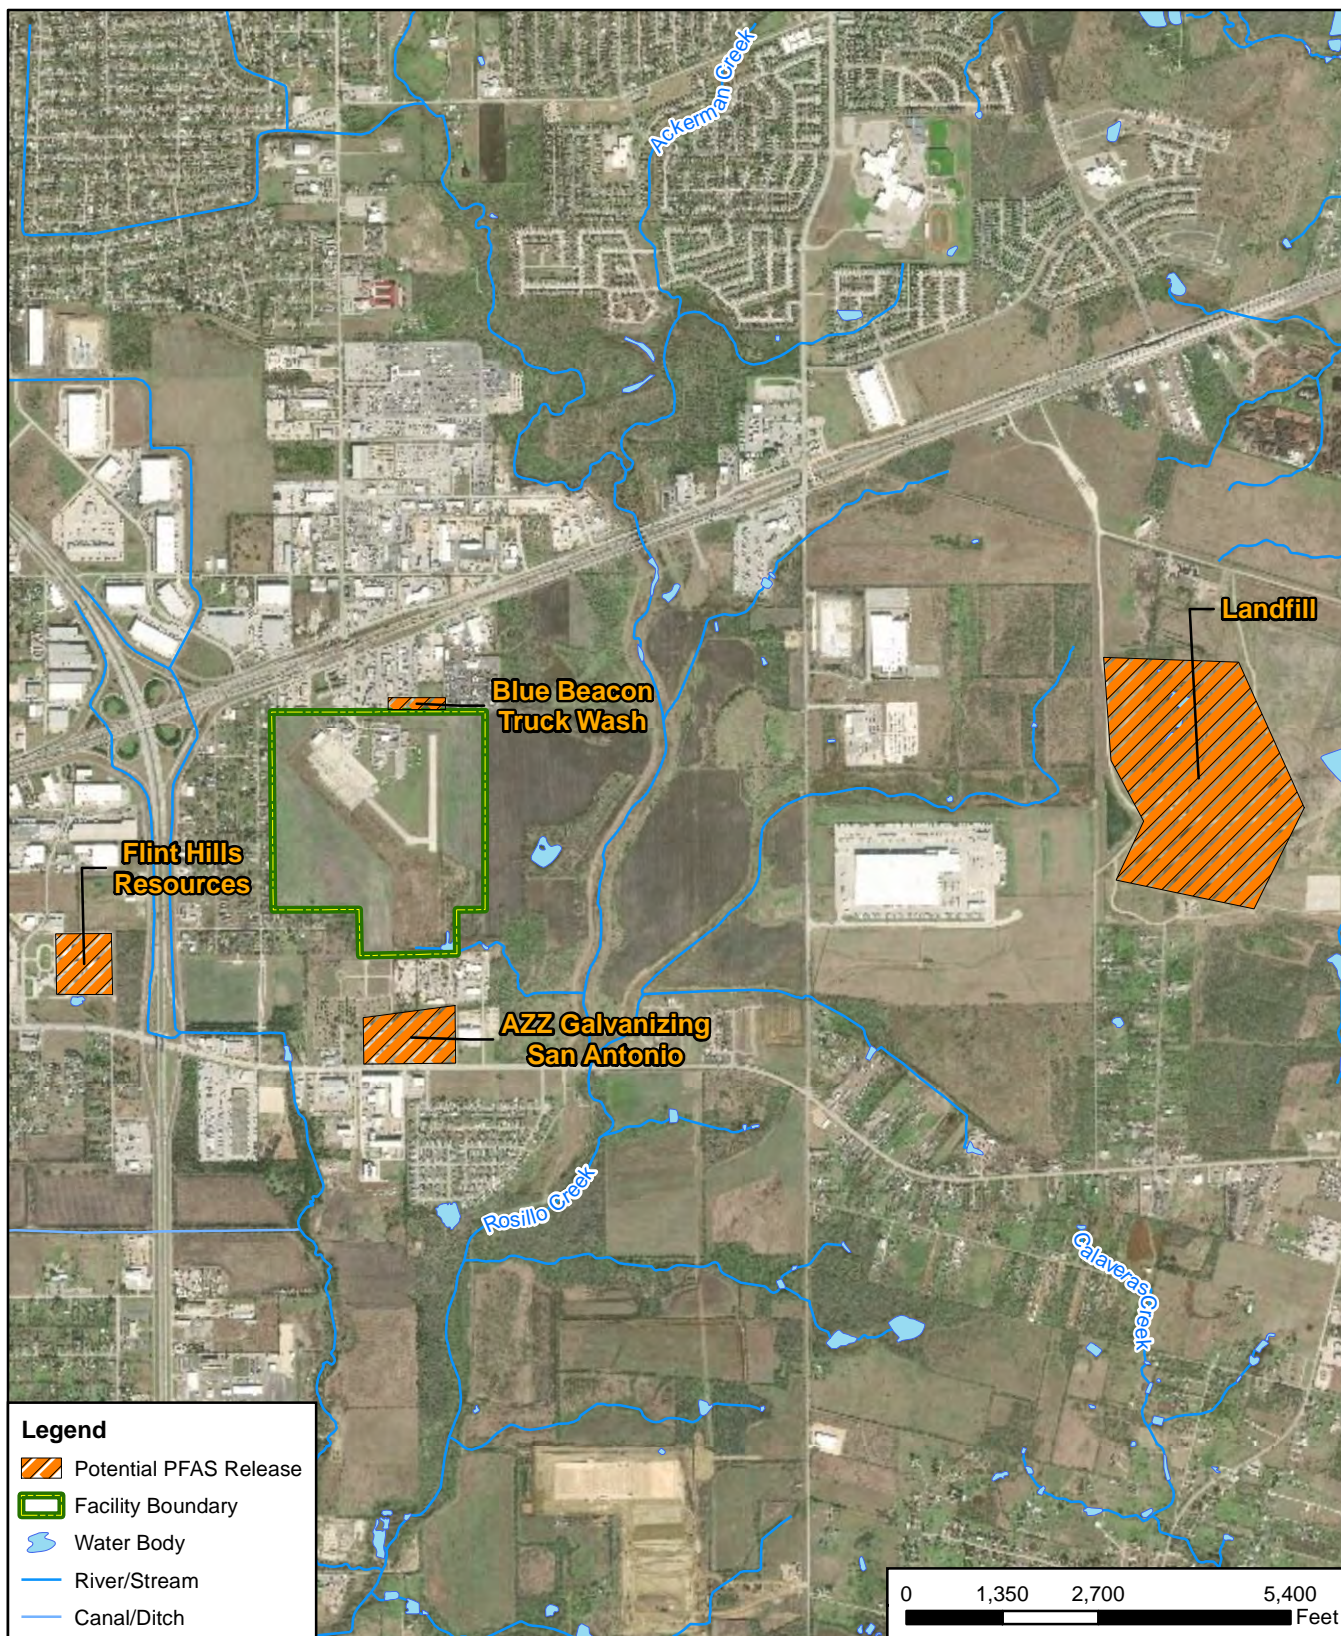
12420 Milestone Center Drive Germantown, MD 20876	Figure 5-1
SCALE	1:32,400	CHK BY	MC	12/13/2019			
Base Map: Source: Esri, DigitalGlobe, GeoEye, Earthstar Geographics, CNES/Airbus DS, USDA, USGS,		PM	RG	12/13/2019

Adjacent sources of potential PFAS include the Republic Services Landfill, the Flint Hills Resources gas storage facility, AZZ Galvanizing San Antonio, and Blue Beacon Truck Wash. **Figure 5-1** shows the various adjacent sources described in this section. The groundwater flow direction at the facility is inferred to be to the southeast, as this is the regional groundwater flow direction in the San Antonio area. Both the Flint Hills Resources gas storage facility and the landfill are cross-gradient from the AASF, with the Flint Hills Resources gas storage facility located to the southwest, and the landfill located to the east of the facility. Blue Beacon Truck Wash is upgradient of the facility, and AZZ Galvanizing is downgradient of the facility.
