FINAL Preliminary Assessment Report Martindale Army Aviation Support Facility San Antonio, Texas

Perfluorooctanesulfonic Acid (PFOS) and Perfluorooctanoic
Acid (PFOA) Impacted Sites
ARNG Installations, Nationwide

July 2020

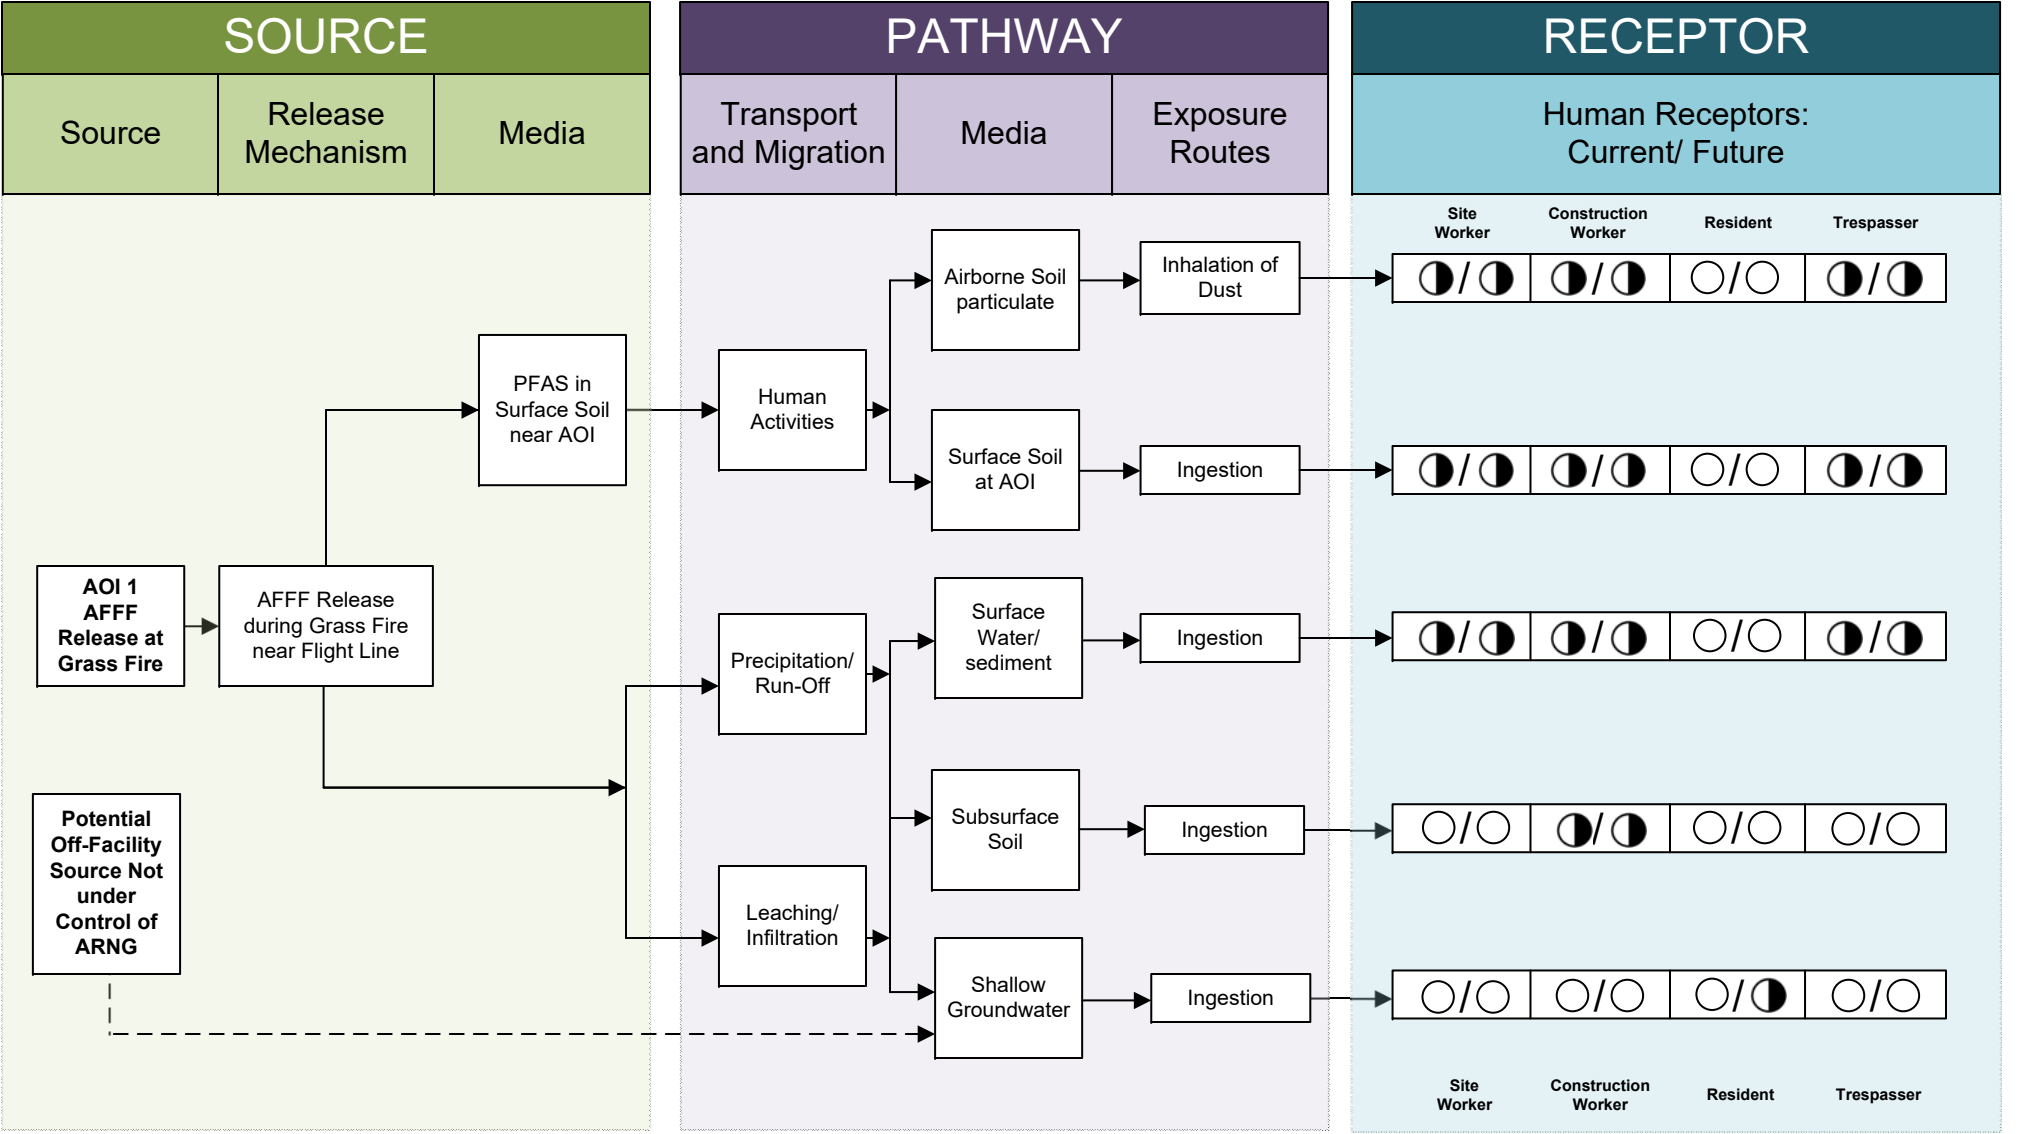
Figure 6-2
Preliminary Conceptual Site Model
AOI 1 AFFF Release at Grass Fire near Flight Line at Martindale AASF 24

Releases at the grassy areas on either side of the flight line would eventually infiltrate into the soil and potentially infiltrate to the subsurface and groundwater via rainwater infiltration. Under such scenarios, ground disturbing activities in these areas could result in site or construction worker exposure to PFAS via inhalation of dust or ingestion of exposed soil. PFAS contamination may have further infiltrated to shallow groundwater; however, there are no groundwater receptors identified within a 1-mile radius of the facility, so the groundwater exposure pathway is incomplete. PFAS may have accumulated in nearby storm water ditches, located both north and south of the flight line, creating an exposure pathway to site workers, construction workers, and trespassers from surface water/sediment in this area.

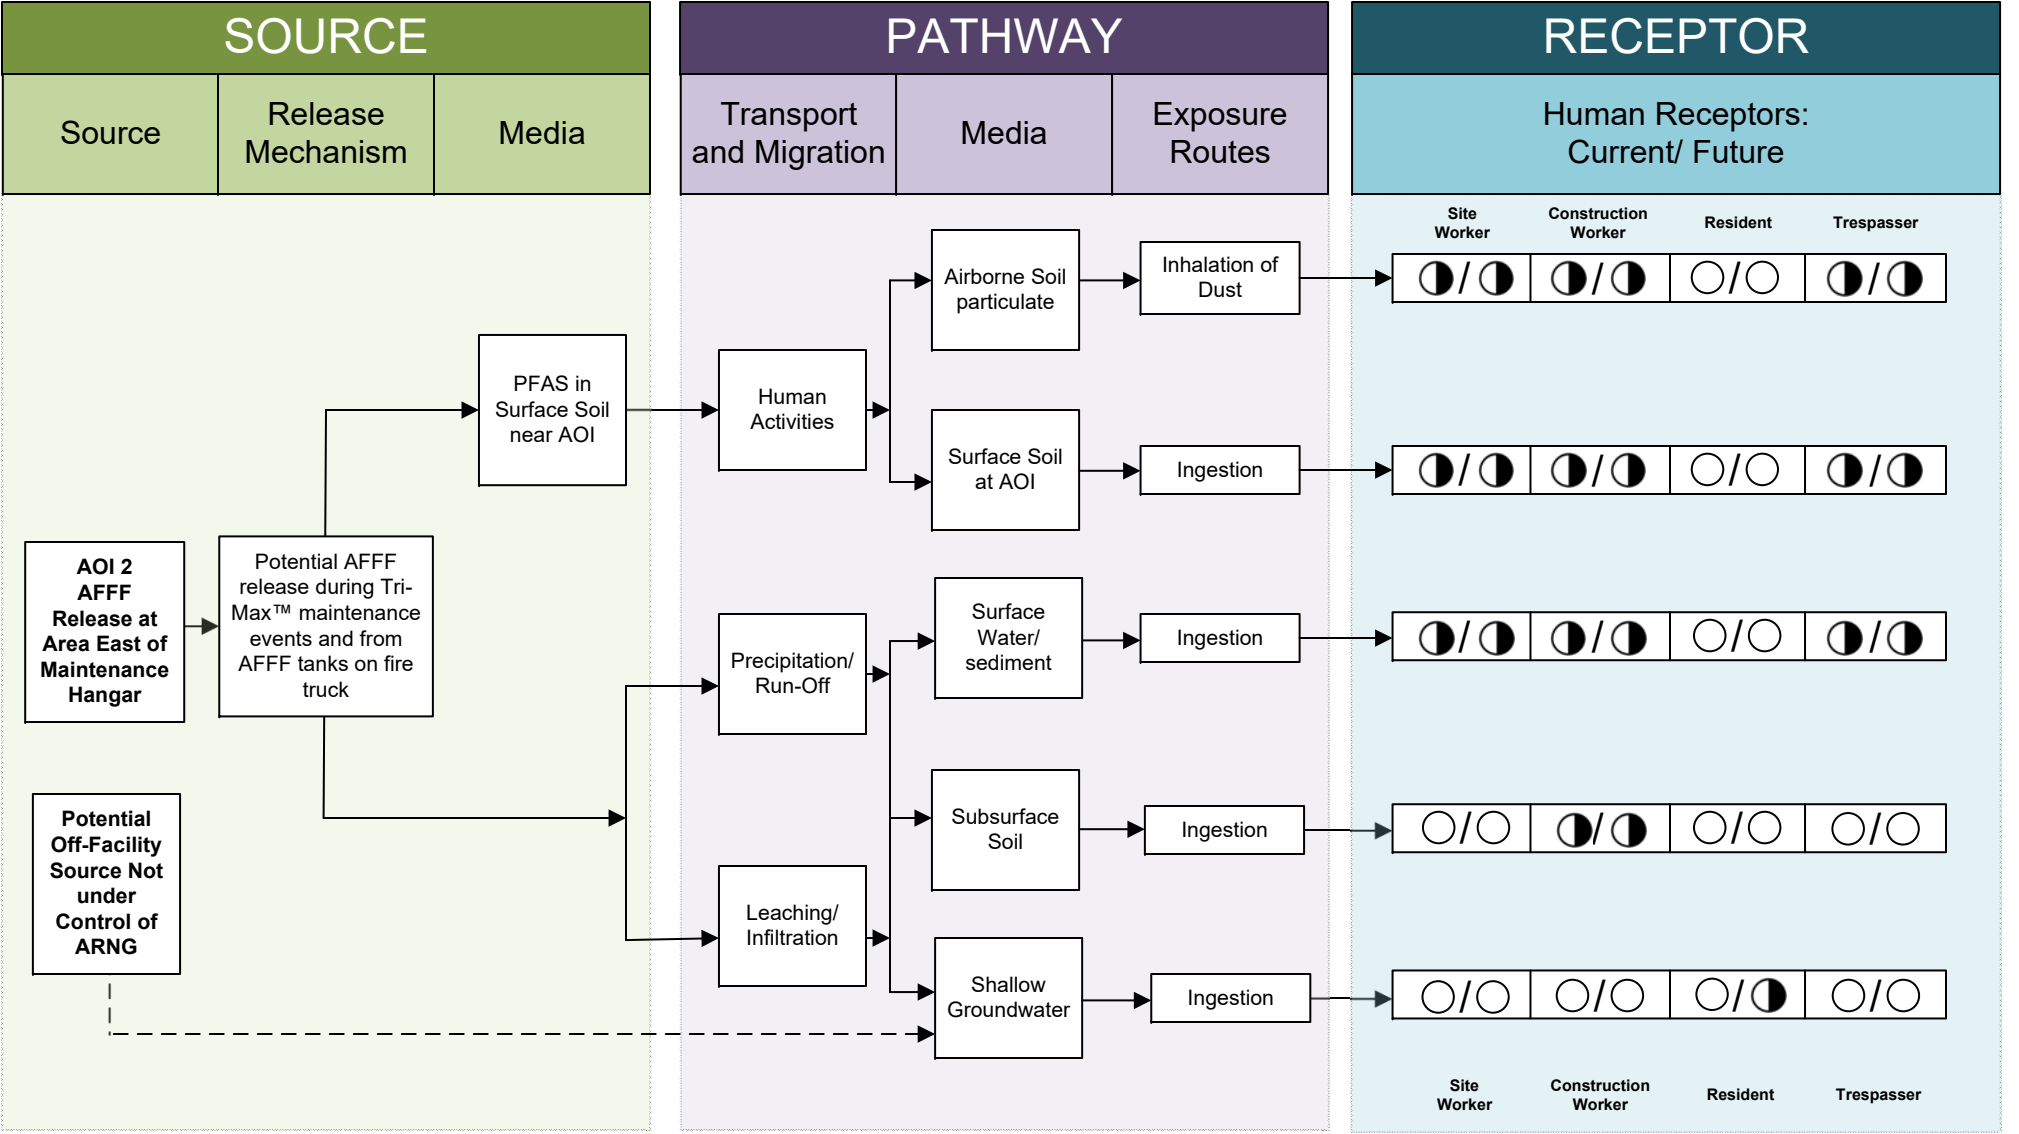
Figure 6-3
Preliminary Conceptual Site Model
AOI 2 AFFF Release at Area East of Maintenance Hangar at Martindale AASF

AFFF was potentially released at the area east of the Maintenance Hangar during Tri-MaxTM maintenance events performed by an outside contractor. The AFFF fluids stored in the Tri-MaxTM units were disposed during these maintenance events. Additionally, the fire truck, which was historically stored further east of the Maintenance Hangar, likely contained AFFF tanks, and AFFF could have leaked on to the gravel surface beneath the truck.

Releases at the area east of the Maintenance Hangar may have infiltrated into surrounding grassy areas when washed off the concrete surface, and potential releases at the fire truck may have infiltrated into the gravel and soil beneath it. Releases in either area have the potential to infiltrate into soil and further into the subsurface via rainwater infiltration. Under such scenarios, ground disturbing activities in these areas could result in site or construction worker exposure to PFAS via inhalation of dust or ingestion of exposed soil. PFAS contamination may have further infiltrated to shallow groundwater; however, there are no groundwater receptors identified within a 1-mile radius of the facility, so the groundwater exposure pathway is incomplete.

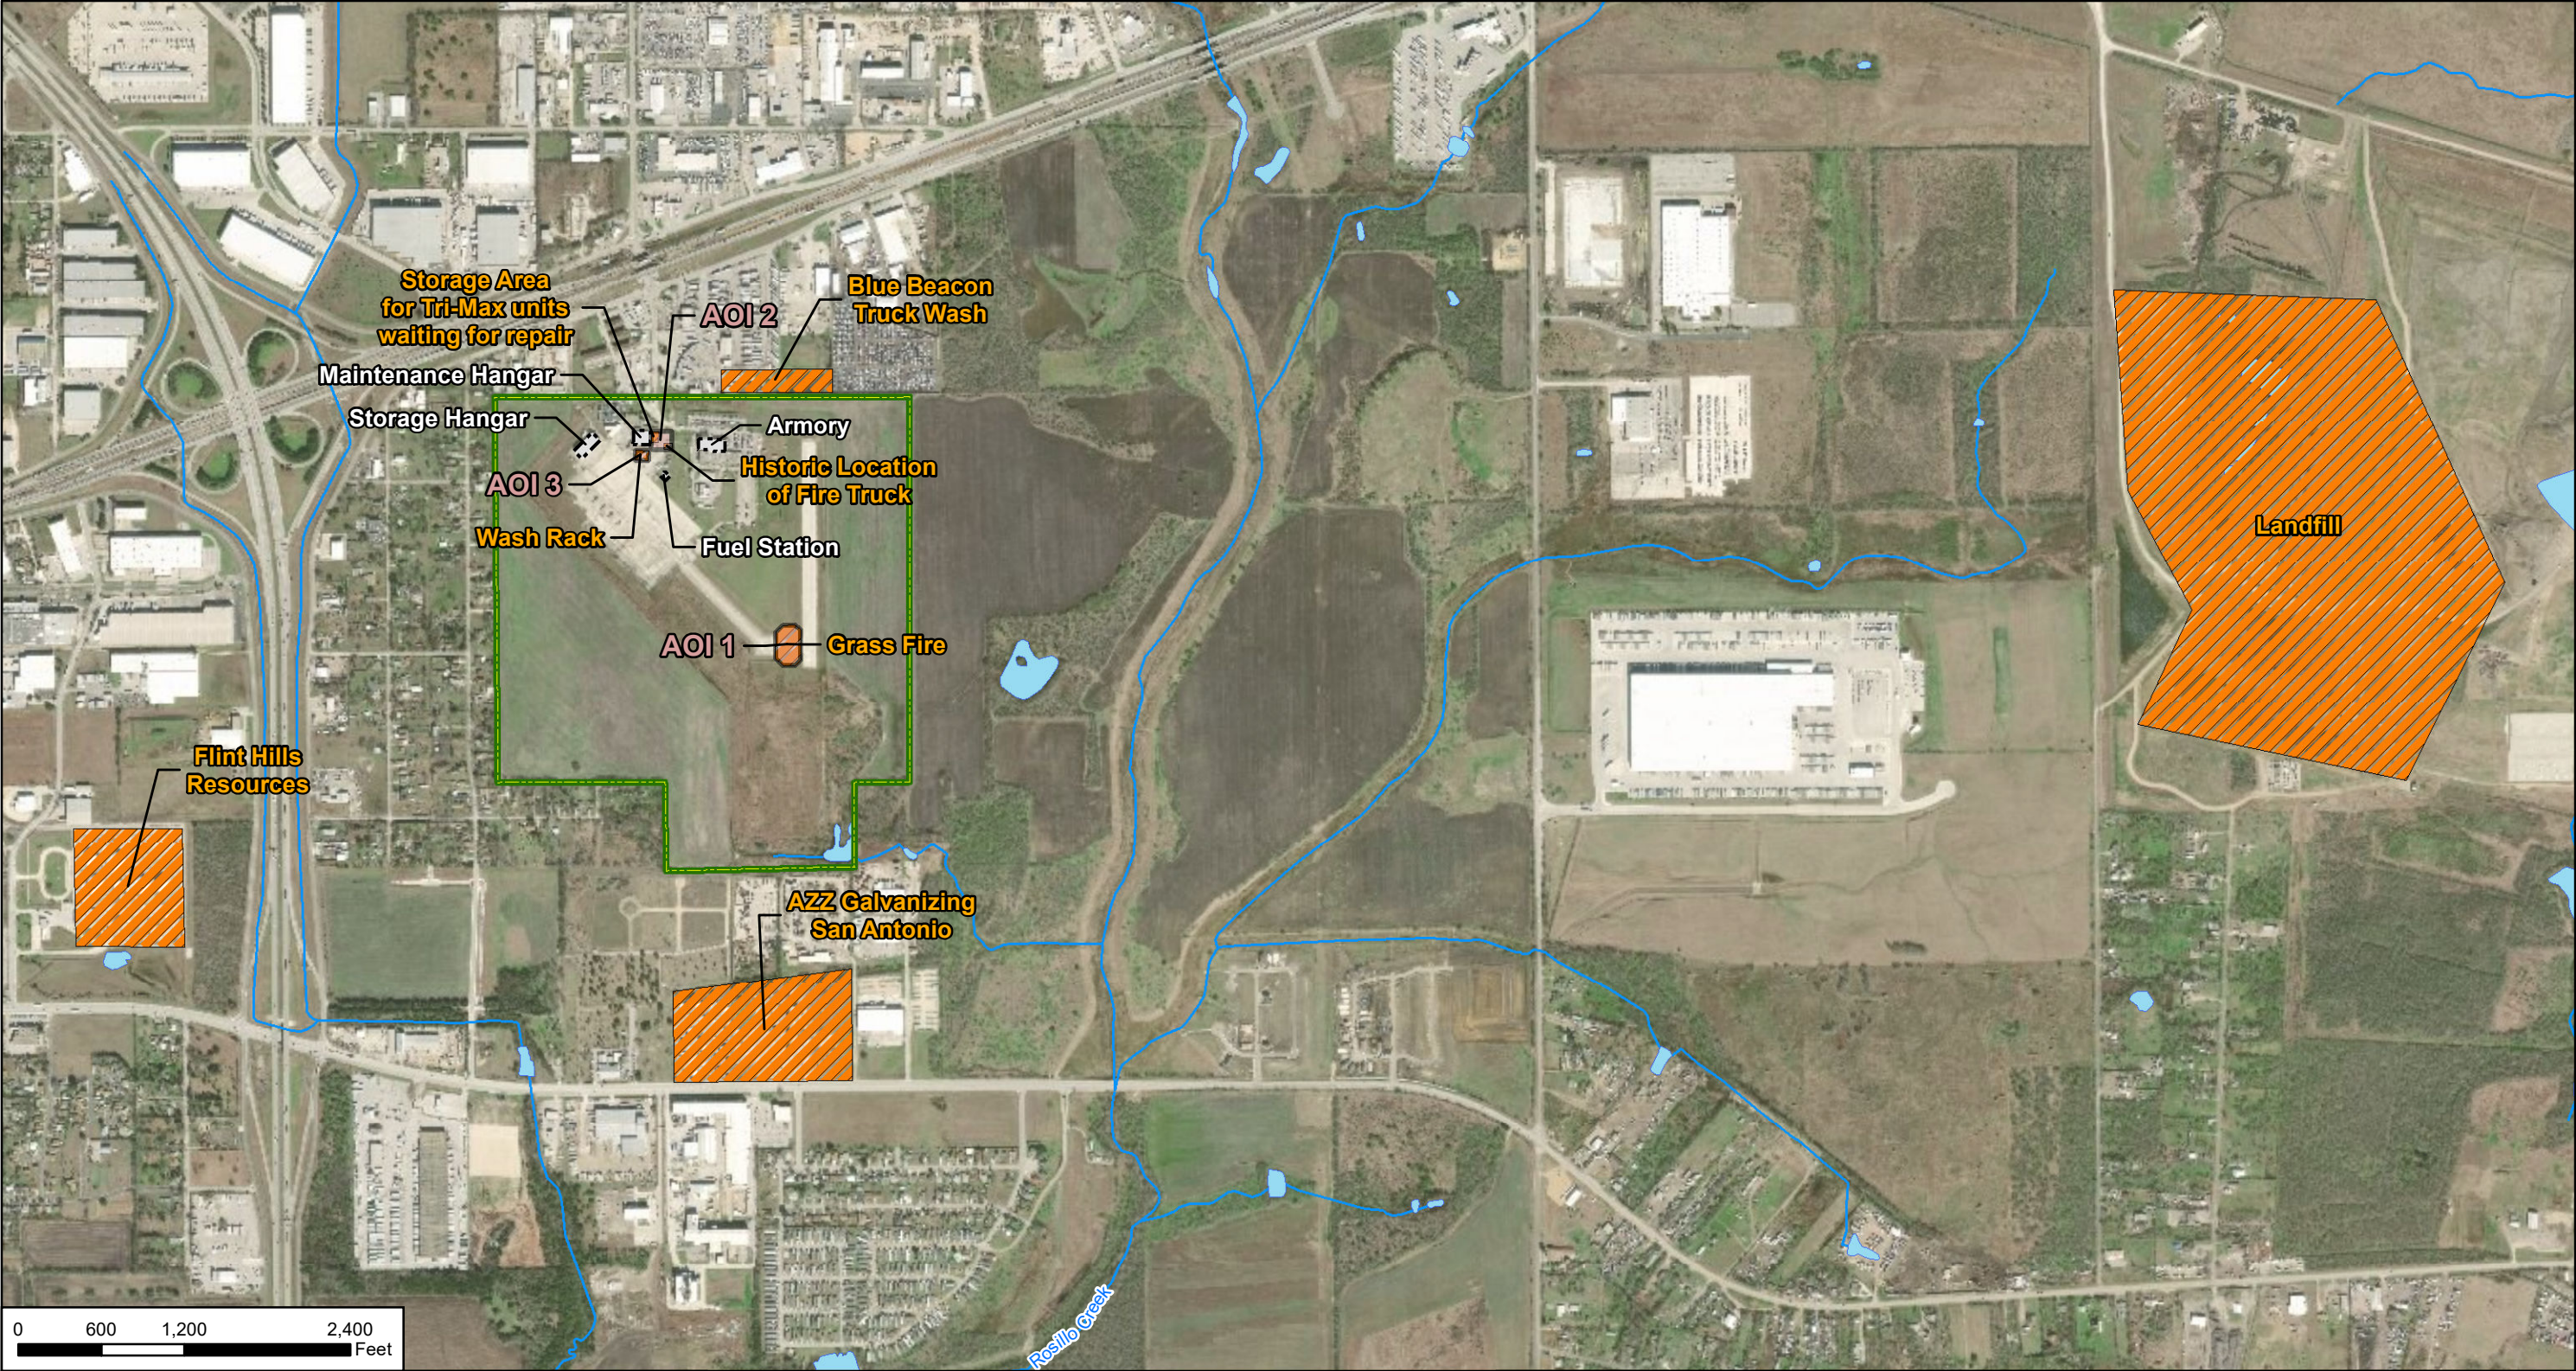
Based on interviews with current AASF personnel, Tri-Max™ units were serviced onsite by an outside contractor and required periodic exchange of the AFFF fluids. These fluids would have been disposed at the facility, either at the area east of the Maintenance Hangar, or at the wash rack. Additionally, a fire truck was stationed further east of the Maintenance Hangar and could have leaked AFFF over the years. Finally, a reported historical AFFF release was associated with the grass fire located near the southeast end of the flight line. These releases indicate the potential for PFAS contamination in surface and subsurface soil to intercept one or more receptors. Groundwater in the area is not used for drinking water. However, PFAS contamination may have accumulated in surface water and sediments in the drainage ditches located near the grass fire, in the grassy areas surrounding the Maintenance Hangar, or in the subsurface beneath the wash rack. No evidence of other accidental or incidental spills or leaks from AFFF storage containers/areas were identified during the site visit. The remaining buildings associated with the AASF are not equipped with or store AFFF. The findings of potential AFFF release are summarized in **Table 7-1** below.

Area of Interest	AOI Location	Rationale	Potential Future Action
AOI 1: Grass Fire near Flight Line	29°25'51.98"N; 98°22'39.68"W	One or more Tri-Max™ units were used to put out a grass fire near the southeast end of the flight line. AFFF would most likely have infiltrated into the surrounding grassy area and may have collected in nearby surface water and sediment.	Proceed to an SI, focus on soil, surface water/sediment, and groundwater
AOI 2: Area East of the Maintenance Hangar	29°26'07.1"N; 98°22'50.4"W	AFFF was potentially released in this area while Tri-Max™ units were being emptied by an outside contractor. Additionally, the fire truck historically located further east of this area was most likely equipped with AFFF, which may have leaked into the ground over the years. AFFF releases in this area would have infiltrated into soil and potentially groundwater.	Proceed to an SI, focus on soil and groundwater

AOI 3: Wash Rack	29°26'05.7"N; 98°22'51.6"W	During Tri-Max™ maintenance events, AFFF may have been disposed at the wash rack. These fluids would travel to the OWS, and depending on the position of a diverter valve, would either flow via underground piping to the sanitary sewer, or through a series of manholes to Rosillo Creek and then Salado Creek. Leaks in the underground piping may have led to AFFF infiltrating into soil and reaching the subsurface.	Proceed to an SI, focus on soil, surface water/sediment, and groundwater
