FINAL Preliminary Assessment Report Grand Prairie Army Aviation Support Facility Texas

Perfluorooctanesulfonic Acid (PFOS) and Perfluorooctanoic
Acid (PFOA) Impacted Sites
ARNG Installations, Nationwide

July 2020

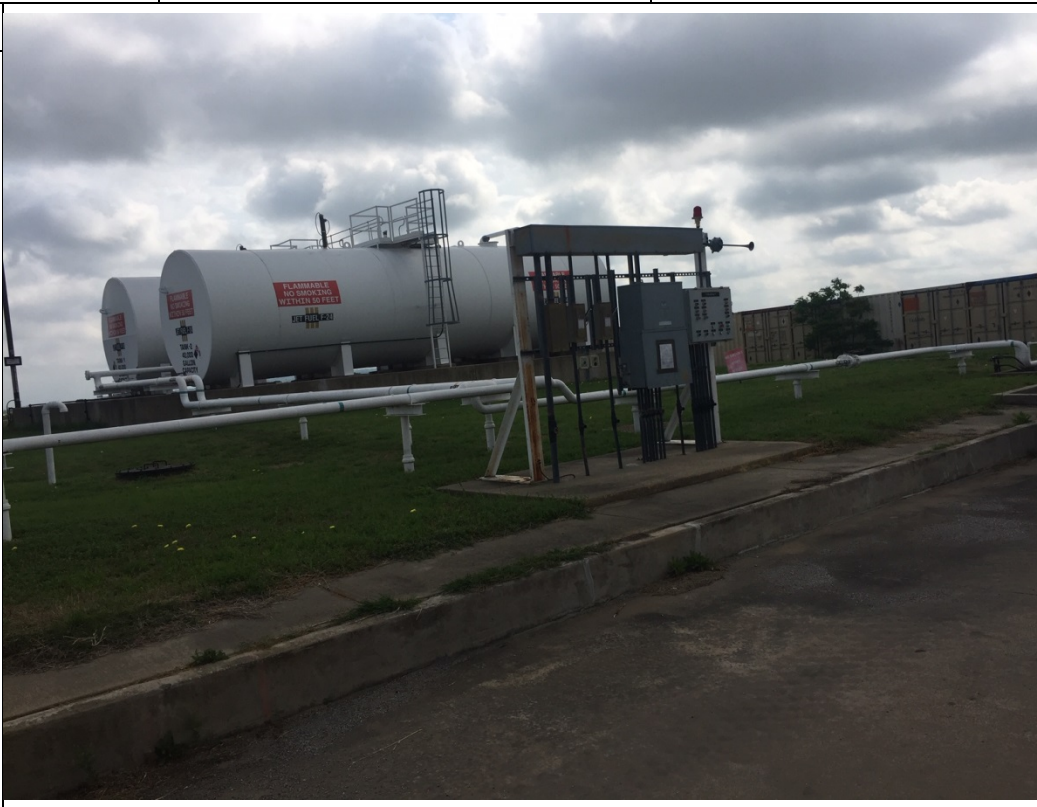
Army National Guard, Preliminary Assessment for PFAS	Grand Prairie AASF	Grand Prairie, Texas
<p>Photograph No. 1</p> <p>Description:</p> <p>April 23, 2019</p> <p>Facing NE, looking out at the Fueling Station. Historically, Tri-Max fire extinguishers were stationed at the fuel station (but never used).</p>

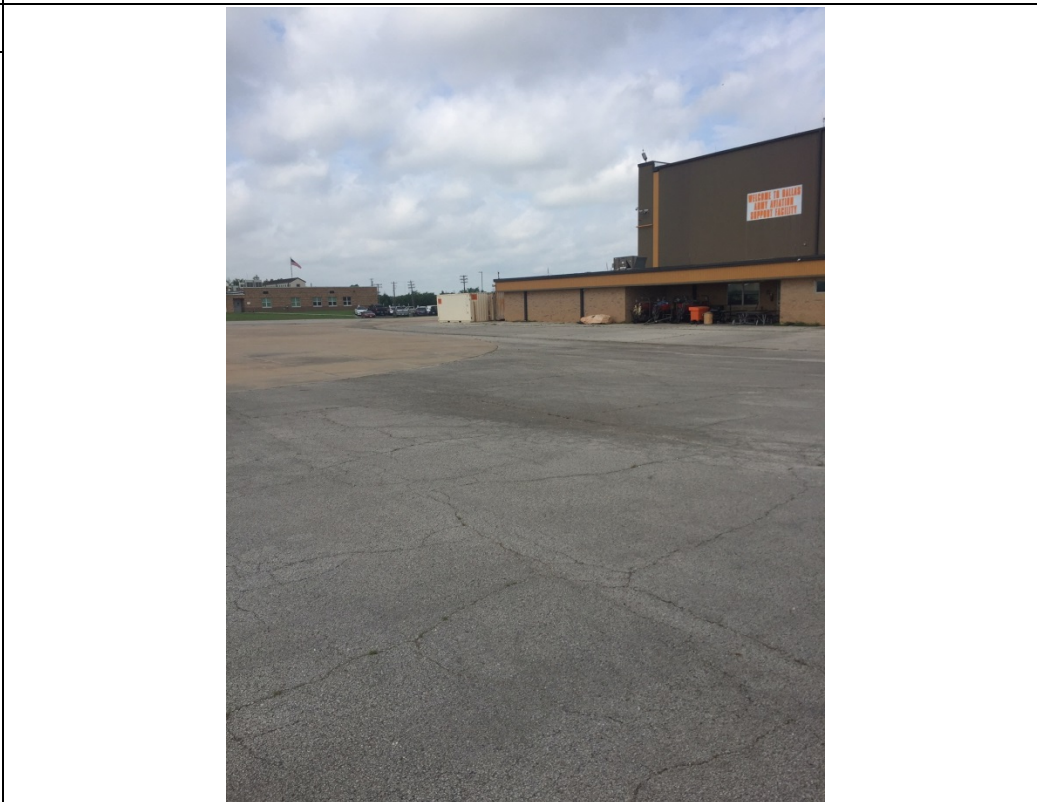
<p>Photograph No. 2</p> <p>Description:</p> <p>April 23, 2019</p> <p>Facing west, looking at the Ramp/Flightline Area where Tri-Max fire extinguishers were historically used for fire training purposes.</p>

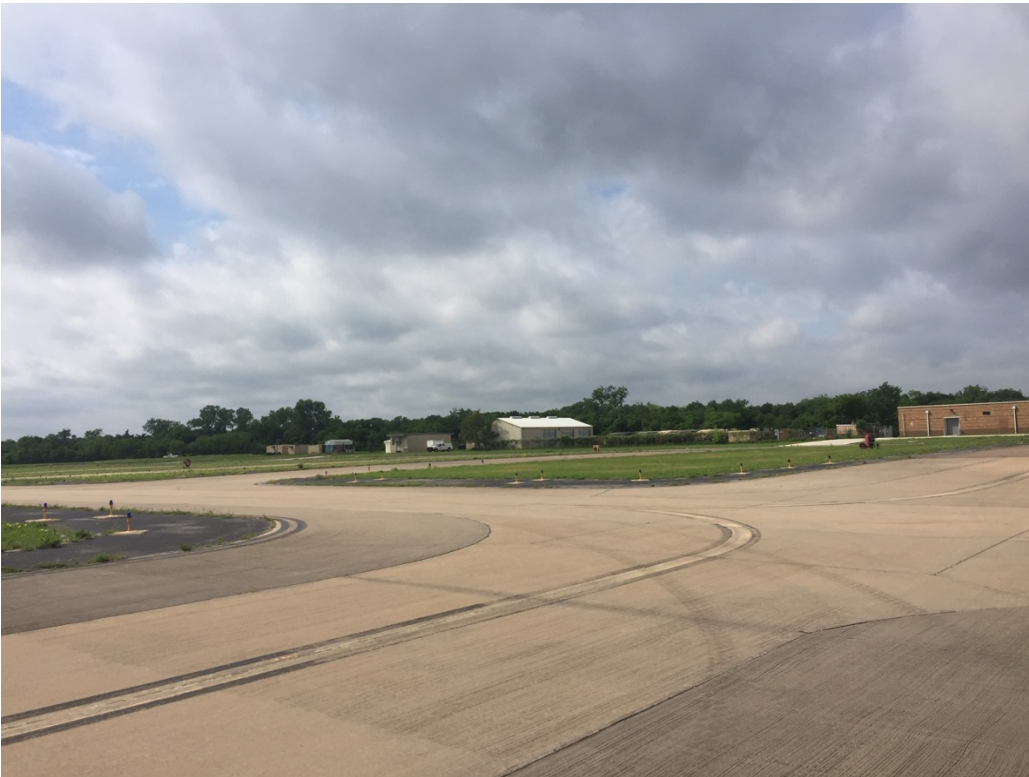
Army National Guard, Preliminary Assessment for PFAS	Grand Prairie AASF	Grand Prairie, Texas
<p>Photograph No. 3</p> <p>Description:</p> <p>April 23, 2019</p> <p>Facing SE, looking at flight lines with existing fire extinguishers (non-AFFF).</p>

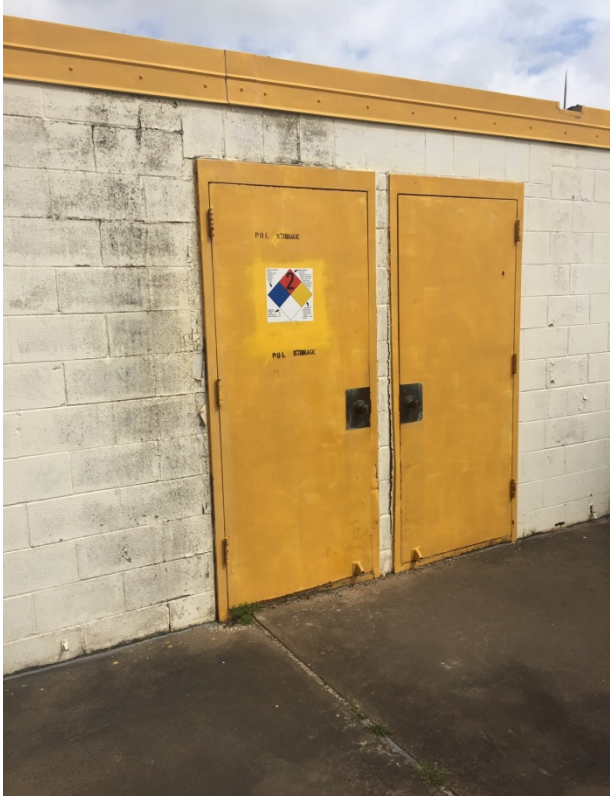
<p>Photograph No. 4</p> <p>Description:</p> <p>April 23, 2019</p> <p>Facing north, looking at the bulk chemical storage building. Historically, 30 – 5 gallon buckets of 3% AFFF was stored in this building.</p>
