# FINAL Preliminary Assessment Report Austin Bergstrom Army Aviation Support Facility Austin, Texas

Perfluorooctanesulfonic Acid (PFOS) and Perfluorooctanoic  
Acid (PFOA) Impacted Sites  
ARNG Installations, Nationwide

July 2020

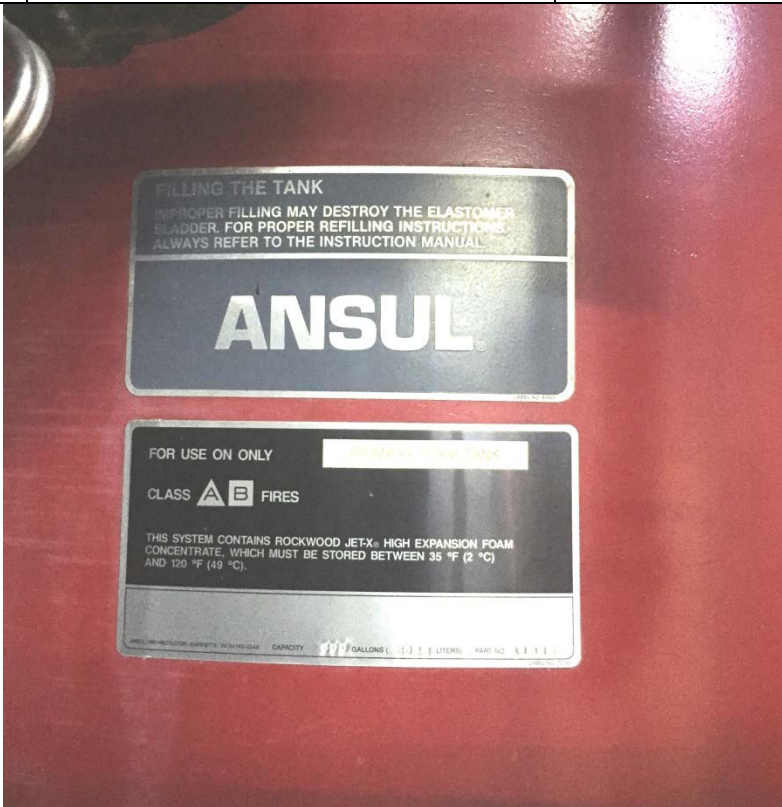
Army National Guard, Preliminary Assessment for PFAS	Austin Bergstrom AASF (April 24, 2019)	Austin, Texas
<p><b>Photograph No. 1</b></p> <p><b>Description:</b></p> <p>1 of 2 - 800 gallon tanks located in the Maintenance Hangar. Tank contains 800 gallons of Rockwood Jet-X® High expansion foam concentrate.</p>

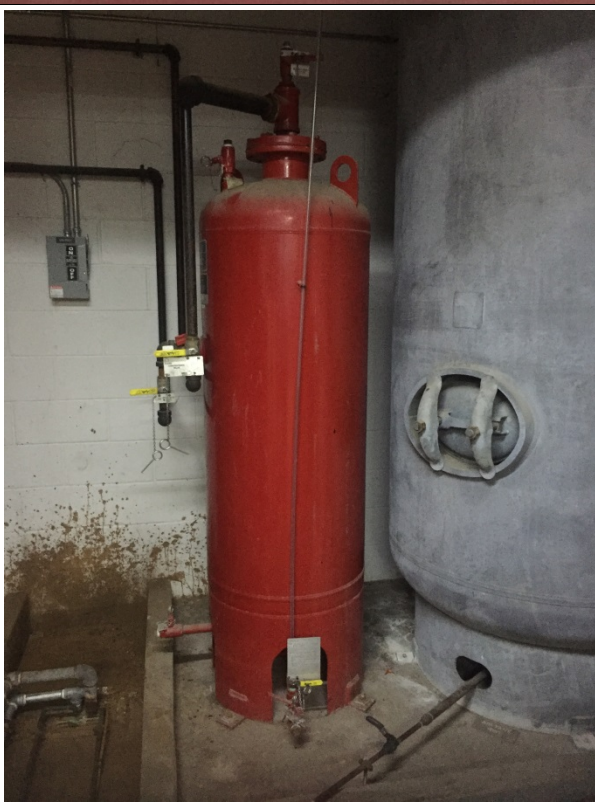
<p><b>Photograph No. 2</b></p> <p><b>Description:</b></p> <p>100 gallon tank of AFFF foam concentrate in Maintenance Hangar. Used to supply Hand Held Hoses with AFFF.</p>

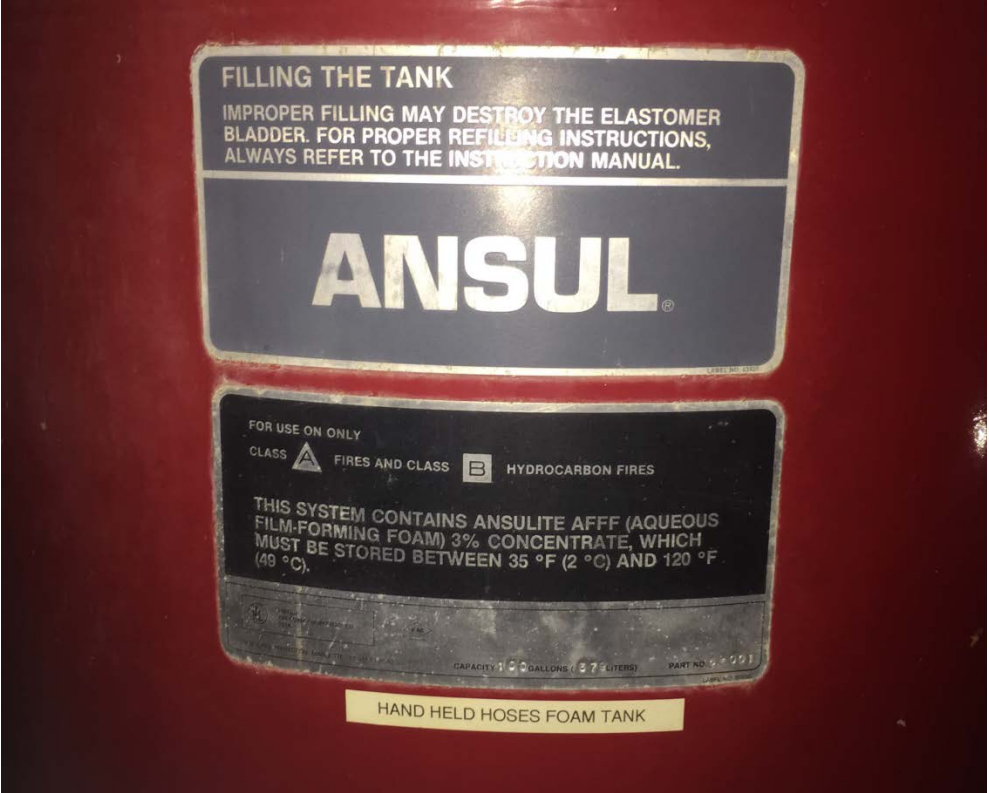
Army National Guard, Preliminary Assessment for PFAS	Austin Bergstrom AASF (April 24, 2019)	Austin, Texas
<p><b>Photograph No. 3</b></p> <p><b>Description:</b></p> <p>Ansulite AFFF 3% concentrate stored in 100 gallon tank in Maintenance Hangar for use in Hand Held Hoses for emergency fire suppression.</p>

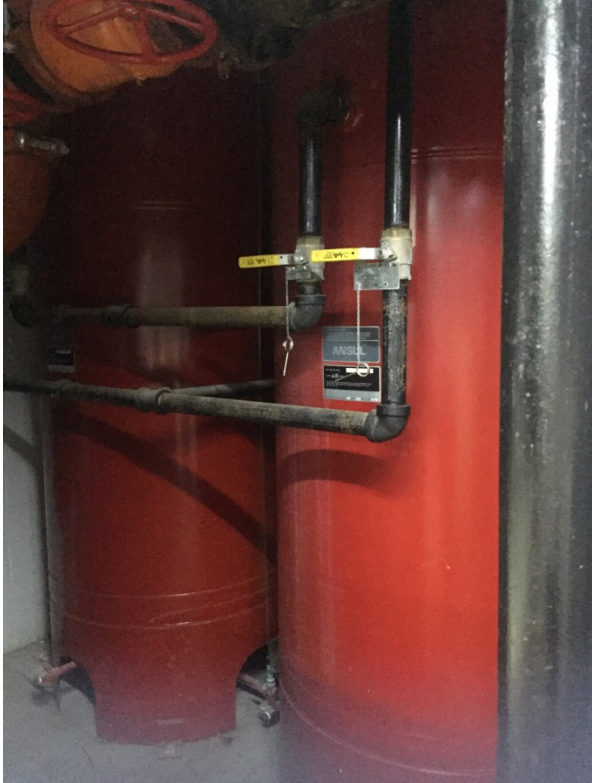
<p><b>Photograph No. 4</b></p> <p><b>Description:</b></p> <p>Photograph of 2 x 800 gallon tanks of Jet-X® High expansion foam concentrate for use in the Maintenance Hangar fire suppression system.</p>

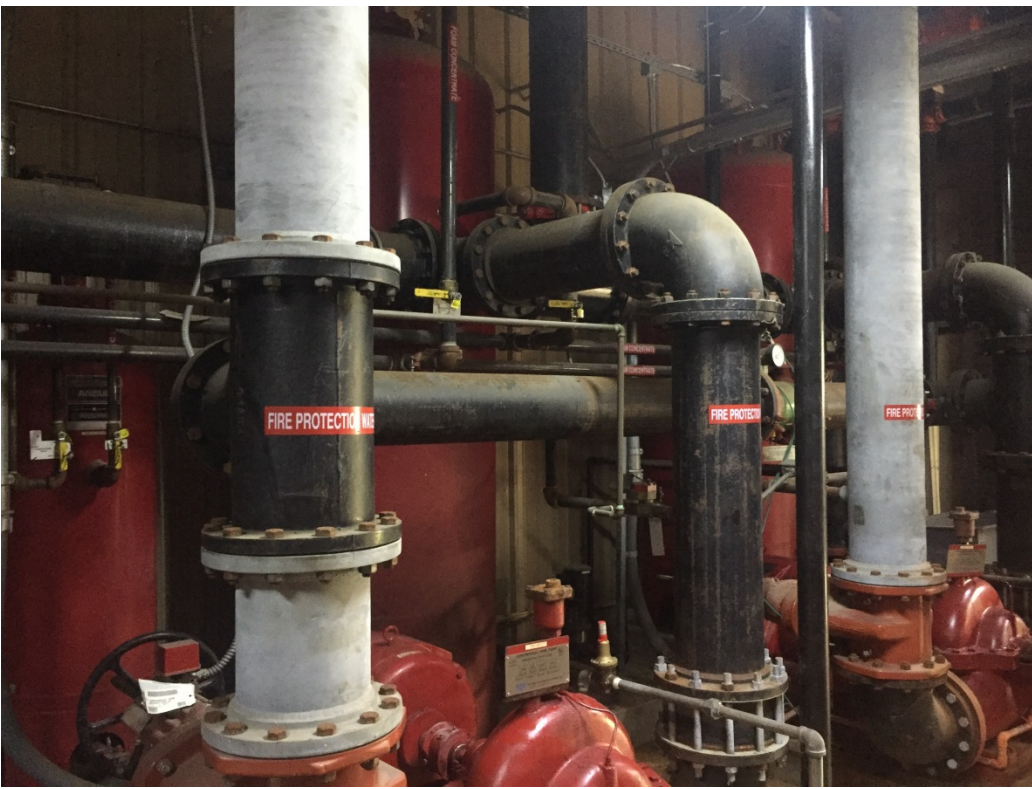
Army National Guard, Preliminary Assessment for PFAS	Austin Bergstrom AASF (April 24, 2019)	Austin, Texas
<p><b>Photograph No. 5</b></p> <p><b>Description:</b></p> <p>Photograph of 2 x 800 gallon Jet-X High expansion foam tanks and 1 x 100 gallon AFFF foam tank in Maintenance Hangar for emergency fire suppression. System is currently offline, waiting for system repairs.</p>

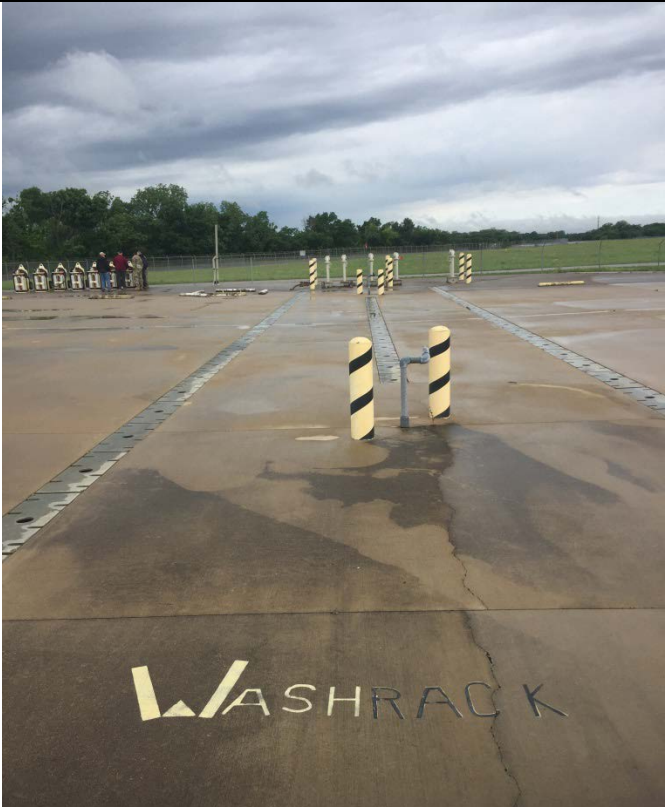
Army National Guard, Preliminary Assessment for PFAS	Austin Bergstrom AASF (April 24, 2019)	Austin, Texas
<p><b>Photograph No. 7</b></p> <p><b>Description:</b></p> <p>Facing west, looking at wash rack. Fire training activities took place in this area in 2009. One Tri-Max unit was used for training in 2009. Training occurred once or twice during 2009.</p>

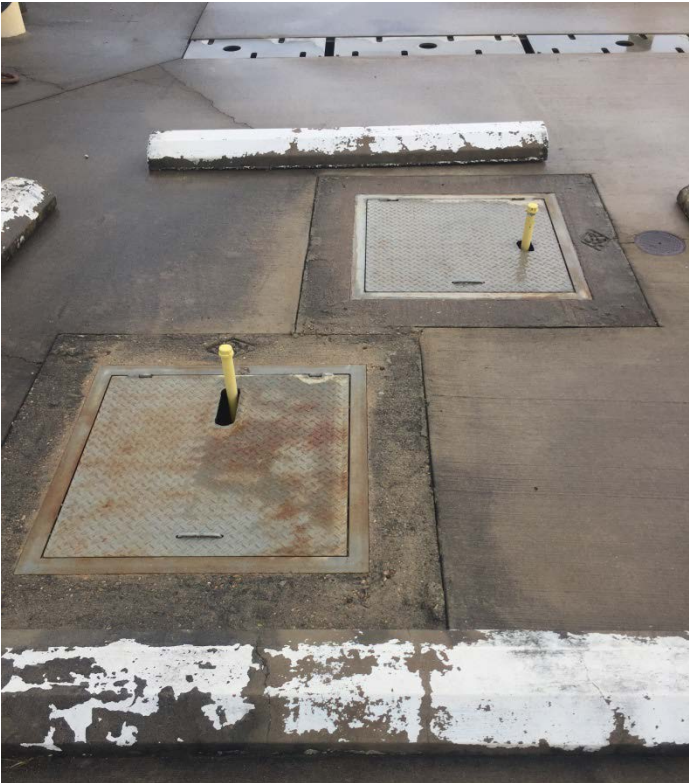
<p><b>Photograph No. 8</b></p> <p><b>Description:</b></p> <p>Diverter valve near wash rack that diverts flow from storm sewer to sanitary sewer when pressure set point is reached.</p>

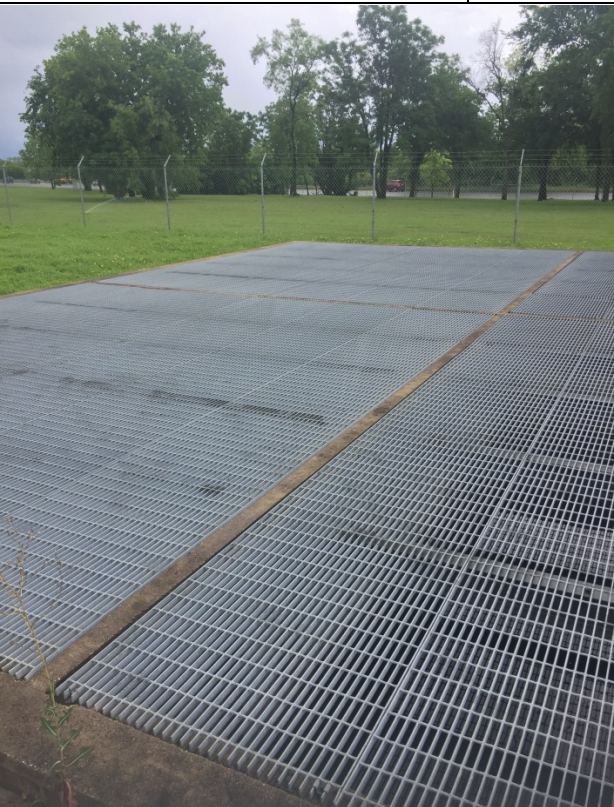
Army National Guard, Preliminary Assessment for PFAS	Austin Bergstrom AASF (April 24, 2019)	Austin, Texas
<p><b>Photograph No. 11</b></p> <p><b>Description:</b></p> <p>50,000 gallon holding tank located along south side of site.</p>

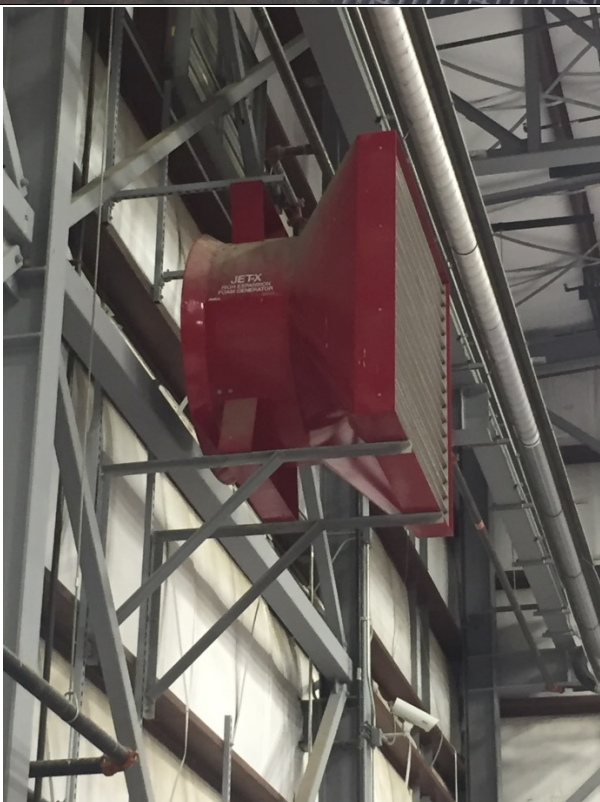
<p><b>Photograph No. 12</b></p> <p><b>Description:</b></p> <p>Jet-X® High expansion foam nozzles used in Maintenance Hangar and Fixed Wing Hanger.</p>

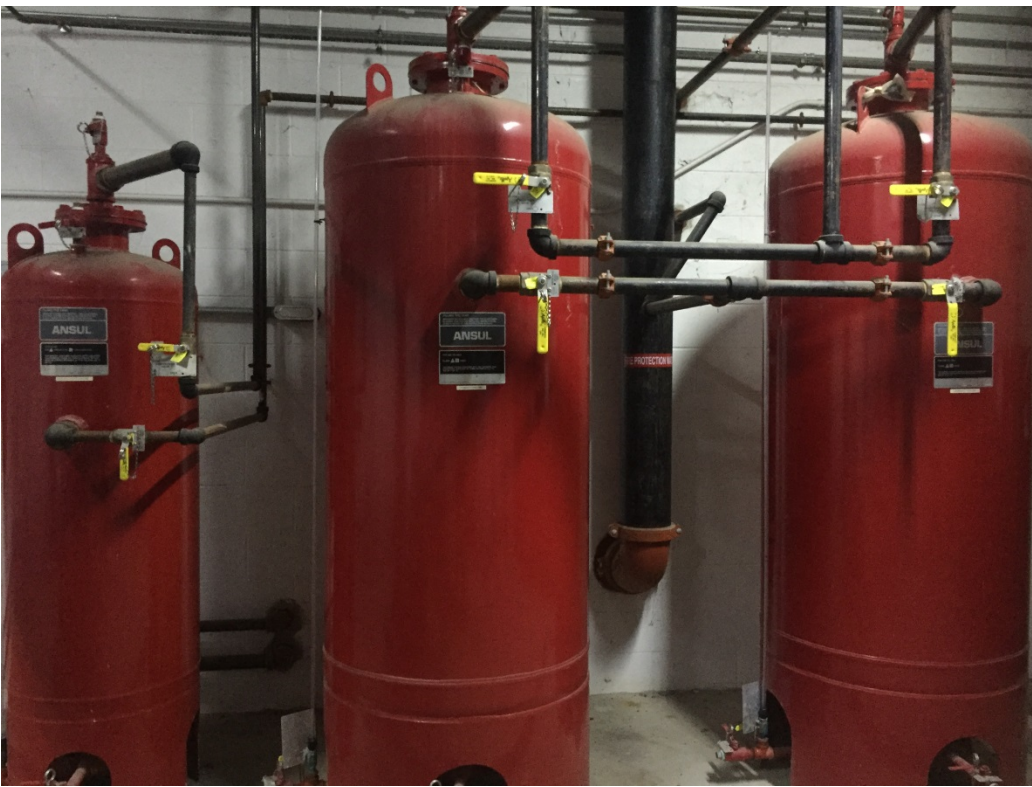
Army National Guard, Preliminary Assessment for PFAS	Austin Bergstrom AASF (April 24, 2019)	Austin, Texas
<p><b>Photograph No. 13</b></p> <p><b>Description:</b></p> <p>Fixed Wing Hangar with 1 x 100 gallon tank of AFFF 3% concentrate, and 2 x 300 gallon tanks of Jet-X ® High expansion foam concentrate. All fire suppression systems are currently offline, waiting for maintenance.</p>

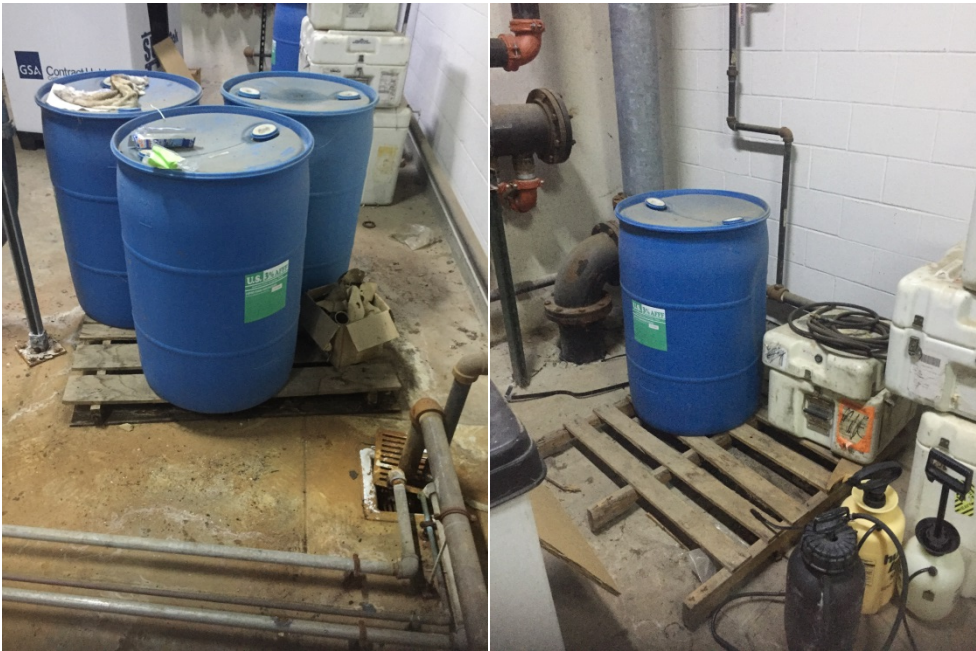
<p><b>Photograph No. 14</b></p> <p><b>Description:</b></p> <p>4 x 55 gallon totes of 3% AFFF foam concentrate stored in Fixed Wing Hangar.</p>

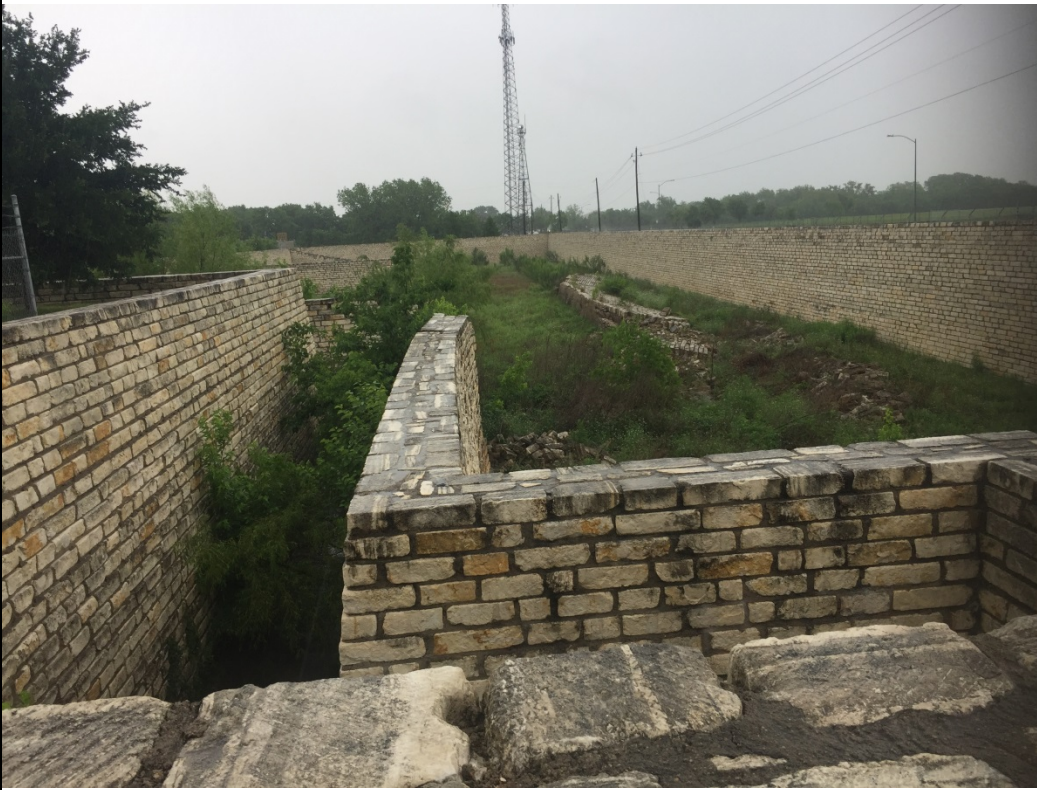
Army National Guard, Preliminary Assessment for PFAS		Austin Bergstrom AASF (April 24, 2019)	Austin, Texas
<b>Photograph No. 17</b>

<b>Description:</b>  Facing northeast, looking out at the Joint Vehicle Maintenance Facility Complex Pond. Storm water collects in this pond before it is used for the irrigation well or discharges to Onion Creek.
