Preliminary Assessment Report Sustained Airborne Training Facility Salt Lake City, Utah

Perfluorooctanesulfonic Acid (PFOS) and
Perfluorooctanoic Acid (PFOA) Impacted Sites
ARNG Installations, Nationwide

September 2020

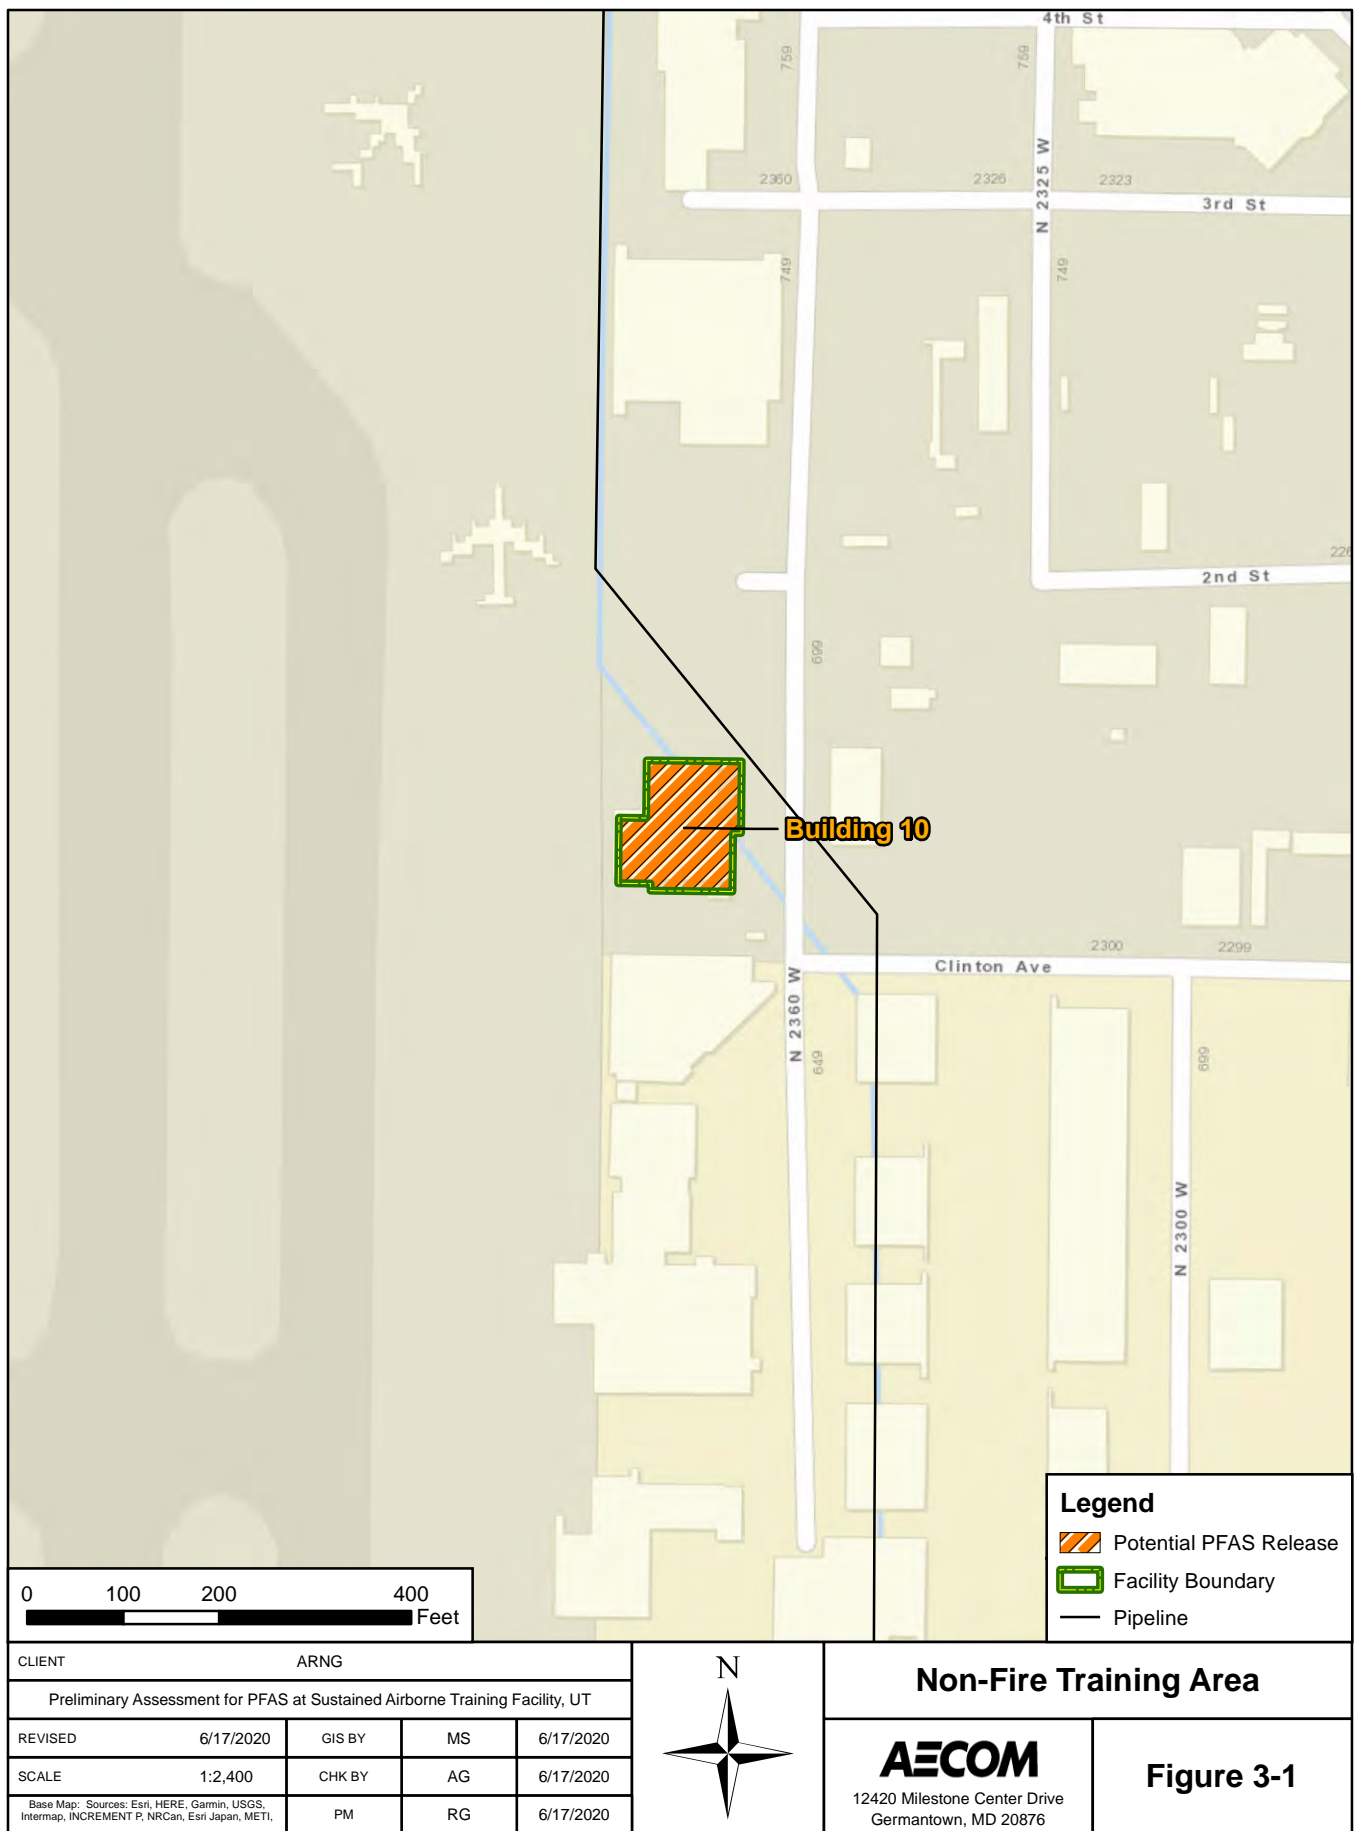
Figure 3-1

In addition to FTAs, the PA evaluated areas where PFAS-containing materials may have been broadly used, stored, or disposed. This may include buildings with fire suppression systems, paint booths, AFFF storage areas, and areas of compliance demonstrations. Information on these features obtained during the PA are included in **Appendices A and B**. One non-FTA where AFFF could have been potentially stored and/or released was investigated during the PA, as described below and shown on **Figure 3-1**.

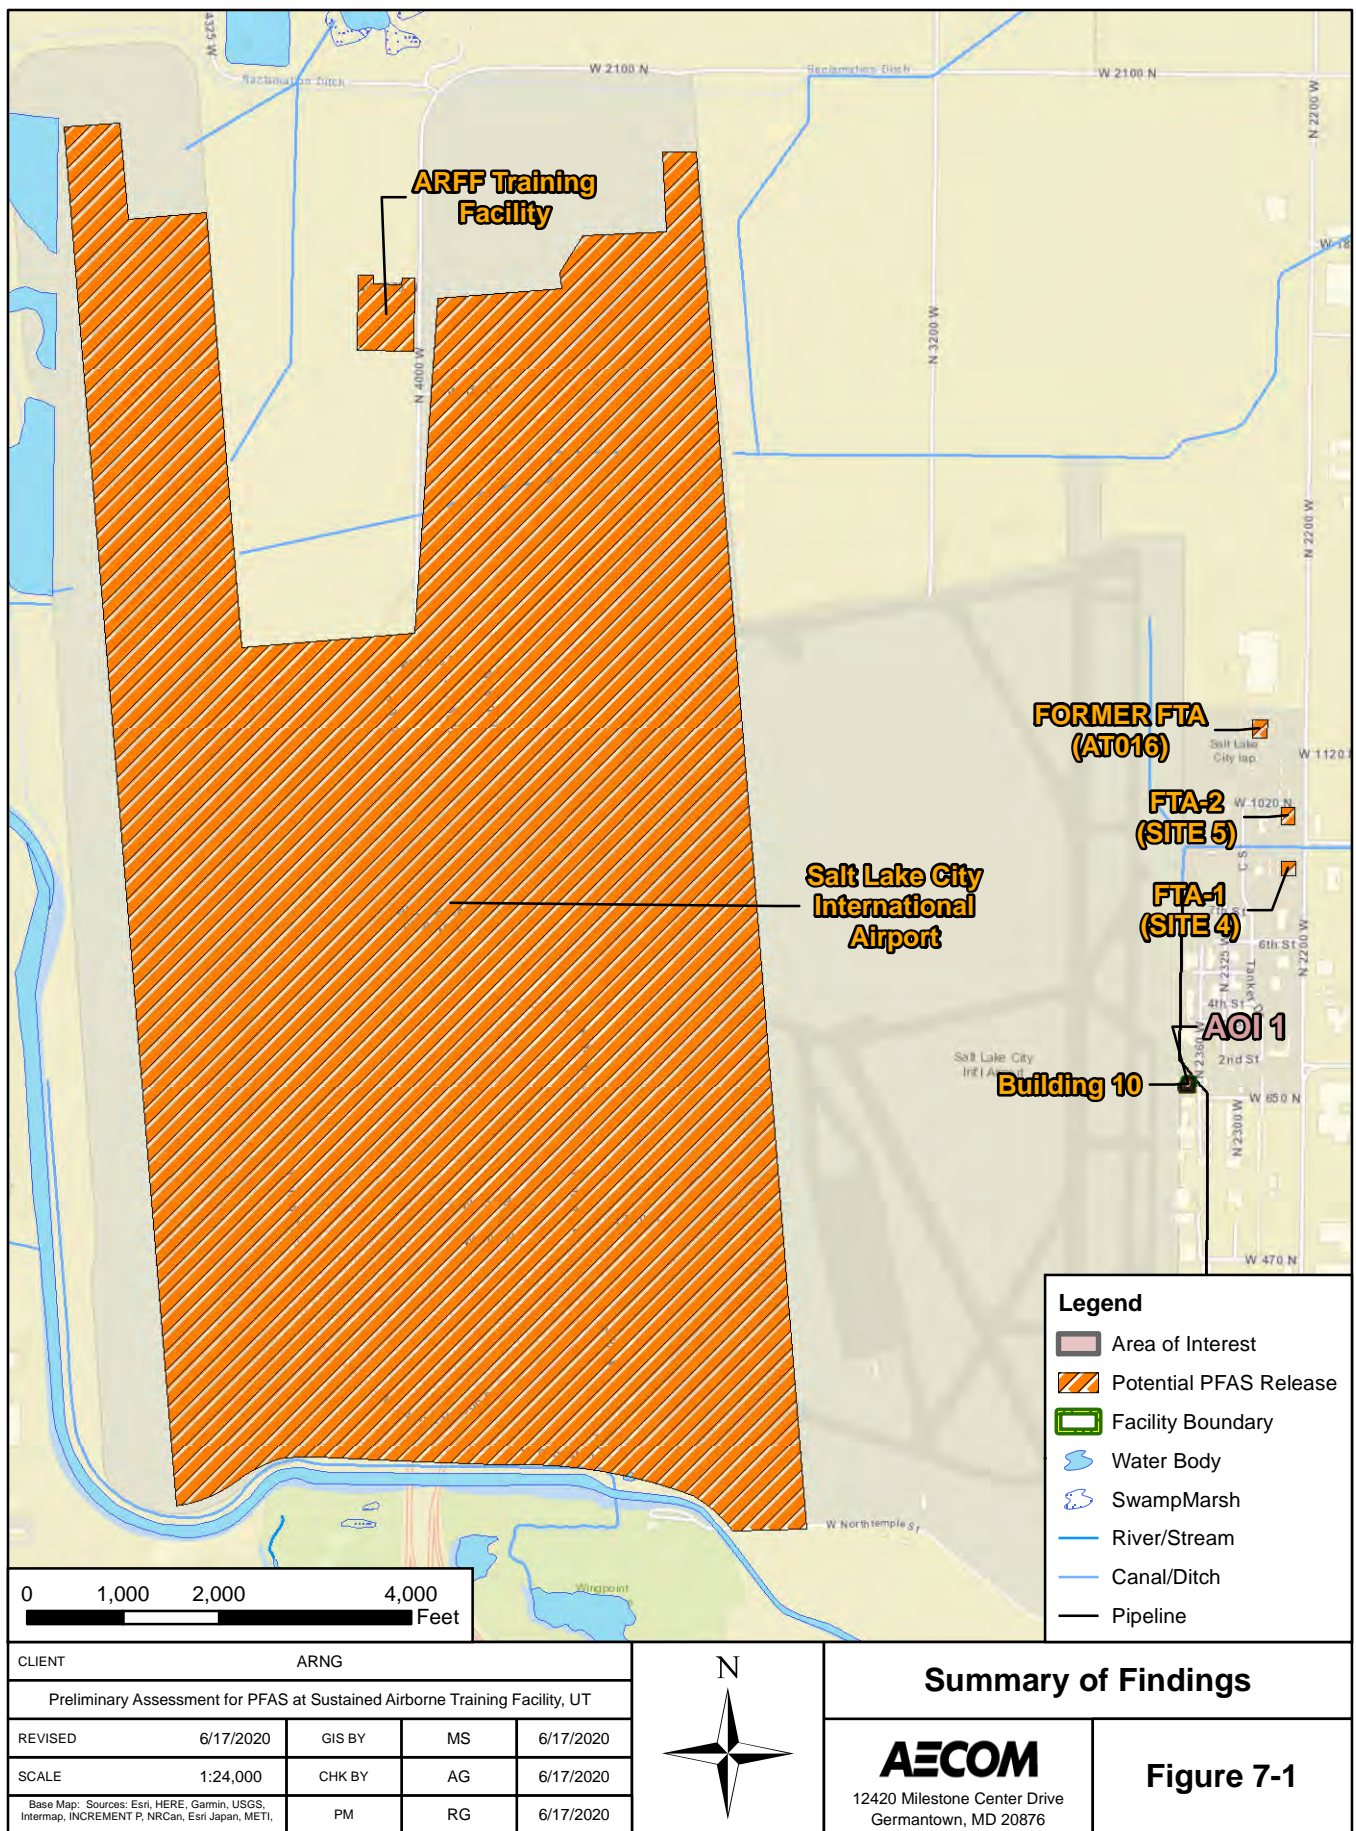
One AOI related to a potential PFAS release was identified (**Table 7-1**) at the SATF during the PA (**Figure 7-1**).

Area of Interest	AOI Location	Rationale	Potential Future Action
AOI 1: Building 10	40°47'03.1"N 111°57'28.4"W	Confirmed location of AFFF system test by interviewee with direct knowledge.	Proceed to an SI, focus on soil, surface water, sediment, and groundwater.

ARNG will evaluate the need for an SI at the SATF based on the potential receptors, the potential migration of PFAS contamination off the facility, and the availability of resources.

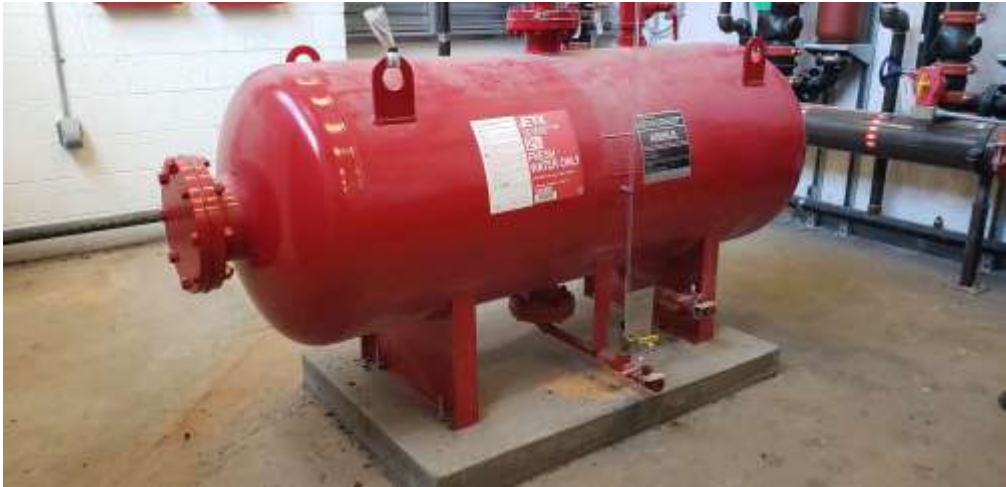
One AFFF tank containing 55 gallons of Jet-X 2% high expansion foam concentrate was observed in the building's mechanical room. Corroded concrete observed below the tank faucet indicated a slow leak coming from the tank. There were no signs that the leak had ever flowed farther than the immediate vicinity of the concrete directly below the tank, and therefore, there is no suspected release to soil, groundwater, or to drains leading to the sanitary sewer system.

Army National Guard, Preliminary Assessment for PFAS	Sustained Airborne Training Facility	Salt Lake City International Airport, UT
<p>Photograph No. 3</p> <p>Date 7/18/2019 Time 10:12</p> <p>Description: Photograph depicts a 200 gallon tank containing Jet-X 2% high expansion foam concentrate, with evidence of a leak on the concrete under tank.</p> <p>Orientation: Northeast</p>

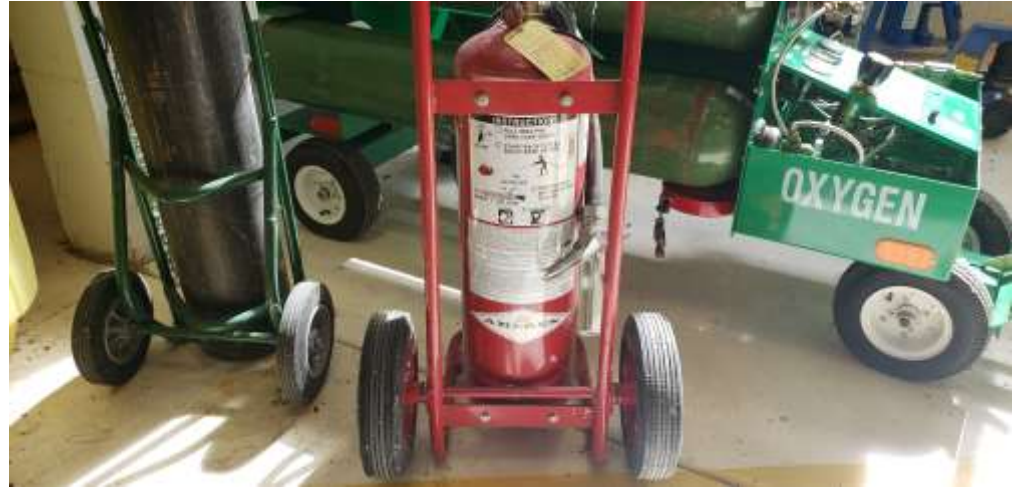
Photograph depicts the mobile Amerex unit observed in the hangar.

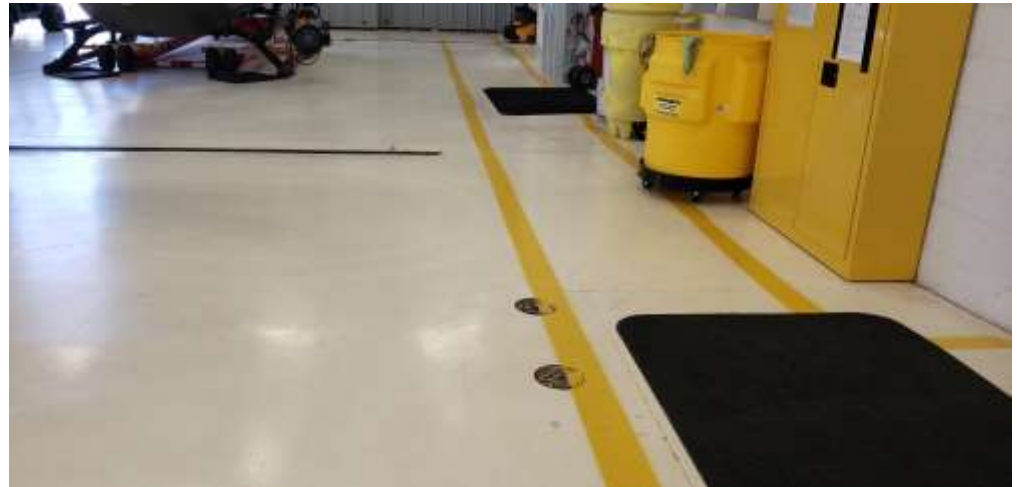
Photograph depicts the trench drains and two monitoring wells observed in the hangar.
