FINAL Preliminary Assessment Report Gary Army Aviation Support Facility, Indiana

Perfluorooctane-Sulfonic Acid (PFOS) and Perfluorooctanoic
Acid (PFOA) Impacted Sites
ARNG Installations, Nationwide

March 2020

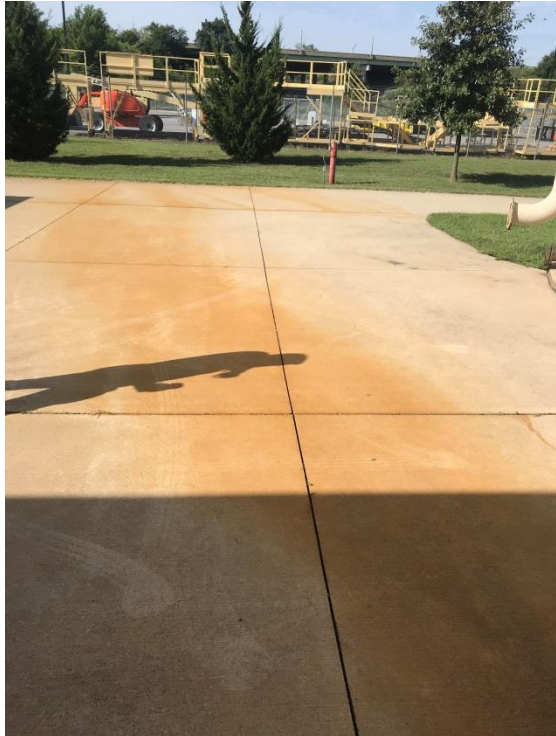
| Army National Guard, Preliminary Assessment for PFAS | | | Gary AASF | Gary Indiana |
|--|--|--|---|---|
| Photograph No. 5 | | | | |

| Army National Guard, Preliminary Assessment for PFAS | | | Gary AASF | Gary Indiana |
|--|--|--|---|---|
| <p>Description:</p> <p>Looking southwest. The concrete area that confined the AFFF leak. Staining is visible on the concrete in the foreground. Interviewees stated that the leak did not migrate to the grassy area in the background.</p> <p>Date Taken:</p> <p>31 August 2018</p> | | | | |
