Final Preliminary Assessment Report Bangor Training Site Bangor, Maine

Perfluorooctane-Sulfonic Acid (PFOS) and Perfluorooctanoic Acid
(PFOA) Impacted Sites
ARNG Installations, Nationwide

January 2020

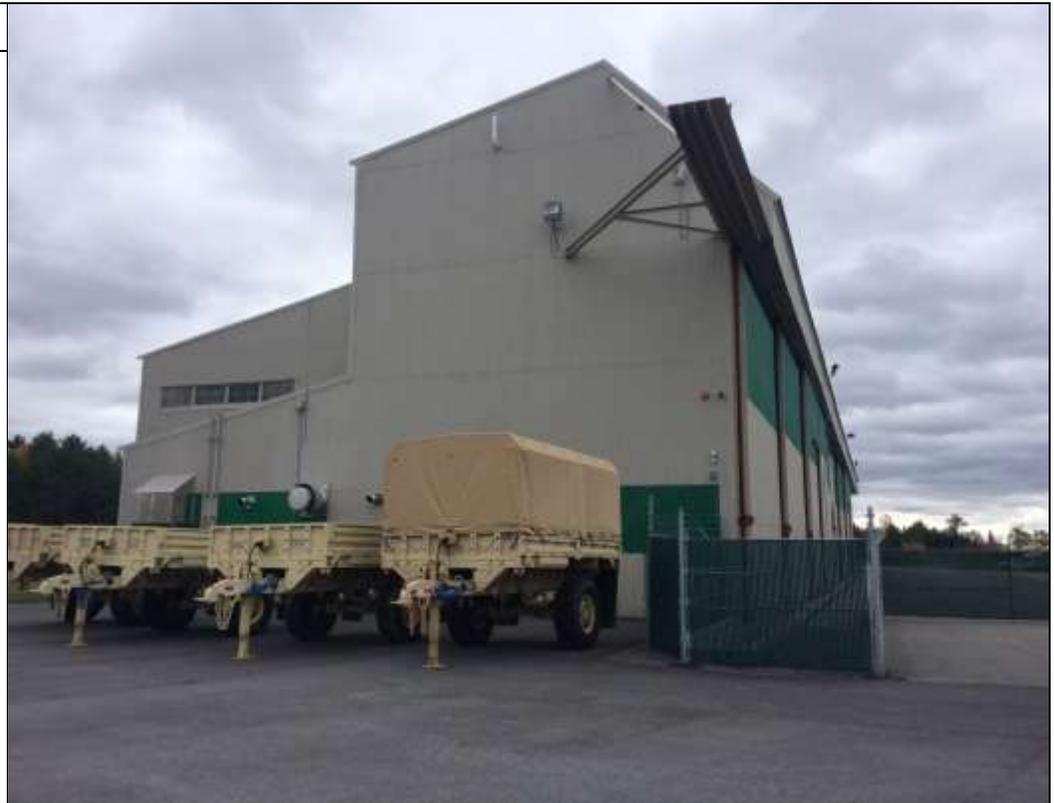
Bangor Training Site Building
254 used for aviation
maintenance and cold storage.
View facing south.

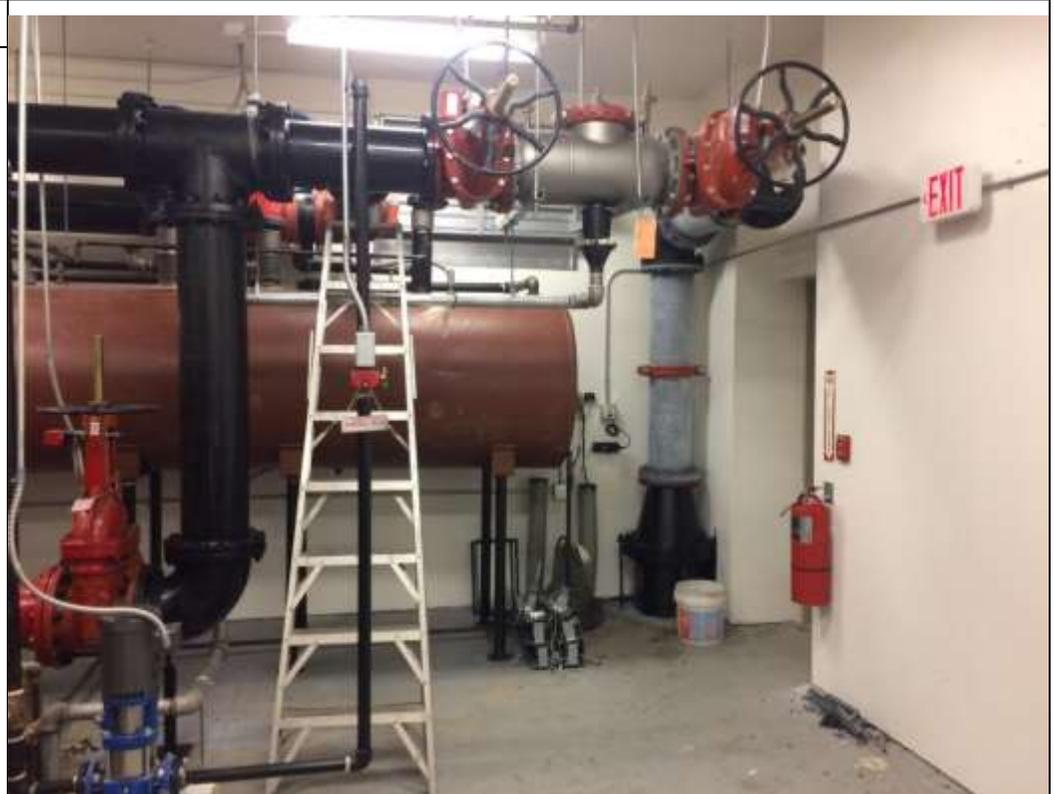
Photograph No. 2

High expansion foam
suppression system storage
room in Building 254.

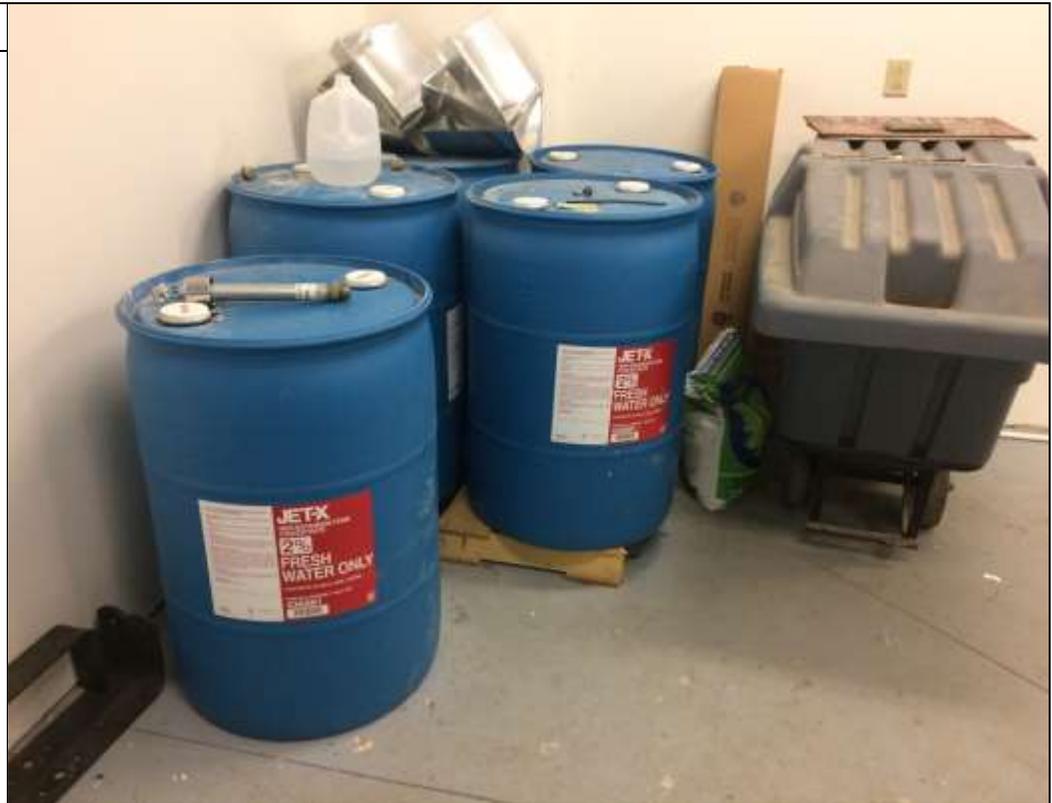
55 gallon drums containing high expansion foam concentrate in the fire suppression system storage room of Building 254.

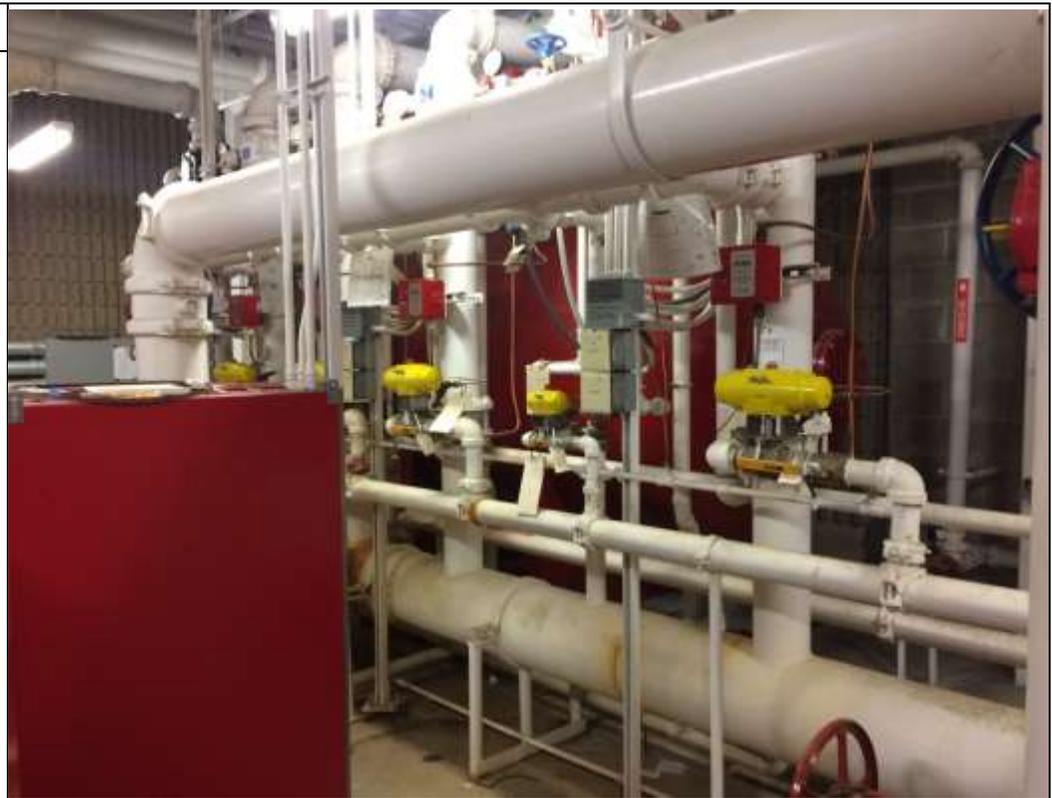
Photograph No. 4

AFFF Storage Tank 01 in the Building 260 Fire Suppression System Storage room.

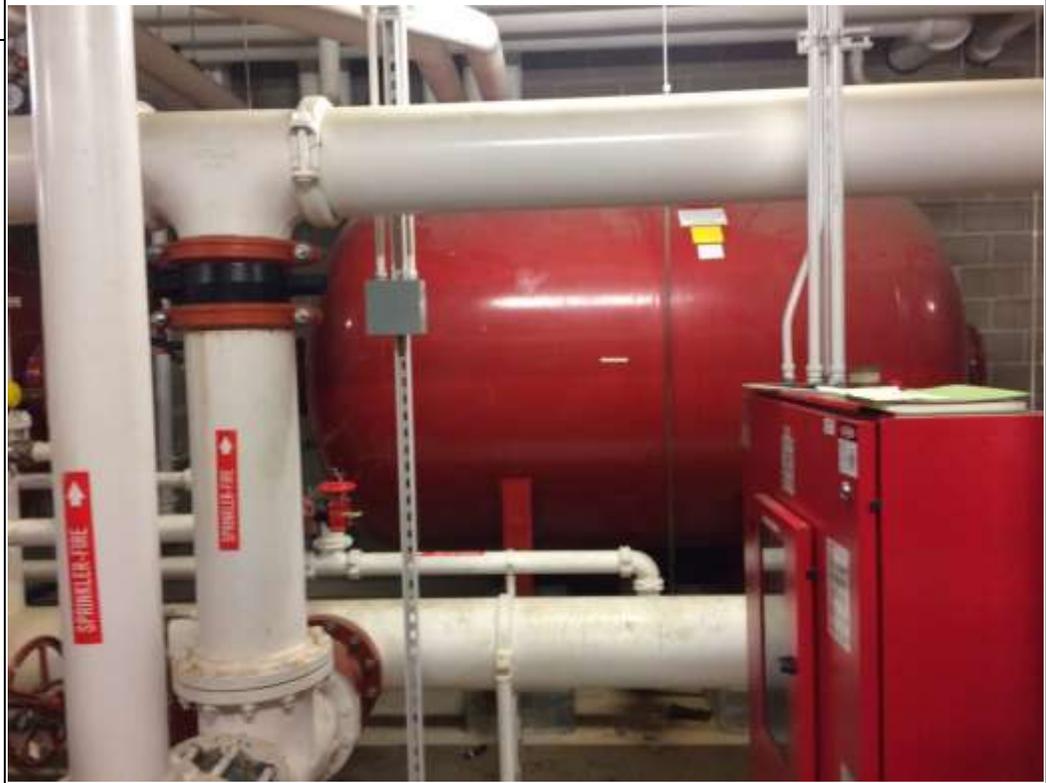
AFFF Storage Tank 02 in the Building 260 Fire Suppression System Storage room.

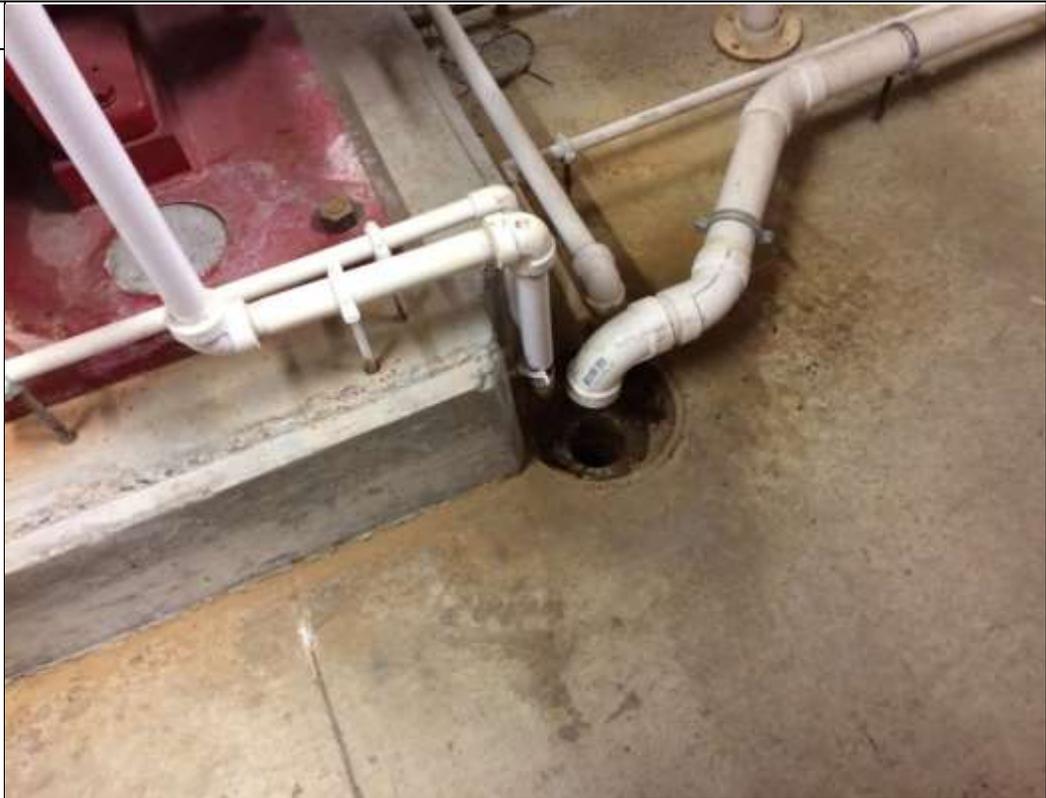
Photograph No. 6

Floor drain in the AFFF Fire Suppression System Storage Room in Building 260.

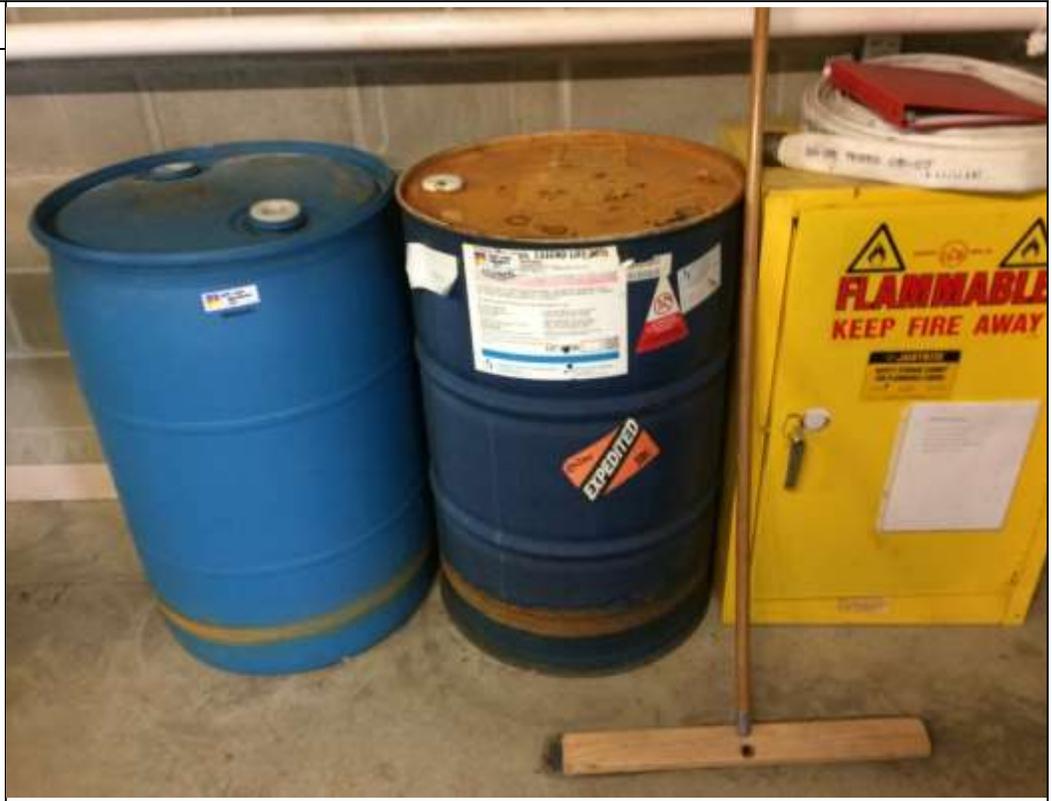
55 gallon drums for storage of residual AFFF concentrate in the AFFF Fire Suppression System Storage Room in Building 260.

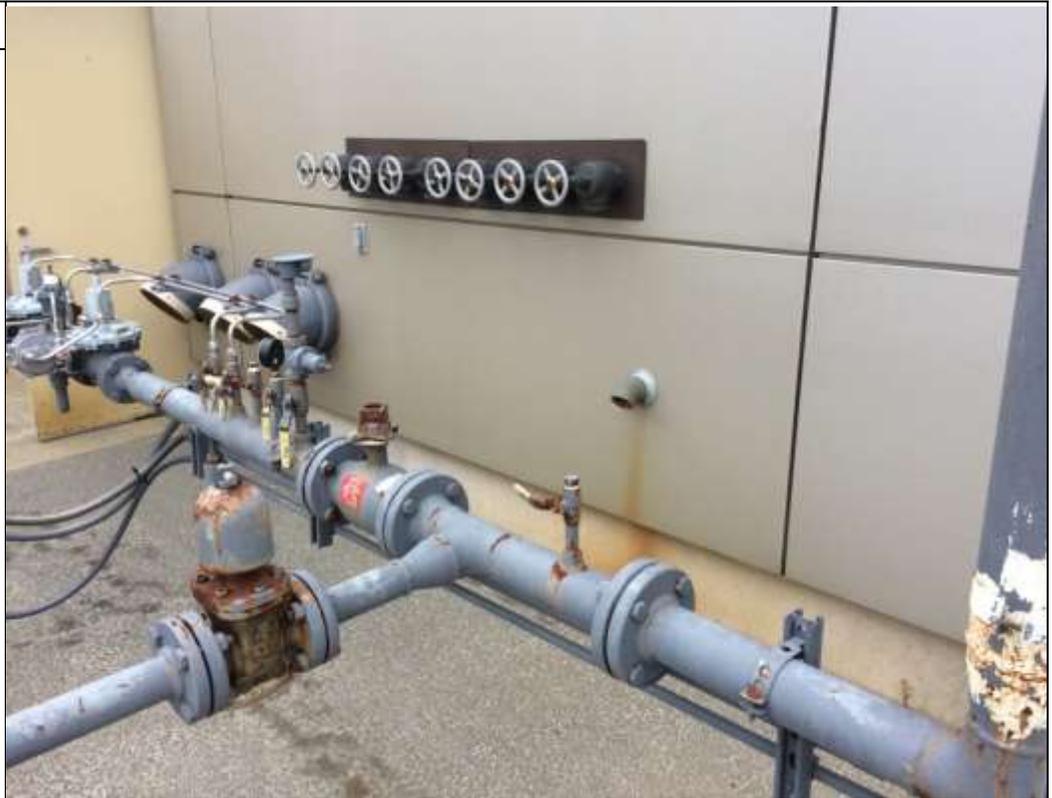
Photograph No. 8

In 2016, another incidental release from the AFFF tanks caused by triggering an incorrectly identified solenoid resulted in 30 gallons of Buckeye BFC-3.1 Platinum 3% AFFF solution spilling across the ramp outside the fire suppression room and into a sump designed to capture runoff. The AFFF solution escaped the suppression room through the 2-inch main drain line to the exterior ramp. According to MEARNG staff, the standing foam reached an approximate height of 1 ft on the ramp outside the fire suppression room. The sump does not have an outlet or discharge drain. The AFFF solution in the sump did not reach a height capable of migrating to the main stormwater sewer. All AFFF was captured and contained within the ramp area and the sump, and the released AFFF was subsequently vacuumed out of the sump in a controlled manner.

Drainage pipe on the outside of the Building 260 AFFF Fire Suppression System Storage Room. AFFF escaped through pictured outlet during accidental release in 2016. Estimated 30 gallons of AFFF concentrate released.

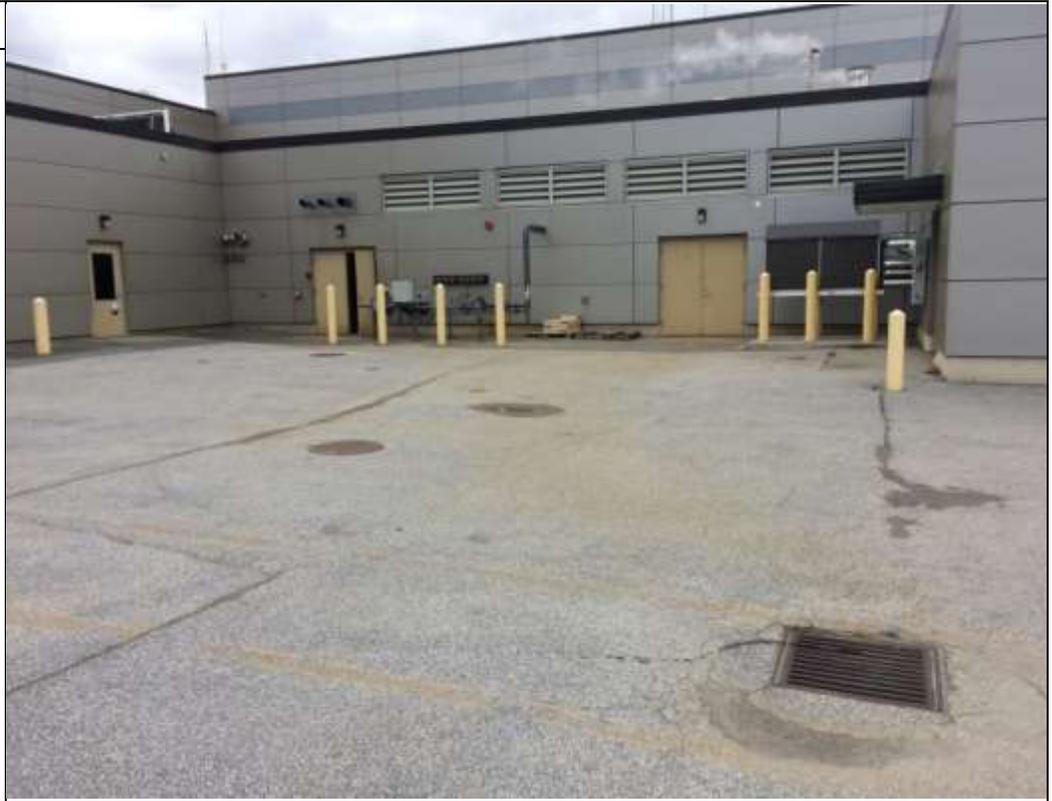
Ramp area outside Building 260 AFFF Fire Suppression System Storage Room. Pictured area includes the extent to which AFFF concentrate was released during incident in 2016. Released AFFF was captured by the sum drain pictured at bottom right.

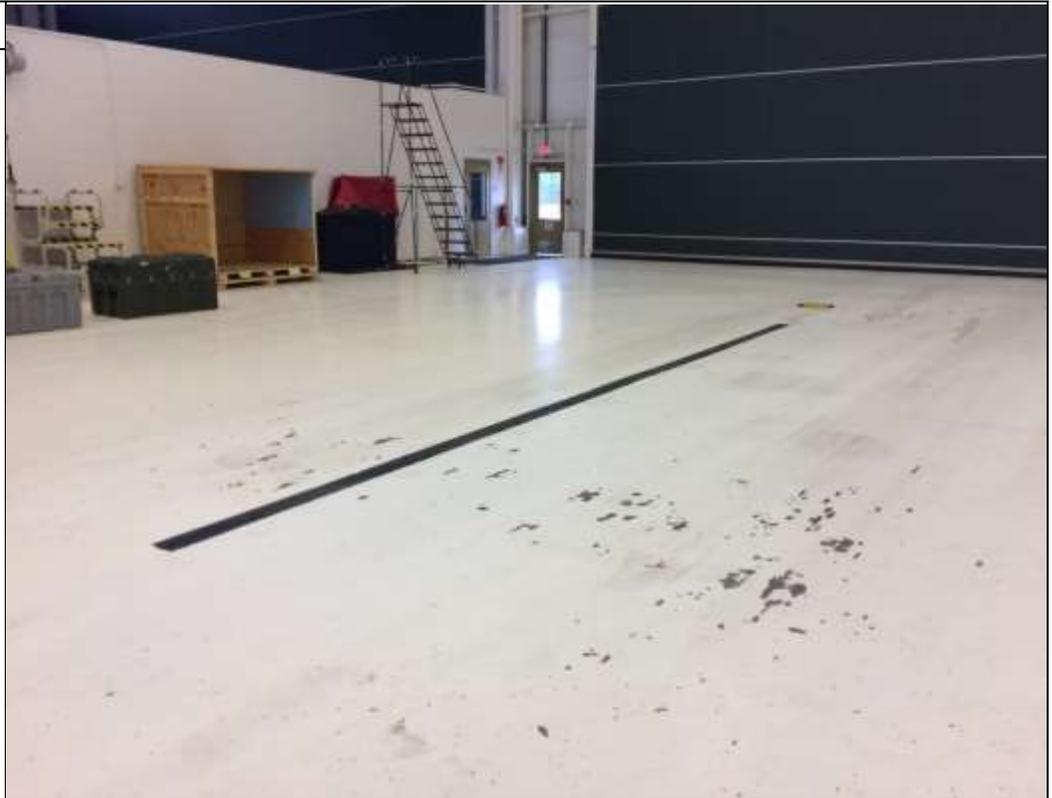
Photograph No. 10

Floor drains in Building 260 hangar area.

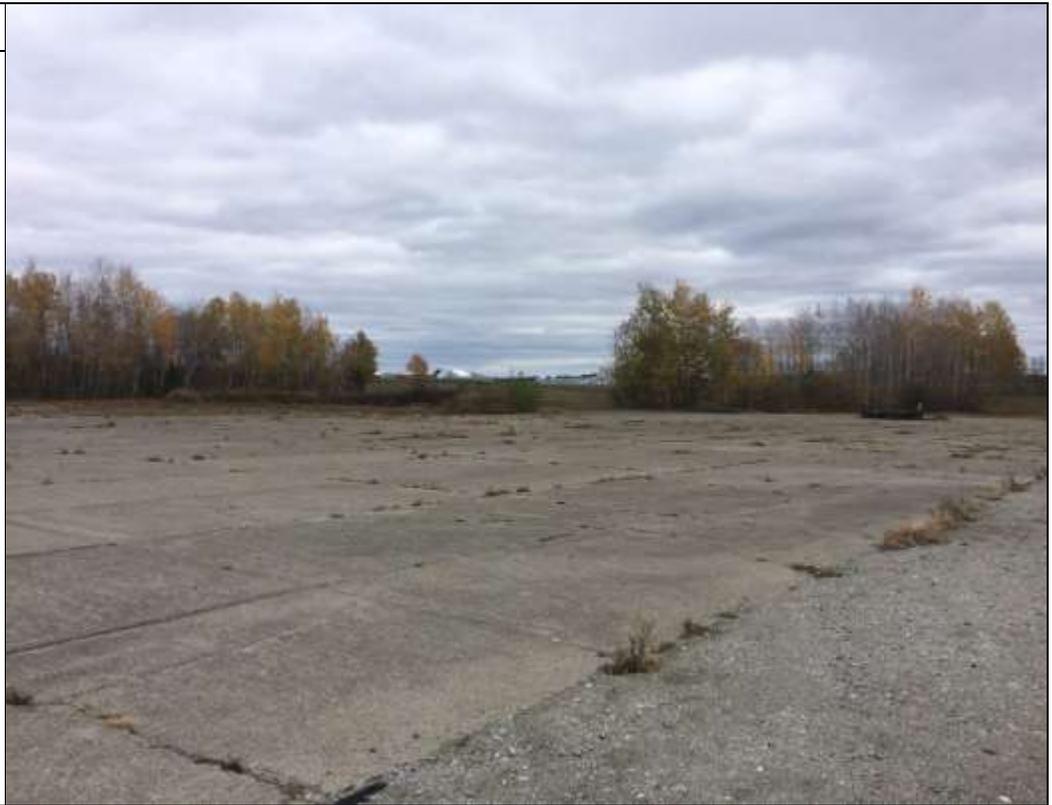
Fire training area (FTA) on west side of Bangor International Airport runway. Wooden pallets pictured at right; earthen berm pictured at left. No known use of FTA by MEARNG. View facing east.

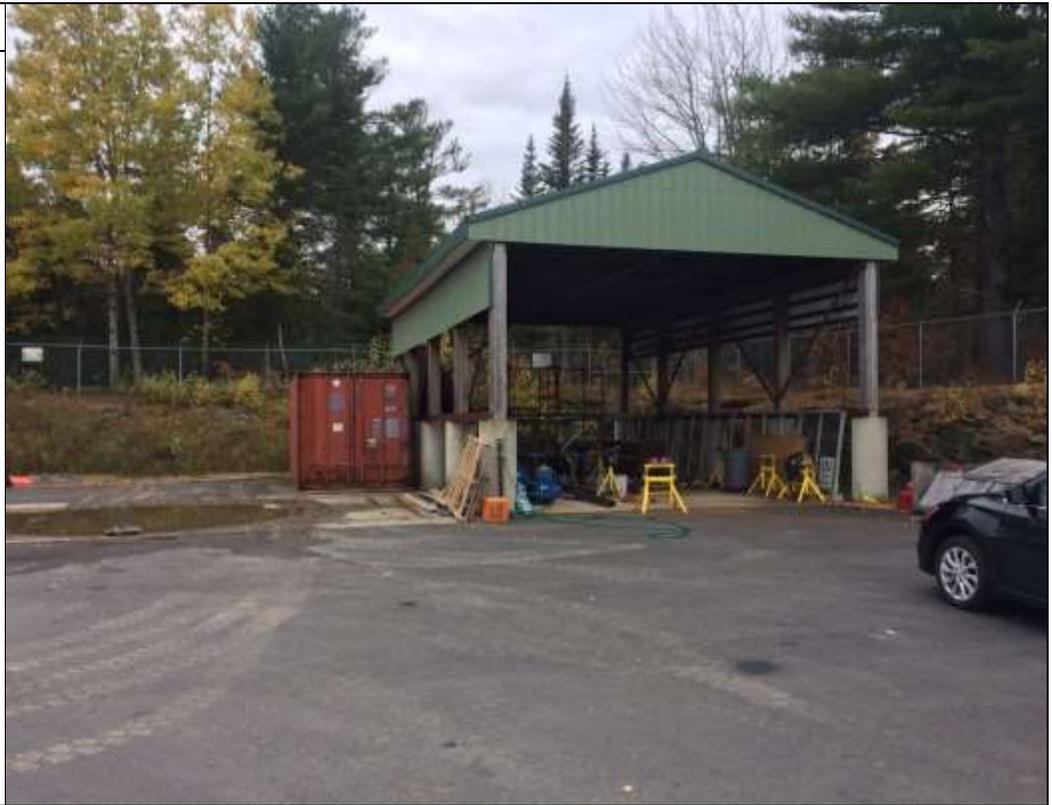
Vehicle maintenance area at the Navy/MEARNG the Armed Forces Reserve Center (AFRC) on the western MEARNG property in Bangor. Maintenance area never used for vehicle maintenance. View facing northwest.

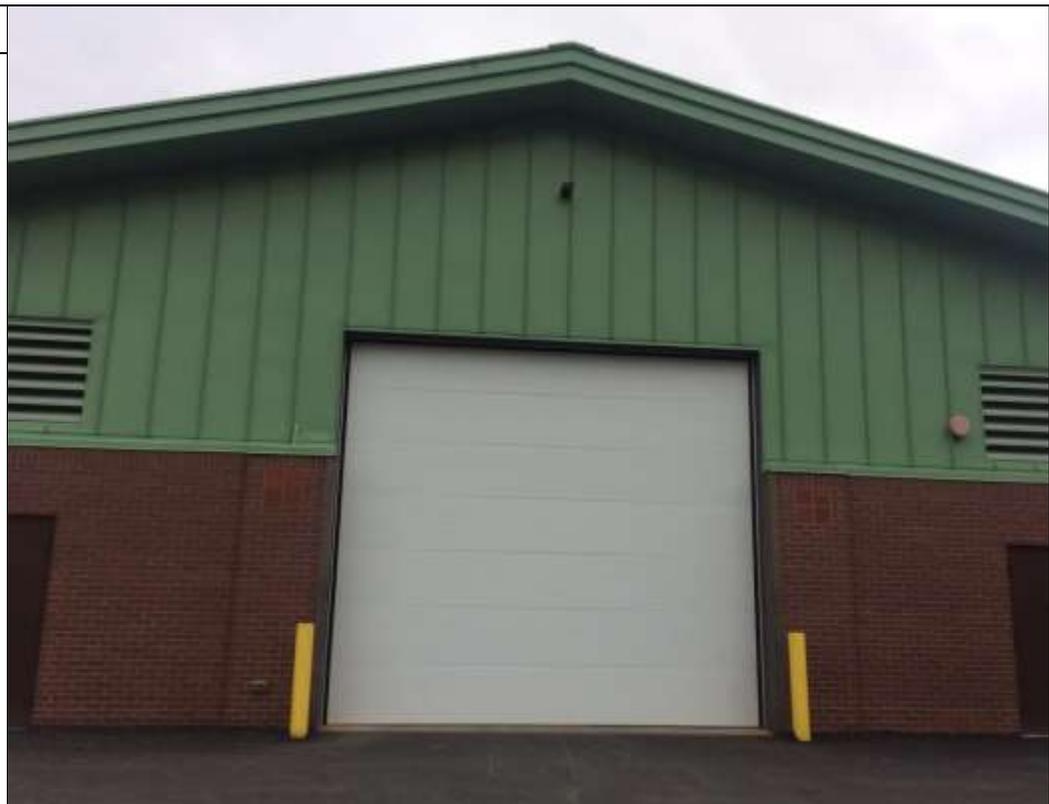
Maintenance bay door at the Navy/MEARNG AFRC. Maintenance area outside door unused for vehicle maintenance. View facing south.
