FINAL Preliminary Assessment Report AASF 1 Green Township, Summit County, Ohio

Perfluorooctanesulfonic Acid (PFOS) and Perfluorooctanoic
Acid (PFOA) Impacted Sites
ARNG Installations, Nationwide

June 2020

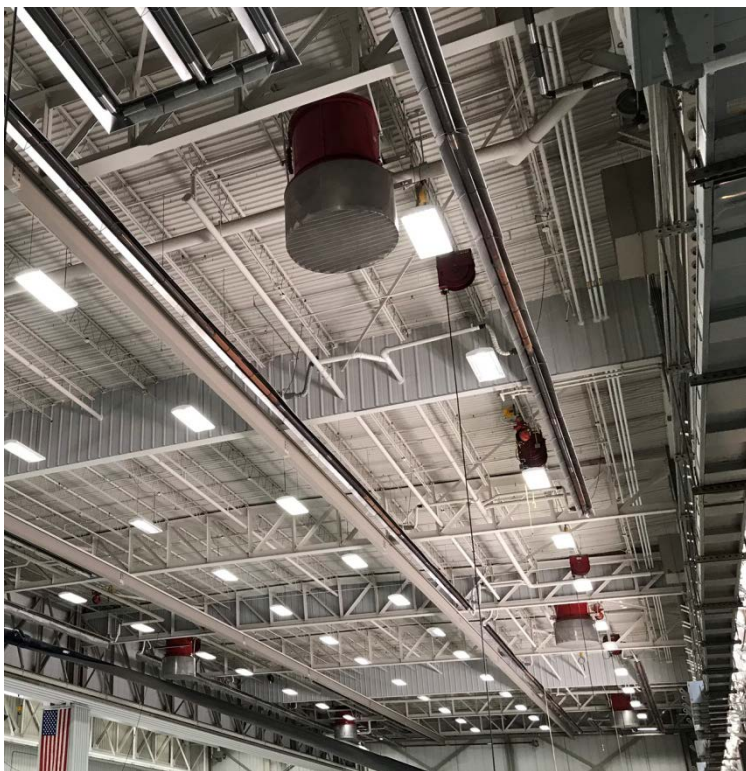
Photograph No. 2

The overhead high expansion foam (HEF) fire suppression system inside of the AASF 1.

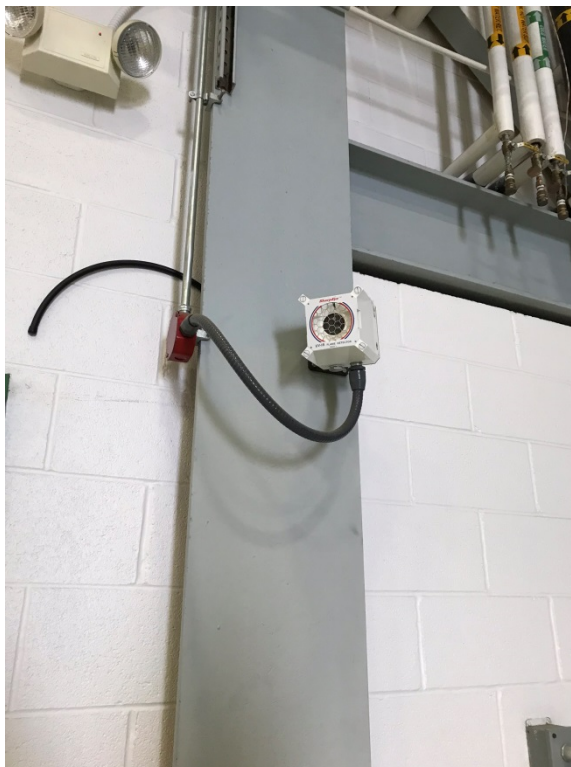
The thermal sensor used in the HEF fire suppression system within the AASF 1.

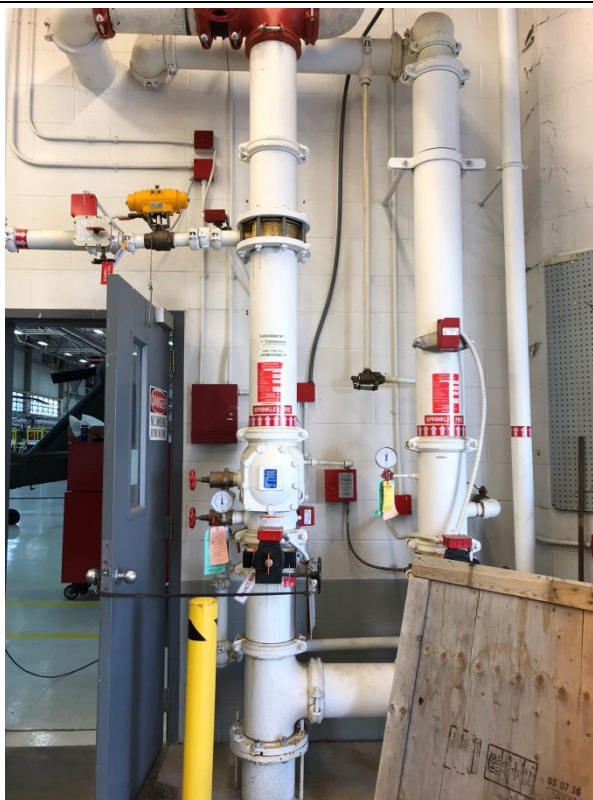
Photograph No. 4

The nozzle testing area within
the AASF 1.

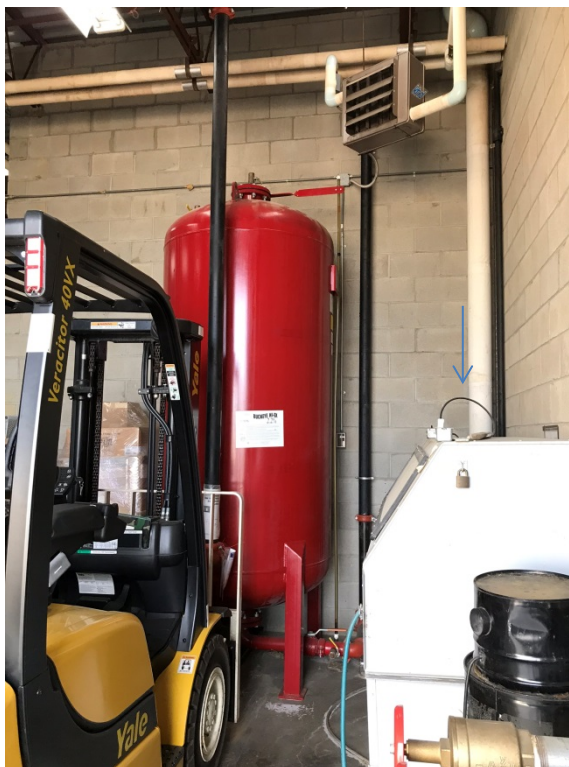
The 400-gallon tank
containing Buckeye 2.2%
HEF within the AASF 1
building.

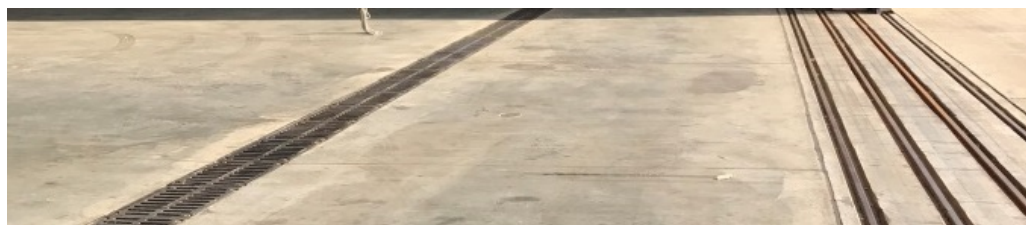
Photograph No. 6

Facing east. View of the floor drains inside of the AASF 1 hangar.

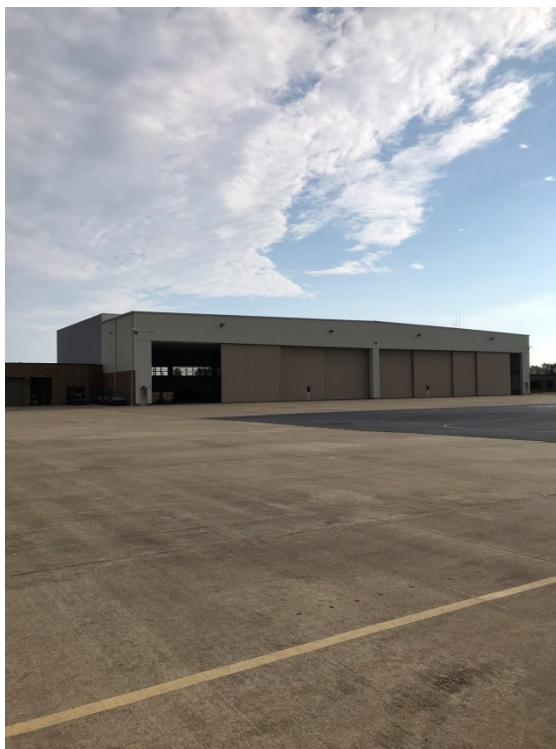
Facing north. The view of the AASF 1 hangar from the front of Building 5. Storm drains are located throughout the paved asphalt area, with the closest drain approximately 100 feet from the AASF 1 hangar doors.

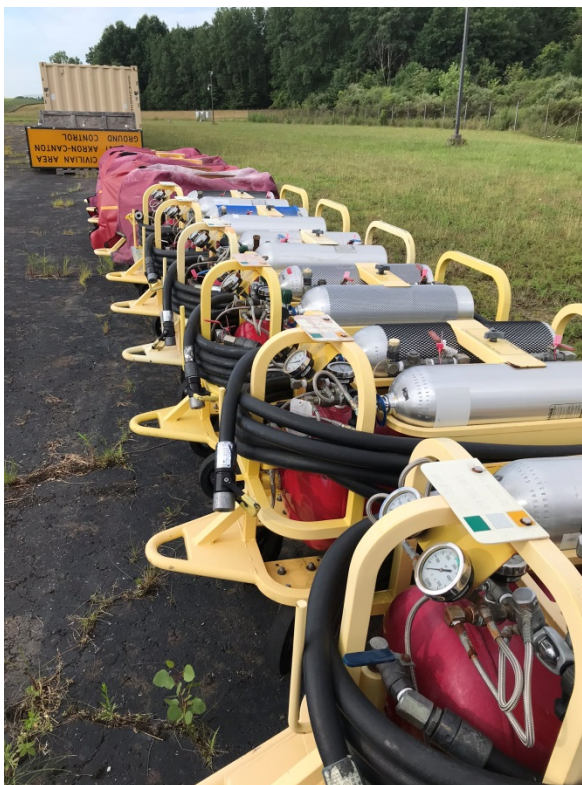
While no spills or releases have been reported from the nine full tanks stored outside, the storage of these tanks in a non-climate controlled area since at least 2017 without inspection for several years indicates a potential for unintended spills or releases. The long-term storage location of the TriMax™ tanks falls within a surface water divide; depending on various factors, surface water can flow to either the east or the west. Surface water flow to the west migrates towards off-site wetlands and other grassy areas. Surface water flow to the east is towards an identified on-site wetland, as well as towards a designated surface drainage system. Any potential spills or releases on or around this TriMax™ Storage Area have the potential to migrate and impact these various areas.

Facing south. View of the 11 TriMax tanks lined up on the paved asphalt area, approximately 200 feet from Building 5.
