FINAL Preliminary Assessment Report Fresno TASMG, California

Perfluorooctane-Sulfonic Acid (PFOS) and Perfluorooctanoic Acid (PFOA) Impacted Sites ARNG Installations, Nationwide

February 2020

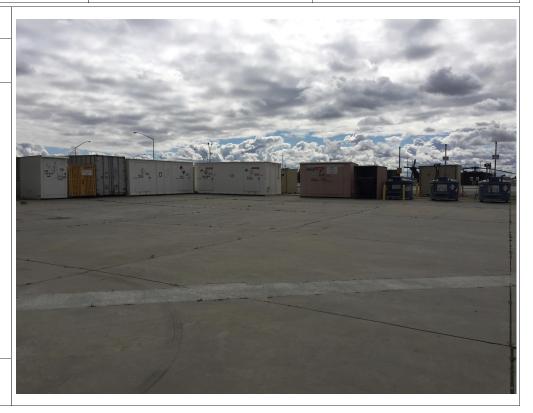
Wash rack area and HAZMAT locker with AFFF storage; Tri-Max 30 mobile fire extinguishers containing AFFF were discharged in the wash rack area

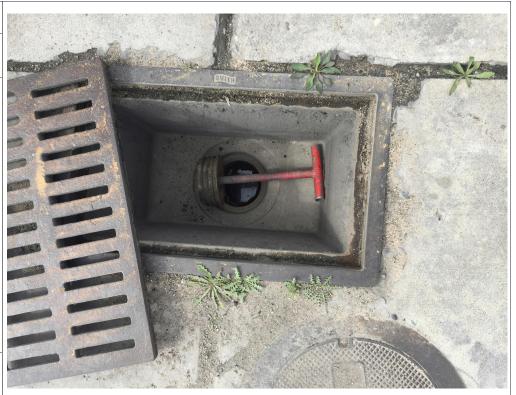
Wash rack drains were plugged whenever Tri-Max fire extinguishers were discharged in the wash rack

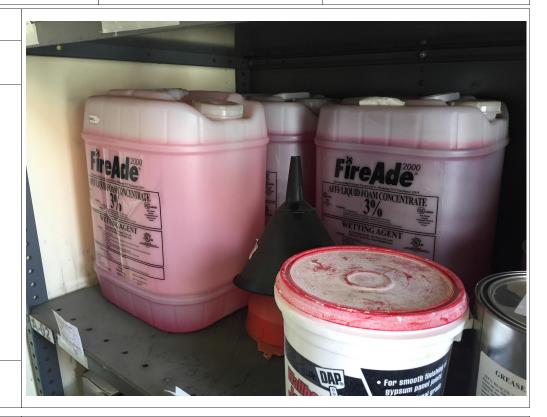
Three 19-Liter (5-gallon) canisters of FireAde 3% AFFF Liquid Foam Concentrate stored in the HAZMAT locker

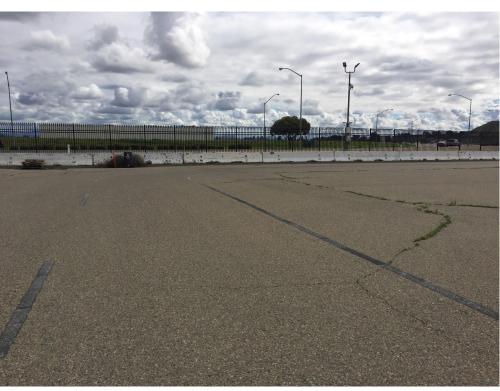
Taxiway east of airfield where Tri-Max 30 fire extinguishers containing AFFF were serviced and then discharged

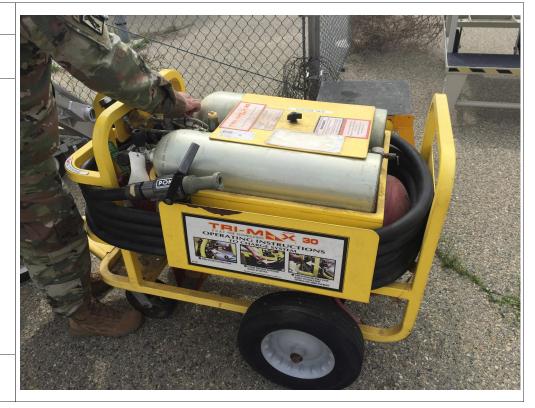
Tri-Max 30 fire extinguisher containing 3% AFFF concentrate; approximately seven Tri-Max extinguishers were observed on or surrounding the airfield

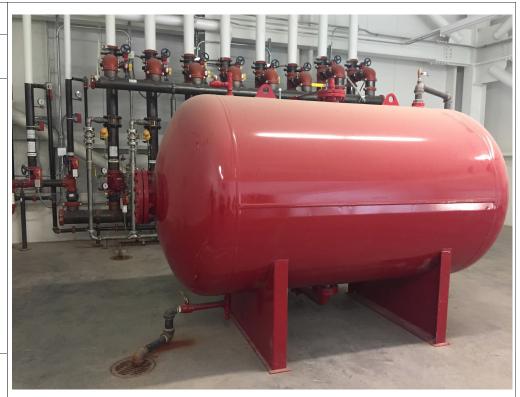
Site personnel with first-hand knowledge did not recall any accidental release of AFFF since the time of installation; however, it was reported that there was a small drip leak at one of the pumps approximately six to eight months after the AFFF fire suppression system was installed. The leak was fixed and cleaned by an outside contractor approximately one week after the incident was reported. This leak is not considered to be a significant PFAS release.

1,100-gallon tank of 3% AFFF by Chemguard, Inc. for fire suppression system contained in the upper deck of the Corrosion Control Facility

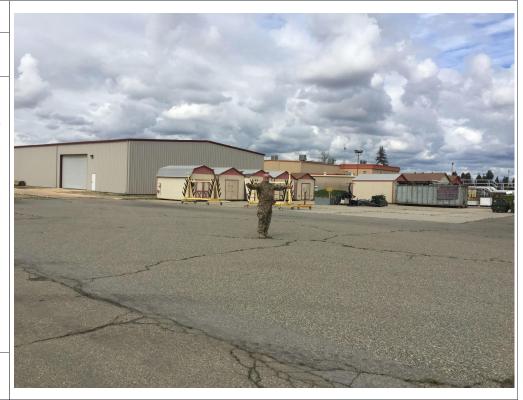
TASMG personnel demonstrates where collective fire training exercises took place outside the TASMG Hangar
