Preliminary Assessment Report

Stockton AASF, California

Perfluorooctane-Sulfonic Acid (PFOS) and Perfluorooctanoic Acid (PFOA) Impacted Sites
ARNG Installations, Nationwide

January 2020

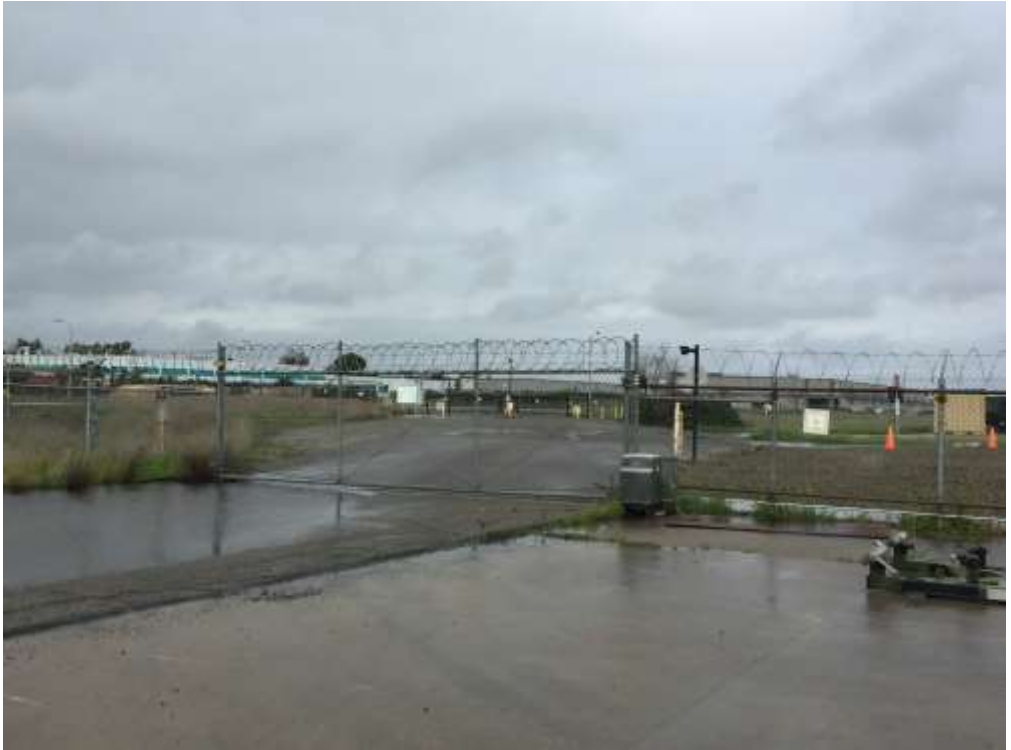
| Army National Guard, Preliminary Assessment for PFAS | | Stockton AASF | Stockton, California |
|--|--|---|---|
| Photograph No. 1 | | | |

During the PA site visit, potentially distressed vegetation was observed in the grassy area adjacent to the paved parking lot. Some minor flooding was also observed leading into the area from the south. The paved parking lot is in a restricted, fenced area with an access gate located on the northwest side.

| Army National Guard, Preliminary Assessment for PFAS | | Stockton AASF | Stockton, California |
|--|--|---|---|
| Description: Fire training area shown just past the fence and west of the Butler Building; some flooding and vegetative stress is observed | | | |

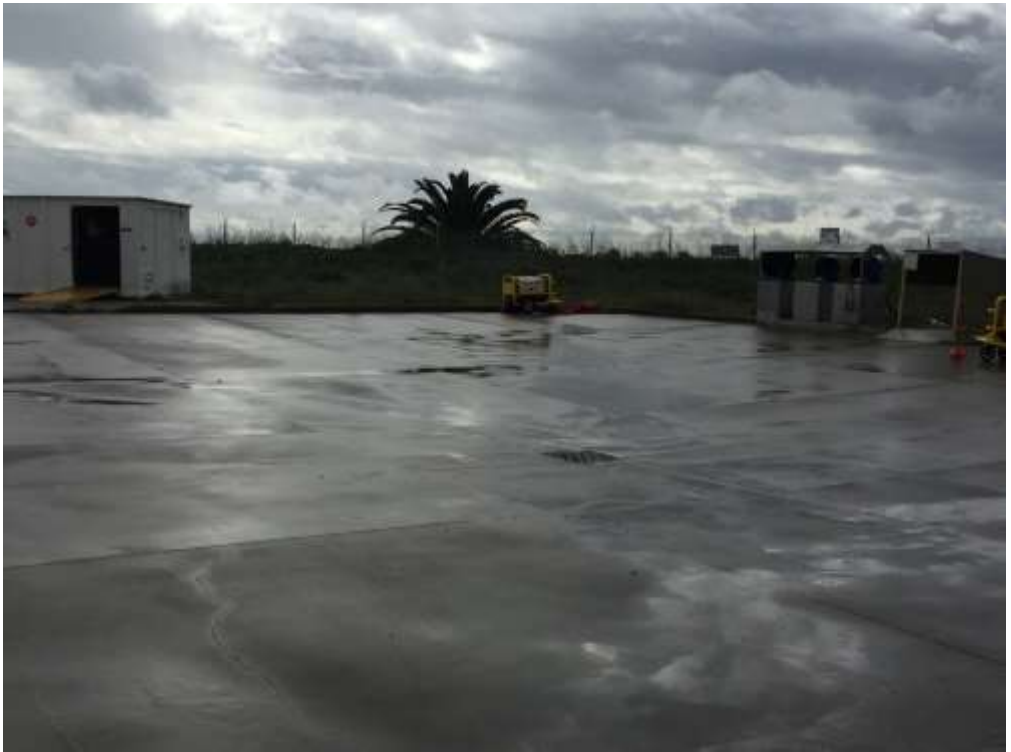
| Army National Guard, Preliminary Assessment for PFAS | | Stockton AASF | Stockton, California |
|--|--|---|---|
| Photograph No. 2 | | | |

A hazardous materials (HAZMAT) locker is located on the southwest corner of the wash rack. During the PA site visit, eighteen 5-gallon 6% AFFF canisters of the brand FireAde Mil-Spec were observed in the HAZMAT locker. Refilling of the Tri-Max™ extinguishers also occurred in the wash rack area, but only minimal spills, if any, would have occurred during this operation. According to an interview with a Maintenance Officer, AASF personnel also used to wash out aircraft tanks at the wash rack with an unknown type and quantity of foam or soap. However, personnel stopped using the foam or soap approximately five to six years ago at the request of the California Department of Forestry and Fire Protection (CAL FIRE) due to environmental reasons. One Tri-Max™ fire extinguisher was also observed stationed nearby the HAZMAT locker.

| Army National Guard, Preliminary Assessment for PFAS | | Stockton AASF | Stockton, California |
|--|--|---|---|
| Description: Wash rack area with HAZMAT locker and Tri-Max 30 mobile fire extinguisher in distance | | | |

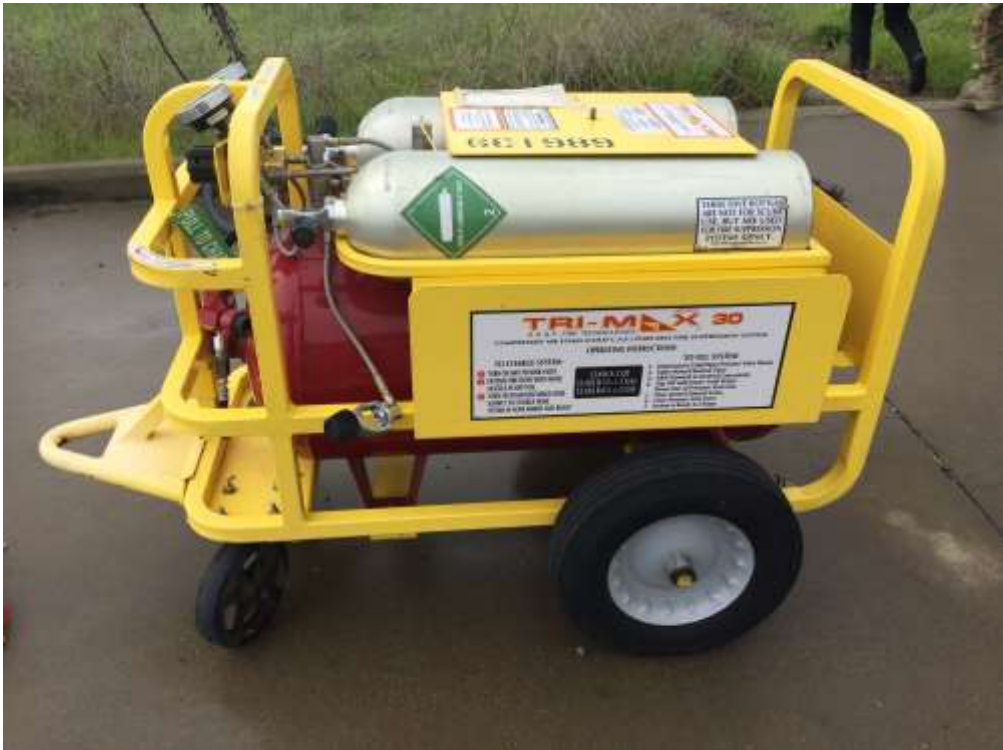
Approximately 13 Tri-Max™ fire extinguishers were observed on or in the vicinity of the airfield during the VSI. Most of the Tri-Max™ extinguishers were stationed next to helipads on the airfield. At least two Tri-Max™ extinguishers were observed in the northern adjacent helicopter parking area. The Tri-Max™ extinguishers remain equipped with presumably either 3% or 6% AFFF, based on previous and current facility supplies.

| Army National Guard, Preliminary Assessment for PFAS | Stockton AASF | Stockton, California |
|---|--|---|
| <p>Photograph No. 3</p> <p>Date 3/6/2019 Time 9:46</p> <p>Description: Tri-Max 30 mobile fire extinguishers found parked nearby the AASF Airfield</p> <p>Orientation: Southwest</p> | | |

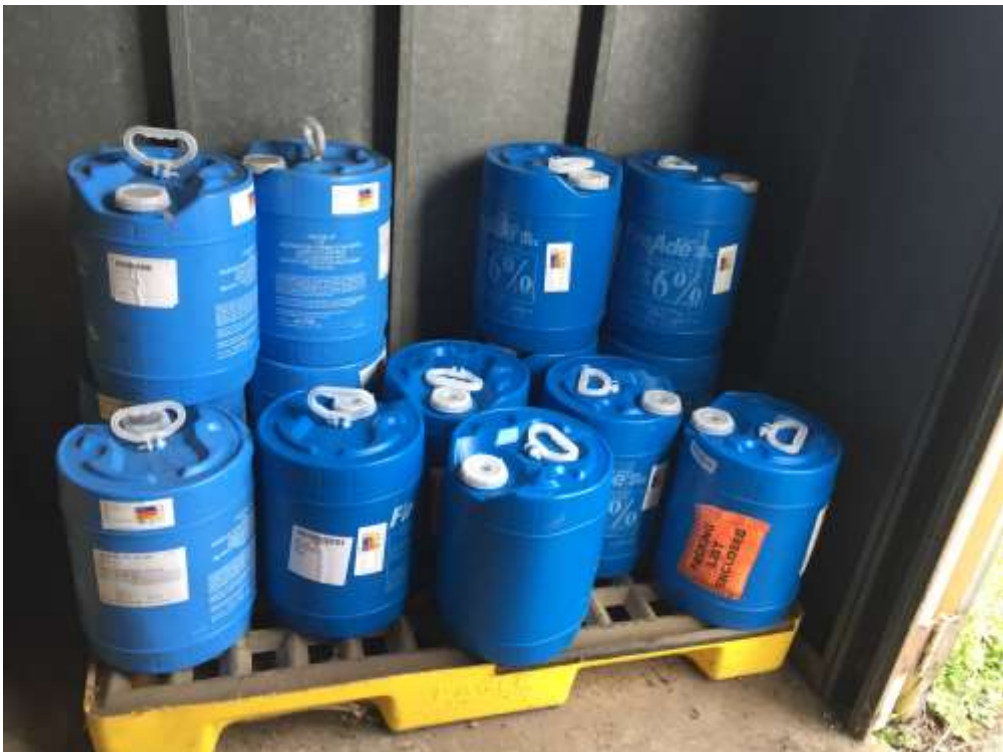
| Army National Guard, Preliminary Assessment for PFAS | Stockton AASF | Stockton, California |
|---|--|---|
| <p>Photograph No. 4</p> <p>Date 3/6/2019 Time 9:47</p> <p>Description: Multiple 5-gallon buckets of 6% AFFF FireAde 2000 Mil Spec observed in the HAZMAT locker</p> <p>Orientation: Northwest</p> | | |

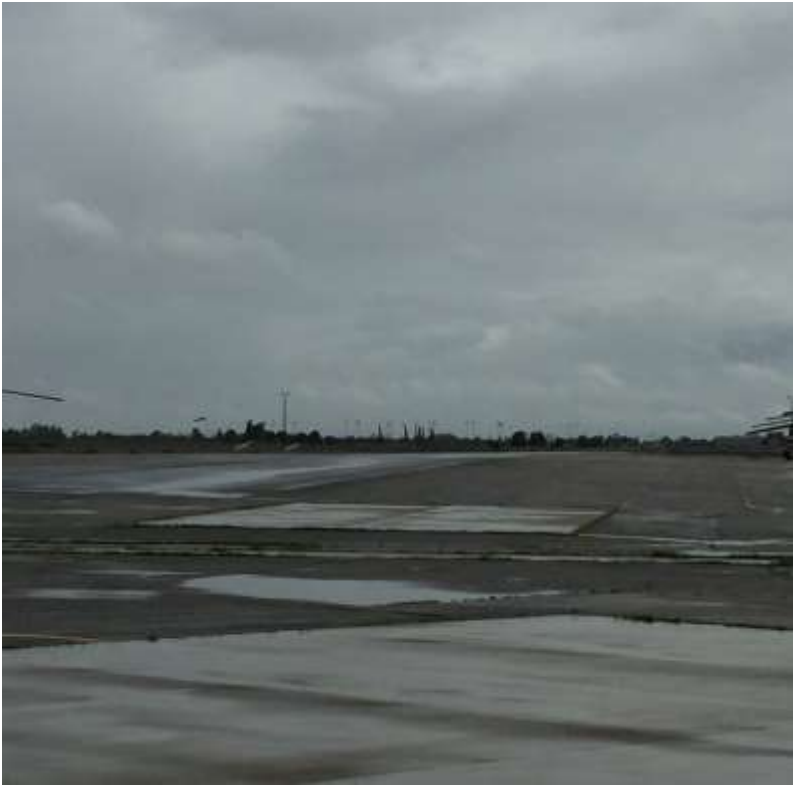
| Appendix C - Photographic Log | | |
|---|--|---|
| Photograph No. 5 Date 3/6/2019 Time 9:51 Description: Fire training area shown on the airfield Orientation: Northeast | | |

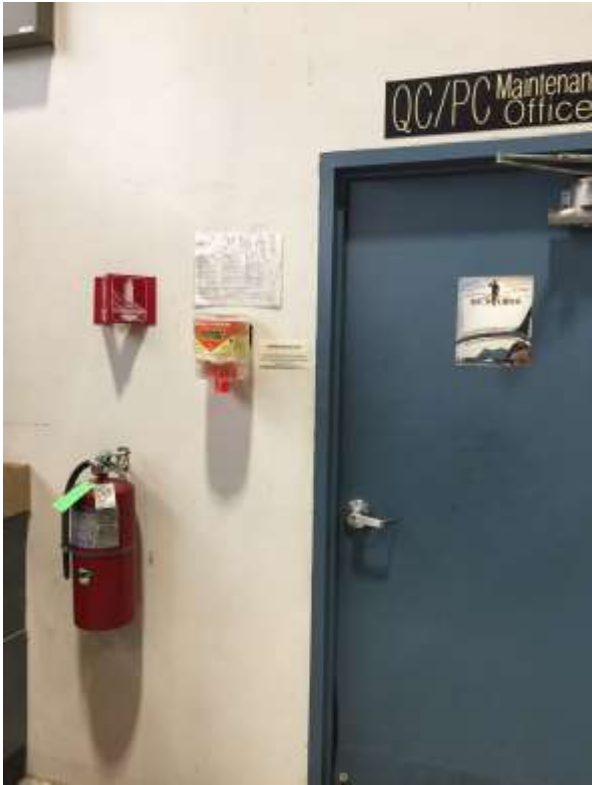
The hangar was toured during the VSI and was not found to have any storage of AFFF or contain a fire suppression system. The building is equipped with dry chemical (non-AFFF) fire extinguishers. According to interviews with AASF personnel, whose knowledge covers the period of 1992 to present day, AFFF has not been stored or used historically at the hangar.

| Appendix C - Photographic Log | | |
|---|--|---|
| Photograph No. 6 Date 3/6/2019 Time 10:07 Description: A dry chemical (non-AFFF) fire extinguisher observed in the Maintenance Hangar Orientation: Southeast | | |
