Preliminary Assessment Report

Stockton AASF, California

Perfluorooctane-Sulfonic Acid (PFOS) and Perfluorooctanoic Acid (PFOA) Impacted Sites
ARNG Installations, Nationwide

January 2020

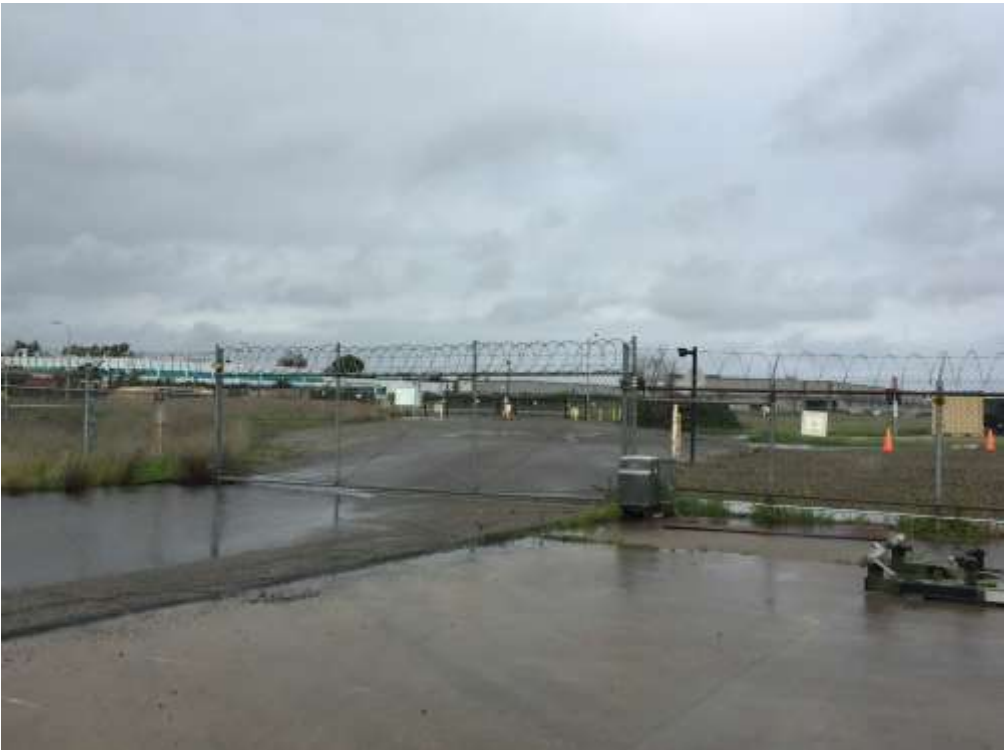
Photograph No. 1

During the PA site visit, potentially distressed vegetation was observed in the grassy area adjacent to the paved parking lot. Some minor flooding was also observed leading into the area from the south. The paved parking lot is in a restricted, fenced area with an access gate located on the northwest side.

Date 3/6/2019 Time 9:42	
Description: Fire training area shown just past the fence and west of the Butler Building; some flooding and vegetative stress is observed	
Orientation: Northwest

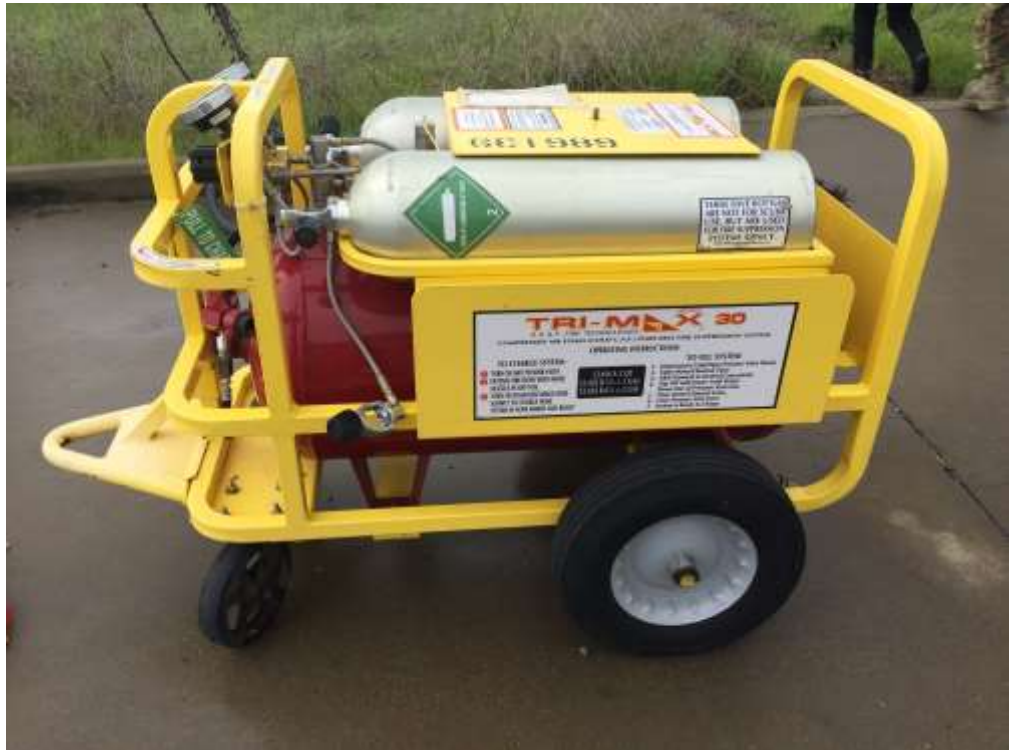
Photograph No. 4

A hazardous materials (HAZMAT) locker is located on the southwest corner of the wash rack. During the PA site visit, eighteen 5-gallon 6% AFFF canisters of the brand FireAde Mil-Spec were observed in the HAZMAT locker. Refilling of the Tri-Max™ extinguishers also occurred in the wash rack area, but only minimal spills, if any, would have occurred during this operation. According to an interview with a Maintenance Officer, AASF personnel also used to wash out aircraft tanks at the wash rack with an unknown type and quantity of foam or soap. However, personnel stopped using the foam or soap approximately five to six years ago at the request of the California Department of Forestry and Fire Protection (CAL FIRE) due to environmental reasons. One Tri-Max™ fire extinguisher was also observed stationed nearby the HAZMAT locker.

Description:
 Multiple 5-gallon buckets of 6% AFFF FireAde 2000 Mil Spec observed in the HAZMAT locker

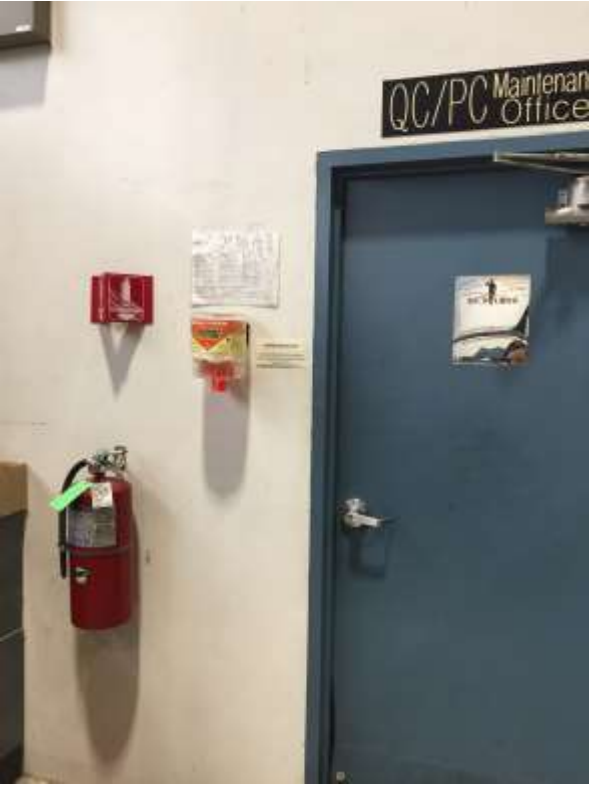
Photograph No. 6

The hangar was toured during the VSI and was not found to have any storage of AFFF or contain a fire suppression system. The building is equipped with dry chemical (non-AFFF) fire extinguishers. According to interviews with AASF personnel, whose knowledge covers the period of 1992 to present day, AFFF has not been stored or used historically at the hangar.

Date 3/6/2019	
Time 10:07	
Description: A dry chemical (non-AFFF) fire extinguisher observed in the Maintenance Hangar	
Orientation: Southeast
