Industrial Hygiene Report
For
Georgia National Guard
HHC 1st BN 121ST IN
95 Maynard St.
Winder, Georgia 30680

SUBJECT: HHC Company 1st BN 121ST IN and Downtown (Temporary) FMS Shop
National Guard Armory February 17, 2012.

- a) An Industrial Hygiene survey was conducted at HHC Company 1st BN 121ST IN National Guard Armory February 17, 2012. The purpose of this visit was to conduct a formal walk through while identifying hazards and making recommendations regarding those hazards. During the survey lead wipe test,

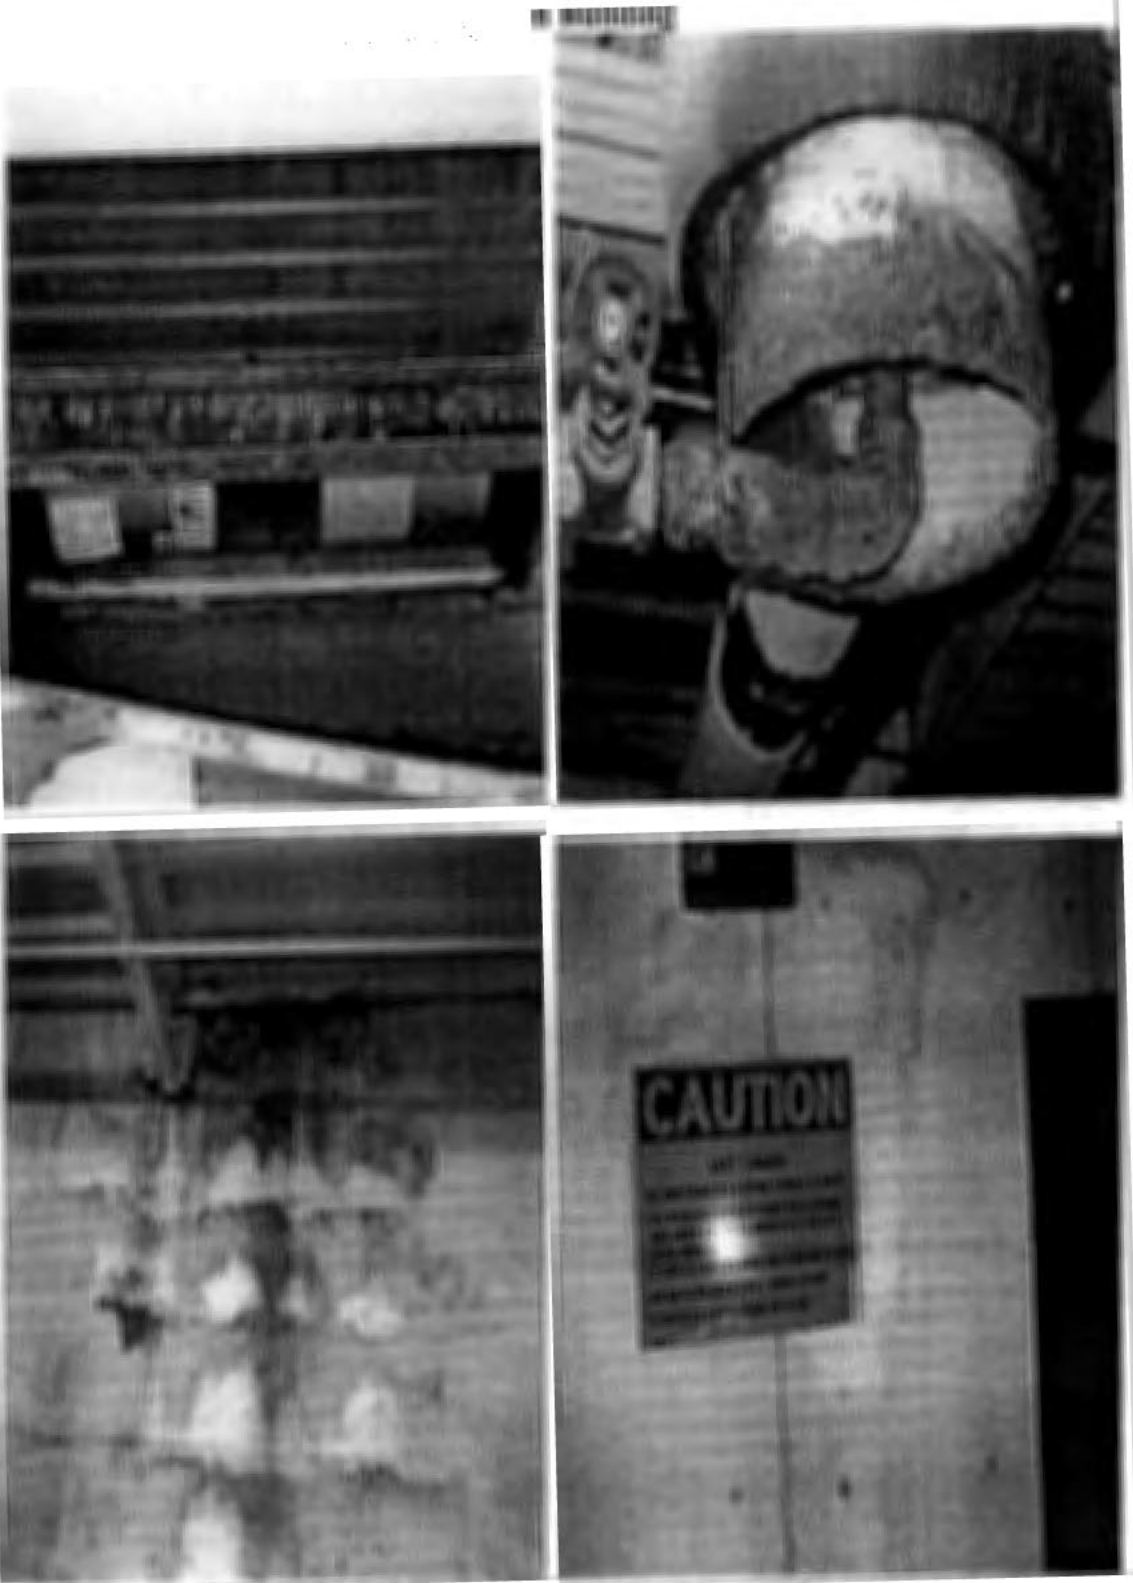
Mai 1988

- a) Efflorescence was seen in numerous amounts in the Indoor Firing Range in the basement. Efflorescence occurs when water soluble salt minerals seep from cement. Water moving through the material to carry the salts to the surface. The water evaporates and leaves the white powder behind.

- b) Due to the leaks in the building mold is apparent on the walls in the facility. Until the roof is repaired mold will continue to reappear on the walls. Also the holes in the roof are contributing to the damages to the ceiling tile.

- a) Repair all leaks in the roof and replace all ceiling tiles that have obvious watermarks. Replace all missing ceiling tiles.
- b) Place a sign on the outside of the Indoor Firing Range door indicating the presence of lead. Do not take anything out or into the range. All items inside must be either cleaned of lead or disposed according NG PAM 420-15, before removal.**
- c) Mold in the air conditioning units and on the walls should be removed IAW TG 277 & TG 278.**
- d) Replace all pipeline insulation that has water damage and those exposing pipe.
- e) Storage Rooms that do not have ventilation are being used to house various soldier activities. Find other rooms for these soldiers to work in.
- f) Replace all burned out and missing light fixtures and covers.
- g) Make duplicate MSDS binders and place in areas hazardous chemicals are stored.

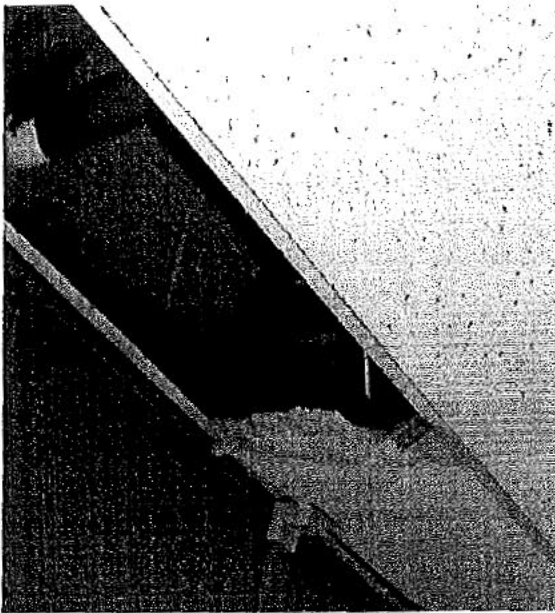
- c) Sewage backed up into the latrines. While surveying the area workers were diligently trying to fix the issue.
- d) Mold was found on the air conditioning units that were checked. Soldiers stated mold is growing in all air conditioning units.

- f) The boiler room has rusty pipes, due to the high humidity in the room. The pipeline insulation throughout the facility has obvious water damage.
- g) Soldiers stated the water fountain leaked when plugged in because of this it is not currently in use.
- h) Light fixtures should be fixed and bulbs replaced to illuminate the facility better. Continue with the plan to fix lights in the drill hall when scissor lift arrives.
- i) Material Safety Data Sheets (MSDS) were in binders with chemical inventory list. MSDS should be located near hazardous material.

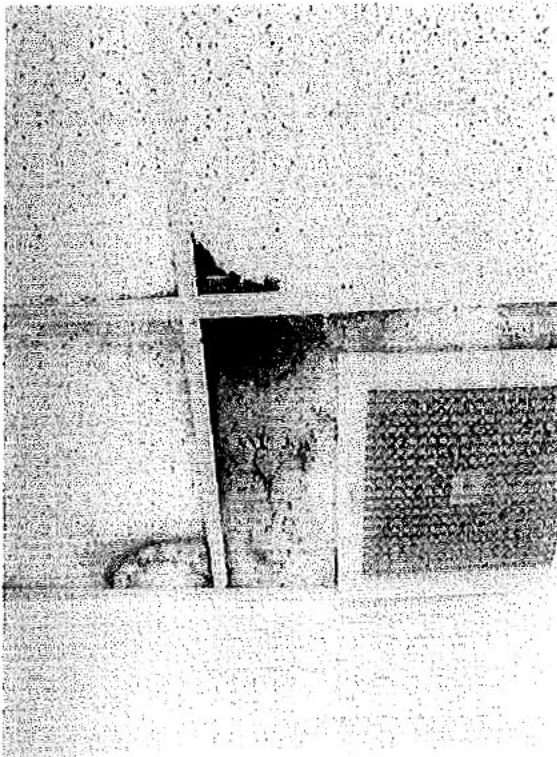
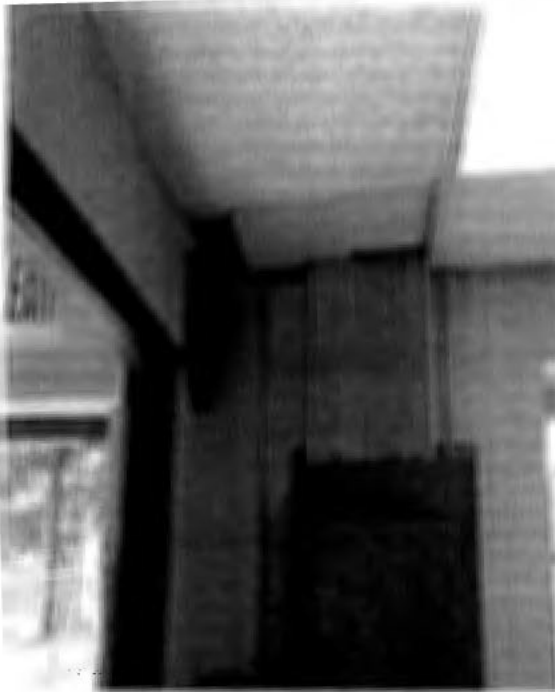
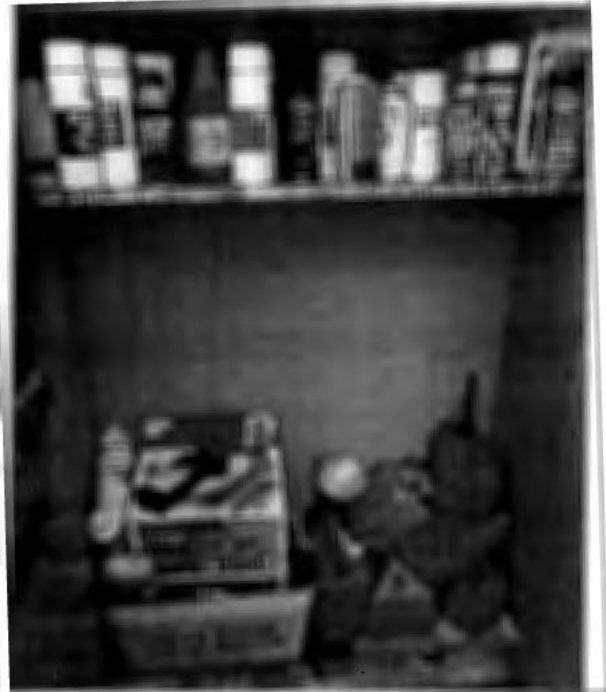
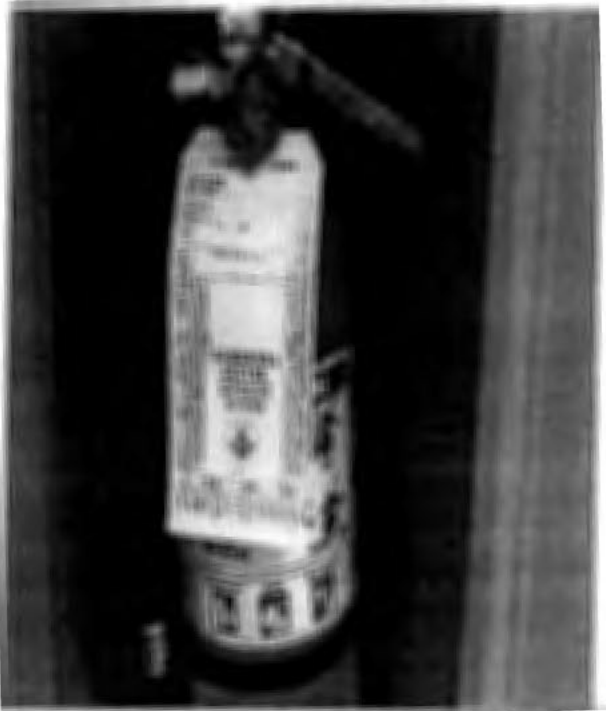
FMS Building

- a) Mold was found in the latrine.
- b) Mold growing on the walls because of water damage.
- c) Ceiling tiles has apparent water damage.
- d) Water was not readily available throughout the FMS facility other than the latrine.
- e) Exhaust fan need to be clean.
- f) Exposed pipes were found in the facility.
- g) Eyewash stations need to be replaced. Shower station was not present.
- h) One fire extinguisher was present but had not been checked since 2008.
- i) Flammable cabinets were not organize and did not have appropriate labeling to inform other what it is housing.
- j) Safety signs were seen posted on the wall in the facility.

- a) Remove mold in building IAW TG 277 & TG 278.
- b) Repair leaks in the roof and then replace all water stained ceiling tiles.
- c) Clean all exhaust fans in building.
- d) Insulate all exposed pipes in building.
- e) Eyewash station should be replaced with a more efficient station. Also a shower station should be present in the facility.
- f) There should be multiple fire extinguishers in the facility and they should be inspected regularly.
- g) Flammable cabinets should be organized and signs and labels should be posted.
