1. PURPOSE OF EVALUATION. To conduct surveys at Maryland Army National Guard (MDARNG) facilities to identify and measure the existence and extent of potentially hazardous operations or conditions.

2. PURPOSE. To conduct an industrial hygiene survey at the Maryland Army National Guard (MDARNG) MG Harry C. Ruhl Armory, Towson, MD, to identify and measure the existence and extent of potentially hazardous operations or conditions. This survey will serve as a baseline so that an occupational exposure history can be compiled for each civilian or military employee.

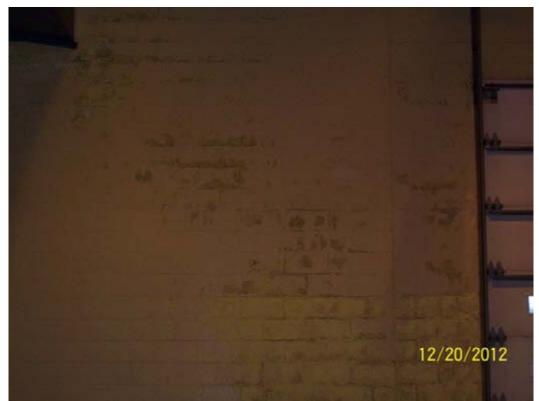
Drill Hall South Wall Water Damage

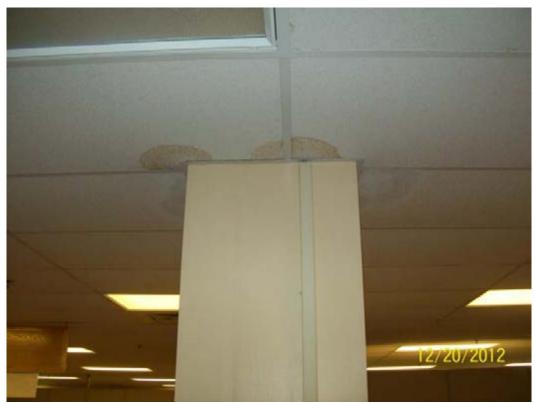
Command Section Water Damage

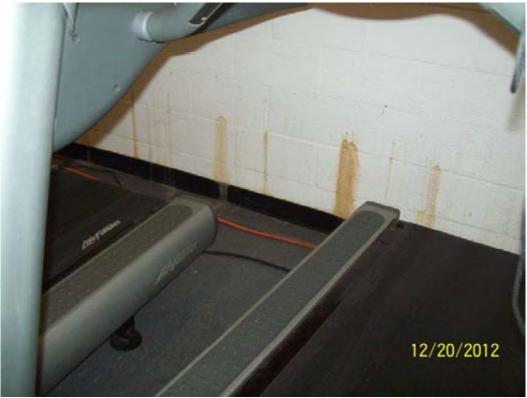
Exercise Water Damage

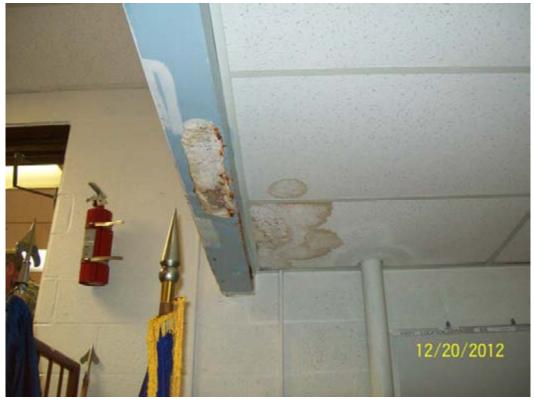
HHC Water Damage

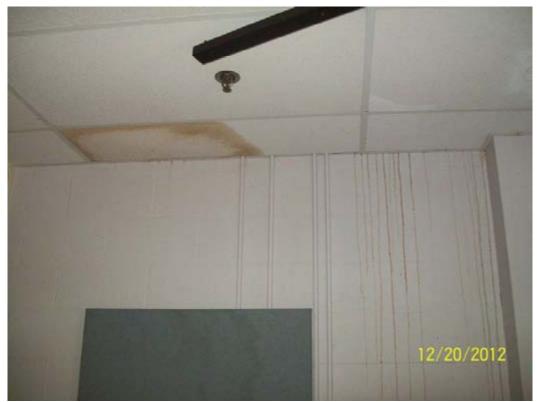
Legal Office Water Damage

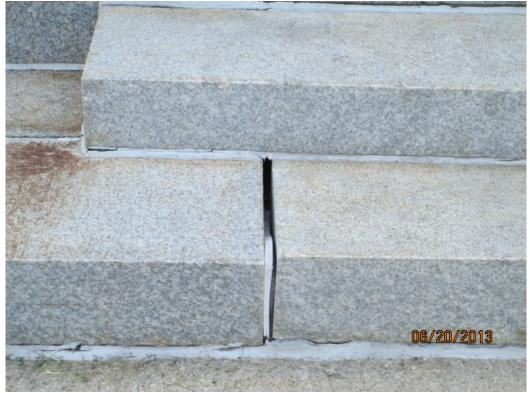
Damaged Caulking on Front Steps

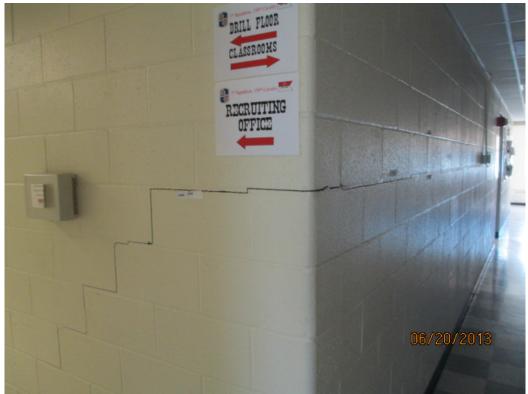
Structural Damage to Walls of New Addition

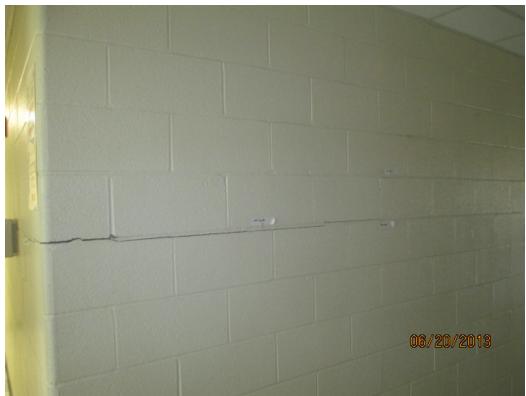
More Structural Damage to Walls of New Addition

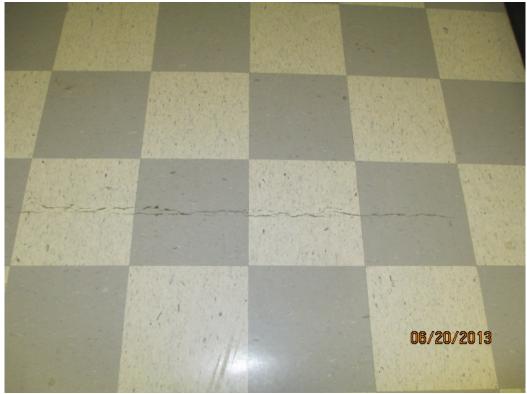
Structural Damage to New Addition Floor

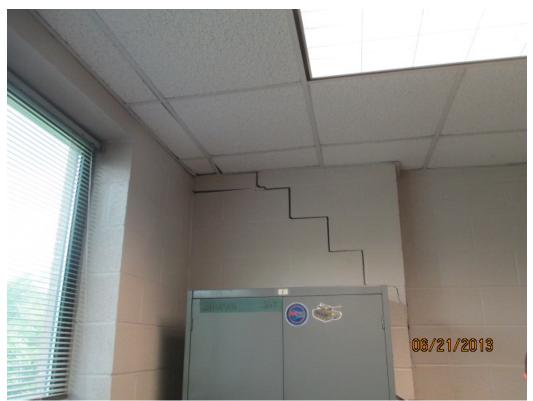
Structural Wall Damage in Office 111

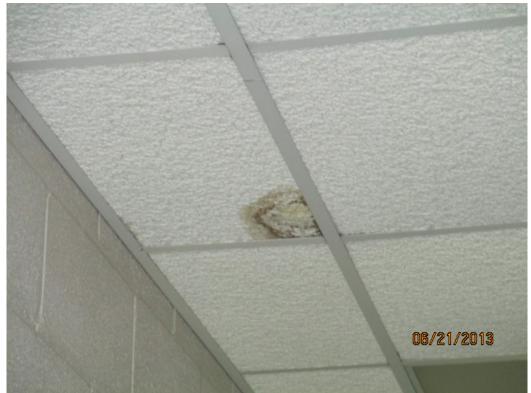
Water Stained Ceiling Tile

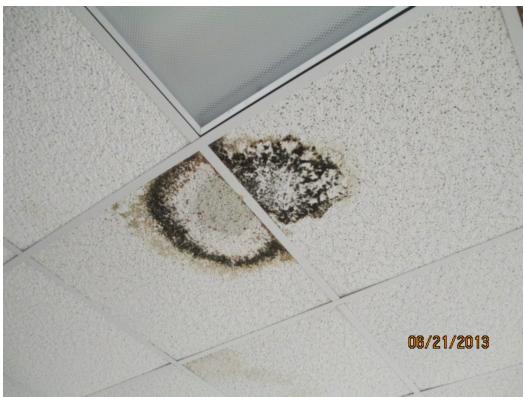
Ceiling Tile Visible Fungal Growth

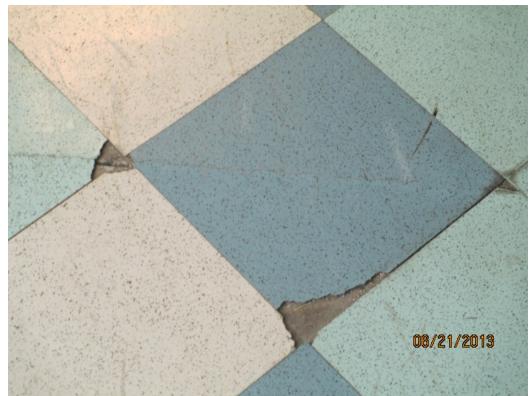
Damaged Floor Tiles in Corridor

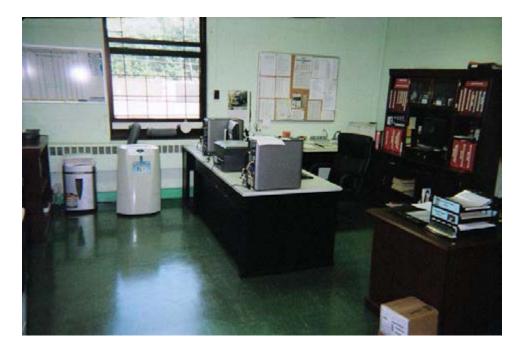
Basement, FMS Unit Office, nine inch square floor tile maintained in good condition.

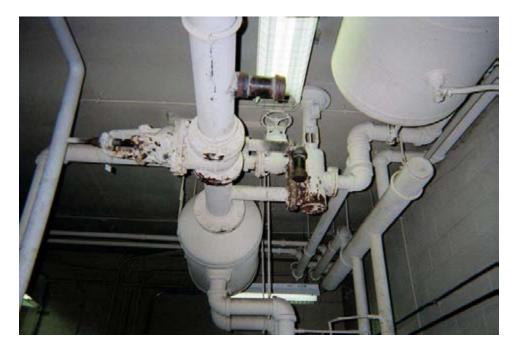
Basement, Boiler Room, delaminating paint from valves
