July 13, 2010 Project No. 1061-03

Project: Army National Guard Readiness Center, Industrial Hygiene Evaluation

Glen Burnie Army National Guard Armory

1.0 - EXECUTIVE SUMMARY

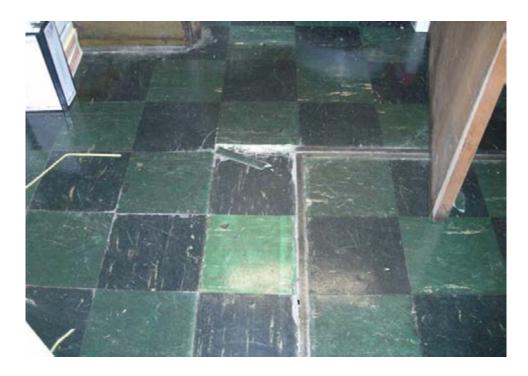
Photograph #5 – Damaged 9" x 9" Floor Tiles

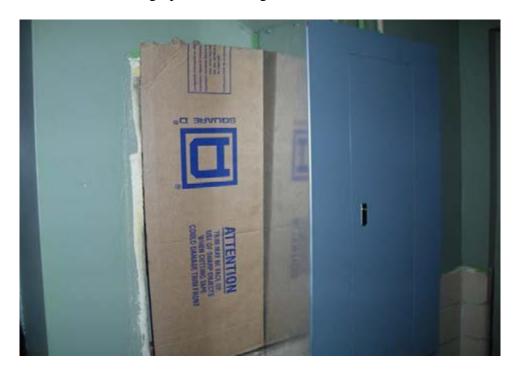
Photograph #6 – Cardboard Guarding Exposed Wiring

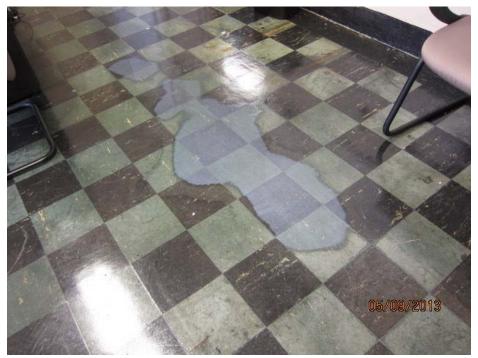
Standing water on the 9"X9" brown and white floor tile from an active roof leak.

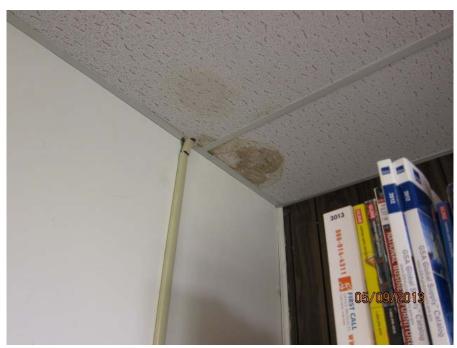
Water stained ceiling tile

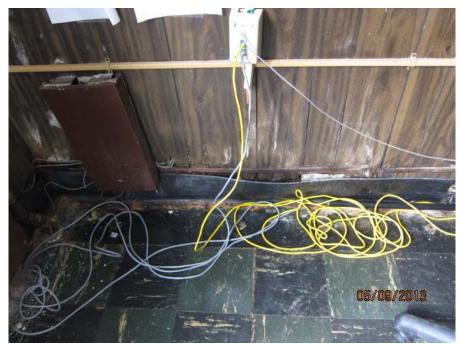
Water damaged paneling from roof leak in the supply NCO office

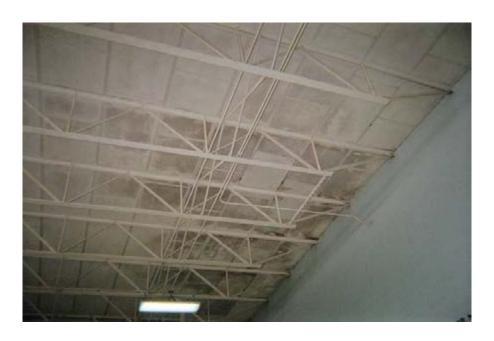
Photograph #2 – Drill Hall, Tectum Ceiling Material, apparent water staining

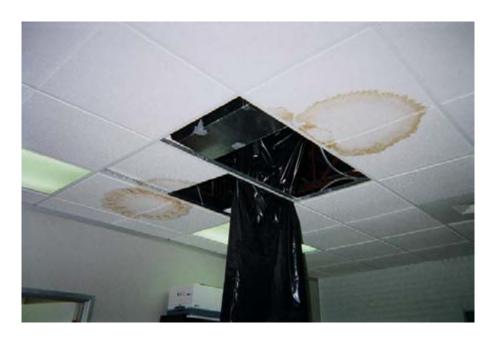
Photograph #11 – Administrative Area outside NCO Office, continuing water leak

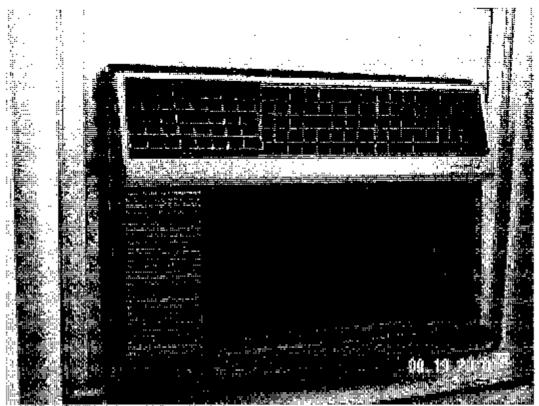
Photo II: Boem 107: window AC, missing theat (edec and high humidity in resm)

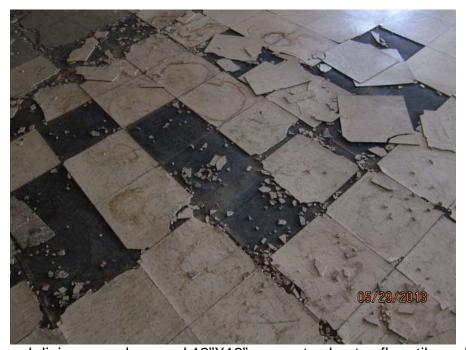
Kitchen and dining area damaged 12"X12" suspect asbestos floor tile and mastic

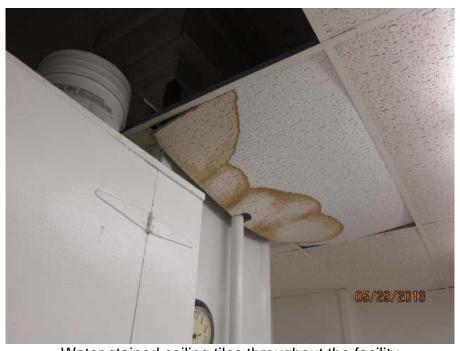
Water stained ceiling tiles throughout the facility

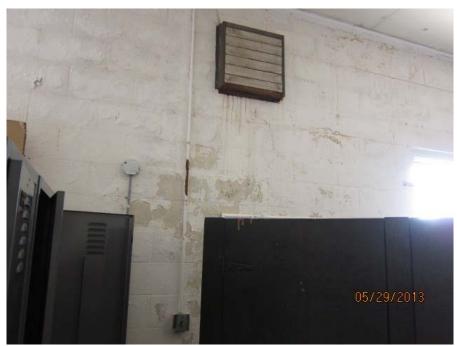
Effloresce on exterior wall in commo room

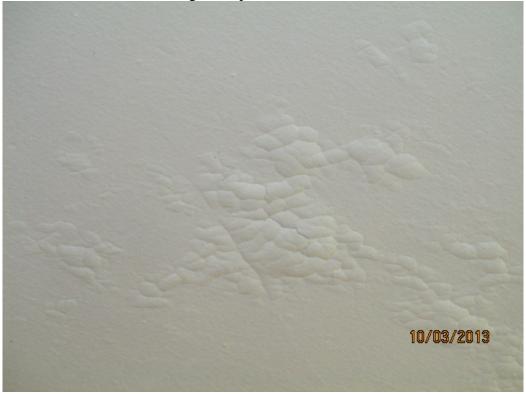
Lobby Water Damaged Ceiling

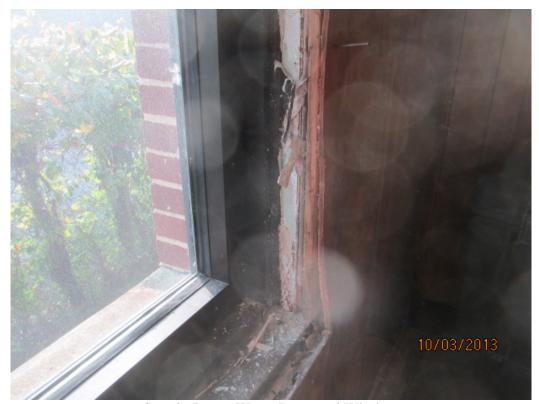
Supply Room Water Damaged Window

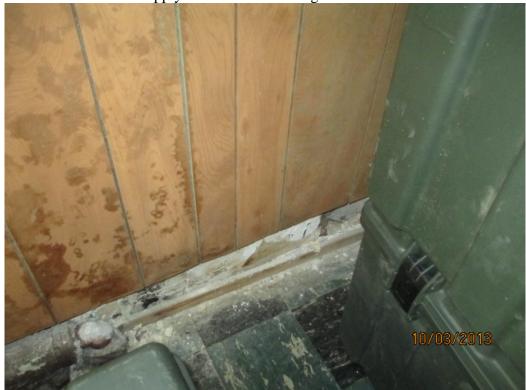
Supply Room Water Damaged Wall

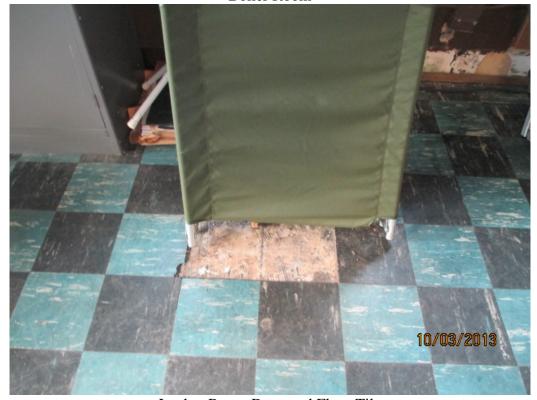
Locker Room Damaged Floor Tile

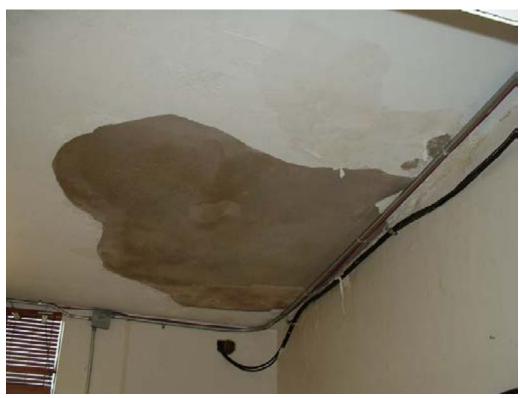
Plaster damage to ceiling. Room 208D

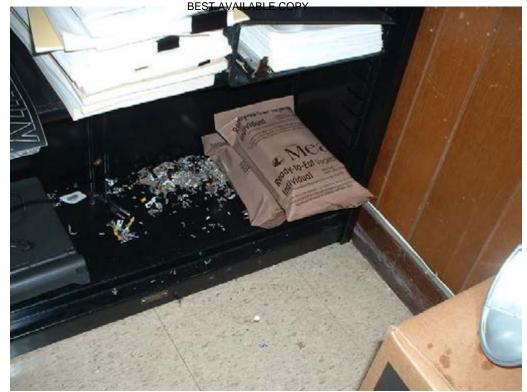
Evidence of rodent infestation: Room 206

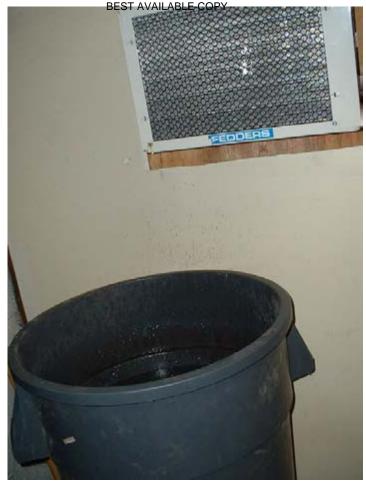
Air conditioning condensate draining into garbage can: Room 124

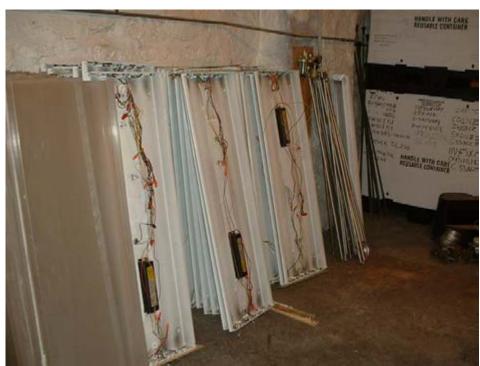
Possible PCB-containing ballasts maintained in Room 124

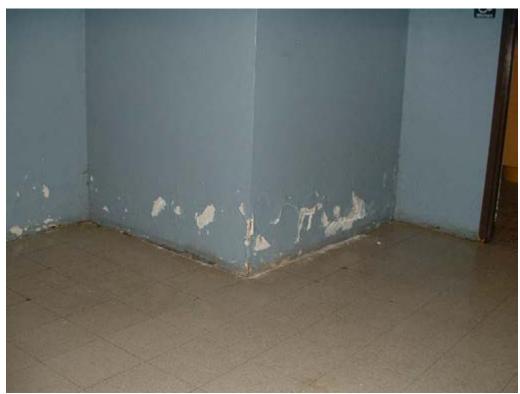
Water damaged plaster in Room 107

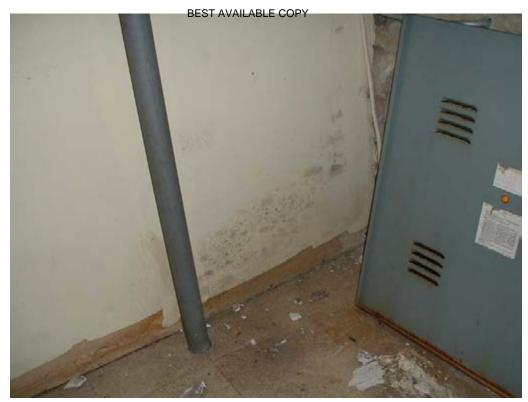
Microbial growth located in Room 201
